Inspection Photos

Loc: 322220

Operator: **JAVERNICK OIL**

Inspection Date: 5/20/2024

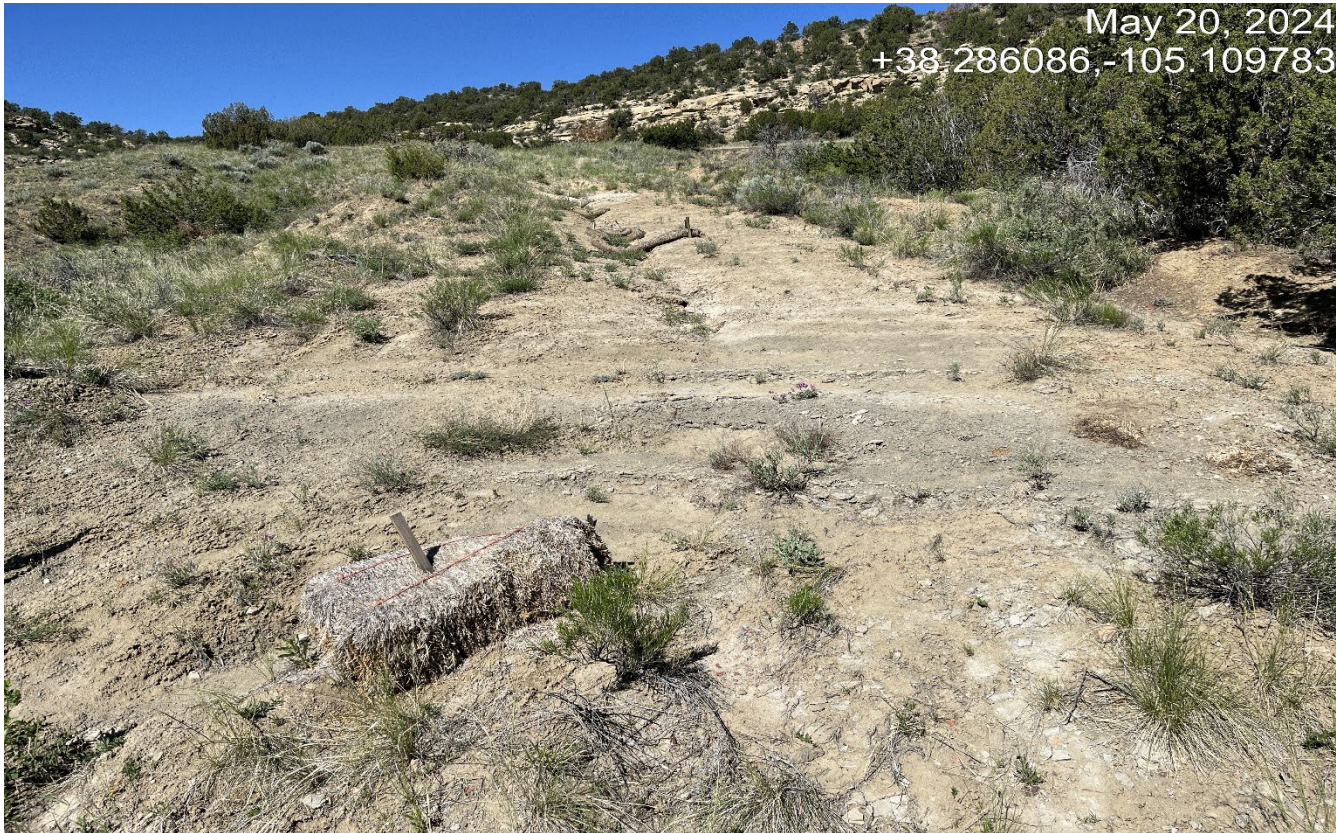
Photo 1. Facing southwest toward the former access road. This area is not stabilized with vegetation and there is erosion has occurred. It appears topsoil has been scoured off this area of the former road. Previous corrective action was not completed.

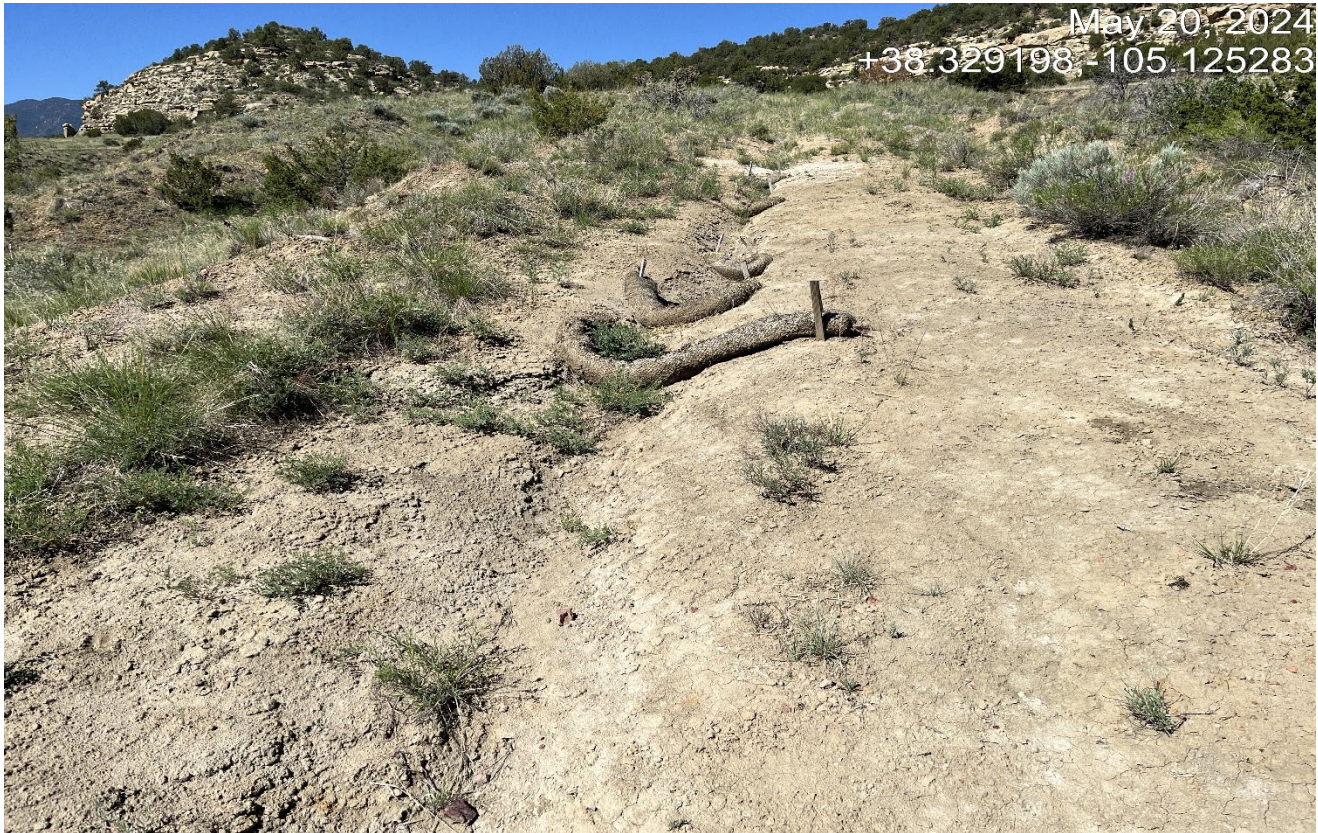
Photo 2. Facing southwest toward the former access road. There were temporary erosion controls installed which have washed out. This area of the access road needs to be reclaimed and stabilized for long term stabilization.

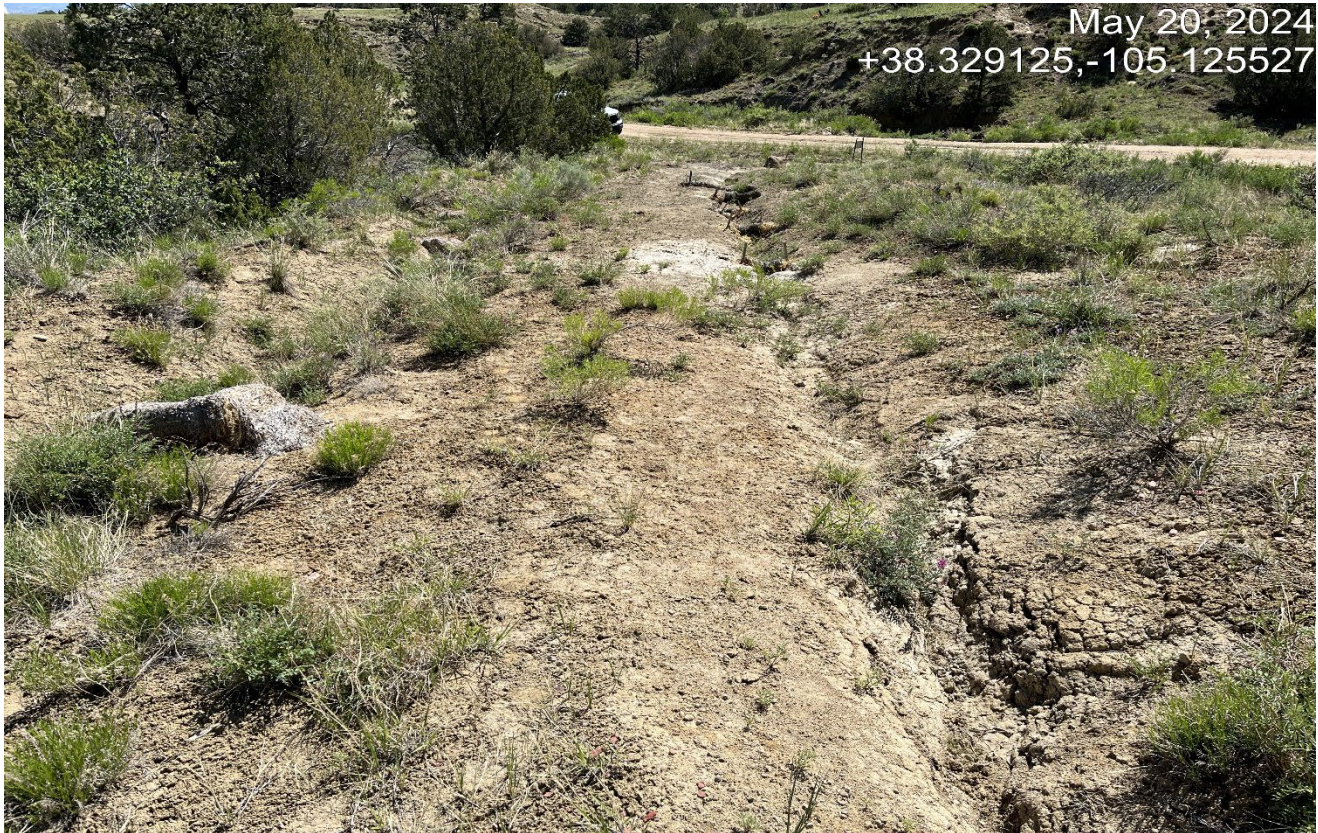
Photo 3. Facing back down the access road. There is stormwater erosion occurring on both side of the former road. Straw bales were placed on the left side and not staked in. The bales are degrading and are insufficient. This area needs to be reclaimed and stabilized for long term stabilization.

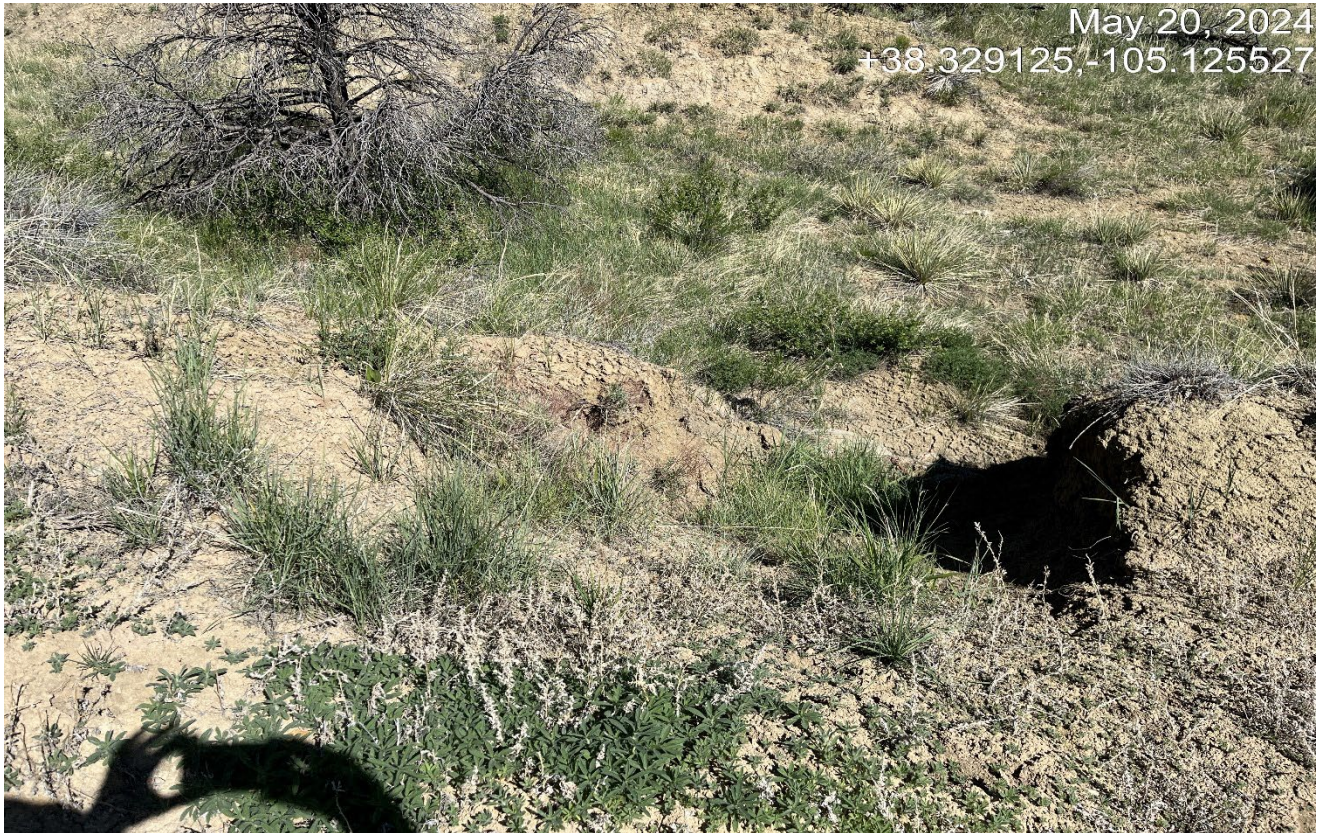
Photo 4. Further up along the access road facing northeast. There is an erosion channel directed down to the left side off the road.

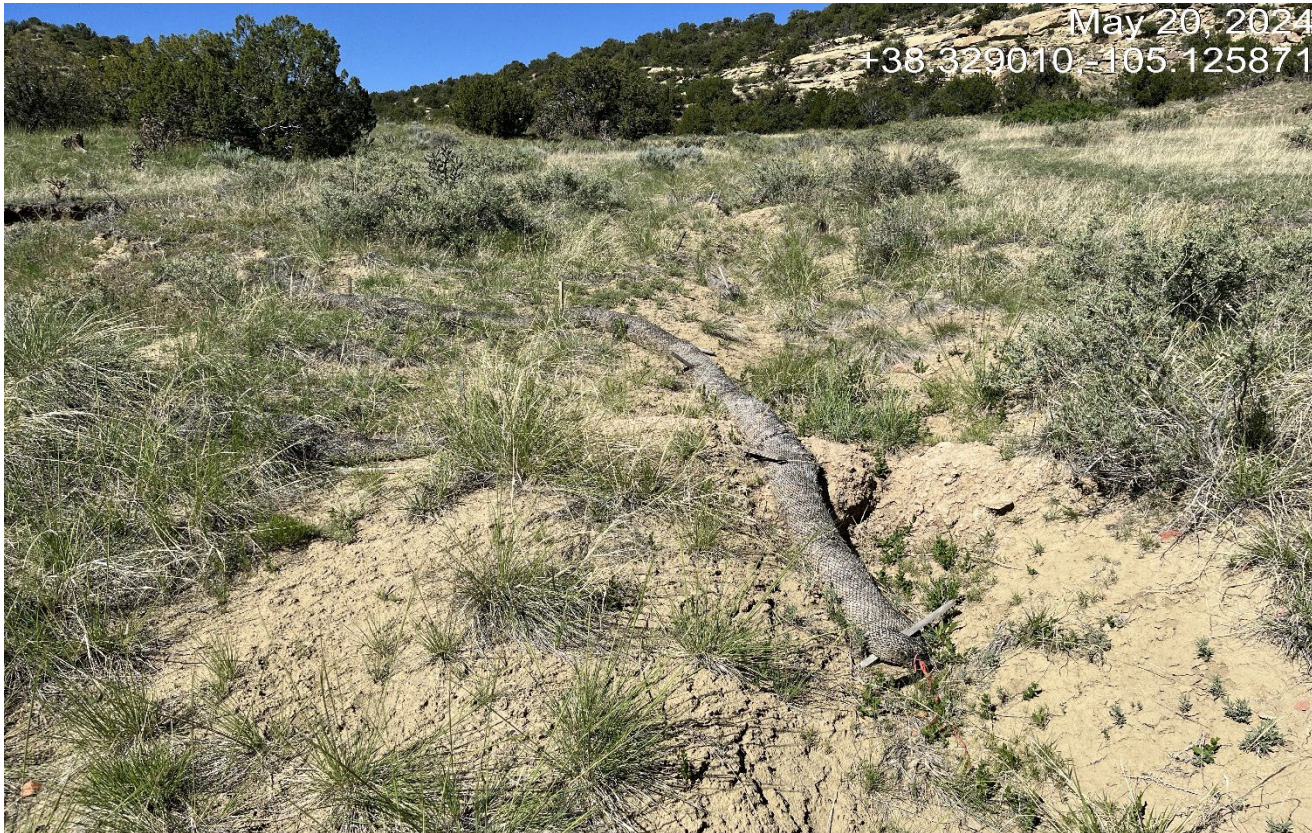
Photo 5. Facing southwest along the former access road. It appears that the stormwater from the location is directed down the road which is causing erosion issues shown in previous photos. Wattles that were installed have been washed out.

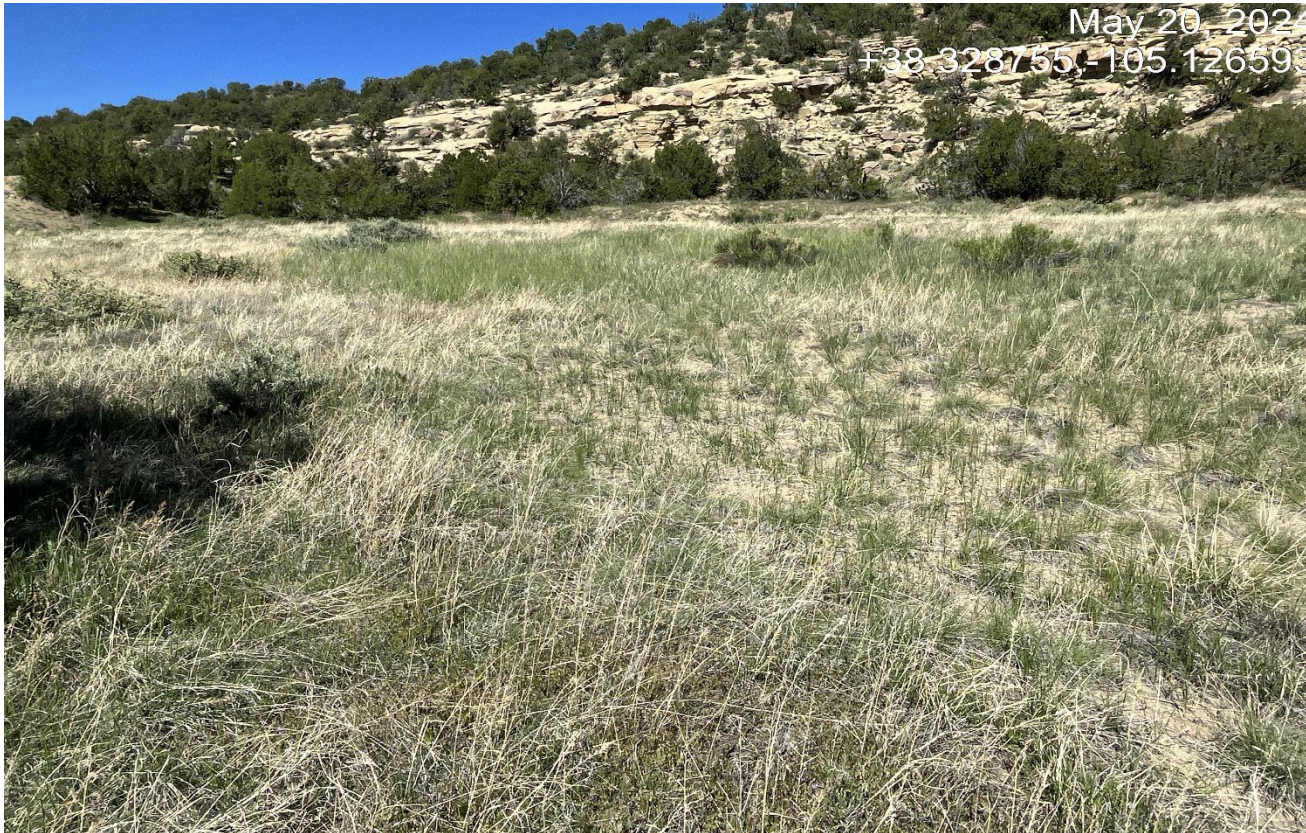
Photo 6. Facing west toward the location. Perennial native vegetation is progressing throughout the location.
