# Construction and Stormwater Inspection

Date: 05/21/2024

Operator: KERR MCGEE OIL & GAS ONSHORE LP -  
47120

Location ID: 485056

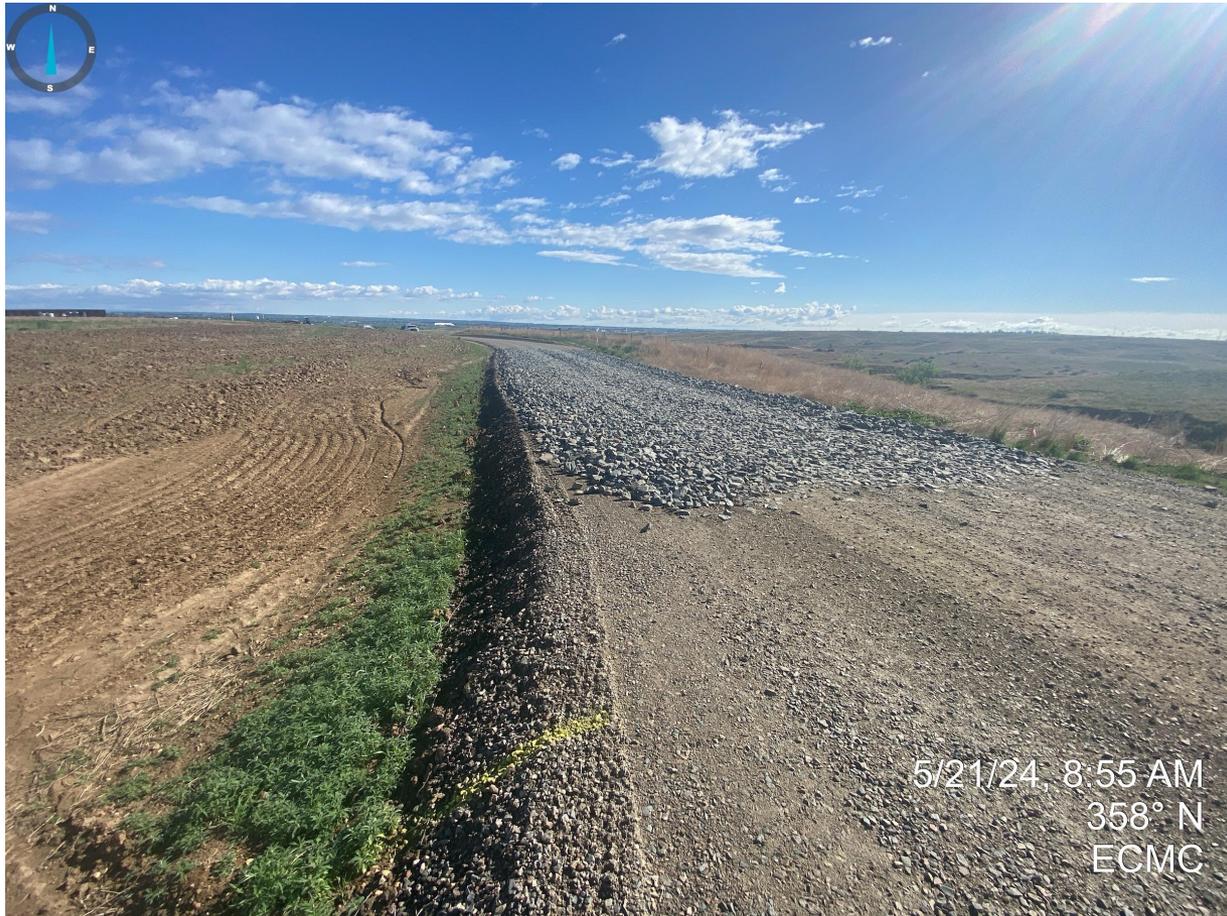
**Photo 1.** Track Out pad installed at the access road entrance.

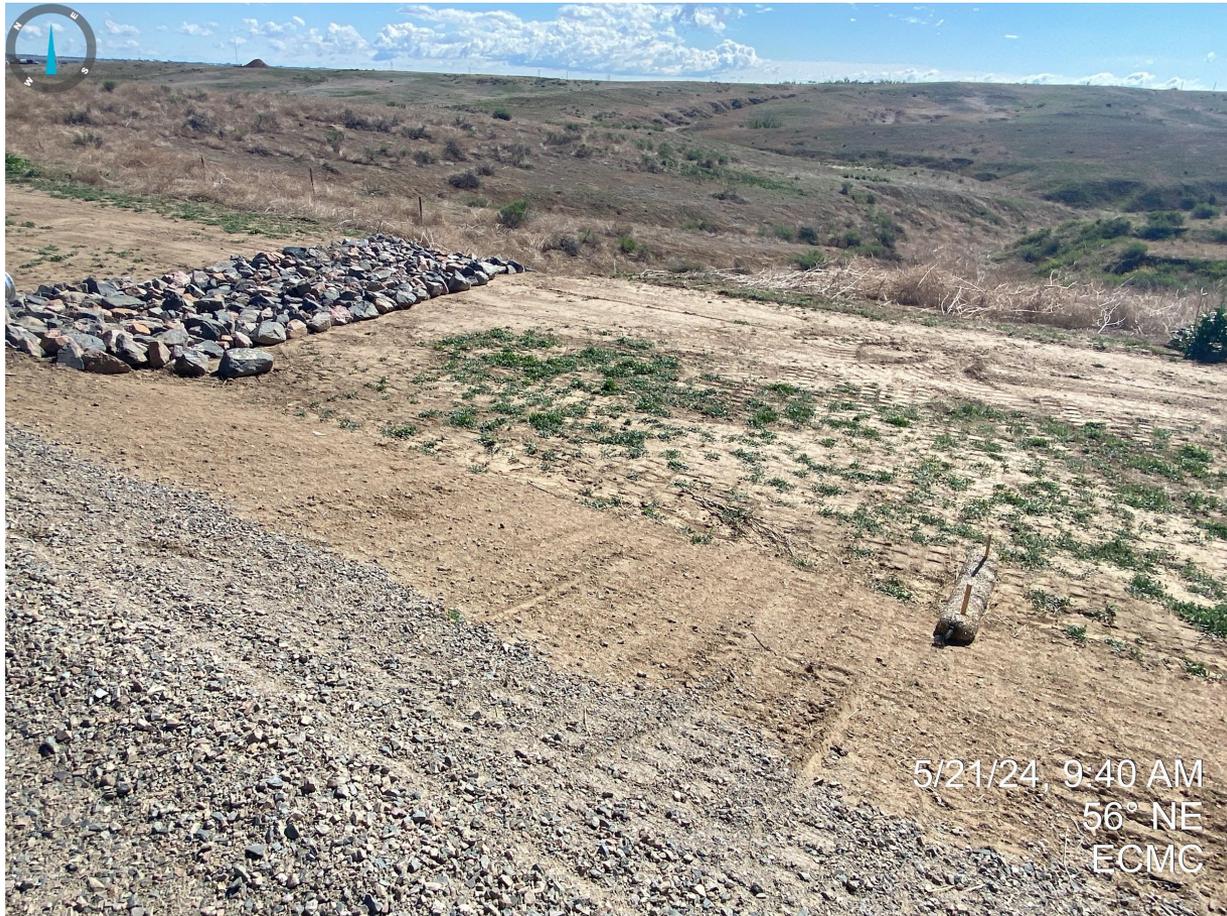
**Photo 2.** Erosion degradation previously documented appears to have been repaired and stormwater control measures/BMPs have been installed.

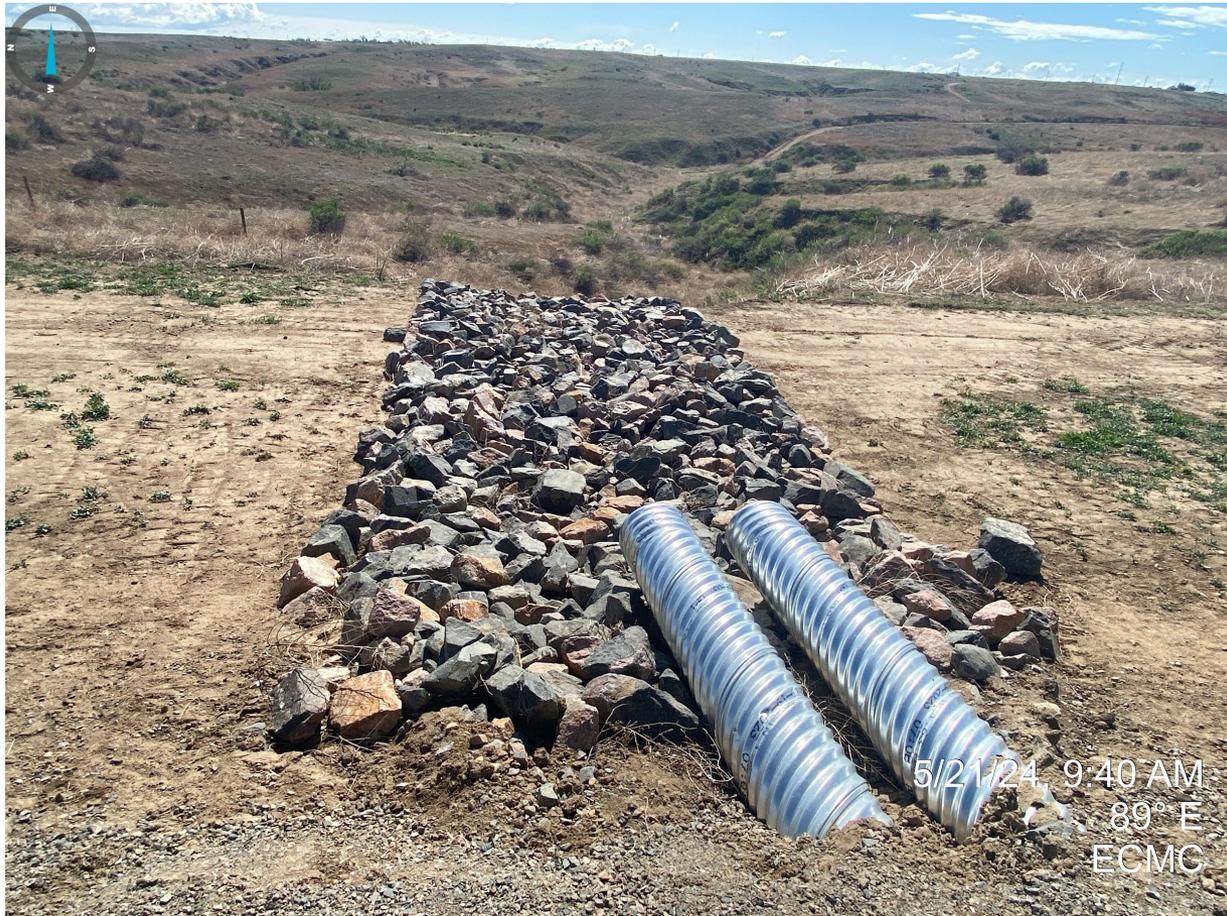
**Photo 3.** See comments in Photo 2.

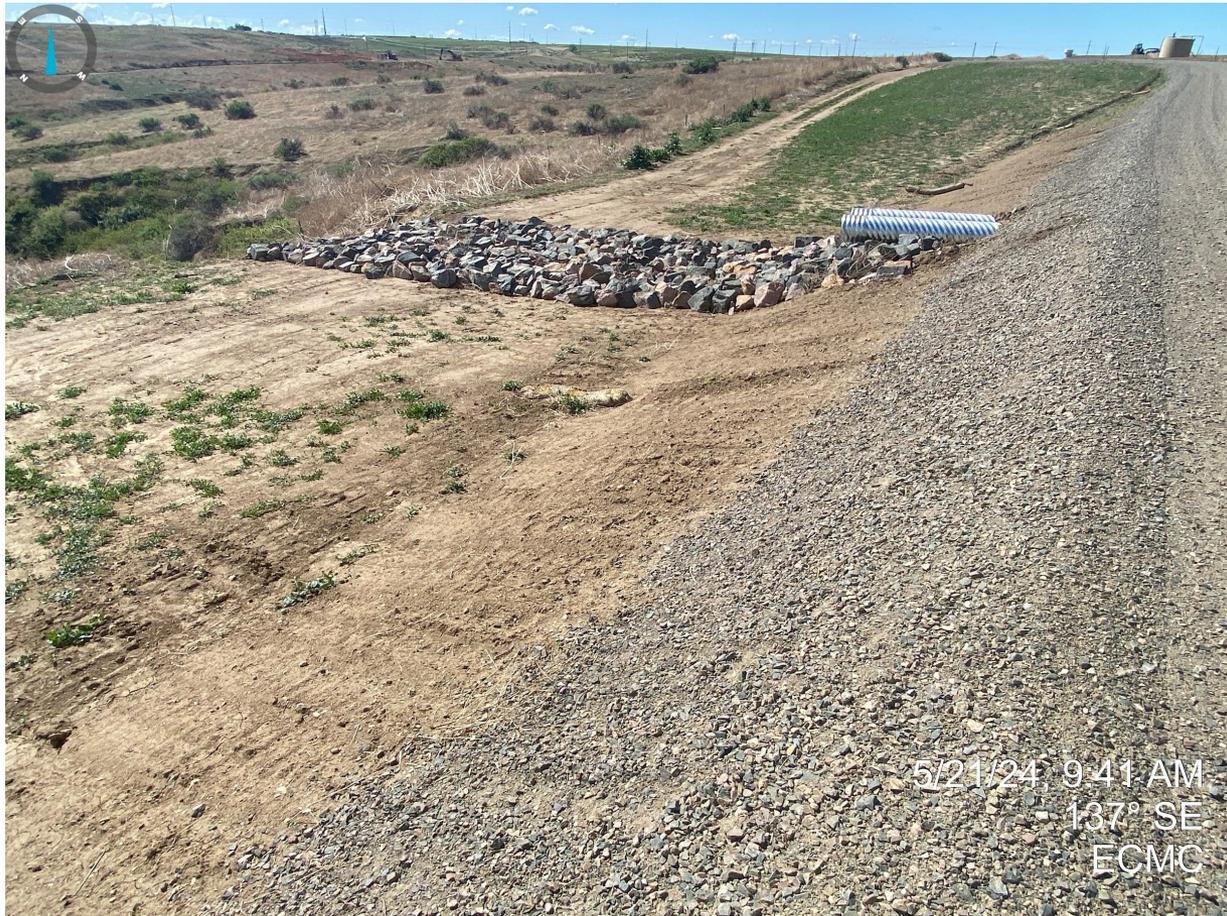
**Photo 4.** See comments in Photo 2.

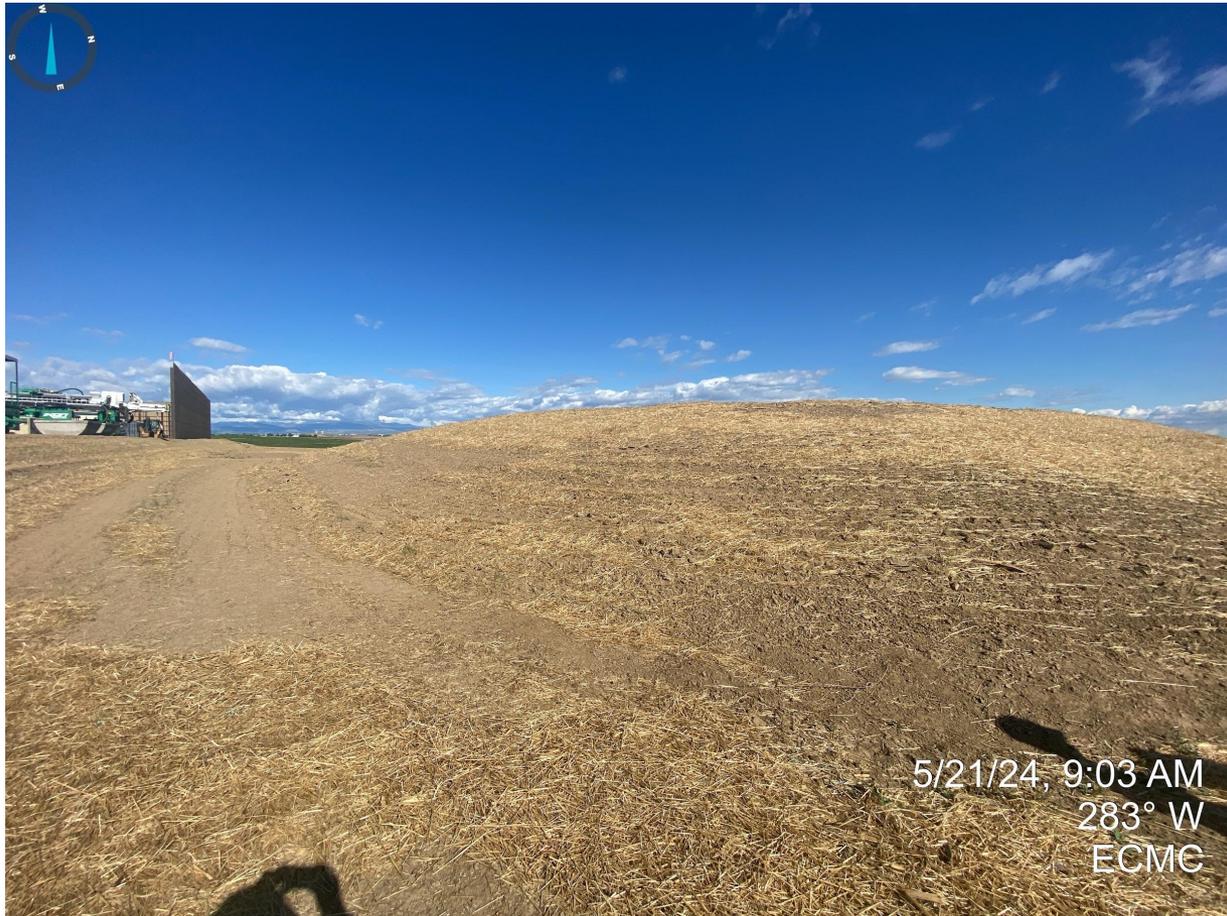
**Photo 5.** Taken from the southeast corner of the topsoil stockpile. Stockpile has been seeded and mulched for long term stabilization. Germination was observed throughout the stockpile at the time of this inspection.

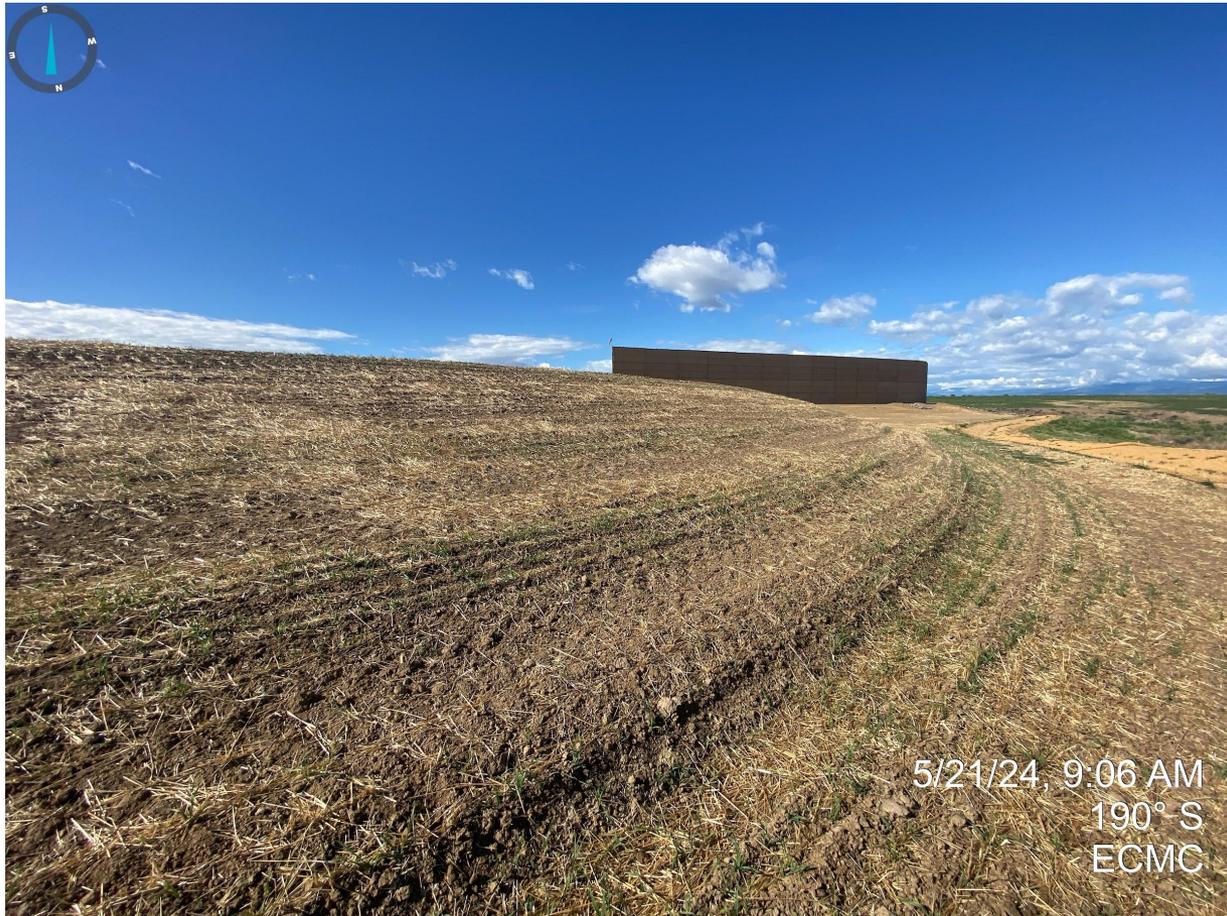
**Photo 6.** North side of topsoil stockpile, facing south; see comments in Photo 5.

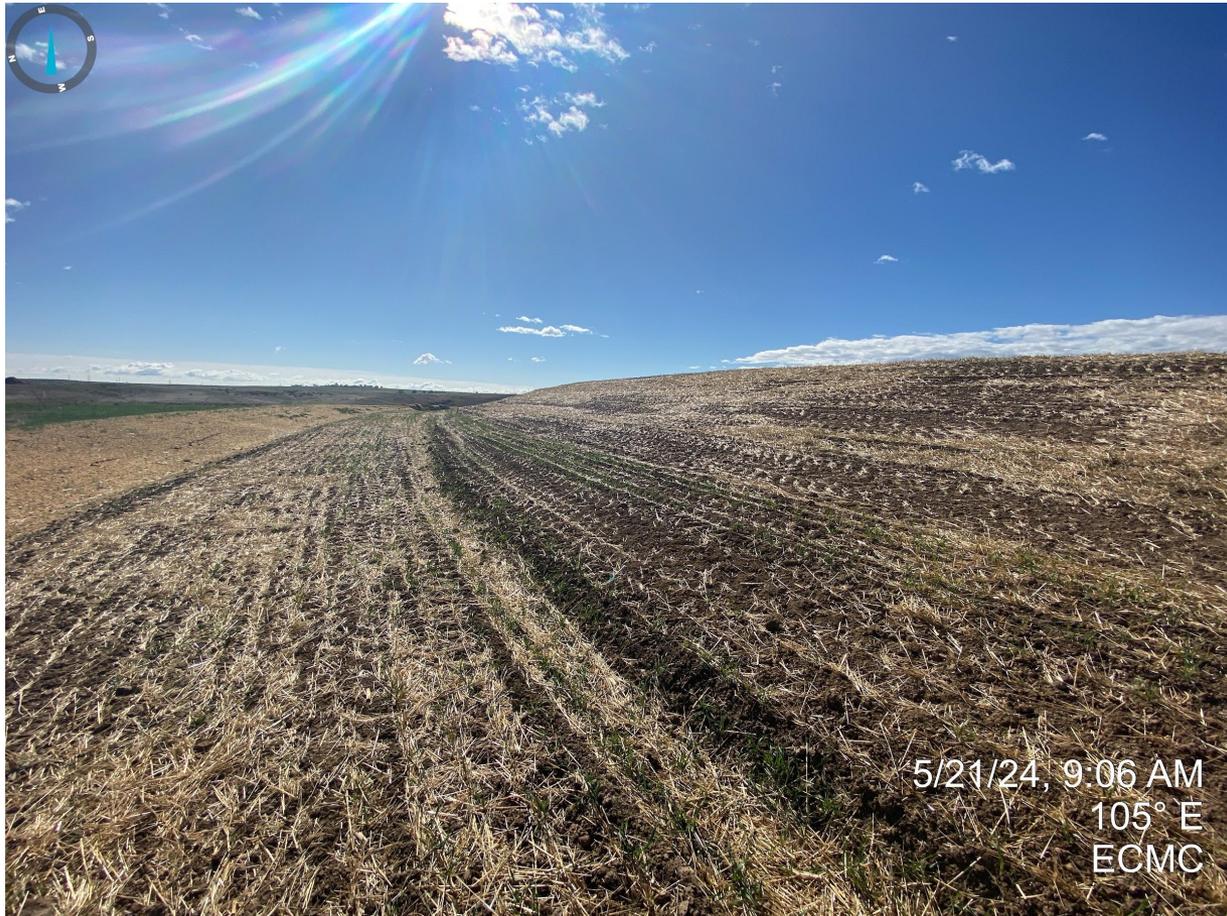
**Photo 7.** North side of topsoil stockpile, facing east; see comments in Photo 5.

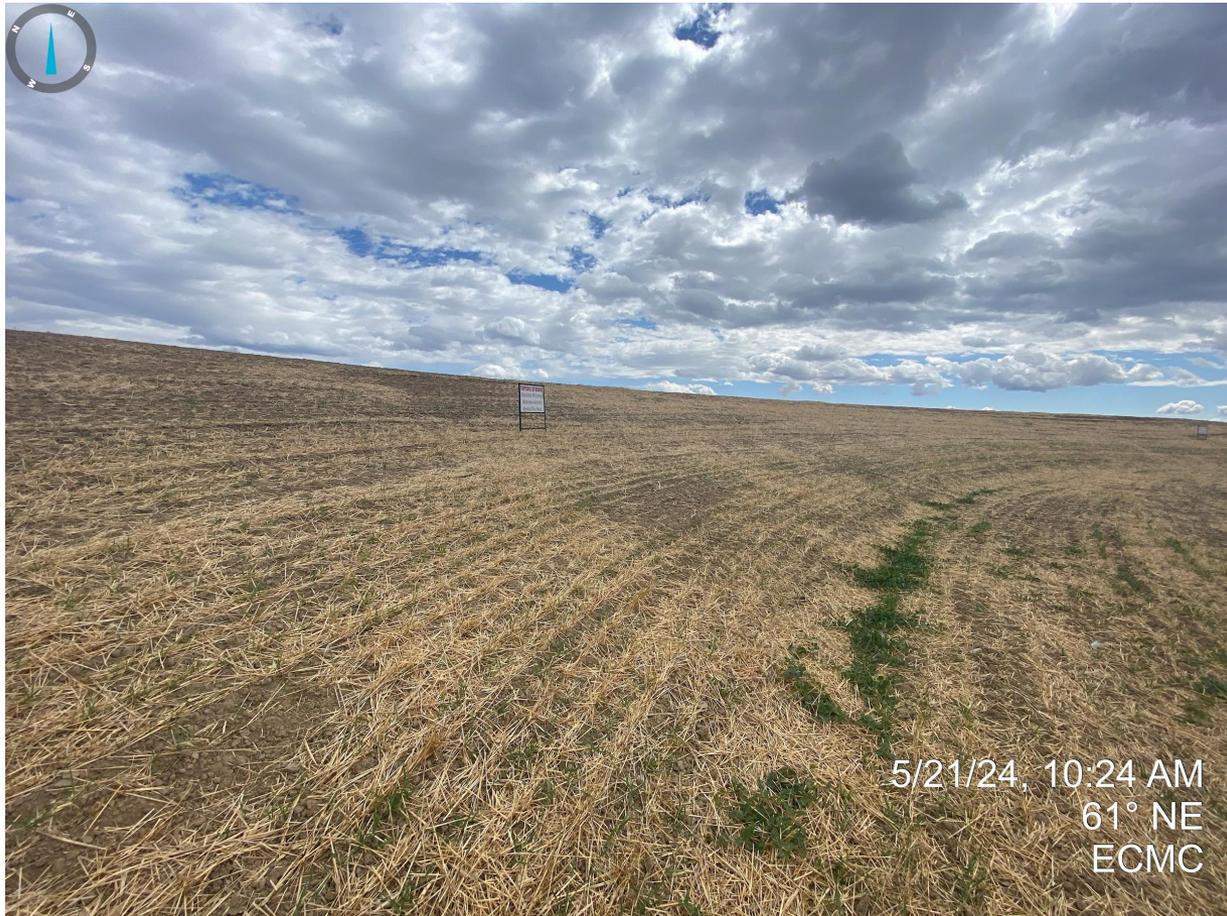
**Photo 8.** Southside of topsoil stockpile, facing northeast; see comments in Photo 5.

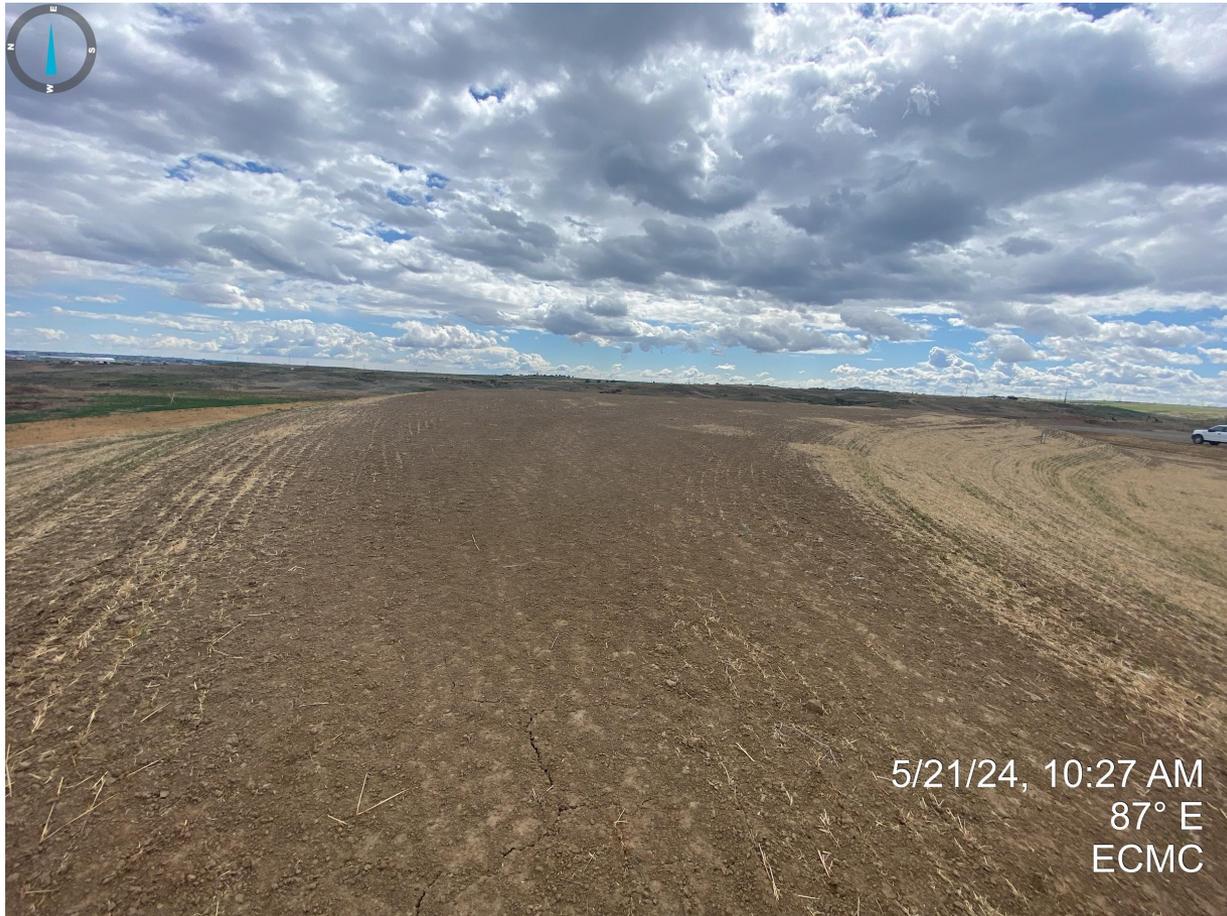
**Photo 9.** Taken from the top/upper portion of the topsoil stockpile. Photo illustrates that straw mulch appears to have blown off the top, though, germination was evident. Operator will need to monitor and manage the stockpile to ensure that it is properly protected against wind/water erosion and stabilized for long term until interim reclamation commences.

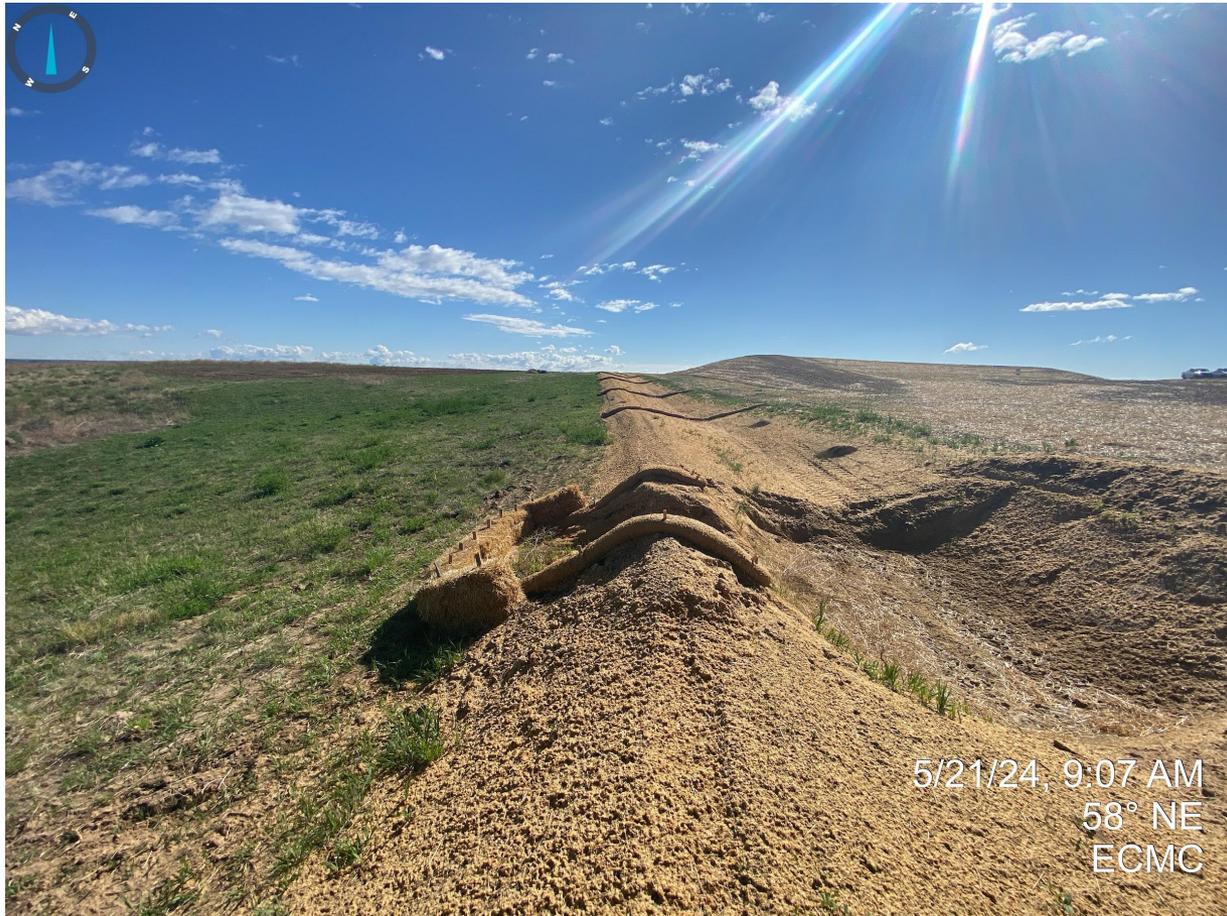
**Photo 10.** Taken from the north/northwest portion of the disturbance area. Perimeter ditch and berm soils appear to have been stabilized with hydromulch.

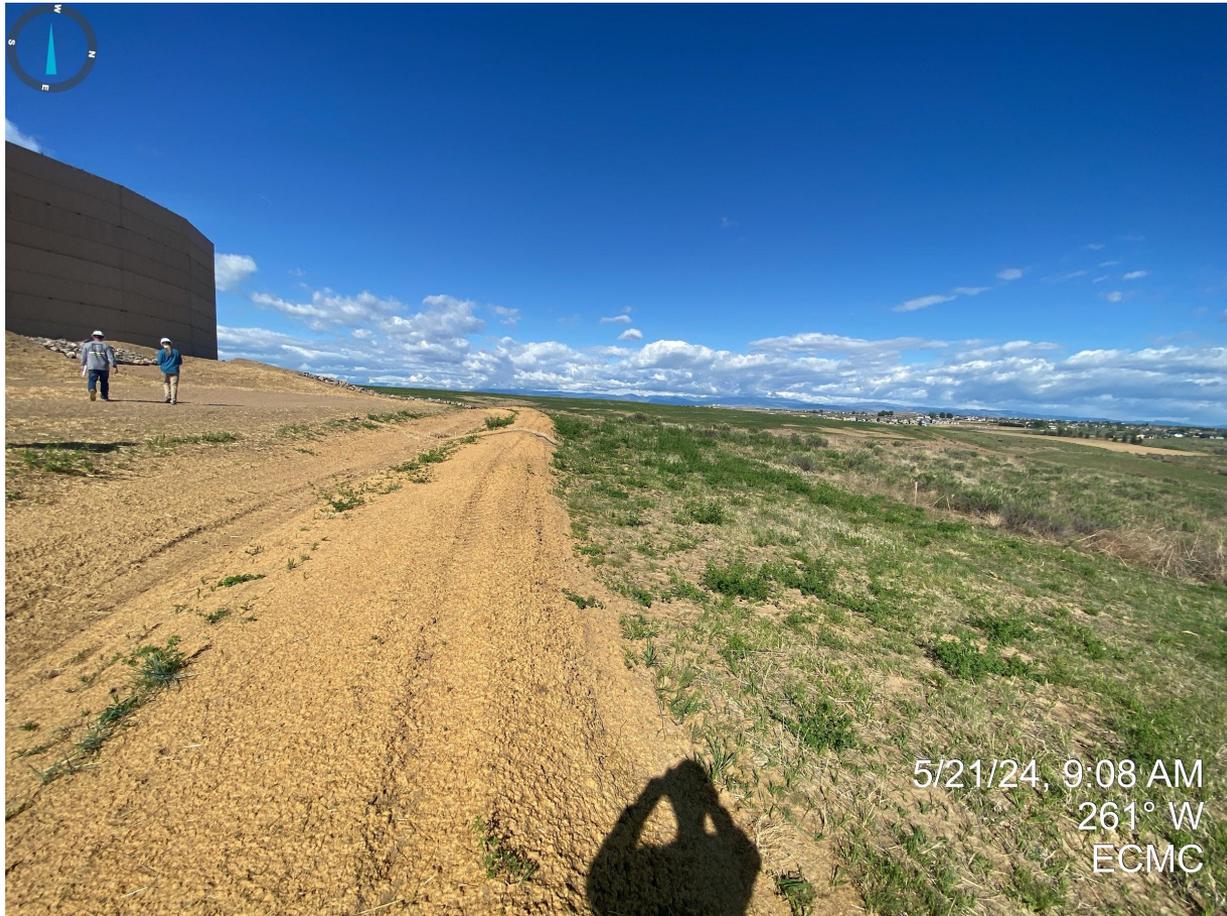
**Photo 11.** Taken from the north/northwest portion of the disturbance area; see comments in Photo 10.

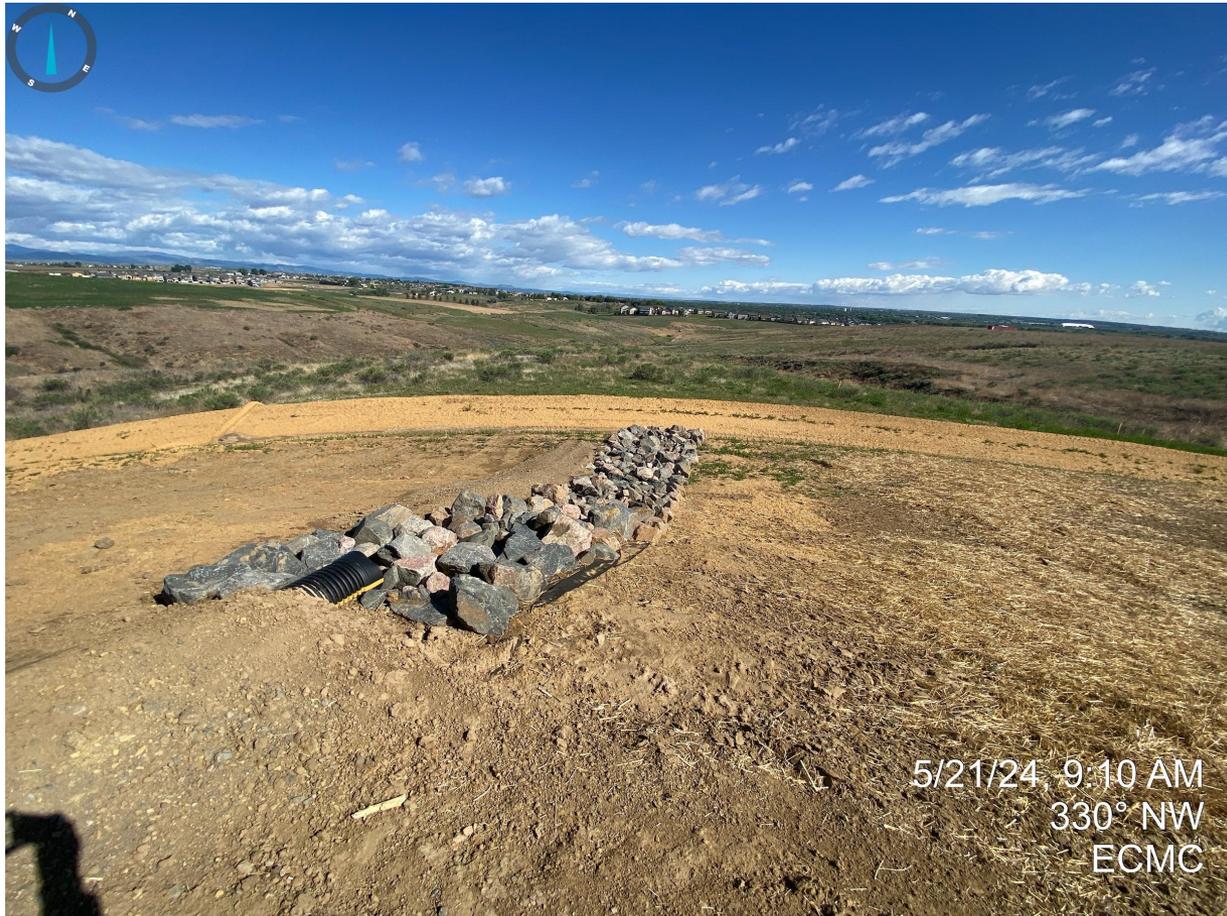
**Photo 12.** Armored spillway located on the northwest corner of the drilling pad.

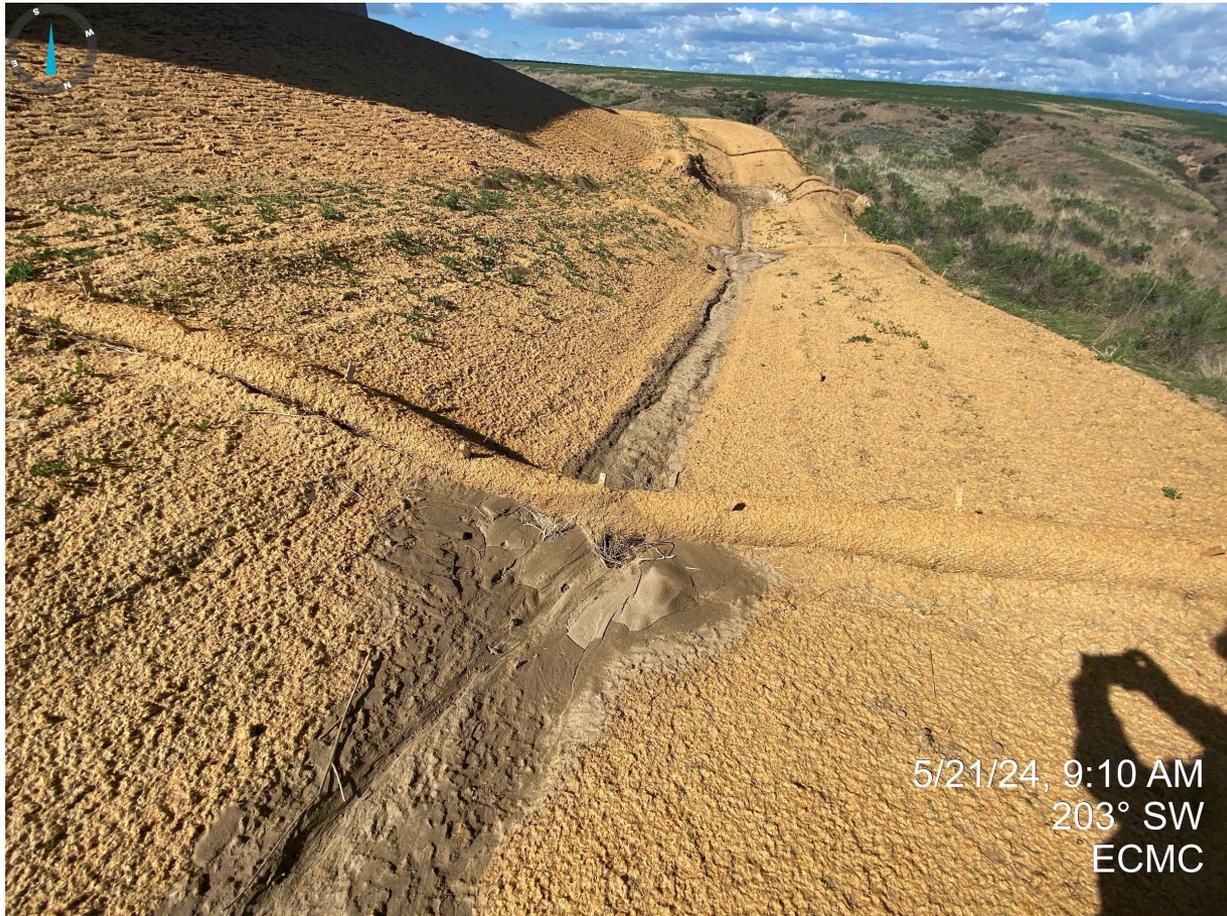
**Photo 13.** Erosion degradation (e.g. riling and sediment deposition) observed on the northwest portion of the location. BMPs require maintenance.

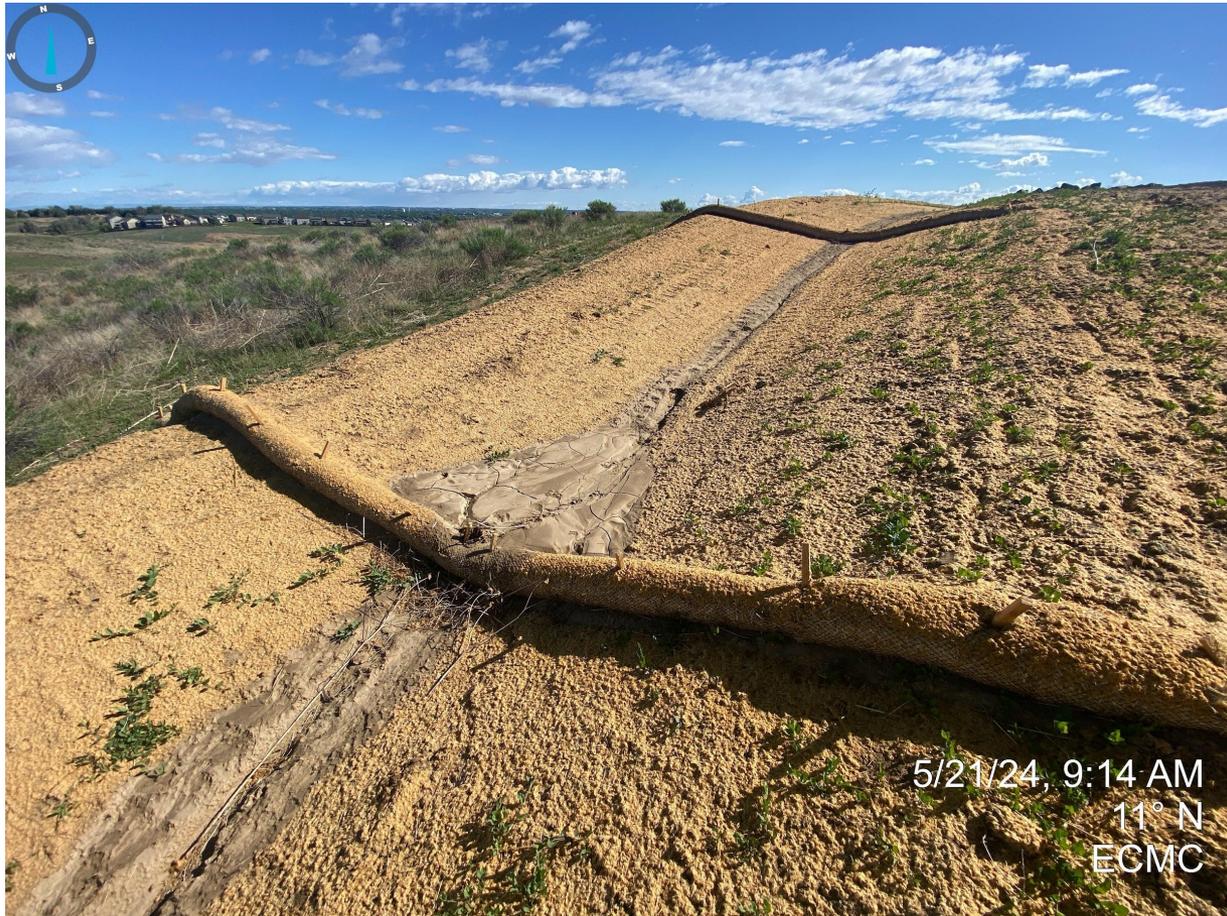
**Photo 14.** Erosion degradation (e.g. riling and sediment deposition) observed on the northwest portion of the location. BMPs require maintenance.

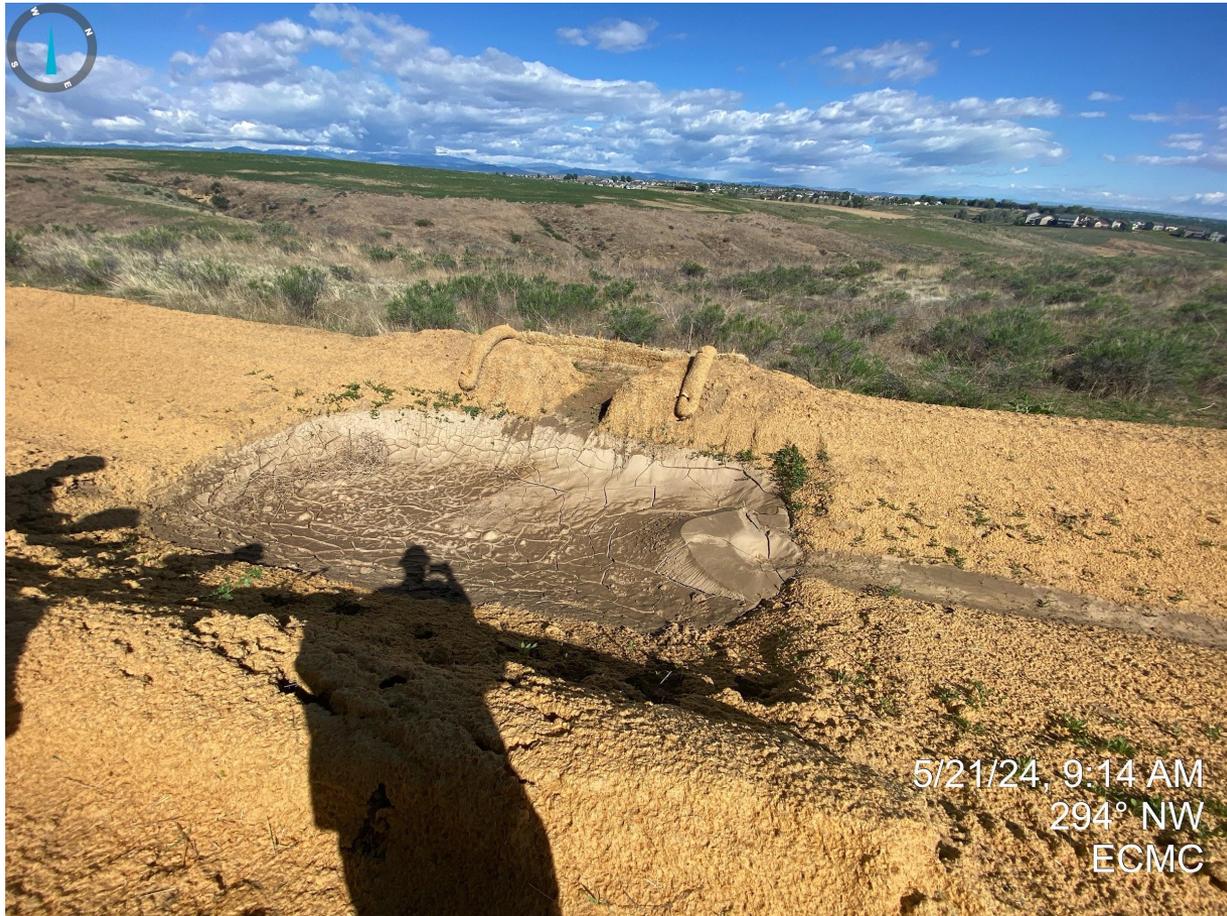
**Photo 15.** Sediment trap requires maintenance.

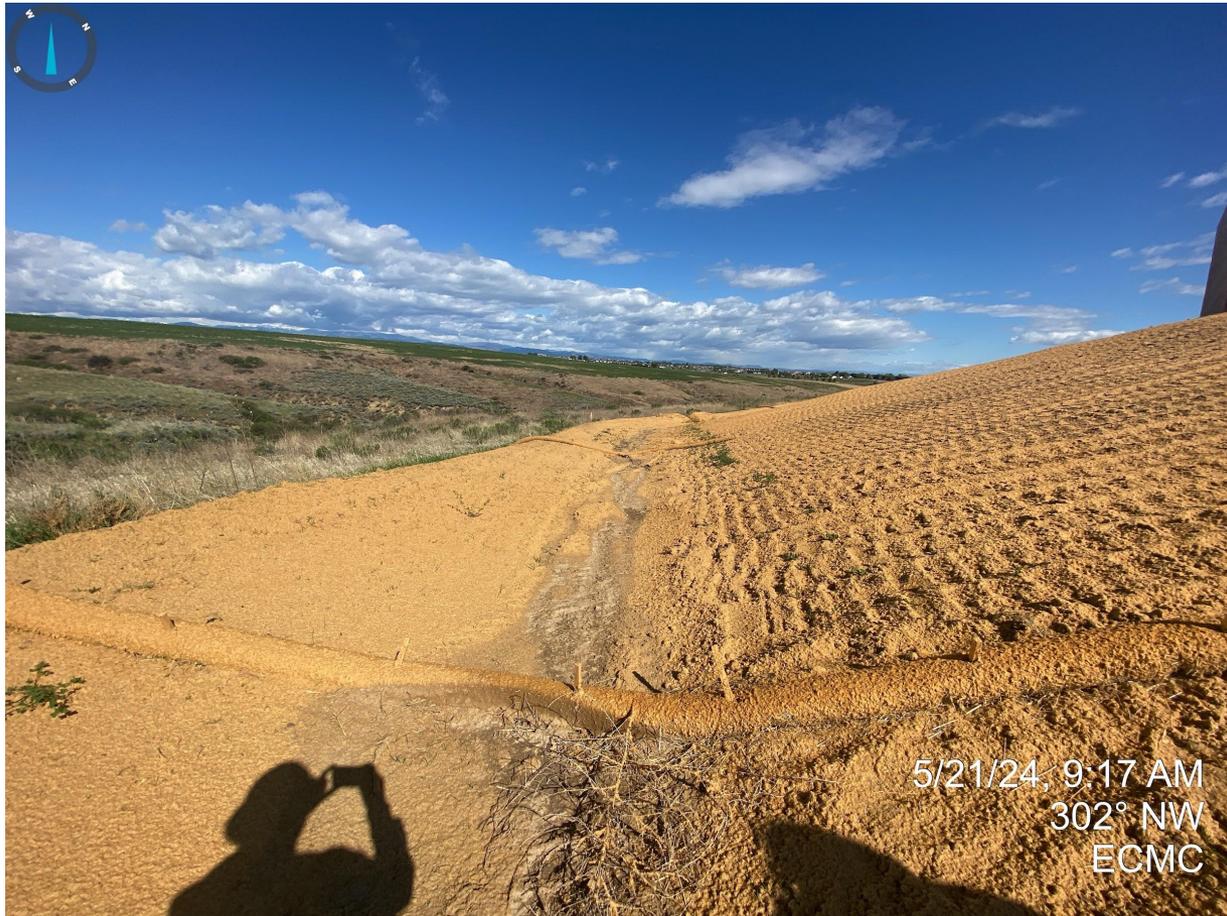
**Photo 16.** Erosion degradation (e.g. riling and sediment deposition) observed on the west portion of the location. BMPs require maintenance.

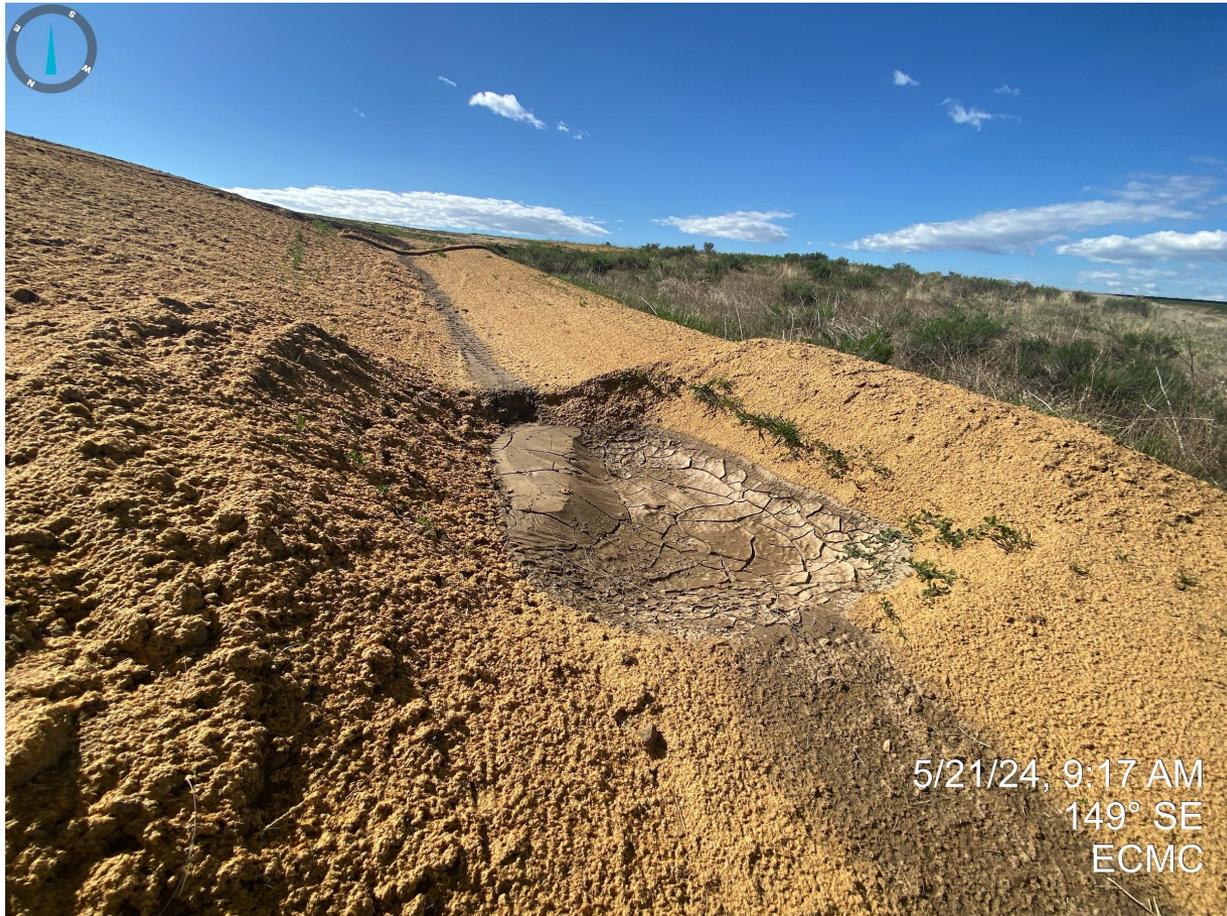
**Photo 17.** Sediment trap requires maintenance.

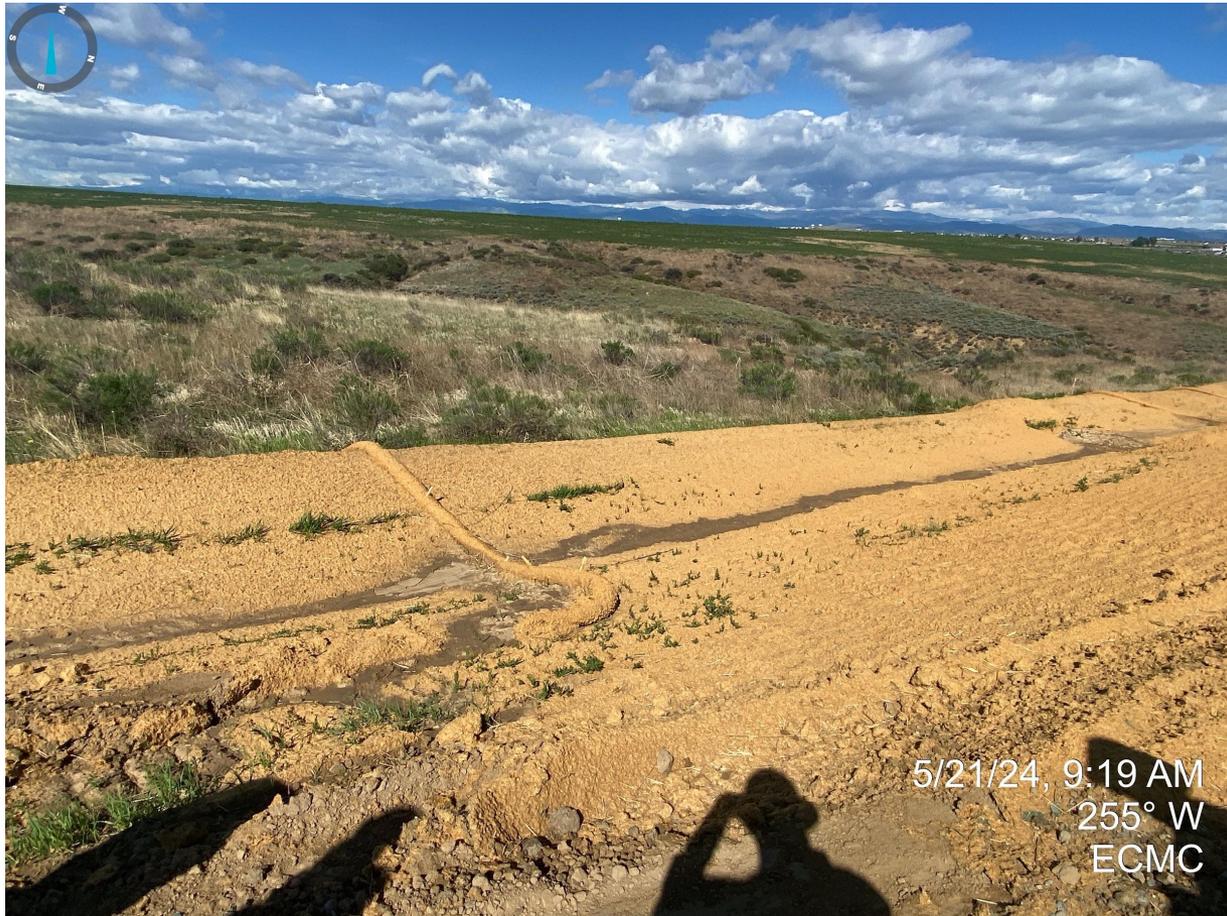
**Photo 18.** Erosion degradation (e.g. riling and sediment deposition) observed on the west portion of the location. BMPs require maintenance.

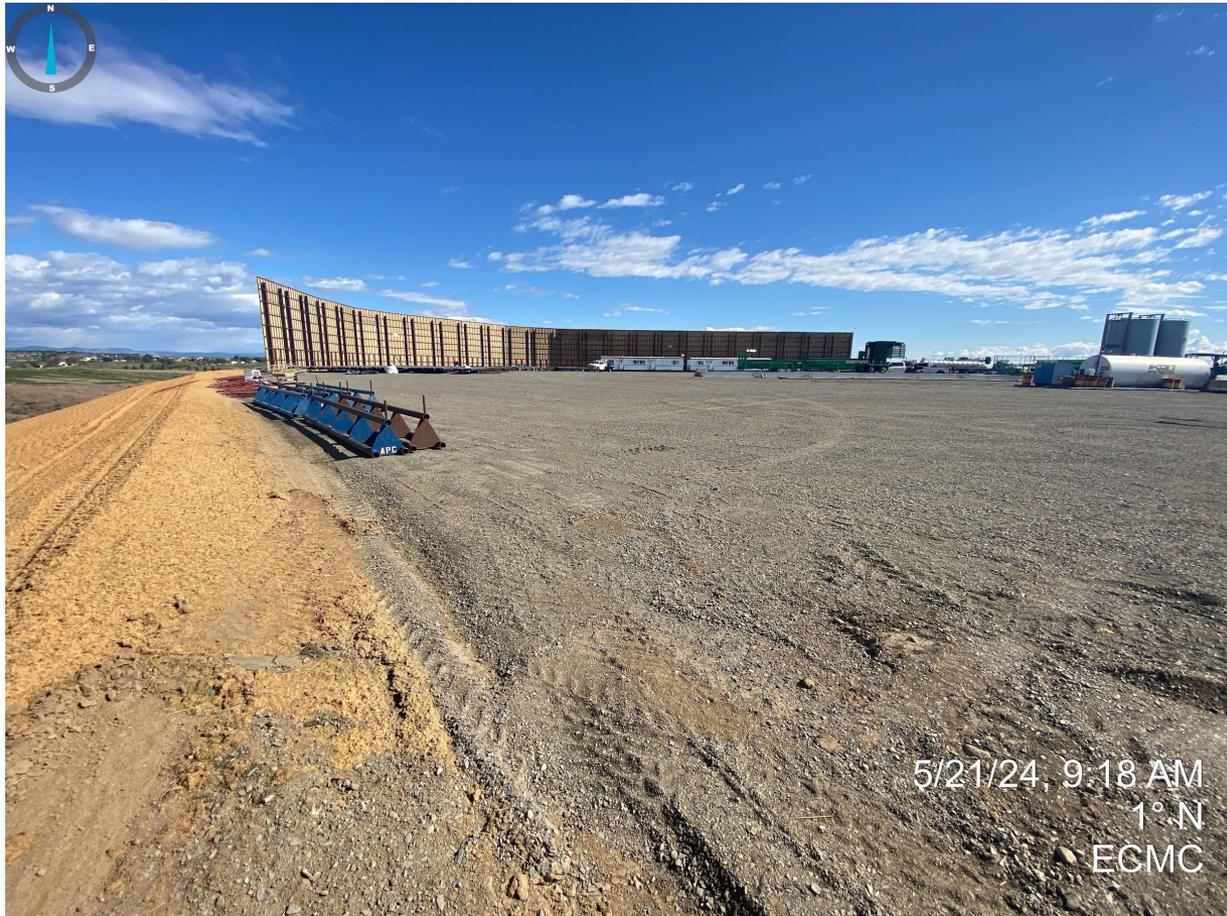
**Photo 19.** Overview of drilling pad, taken from the southwest corner.

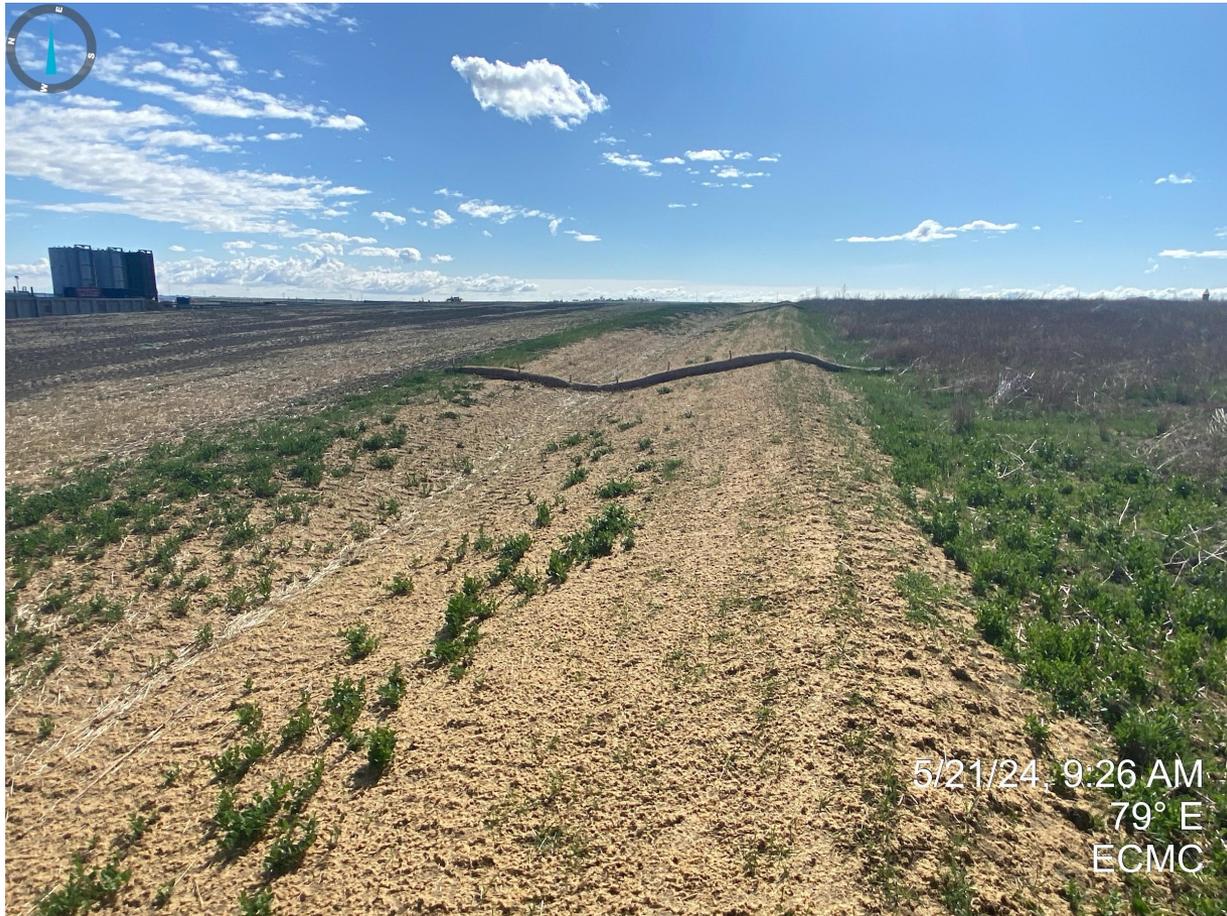
**Photo 20.** Taken near the southwest corner of the location. Field Bindweed (CO List C Noxious Weed) was observed growing throughout. This noxious weed will need to be actively managed.
