# Construction and Stormwater Inspection

Date: 05/21/2024

Operator: KERR MCGEE OIL & GAS ONSHORE LP -  
47120

Location ID: 485056

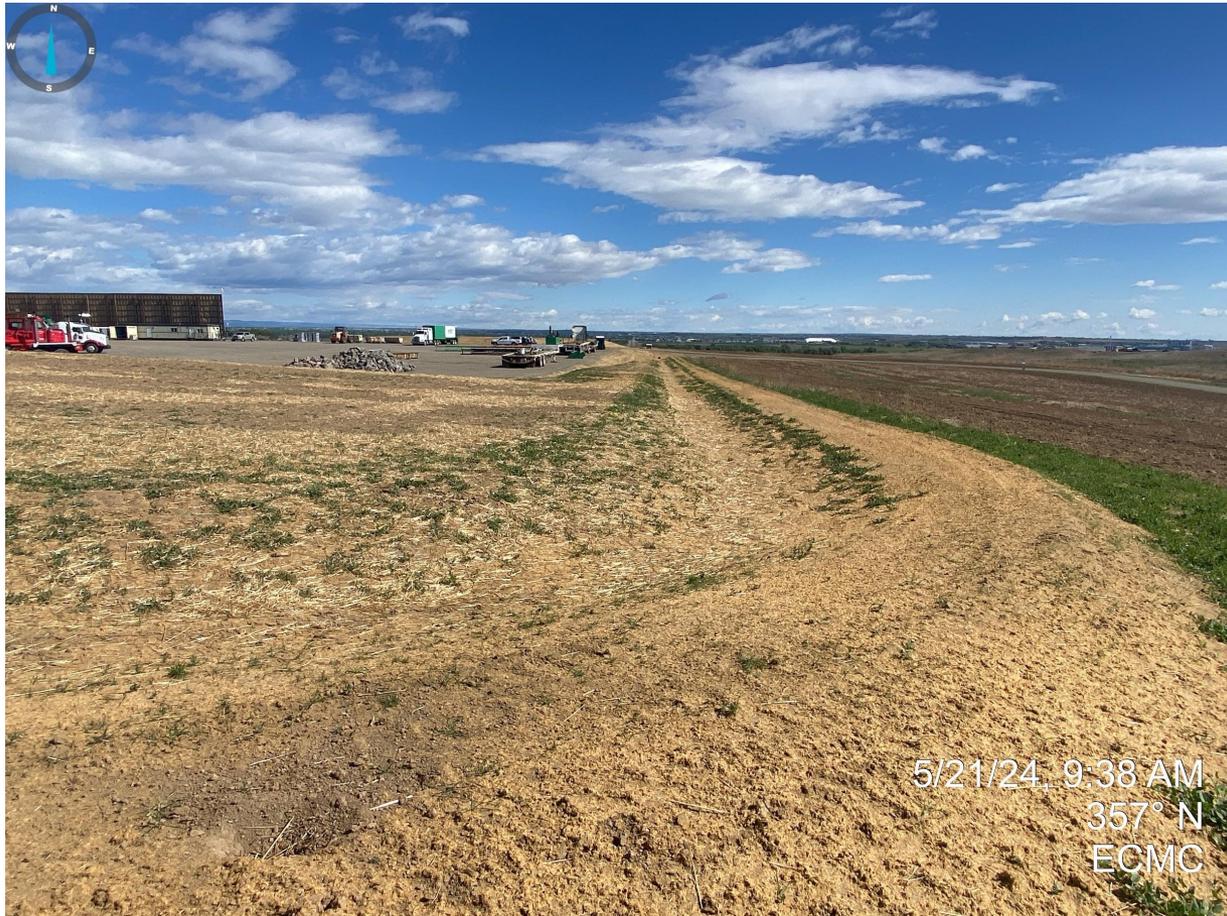
**Photo 21.** Taken from the southeast corner of the location. Field Bindweed (CO List C Noxious Weed) was observed growing throughout. This noxious weed will need to be actively managed.
