Caerus Piceance LLC
Little Hills Federal F31X-35G
Location ID: 316338

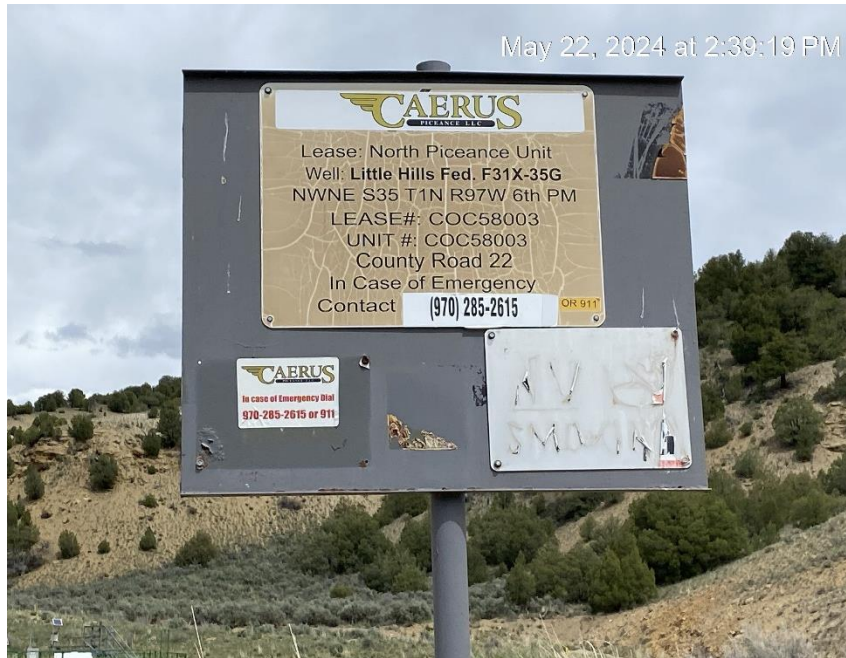
When replaced additional information will be required

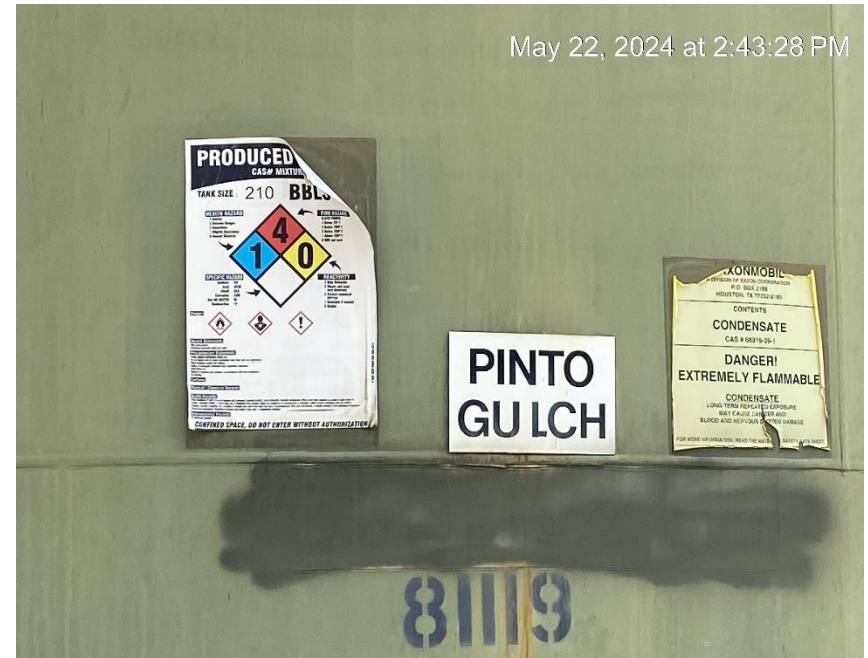
Tank labeling missing required information

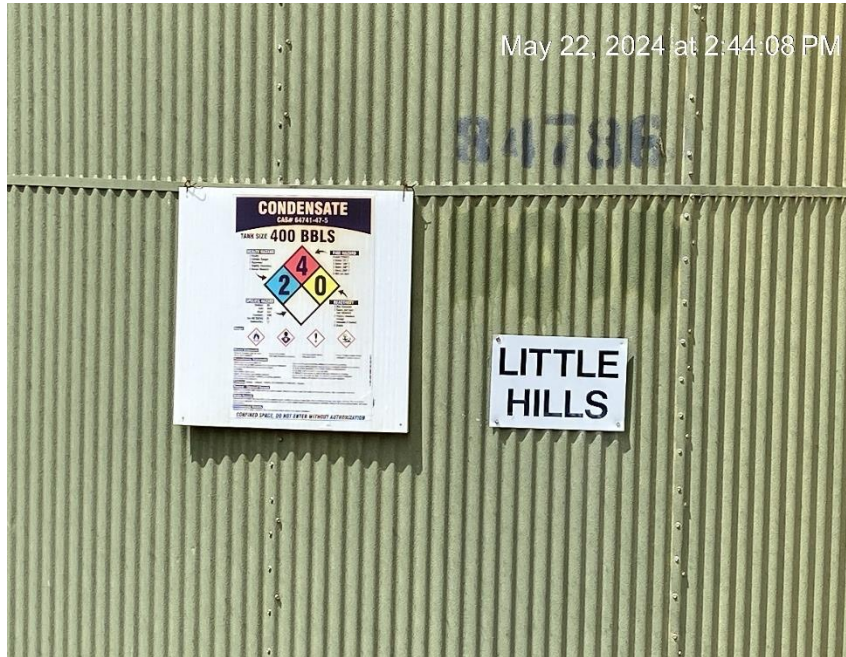
Tank labeling missing required information

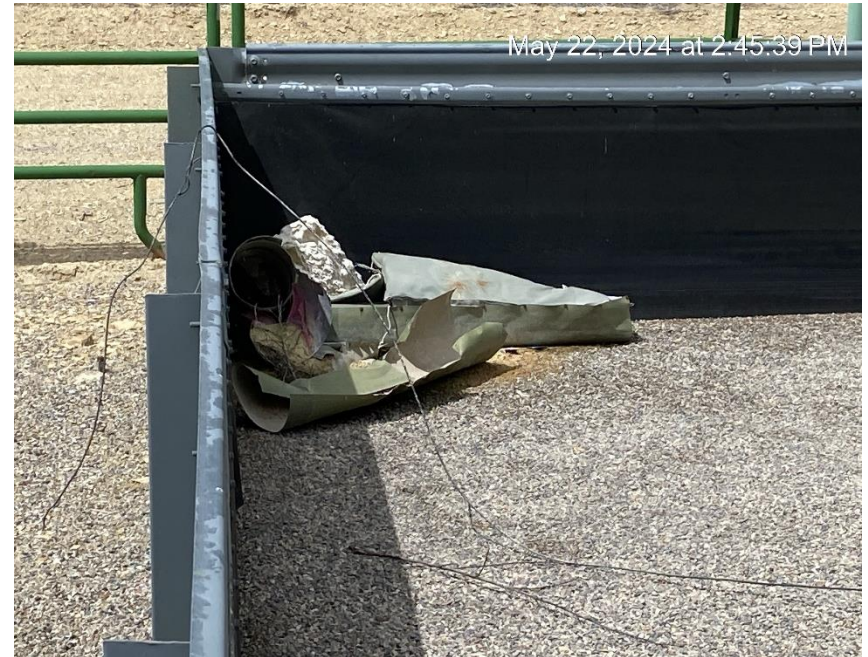
Debris

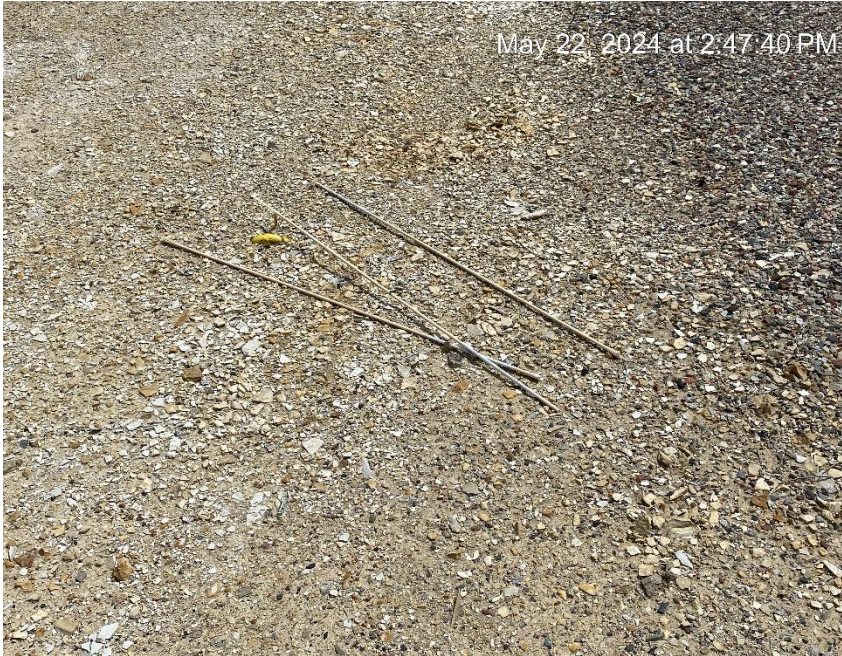
Unmarked anchor

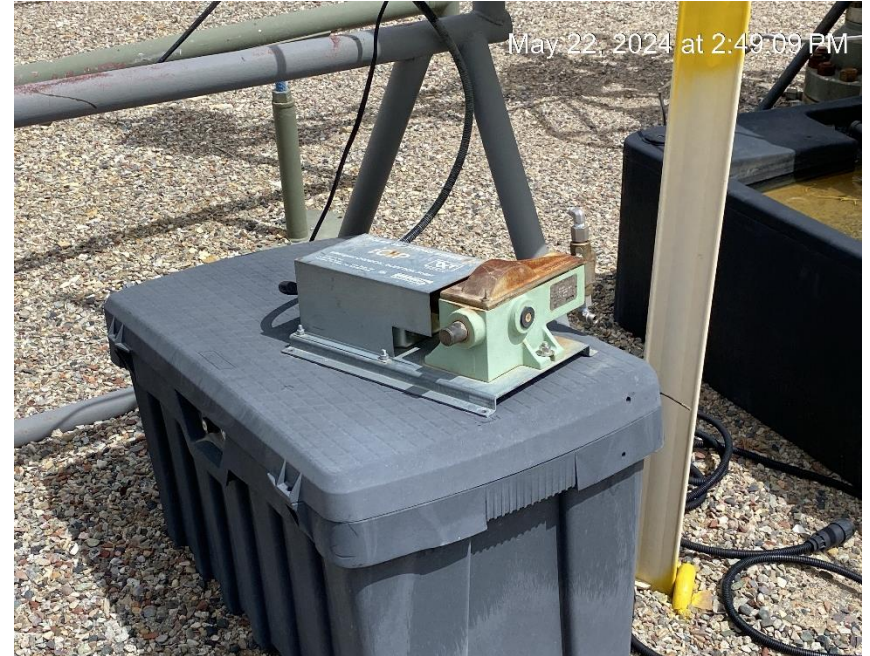
Unused equipment

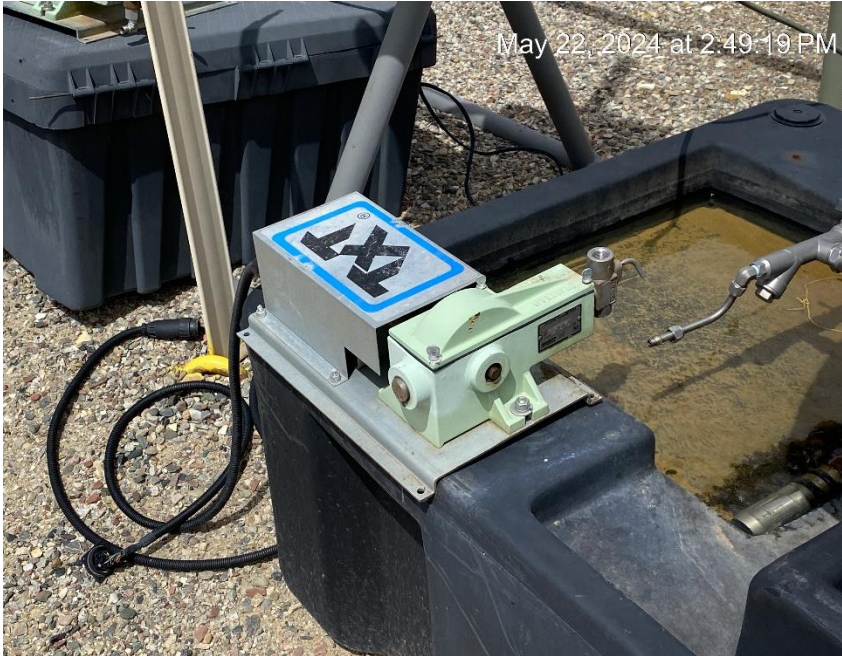
Unused equipment

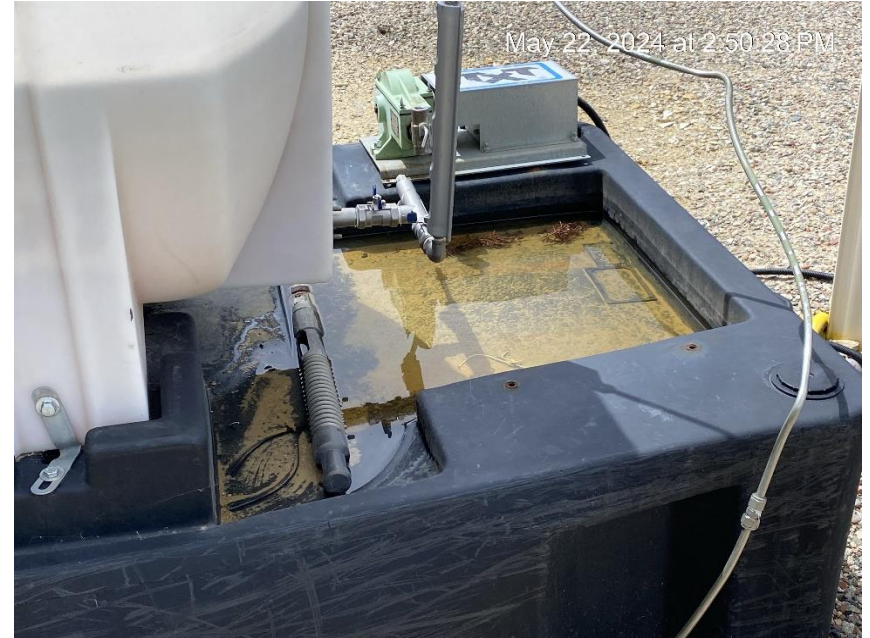
Debris

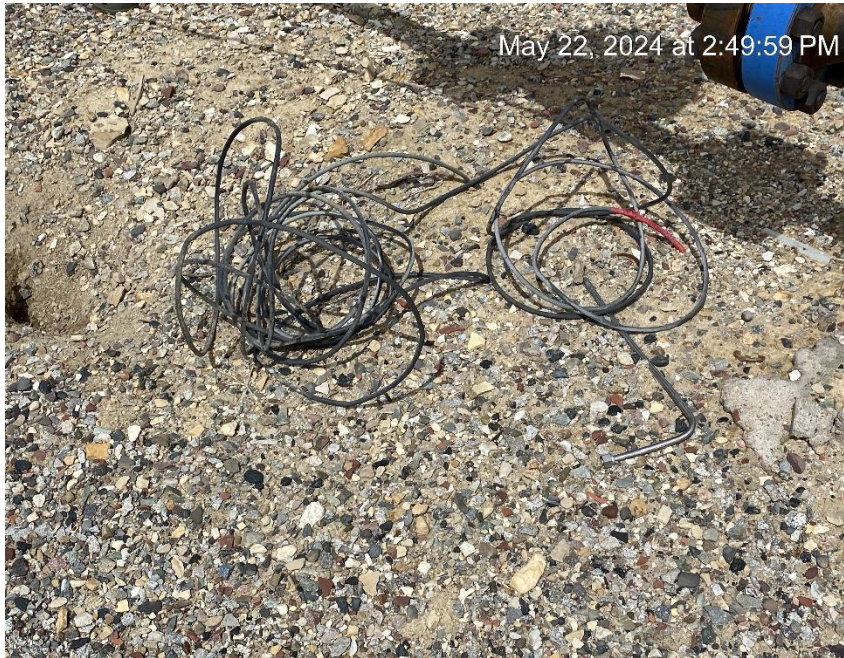
Debris

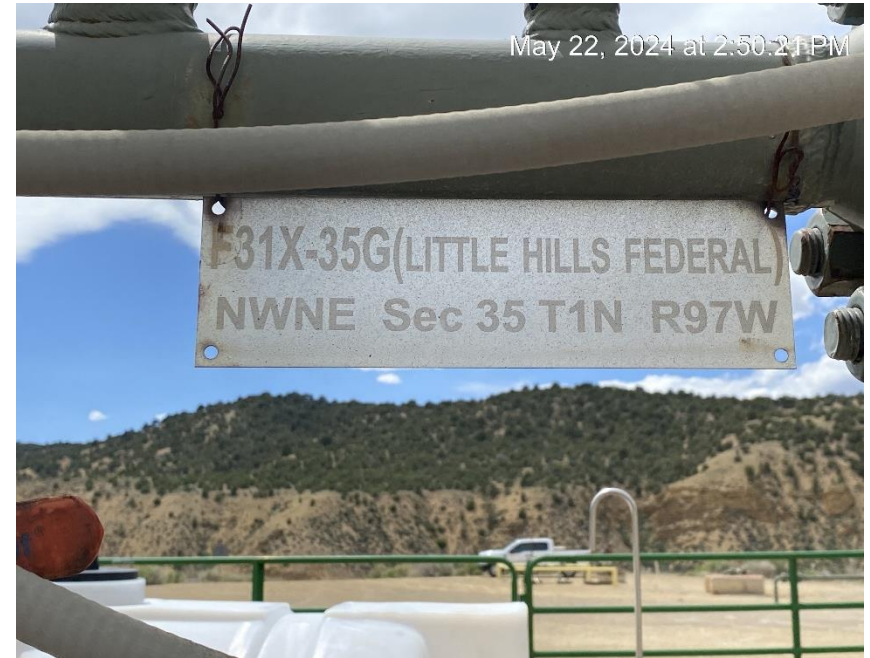
When replaced additional information will be required

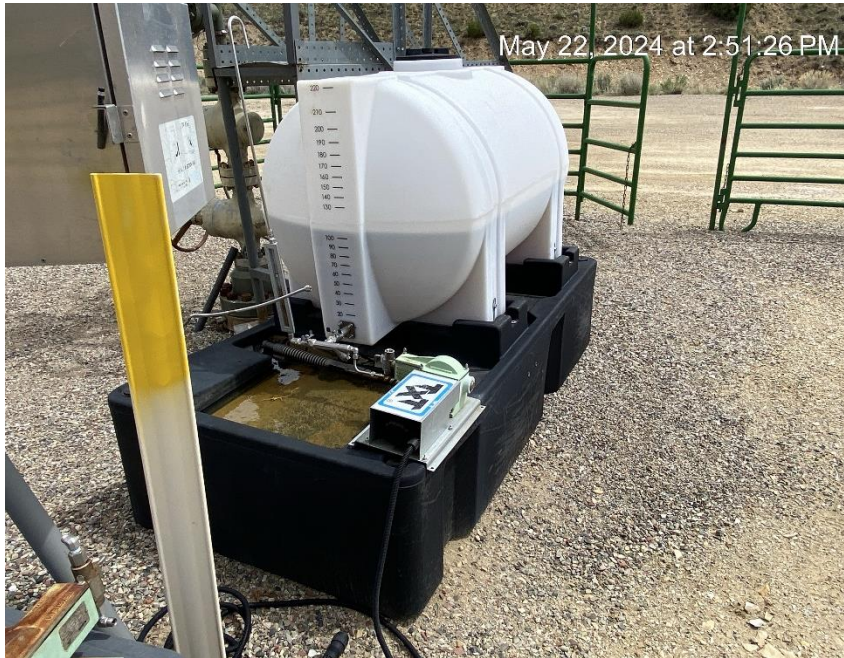
Chemical tank not in use

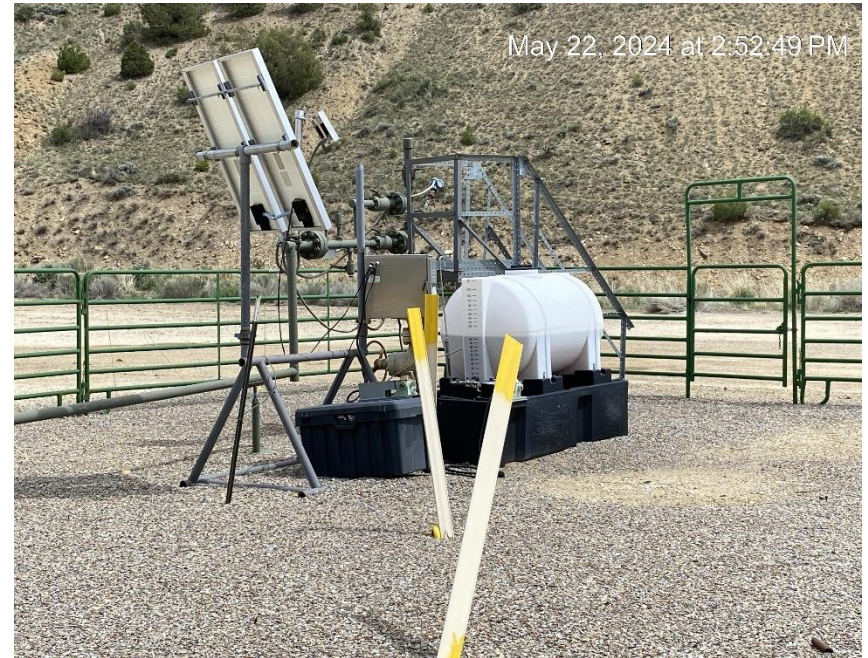
Solar panel not in service

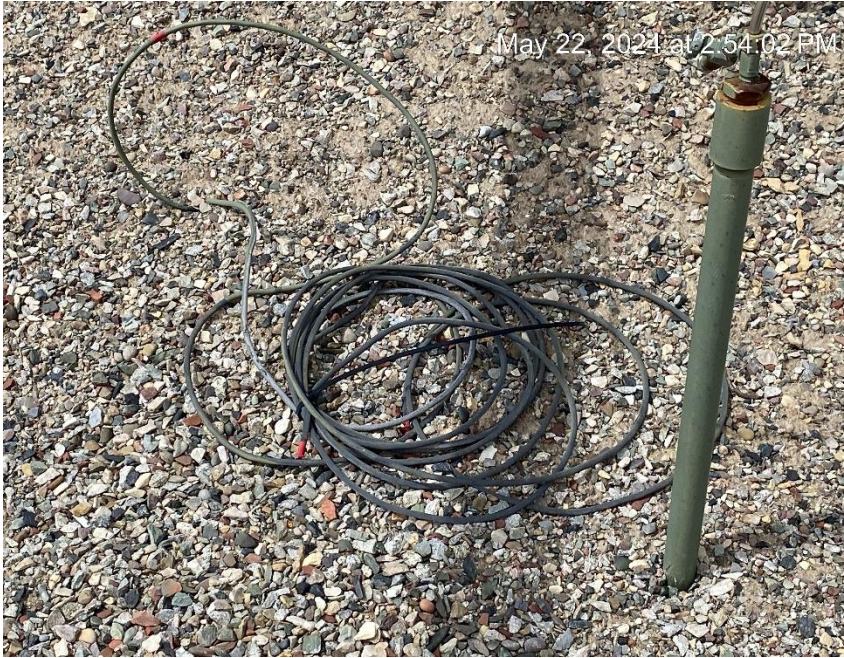
Debris

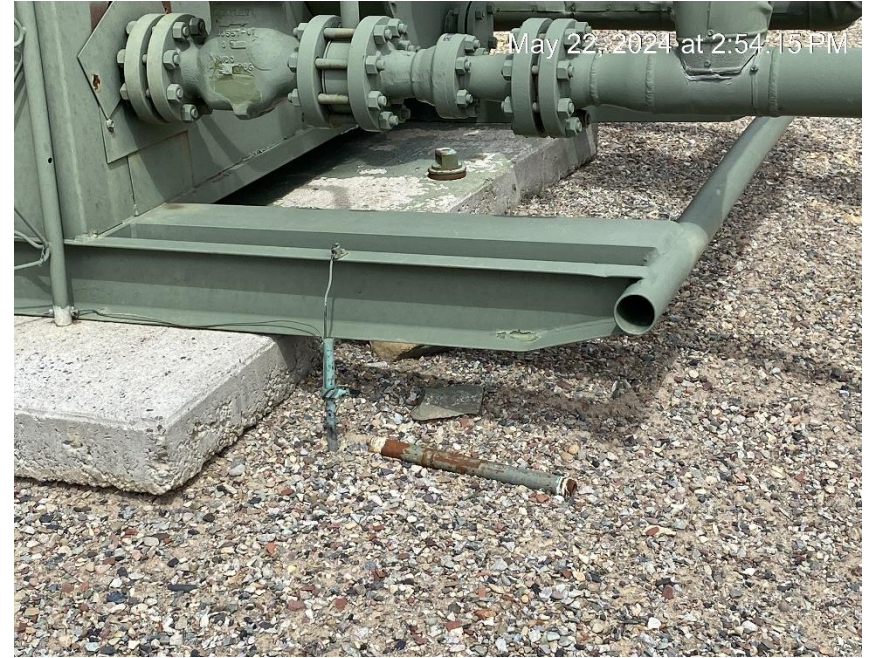
Debris

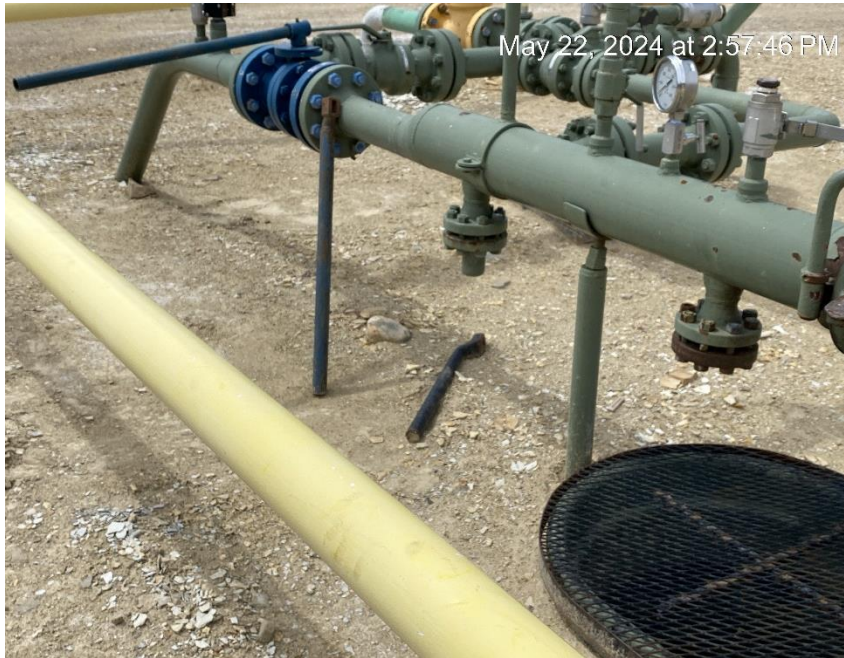
Debris

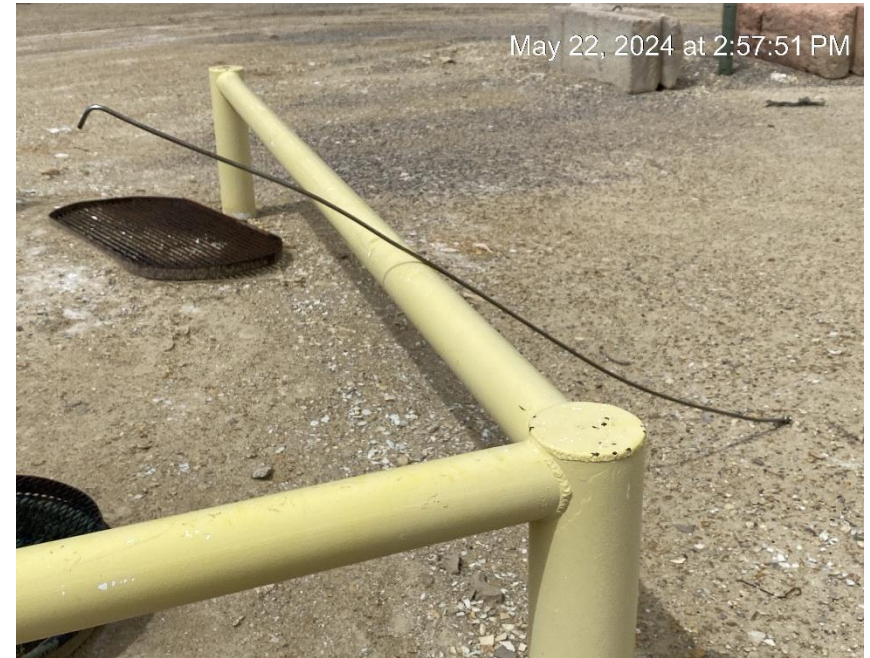
Debris

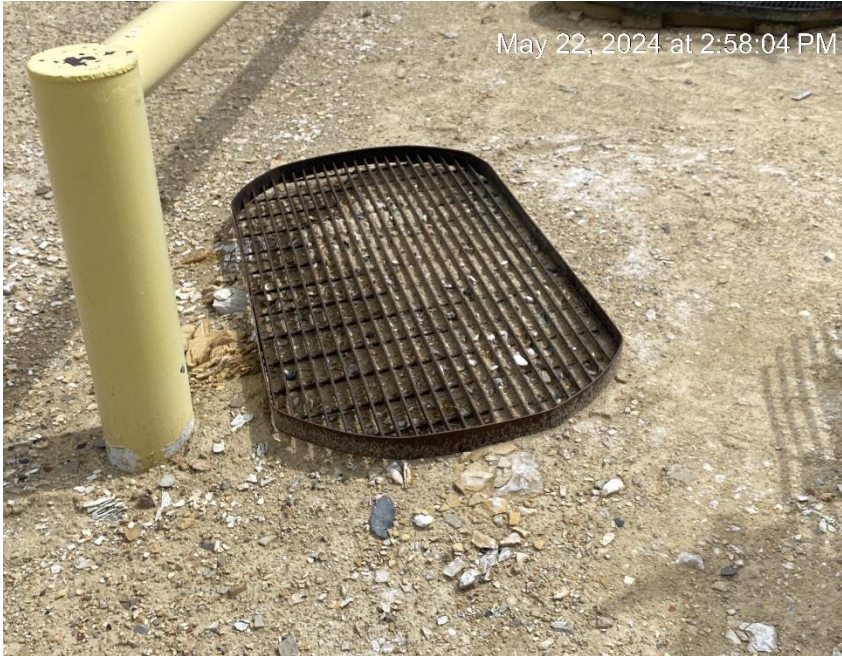
Debris

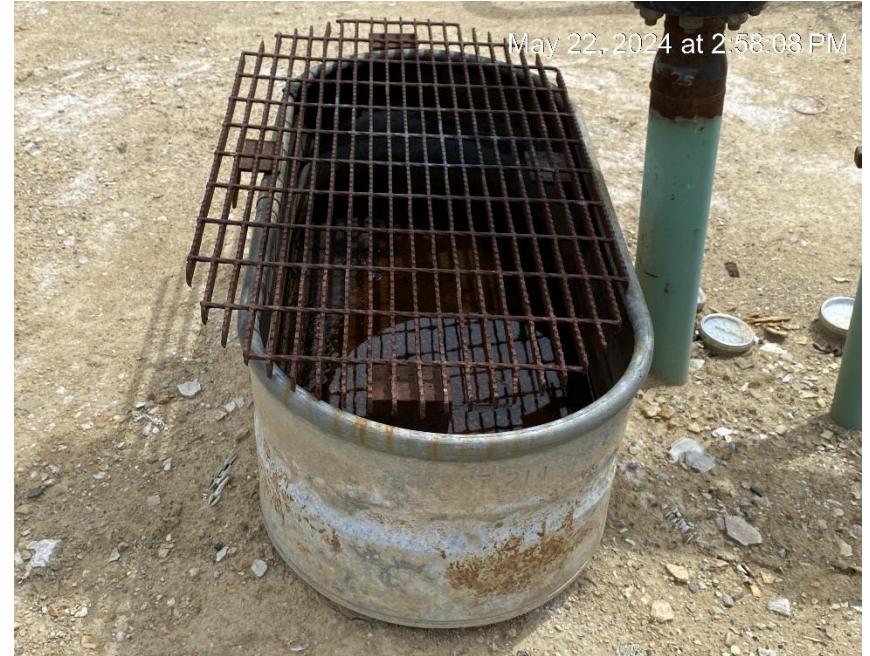
Open to wildlife

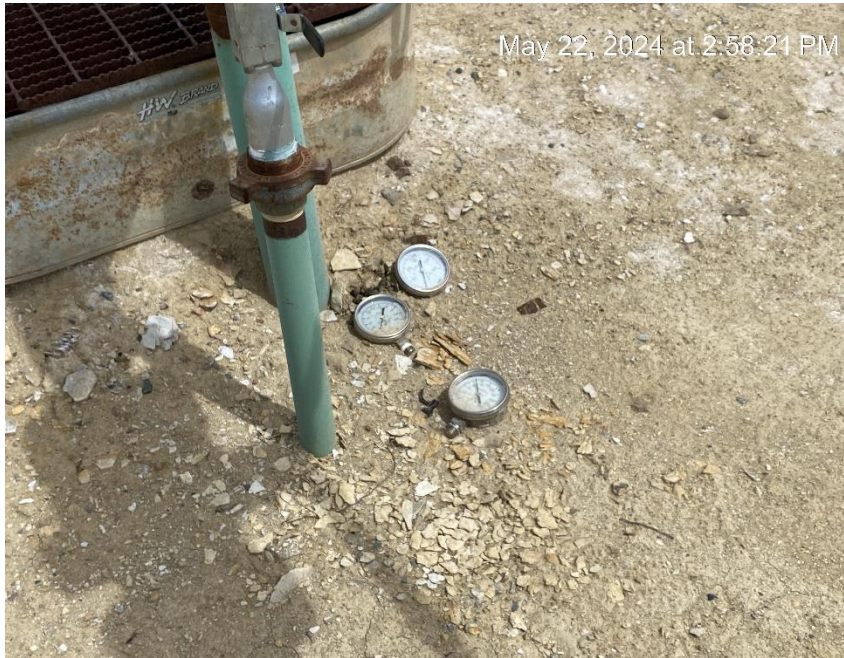
Debris

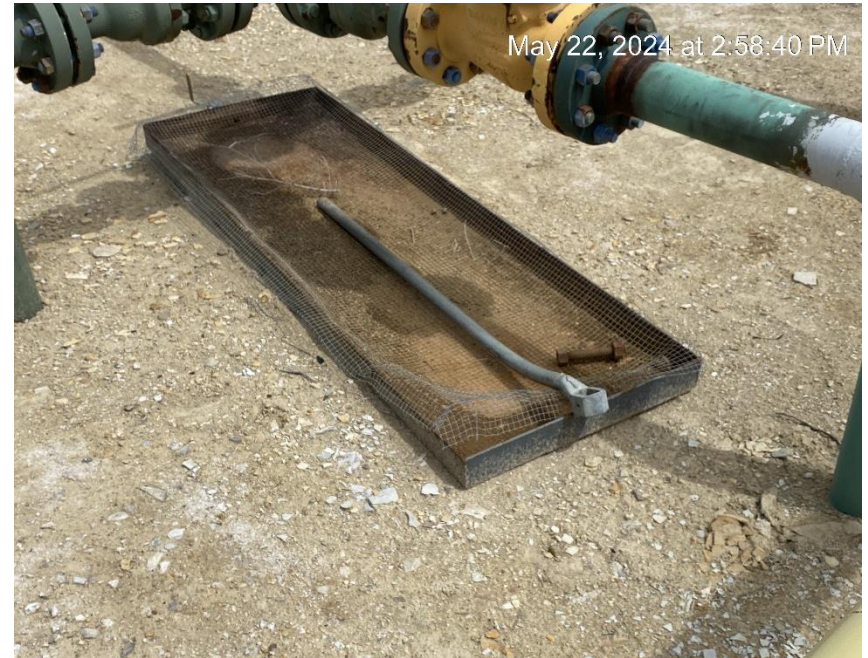
Debris

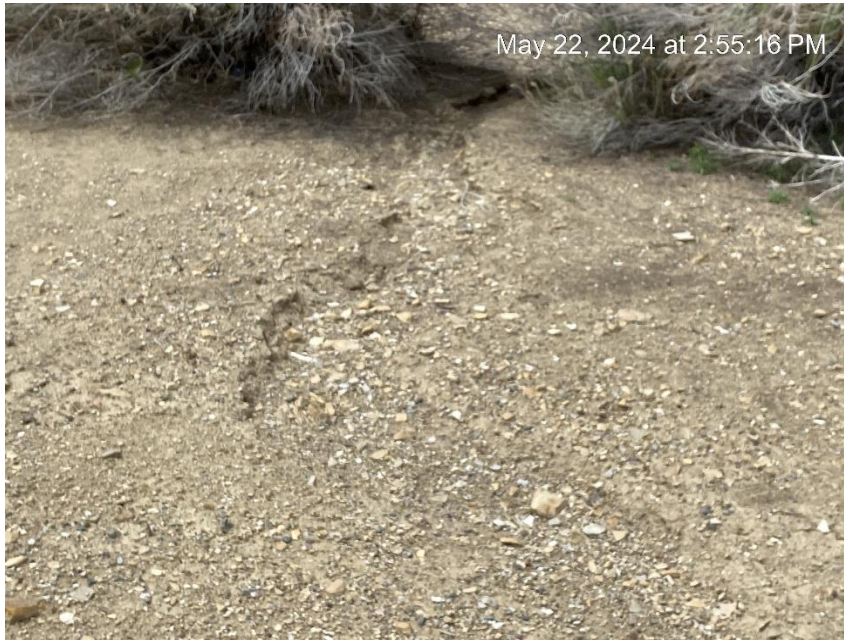
Erosion and sediment migration

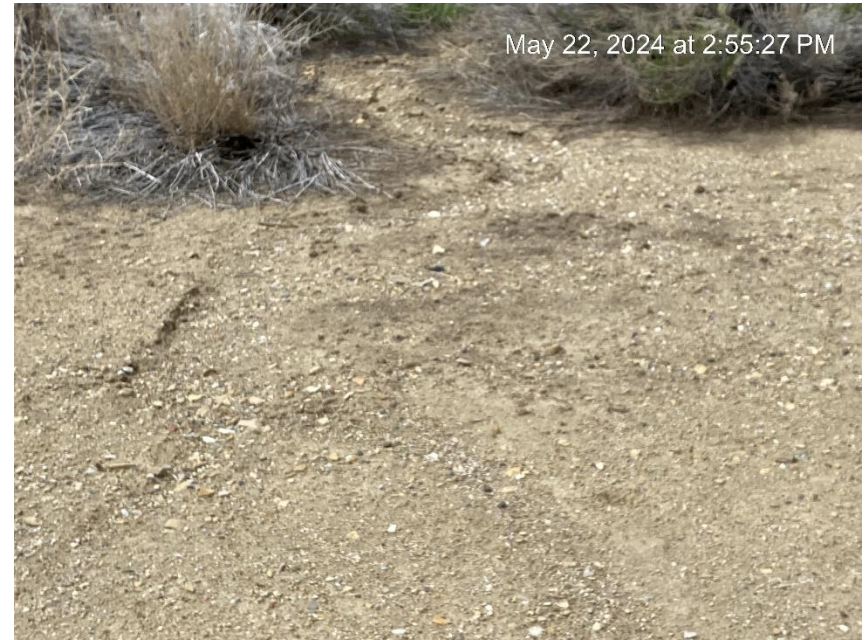
Erosion and sediment migration

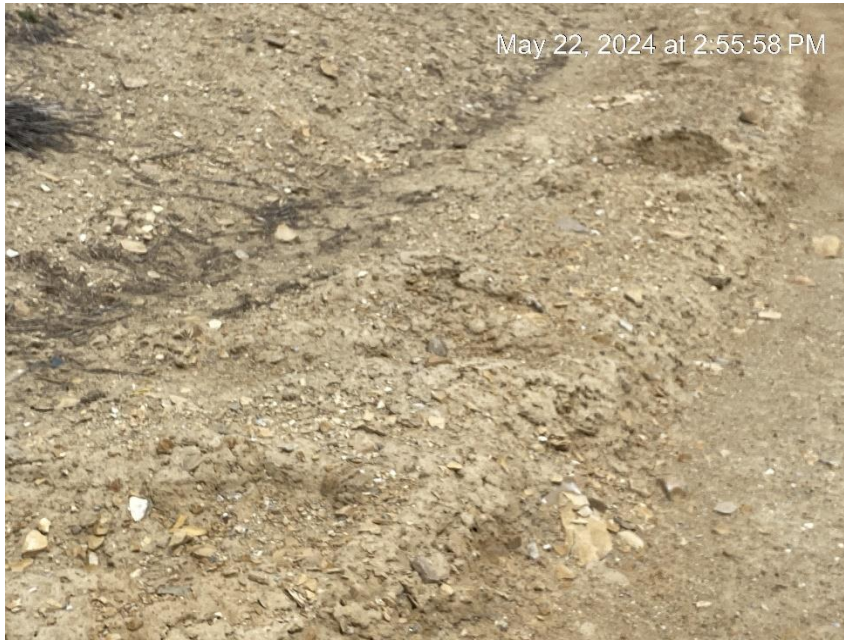
Damaged Stormwater BMP

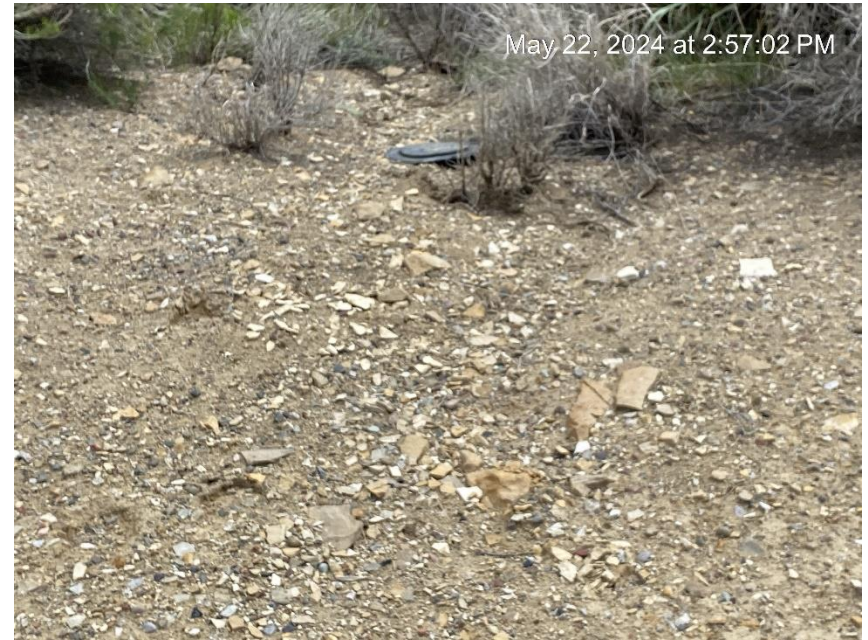
Erosion and sediment migration

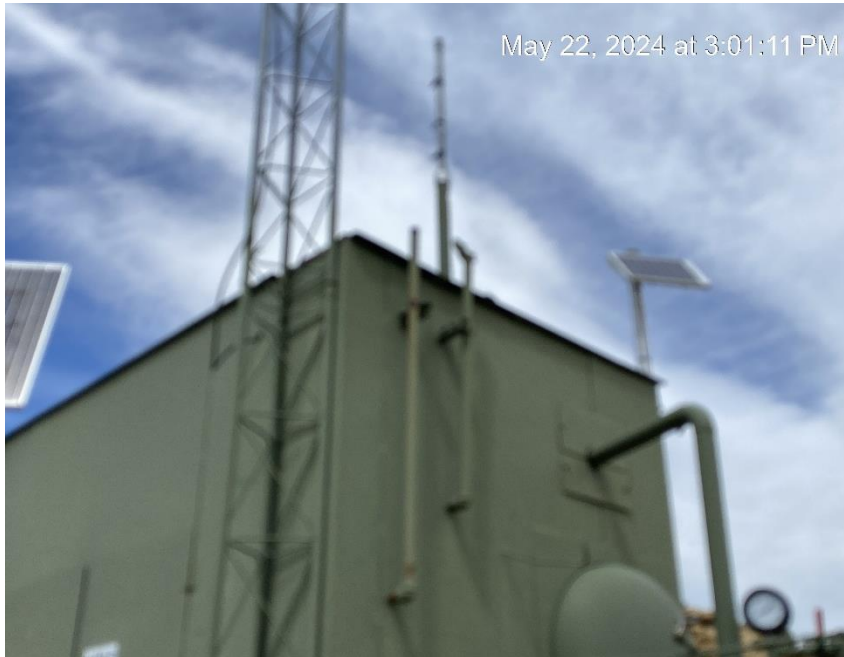
Relief riser missing protective cover
