Inspection Photos

May 21st 2024

Operator: Enduring Resources LLC - 10663

Inspection Photos
Location Name: W. Animas Wheeler 8-1
Location ID: 326325

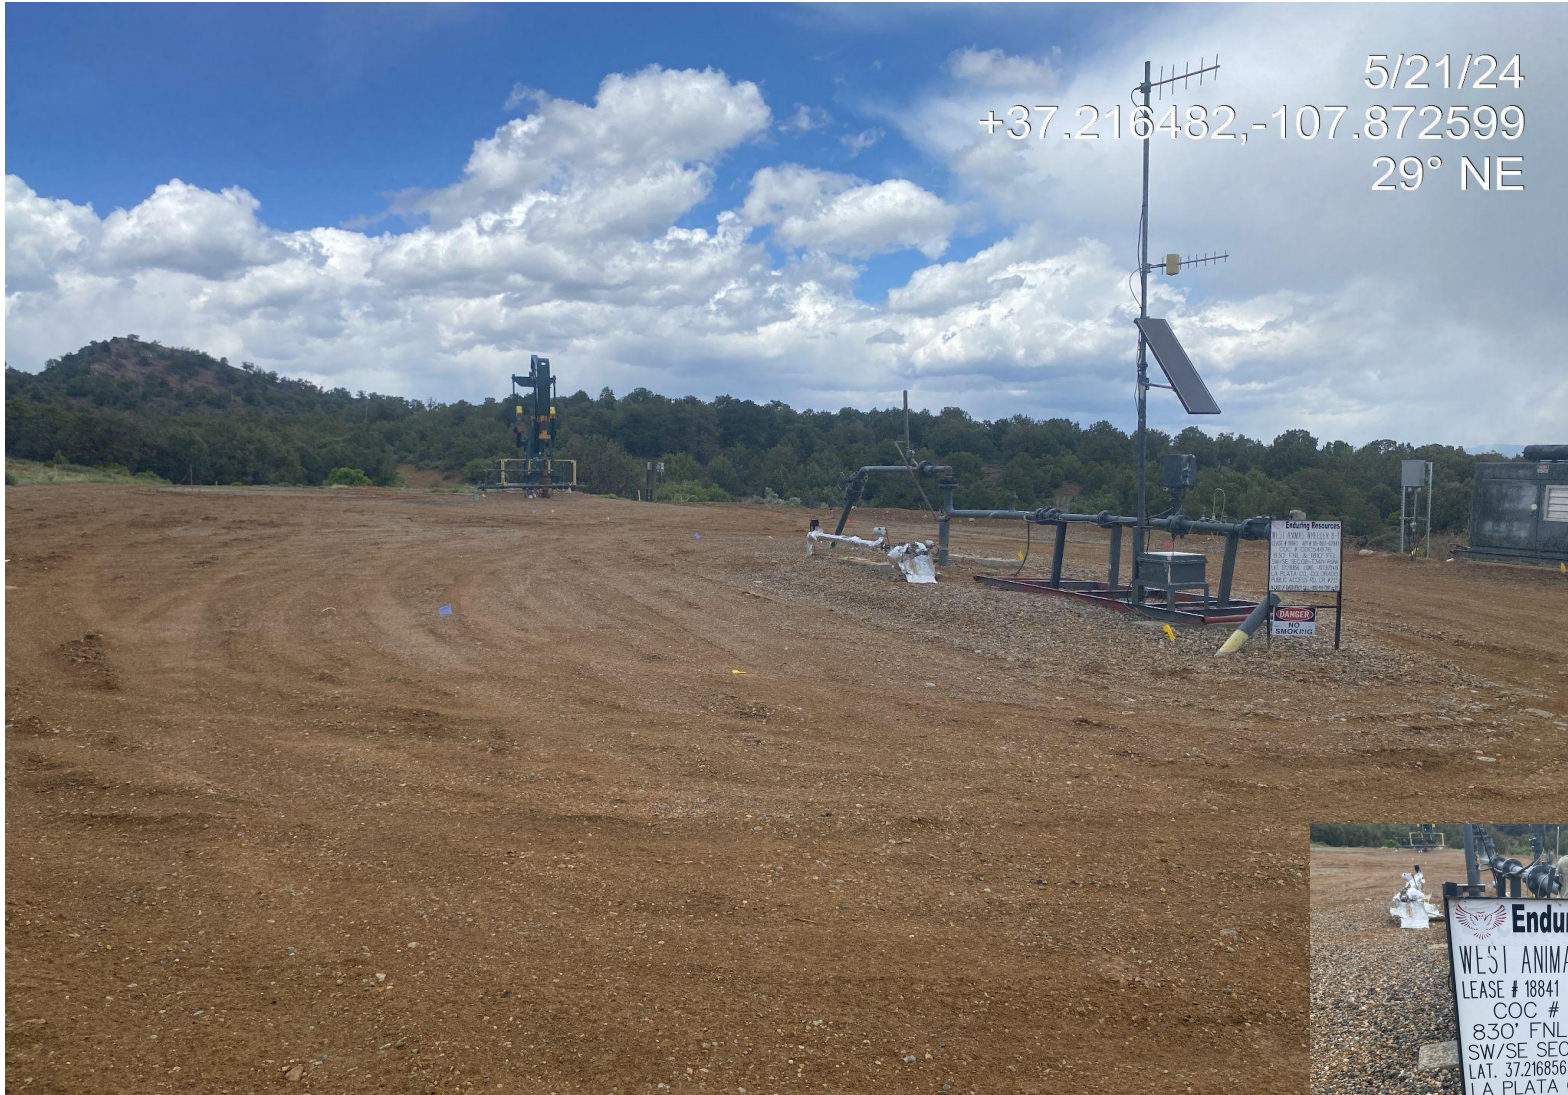
Photo 1. View of the well pad taken from the access point facing center.

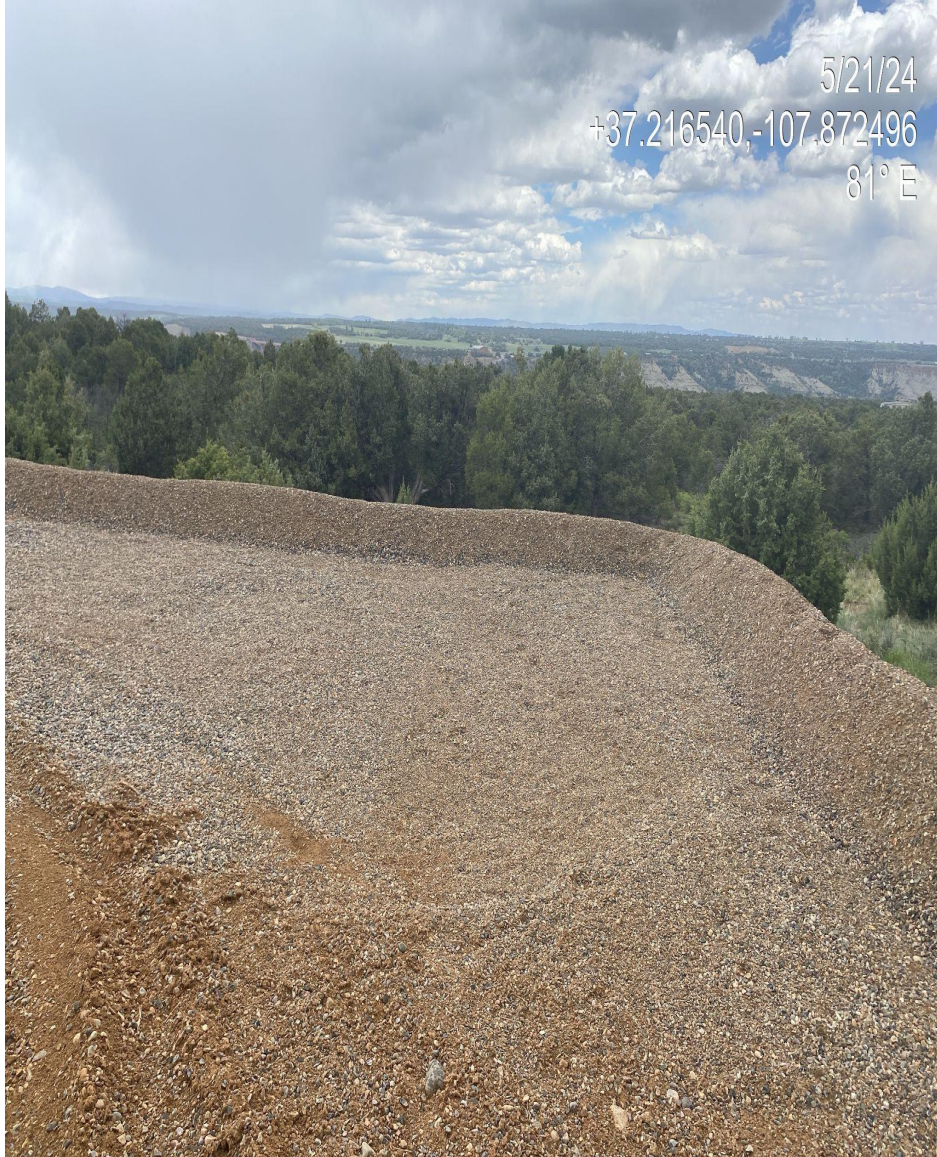
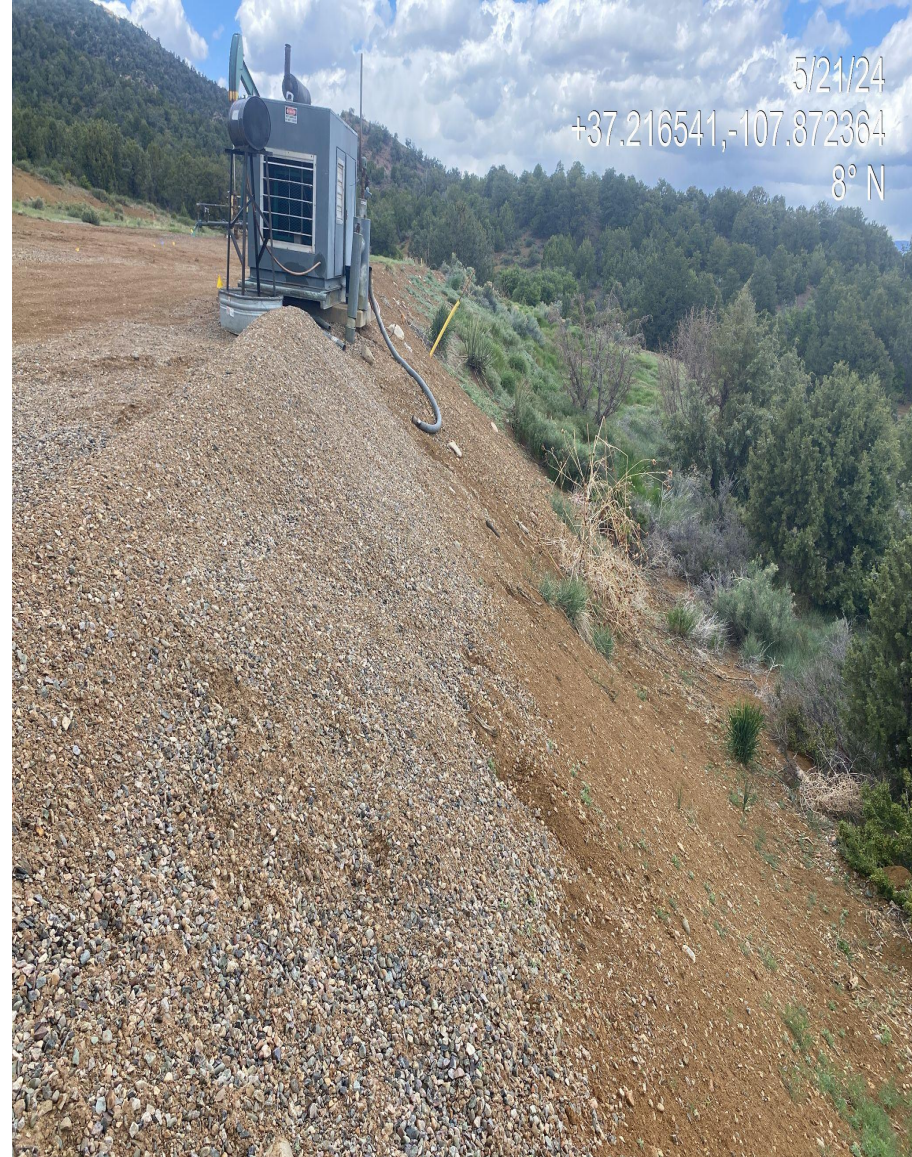
Photo 2. Storm water corrective action identified in the previous inspection doc #714000030 has been addressed/resolved.

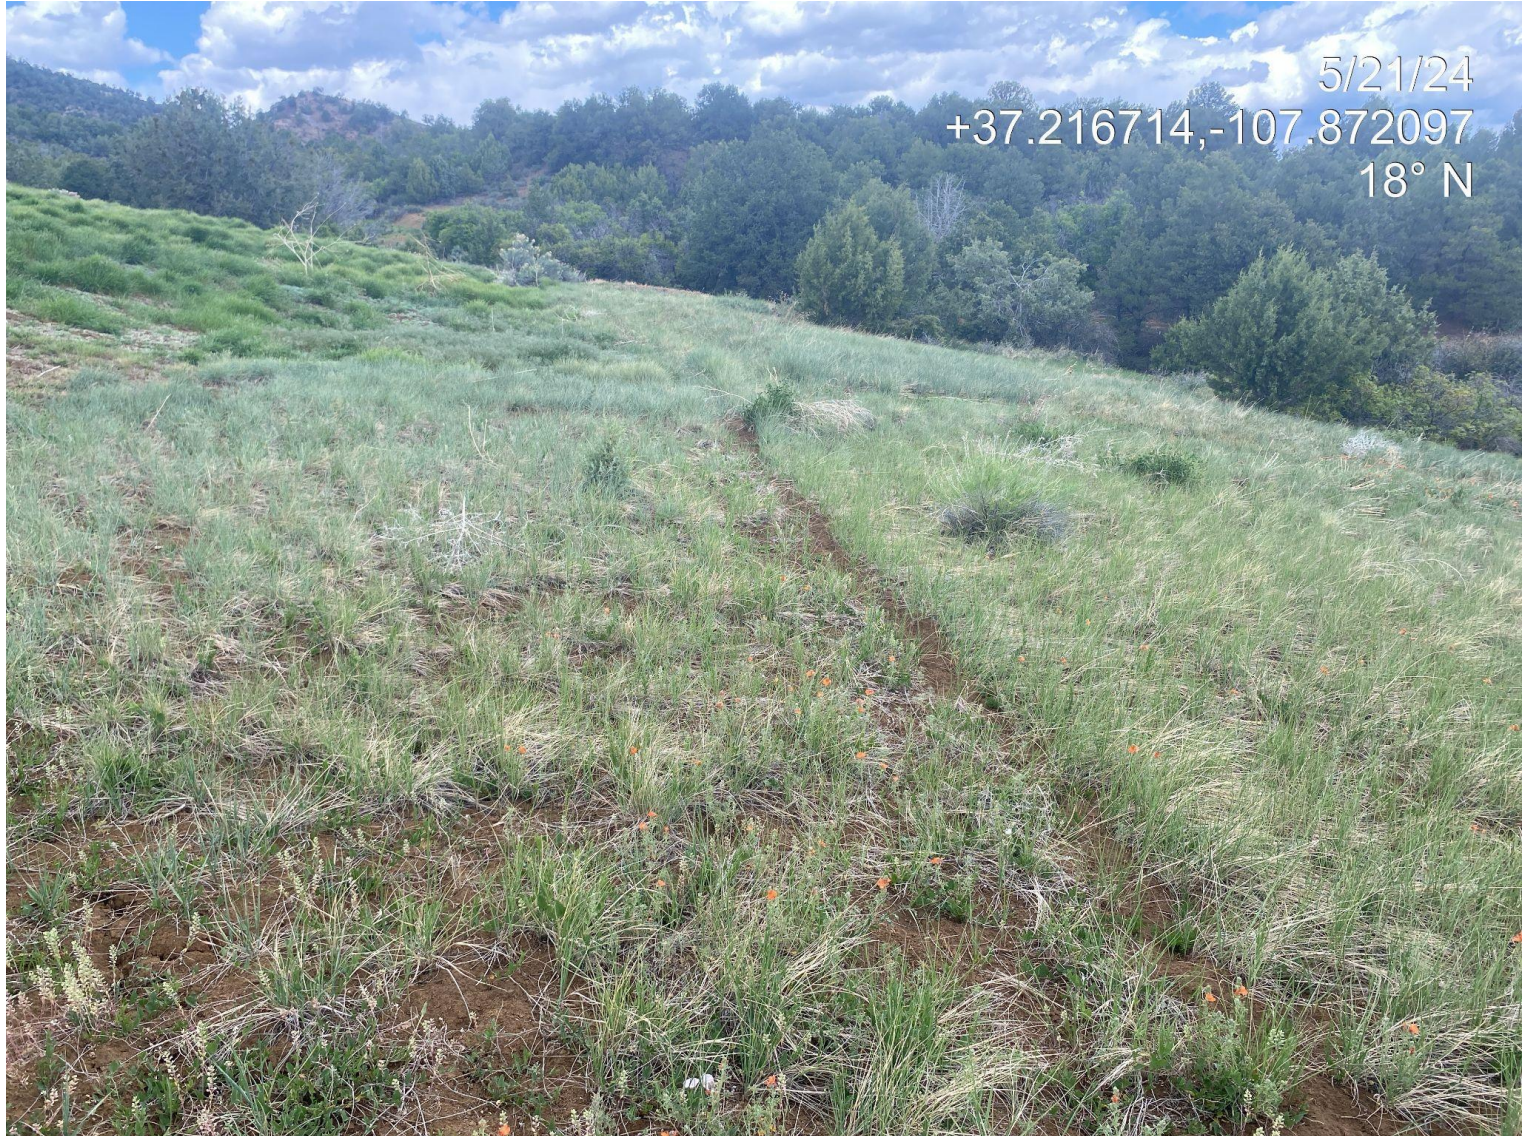
Photo 3. Storm water corrective action identified in the previous inspection doc #714000030 has been addressed/resolved.

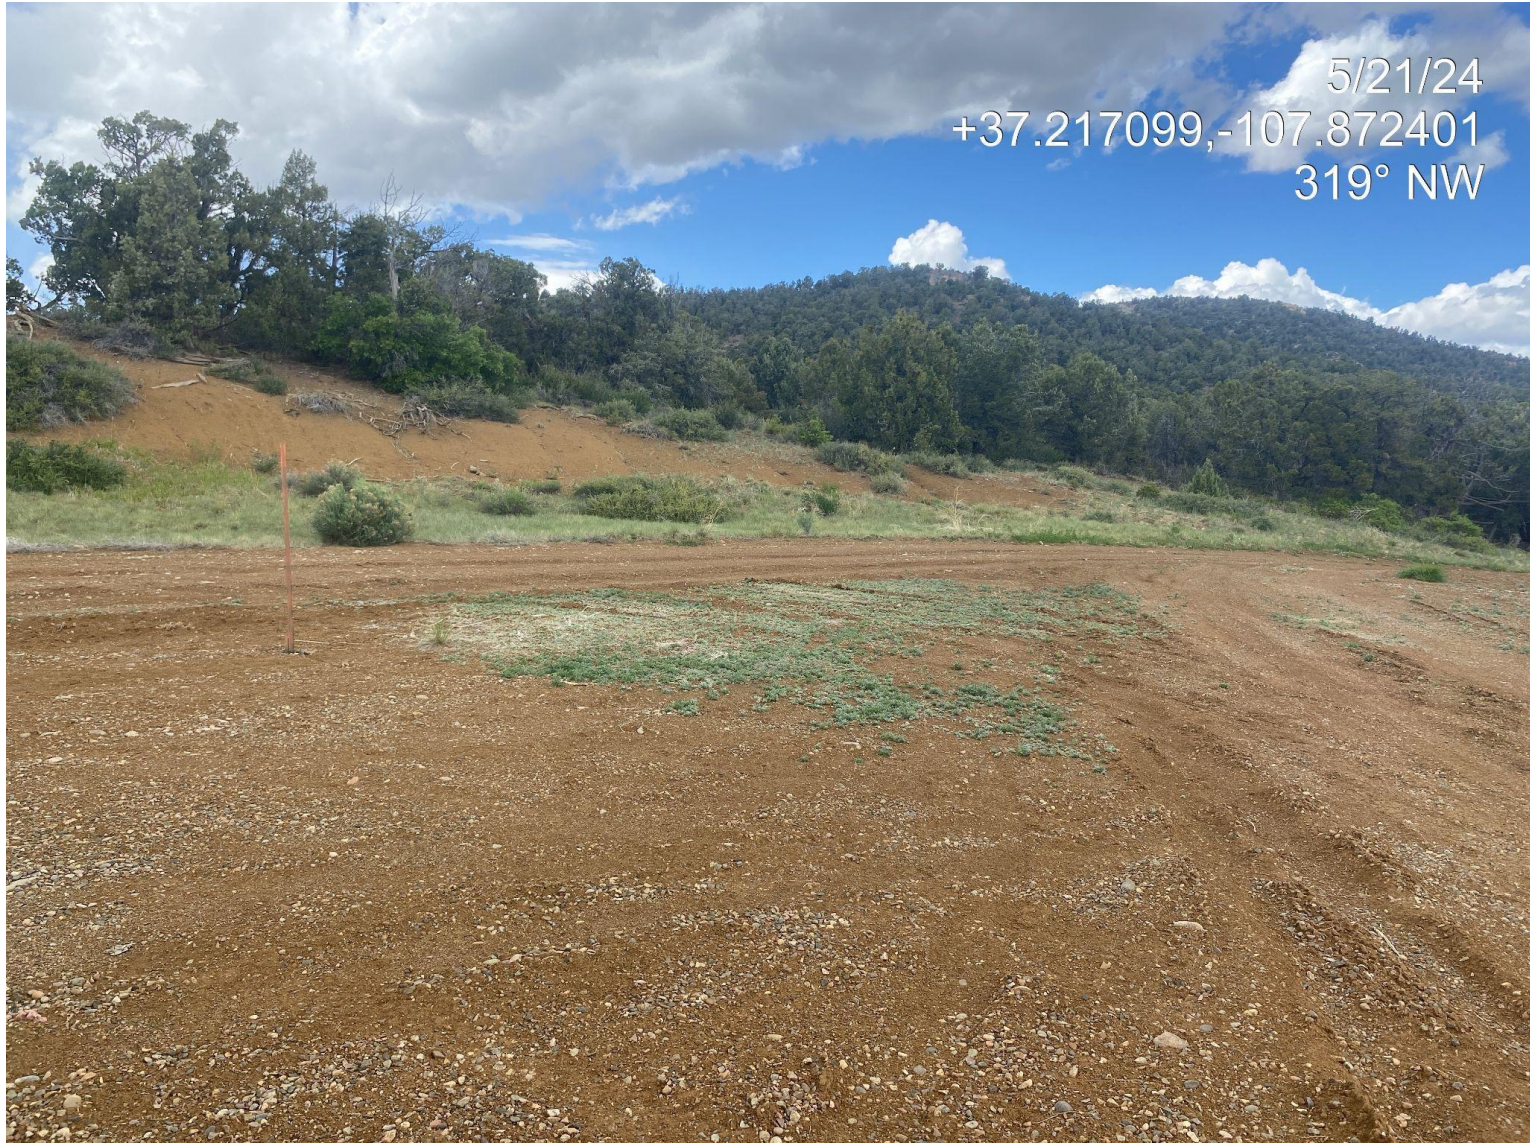
Photo 4. Weedy kochia debris corrective action identified in the previous inspection doc #714000030 has been addressed/resolved.

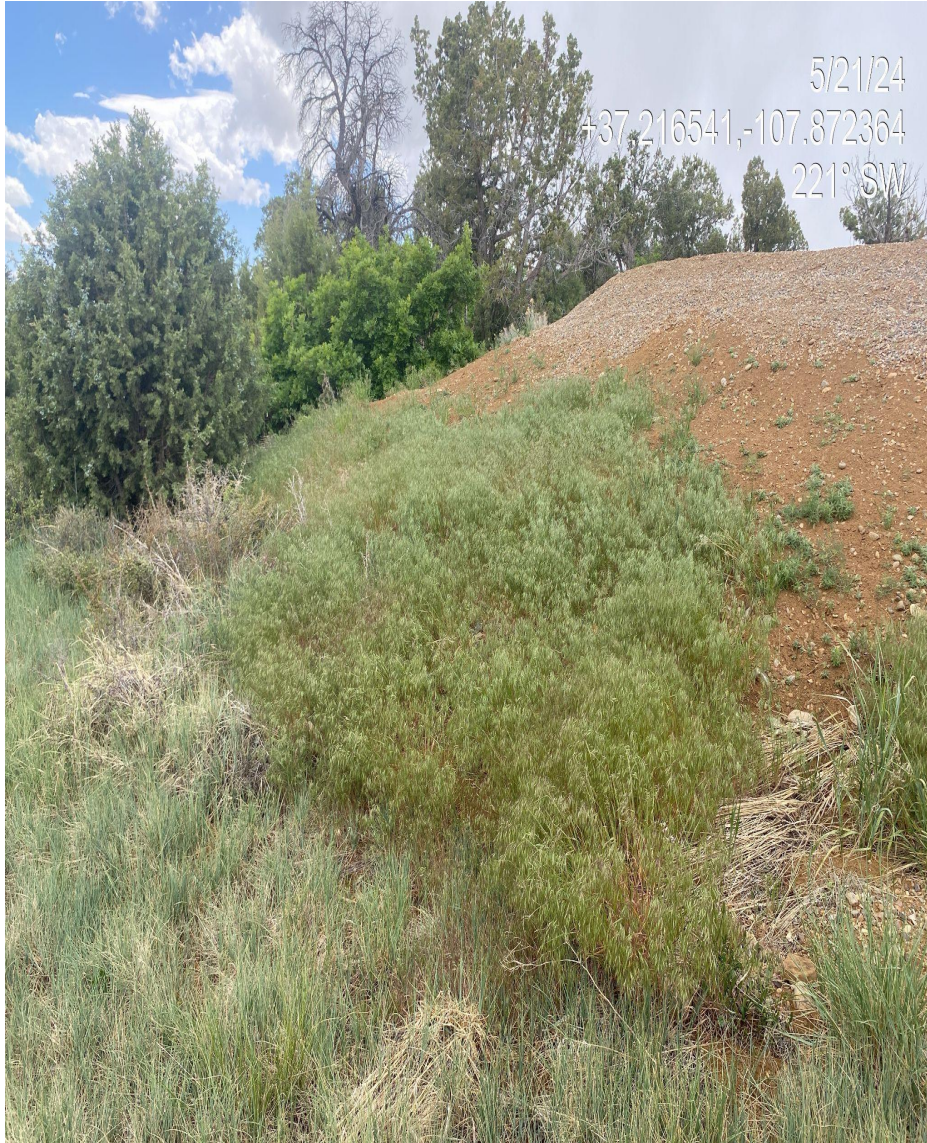
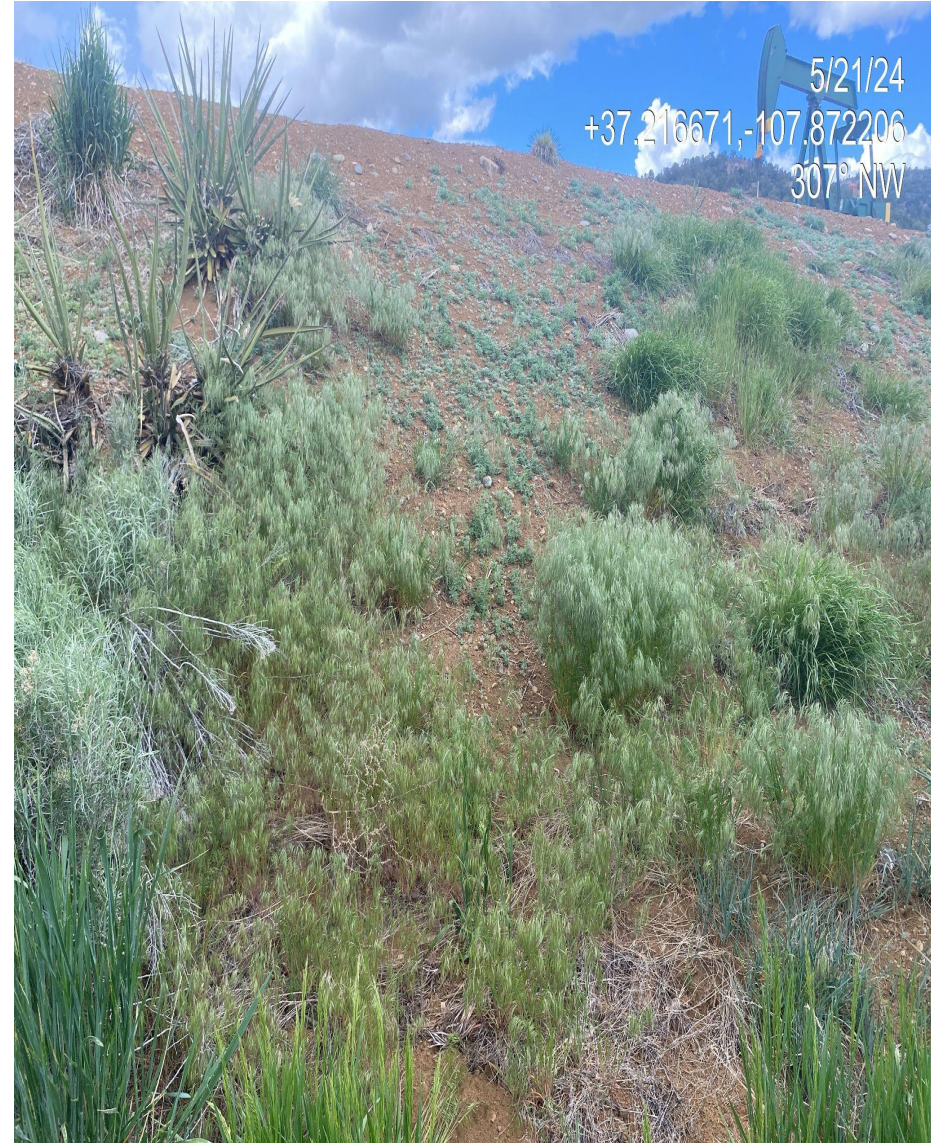
Photo 5. Large patches of cheatgrass observed in the eastern portion of the disturbance along the fill slopes.

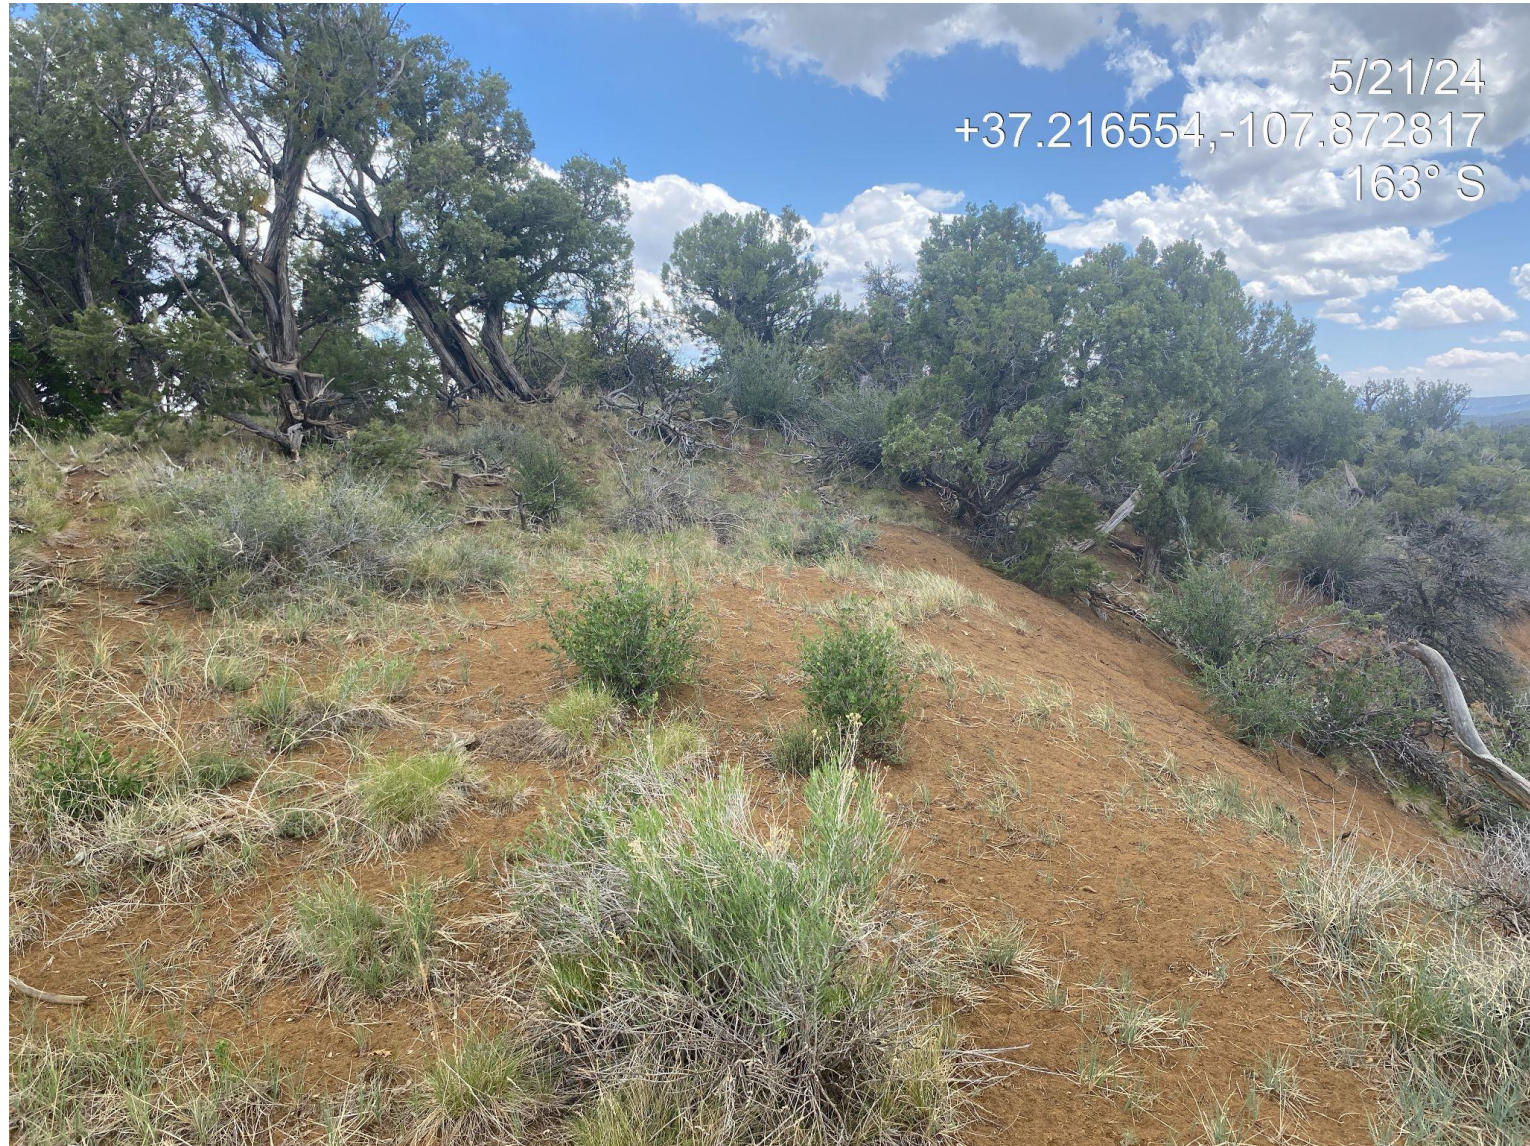
Photo 6. View of the reference area comprised of rabbitbrush, indian rice grass, mountain mahogany and juniper.
