Inspection Photos

Operator: GUNNISON ENERGY LLC - 10515

Location ID: 453805

Inspection Doc: 696205840

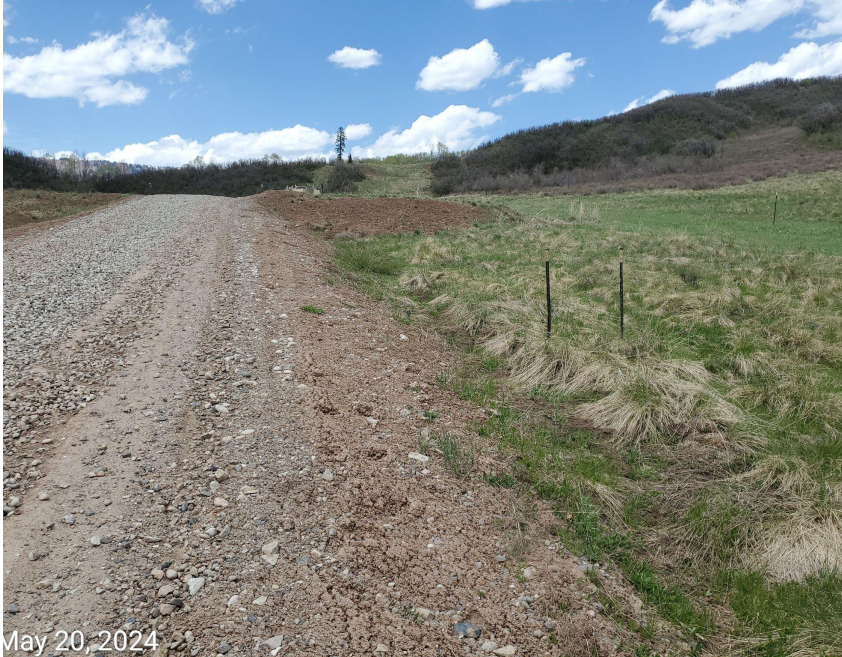
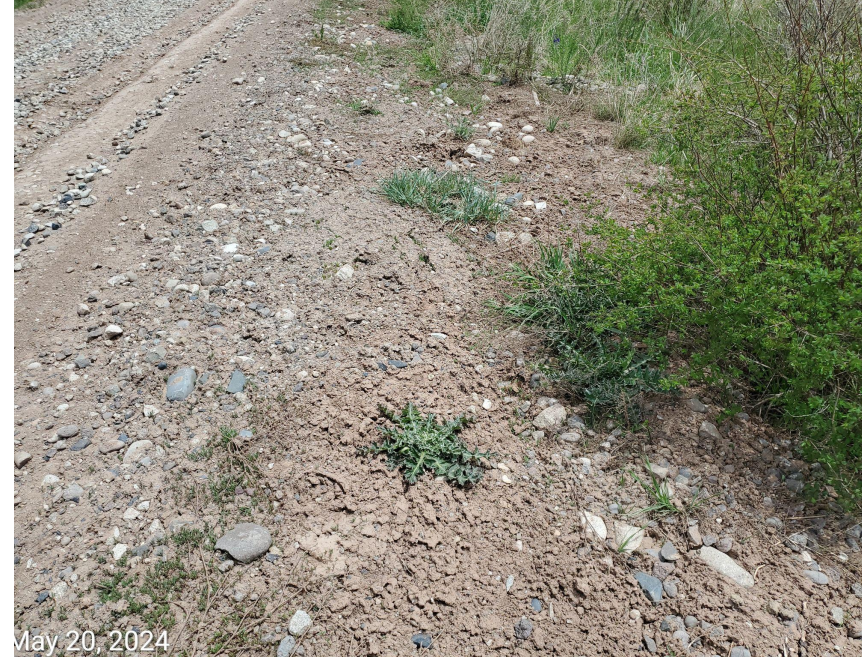
Photo 1: Photos taken from the access road. Photo left shows Location signage has been removed. Photo right example showing noxious weeds observed establishing along the access road.

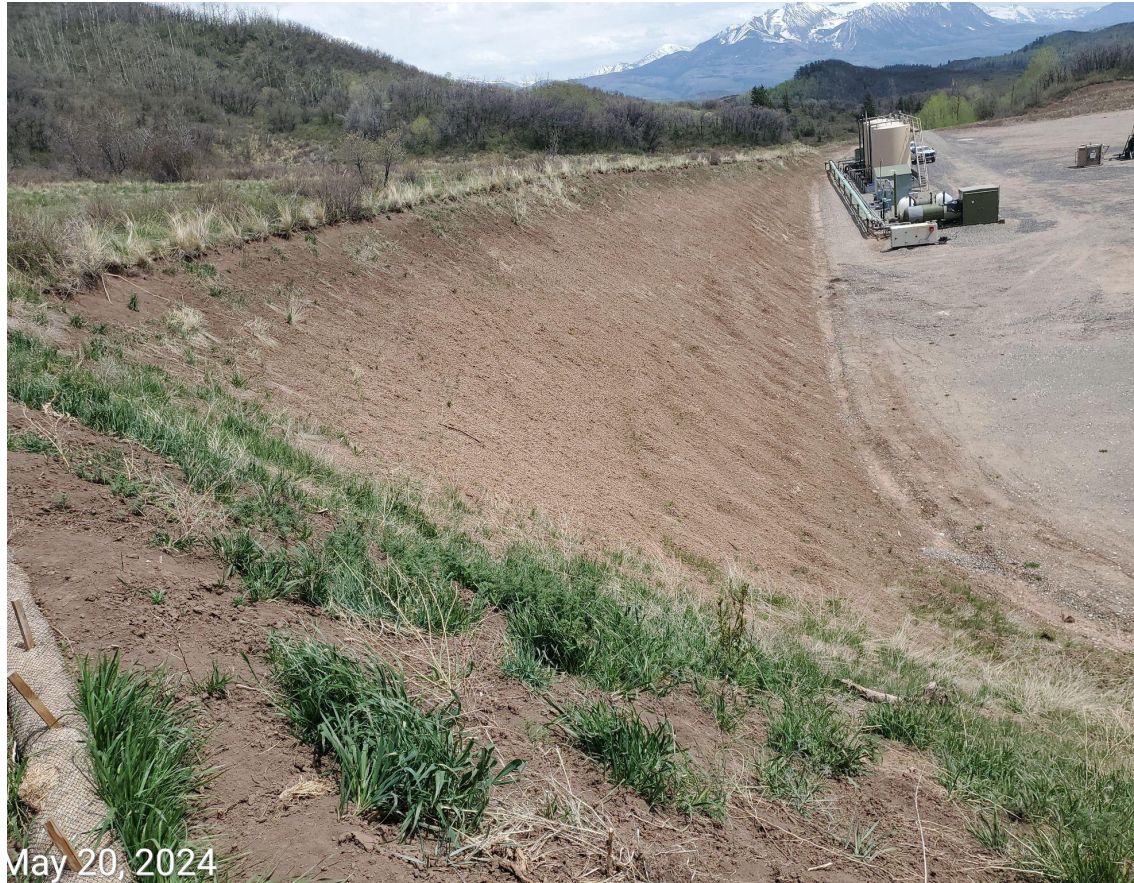
Photo 2: Photo taken from the north end of the Location, facing south. Photo shows stormwater and erosion controls remain missing or insufficient at the cut slopes; slope is bare, exposed and at risk to wind and water erosion. It is noted that there are areas where vegetation is establishing on the cut slopes, however this appears to be from seed within topsoil sediment that has been eroded/transported from the unstabilized stockpile, onto the cut slope during runoff events.

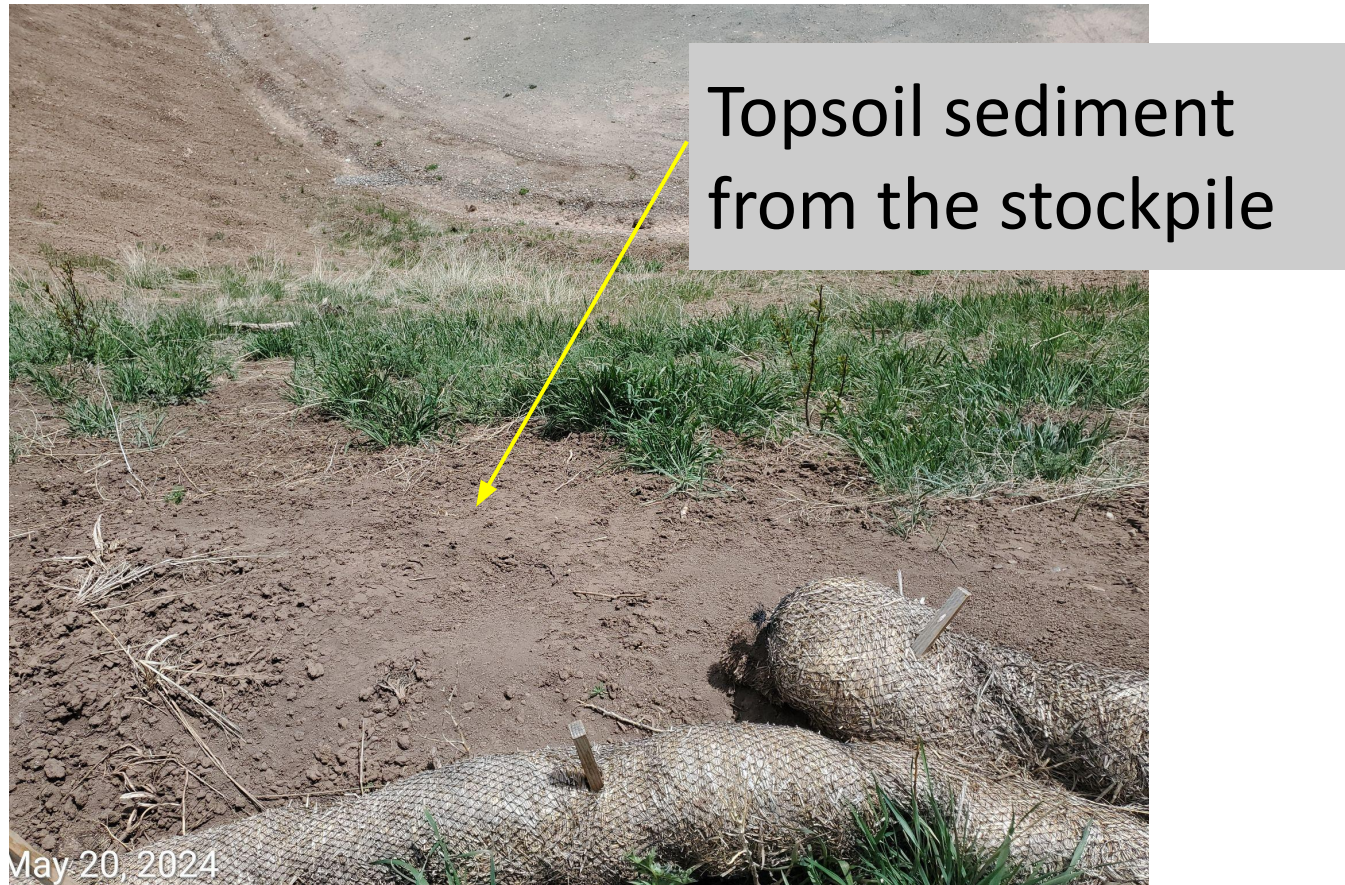
Photo 3: Continued from photo 2- There are areas where vegetation is establishing on the cut slopes, however this appears to be from seed within topsoil sediment that has been eroded/transported from the unstabilized stockpile, onto the cut slope during runoff events.

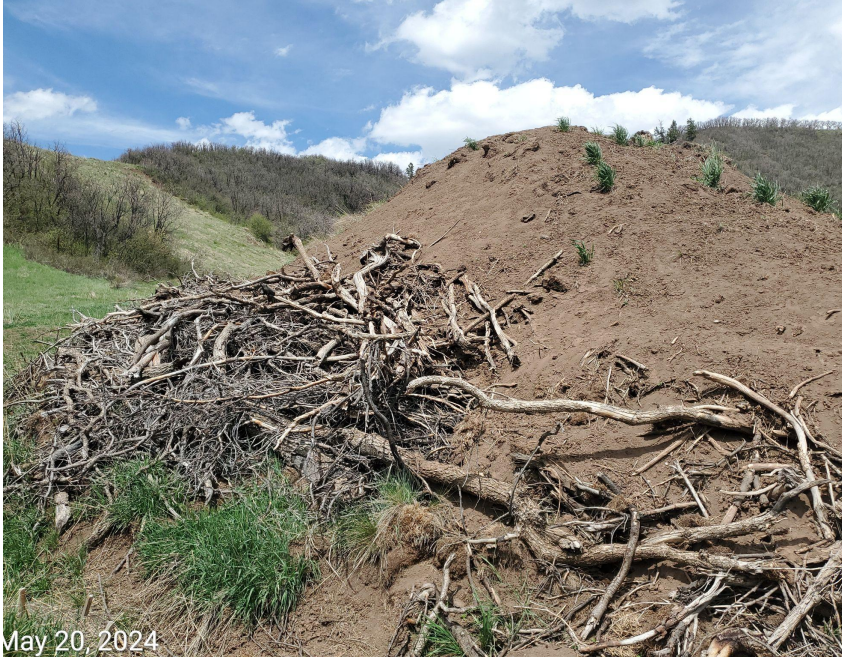
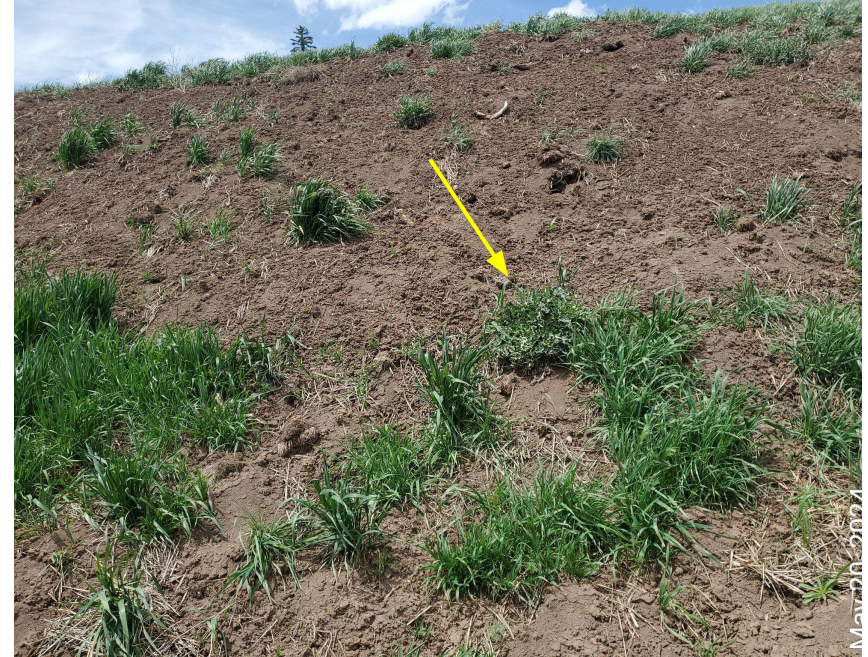
Photo 4: Photos examples showing BMPs to protect the topsoil stockpile have not been installed or maintained in proper functioning condition. Photo right also example showing noxious weed establishment at the topsoil stockpile (Musk thistle).

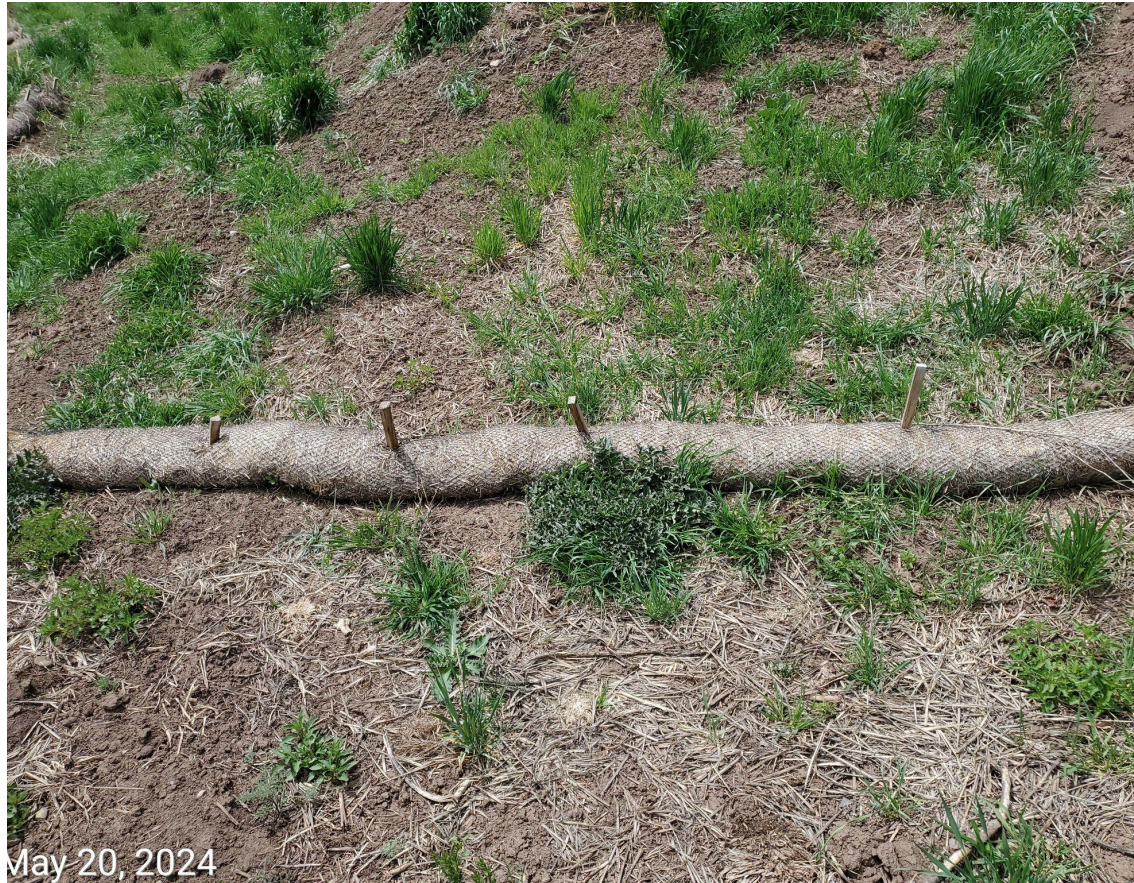
Photo 5: Photo taken from the topsoil stockpile. Photo example showing noxious weed establishment at the topsoil stockpile (Musk thistle).

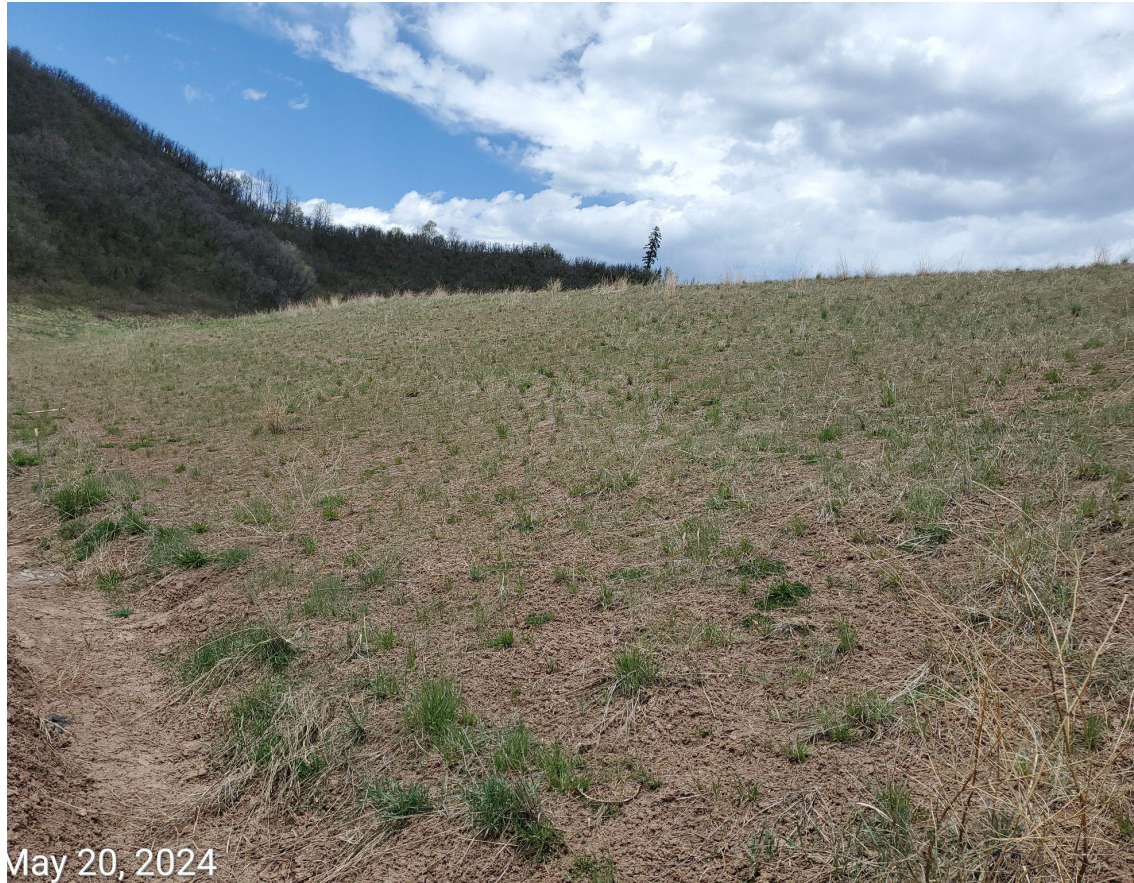
Photo 6: Photo taken from the fill slopes. Photo shows vegetative establishment at the fill slopes appears uniform. Immediate stormwater and erosion issues not apparent at fill slopes.
