Inspection Photos

Location Name: TEP ROCKY MOUNTAIN LLC MOBIL W-20-32 Pad

Location ID: 311555

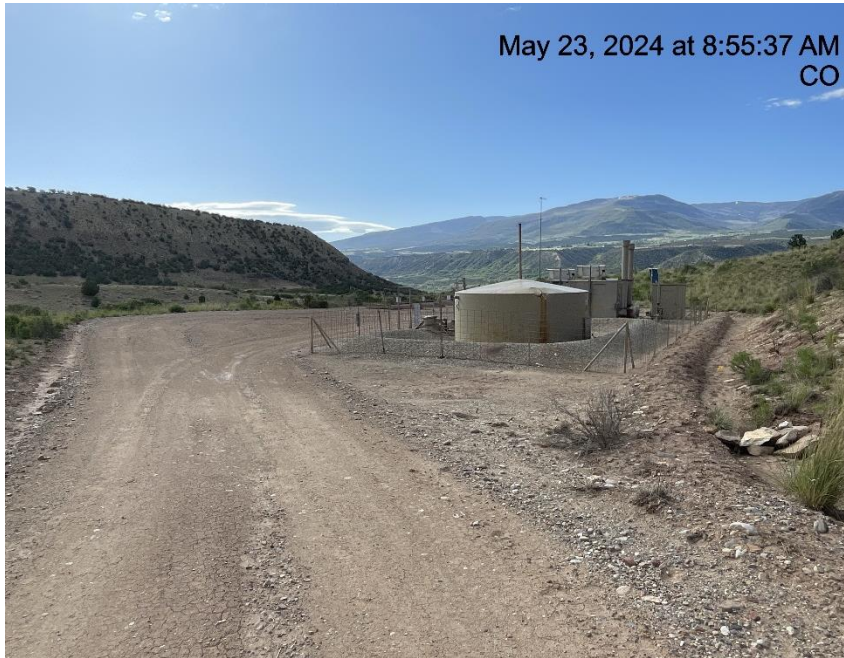
Photo # 8091 From entrance to location

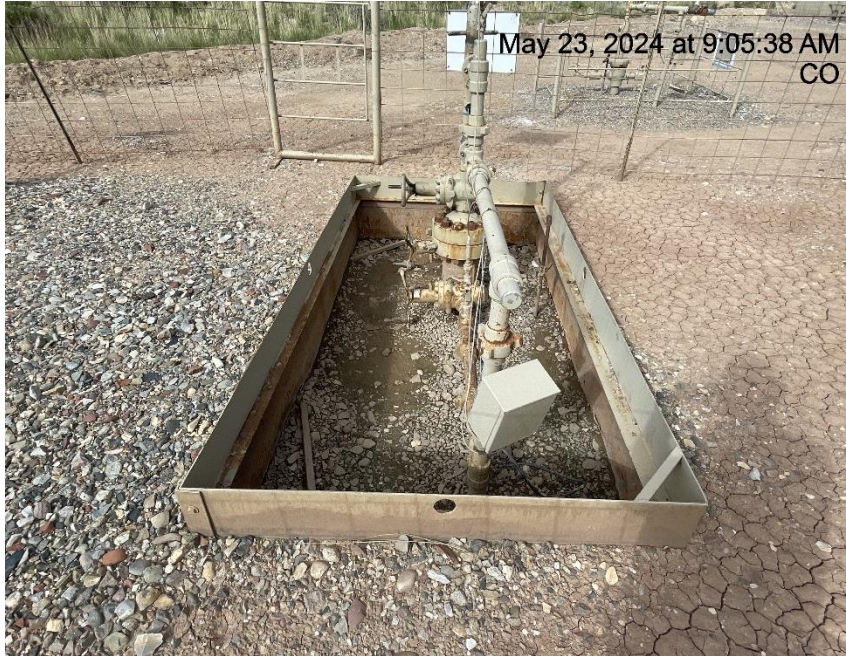
Photo # 8097 Wellhead cellar lacks wildlife protection /wildlife hazard/available for entry by wildlife. Cellar also lacks wildlife egress.

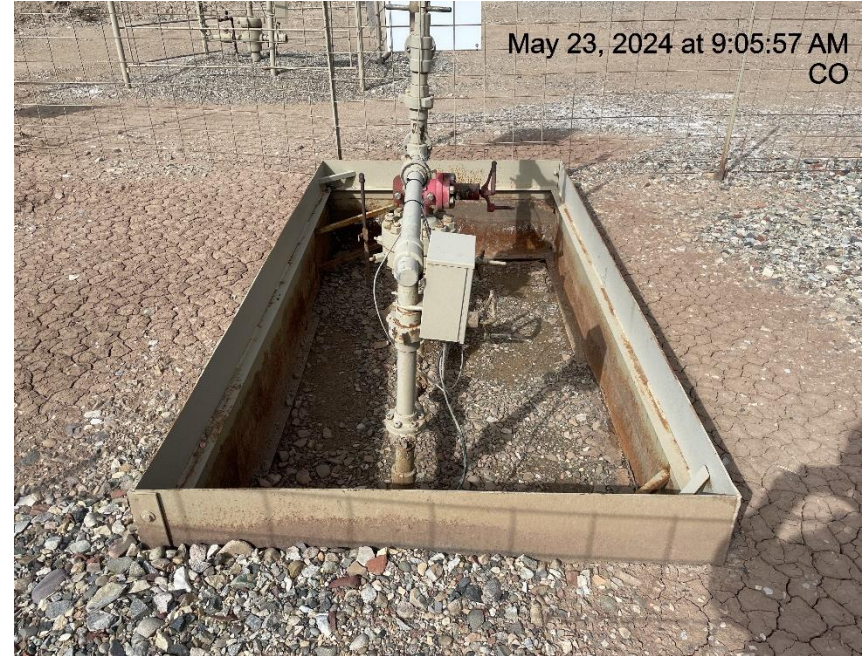
Photo # 8098 Wellhead cellar lacks wildlife protection /wildlife hazard/available for entry by wildlife. Cellar also lacks wildlife egress.

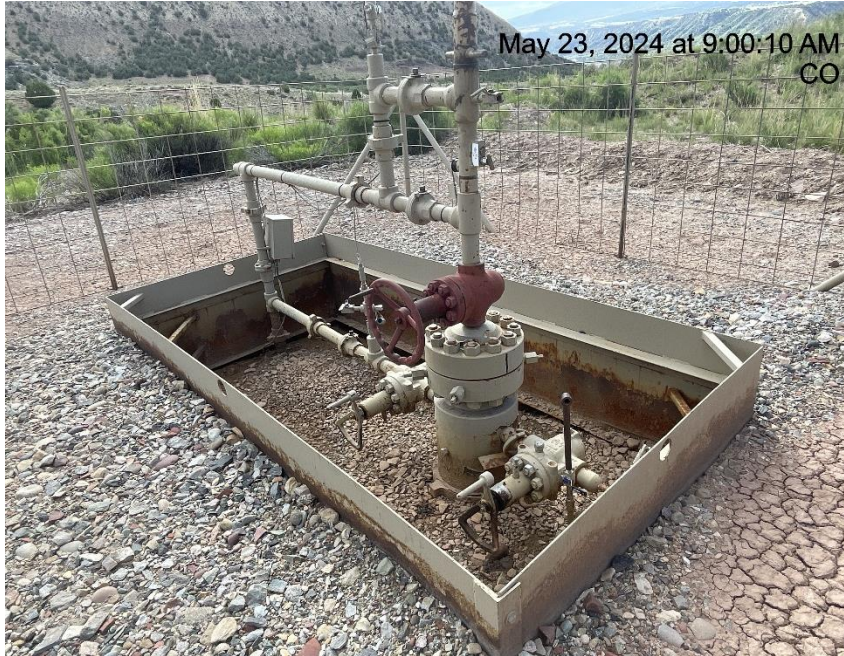
Photo # 8099 Wellhead cellar lacks wildlife protection /wildlife hazard/available for entry by wildlife. Cellar also lacks wildlife egress.

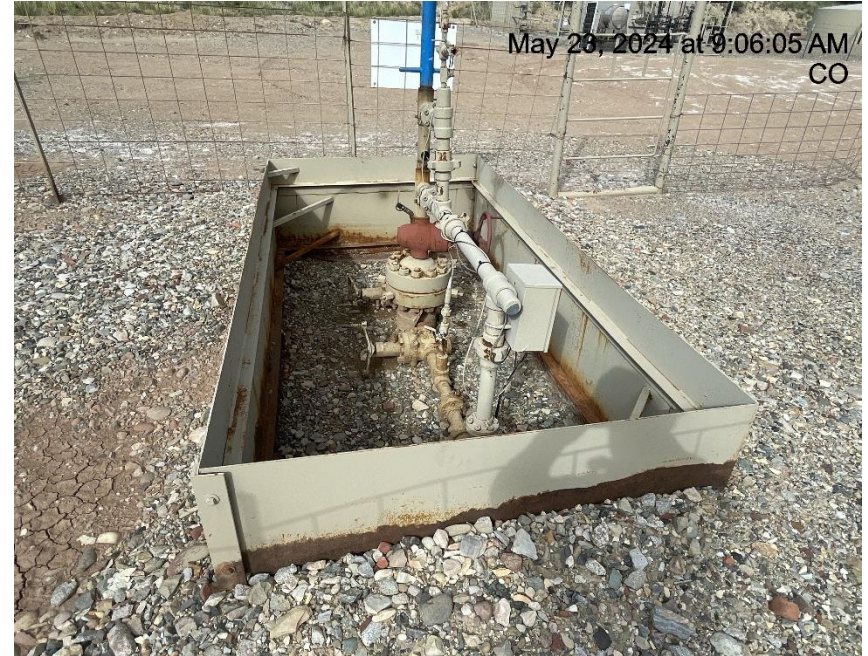
Photo # 8100 Wellhead cellar lacks wildlife protection /wildlife hazard/available for entry by wildlife. Cellar also lacks wildlife egress.

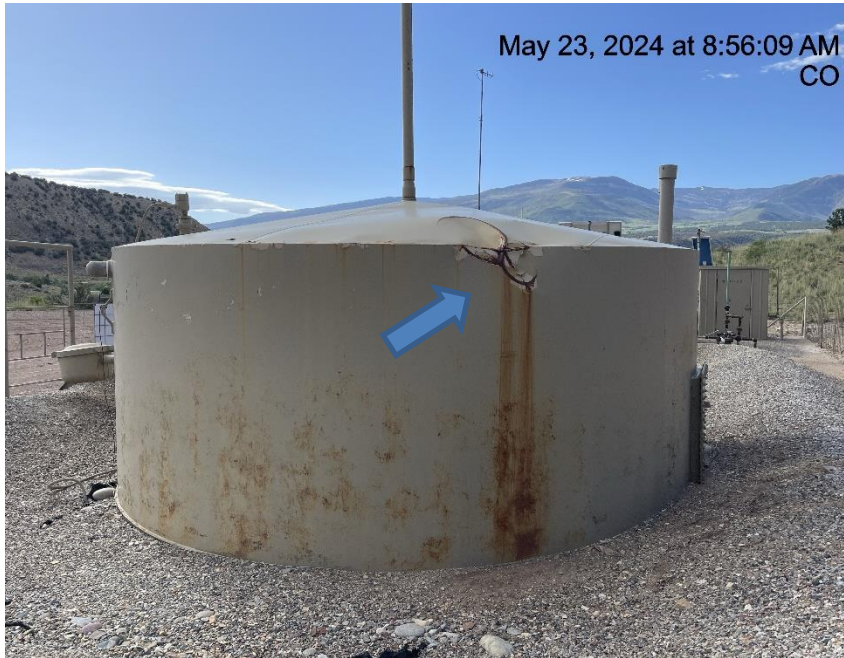
Photo # 8101 Production tank damaged

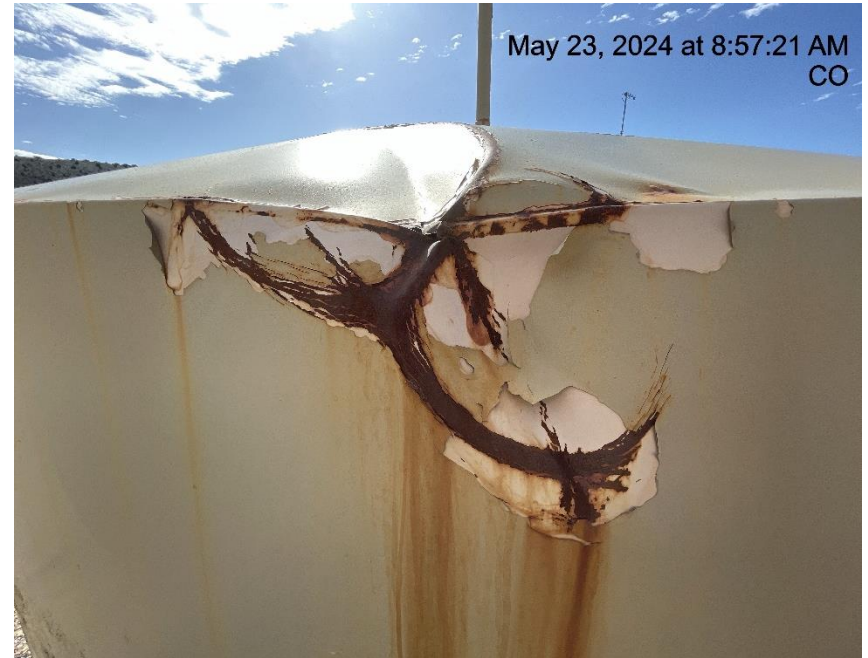
Photo # 8102 Production tank damaged
