Storm Water Management and Erosion control

Location Name: TEP ROCKY MOUNTAIN LLC WASATCH BENCH WATER MGMT FACILITY

Location ID: 414907

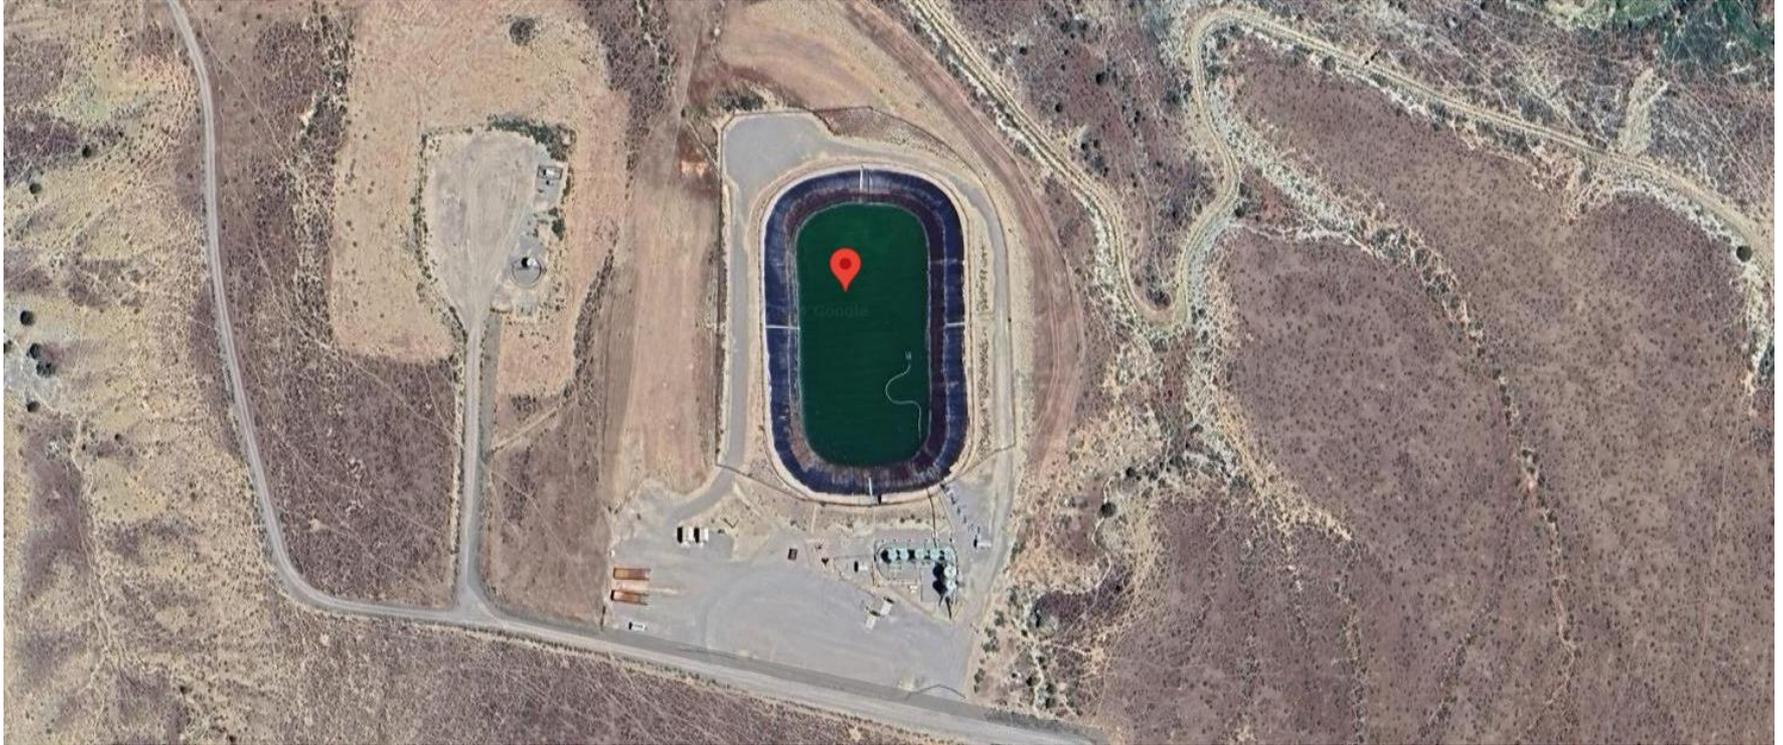
Location Overview: Location is within High Priority/Density/Black Bear Habitat areas & in close proximity to NSO Habitat area. Location is within Rule 411a Surface Water Internal & Intermediate Buffers. Location is approximately 222 yards from Mamm Creek.

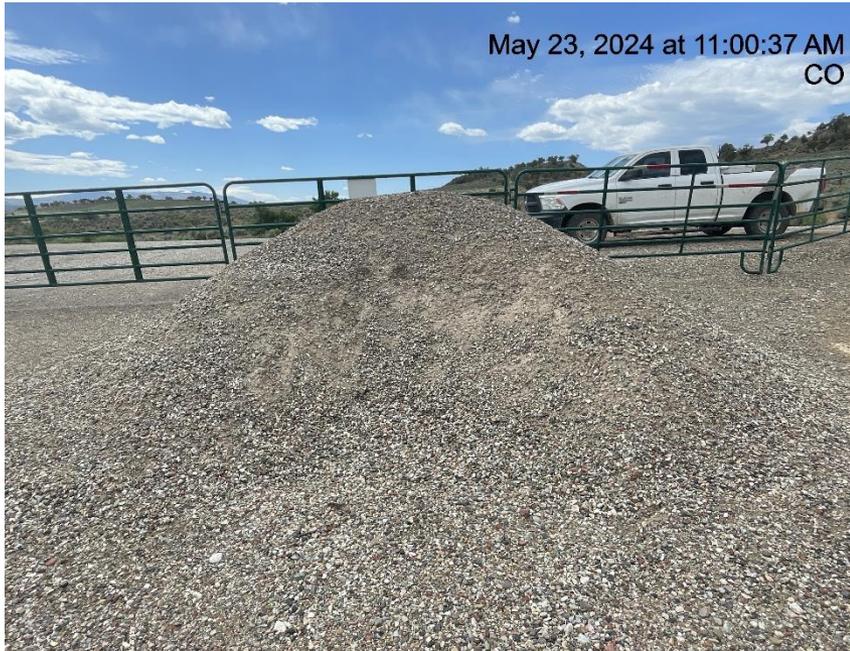
Photo # 8202 Stockpiled soils with no BMP's

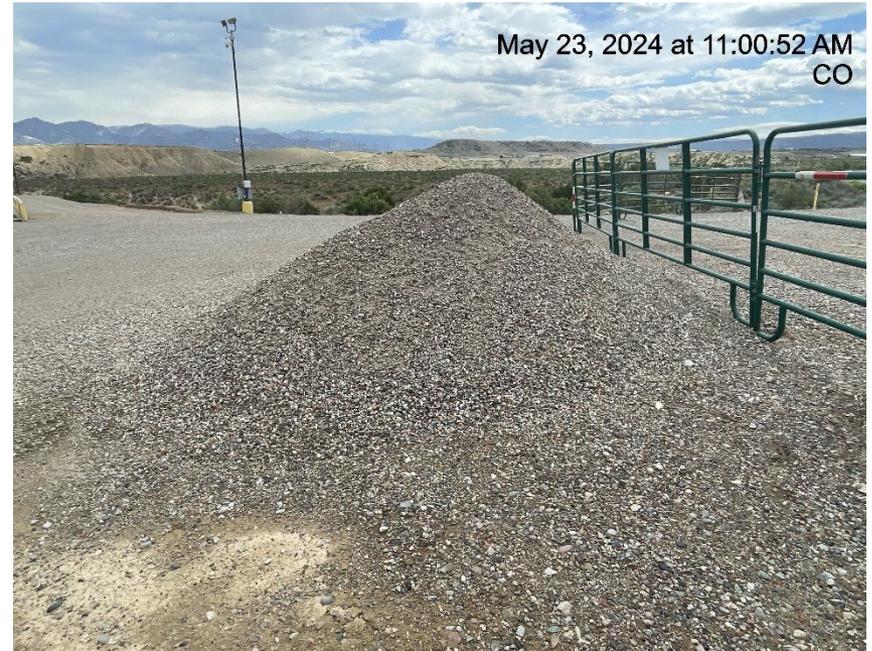
Photo # 8203 Stockpiled soils with no BMP's

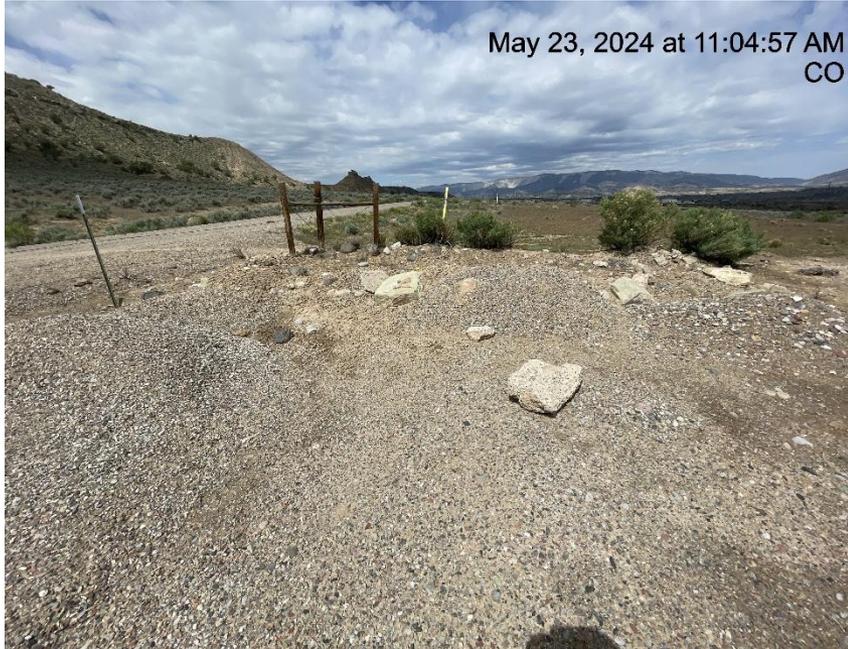
Photo # 8204 Stockpiled soils with no BMP's (S/SW corner)

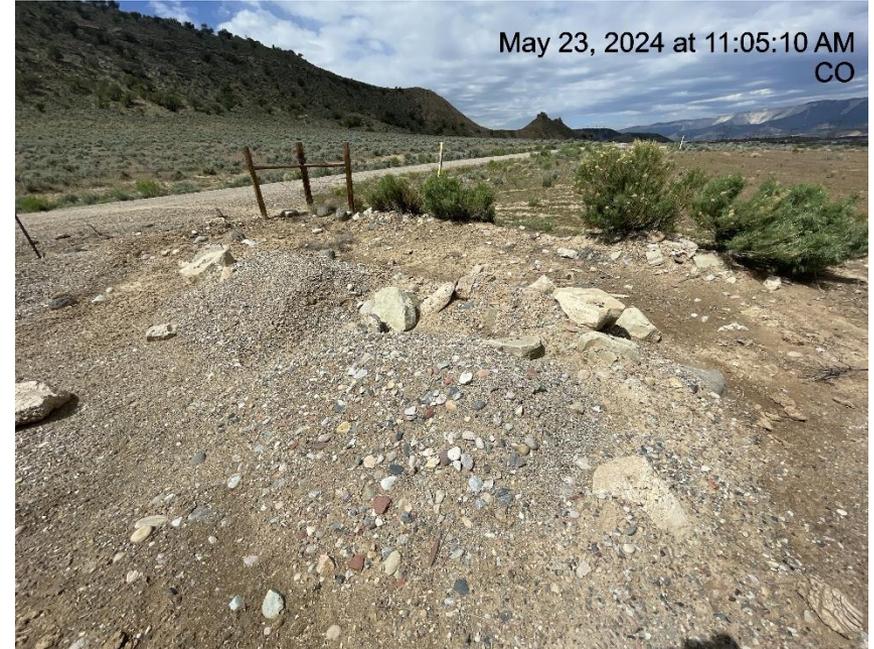
Photo # 8205 Stockpiled soils with no BMP's (S/SW corner)

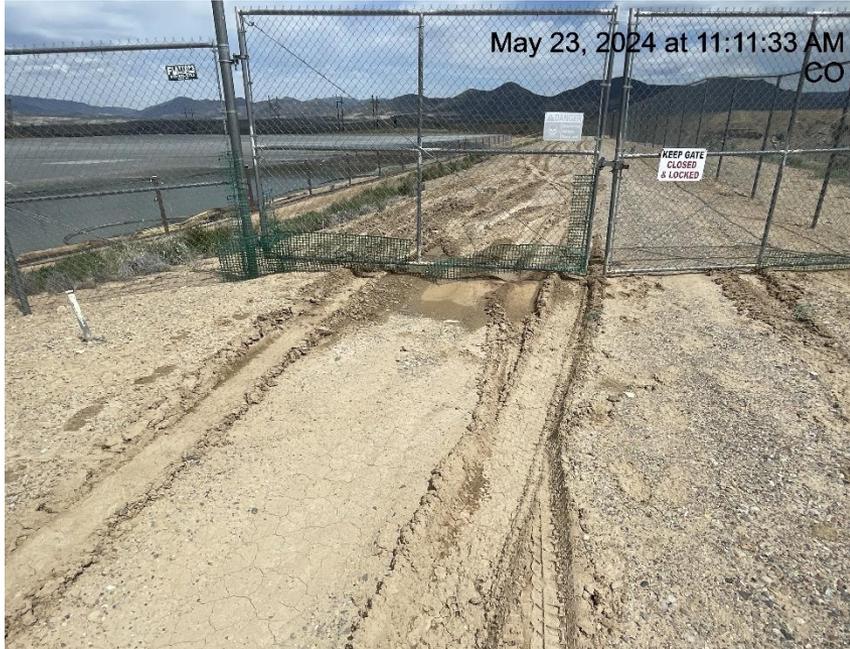
Photo # 8206 Lack of stabilization/compaction

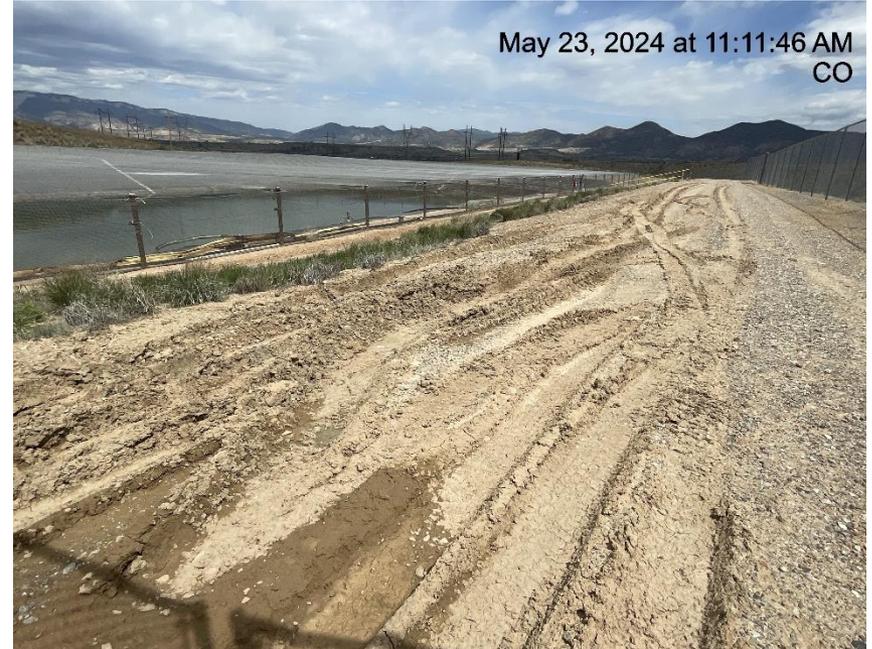
Photo # 8207 Lack of stabilization/compaction

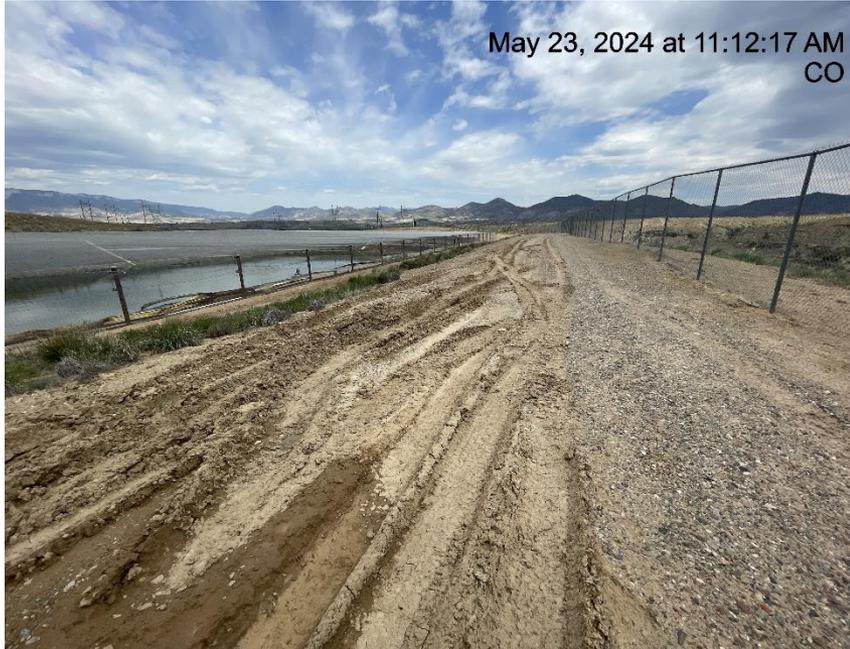
Photo # 8208 Lack of stabilization/compaction

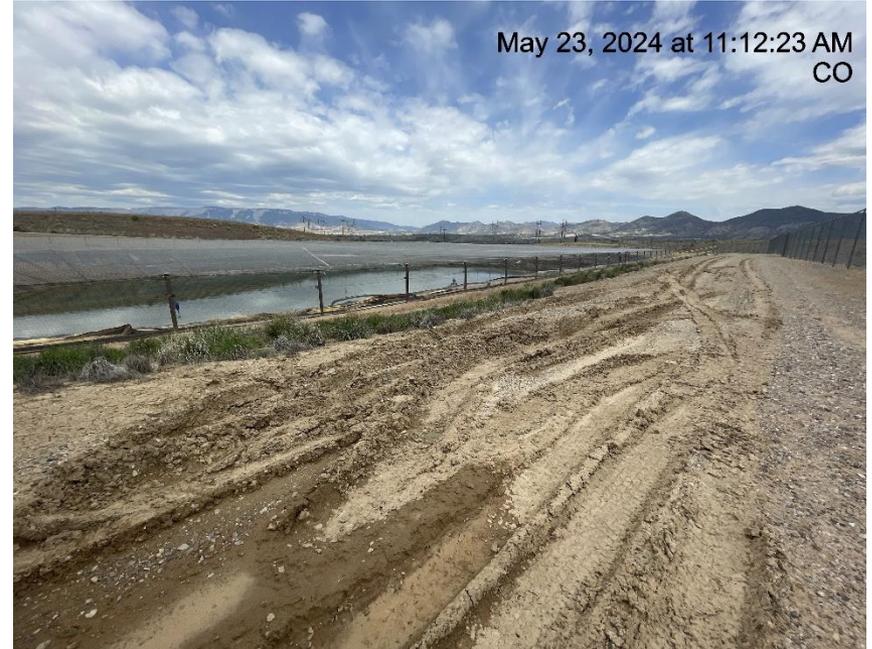
Photo # 8209 Lack of stabilization/compaction

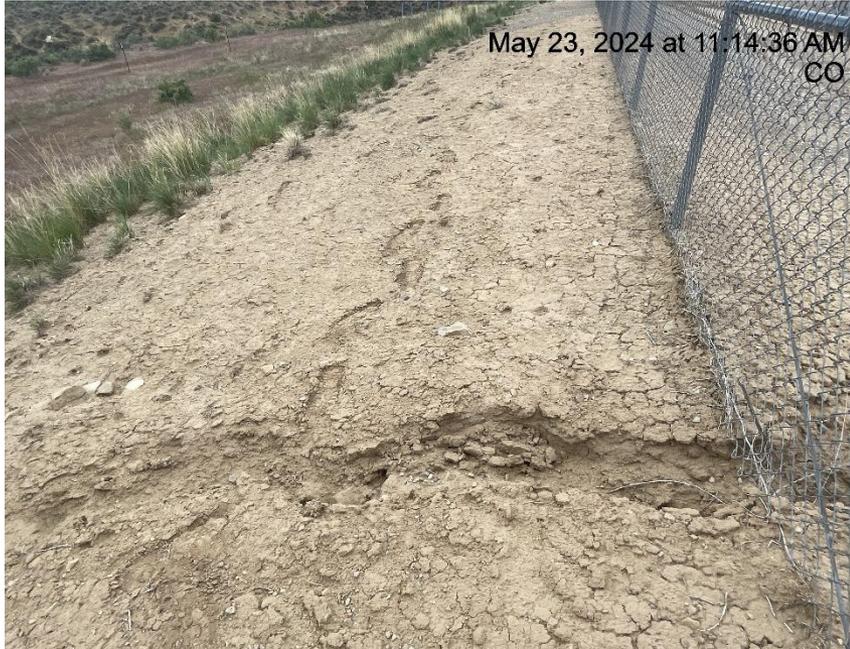
Photo # 8210 Erosion & transport of sediment (East side of location)

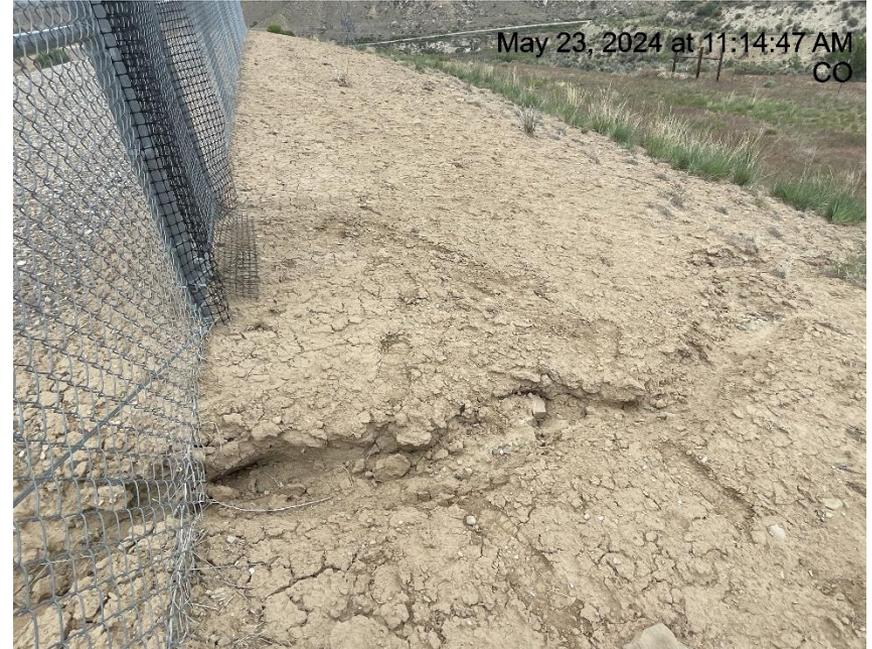
Photo # 8211 Erosion & transport of sediment into a vegetated area (East side of location)

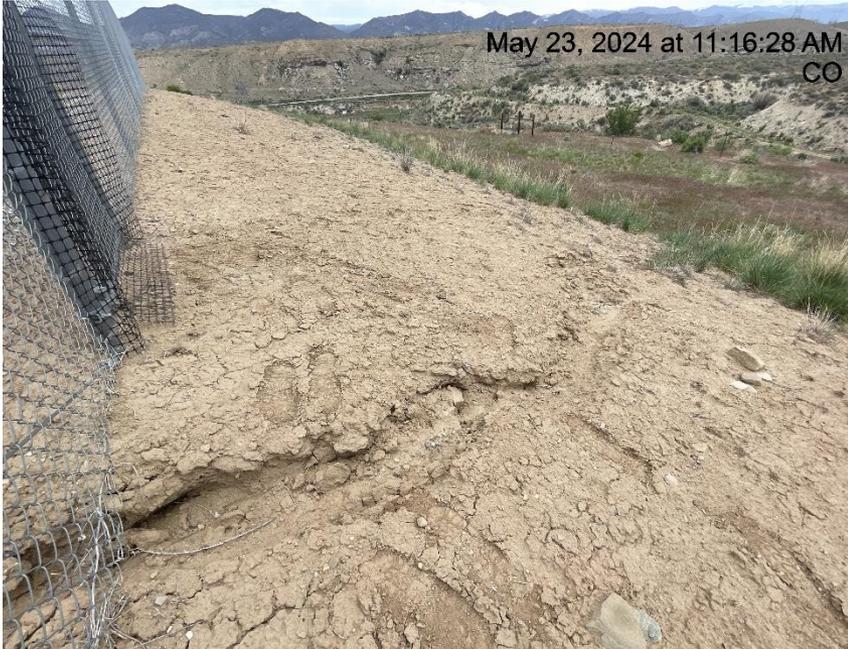
Photo # 8212 Erosion & transport of sediment into a vegetated area (East side of location)

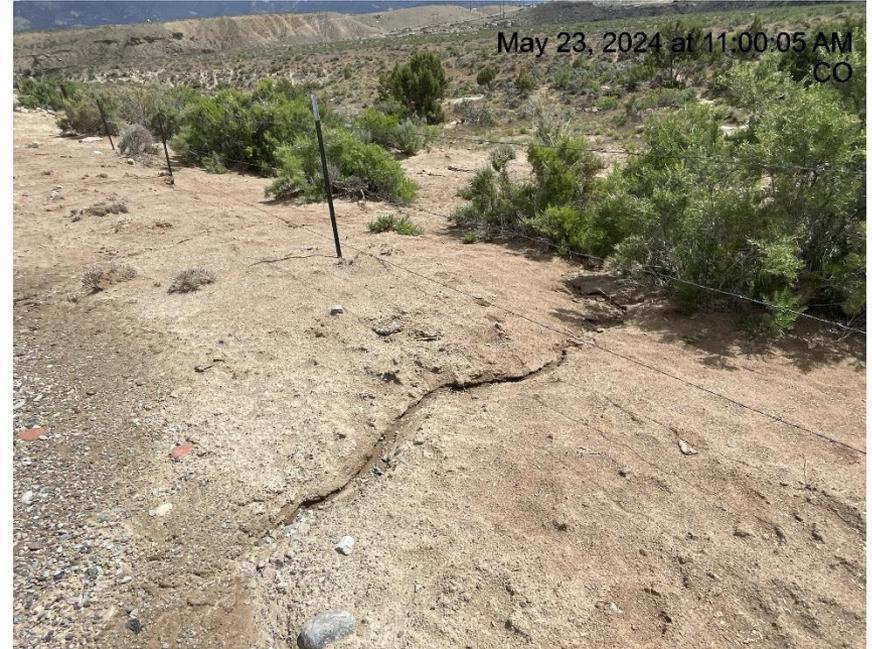
Photo # 8213 Erosion & transport of sediment into a vegetated area (E/SE area of location)

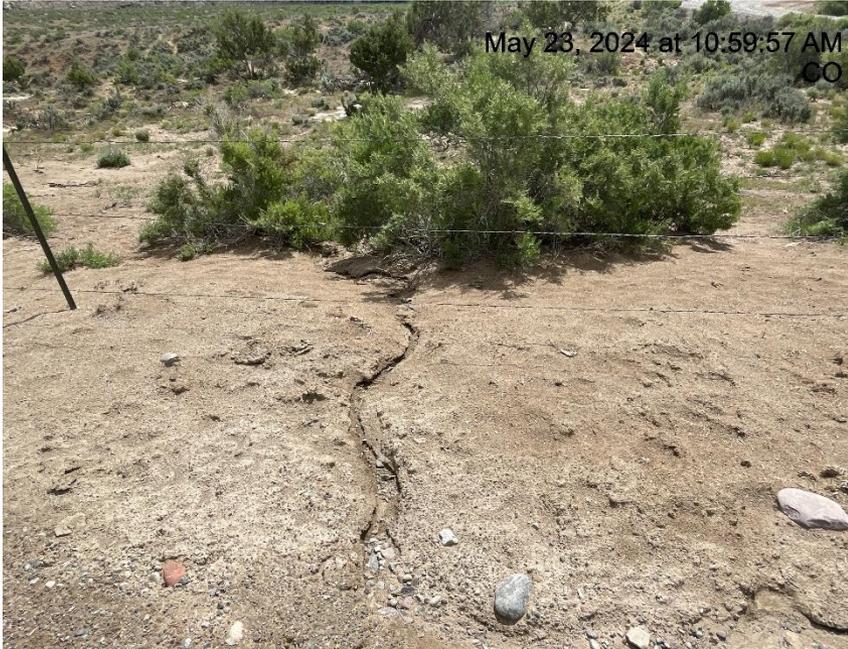
Photo # 8214 Erosion & transport of sediment into a vegetated area (E/SE area of location)
