Inspection Photos

Operator: Simcoe LLC - 10749

Location ID: 325351

Inspection Document #: 714000789

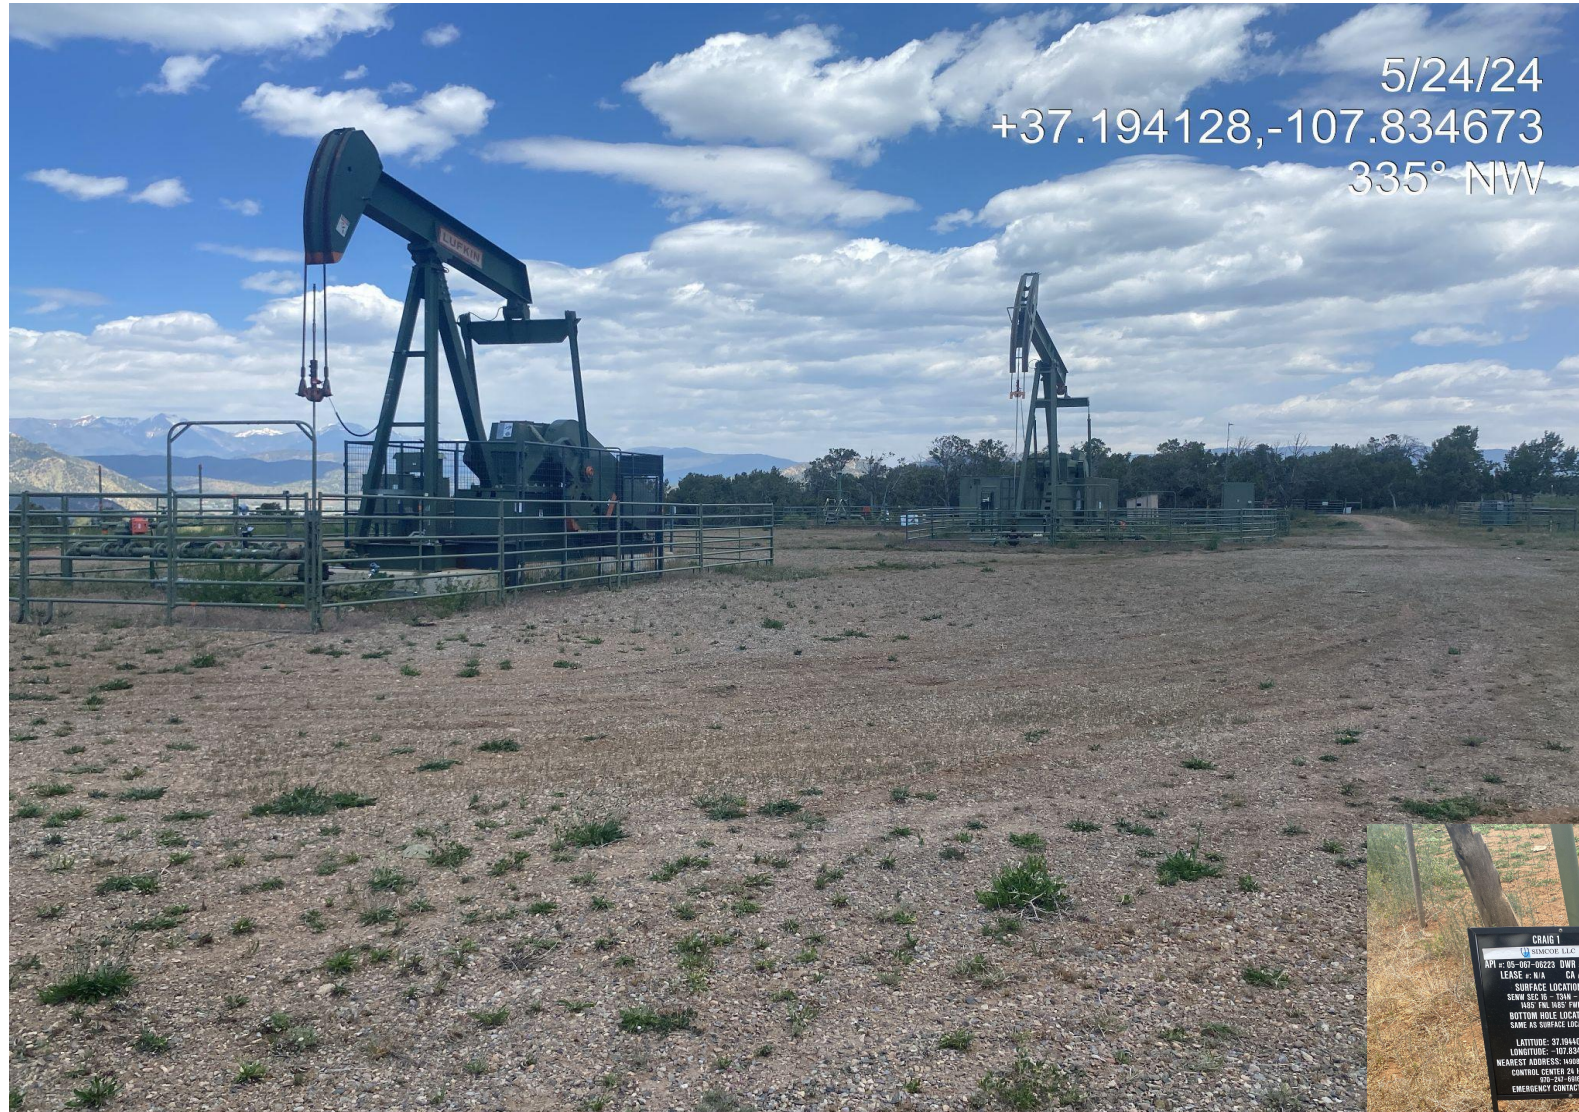
Photo 1. View of the well disturbance taken from the southern edge facing center.

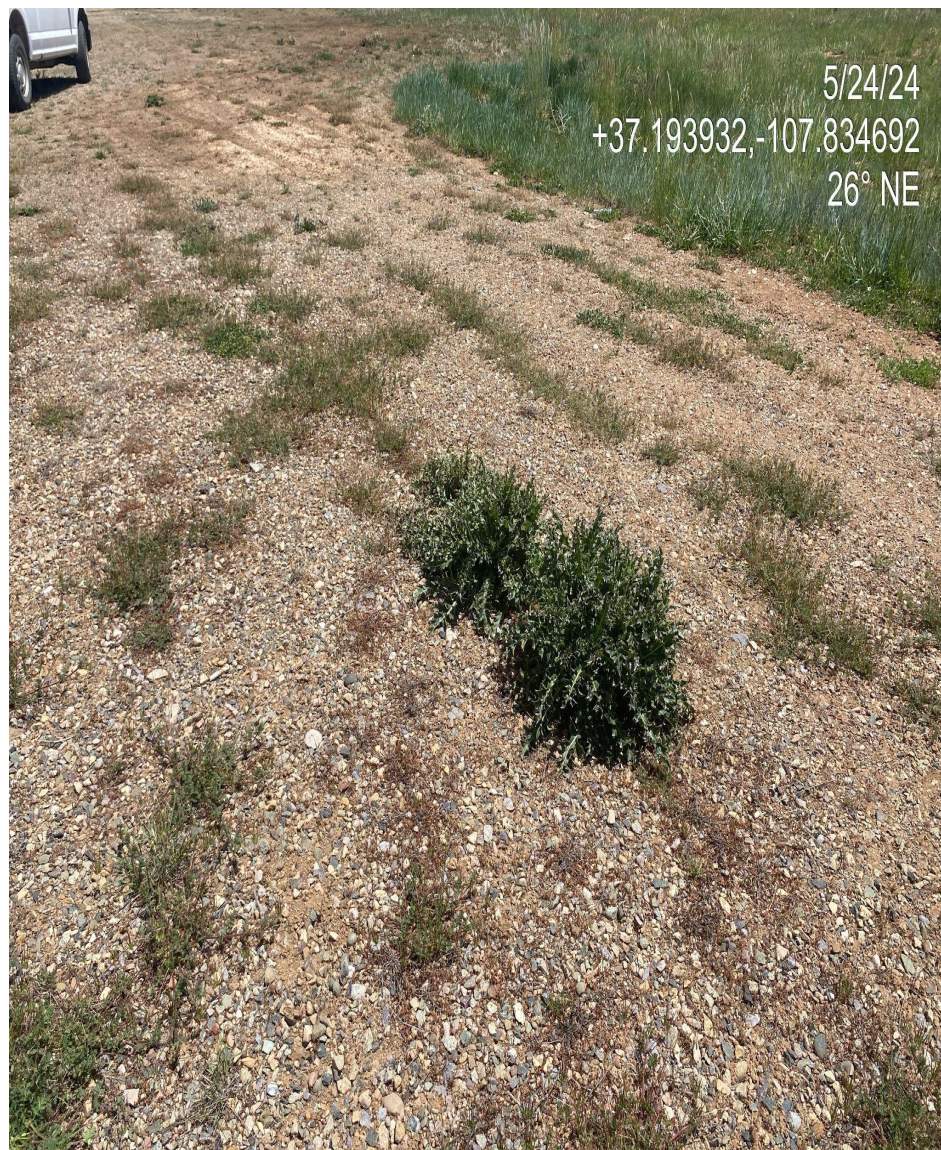
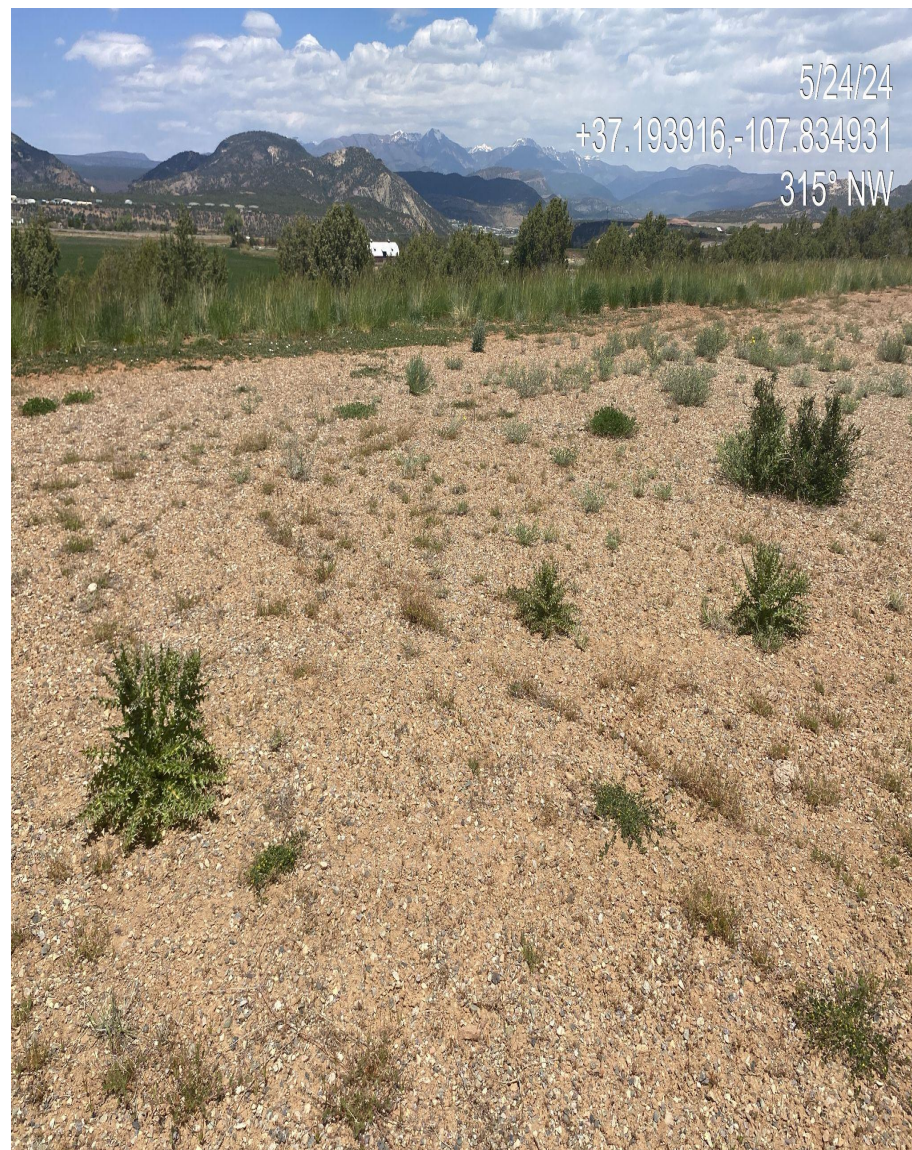
Photo 2. Musk thistle observed on location.

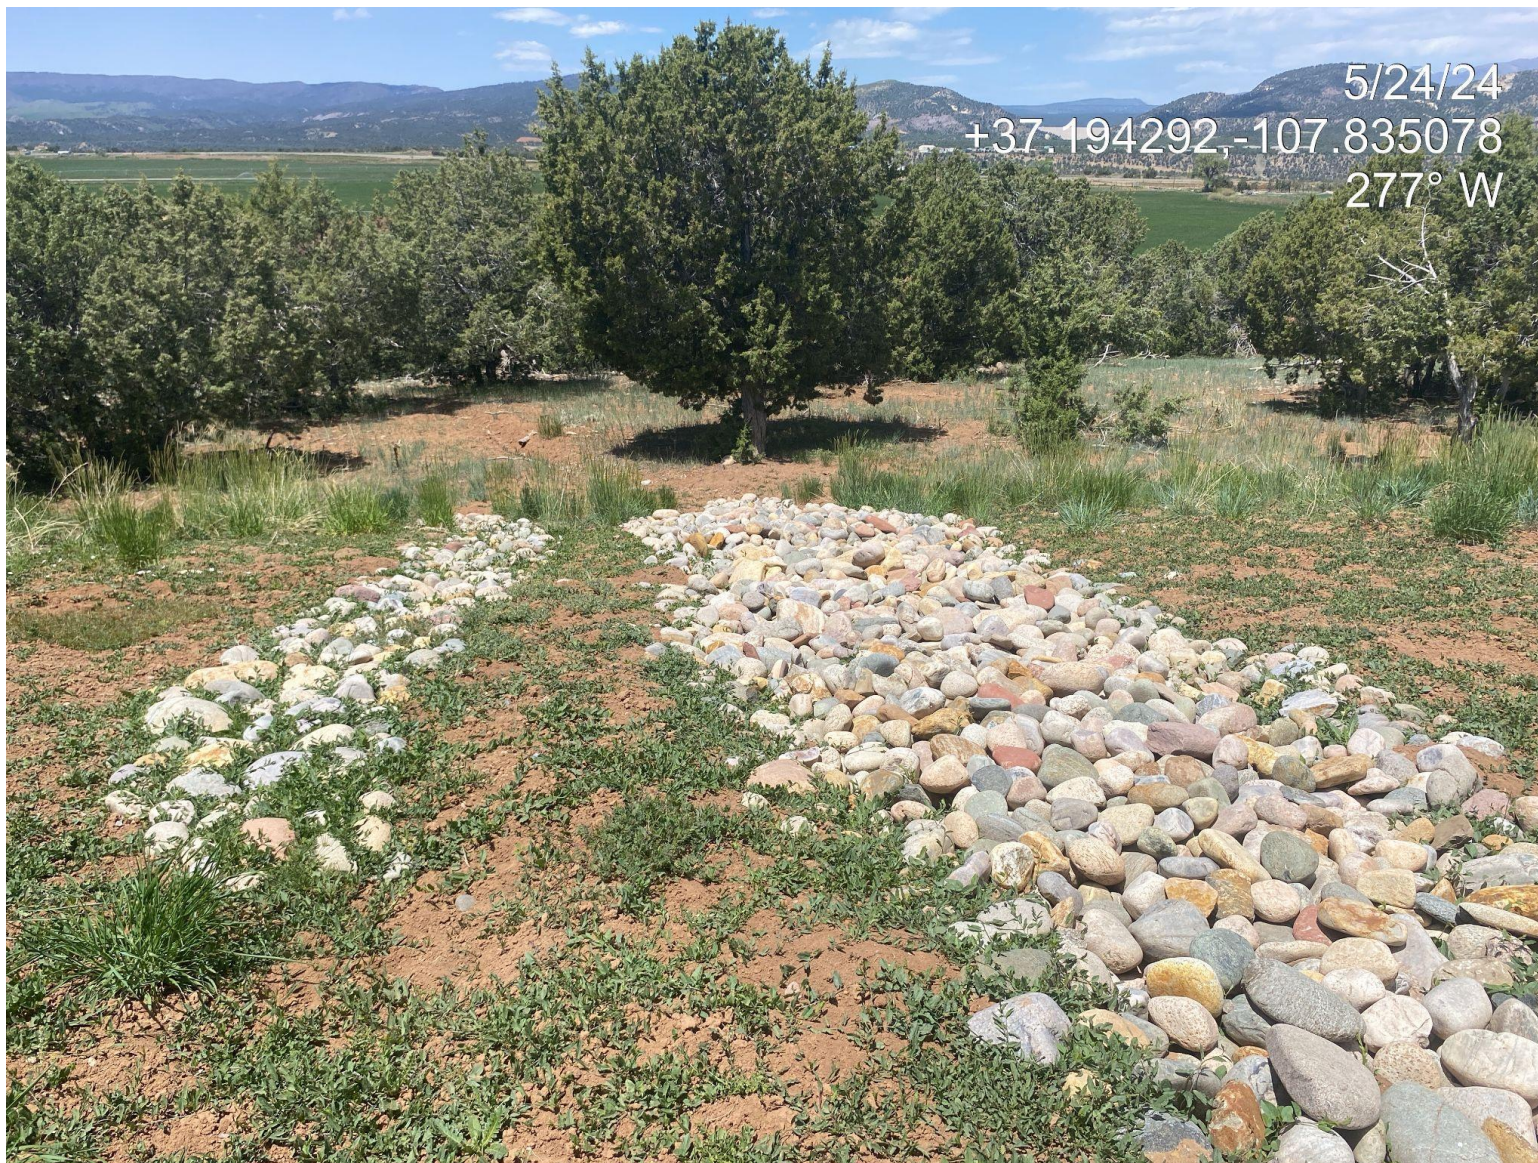
Photo 3. Storm water corrective action identified in the previous inspection doc #714000033 has been addressed/resolved.

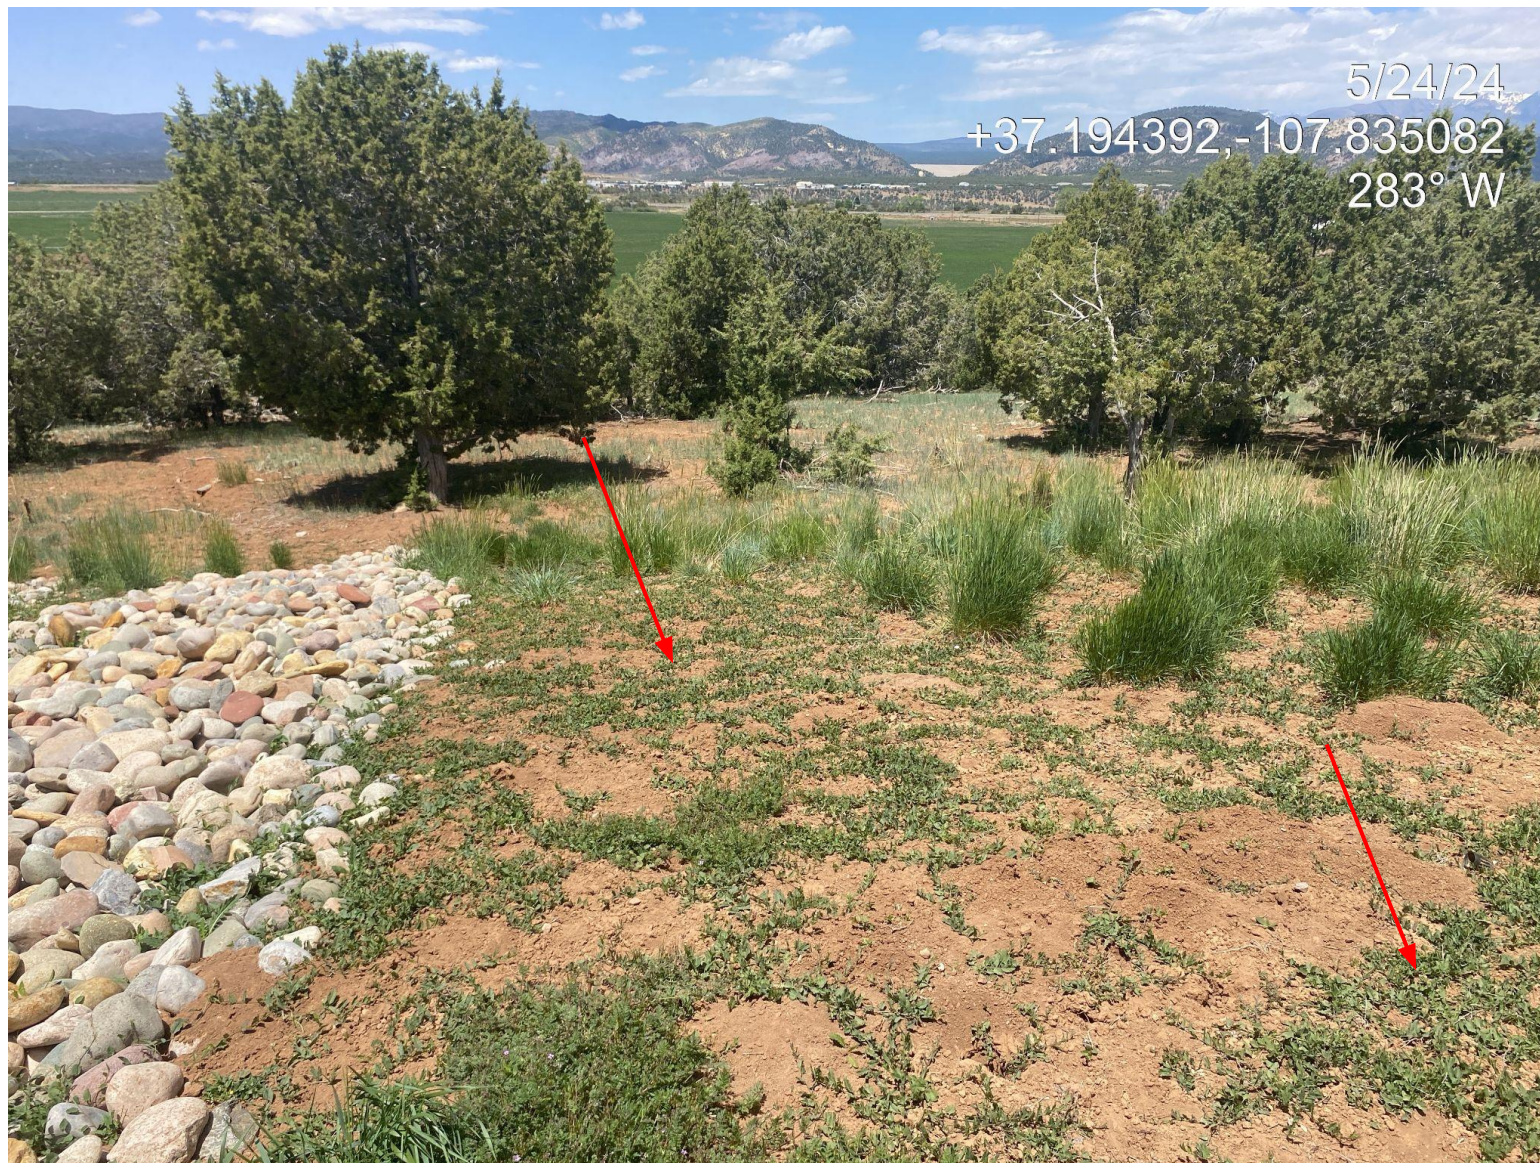
Photo 4. Large patches of field bindweed were observed throughout the western interim reclamation area.

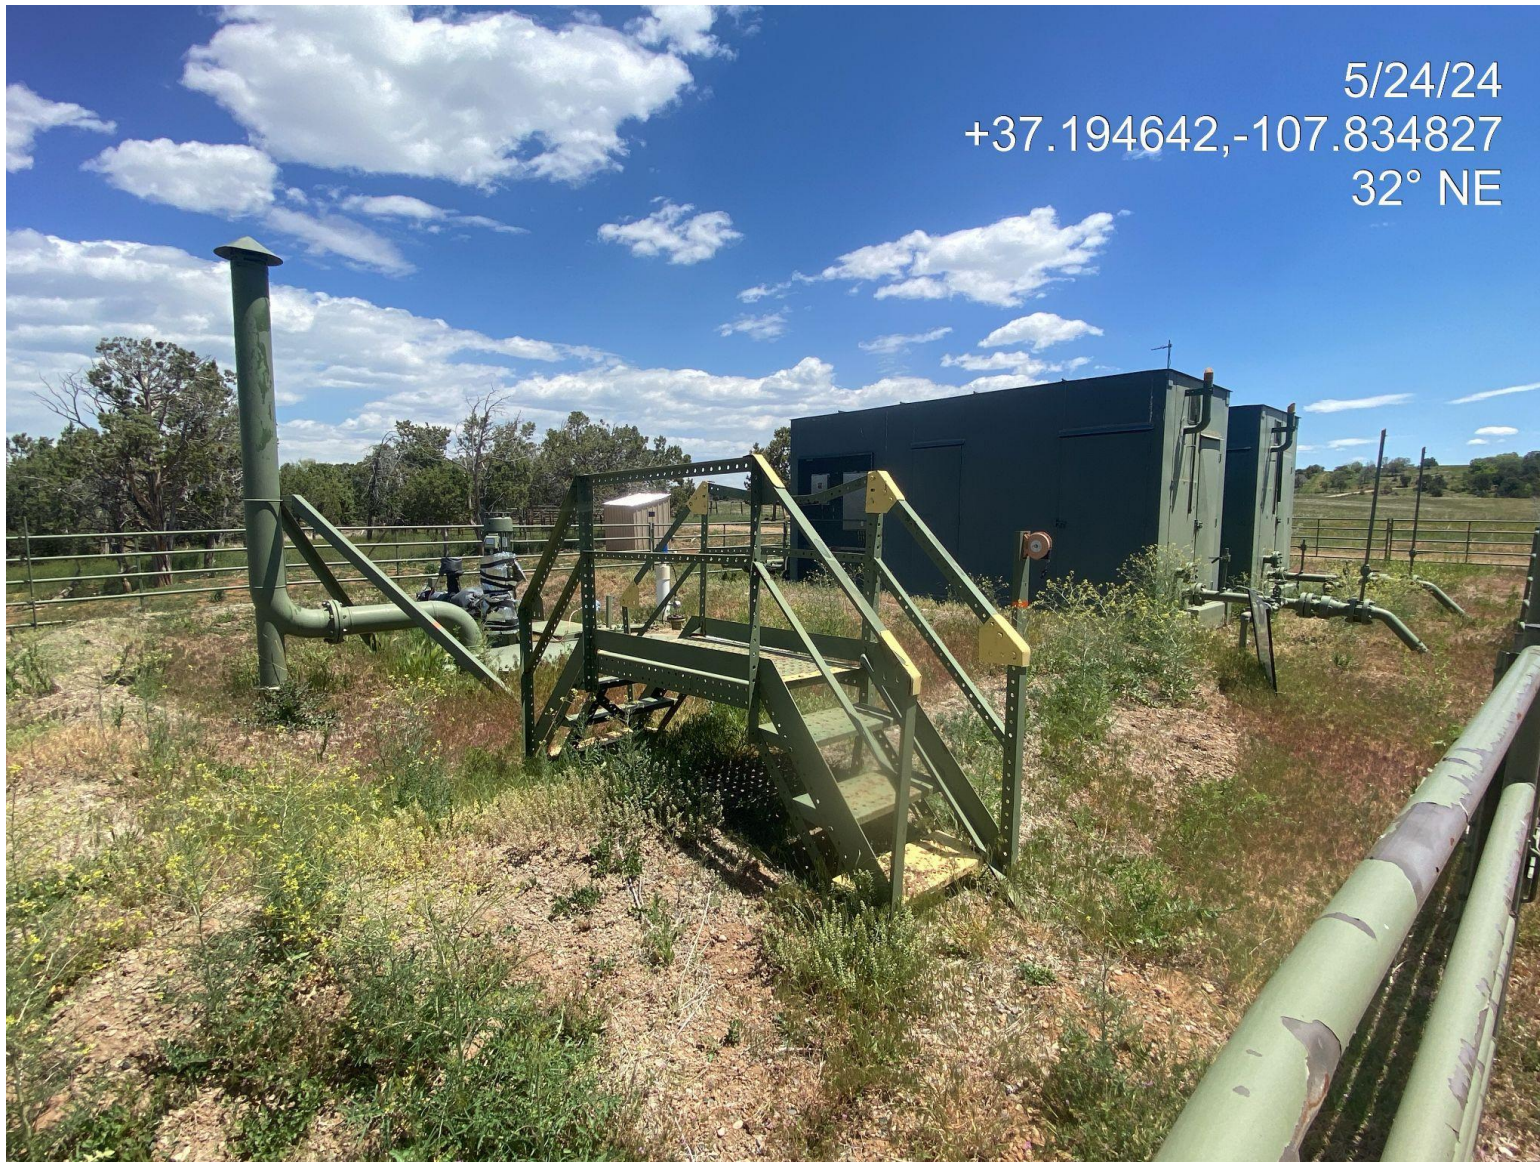
Photo 5. Weedy vegetation observed at active equipment and berms on location.

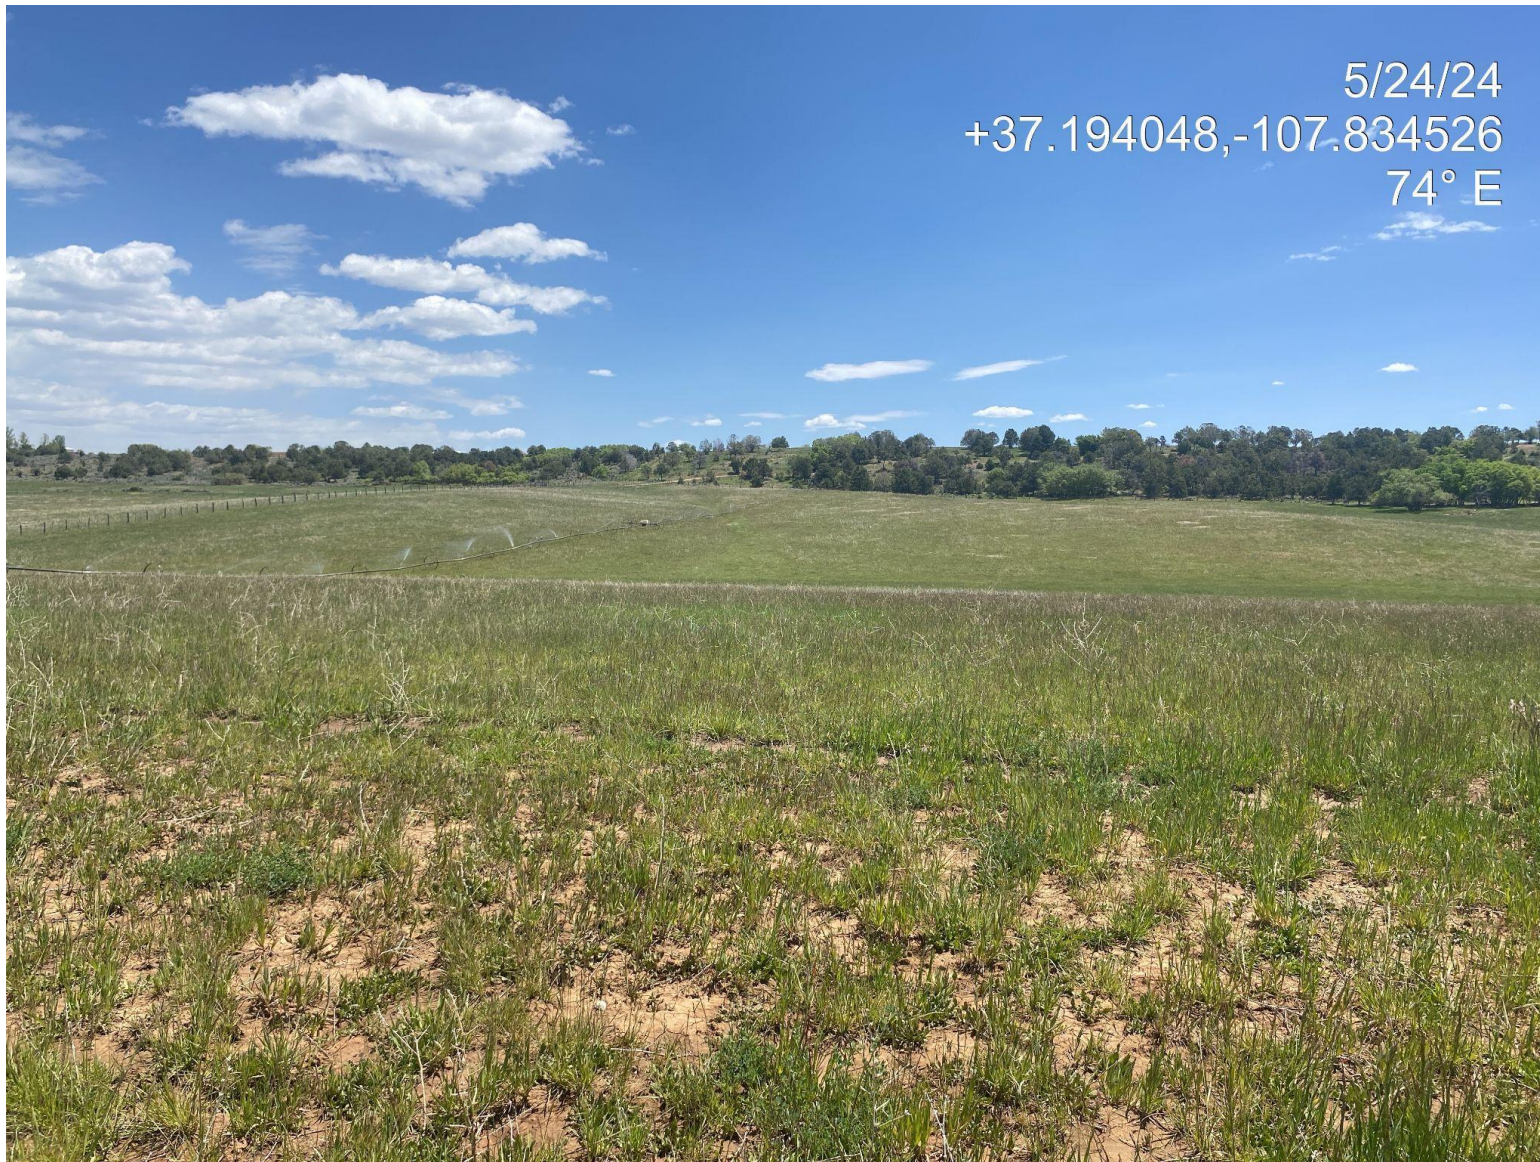
Photo 7. Reference area is an irrigated grass field comprised predominantly of smooth brome.
