Inspection Photos

API: 071-08234

Operator: EVERGREEN NATURAL
RESOURCES LLC

Inspection Date: 5/28/2024

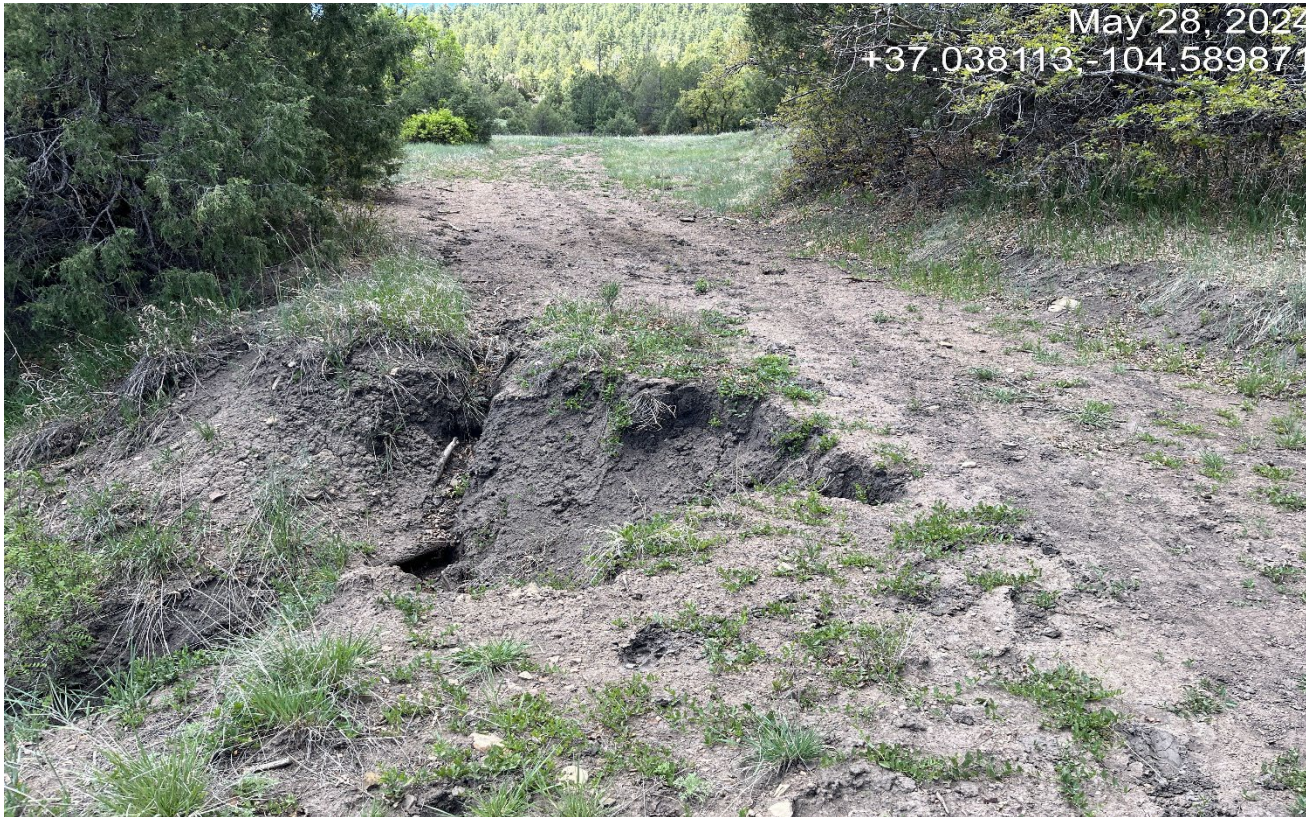
Photo 1. Facing south along the pre-existing access road. This area has washed out and needs to be repaired.

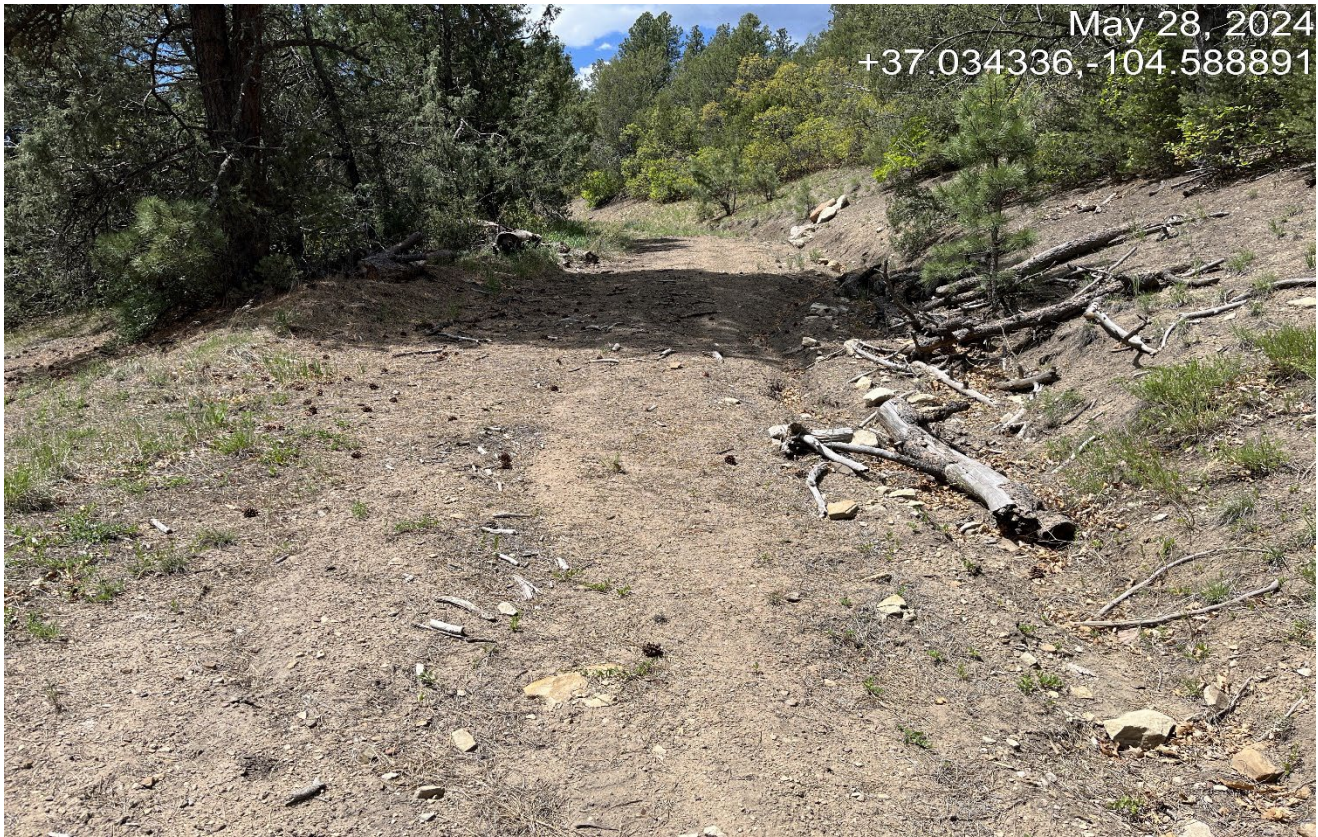
Photo 2. Facing southwest along the access road.

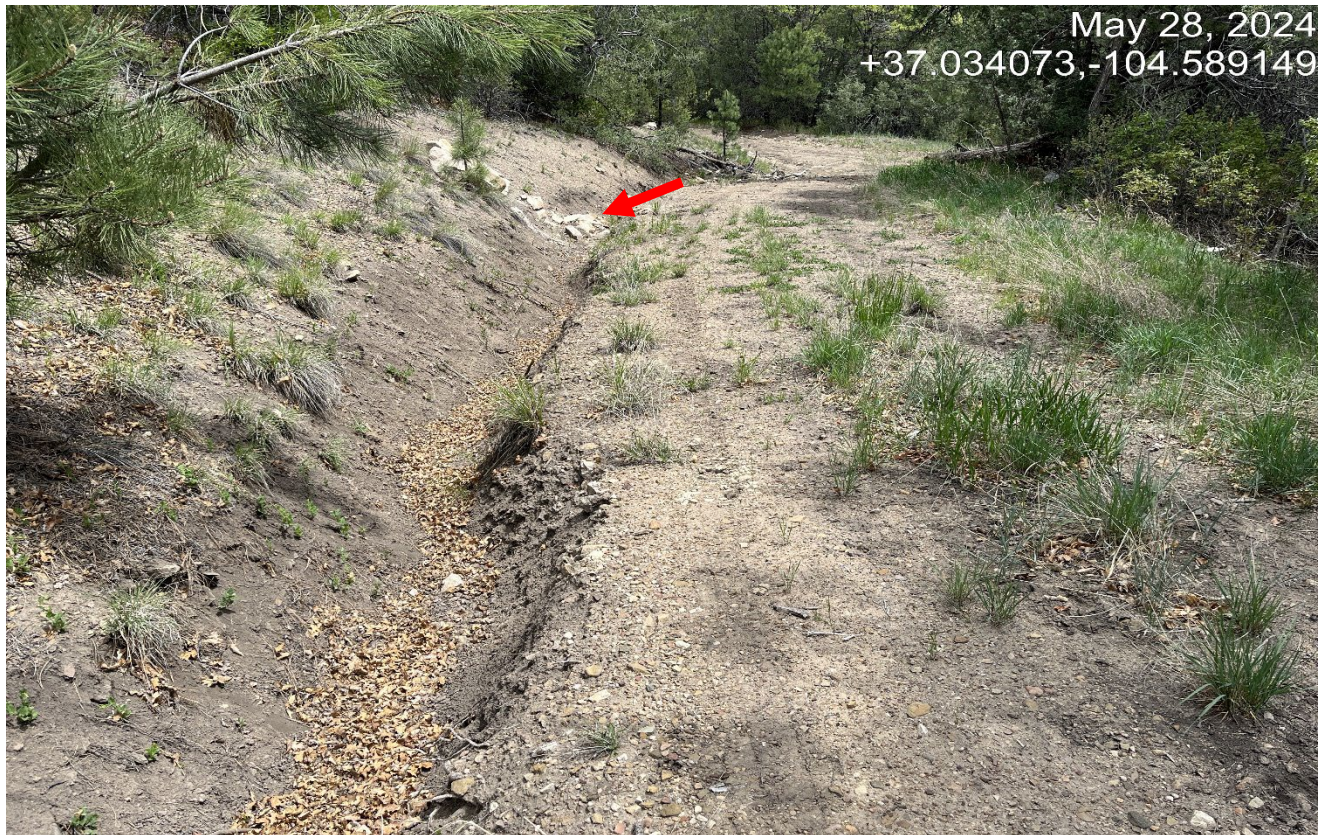
Photo 3. Facing back northeast down the road. Stormwater from the location is directed down the roadside with insufficient BMP's. There is a rock check dam at red arrow that has filled in with sediment.

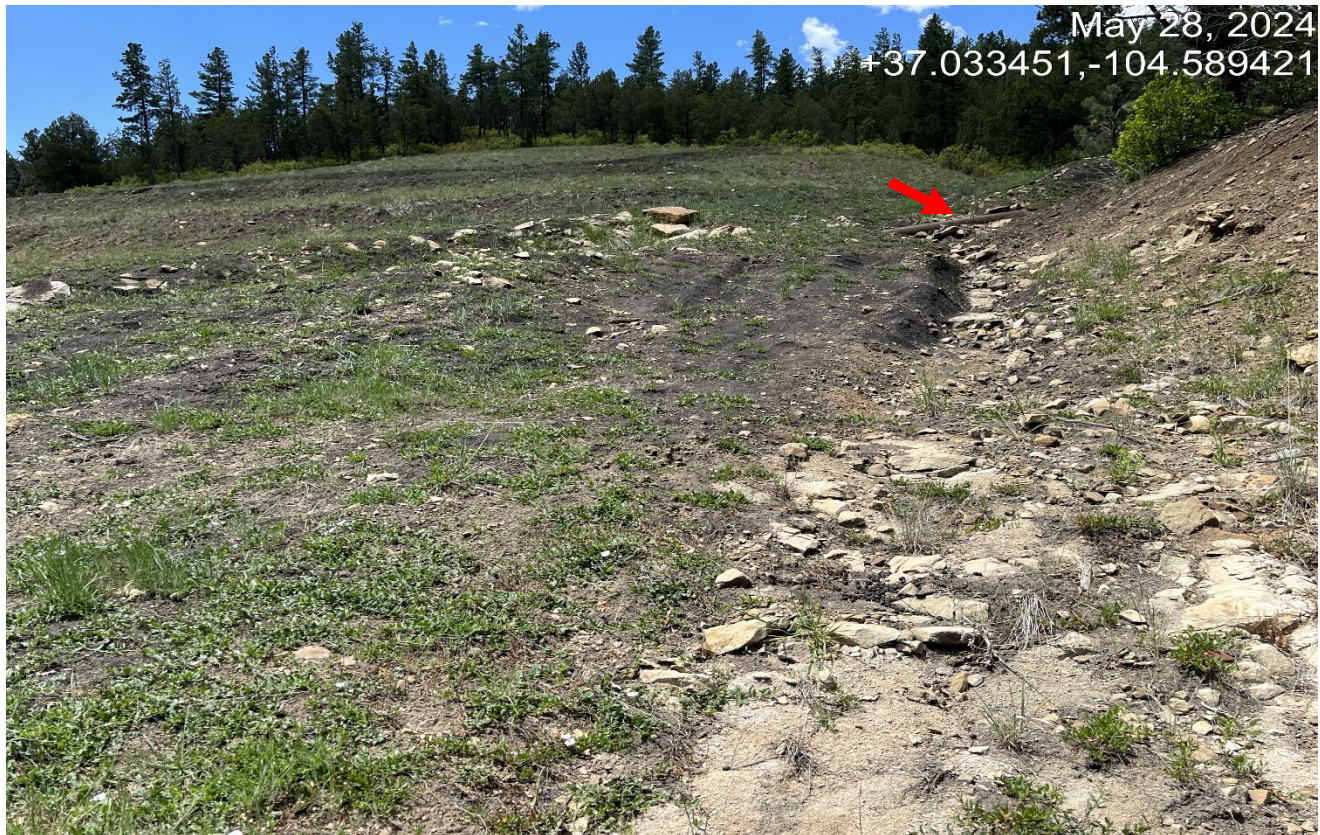
Photo 4. Facing southwest toward the location. The road continues on past the location however there is a culvert at red arrow that has washed out.

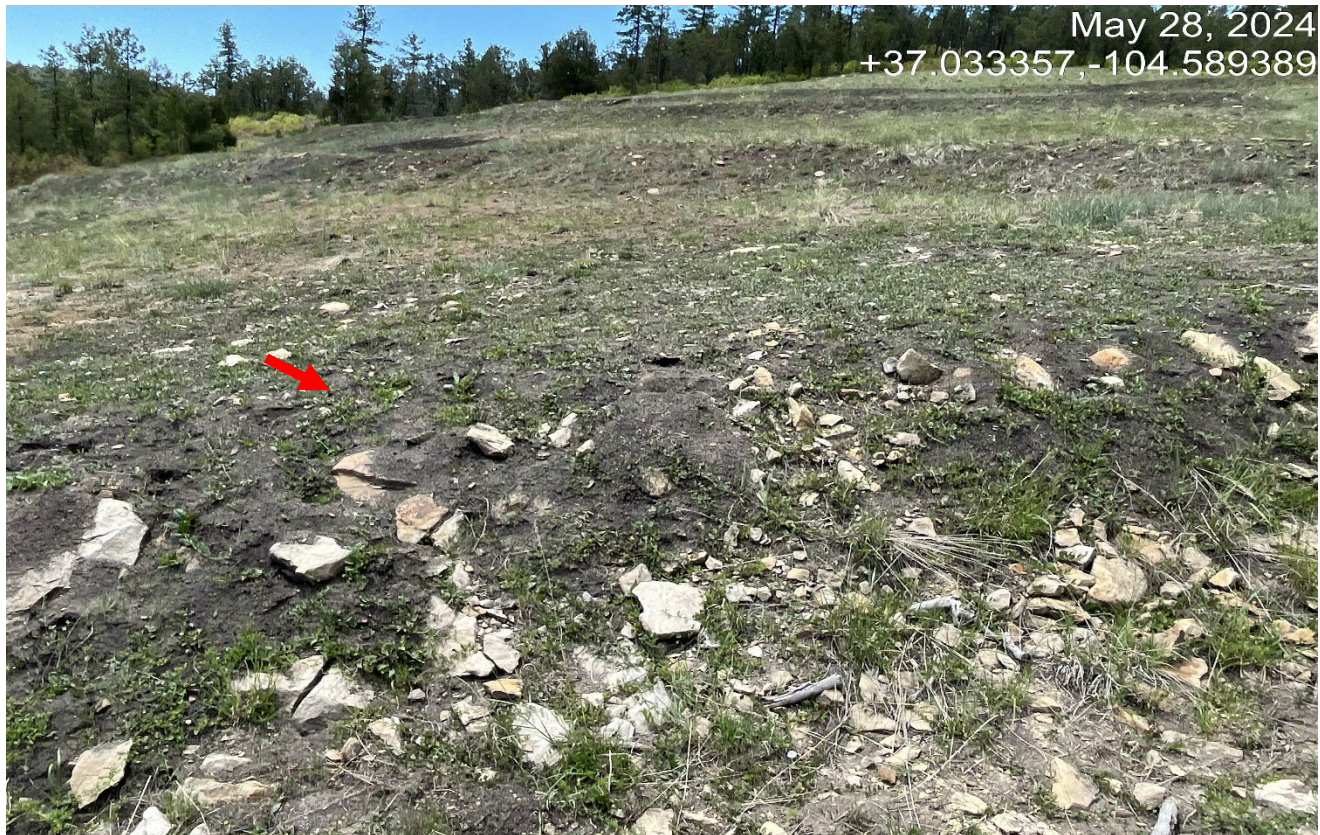
Photo 5. Facing south toward the location. There are areas of the location that are covered with Field bindweed (noxious weed) that will need to be controlled.

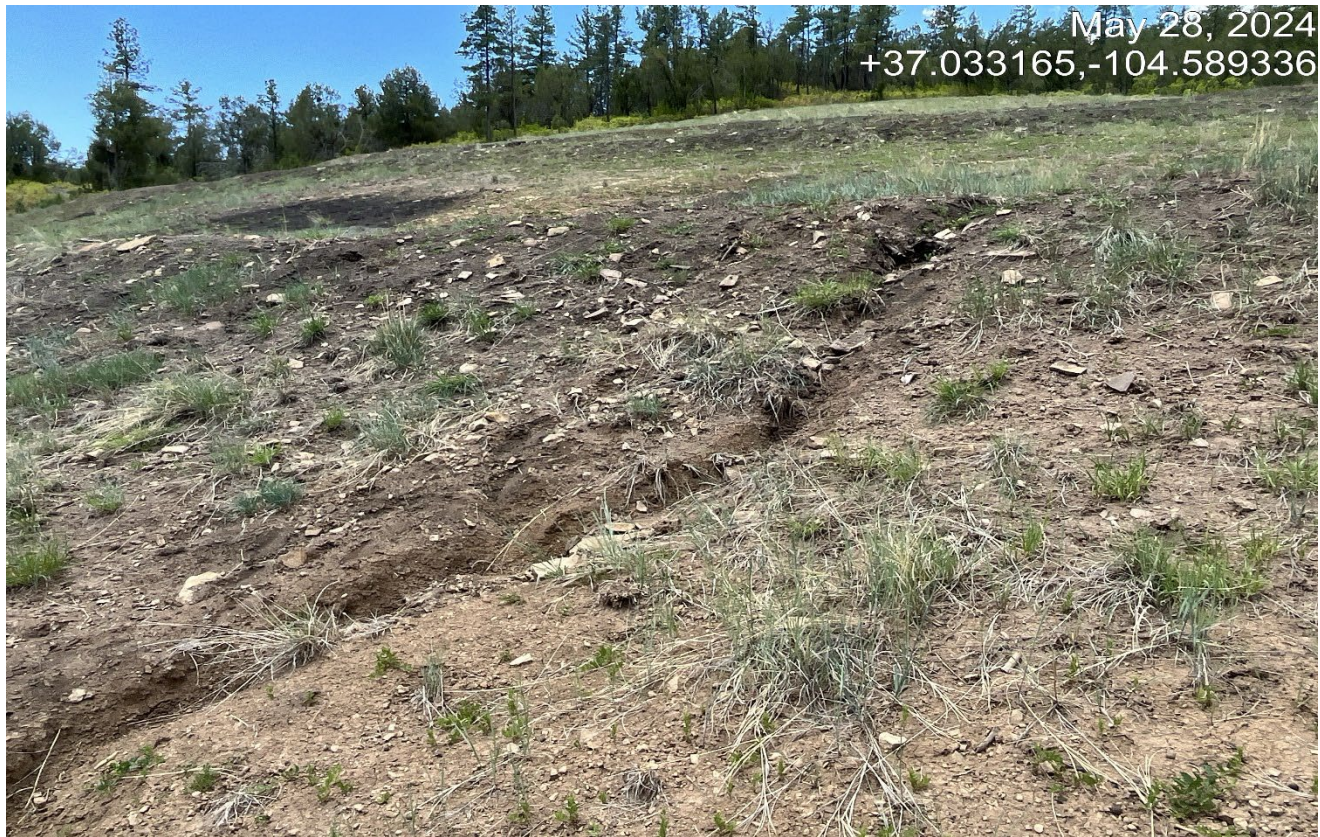
Photo 6. Facing southwest. The berms along the slope have filled in and eroded

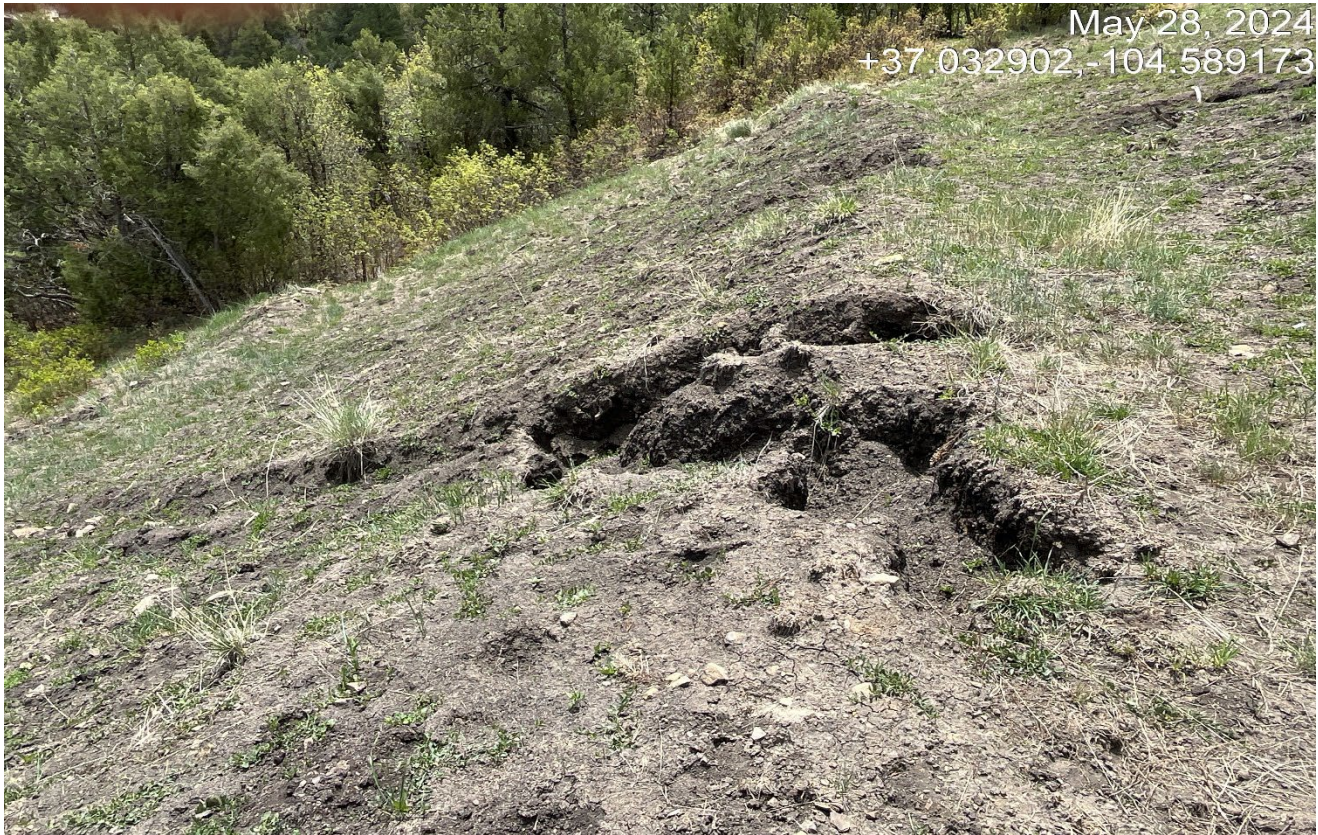
Photo 7. There are several areas where erosion has occurred along the slope where berms have concentrated stormwater flow..

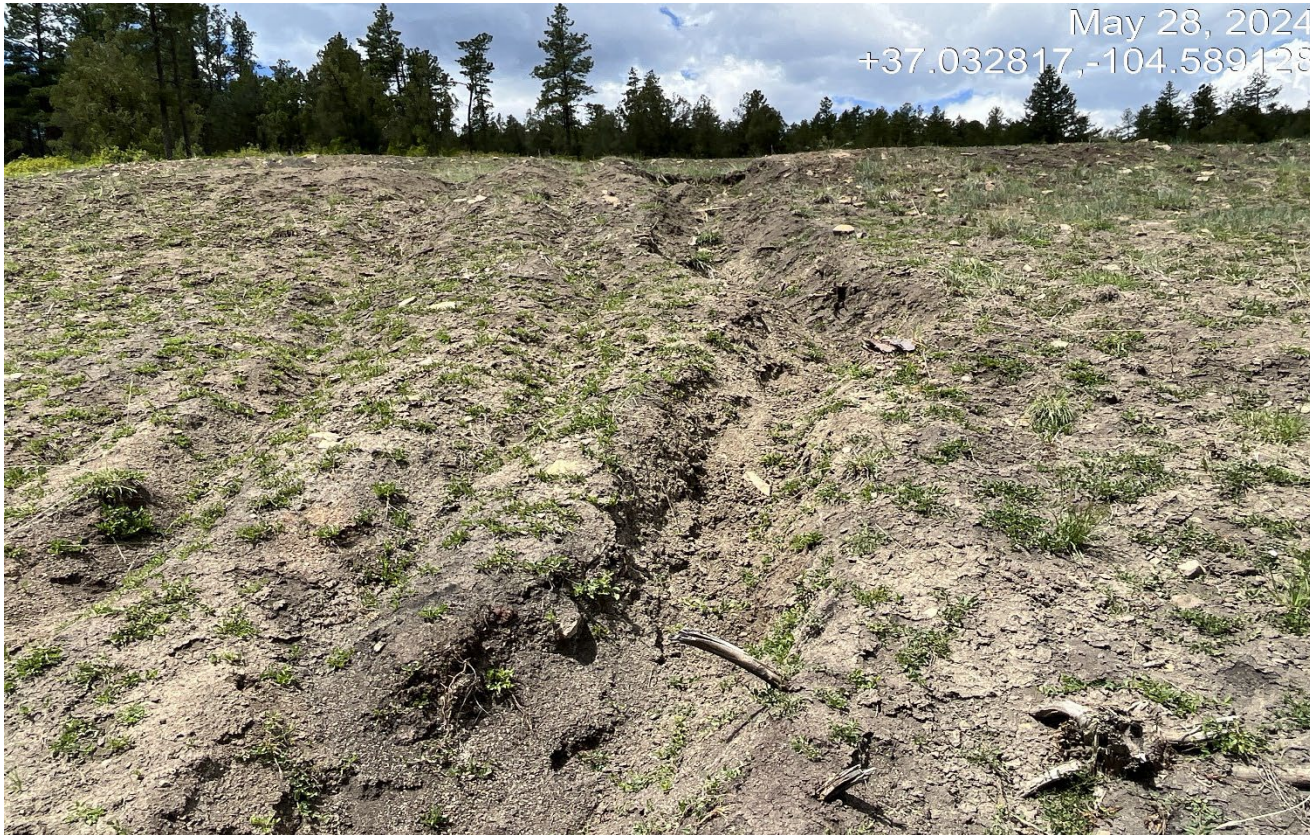
Photo 8. South side of the location facing west The vegetation in this area is predominately Field bindweed which must be controlled. There is also erosion along this area that will need to be repaired.

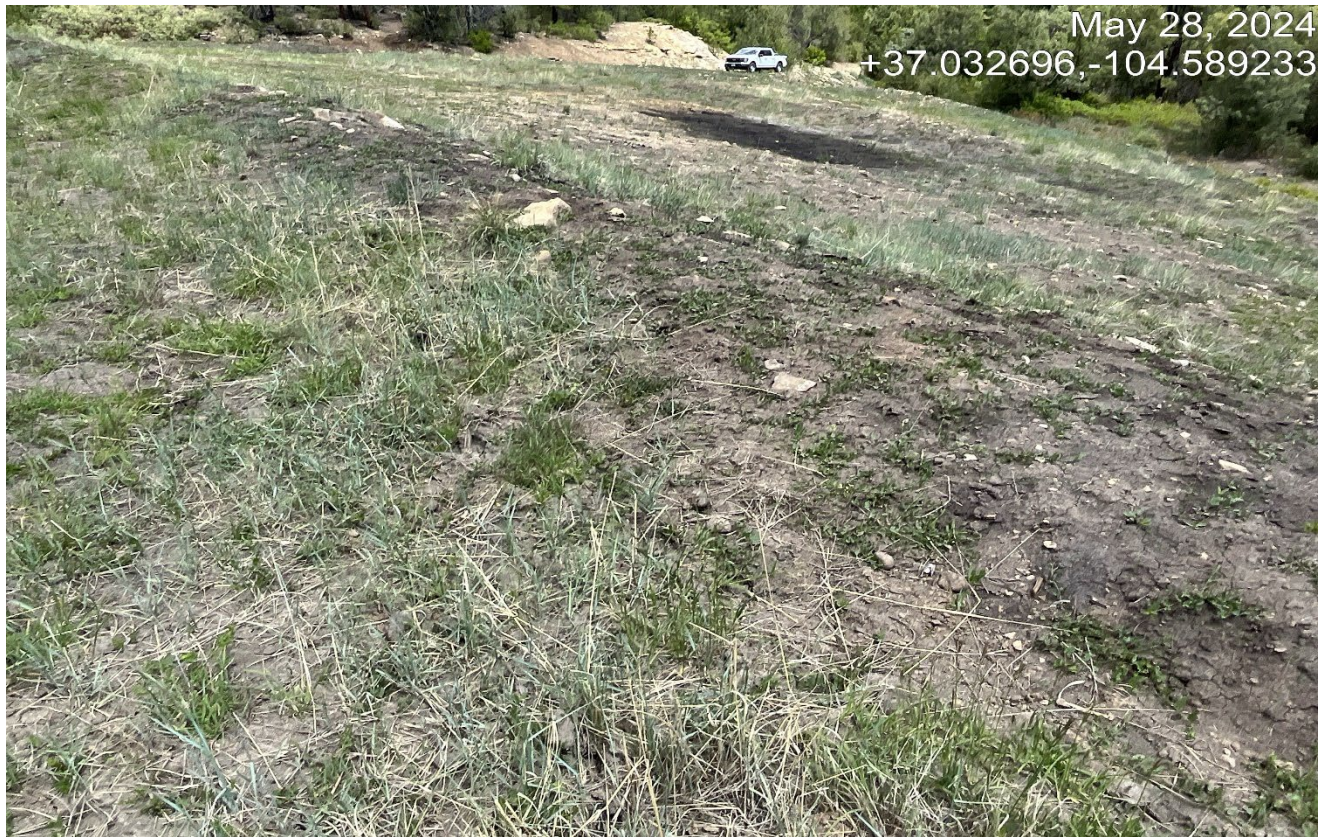
Photo 9. South side of the location facing north.

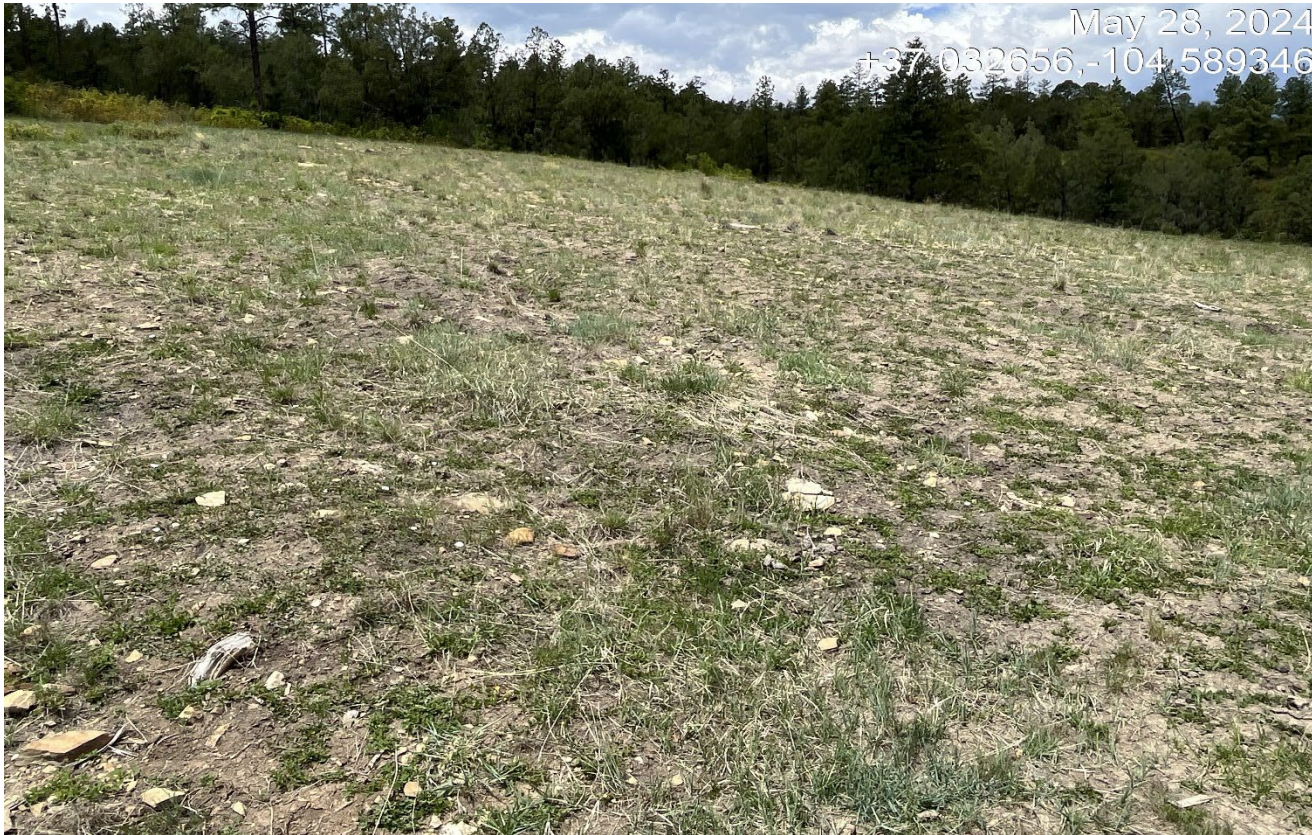
Photo 10. Facing northwest toward the upper portion of the location. The perennial vegetation in this area is progressing well.

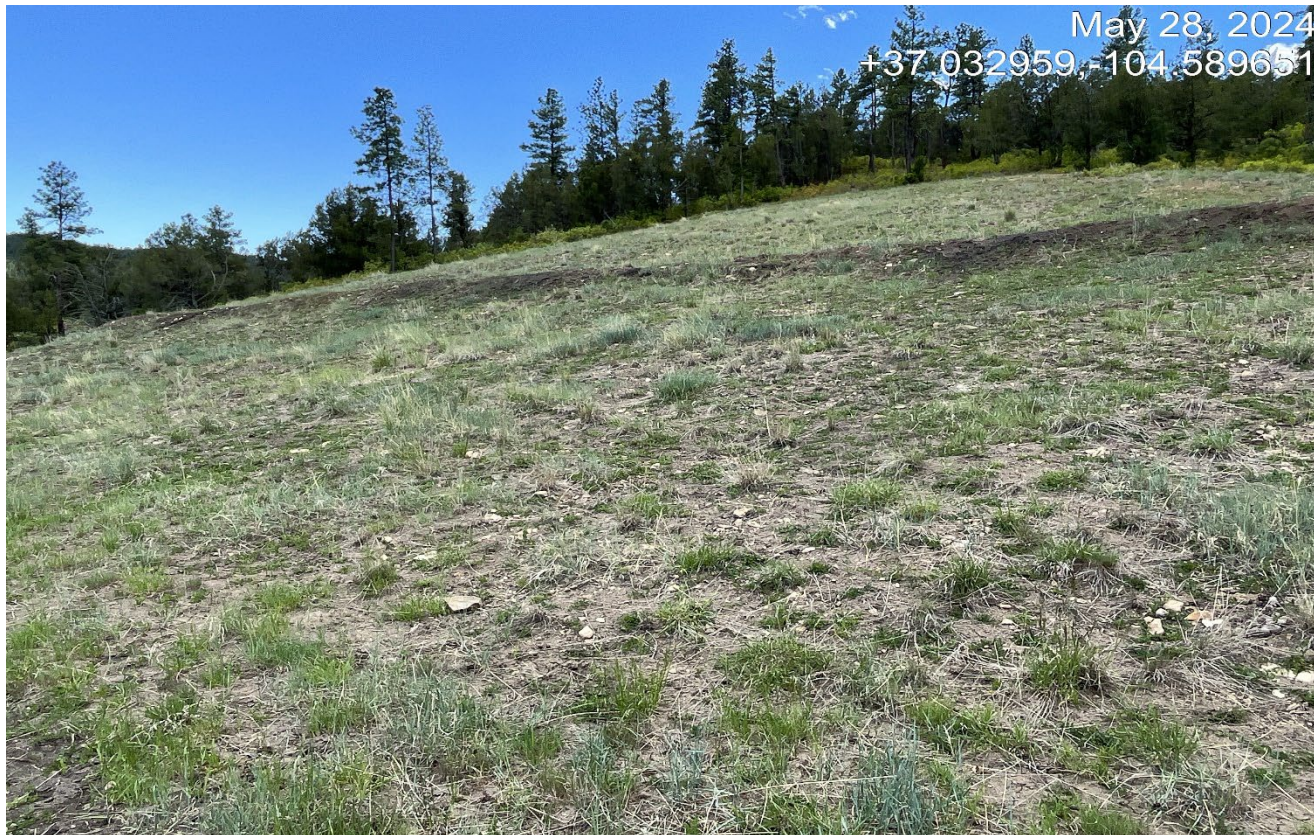
Photo 11. Facing southwest toward the upper portion of the location. The perennial vegetation in this area is progressing well.

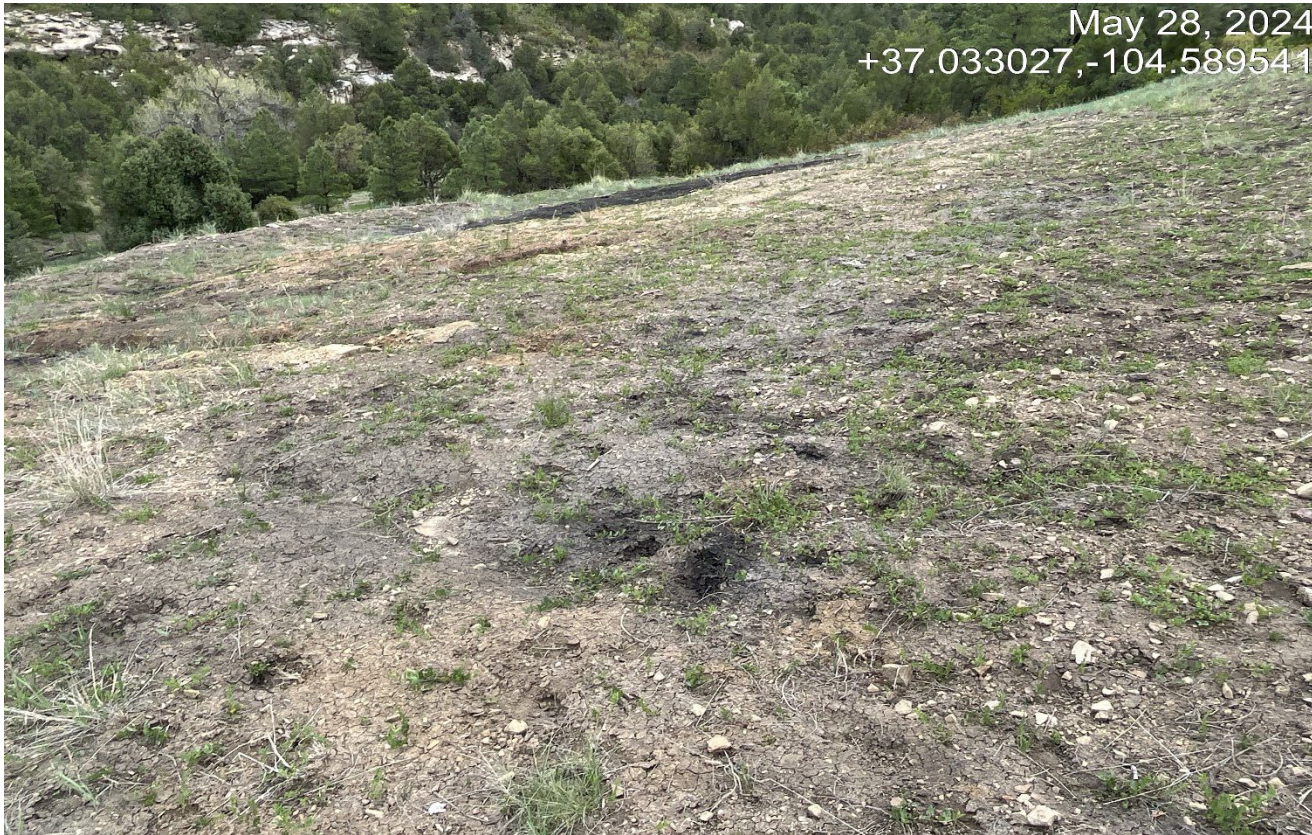
Photo 12. Northside of the location facing southwest. The lower portion of the location is not progressing and there are areas of weeds and erosion.

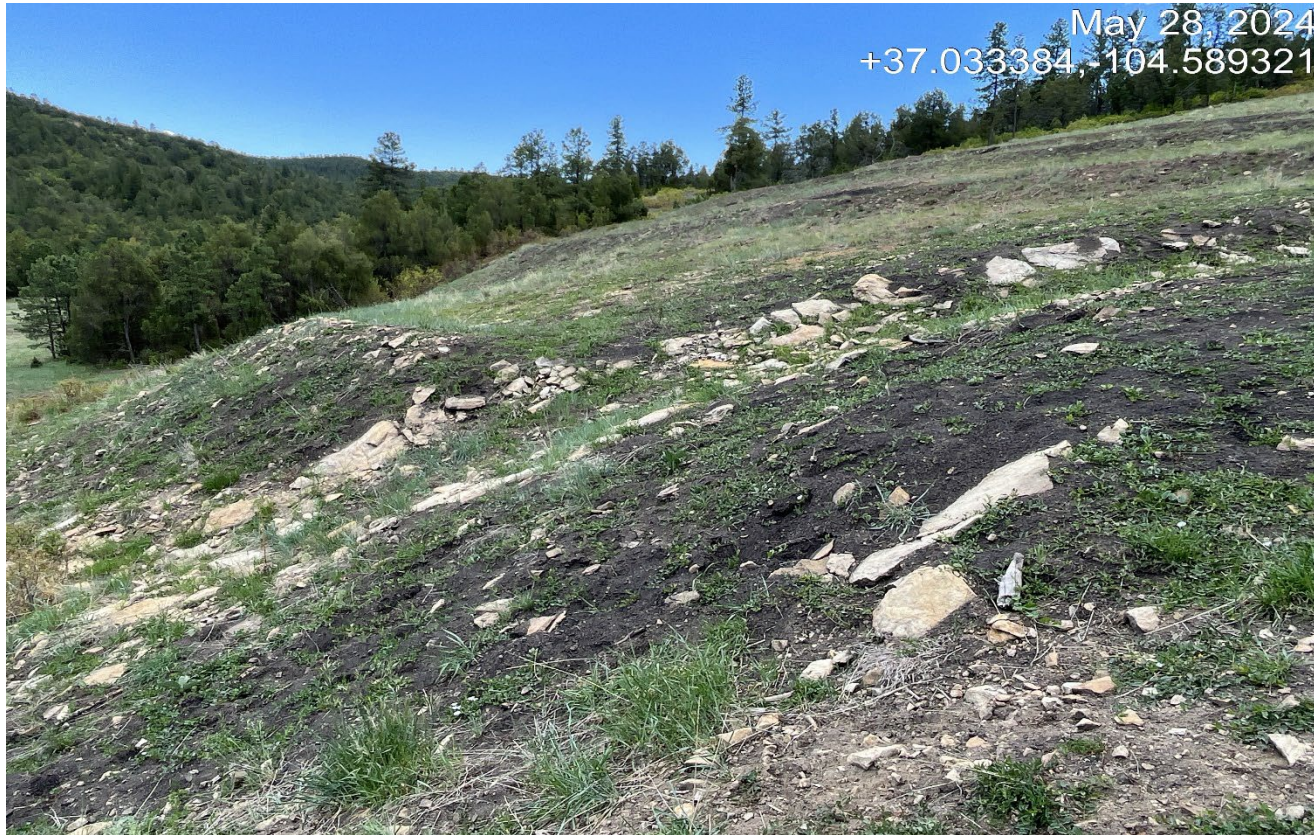
Photo 13. Facing south toward the lower portion of the location. The large berms are filled in with sediment and are increasing the steepness of the slope toward the bottom. Regrading the lower portion of the location may be beneficial as the vegetation is not progressing.
