WELL NAME: HILL RANCH 07-09, API #: 071-08065, INSP. # 695109588

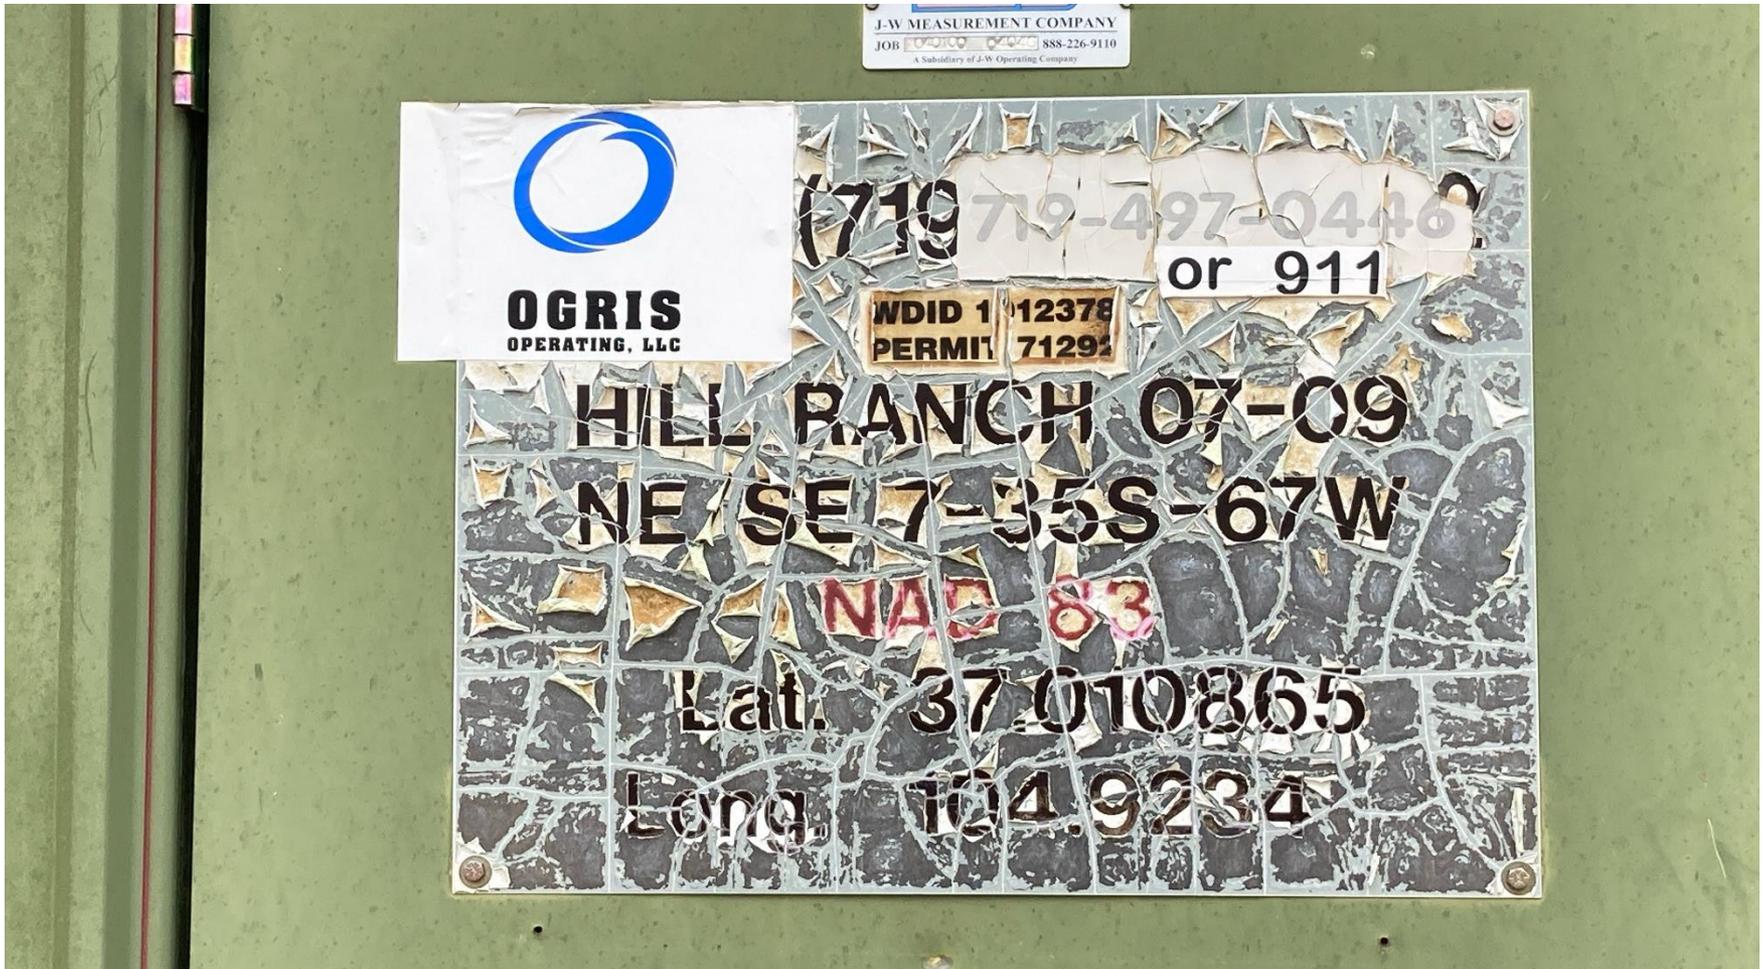
PHOTO 1: WELL SIGN/ SIGN IS DETERIORATING AND NEEDS REPLACED.

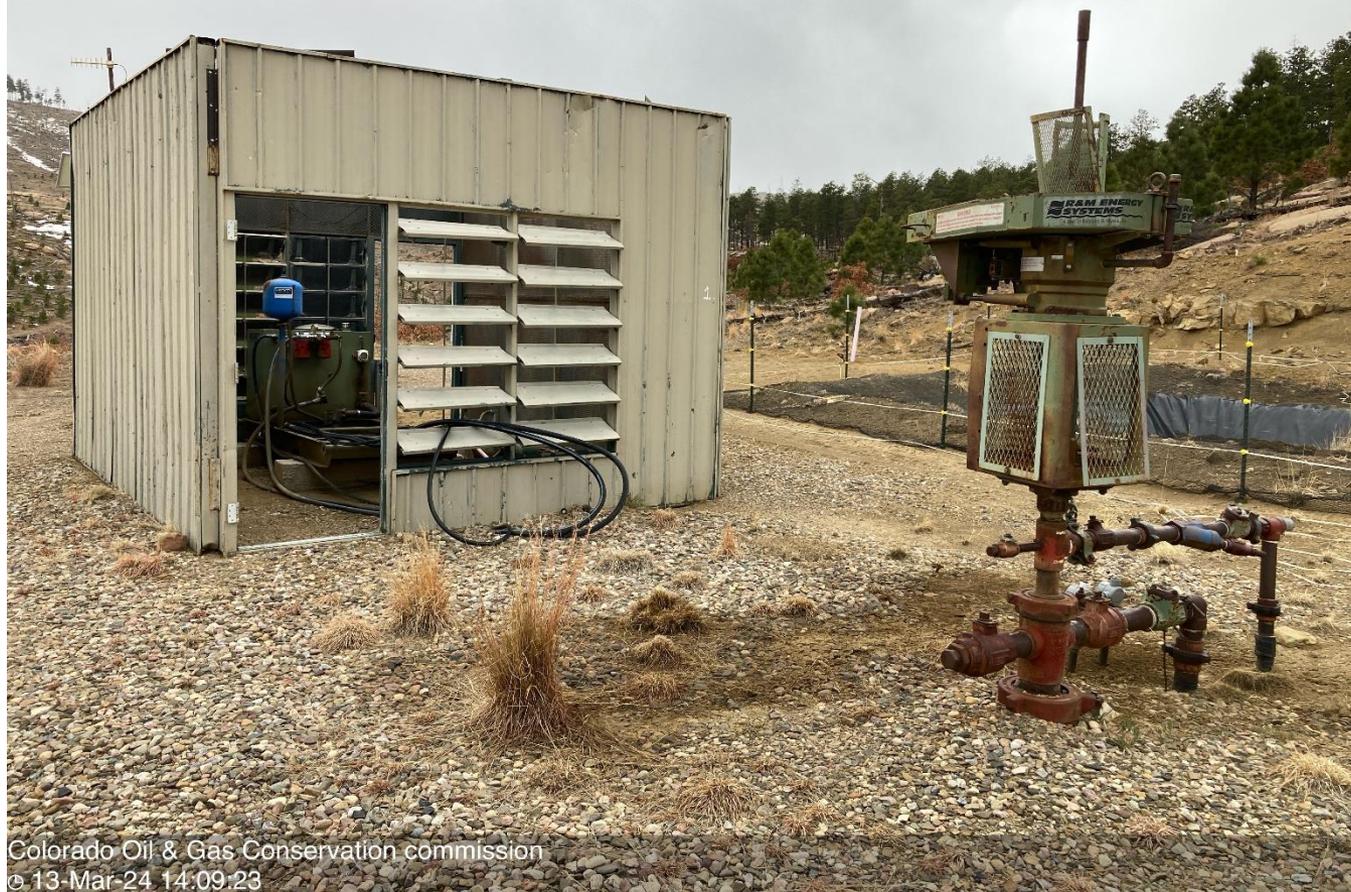
PHOTO 2: WELLHEAD AND EQUIPMENT

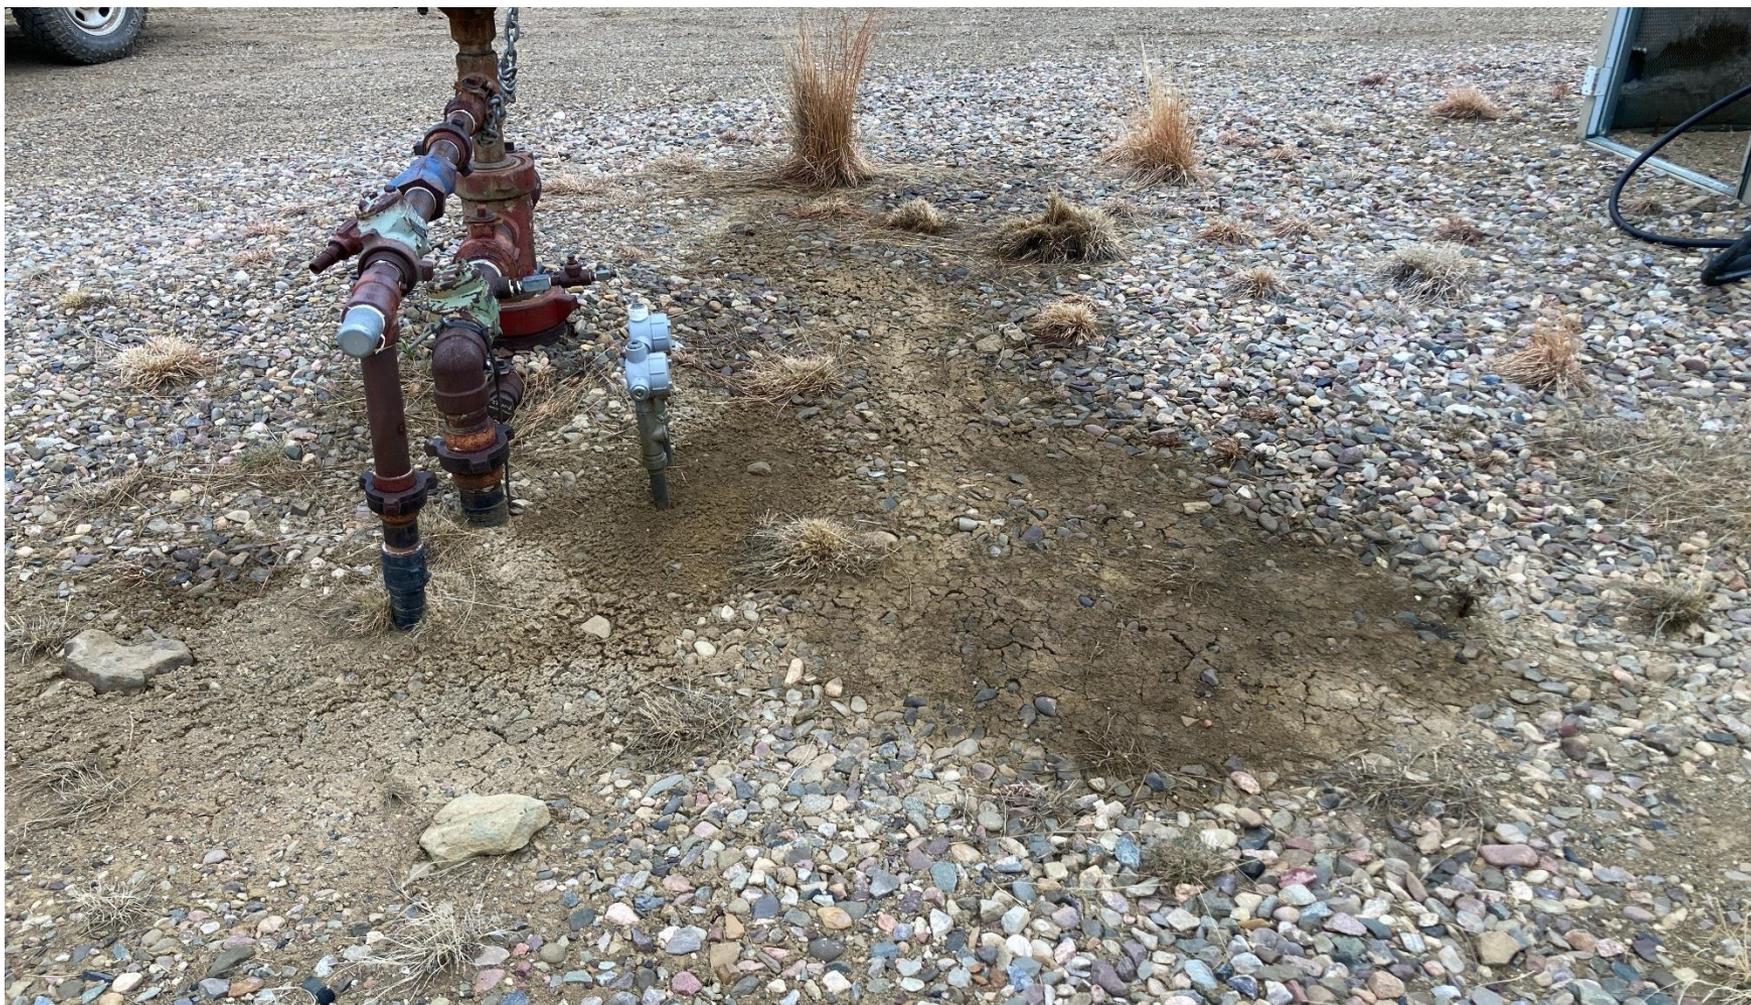
PHOTO 3: AREA OF IMPACTED SOIL NEAR WELLHEAD.

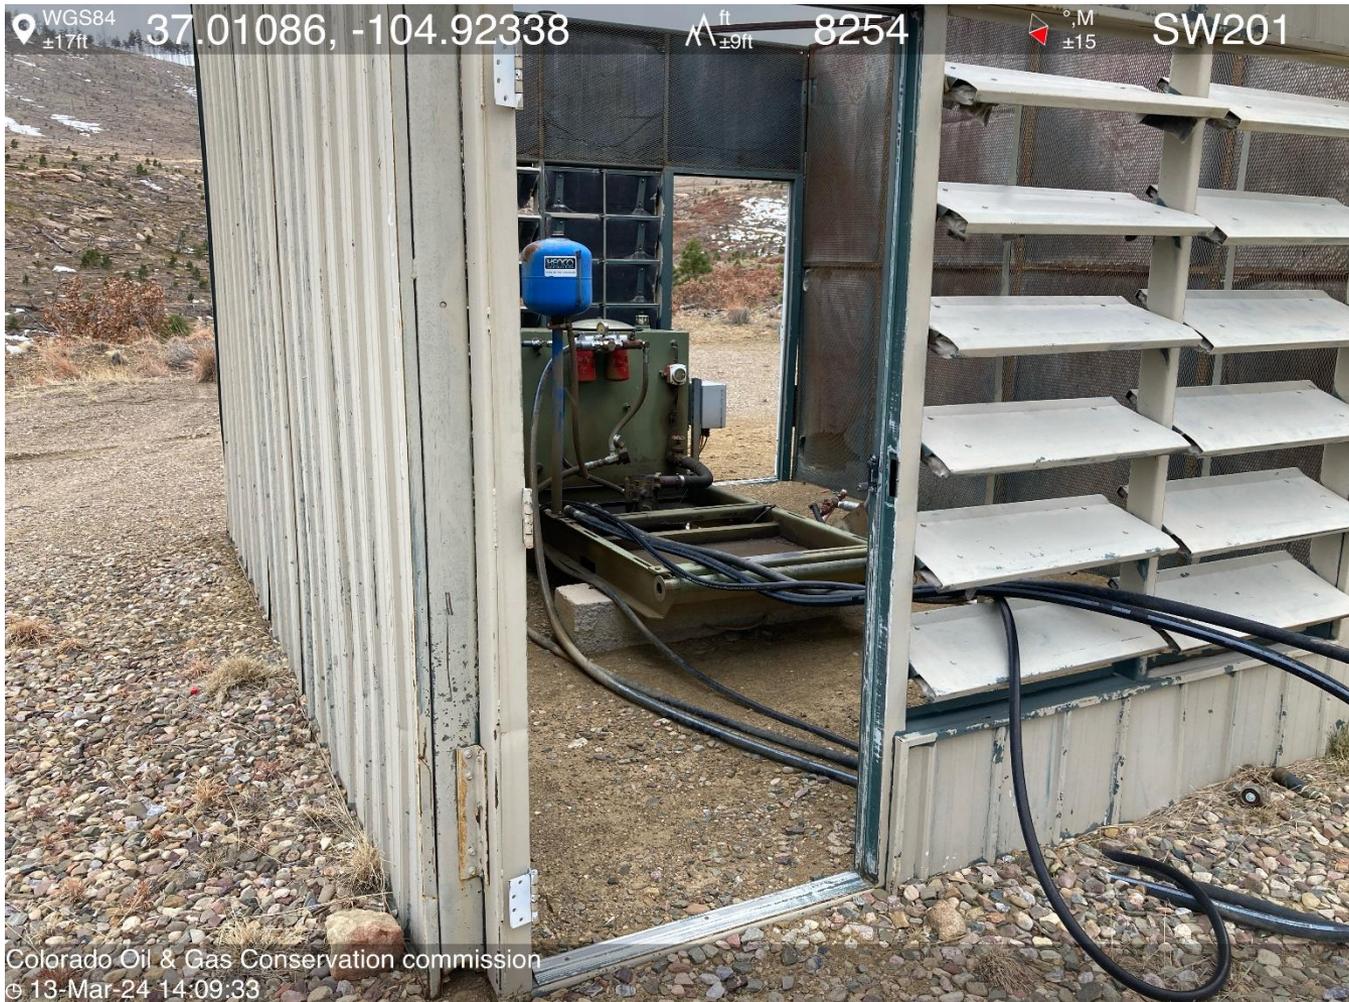
PHOTO 4: ENGINE SKID AND SOUND WALLS ARE UNUSED EQUIPEMT AND SHOULD BE PUT BACK IN WORKING ORDER OR REMOVED FROM LOCATION.

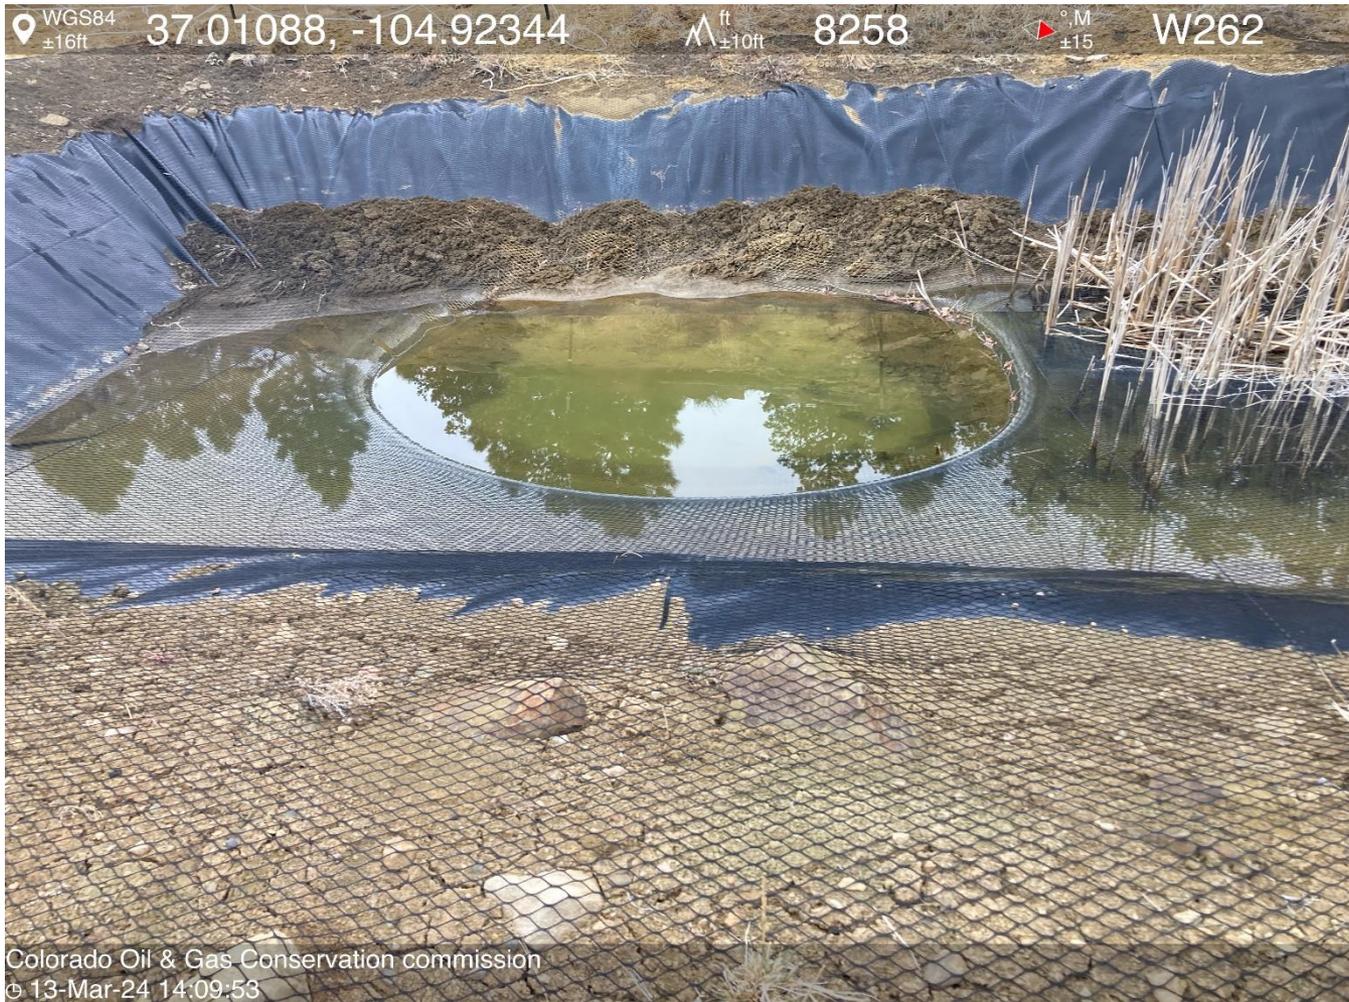
PHOTO 5: NETTING IS TORN AND PART OF IT IS BELOW WATER. REPAIR NETTING.

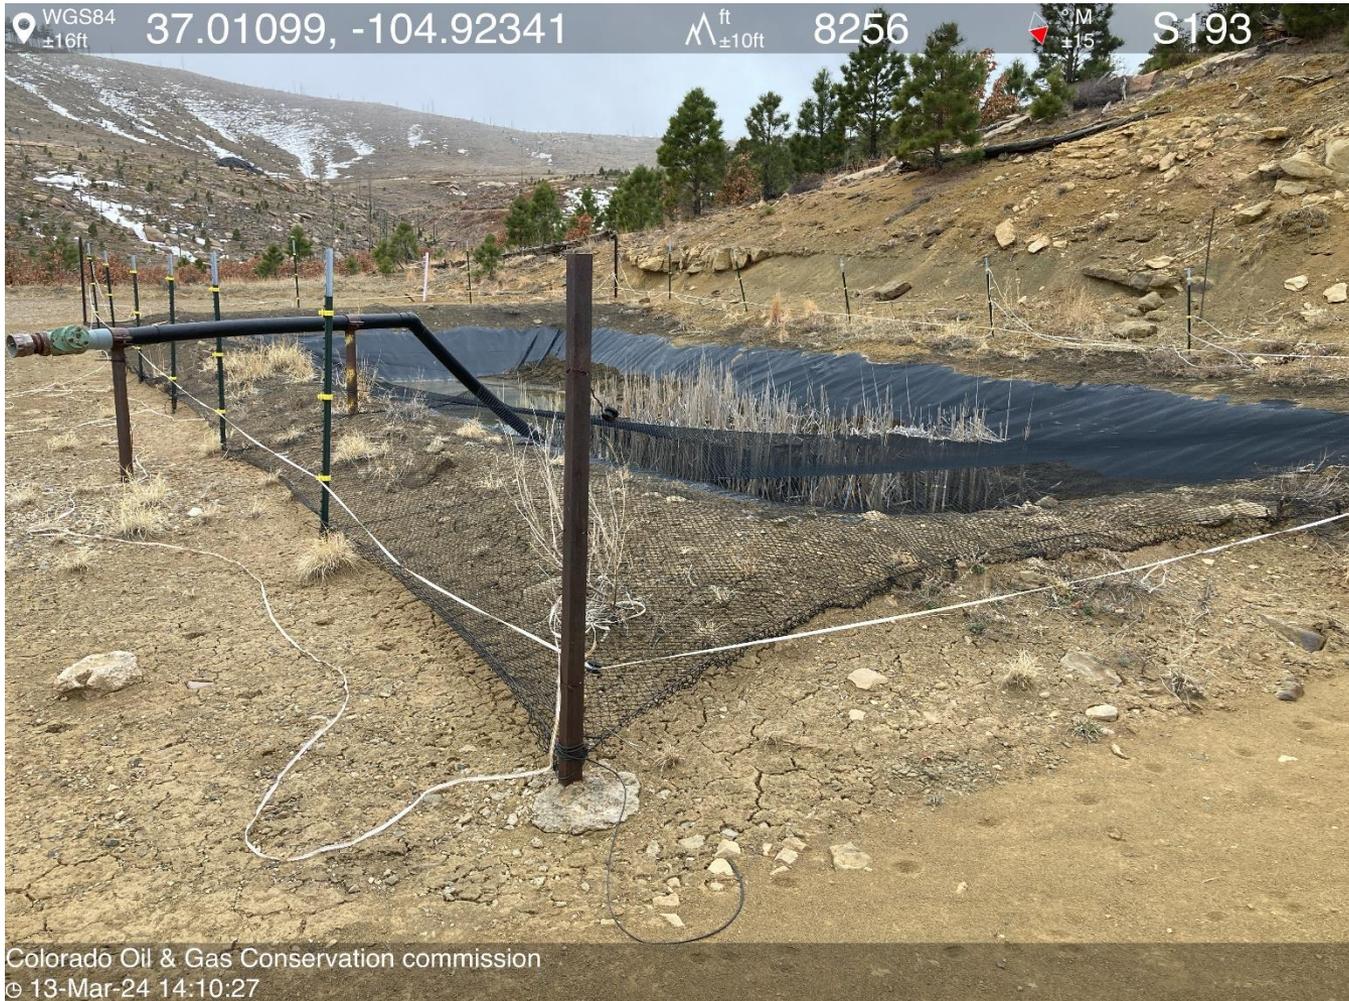
PHOTO 6: FENCING AROUND LINED PIT IS DOWN. REPAIR FENCE.
