Operator: CRESTONE PEAK RESOURCES OPERATING LLC

Location Name: State Challenger 5-65 2-3 3BYH

Loc ID: 451622

Inspection: 713900625

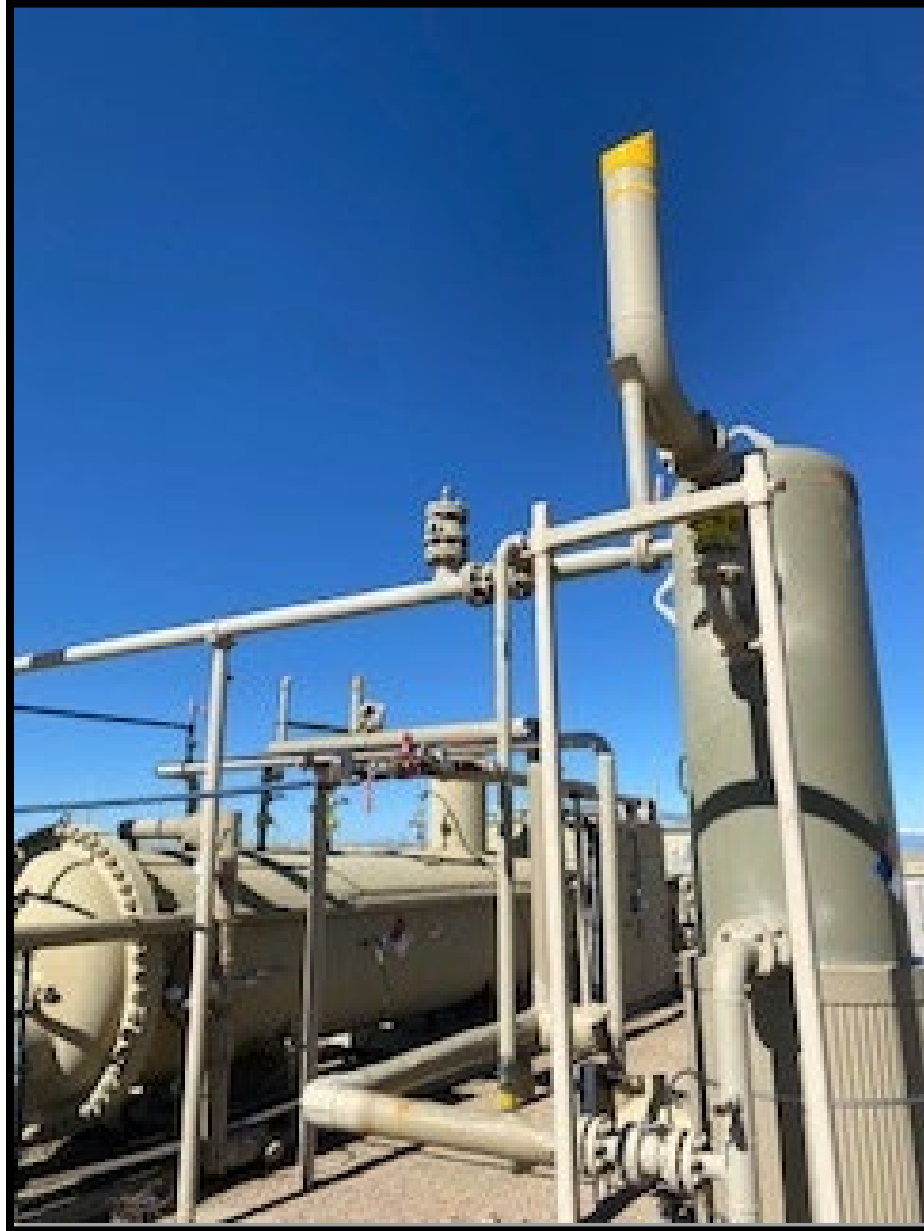
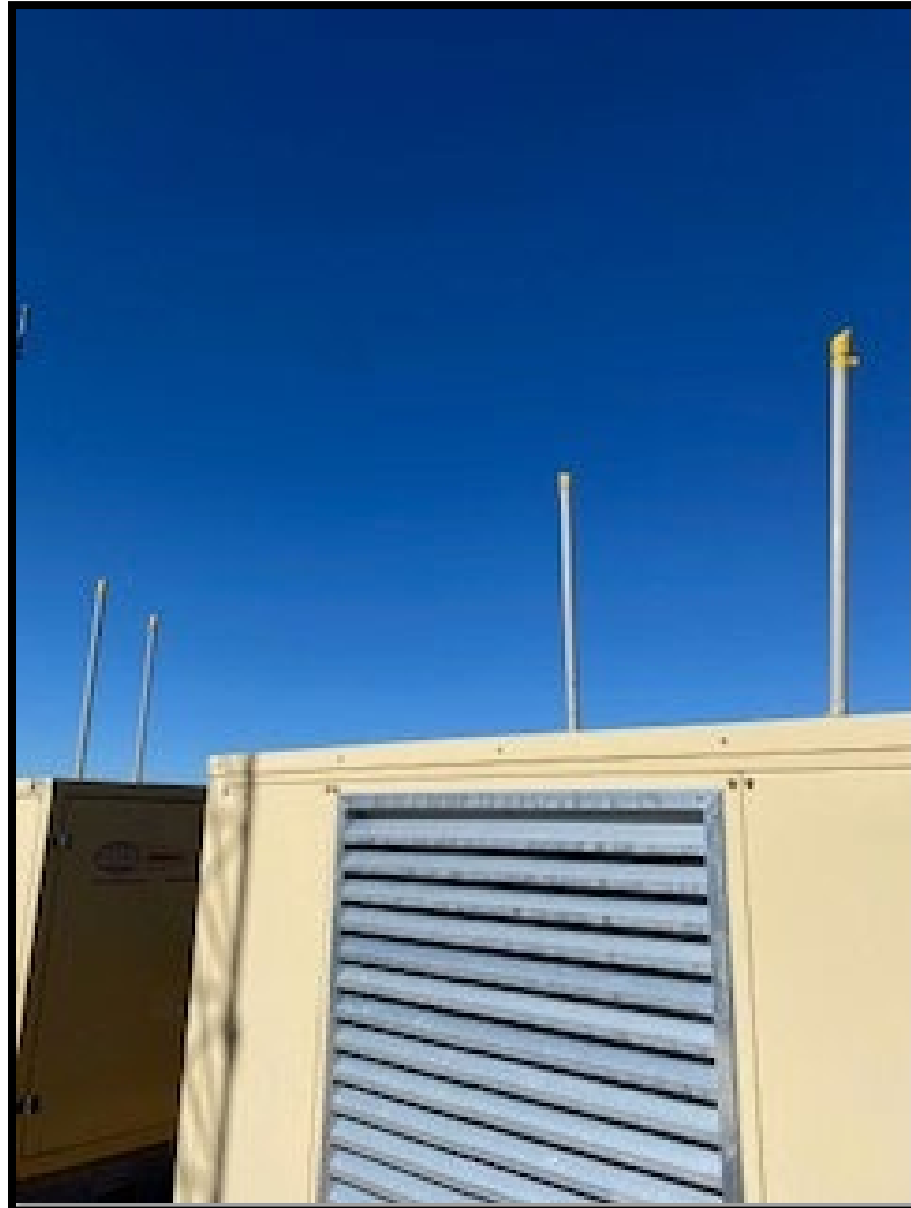
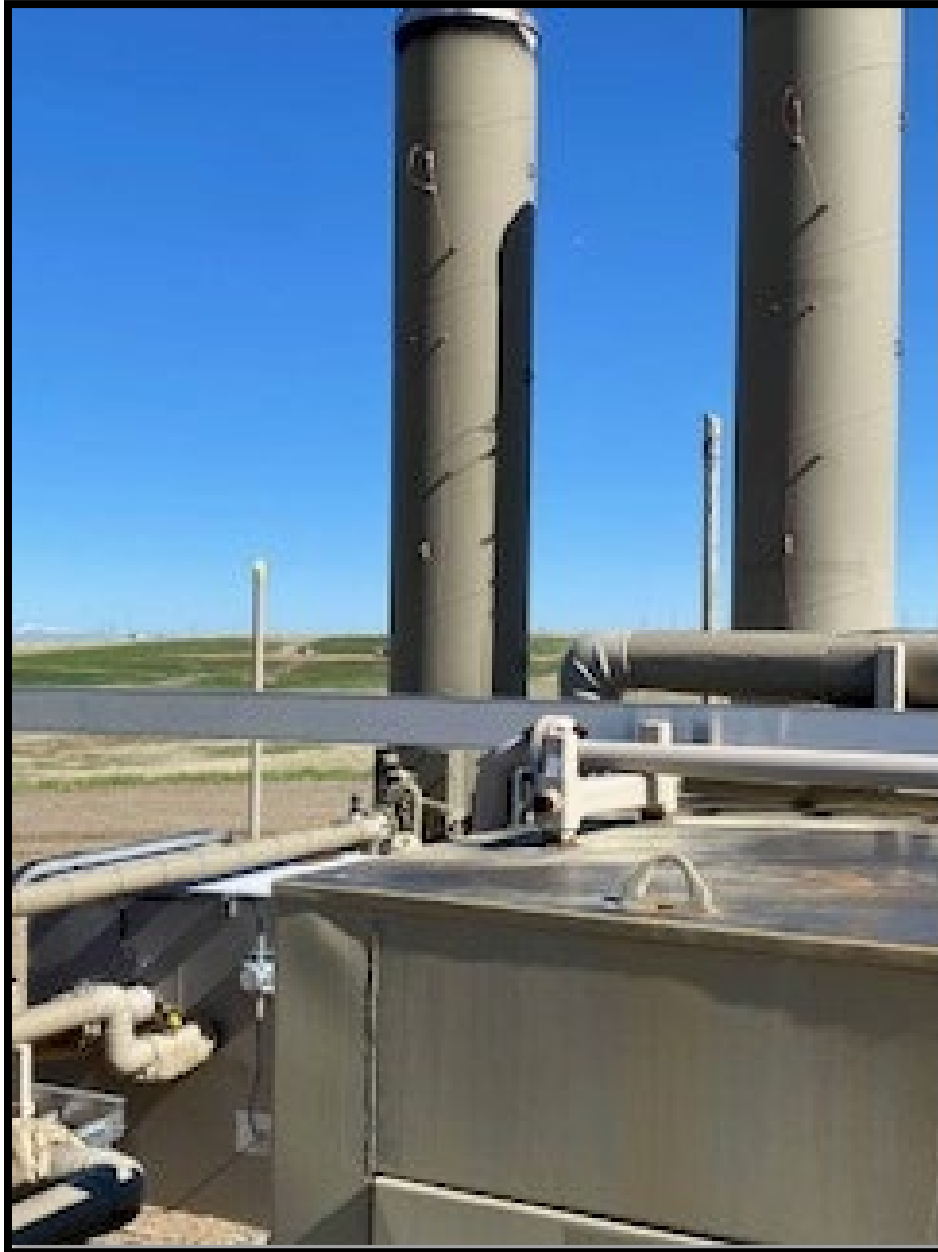
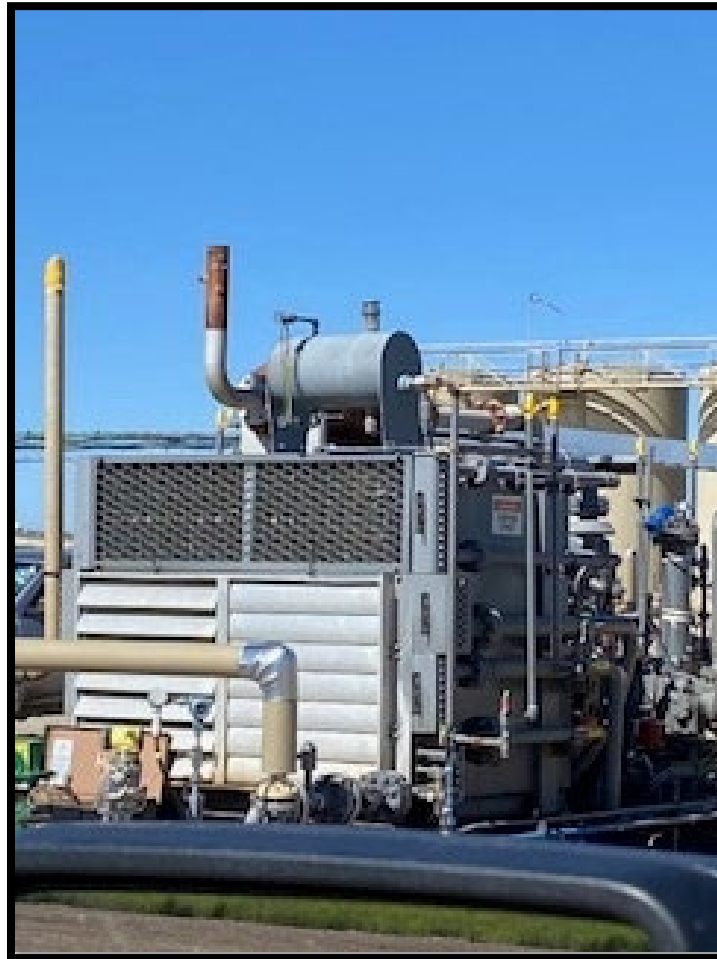
CA: Cover on production equipment exhaust has fallen off. See inspection photos for details. Install wildlife protection equipment per Rule 608.a.

CA Resolution: Operator has reported that rain caps have been installed on all PRVs to comply with Rule 608.a.
