Final Reclamation and Stormwater Inspection

Date: 05/29/2024

Operator: MCCARTNEY ENGINEERING LLC - 55030

Location ID: 320422

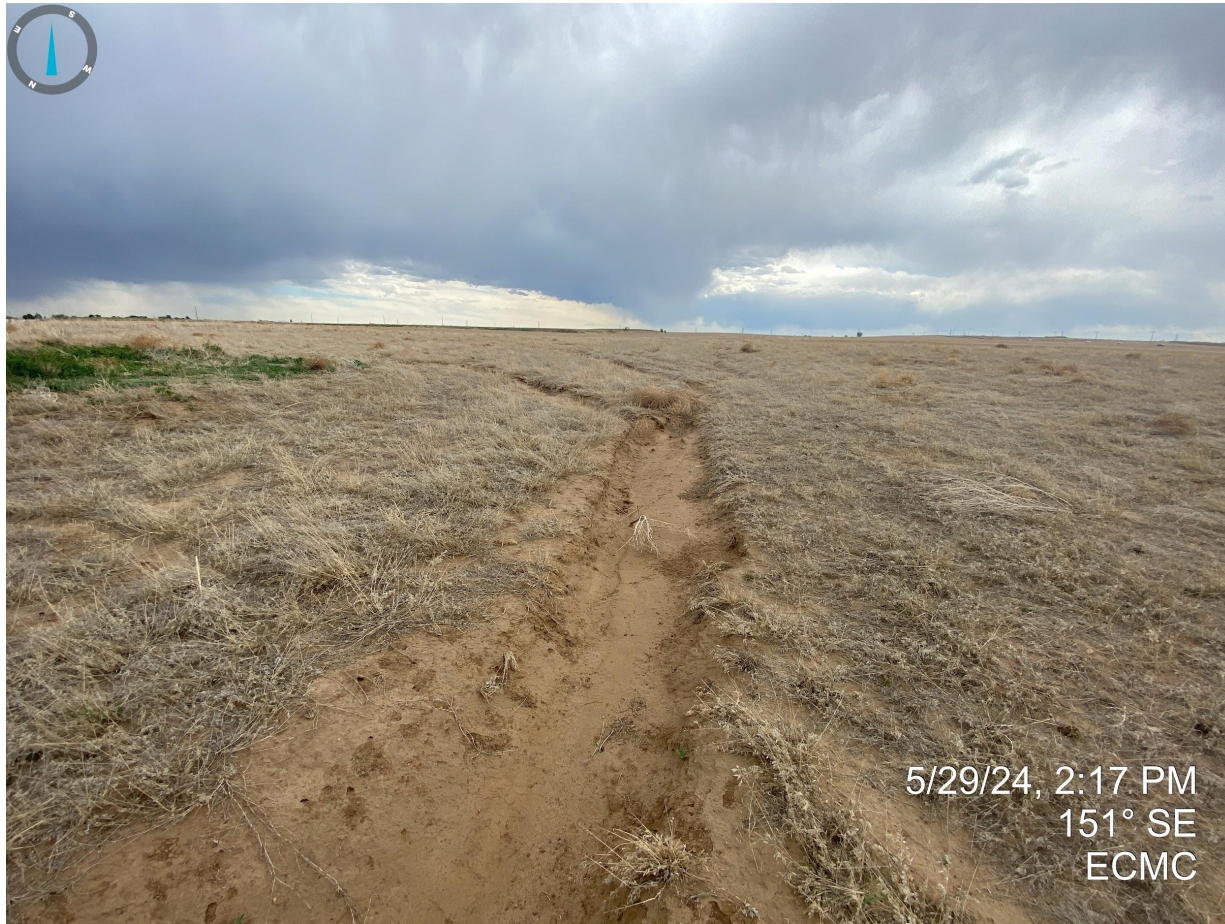
Photo 1. Erosion degradation occurring along the former access road; facing southeast towards the former location.

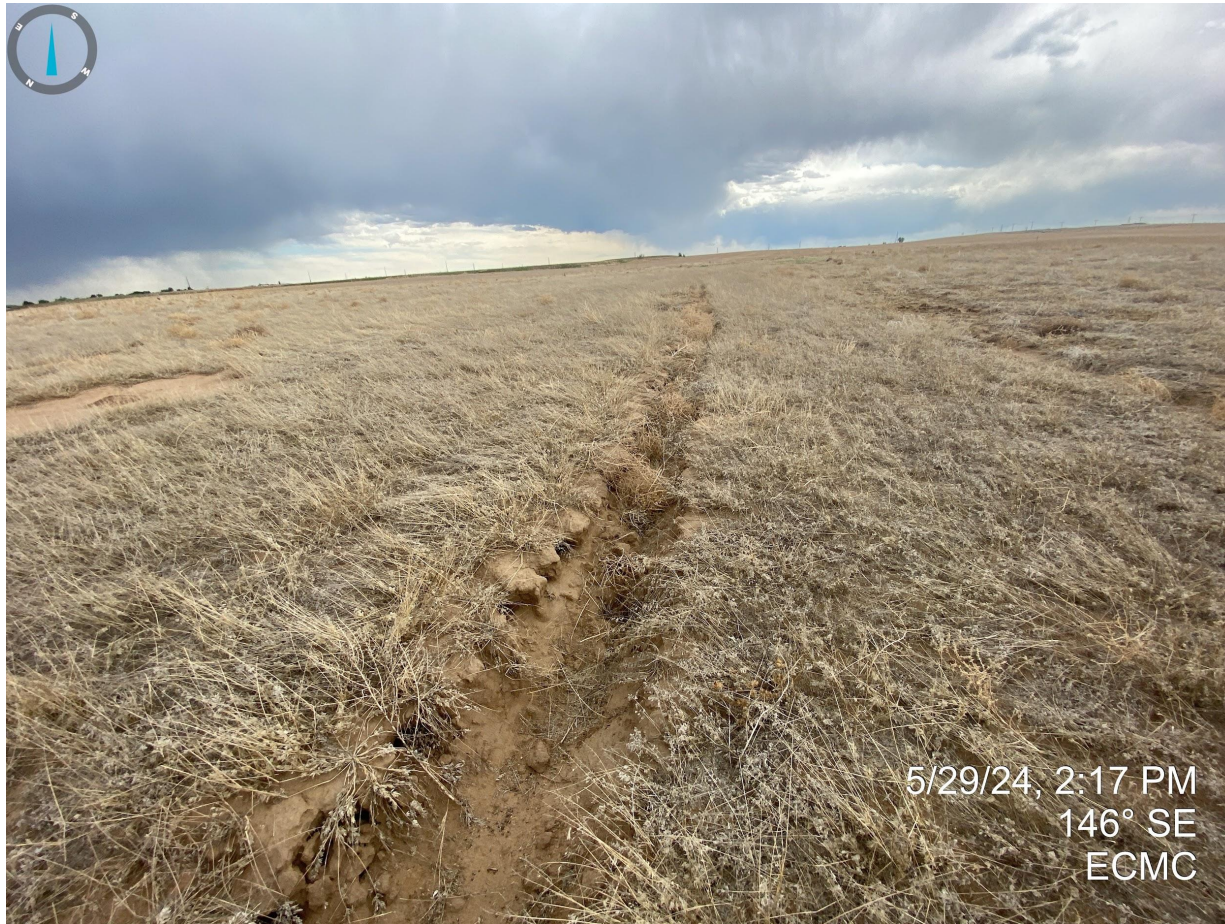
Photo 2. Erosion degradation occurring along the former access road.

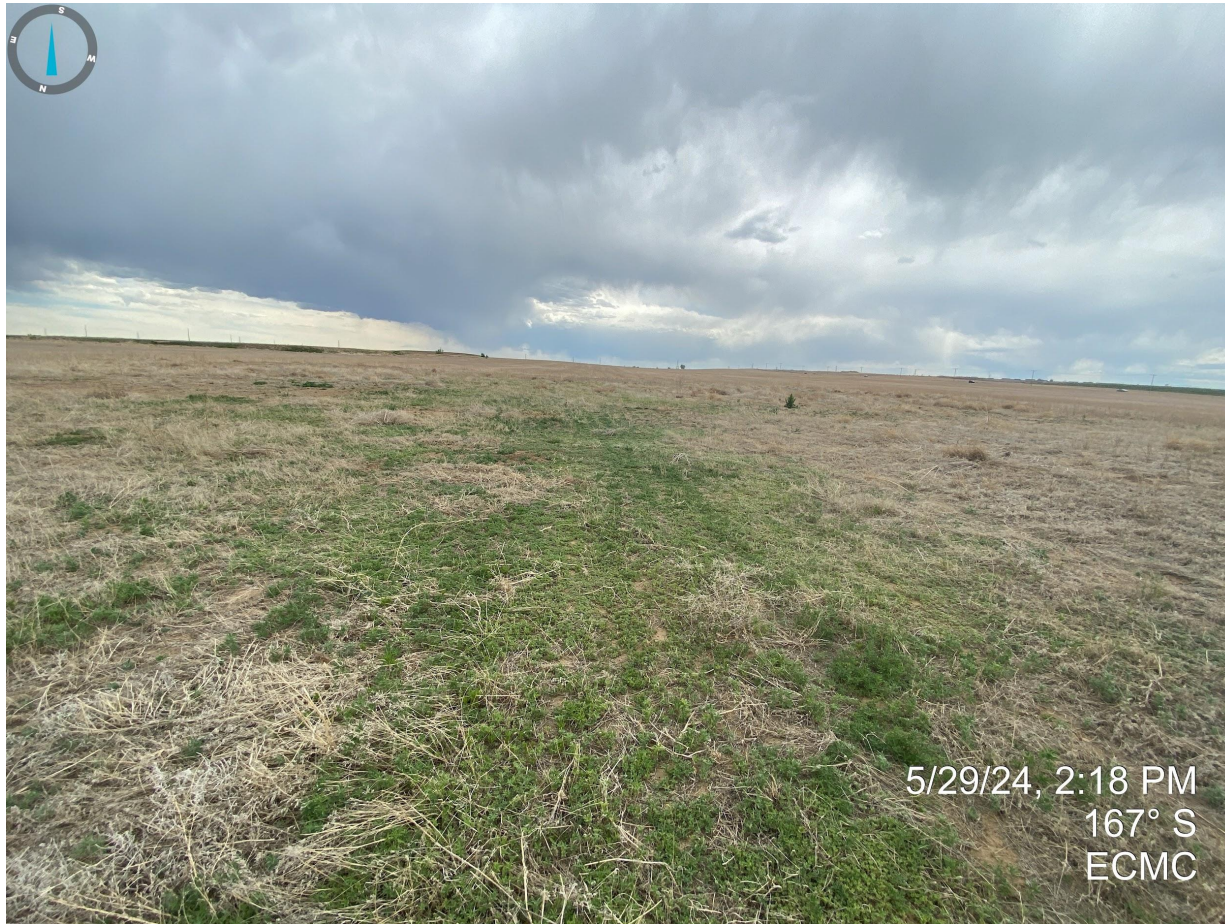
Photo 3. Taken from the northern portion of the former location. Presence of undesirable vegetation (kochia) observed throughout.

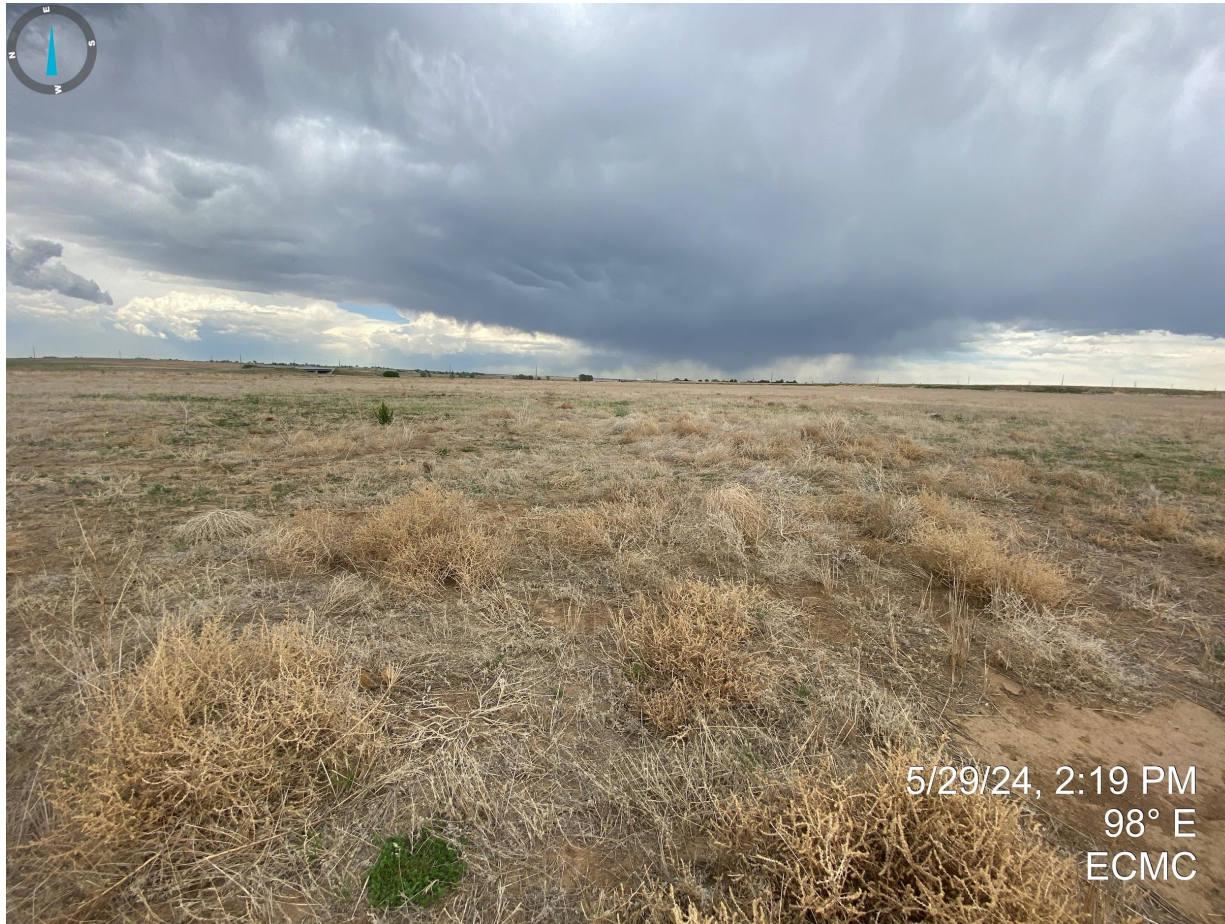
Photo 4. Taken near the former well location; see comments in Photo 3.

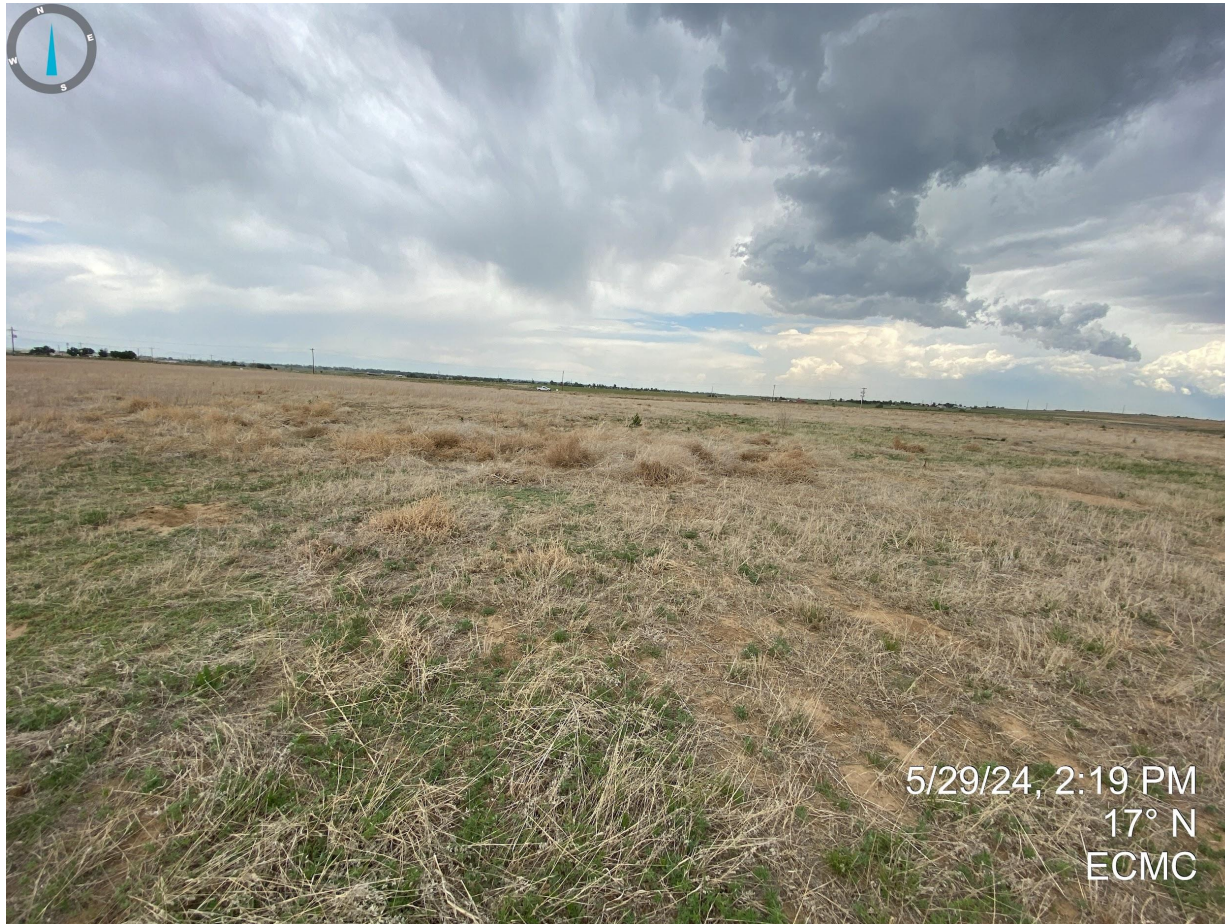
Photo 5. Taken from the southern portion near the former well location; see comments in Photo 3.

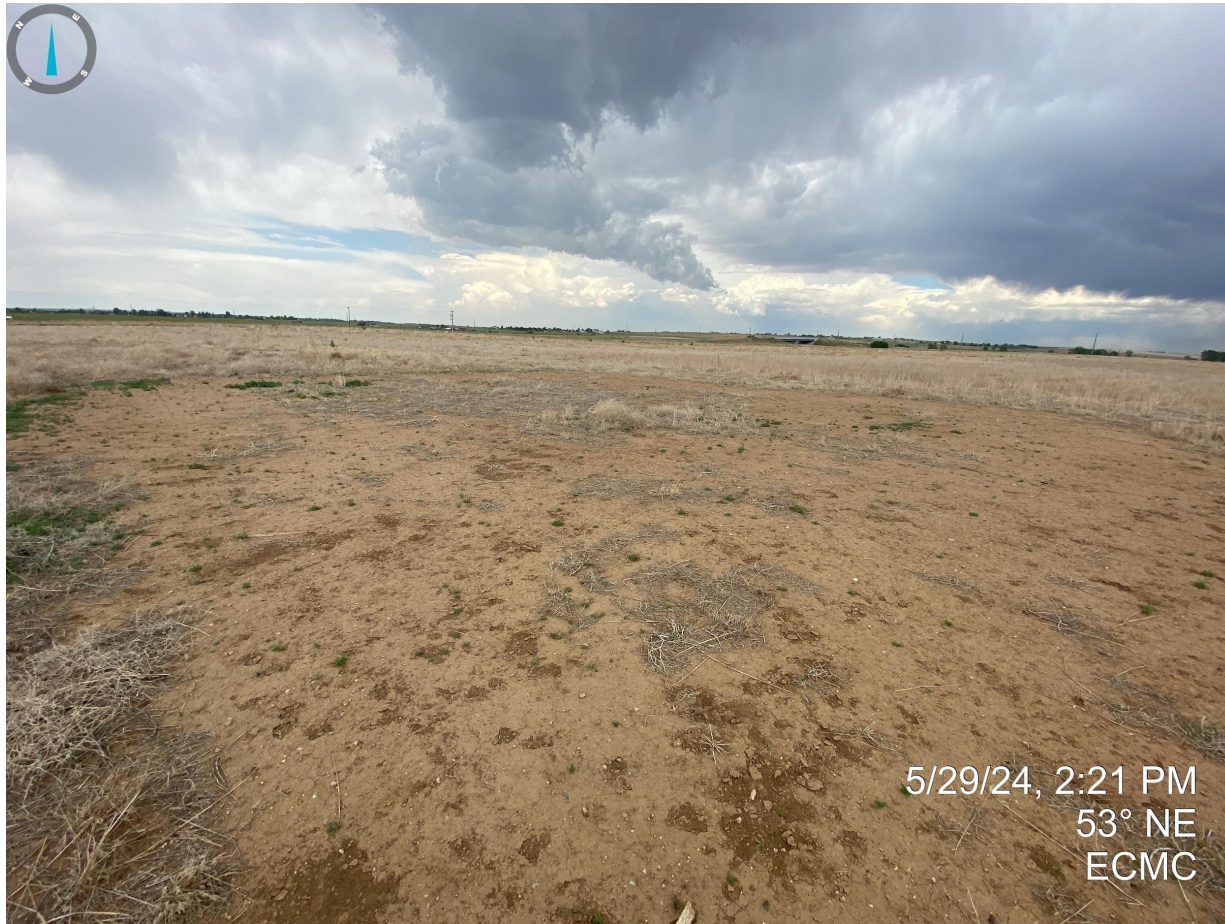
Photo 6. Bare/exposed soils observed near the former tank battery location; photo taken from the southeast corner.

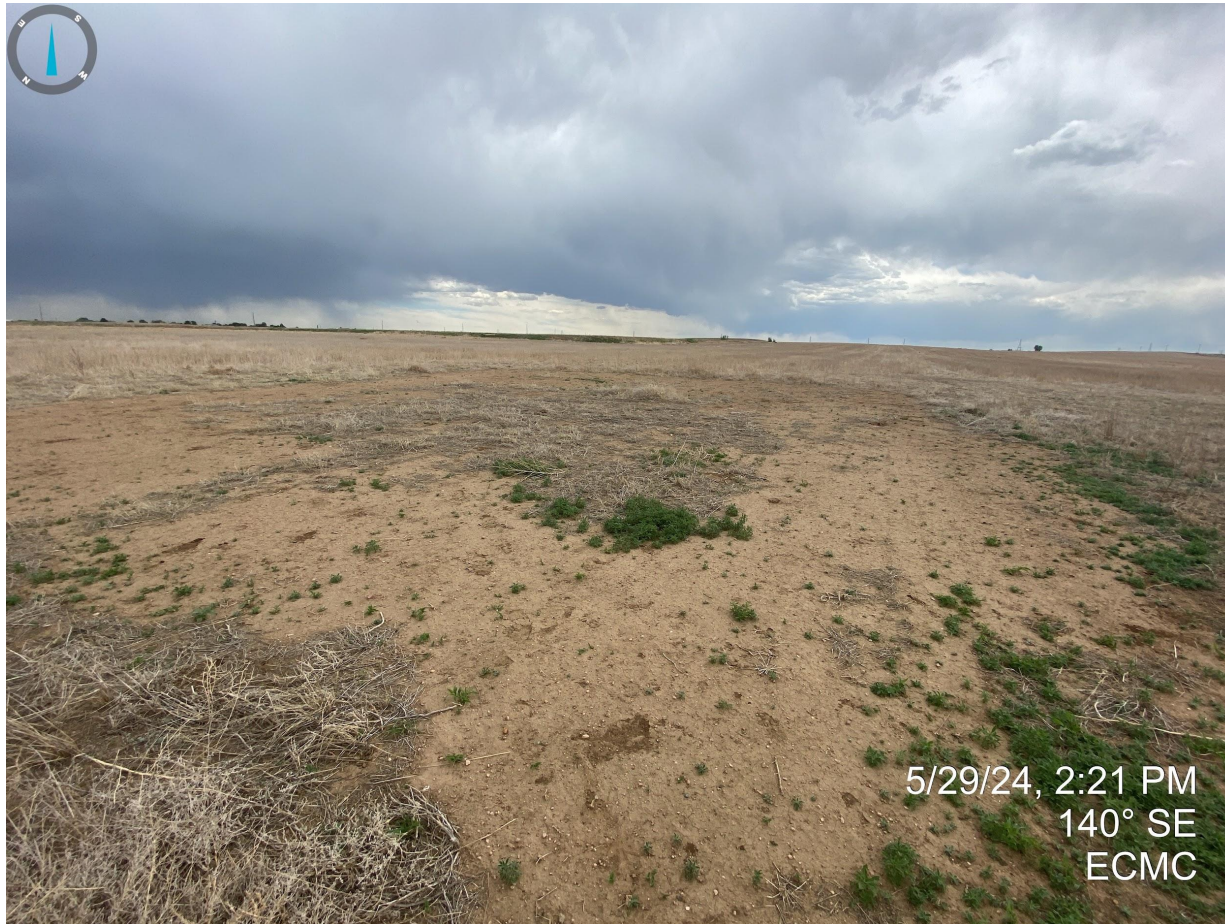
Photo 7. Bare/exposed soils observed near the former tank battery location; photo taken from the northwest corner.

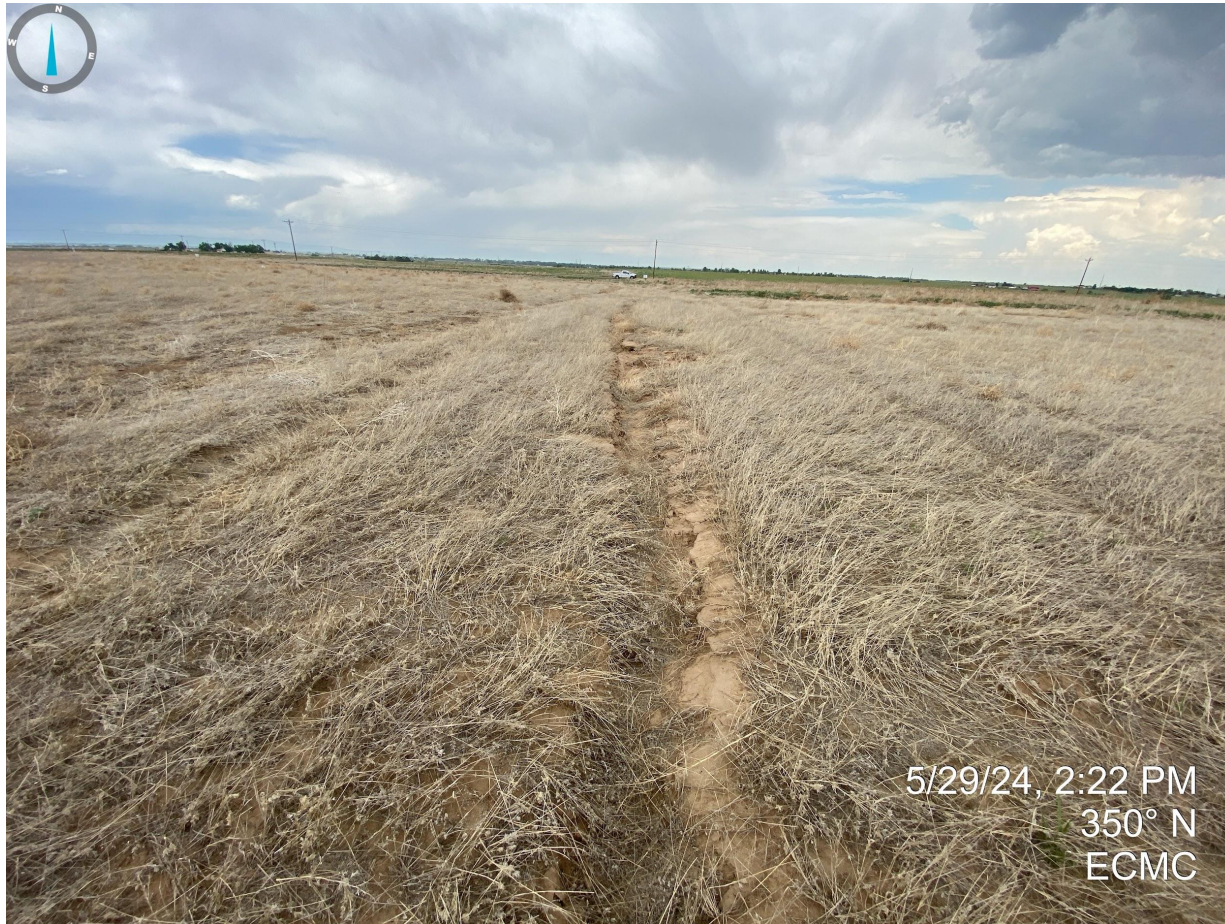
Photo 8. Erosion degradation occurring along the former access road; facing north.
