Inspection Photos
Location: Kamikaze 23-18
Facility ID: 309318

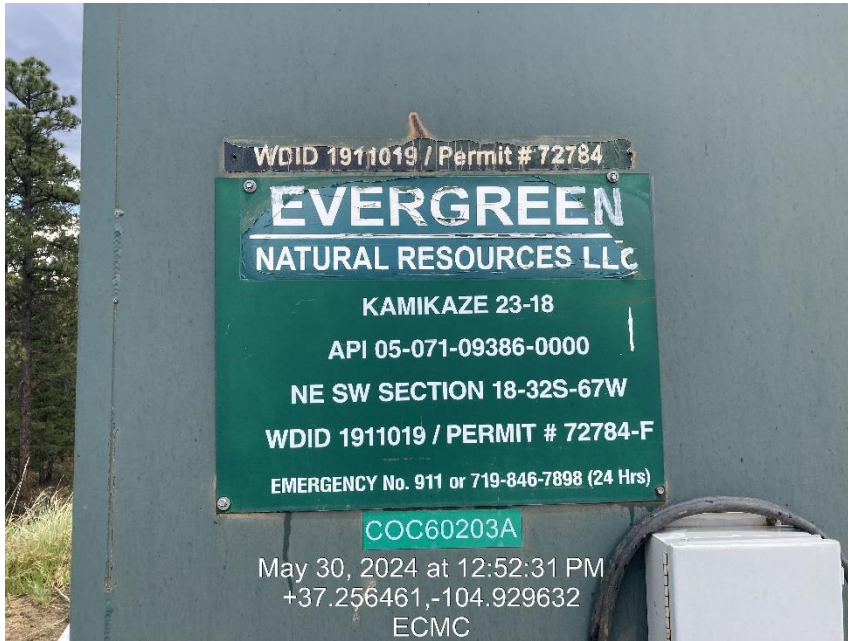
Photo 1 –Well placard

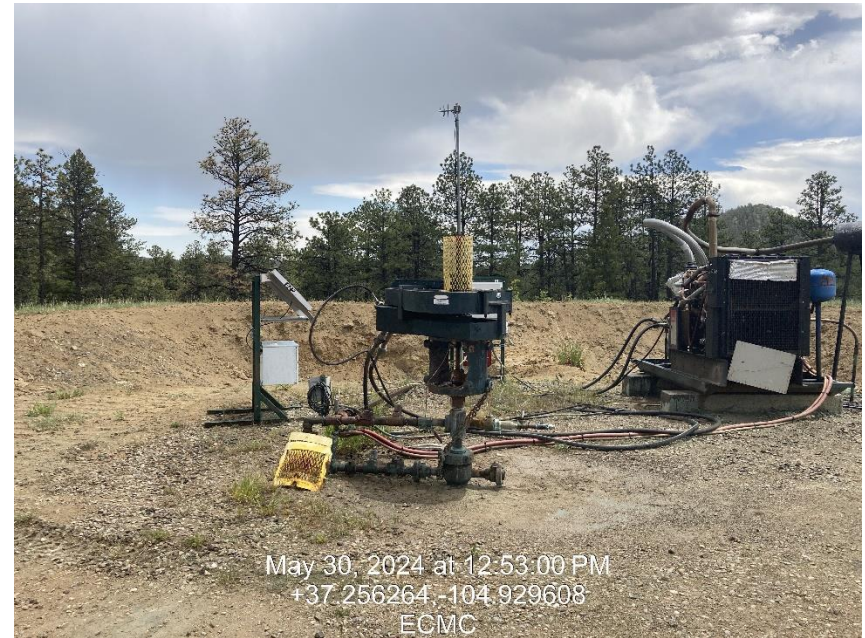
Photo 2 – Wellhead and equipment

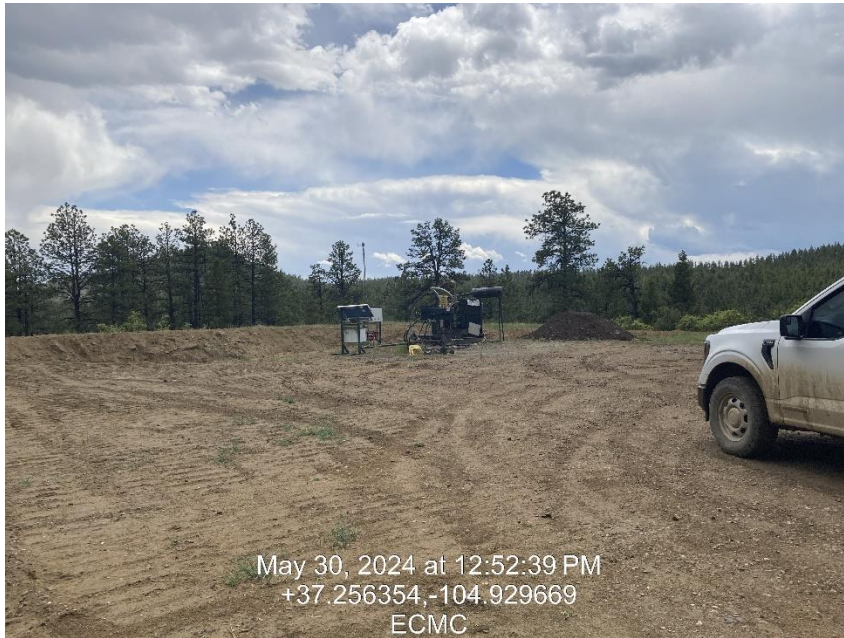
Photo 3 – Location looking southeast

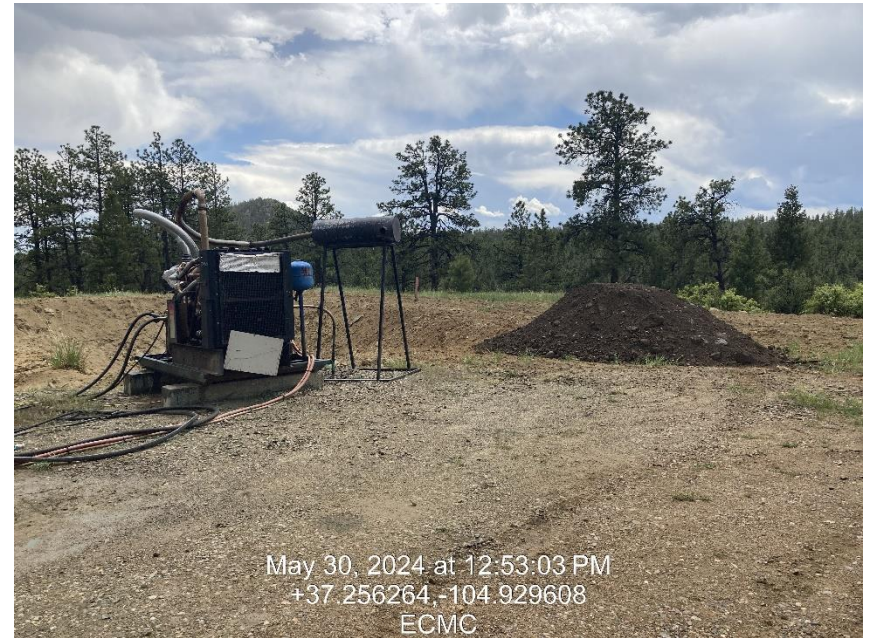
Photo 4 – Engine Skid and Spoil Pile

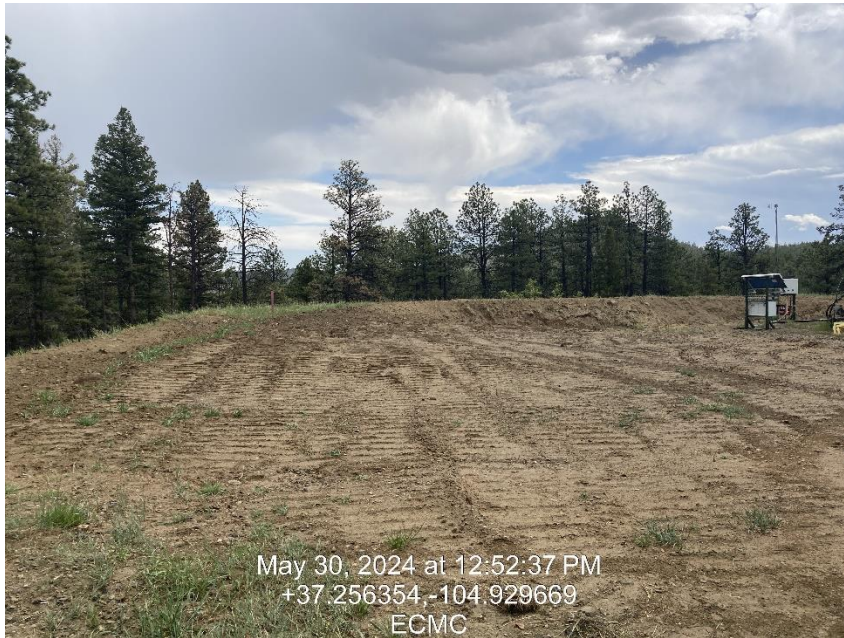
Photo 5 – Location Looking east

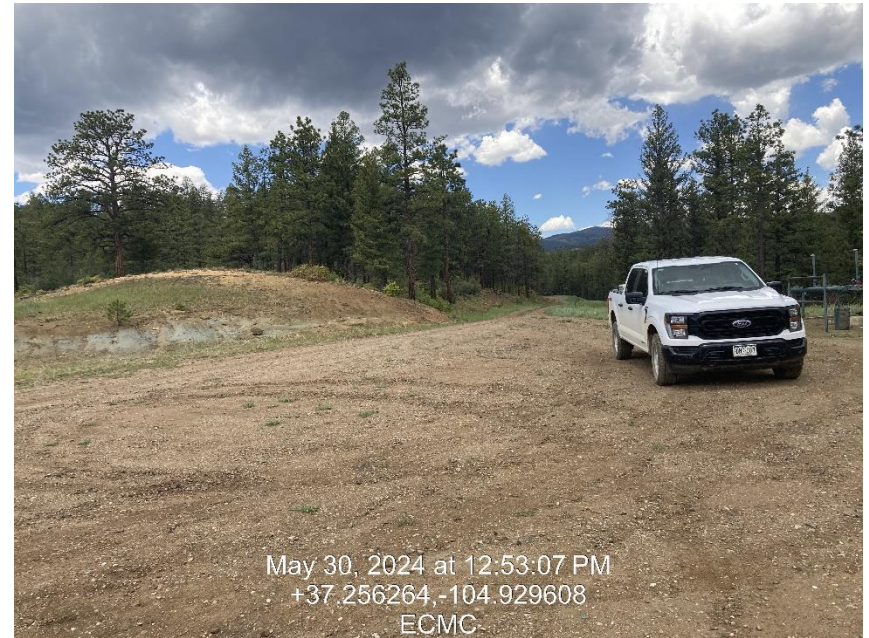
Photo 6 – Location Looking west

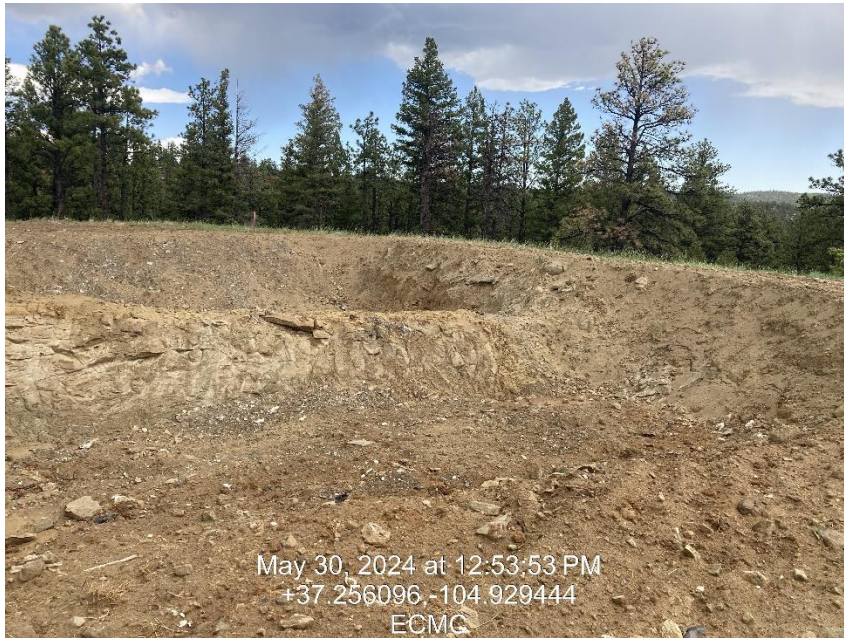
Photo 7 – Pit Facility ID 435026, Pit in the process for closure

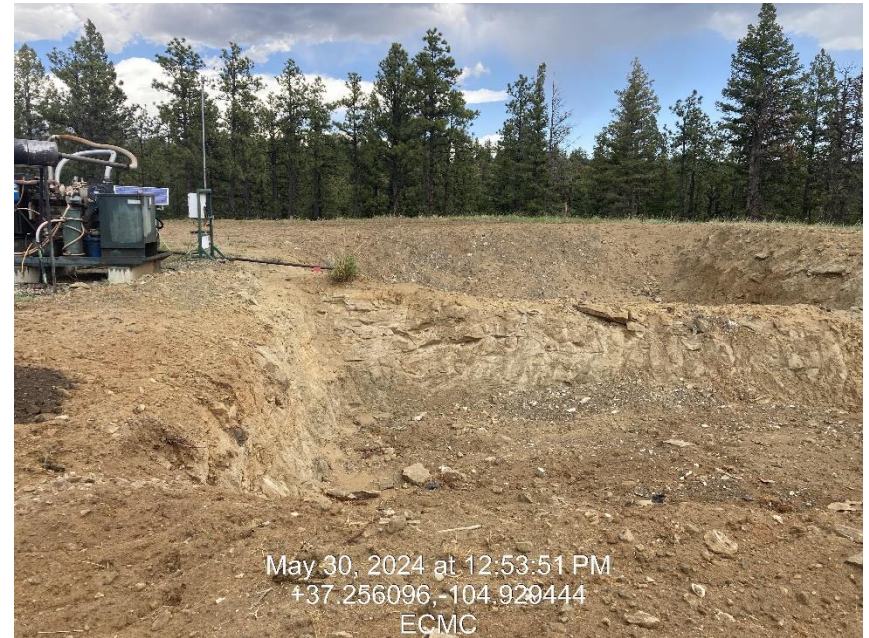
Photo 8 – Pit in closure process

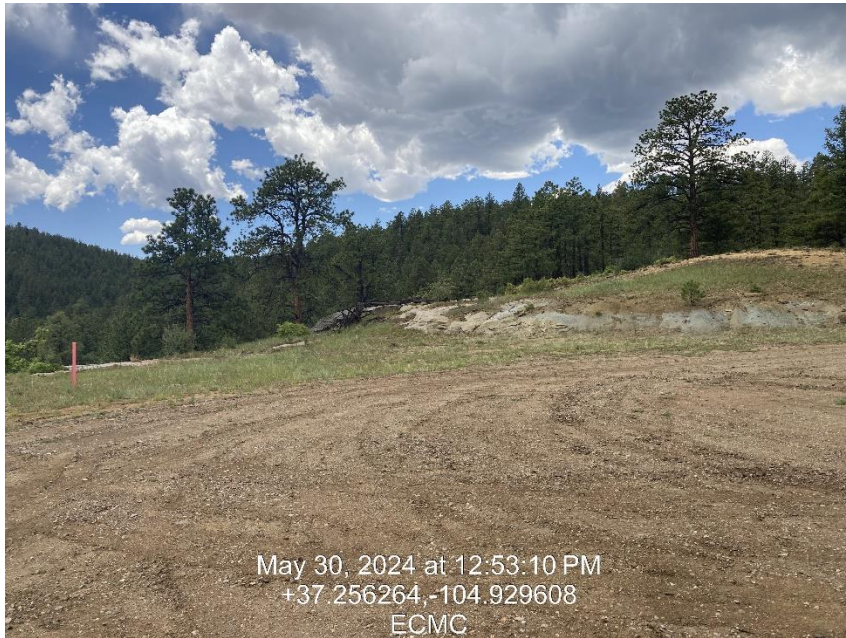
Photo 9 – Location Looking southwest
