**Inspection Photos**  
**Location Name: William D. Lansdown unit D1**  
**Location ID: 318987**

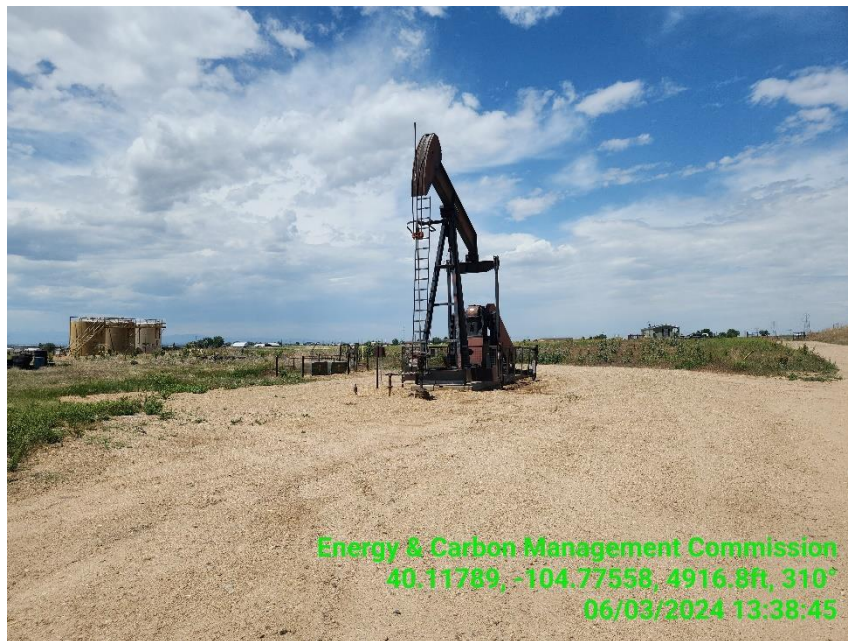
**Photo 1 Location.**

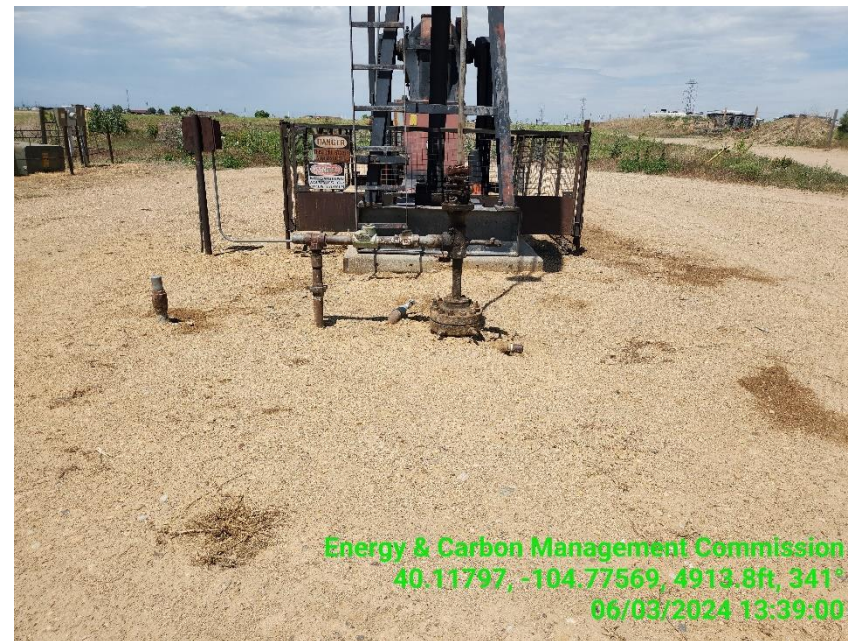
**Photo 2 Stained soil by the WH.**

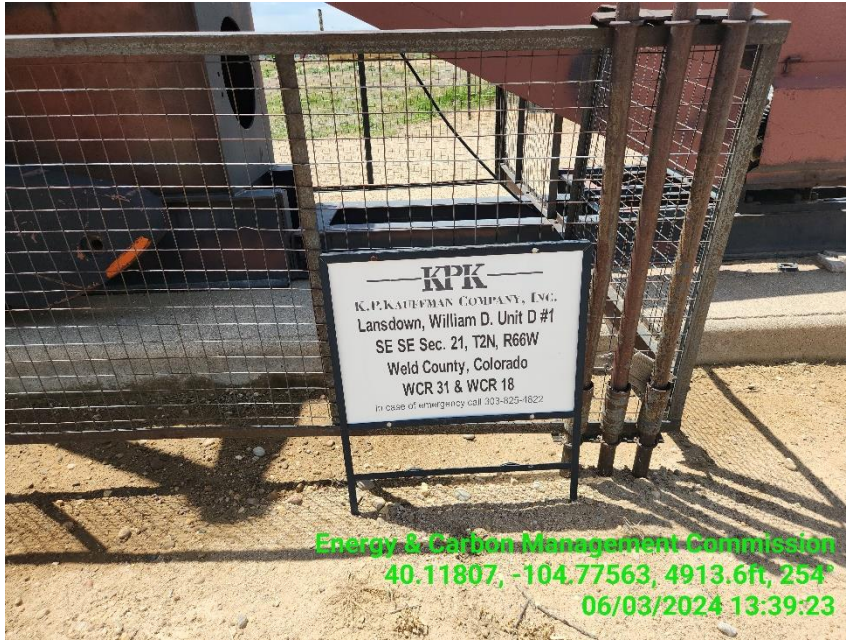
Photo 3 WH sign.

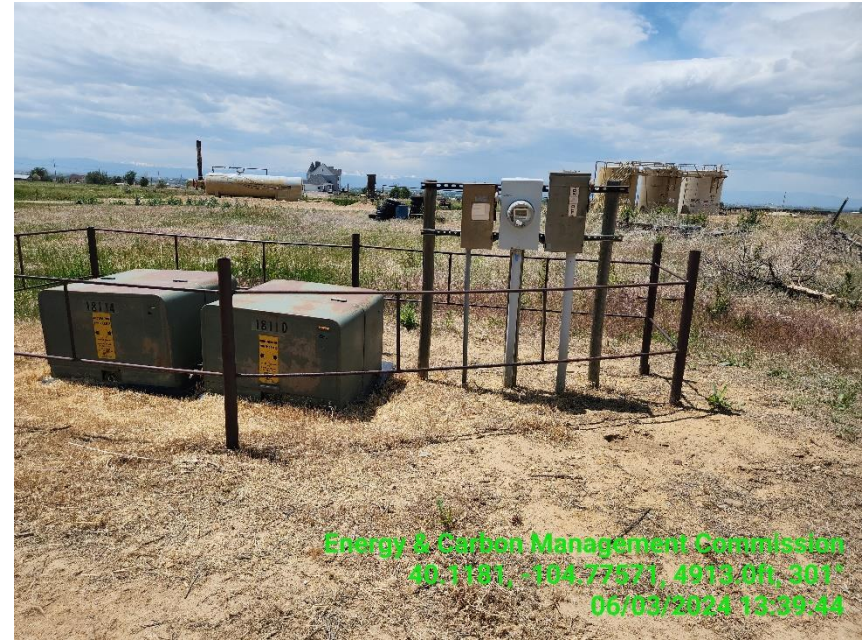
Photo 4 Ancillary equipment.

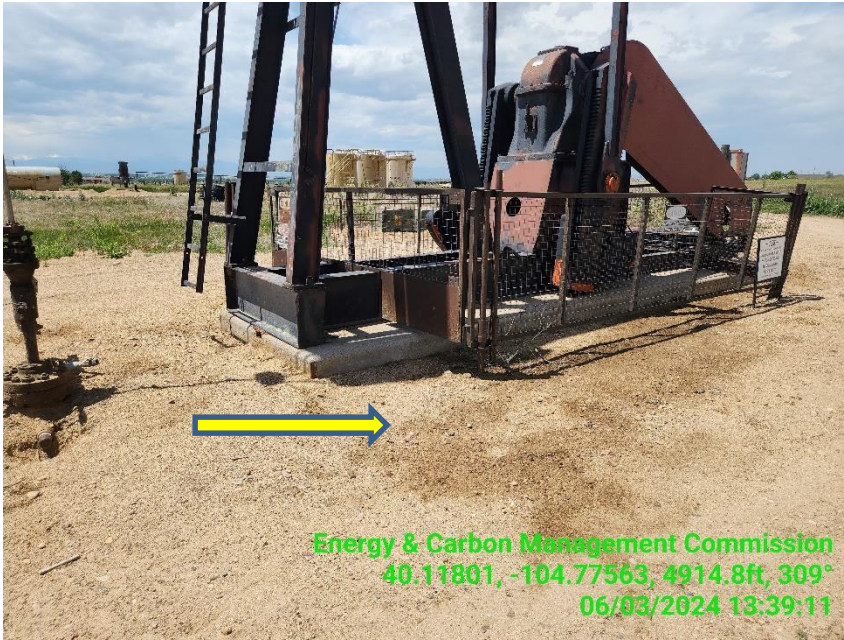
Photo 5 Stained soil around the pump jack base.

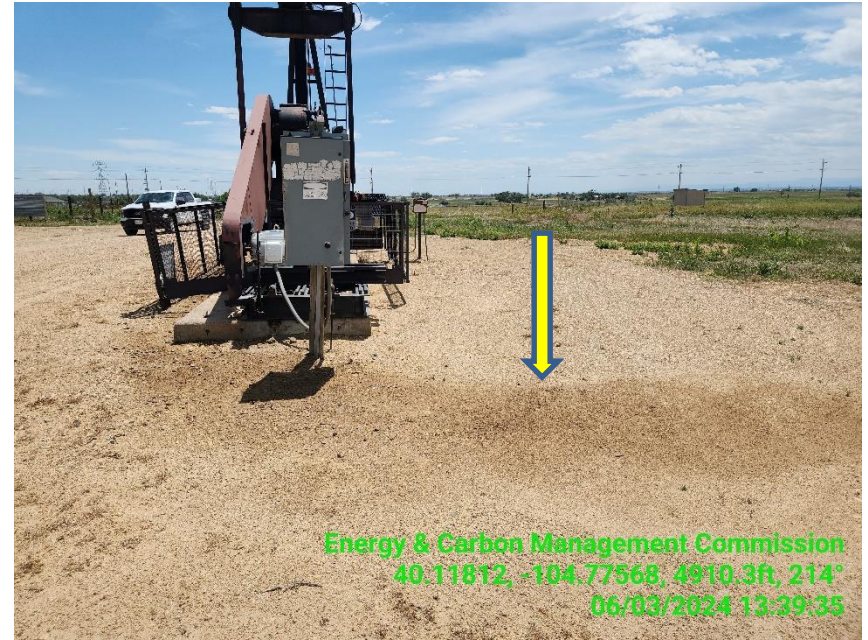
Photo 6 Stained soil around the pump jack base.

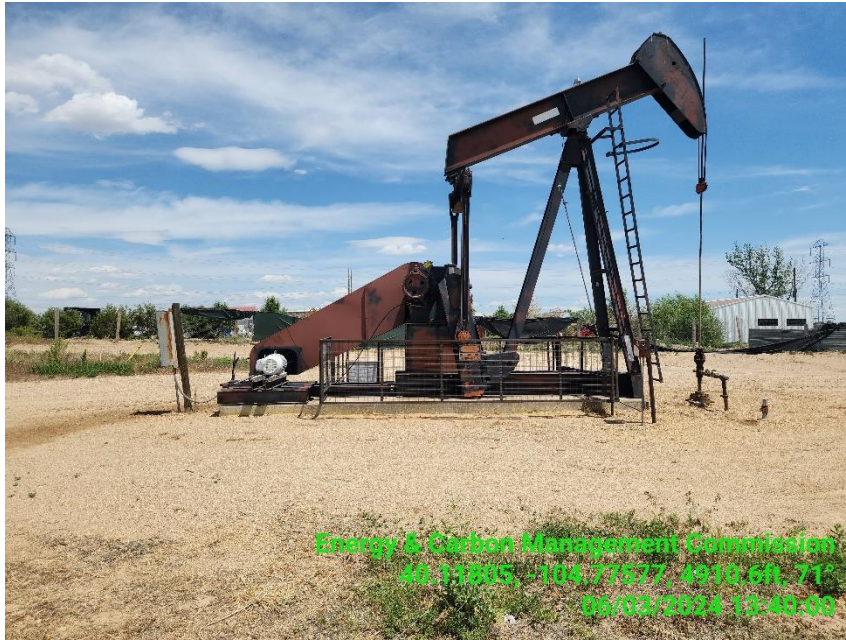
Photo 7 Stained soil around the pump jack base.

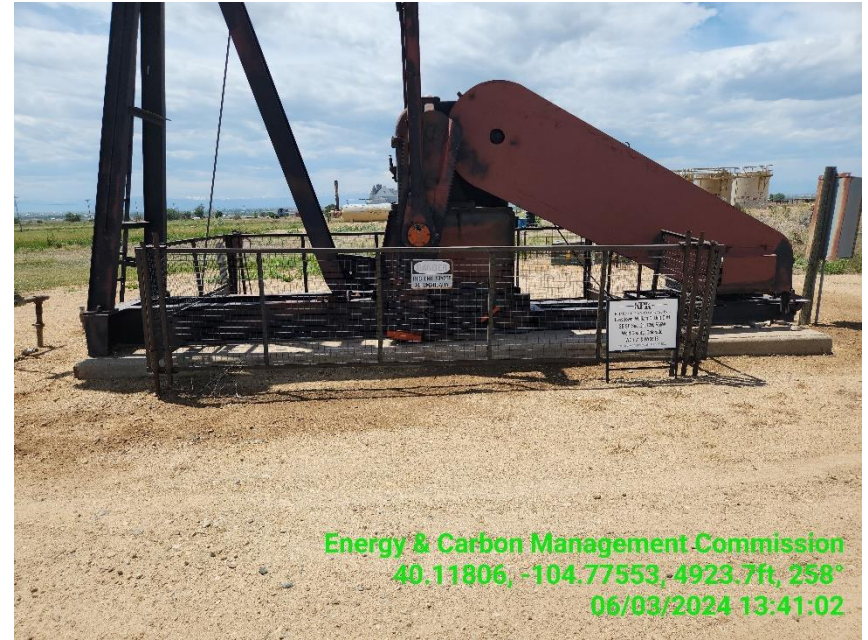
Photo 8 Stained soil around the pump jack base.

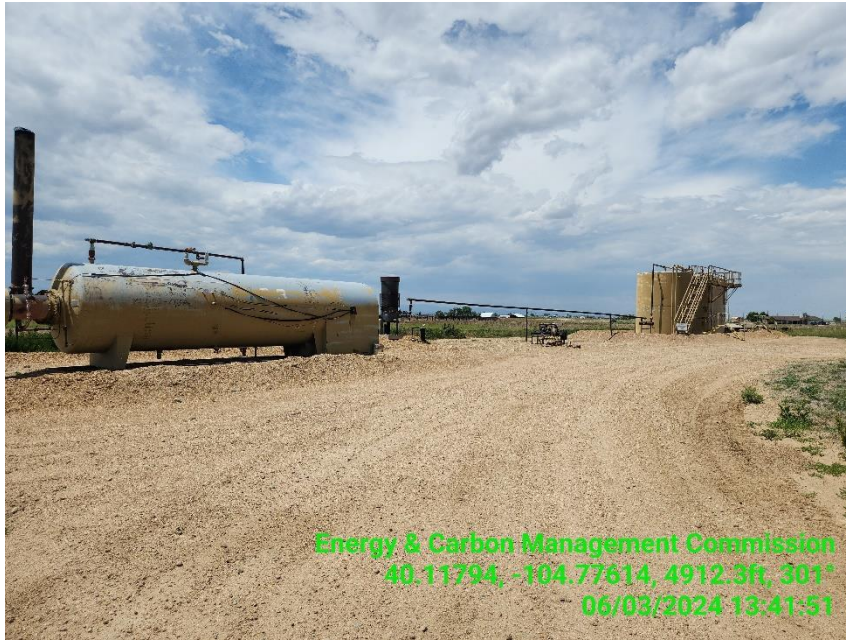
Photo 9 Tank battery location.

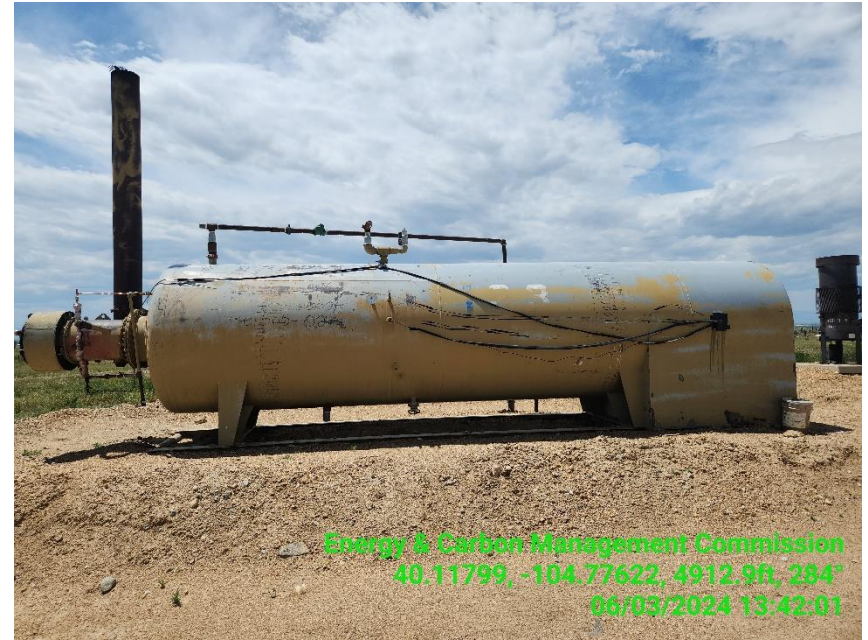
Photo 10 Horizontal heater treater.

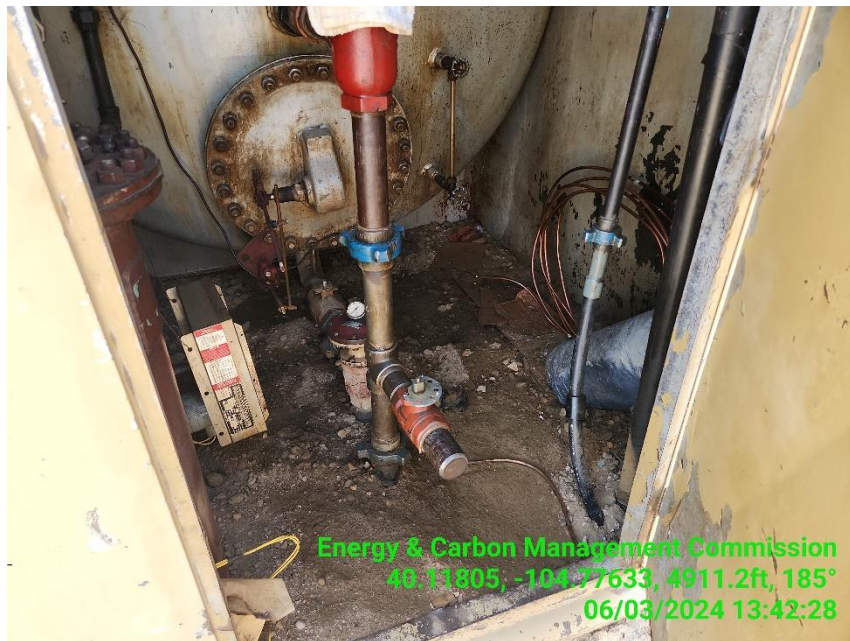
Photo 11 Stained soil inside the Horizontal heater Treater housing.

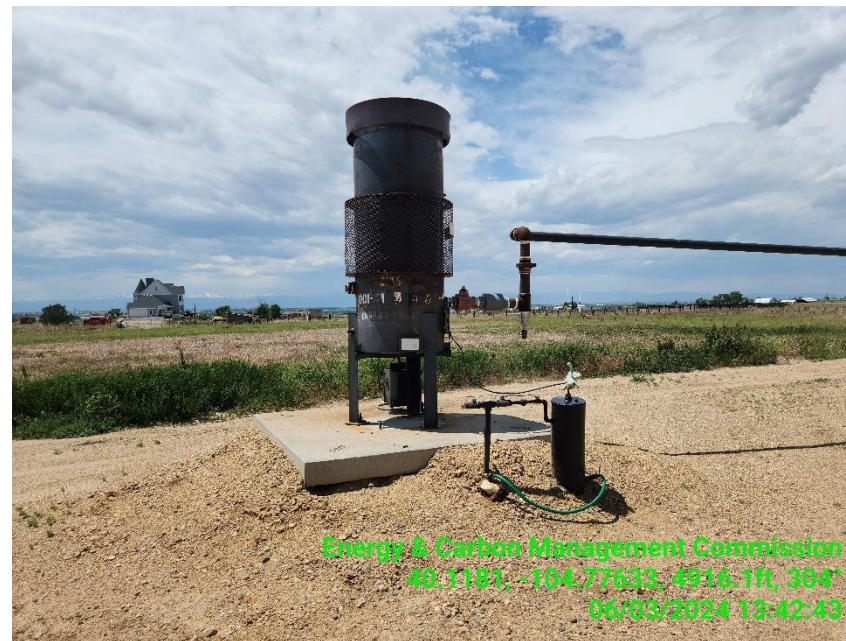
Photo 12 ECD.

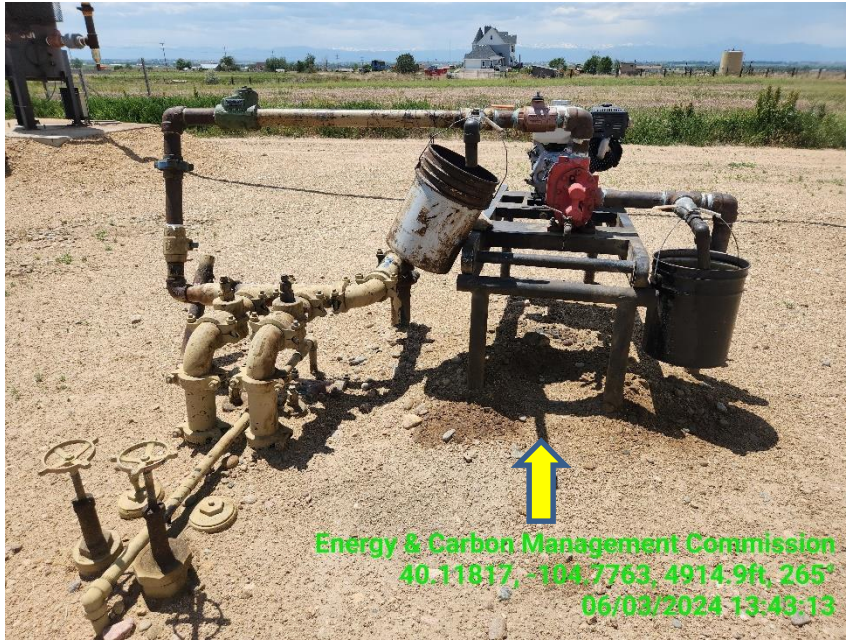
Photo 13 Stained soil by the flow line manifold & aux. pu.mp

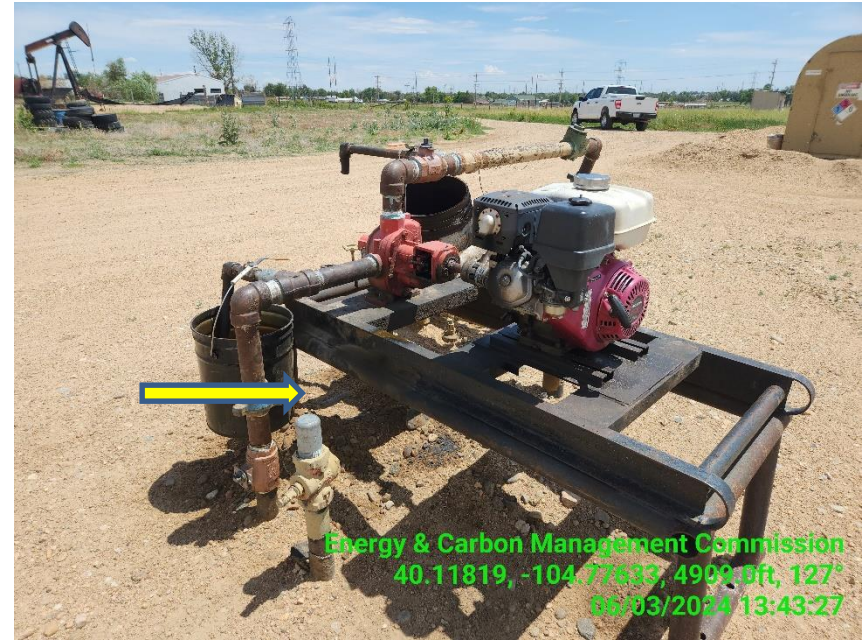
Photo 14 Stained soil by the flow line manifold & aux. pump.

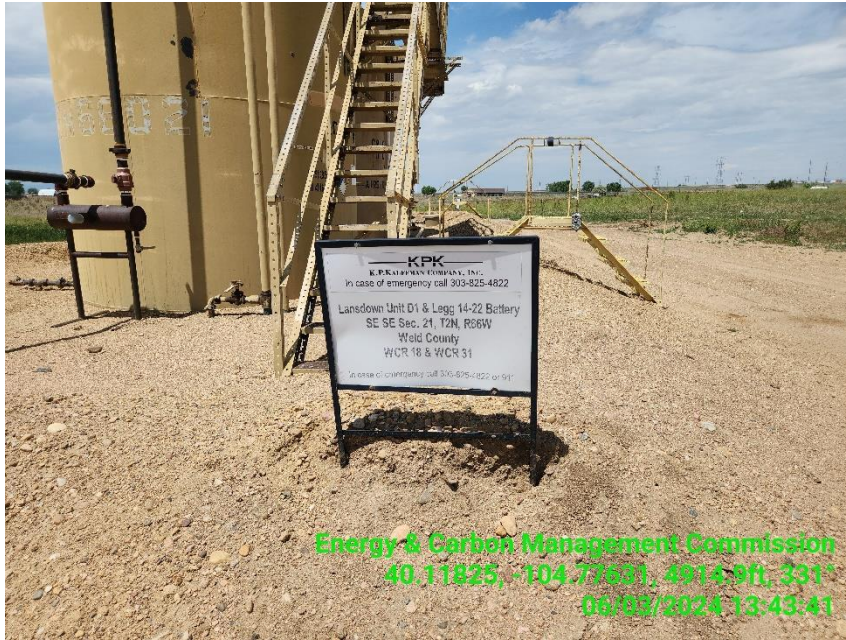
Photo 15 Tank battery sign.

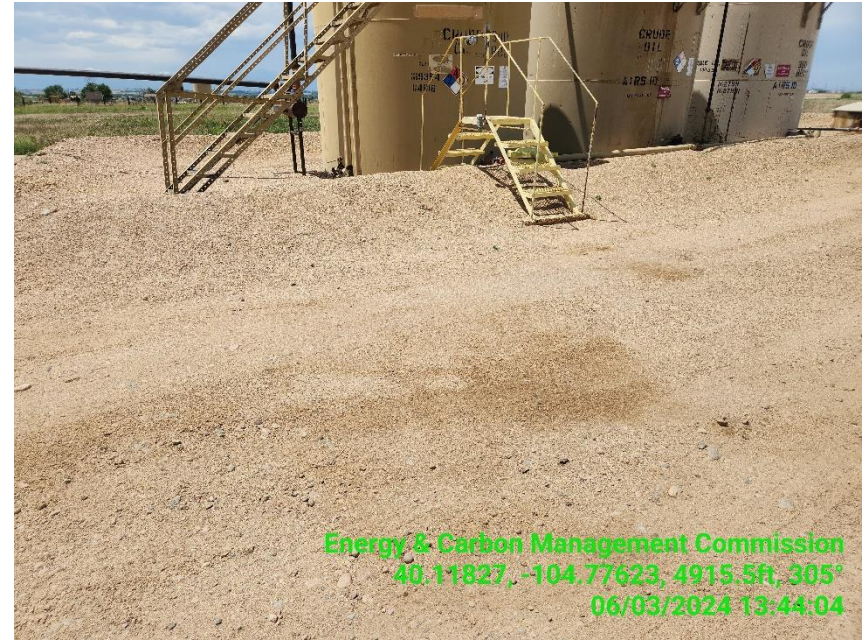
Photo 16 Stained soil by the tank battery.

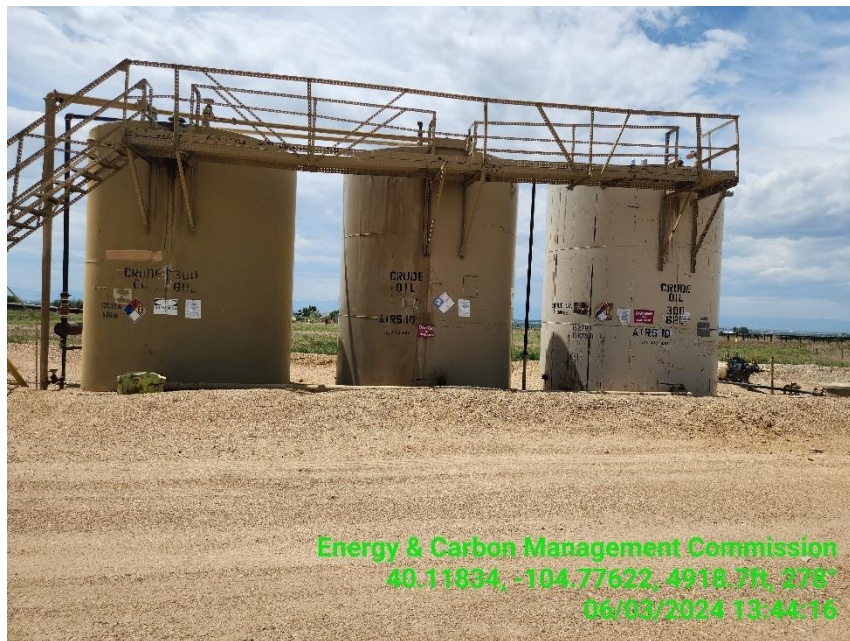
Photo 17 Tank battery.

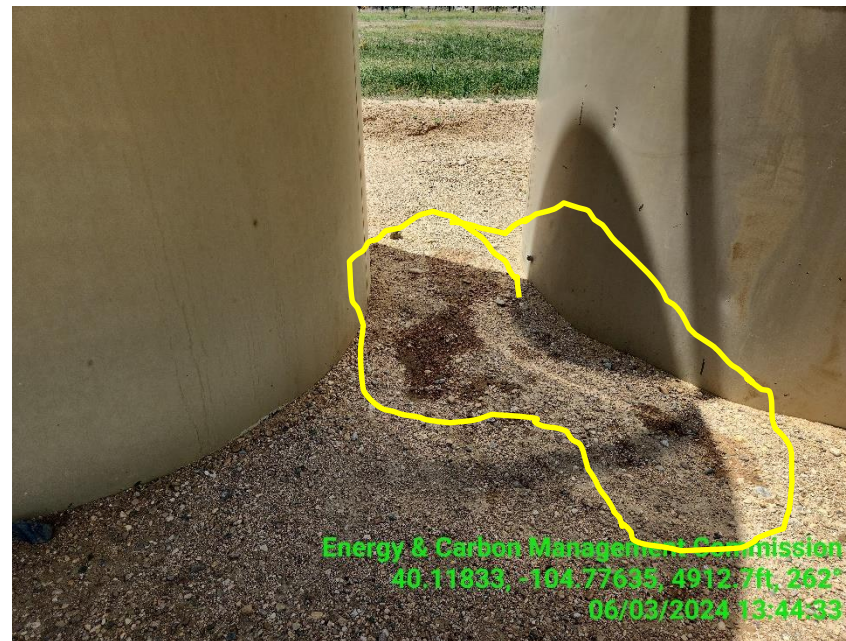
Photo 18 Stained soil between the tanks

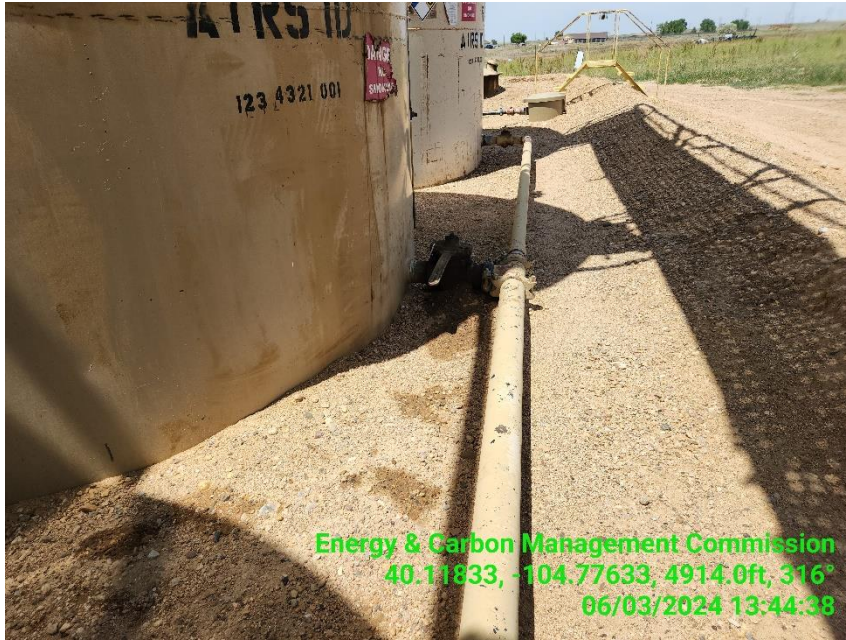
Photo 19 Stained soil by tank load line valve .

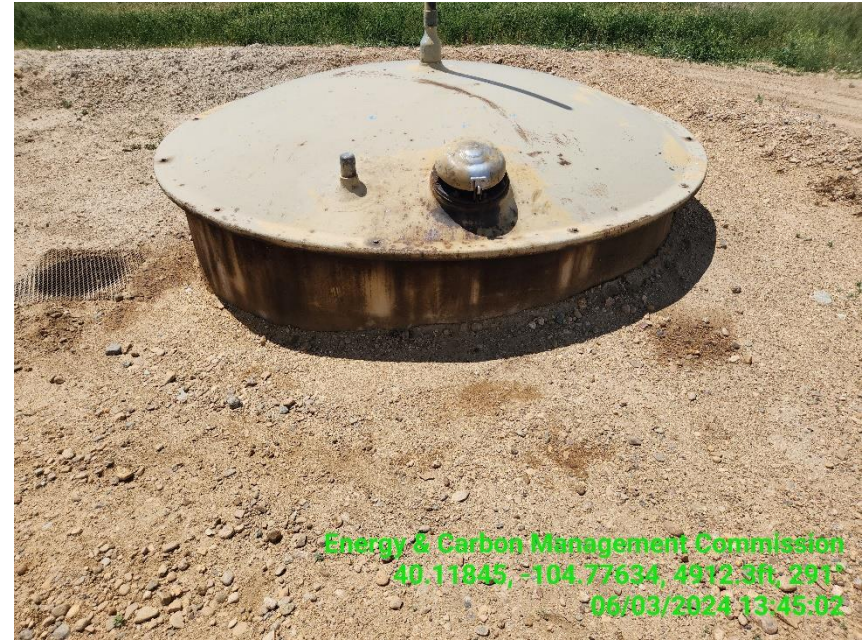
Photo 20 Stained soil around the PW tanks

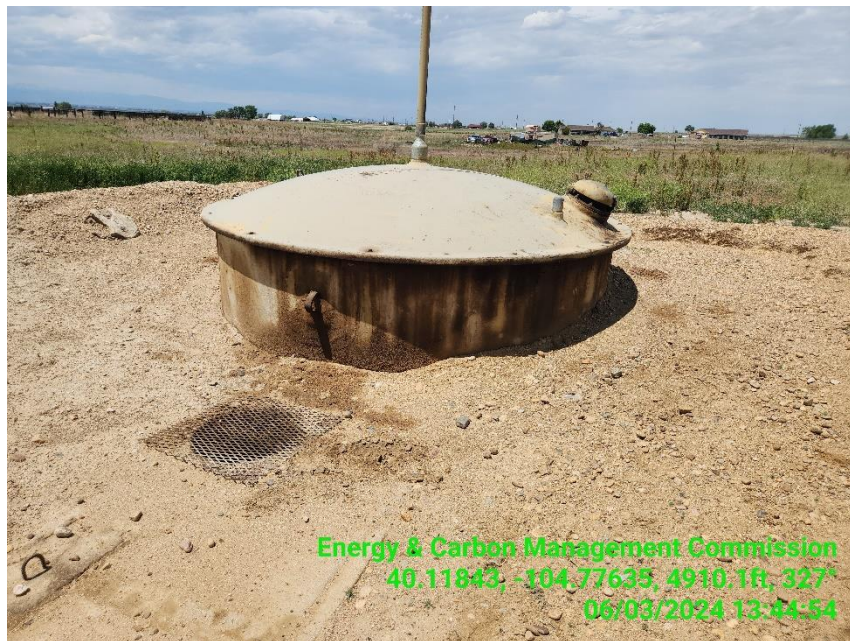
Photo 21 Stained soil by PW tanks.

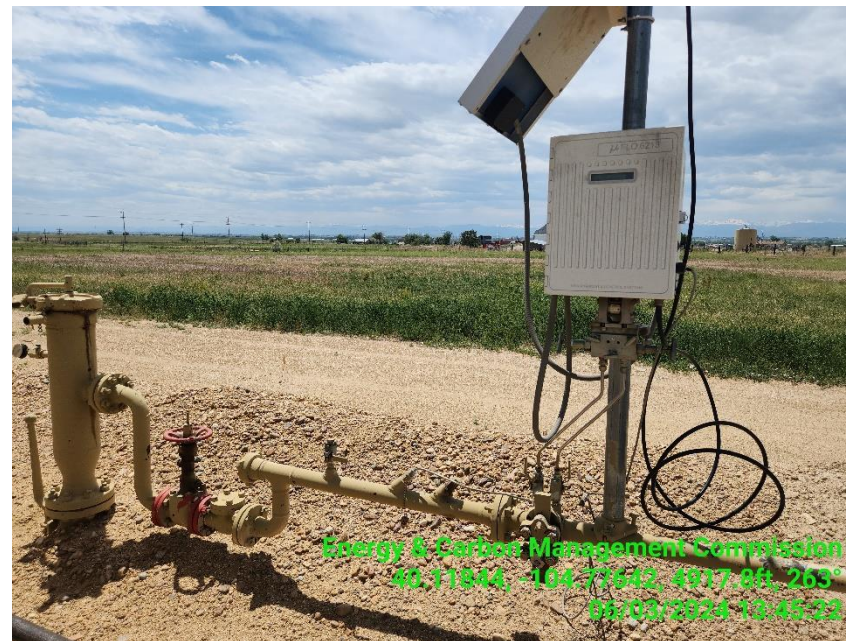
Photo 22 Gas Meter Run.
