**Storm Water Management and Erosion control**  
**Location Name: TEP ROCKY MOUNTAIN LLC DOE 1-M-17 Pad**  
**Location ID: 335248**

**Location Overview: Location is within High Priority/Density  
Habitat areas. Location is approximately 63 yards from a  
creek/drainage that contributes to the Colorado River.**

**Section/Township/Range: 17 6S94W**

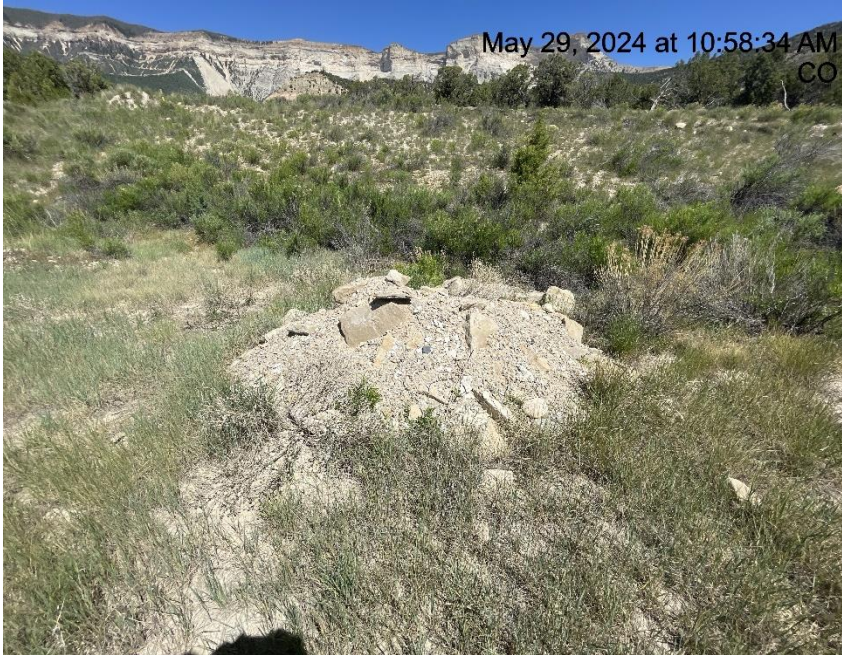
**Photo # 8565 Stockpiled soils**

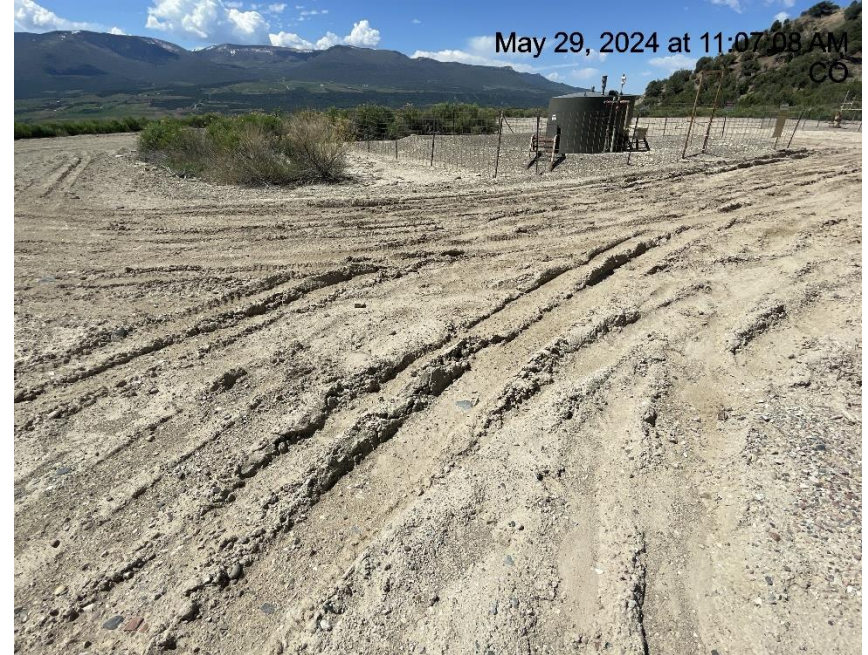
**Photo # 8566 Lack of stabilization/compaction**

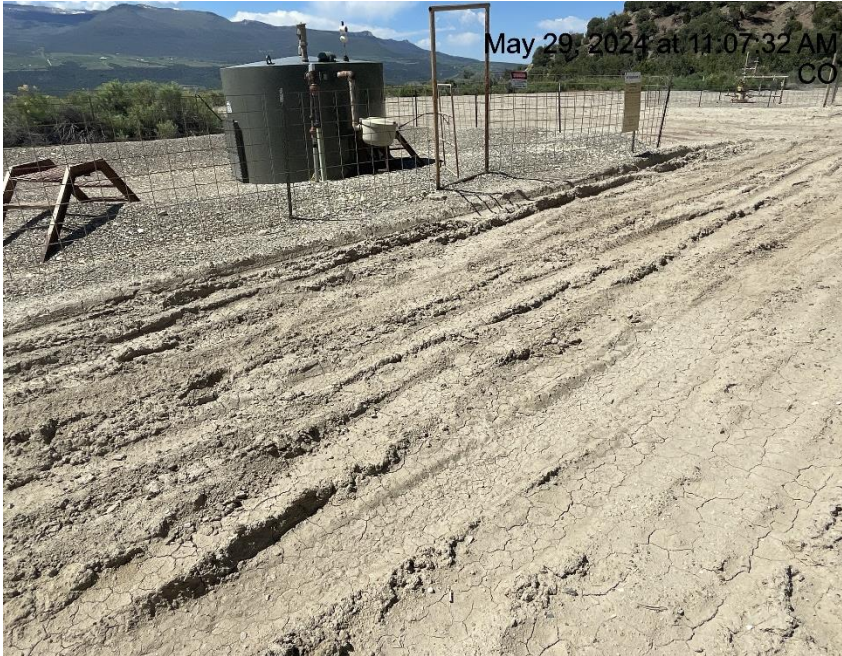
**Photo # 8567 Lack of stabilization/compaction**

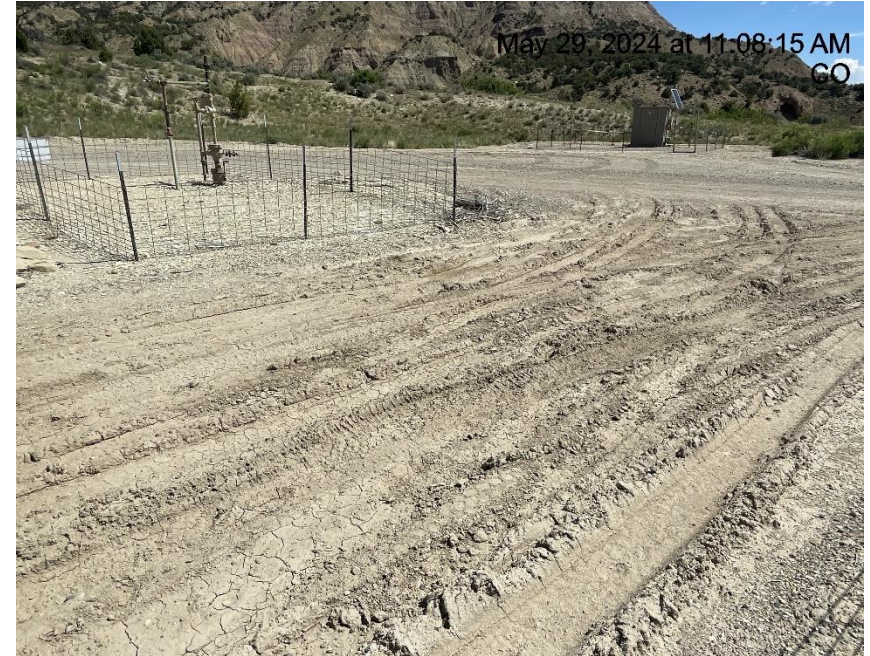
**Photo # 8568 Lack of stabilization/compaction**

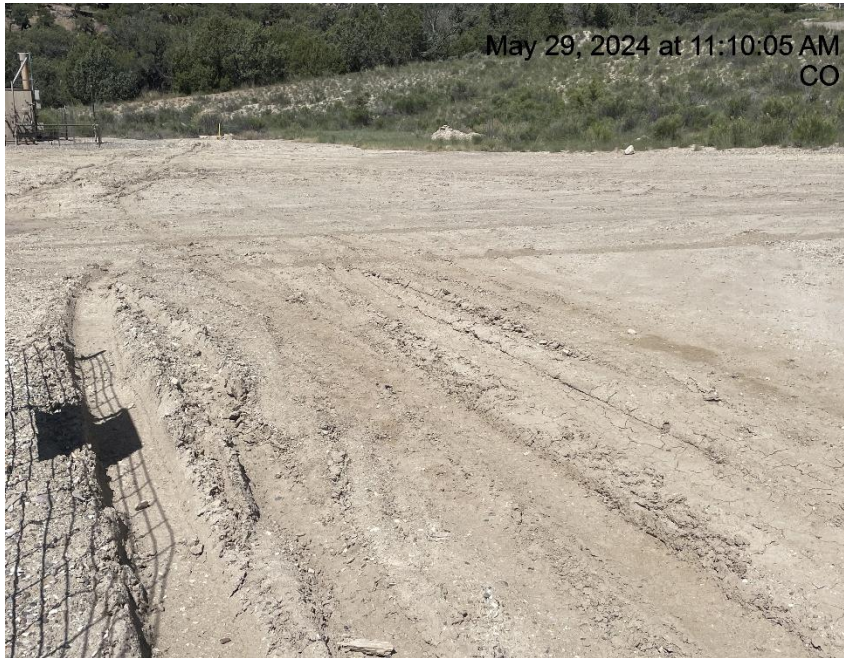
**Photo # 8569 Lack of stabilization/compaction**

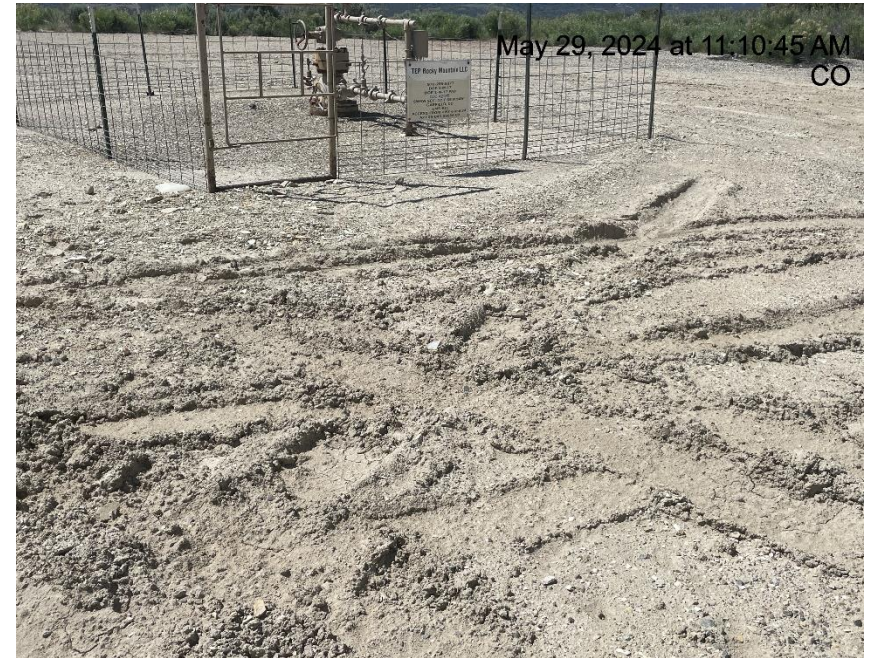
**Photo # 8570 Lack of stabilization/compaction**

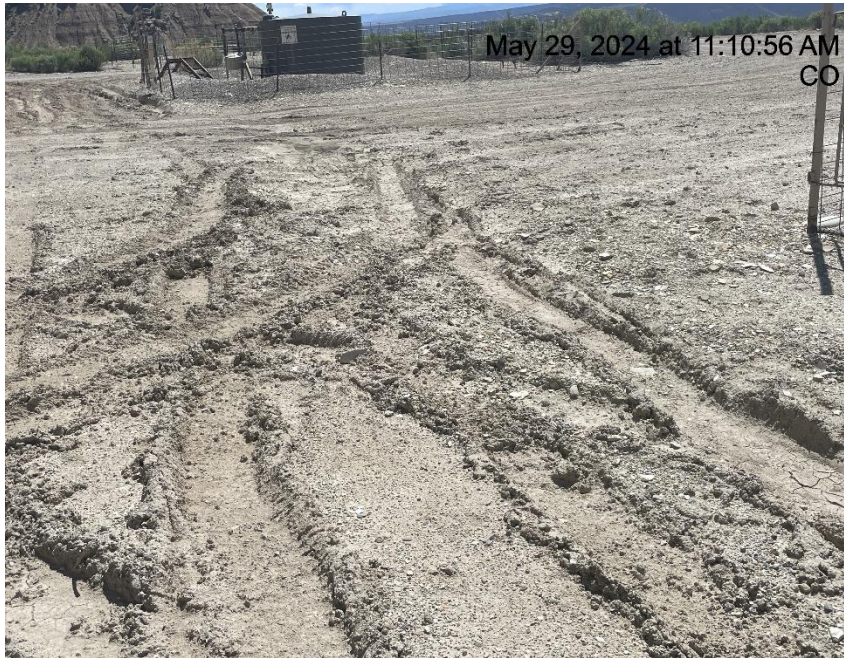
**Photo # 8571 Lack of stabilization/compaction**

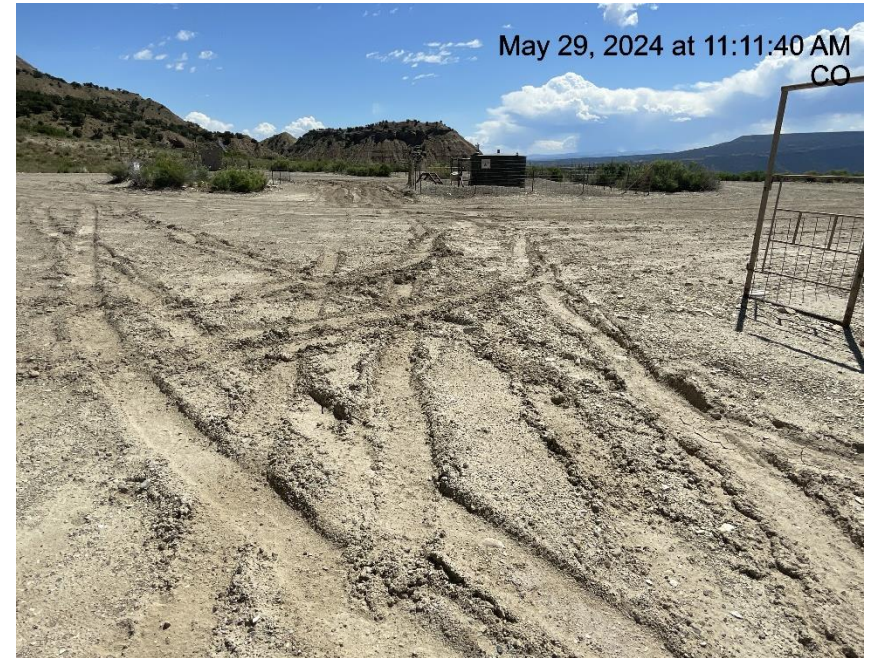
**Photo # 8572 Lack of stabilization/compaction**

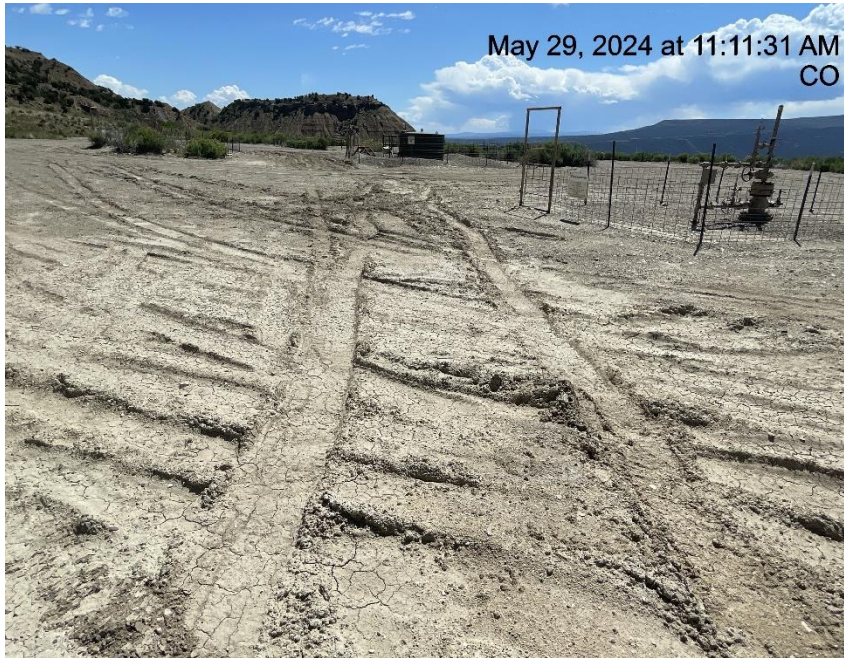
**Photo # 8573 Lack of stabilization/compaction**

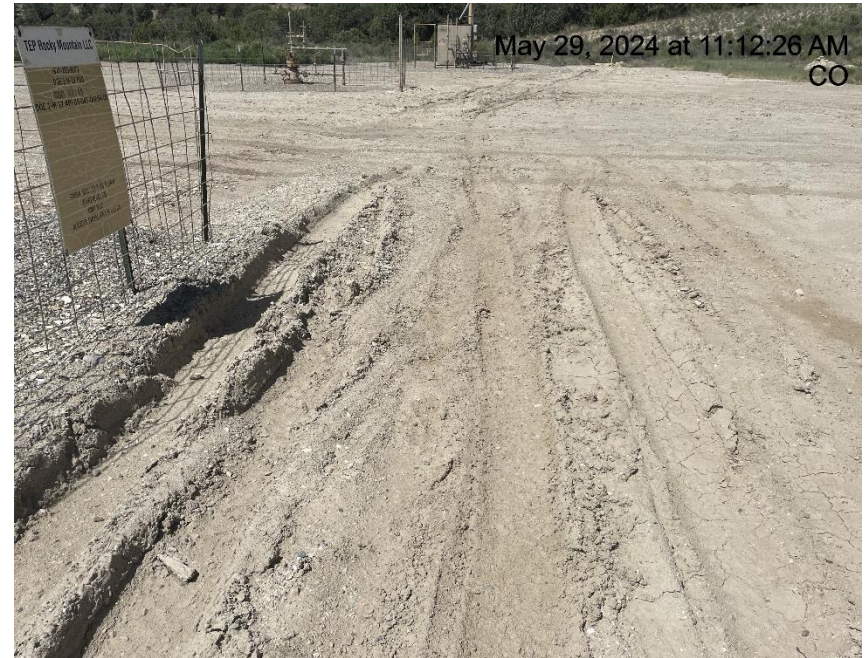
**Photo # 8574 Lack of stabilization/compaction**
