**COLORADO**  
Energy & Carbon Management  
Commission  
Department of Natural Resources

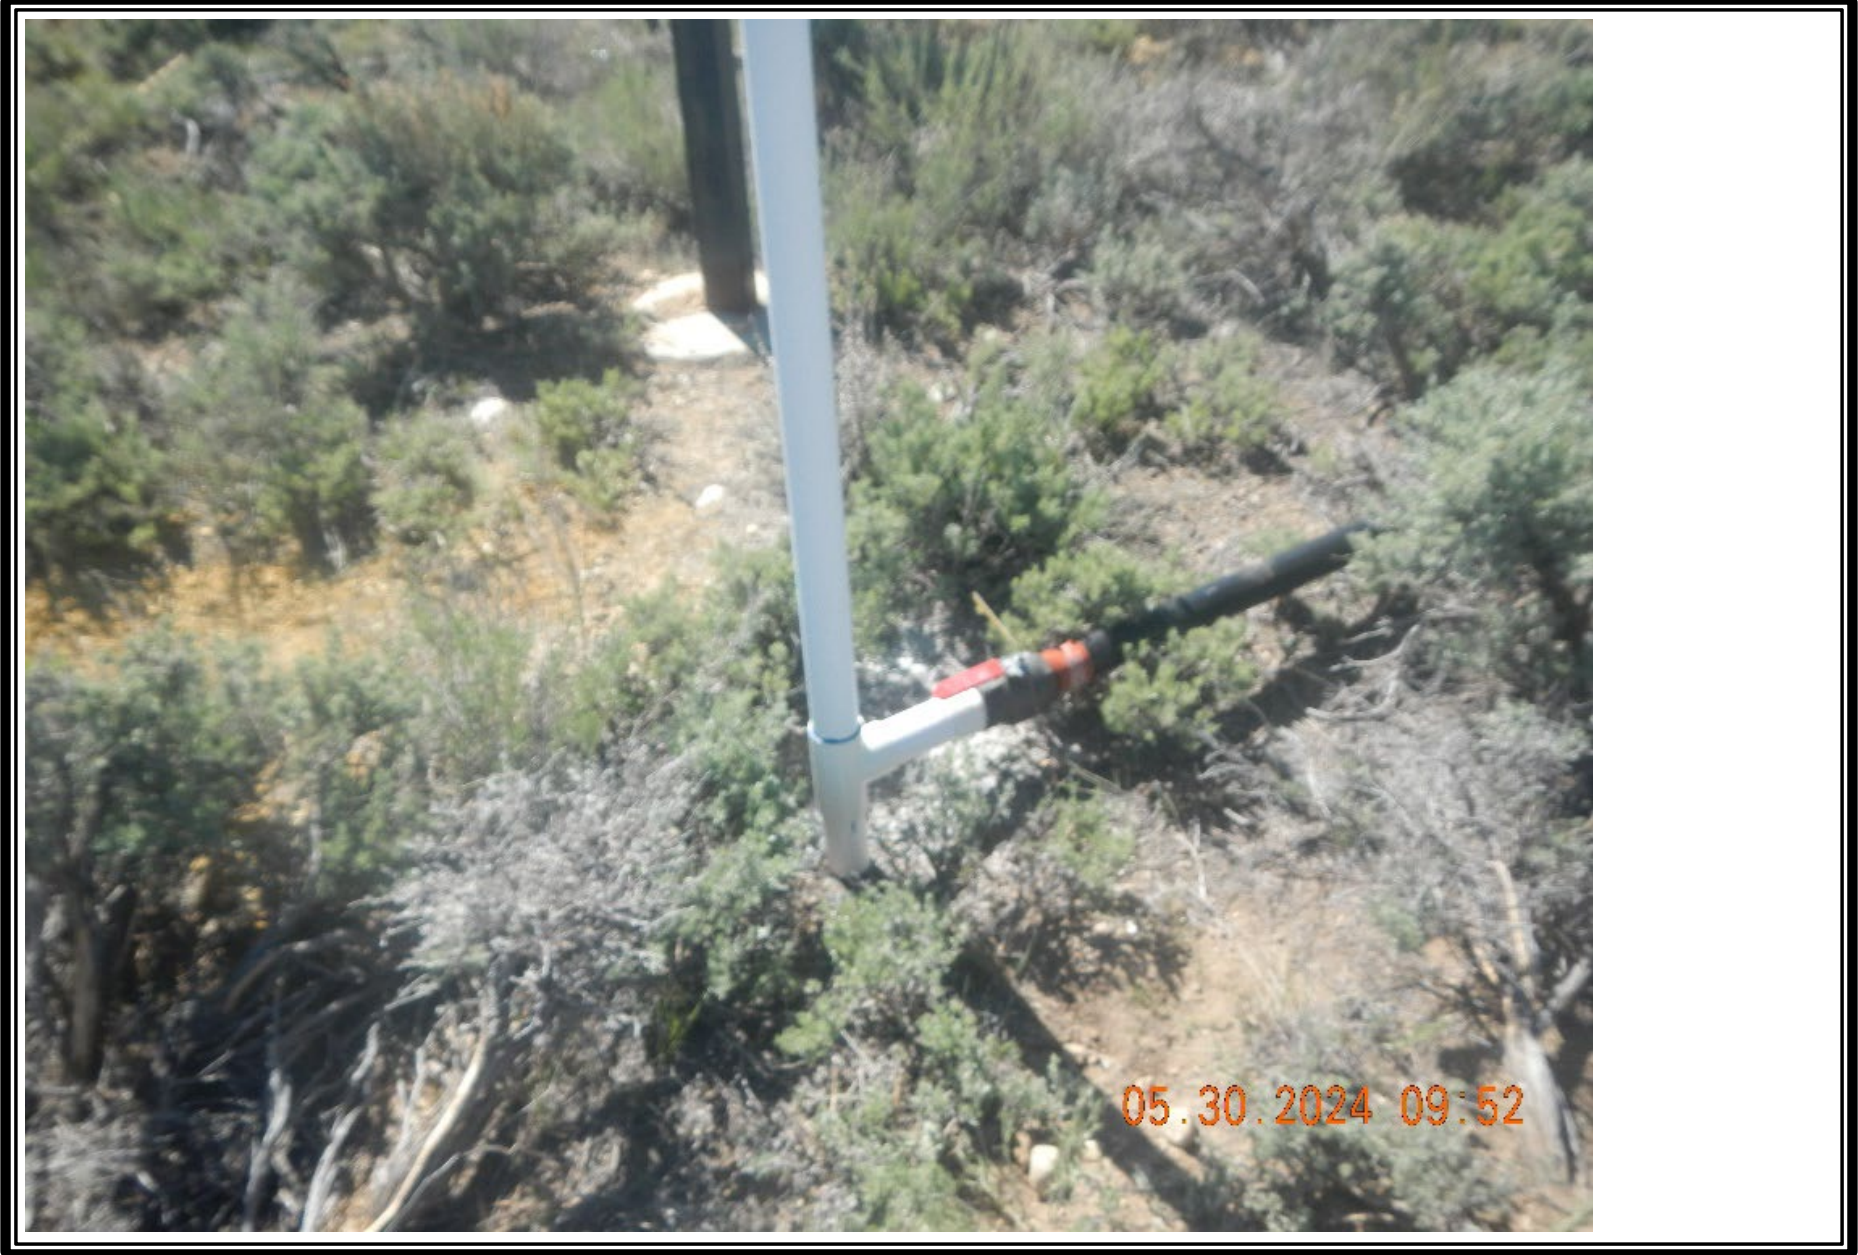
Photo #2 Sparge well. Monitoring well in background.

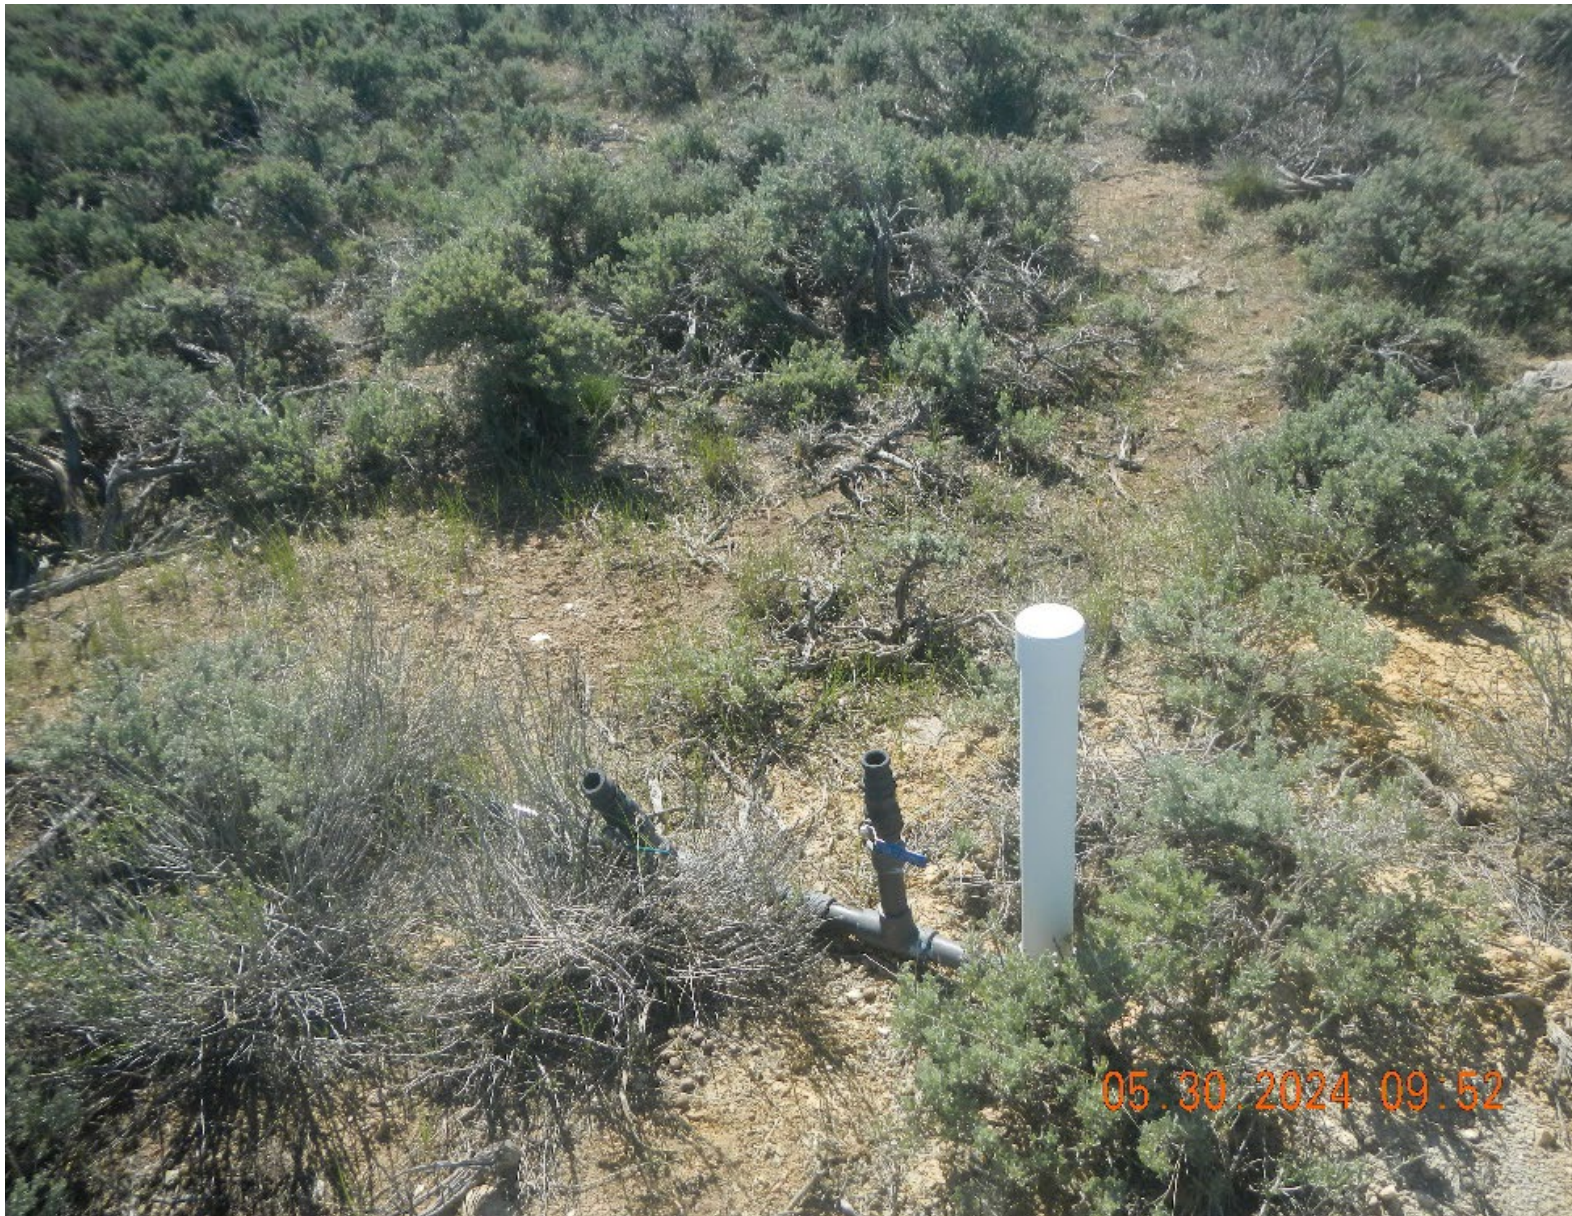
Photo #3 sparge piping.

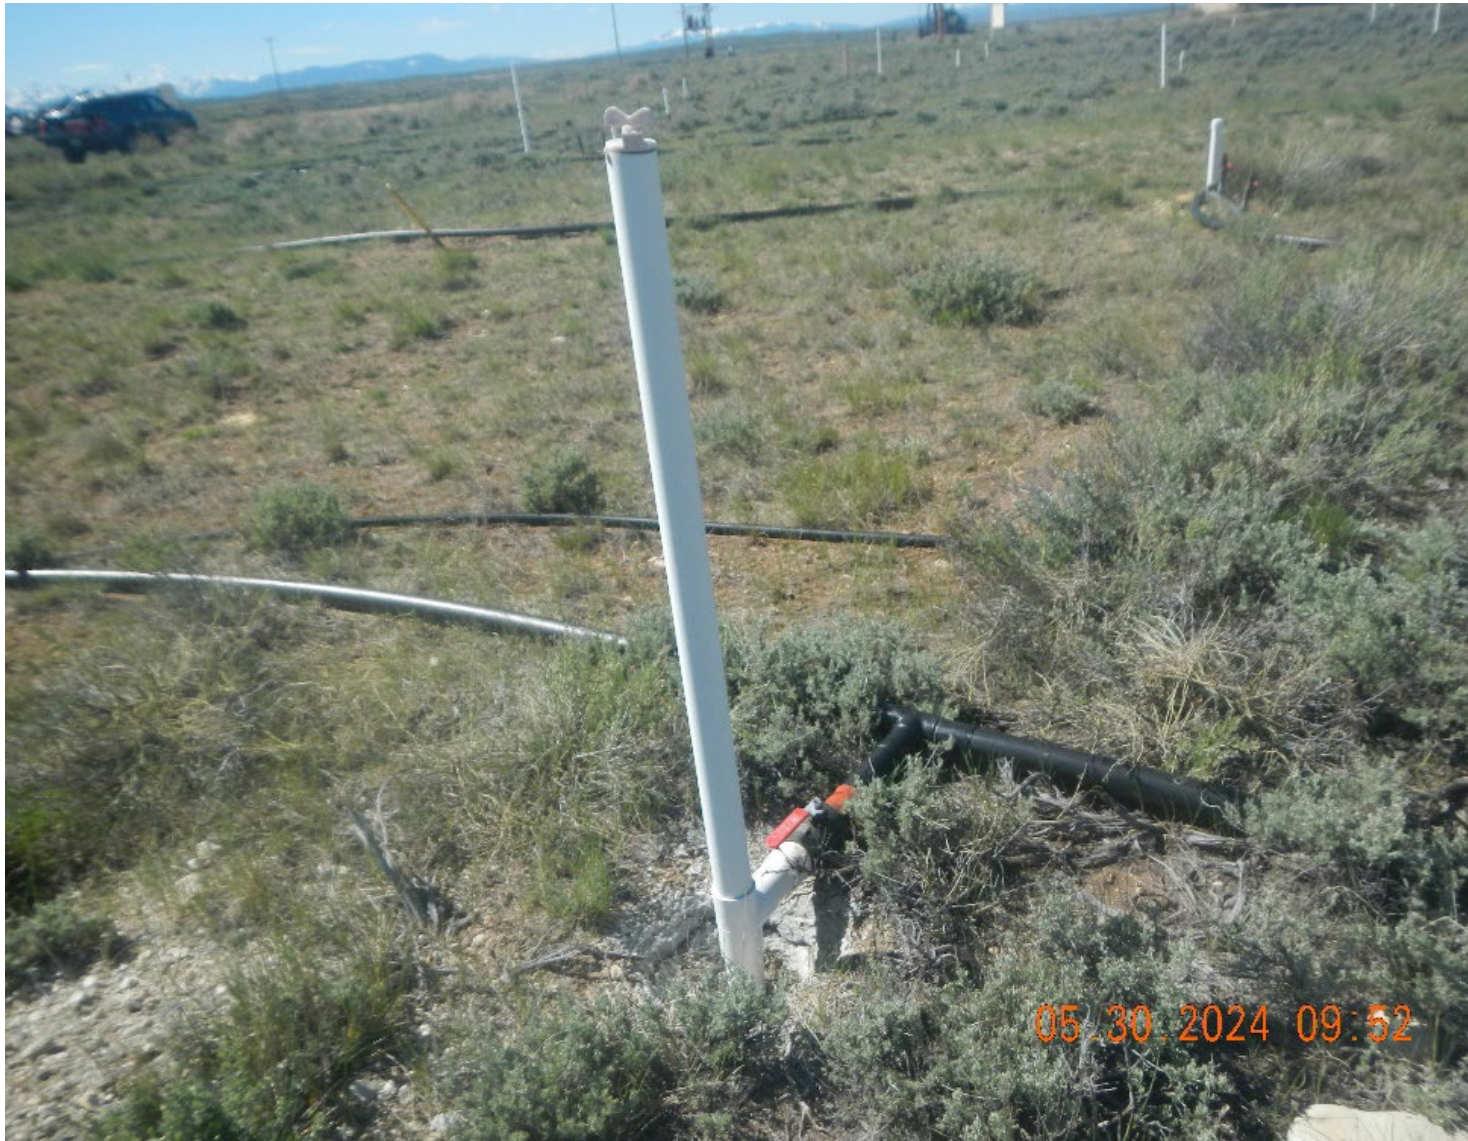
Photo #4 SVE well

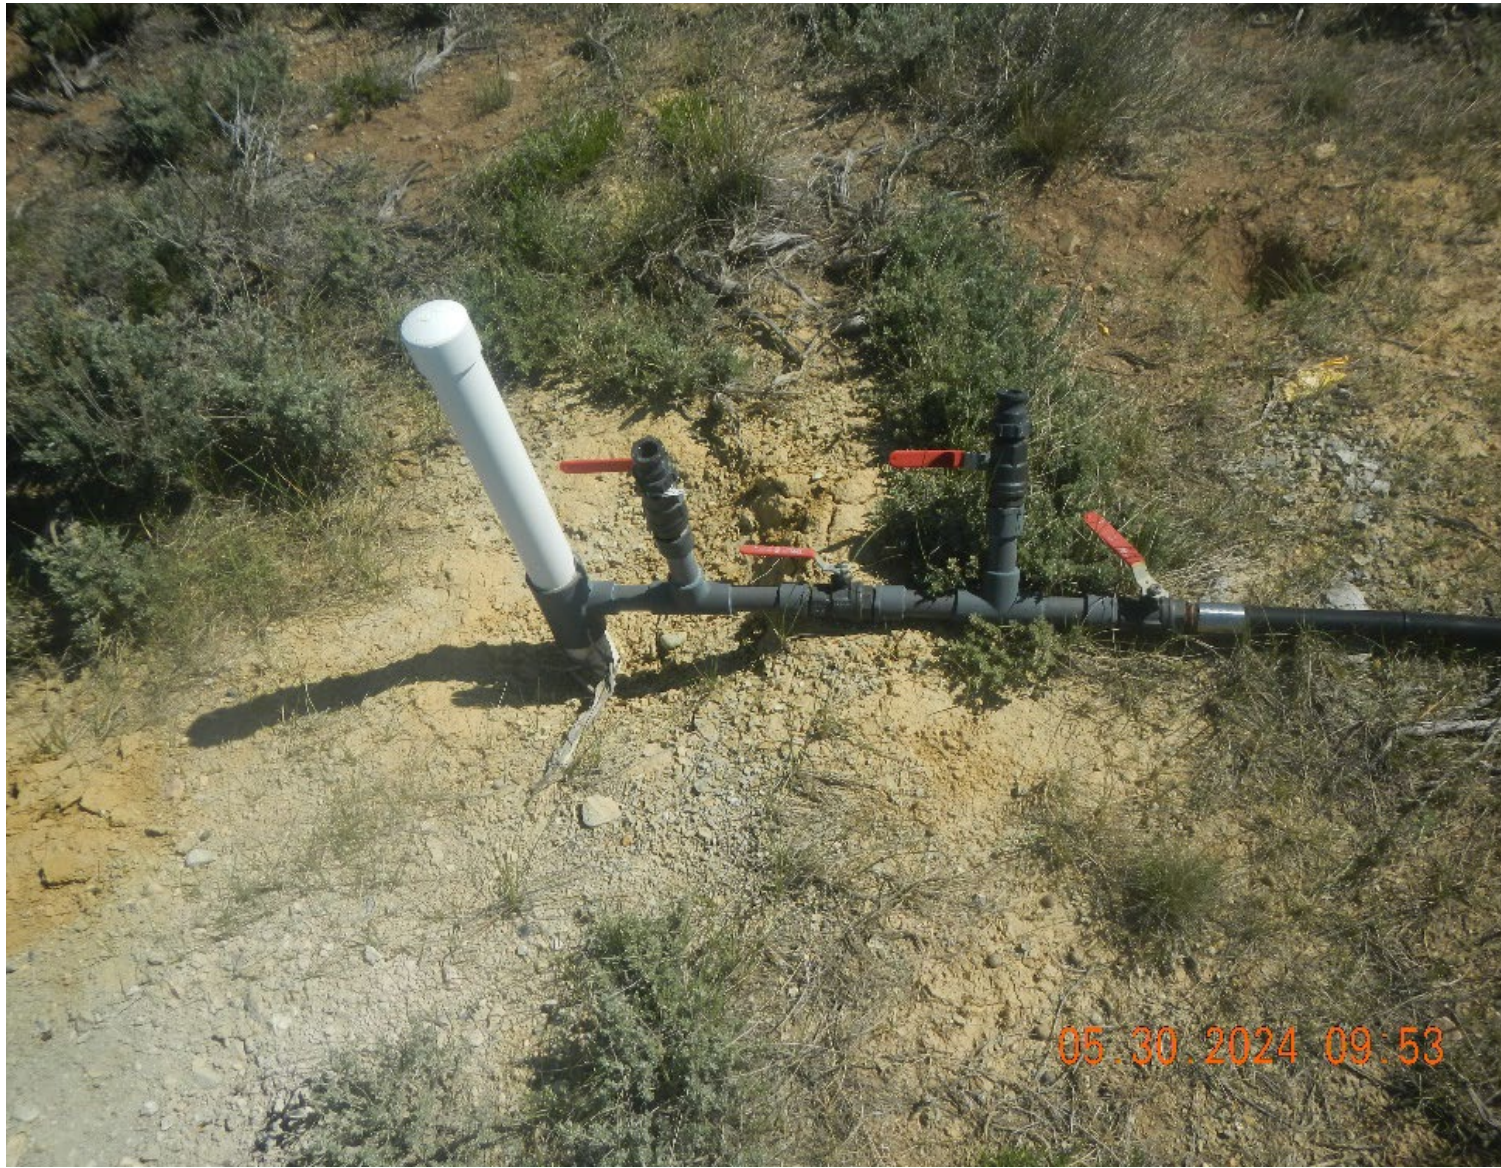
Photo #5 Sparge well and pipe. Note: the position of valve on right, it is throttled.

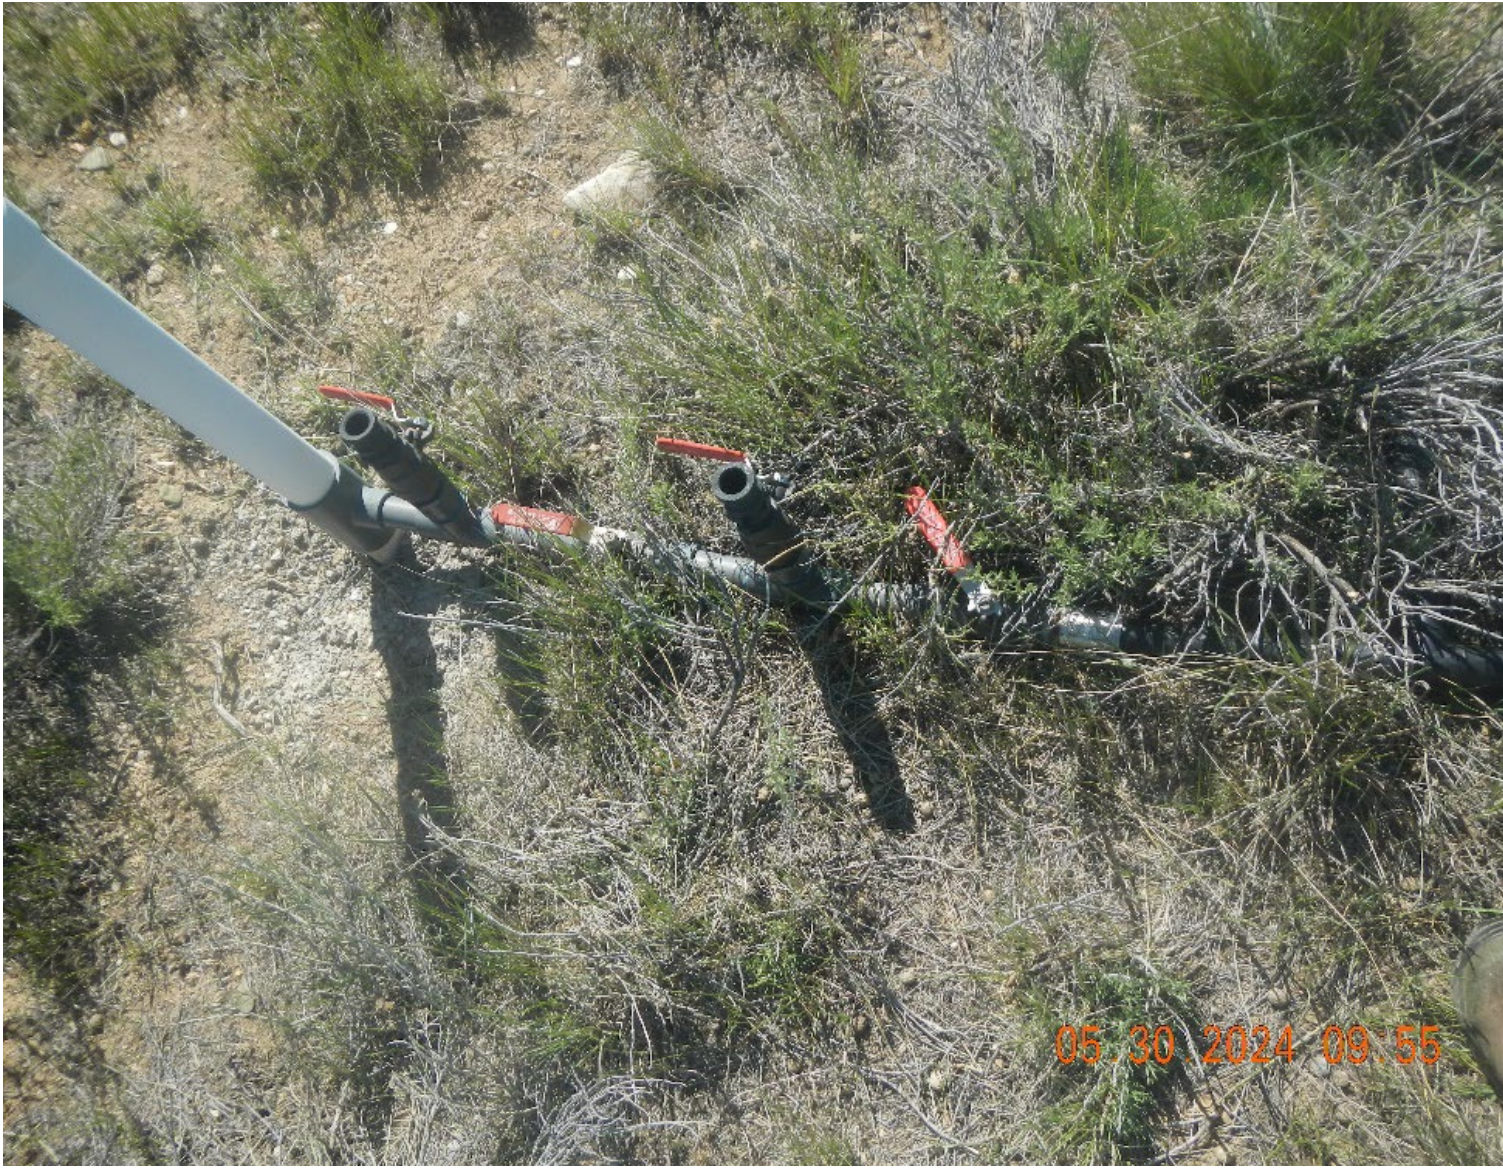
Photo #6 Sparge well and pipe. Note: the position of valve on right, it is throttled.

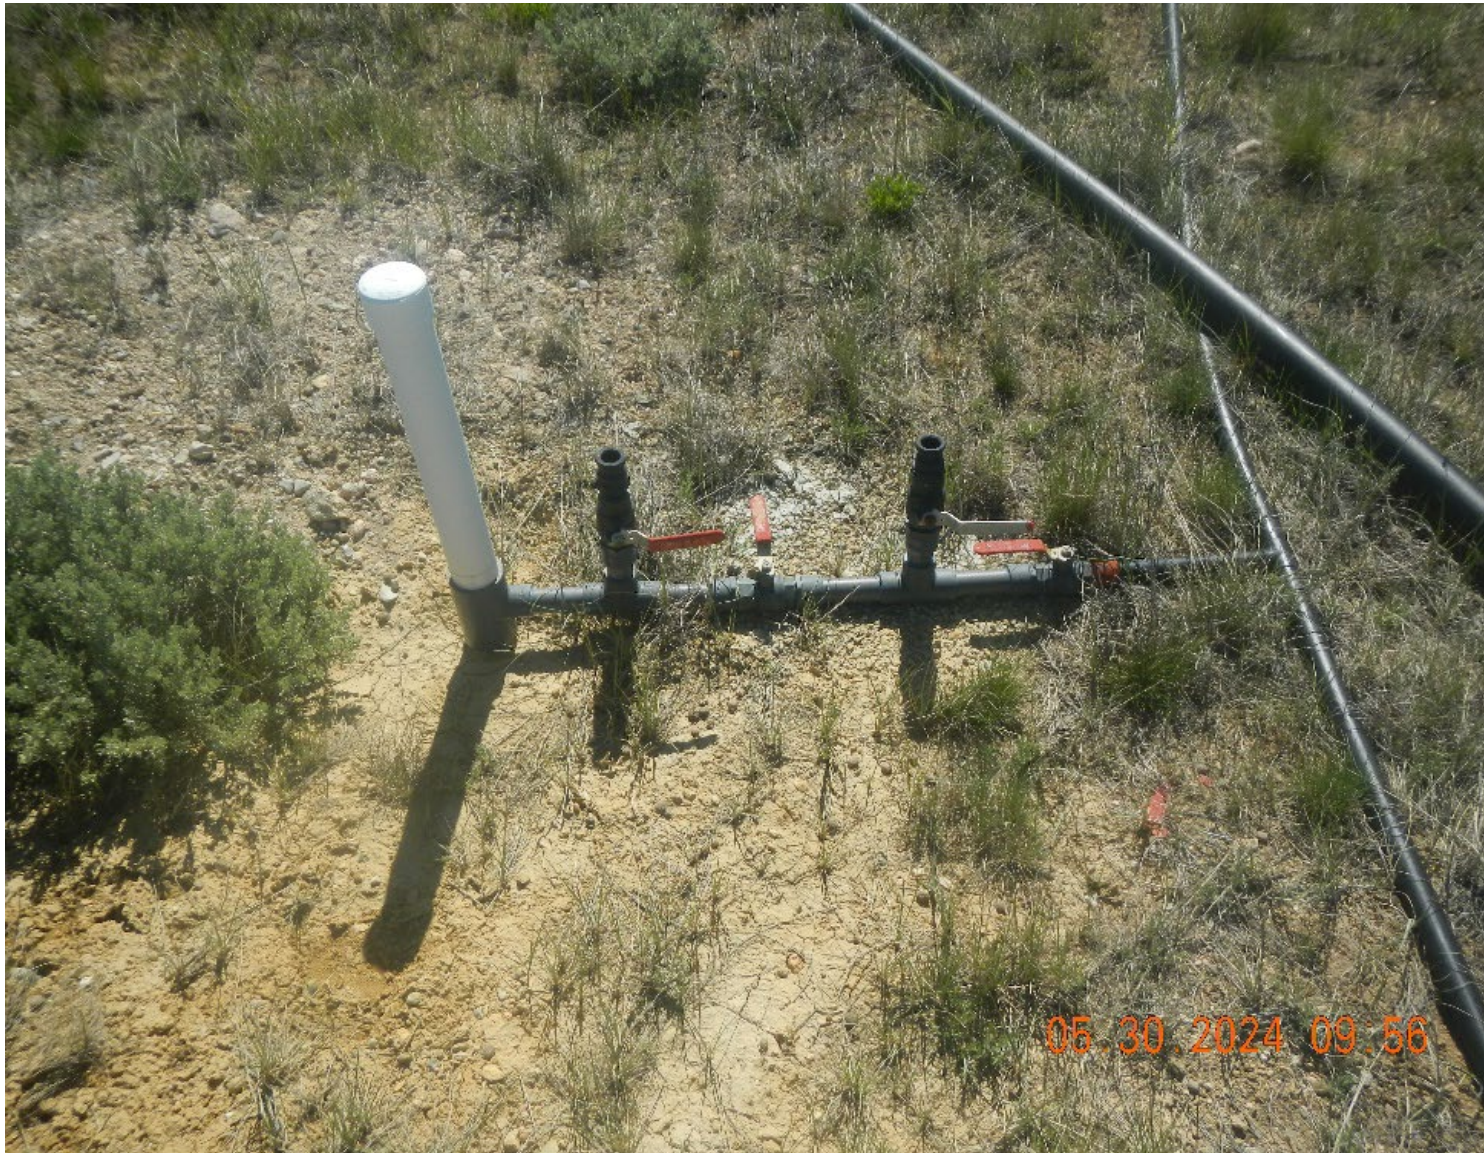
Photo #Sparge well and pipe. Note: the position of valve, it is throttled.

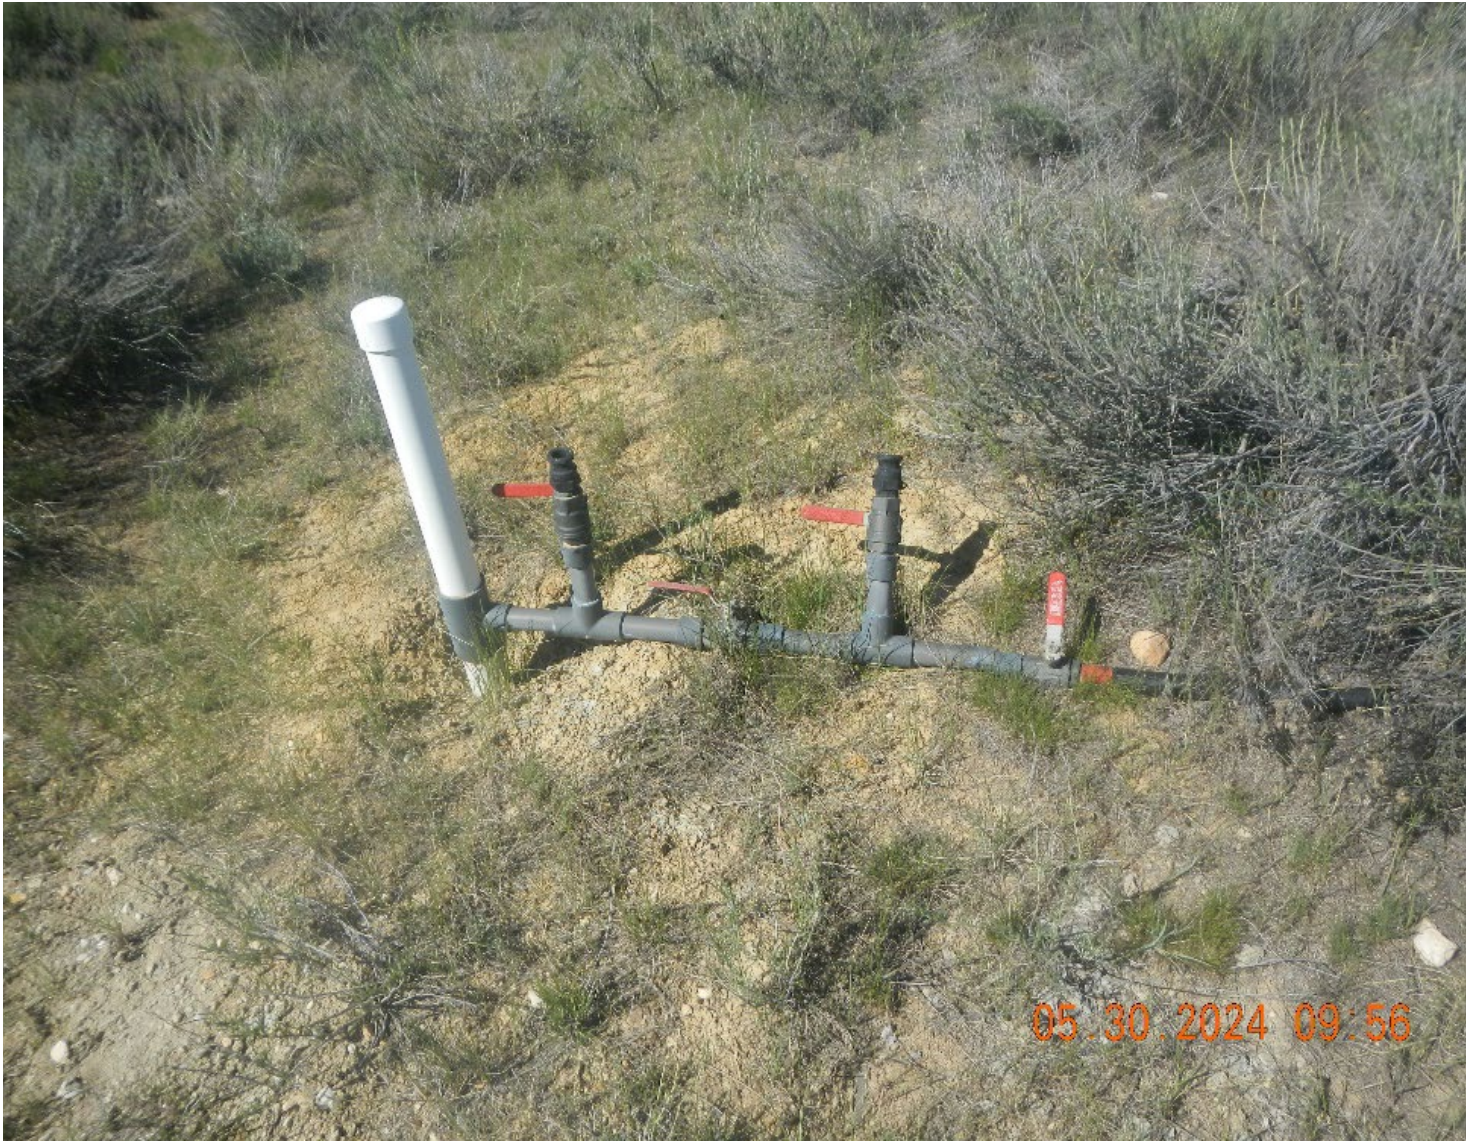
Photo #9 Sparge well and pipe. Note: the position of valve on right, it is closed.

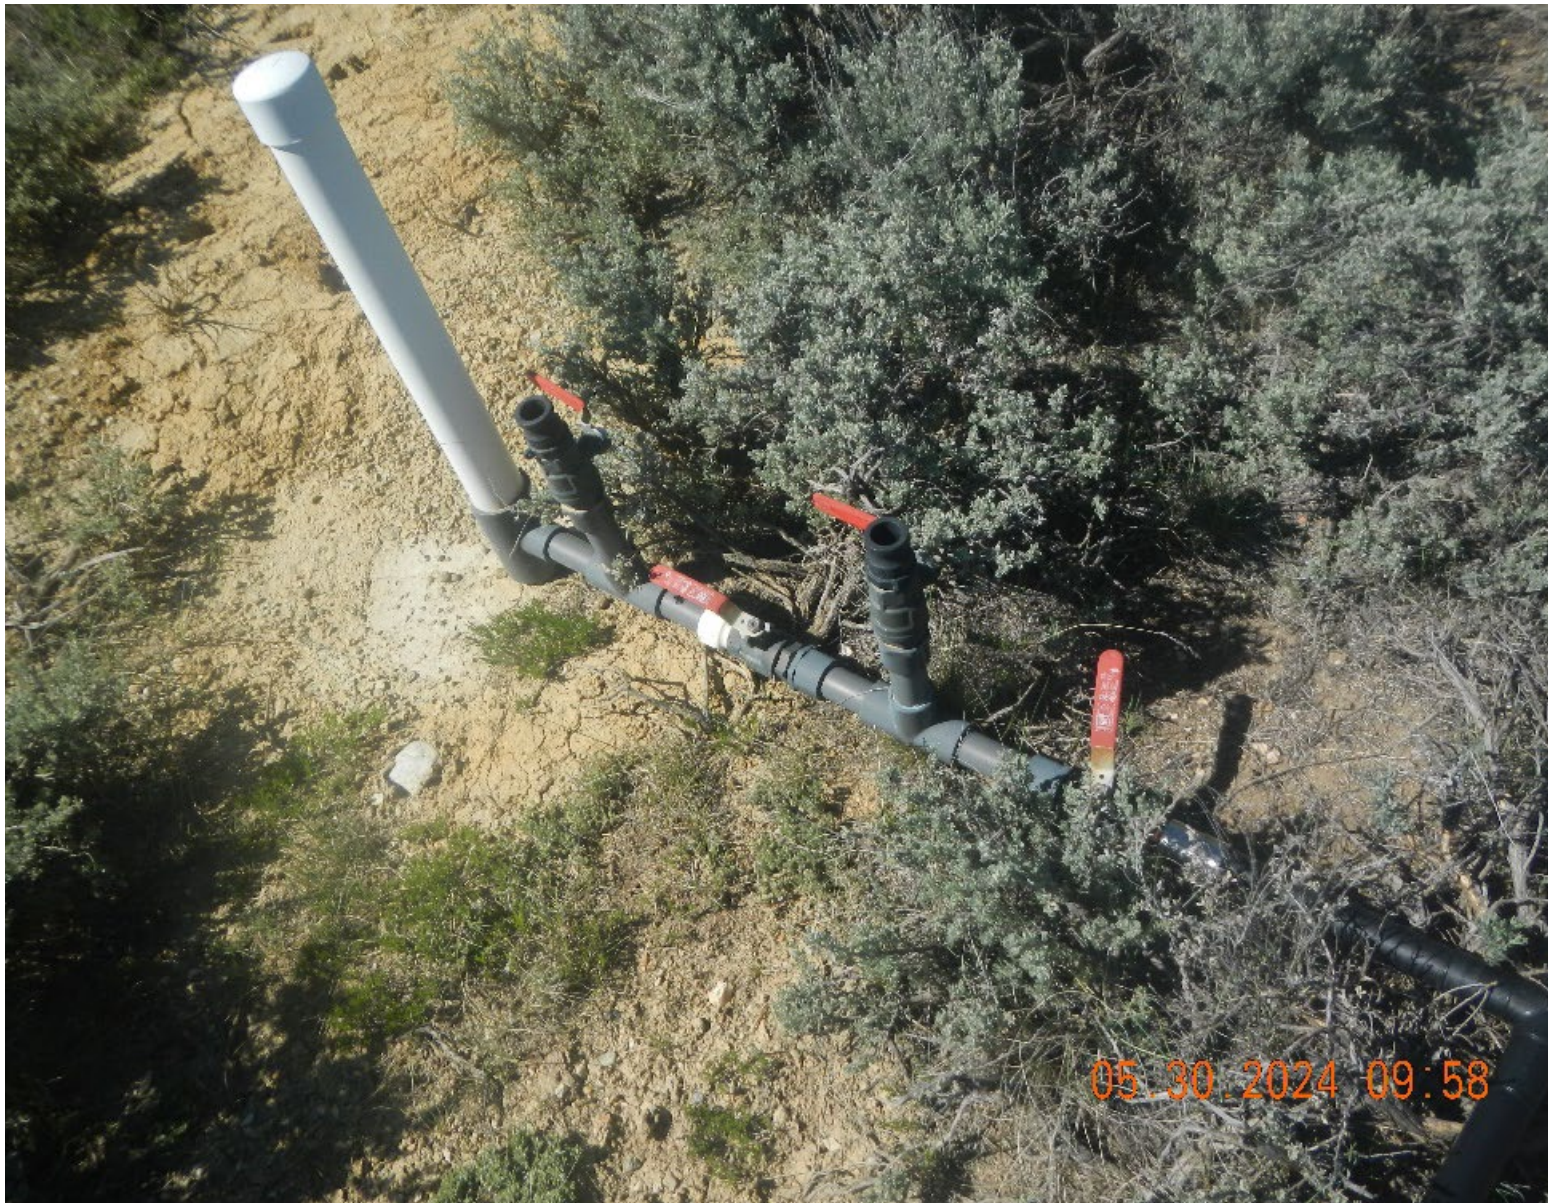
Photo #10 Sparge well and pipe. Note: the position of valve on right, it is throttled.

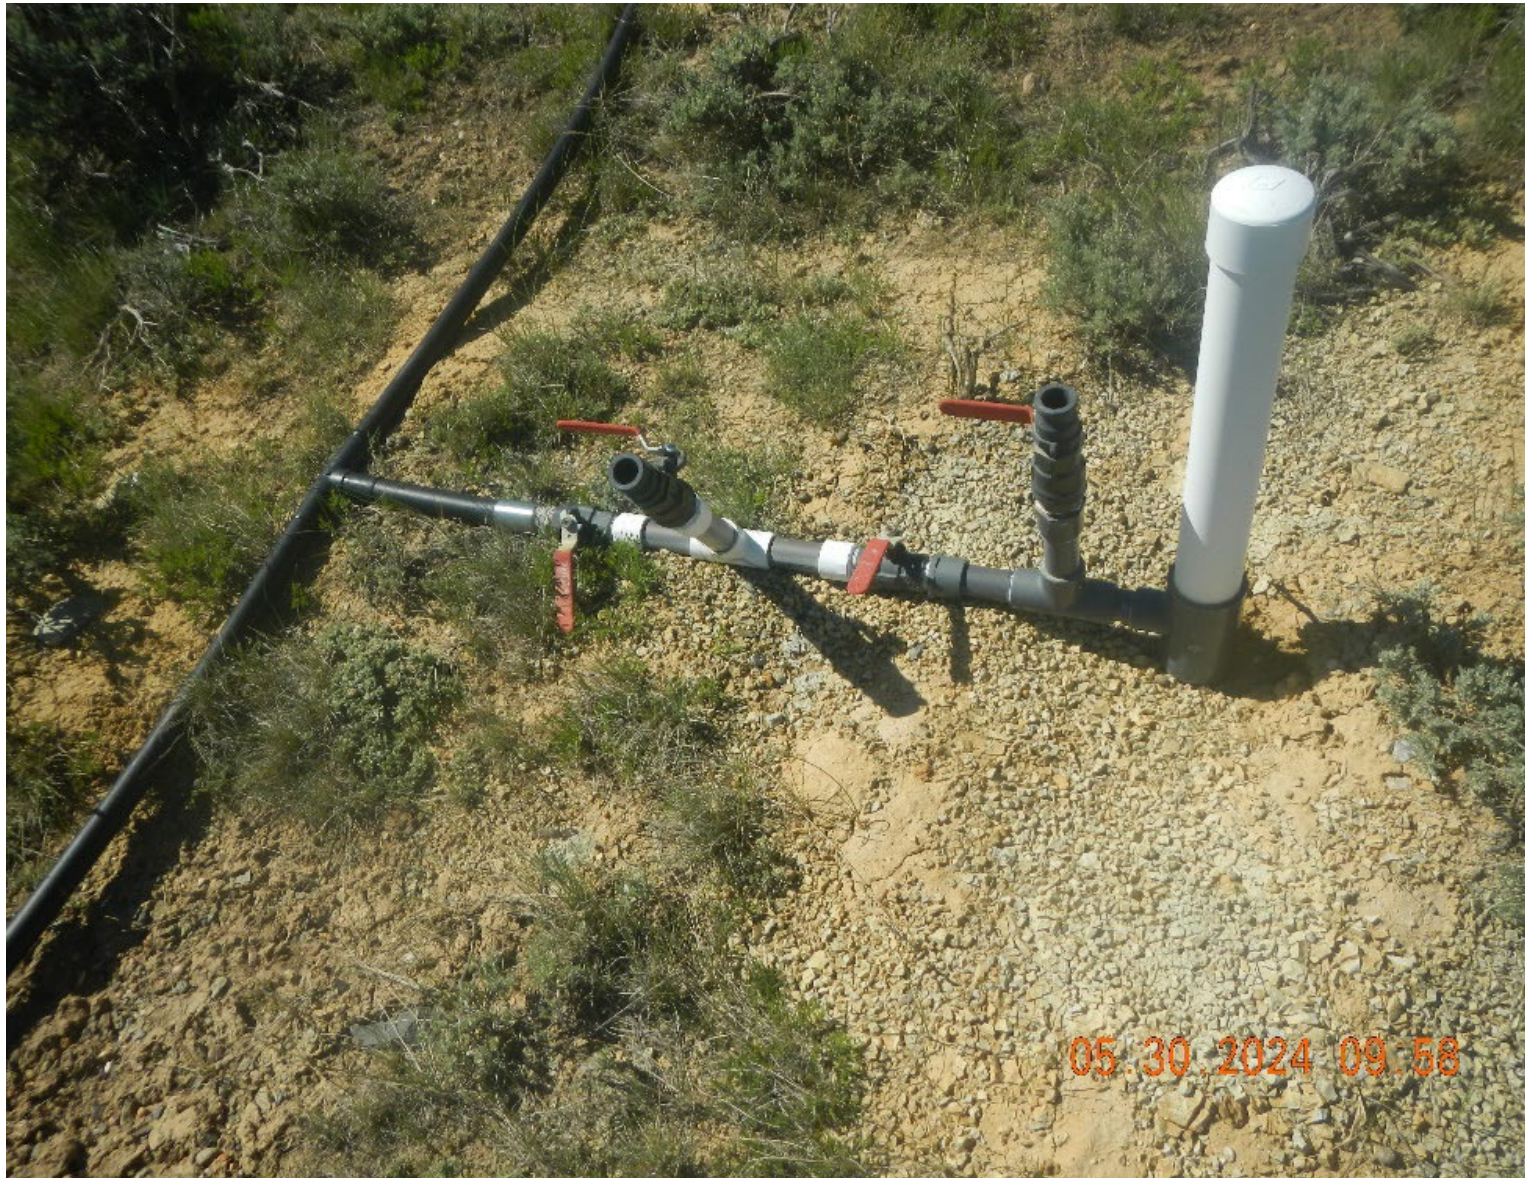
**Photo #11 Sparge well and pipe. Both valves closed**

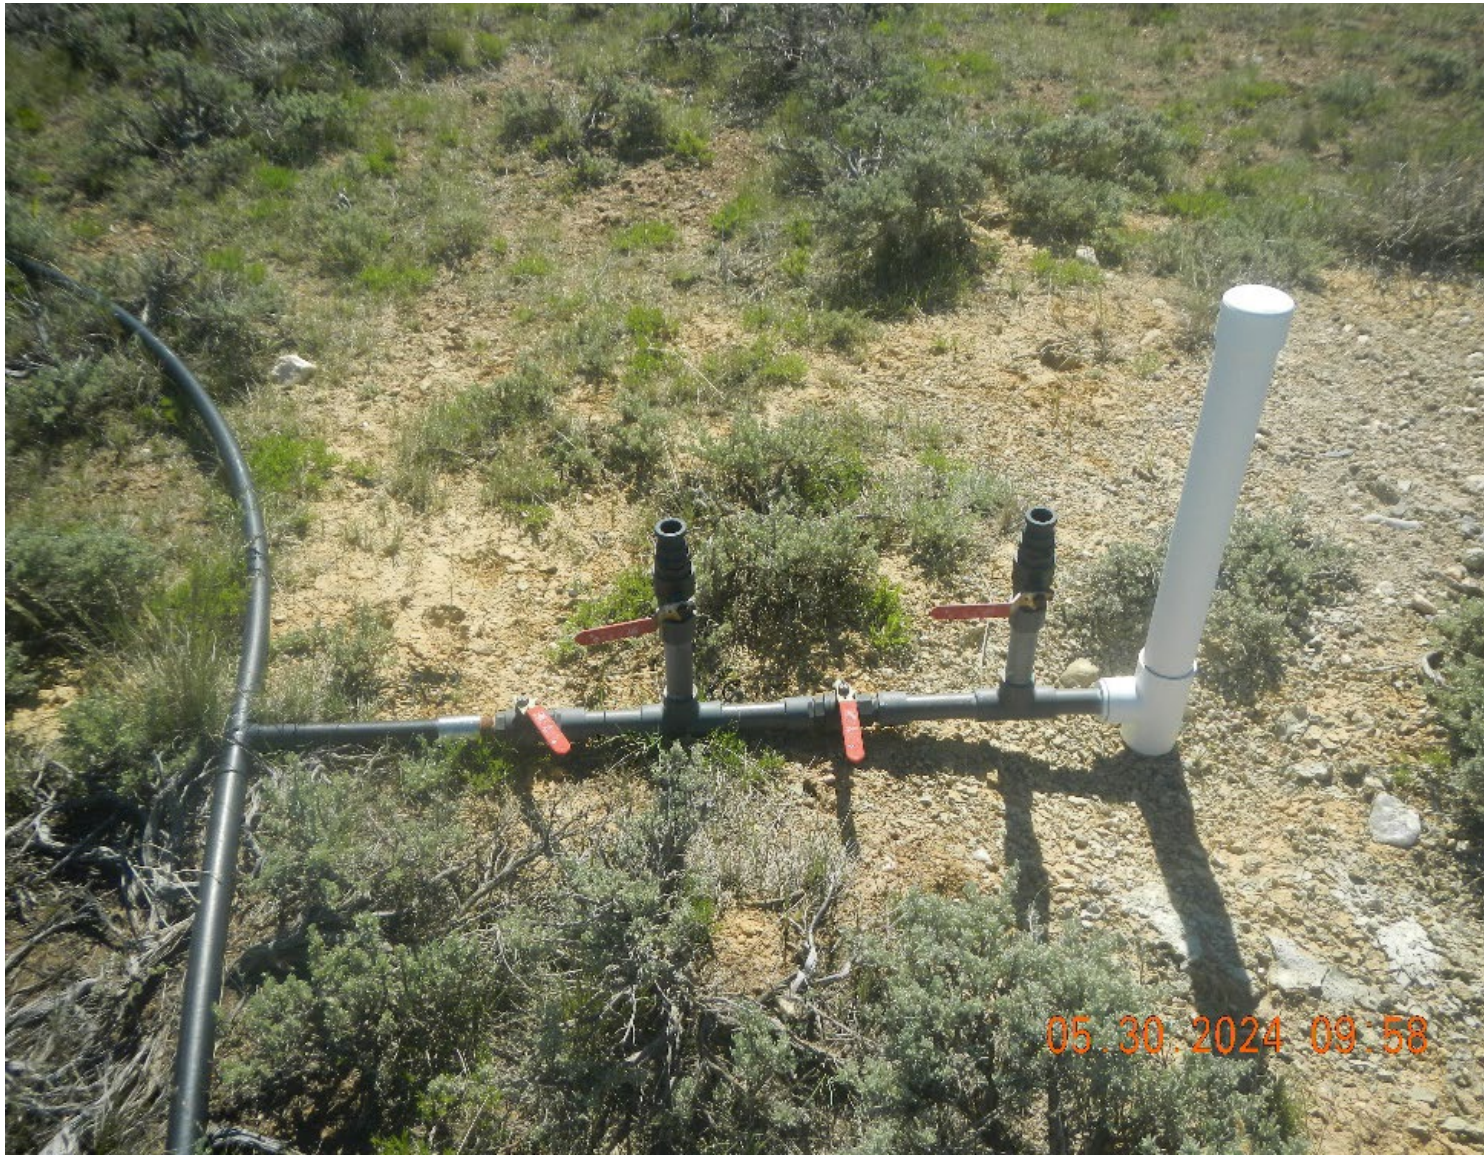
Photo #13 Sparge well and pipe. Note: the position of valves.

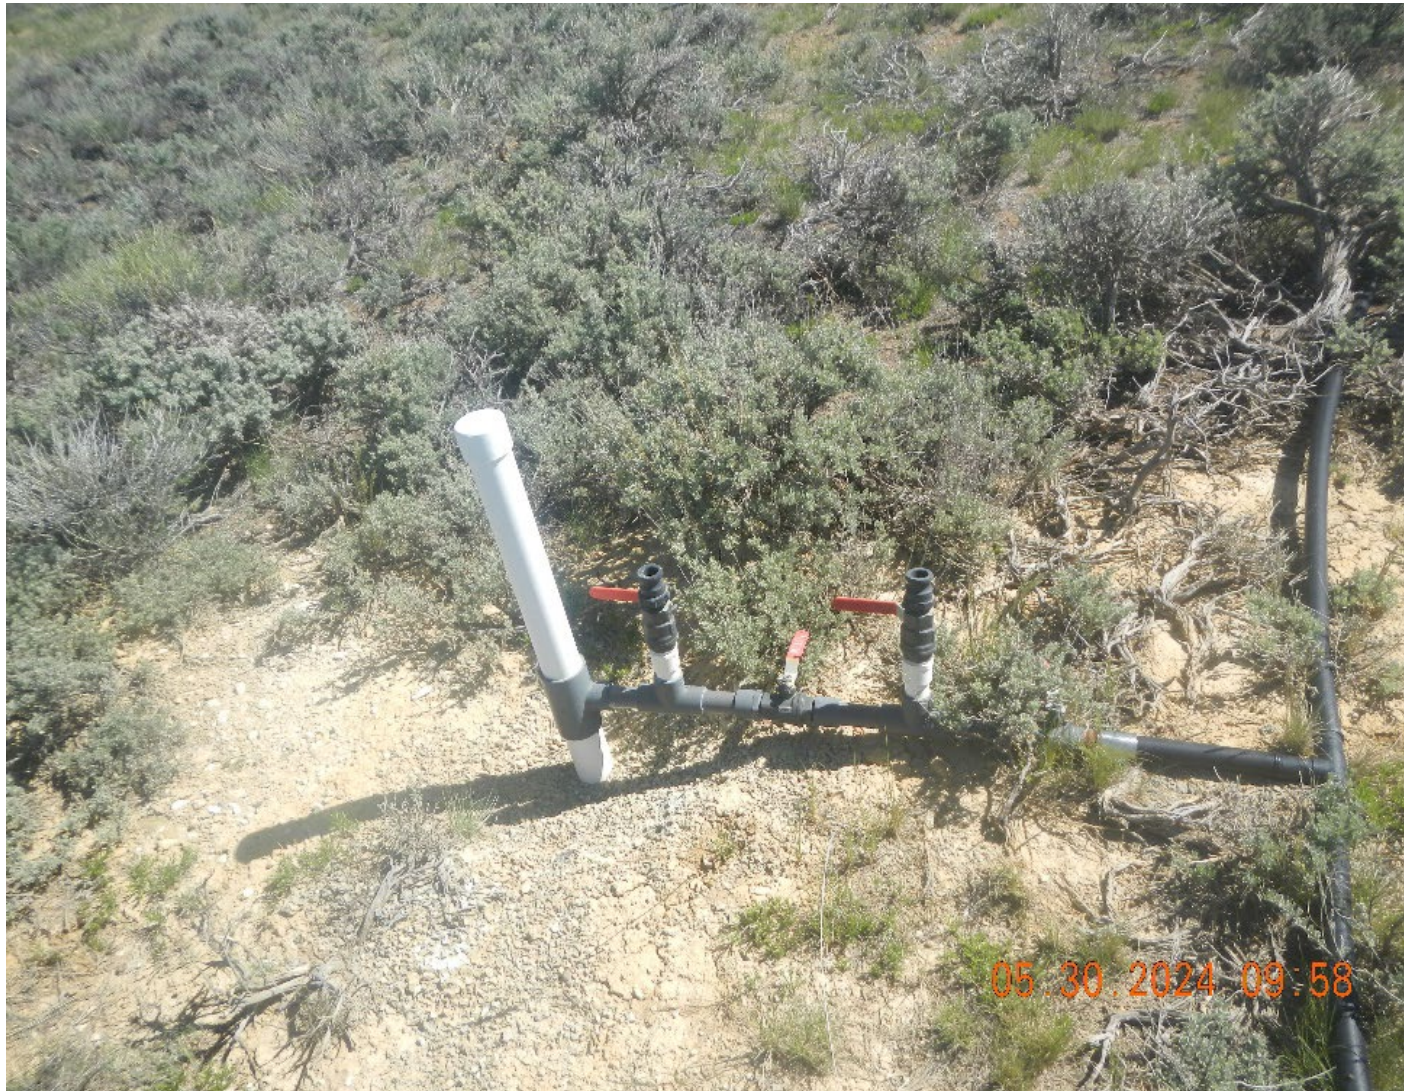
Photo #14 Sparge well and pipe. Note: the position of valves.

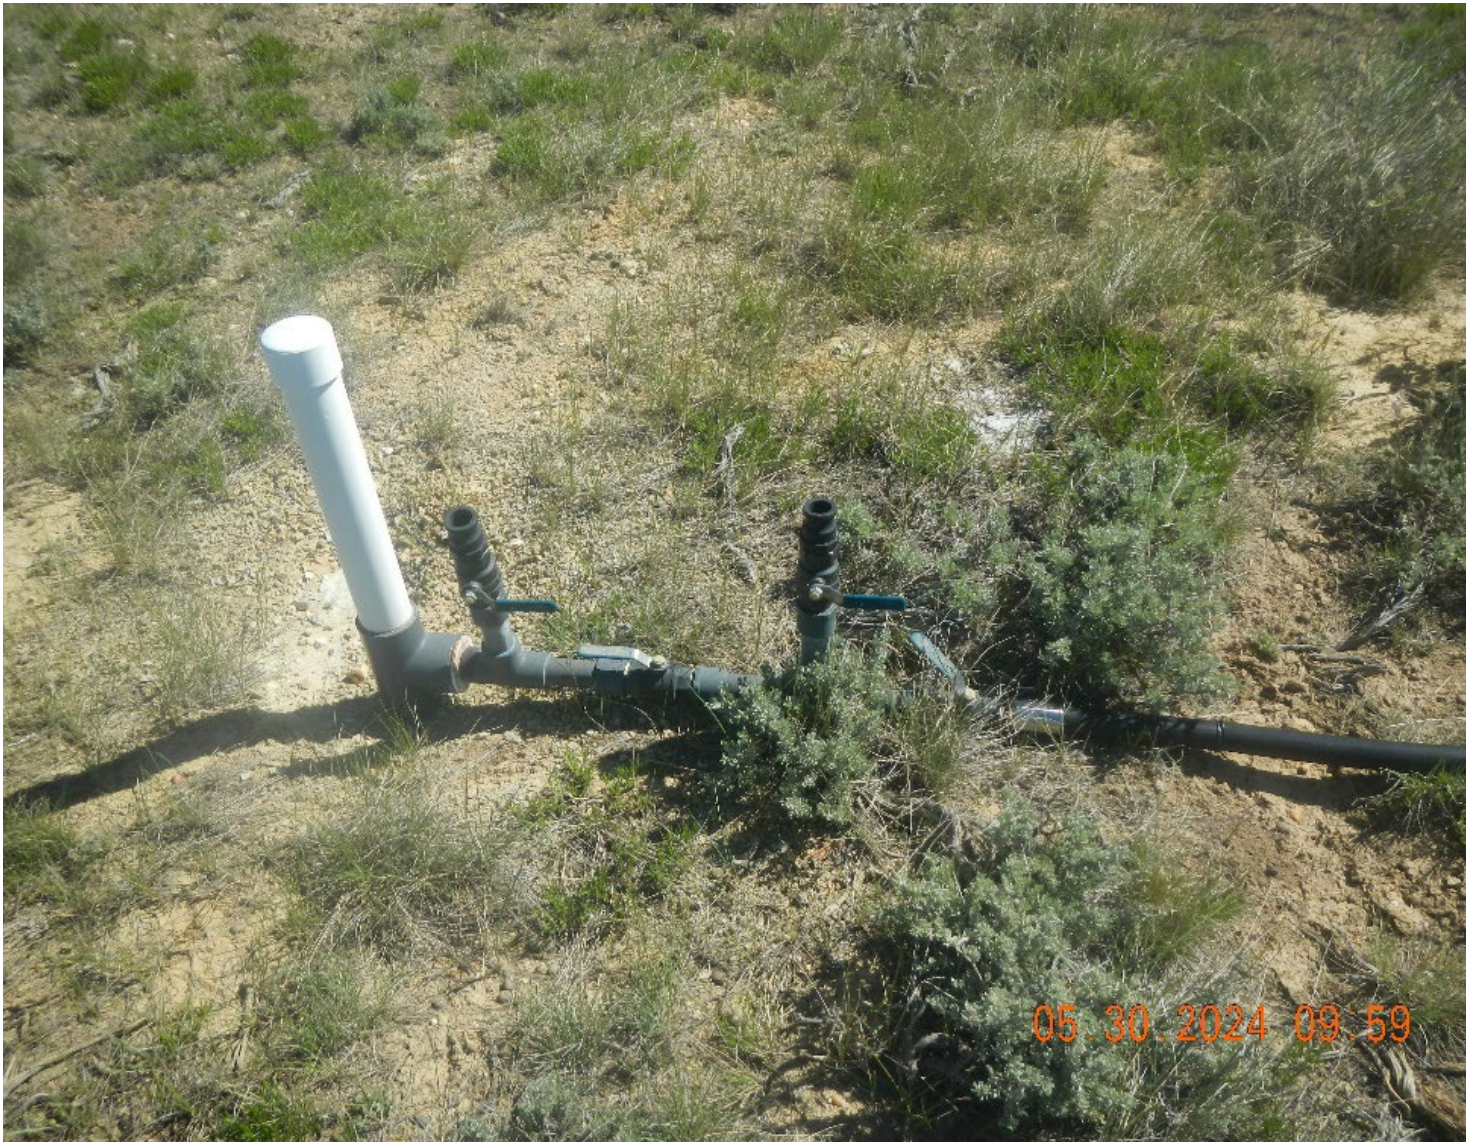
Photo #15 Sparge well and pipe. Note: the position of valve on right, it is throttled.
