**COLORADO**  
Energy & Carbon Management  
Commission  
Department of Natural Resources

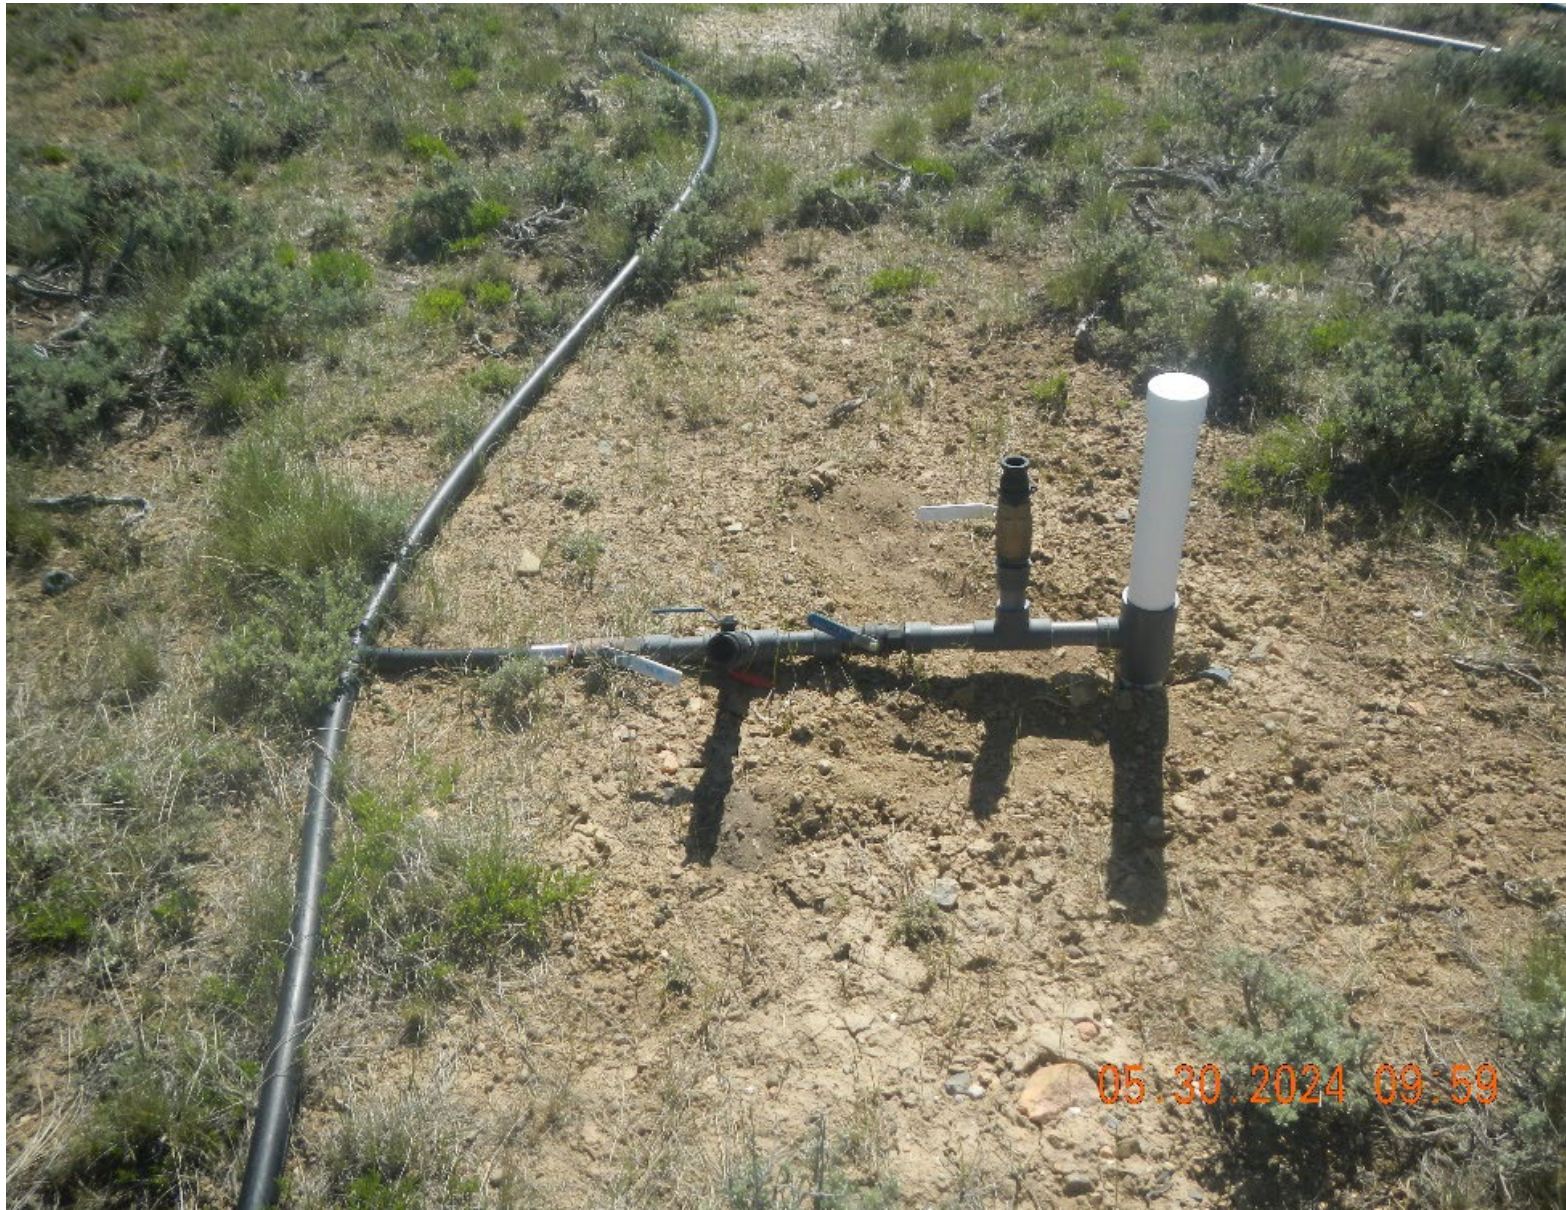
Photo #16 Sparge well and pipe. Note: the position of valves.

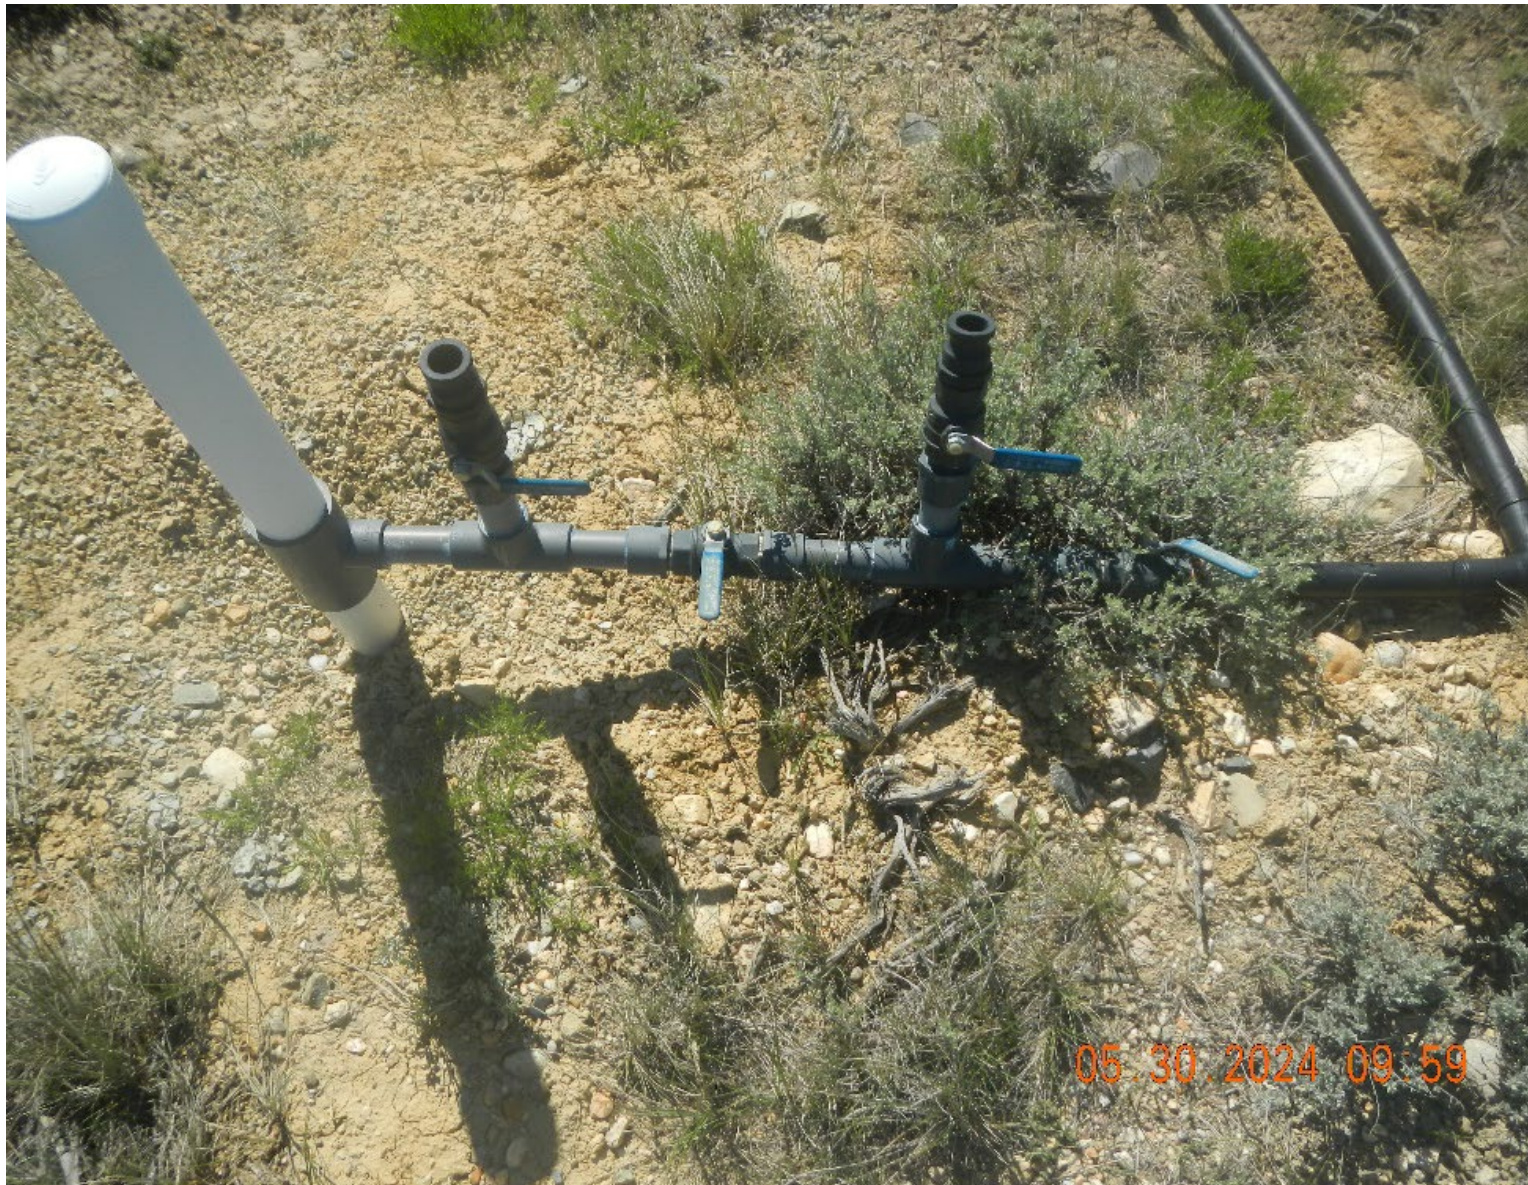
Photo #17 Sparge well and pipe. Note: the position of valve on right, it is throttled.

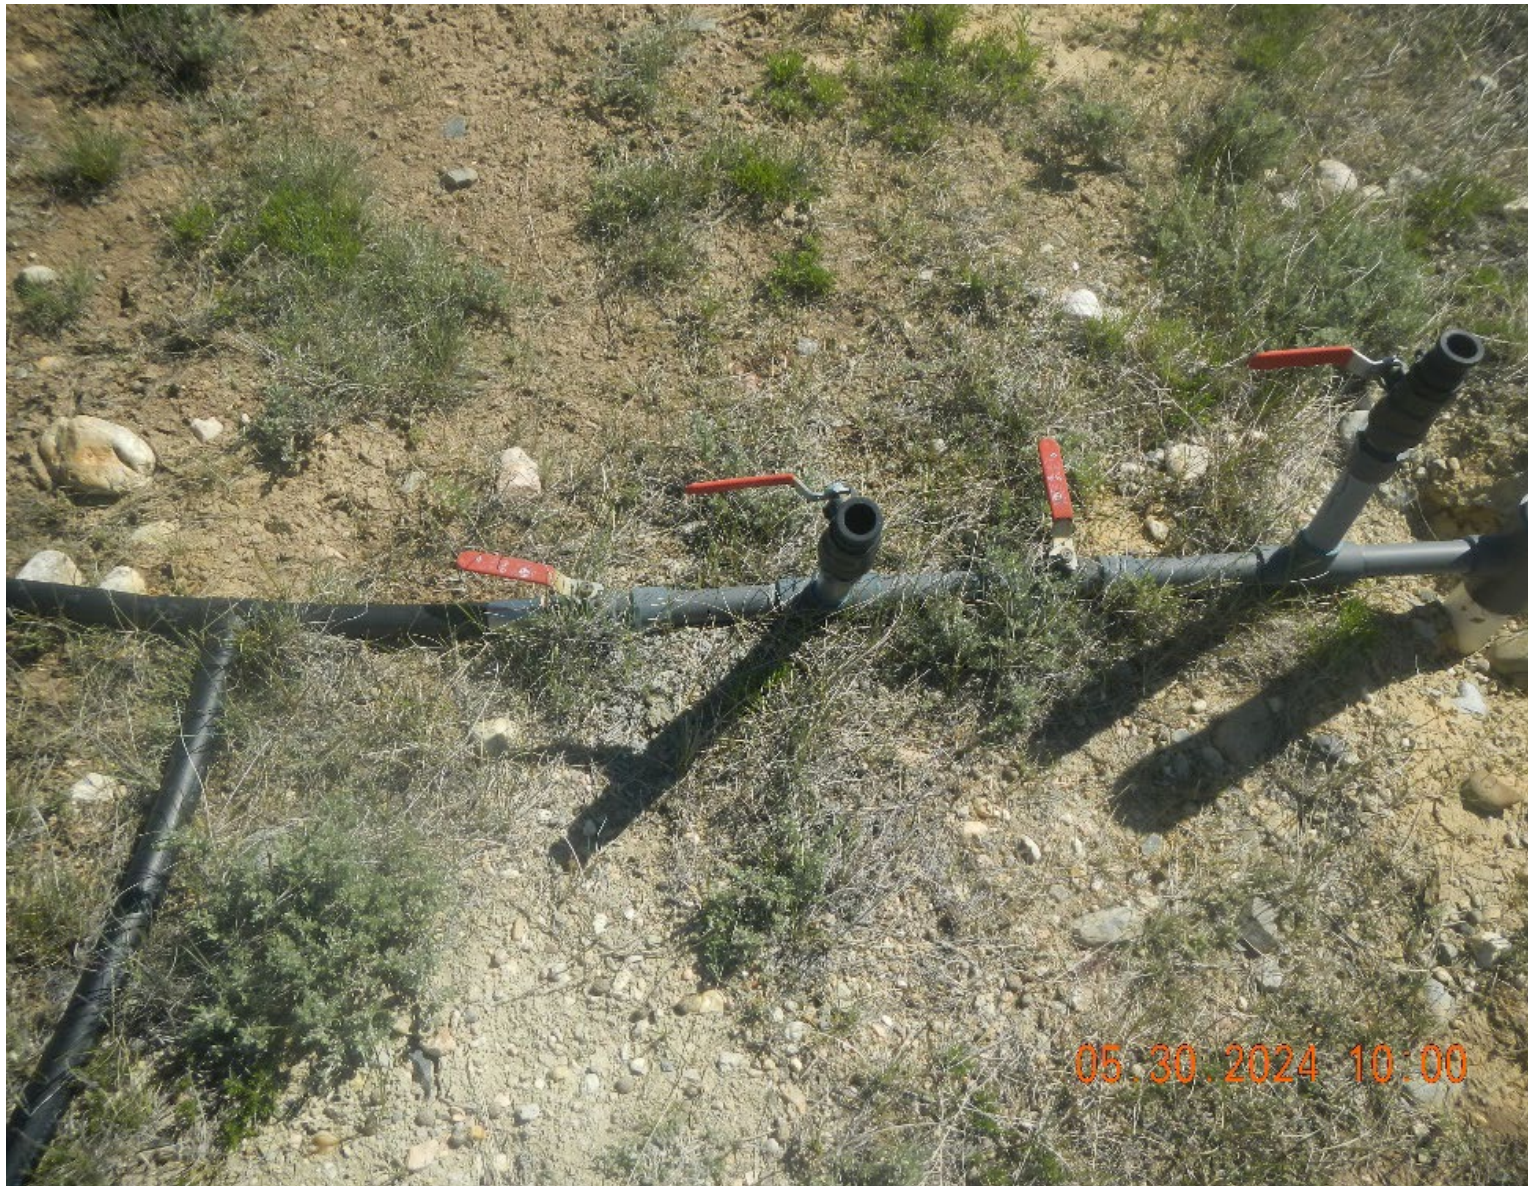
Photo #18 Sparge well and pipe. Note: the position of valves.

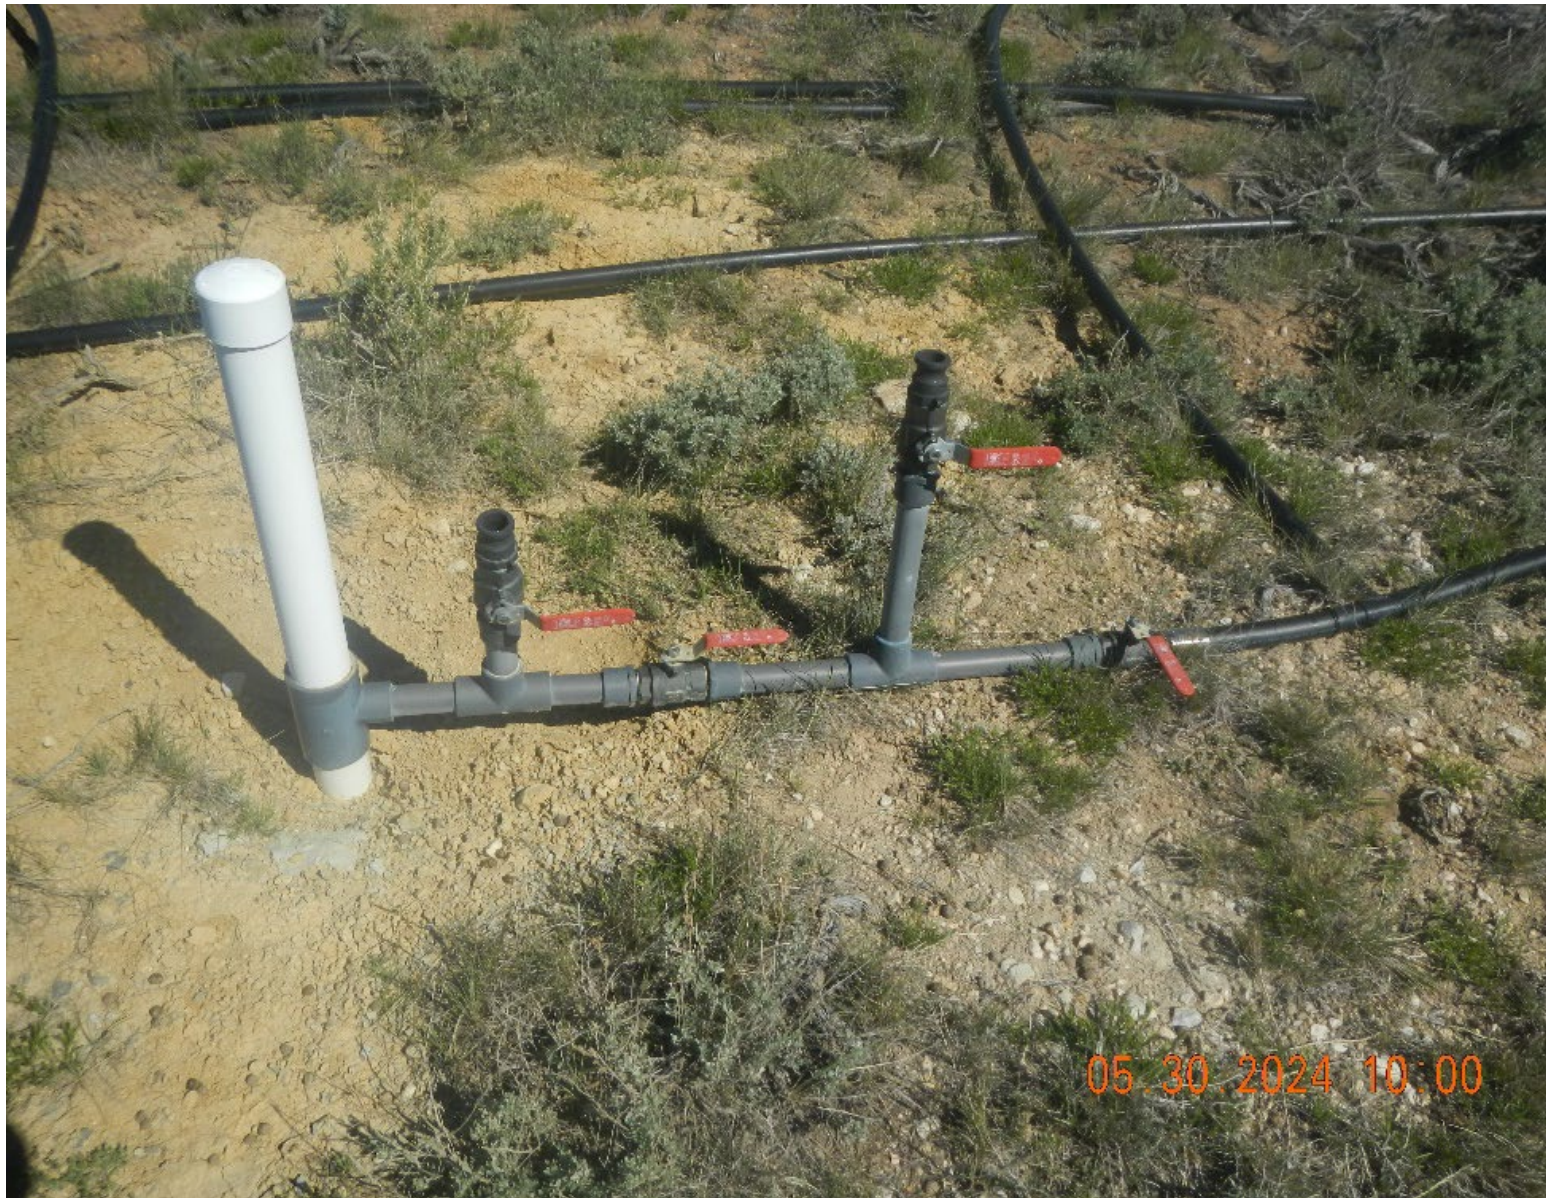
Photo #19 Sparge well and pipe. Note: the position of valve on right, it is throttled.

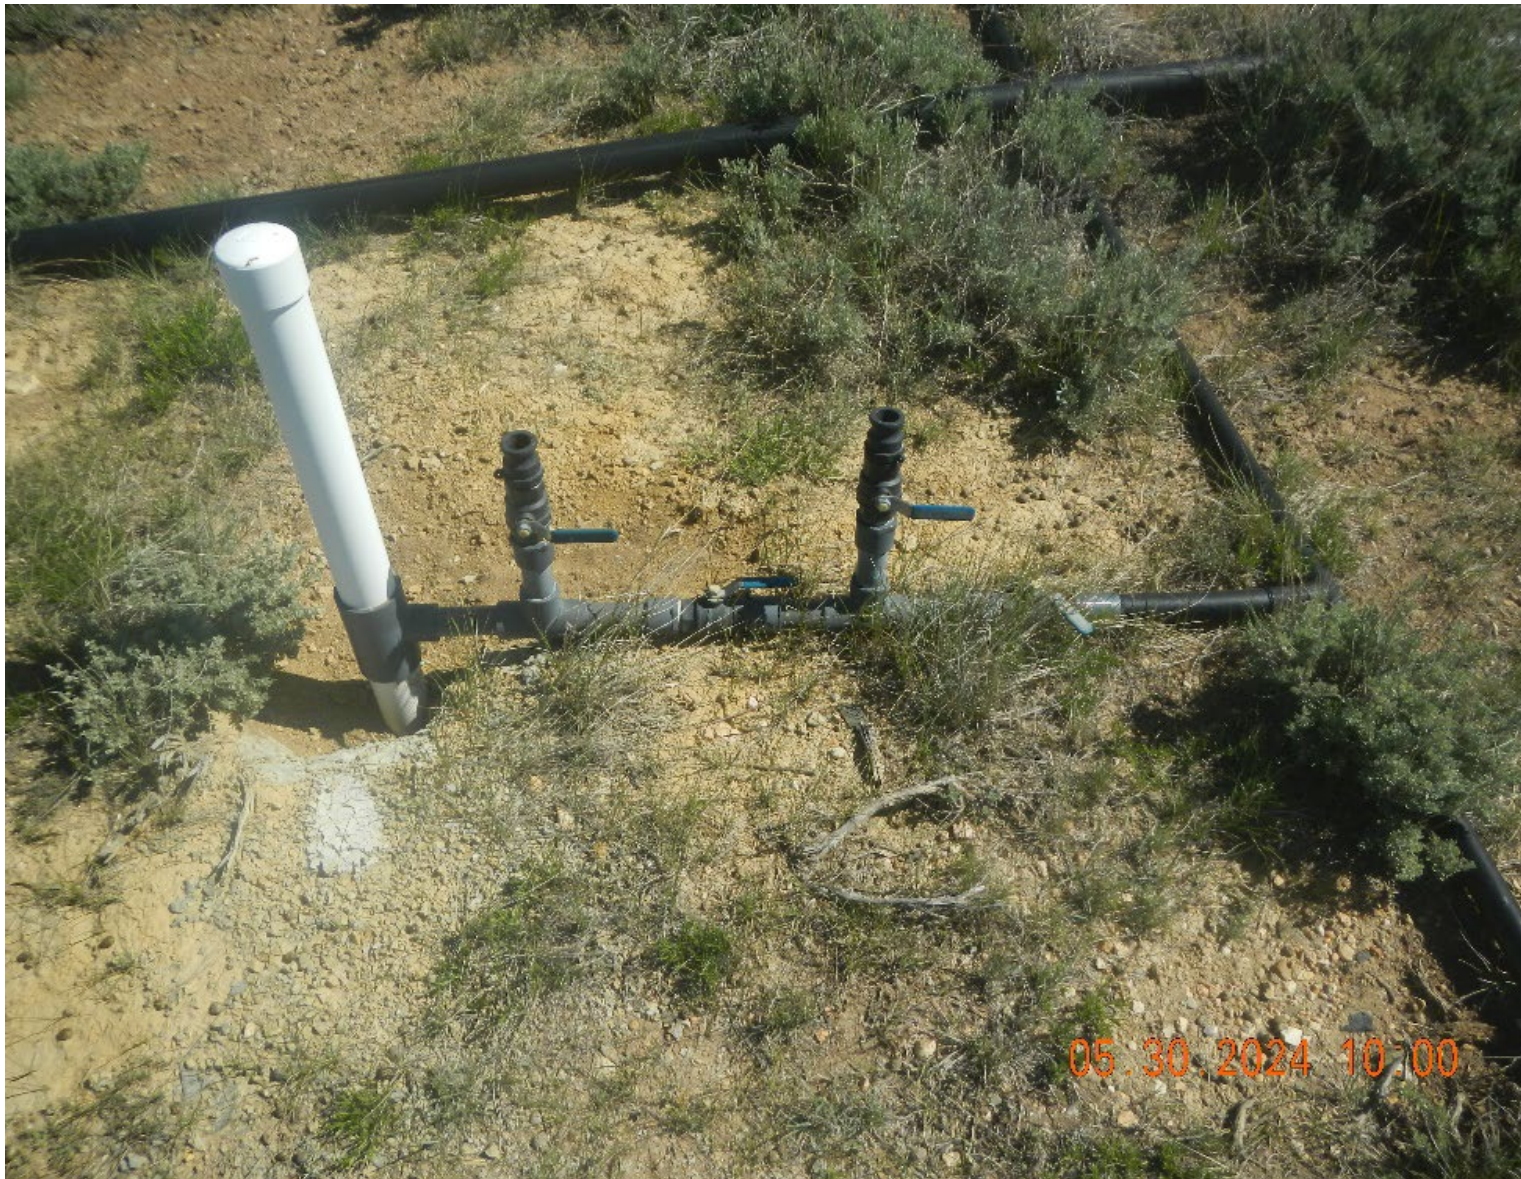
Photo #20 Sparge well and pipe. Note: the position of valve on right, it is throttled.

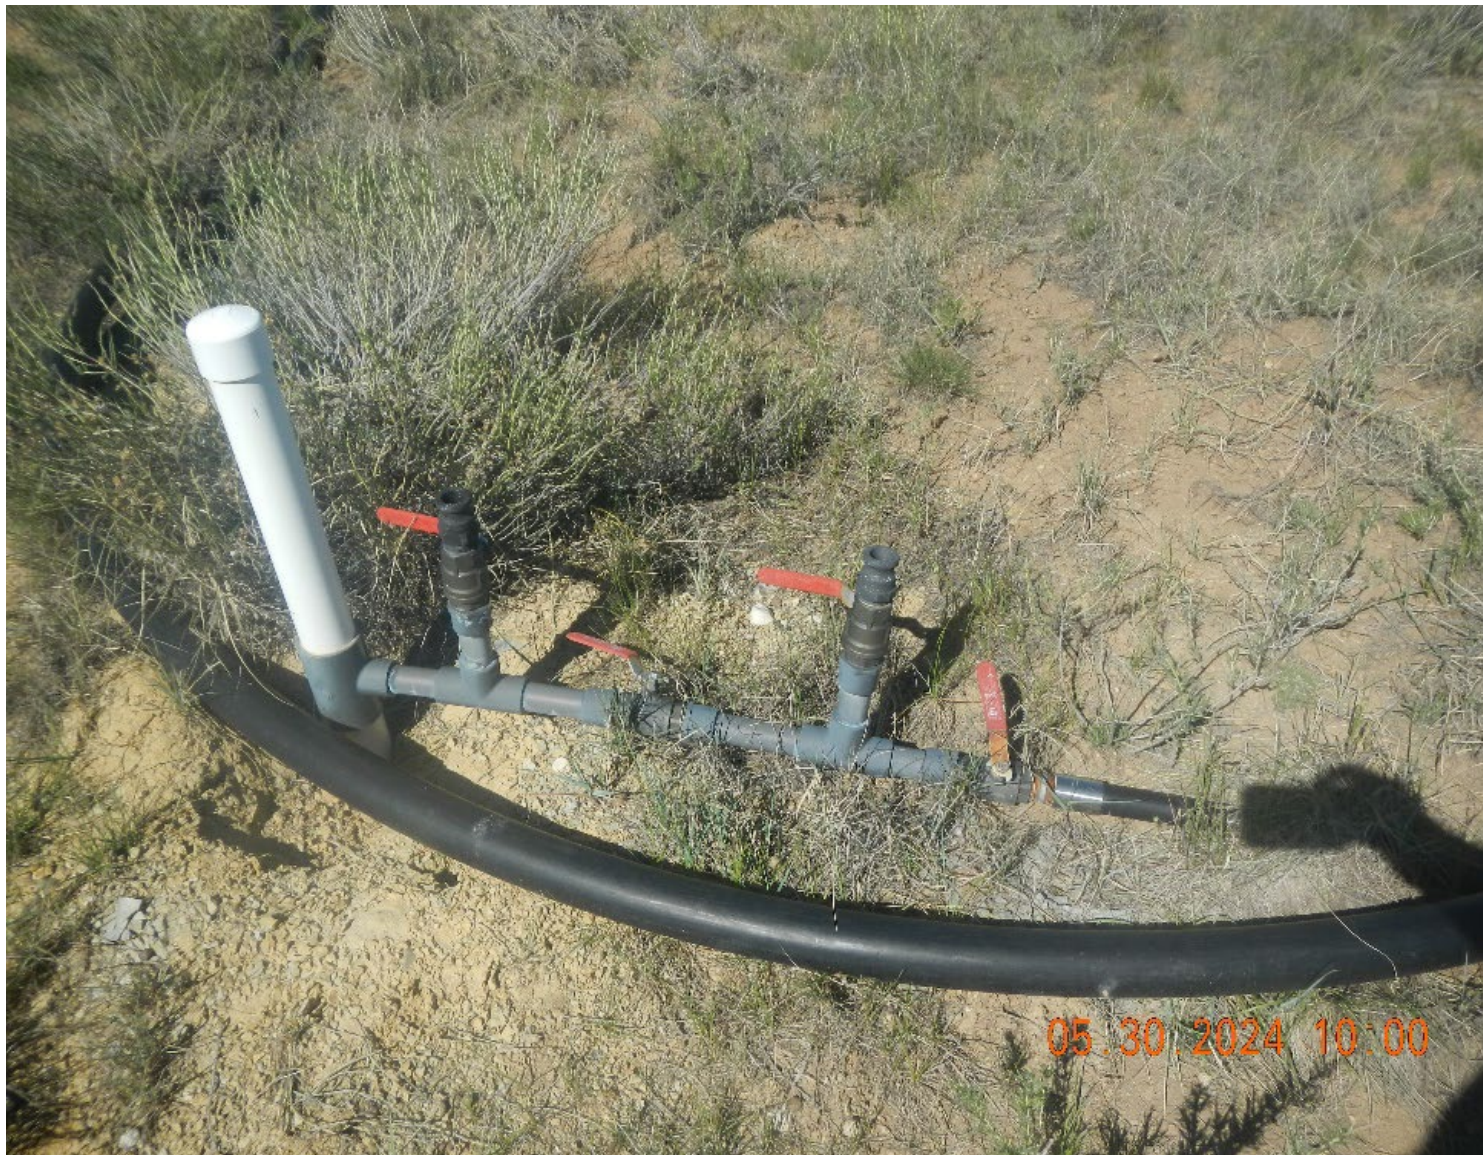
Photo #21 Sparge well and pipe. Note: the position of valve on right, it is throttled.

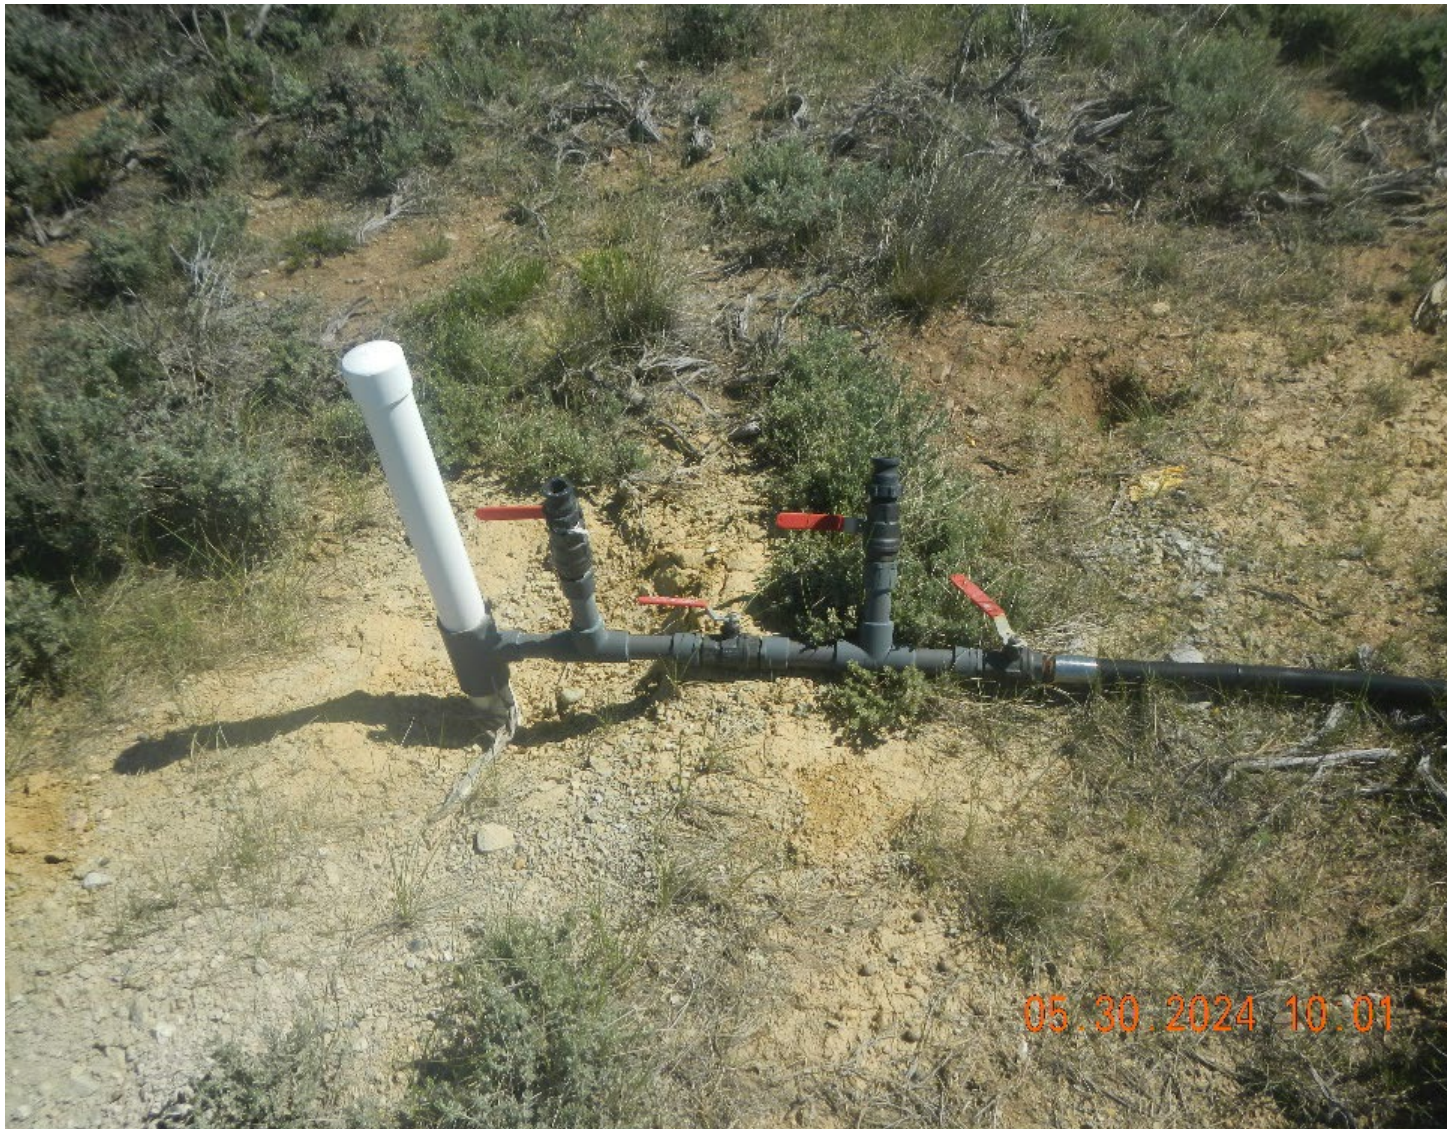
Photo #22 Sparge well and pipe. Note: the position of valve on right, it is throttled.

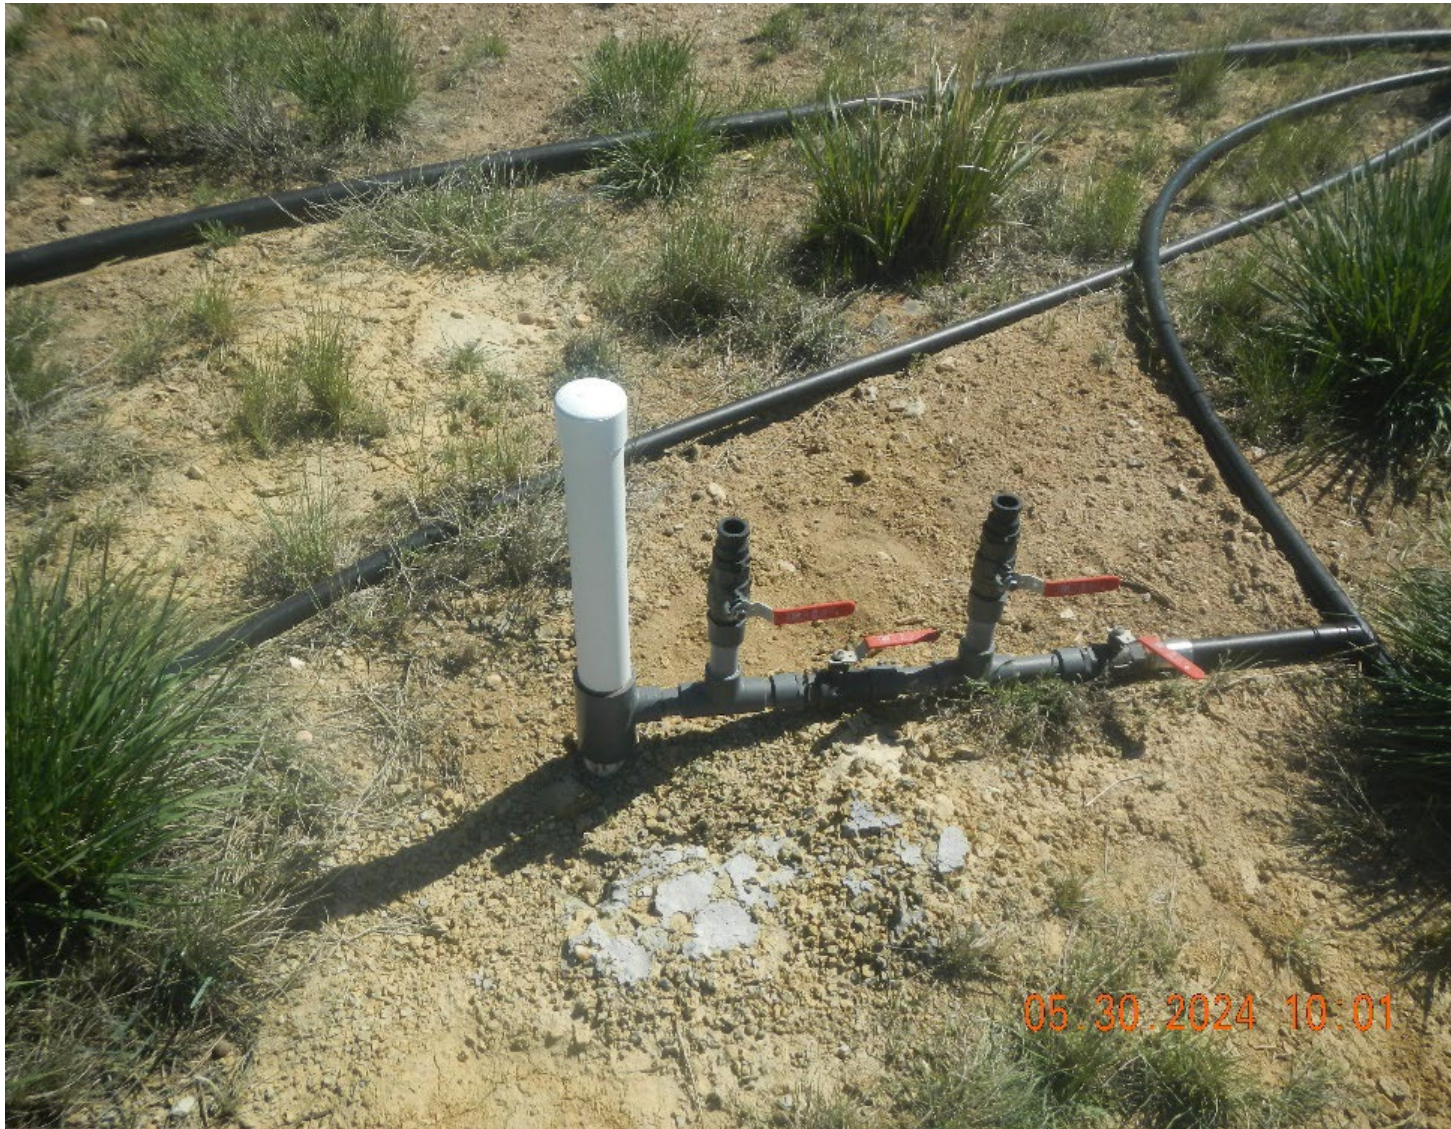
Photo #23 Sparge well and pipe. Note: the position of valve on right, it is throttled.

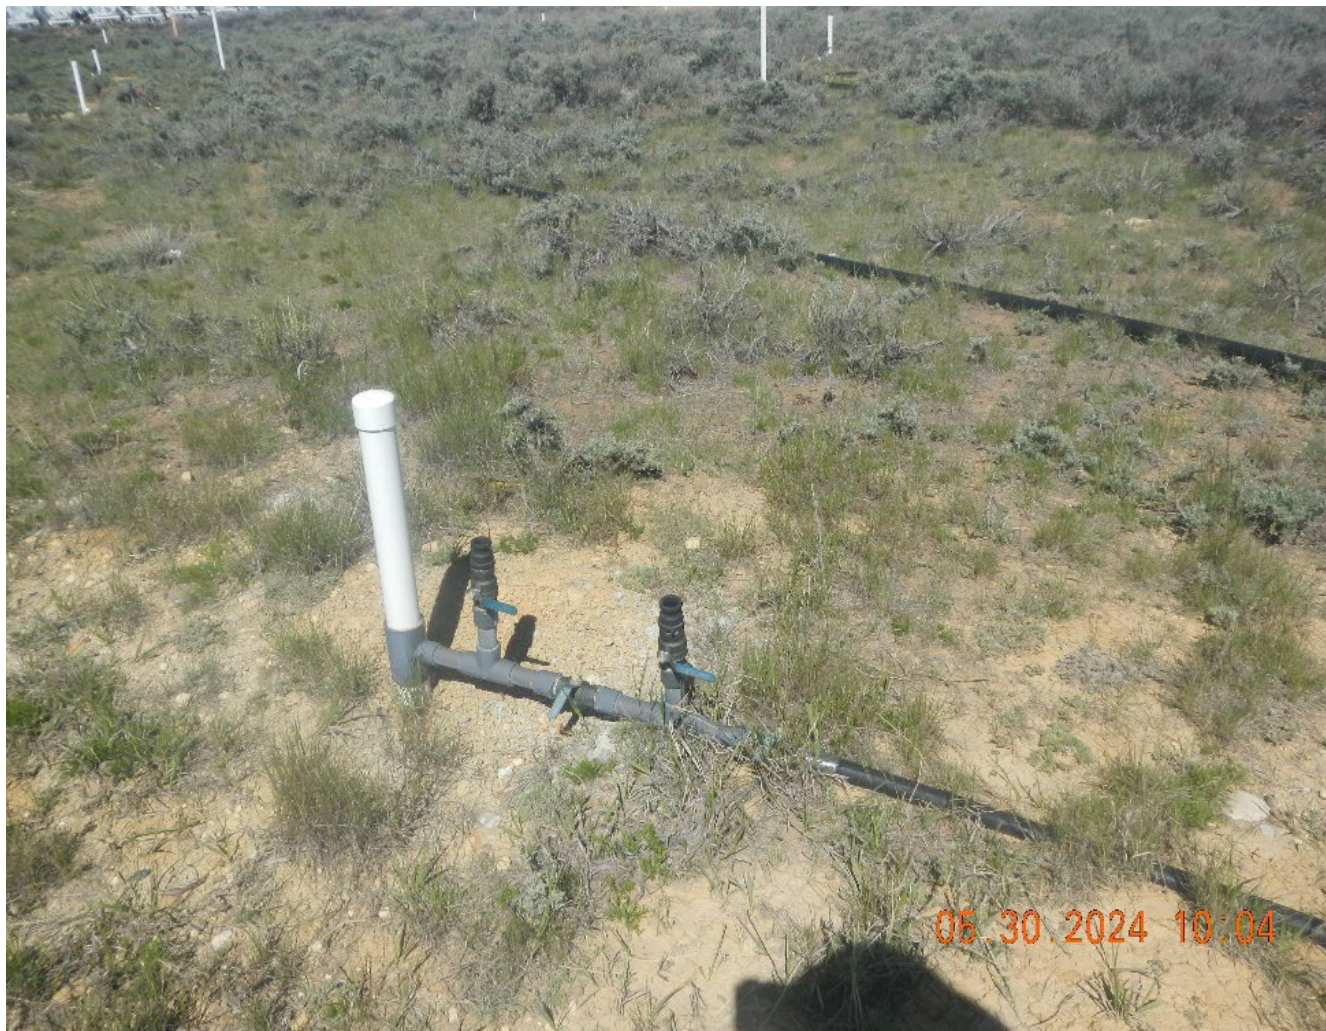
Photo #25 Sparge well and pipe. Note: the position of valve, it is throttled.
