Work Completion Report

Contractor: Peerless

Job Name	Month/Season	Completed By	Completion Date
6-3N-67W NWSW SANFORD TB		Armando Munoz	5/24/2024

Location(s) – Name: SANFORD 13-6

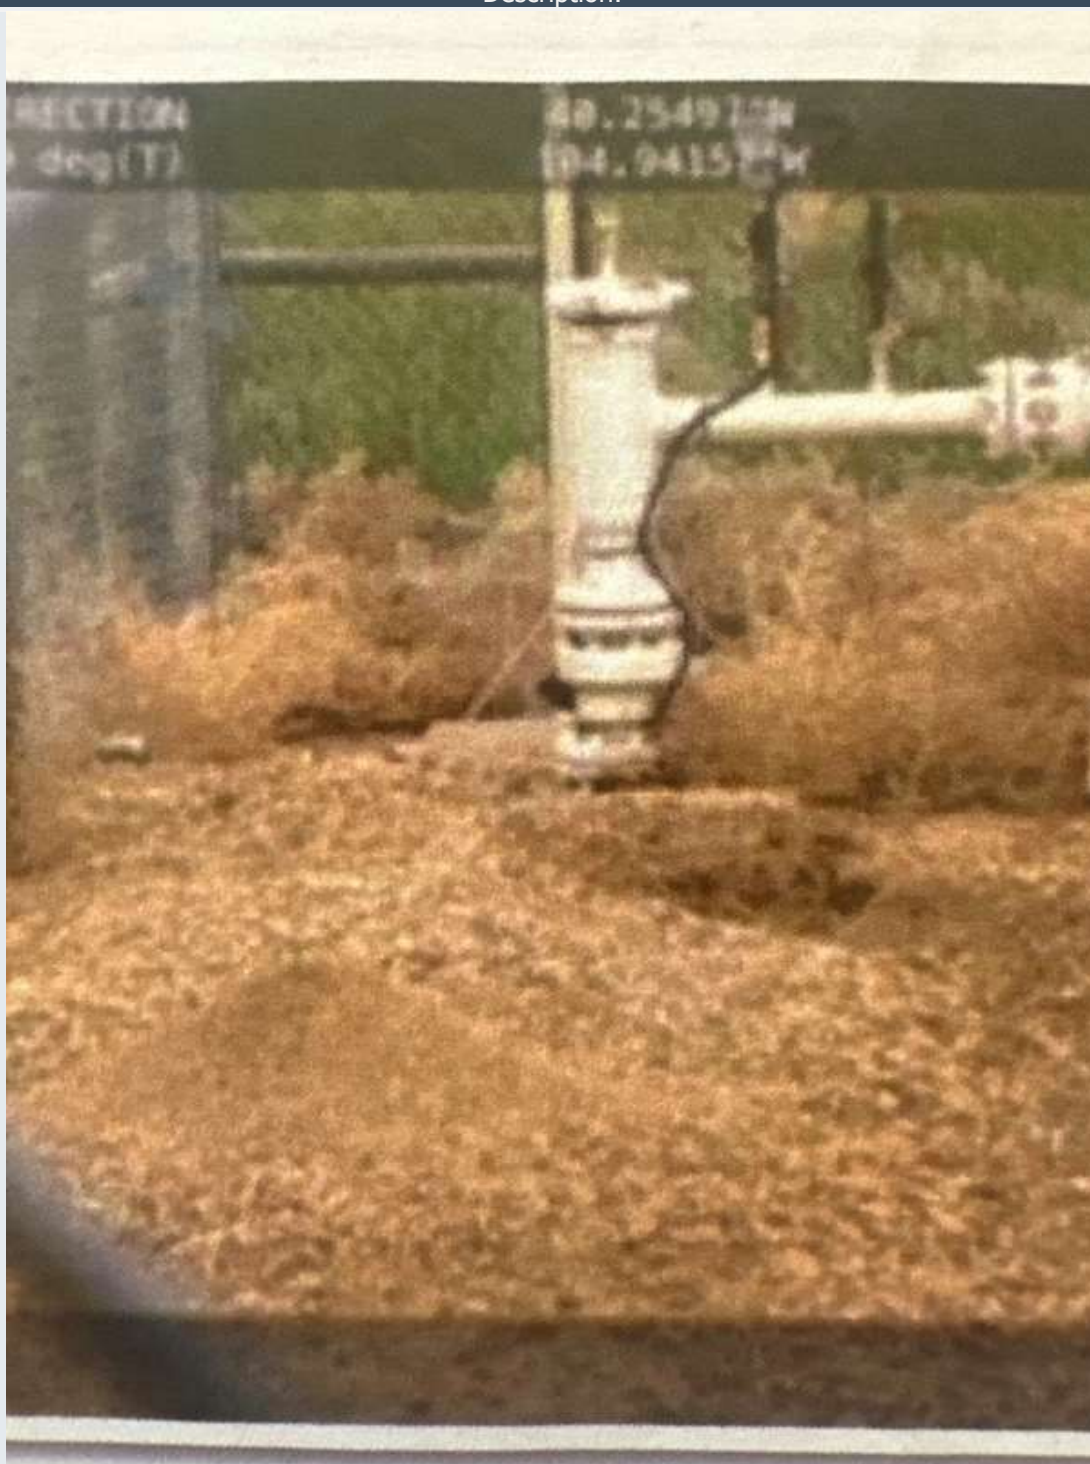
Photo Name: Pre-Completion

Task Name	Priority	COGCC Compliance	Task Location and Notes/Instructions
Stormwater Repairs	High	No	Location(s): SANFORD 13-6 Notes: Repari rutting and damage to berms at NE corner of pad due to stormwater runoff was observed. Area needs to be recompacted and recountoured. All sediment that has migrated offsite needs to be pulled back. Clean any weed carcasses and trash/debris throughout location.

Work Summary	Reclamation Type	Land Use
Repaired rutting and damage to berms at NE corner of pad due to storm water runoff. Recompect pull back all sediment that has migrated offsite. Mowed weed carcasses and picked up trash and debris.	Stormwater	Active Pad
