Inspection Photos

Location Name: TEP ROCKY MOUNTAIN LLC GV 88-1 Frac Pit 1

Location ID: 334734

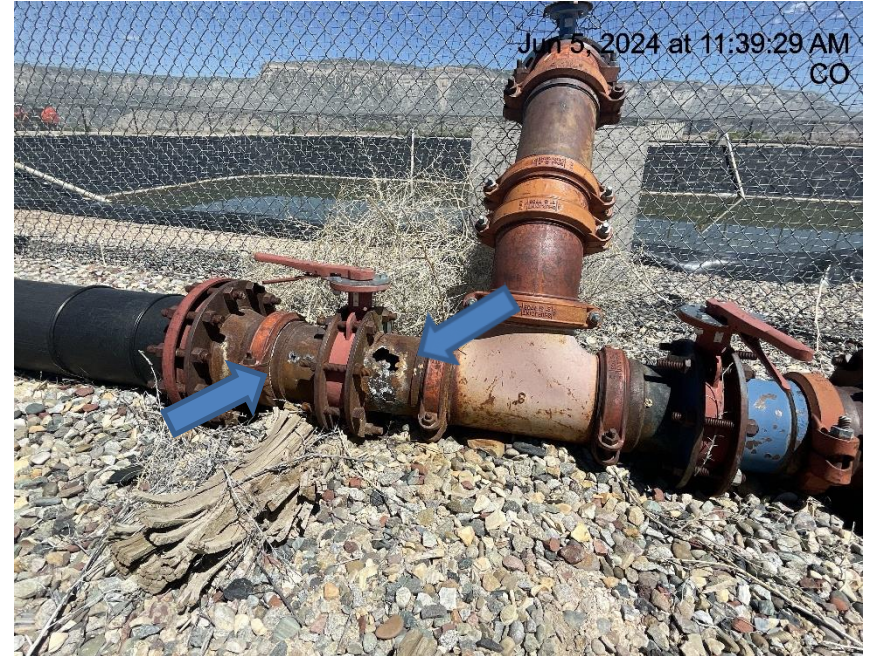
Photo # 9449 Corroded/failed piping

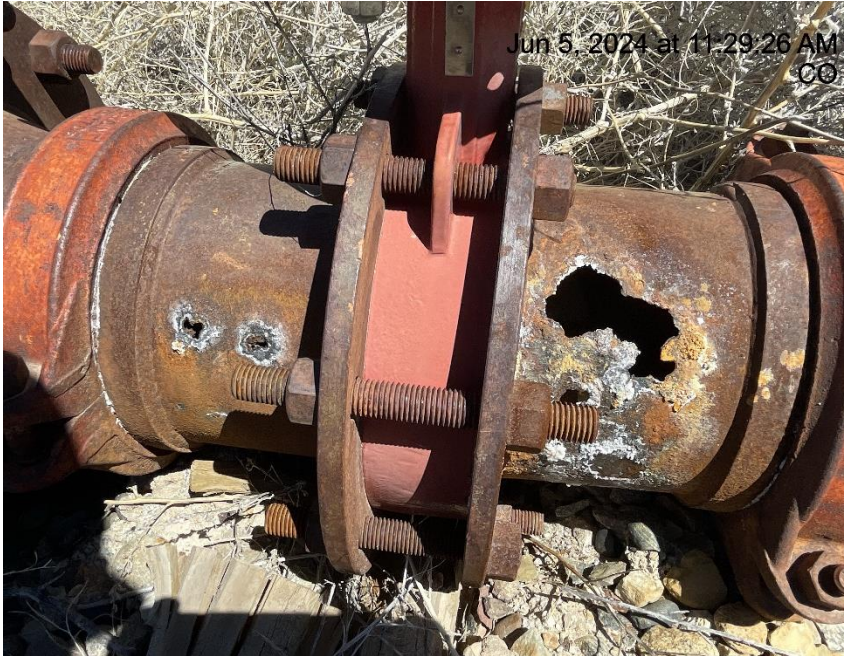
Photo # 9450 Corroded/failed piping

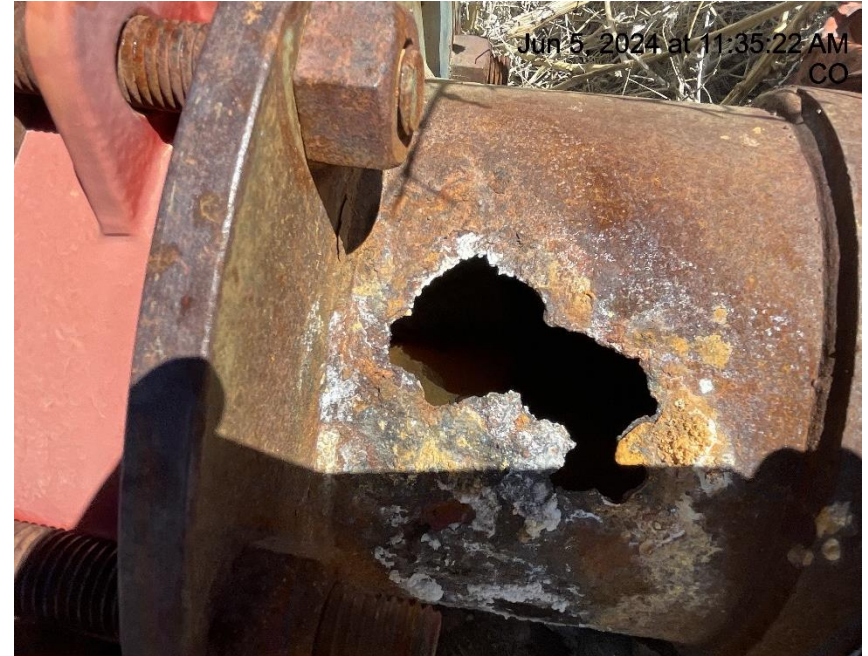
Photo # 9451 Corroded/failed piping

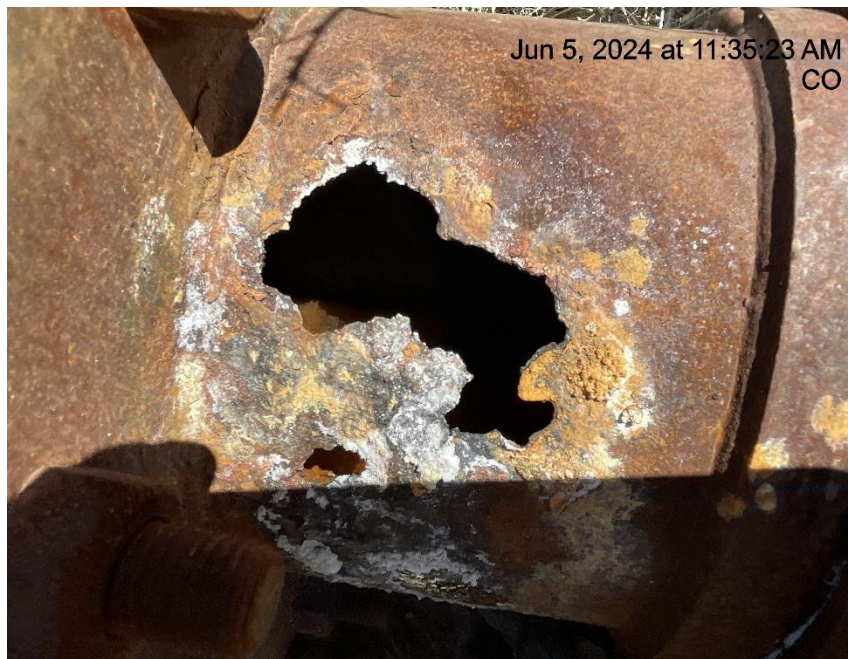
Photo # 9452 Corroded/failed piping

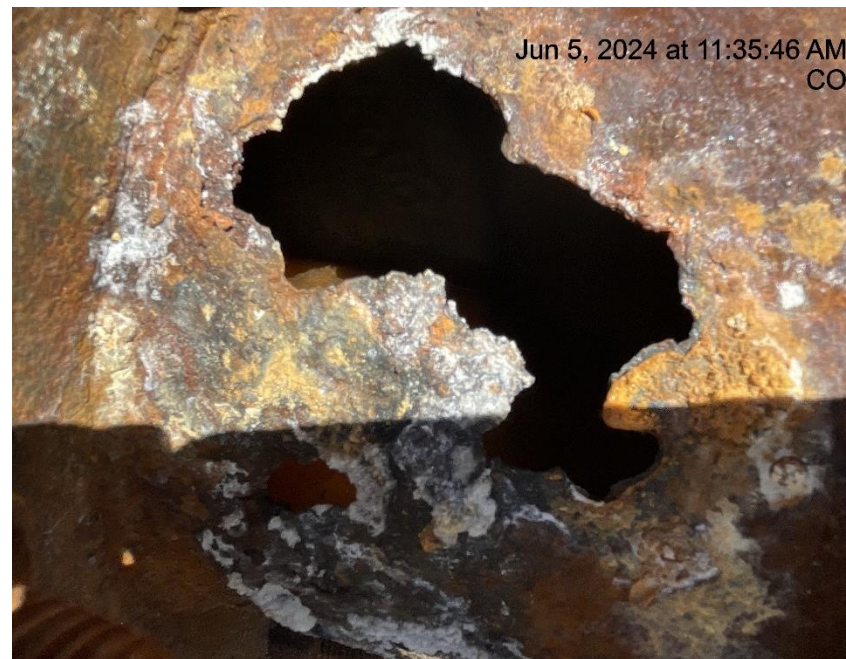
Photo # 9453 Corroded/failed piping

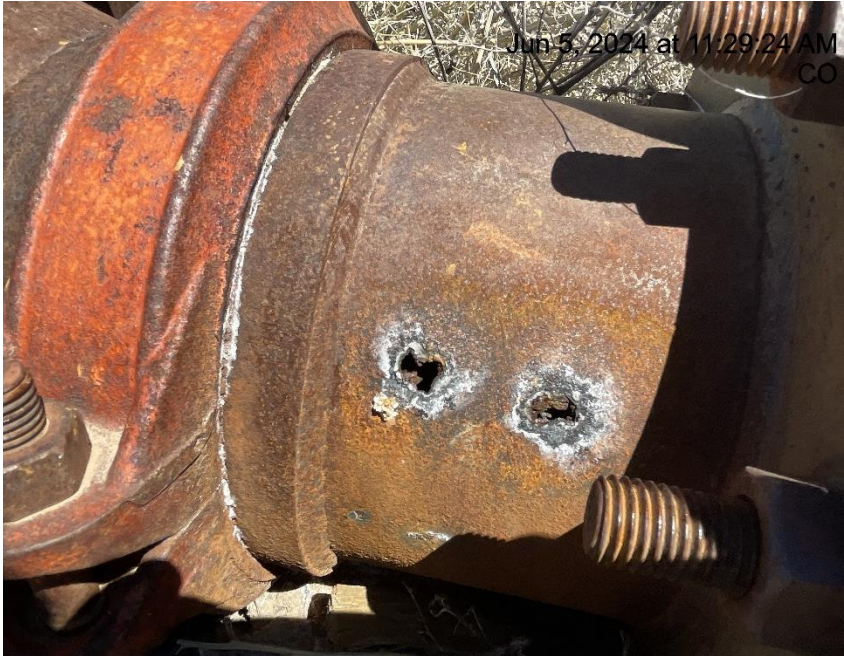
Photo # 9454 Corroded/failed piping

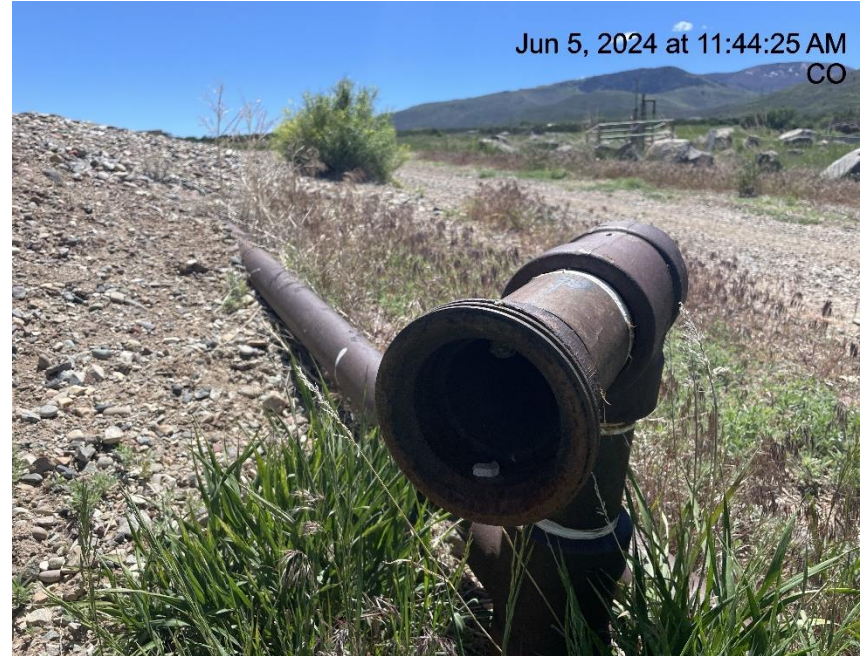
Photo # 9455 Open ended piping/wildlife hazard/available for entry by wildlife

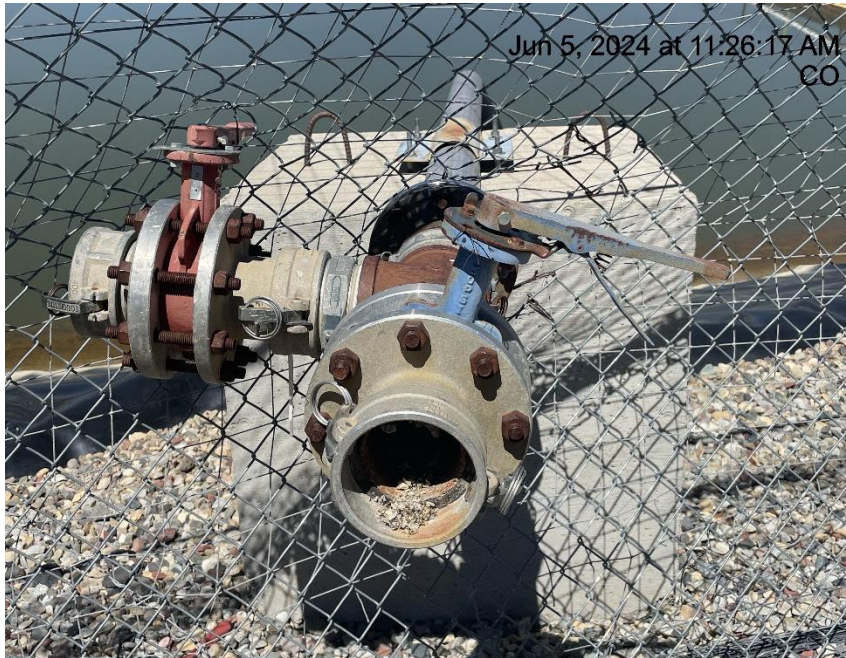
Photo # 9456 Open ended load line

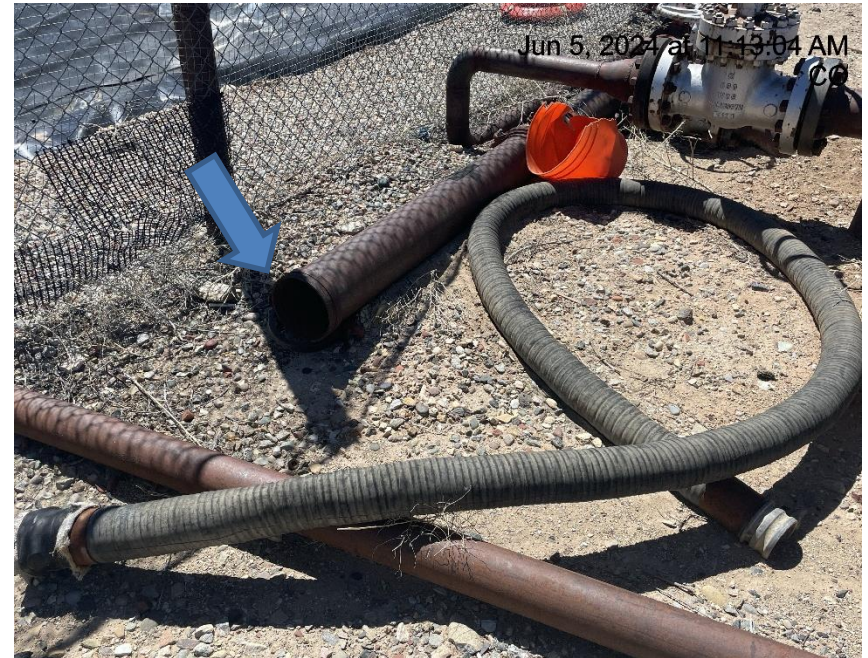
Photo # 9457 Open ended piping/wildlife hazard/available for entry by wildlife

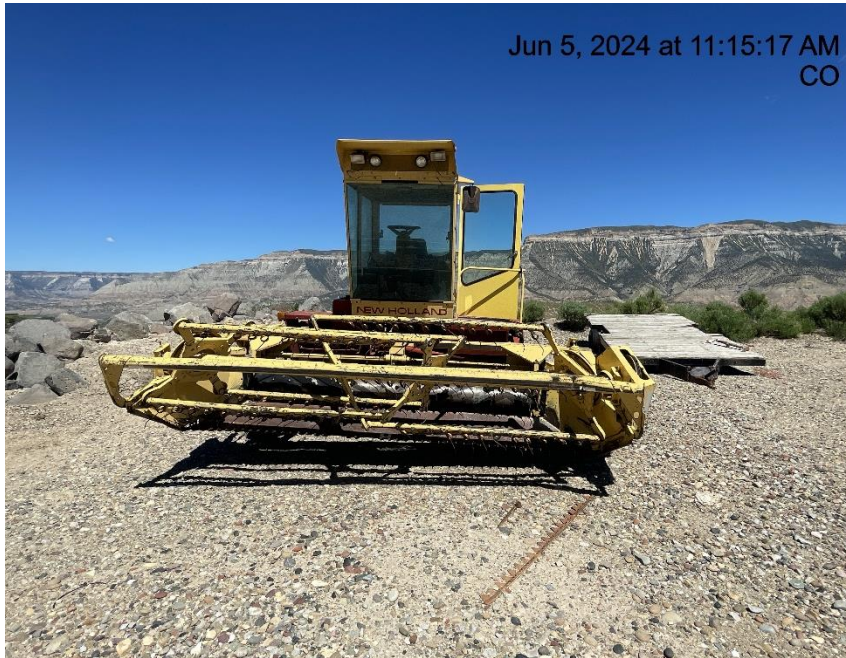
Photo # 9458 Stored farm equipment

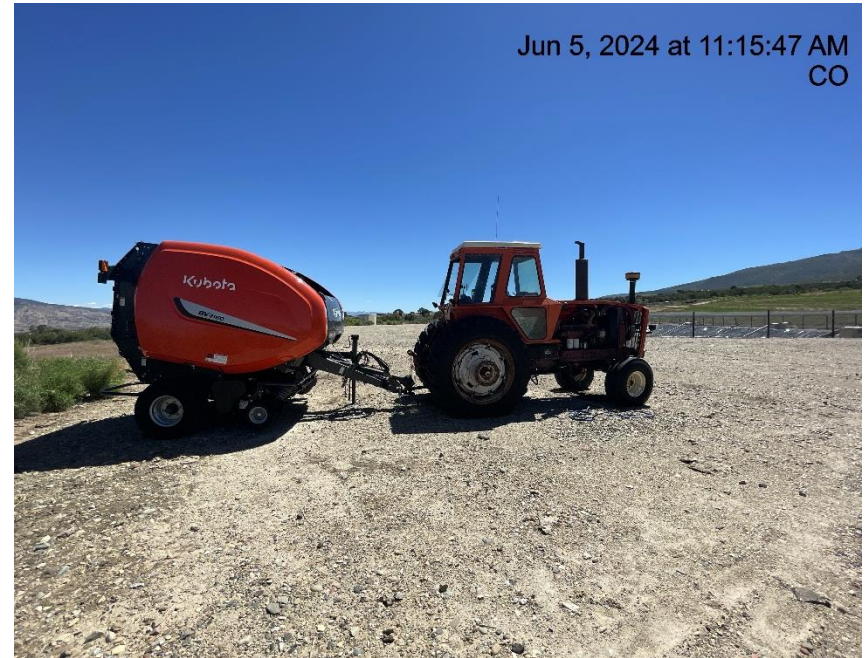
Photo # 9459 Stored farm equipment

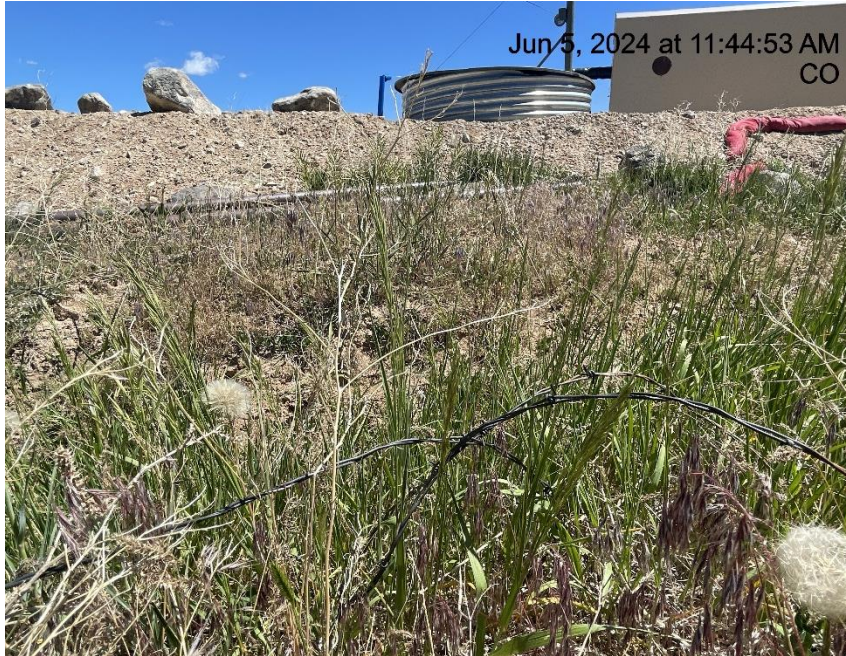
Photo # 9460 Barbed wire fence around location needs maintenance/wildlife hazard

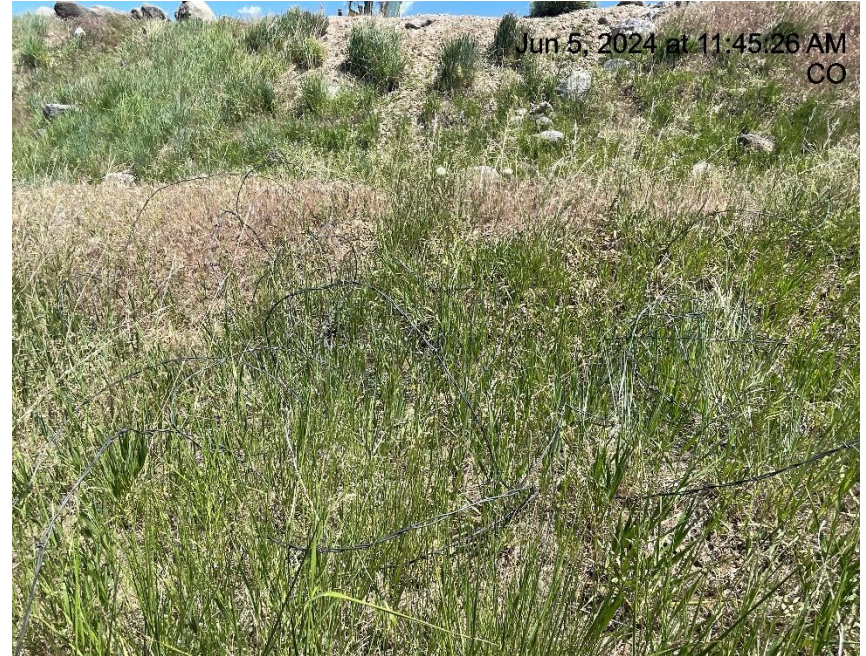
Photo # 9461 Barbed wire fence around location needs maintenance/wildlife hazard

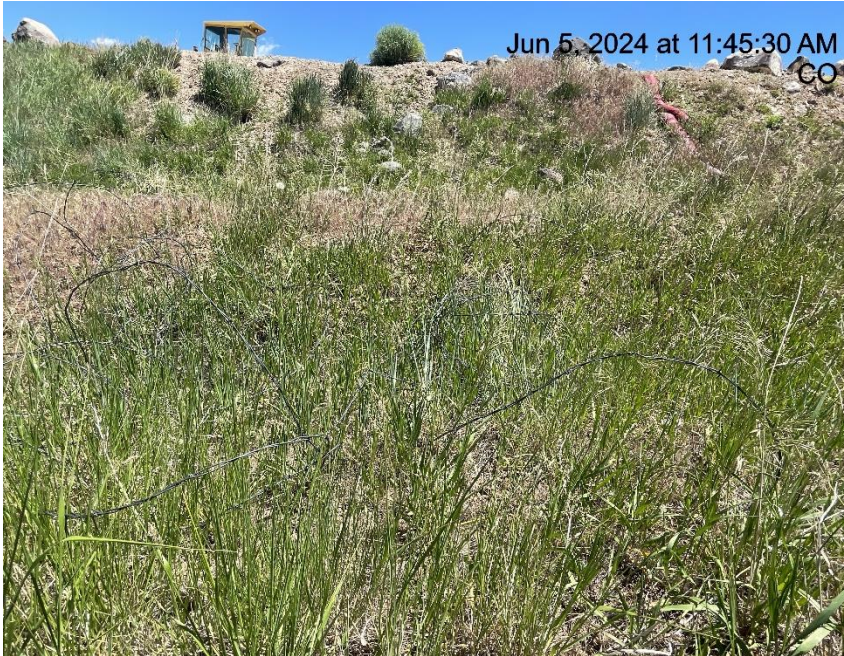
Photo # 9462 Barbed wire fence around location needs maintenance/wildlife hazard

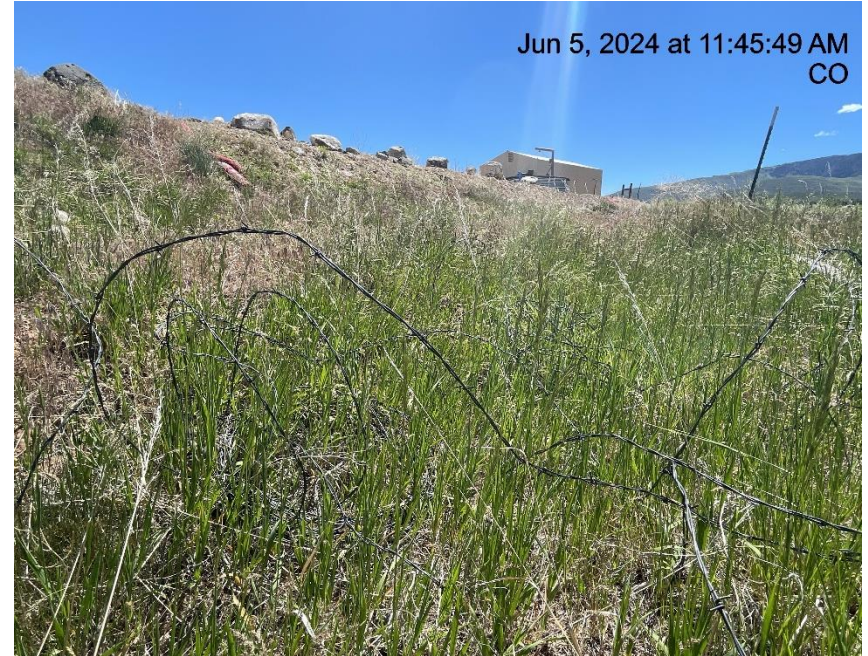
Photo # 9463 Barbed wire fence around location needs maintenance/wildlife hazard

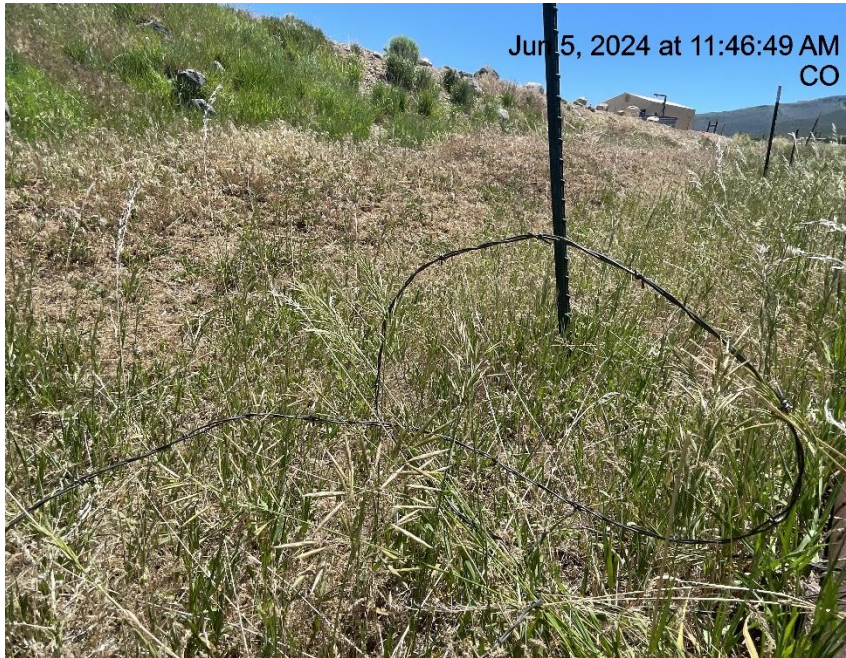
Photo # 9464 Barbed wire fence around location needs maintenance/wildlife hazard

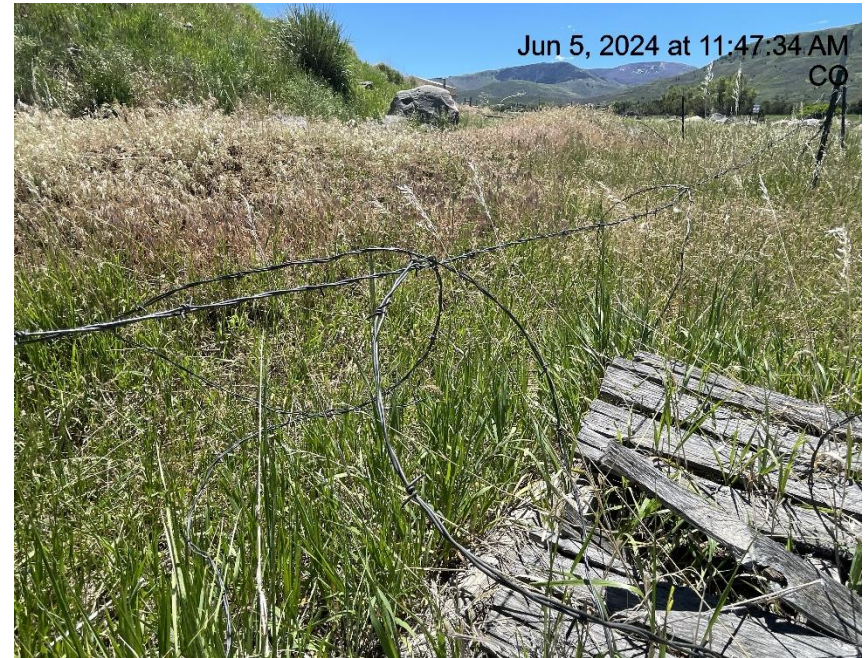
Photo # 9465 Barbed wire fence around location needs maintenance/wildlife hazard

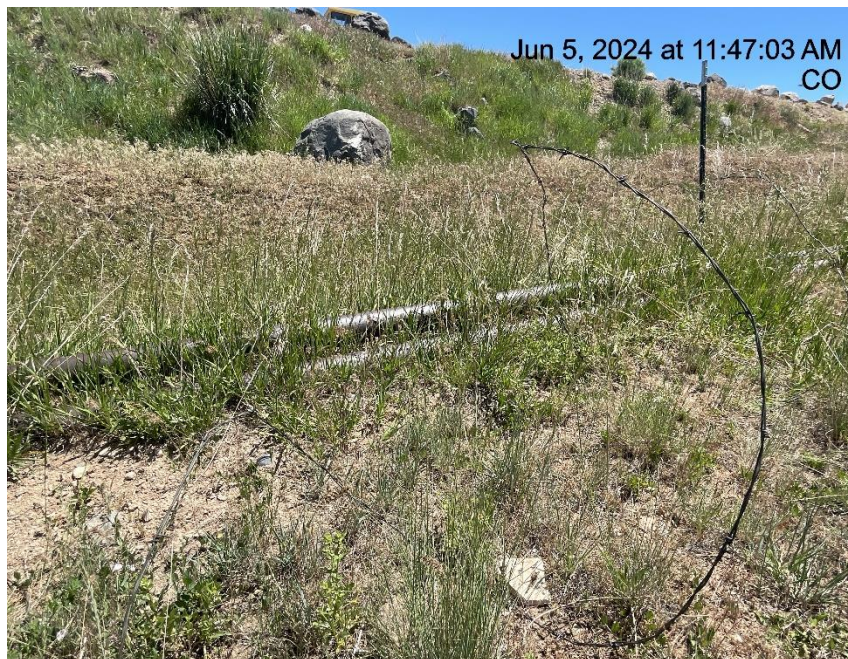
Photo # 9466 Barbed wire fence around location needs maintenance/wildlife hazard

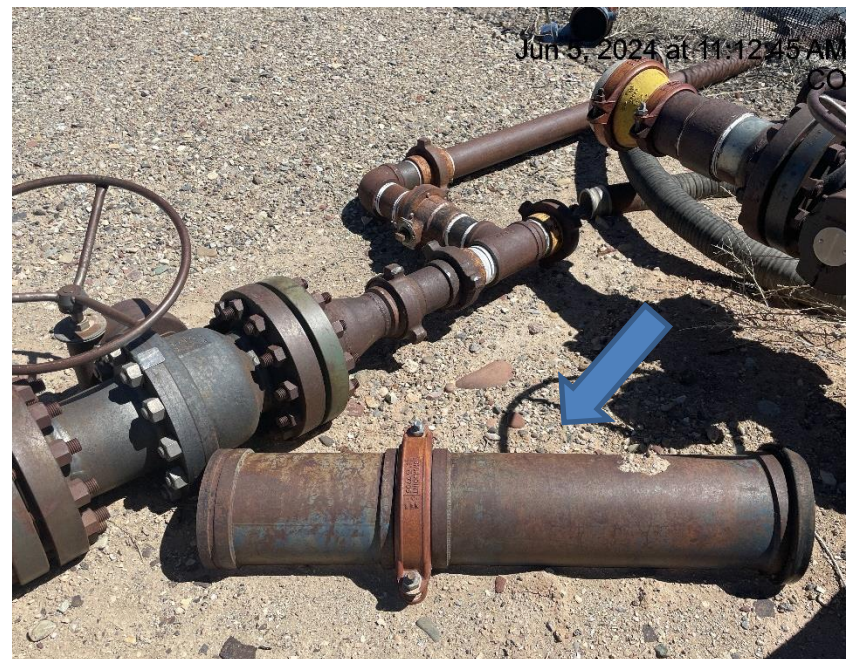
Photo # 9467 Debris

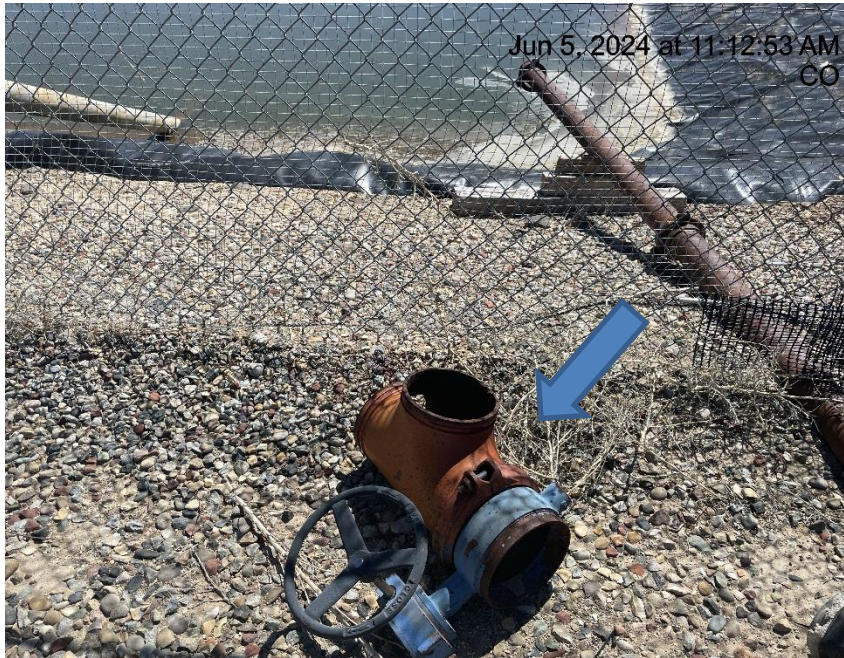
Photo # 9468 Debris

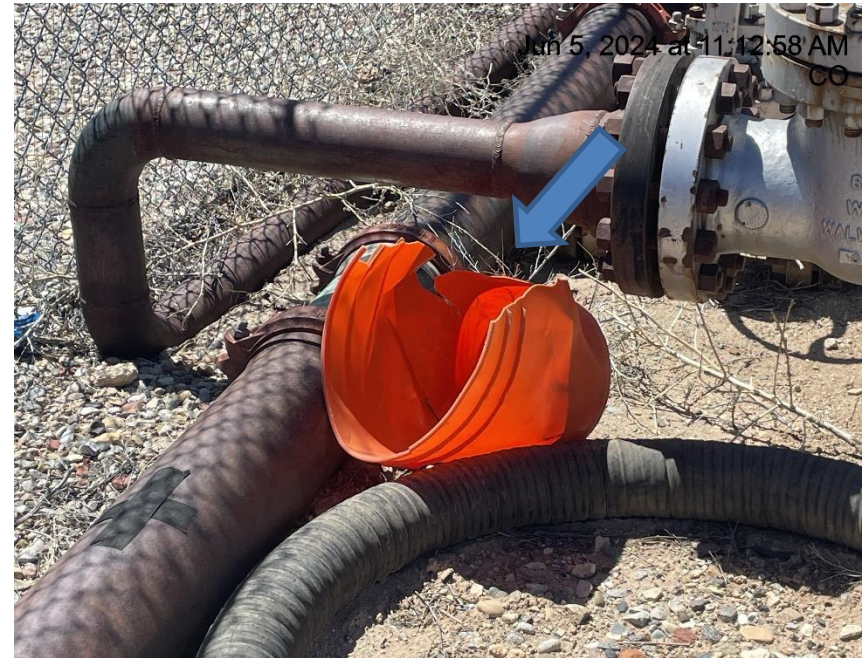
Photo # 9469 Debris

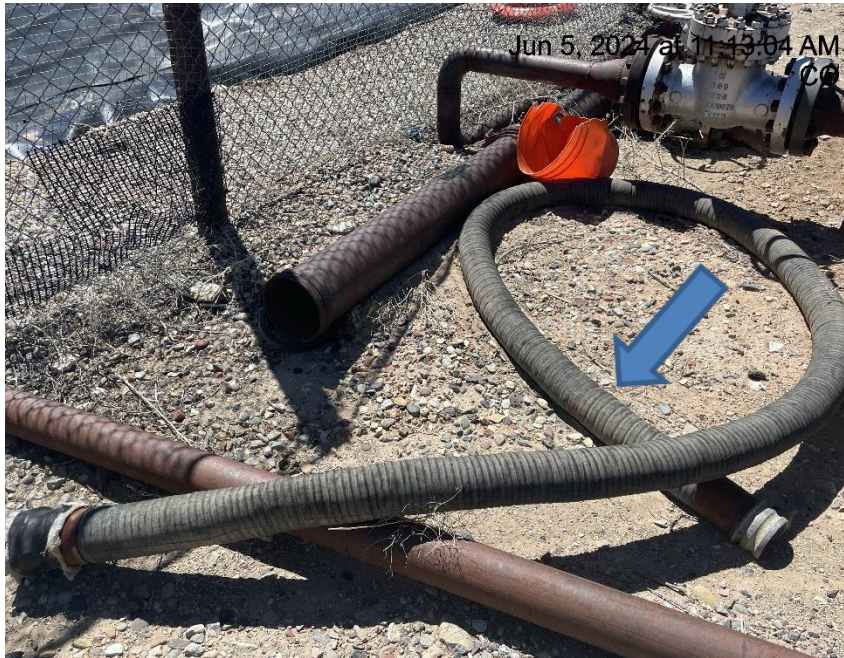
Photo # 9470 Debris

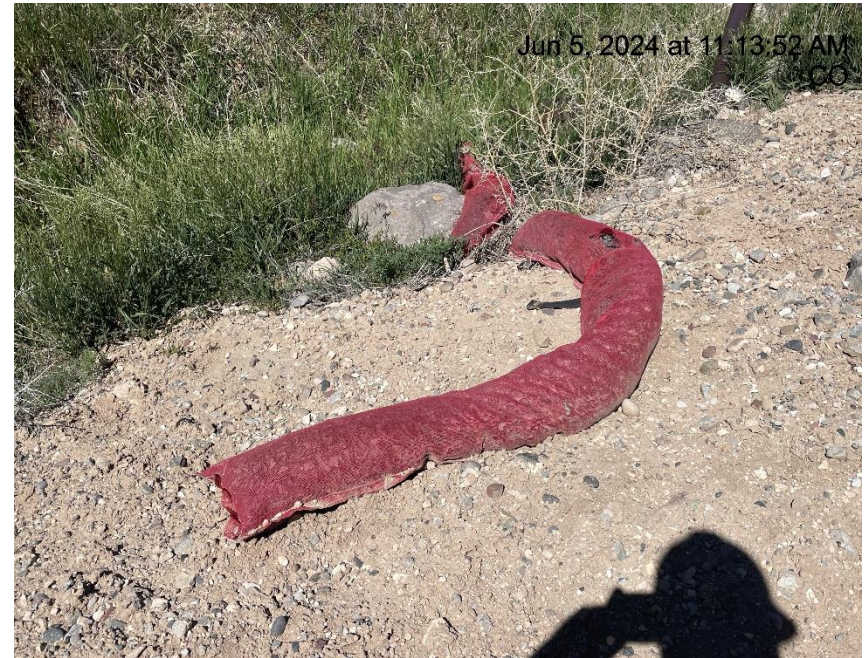
Photo # 9471 Debris

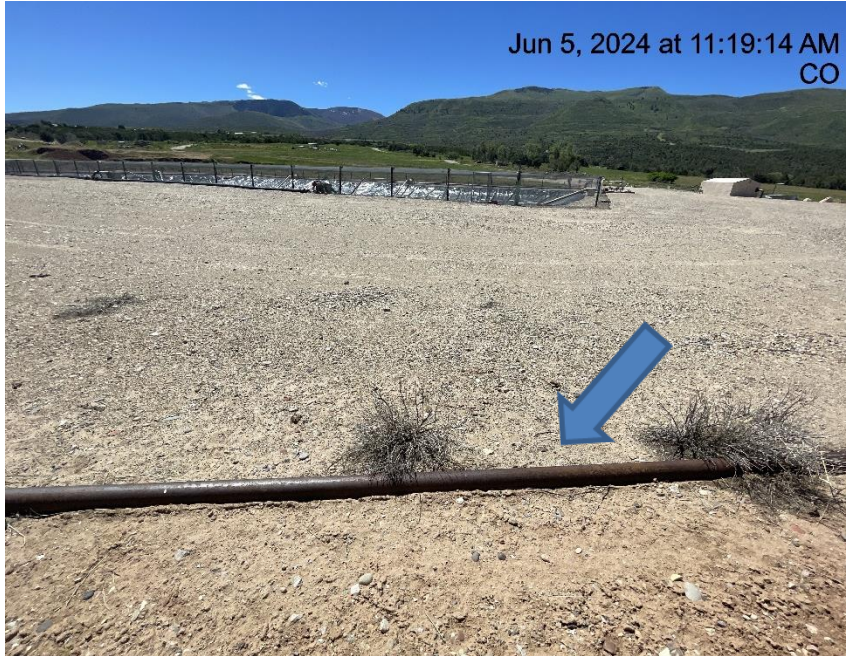
Photo # 9472 Debris

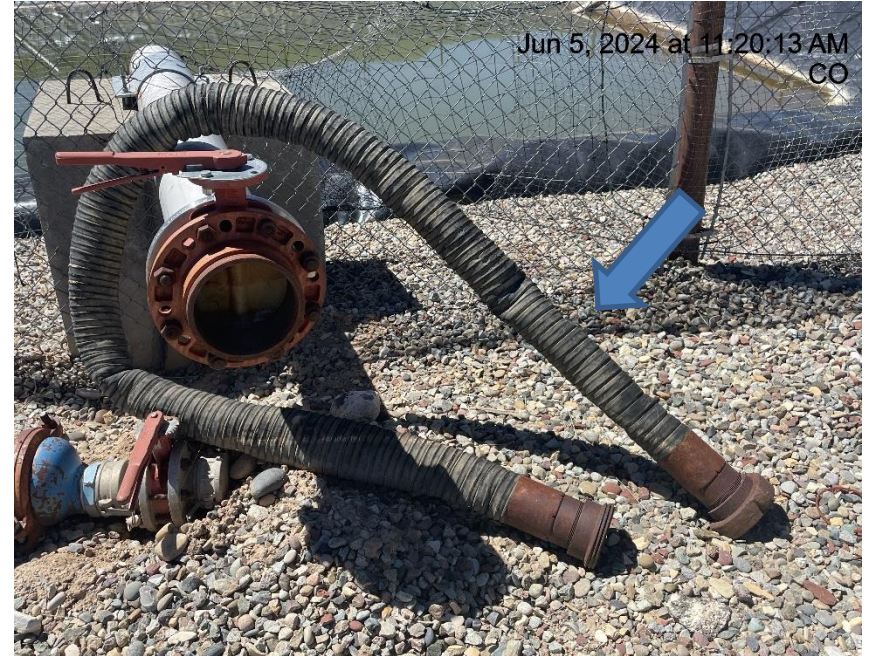
Photo # 9473 Debris

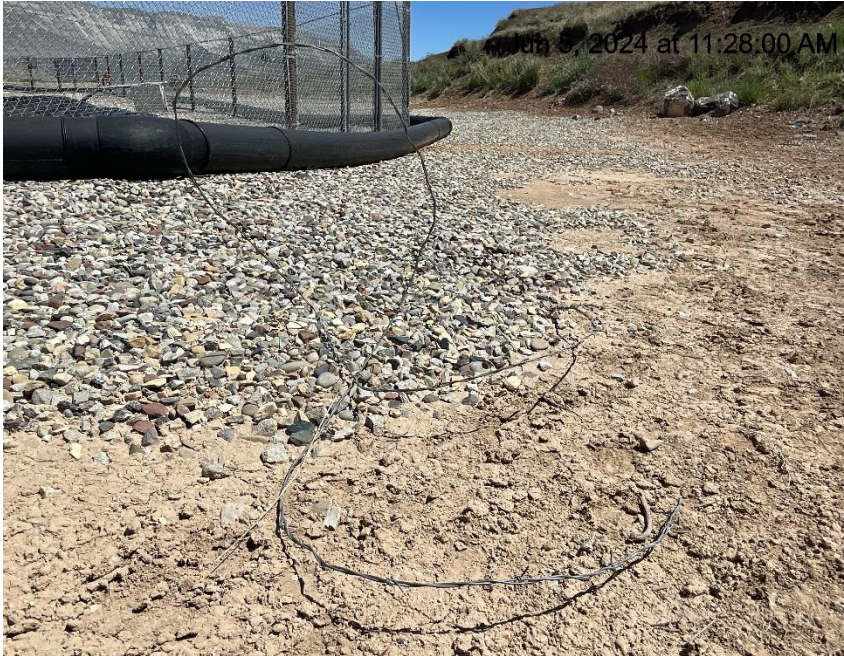
Photo # 9474 Debris

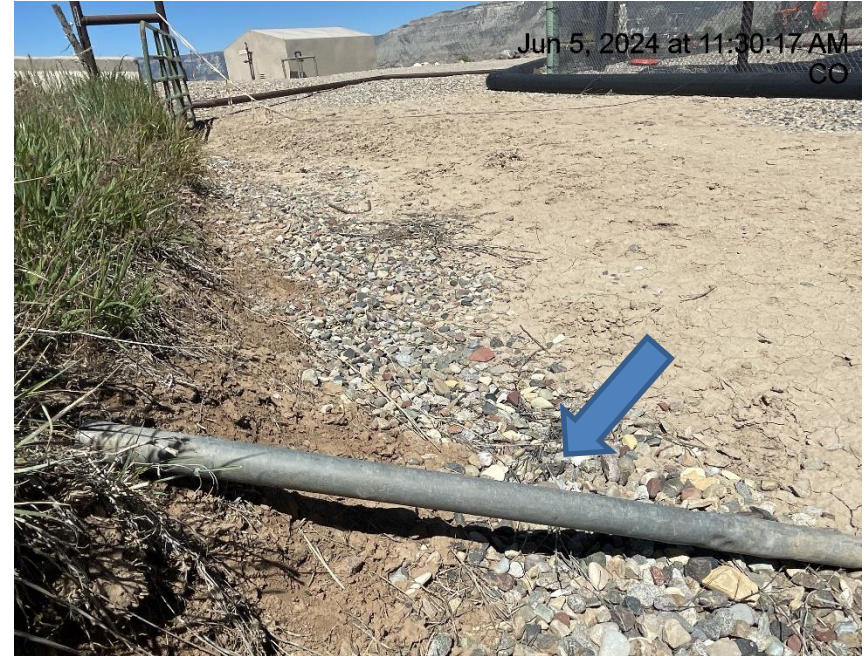
Photo # 9475 Debris
