Inspection Photos
Location Name: Linnebur 4
Location ID: 319762

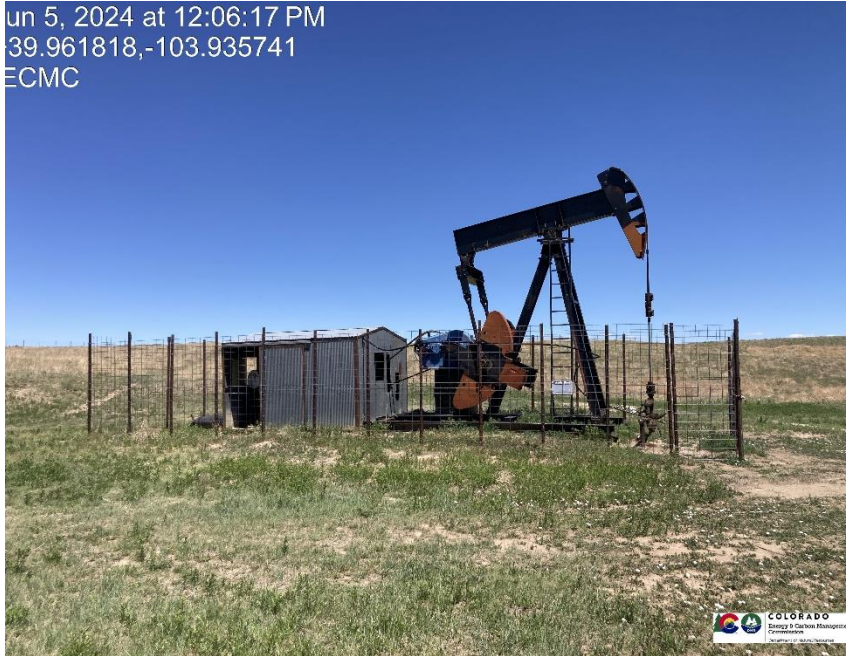
Pic 1 pumpjack

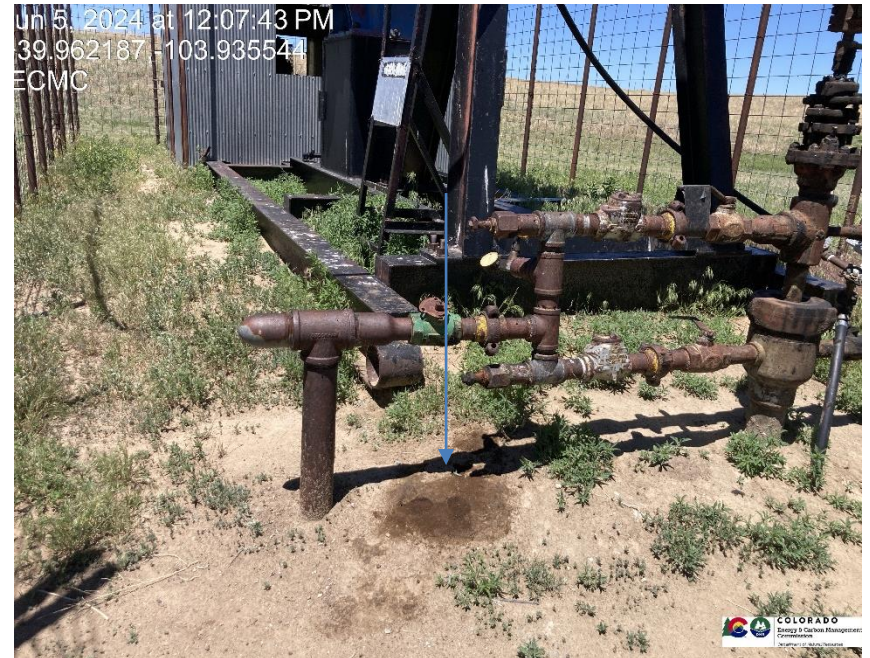
Pic 2 contaminated soil / weeds unmanaged / wellhead sign is incorrect information.

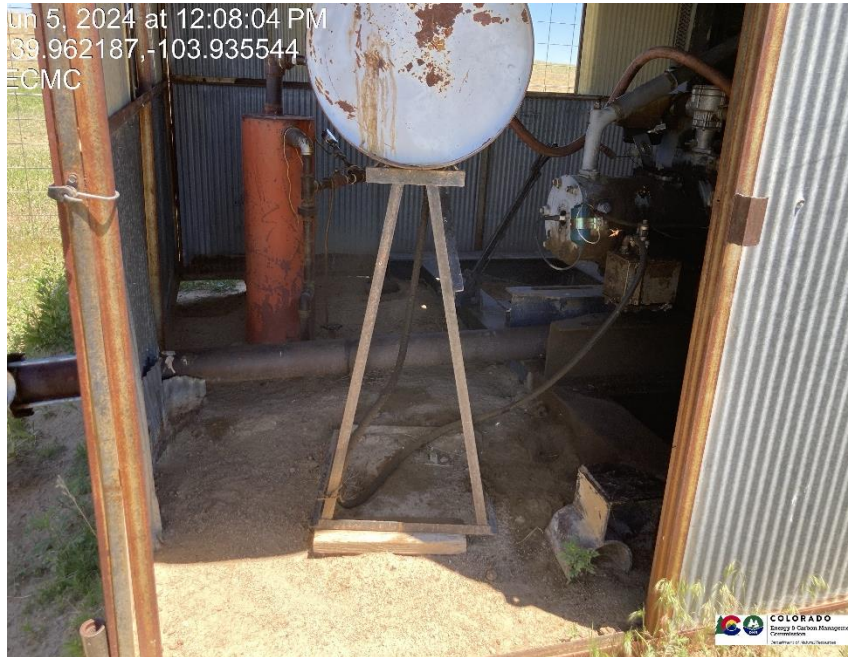
Pic 3 no containment under chemical tank

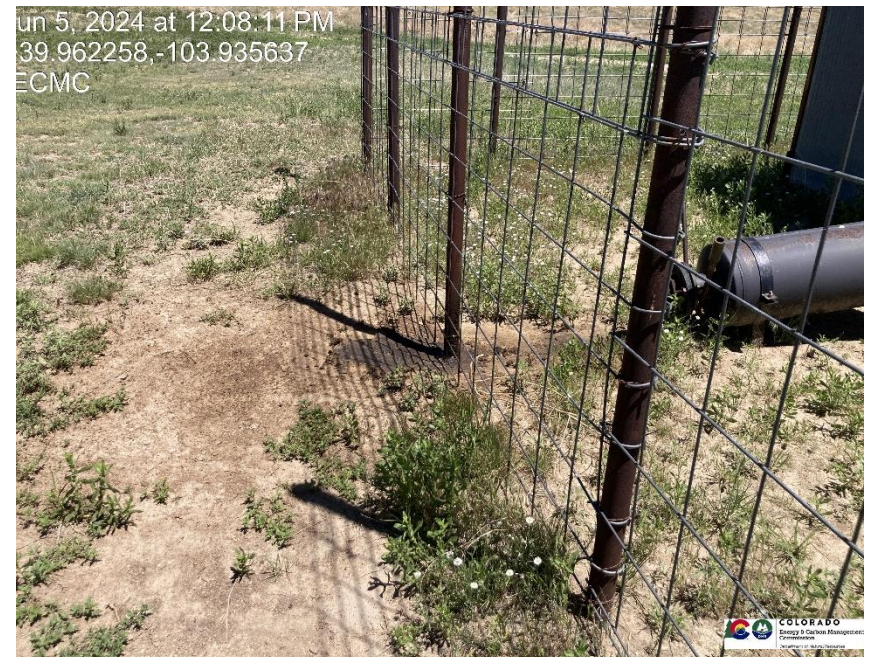
Pic 4 contaminated soil by exhaust needs to be removed

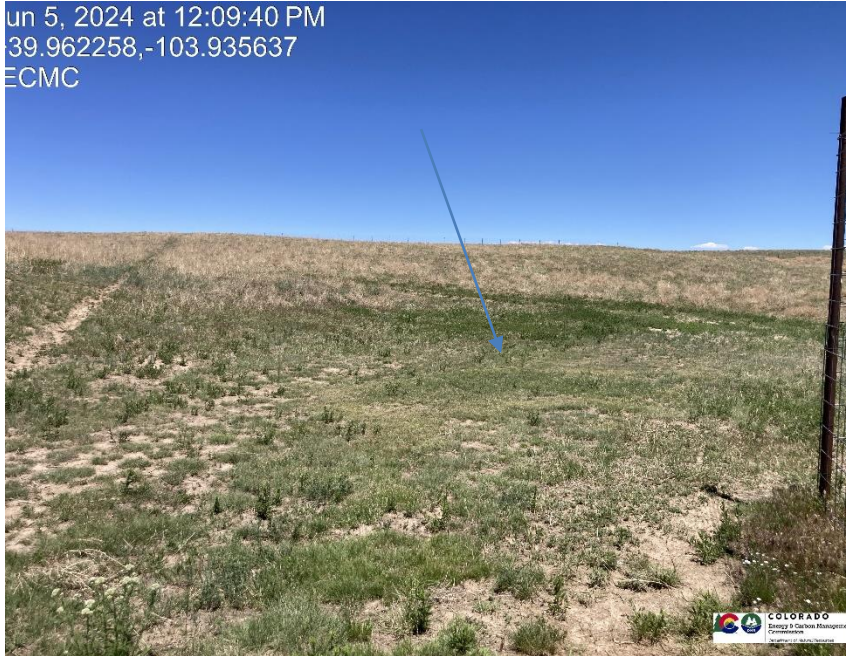
Pic 5 no guy line anchor marker

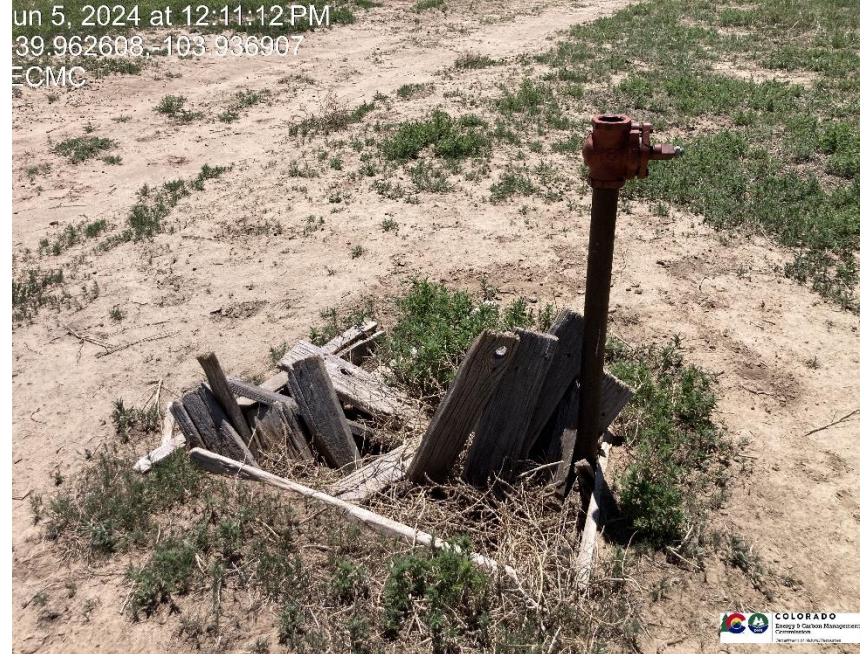
Pic 6 riser located east of pump jack no LOTO

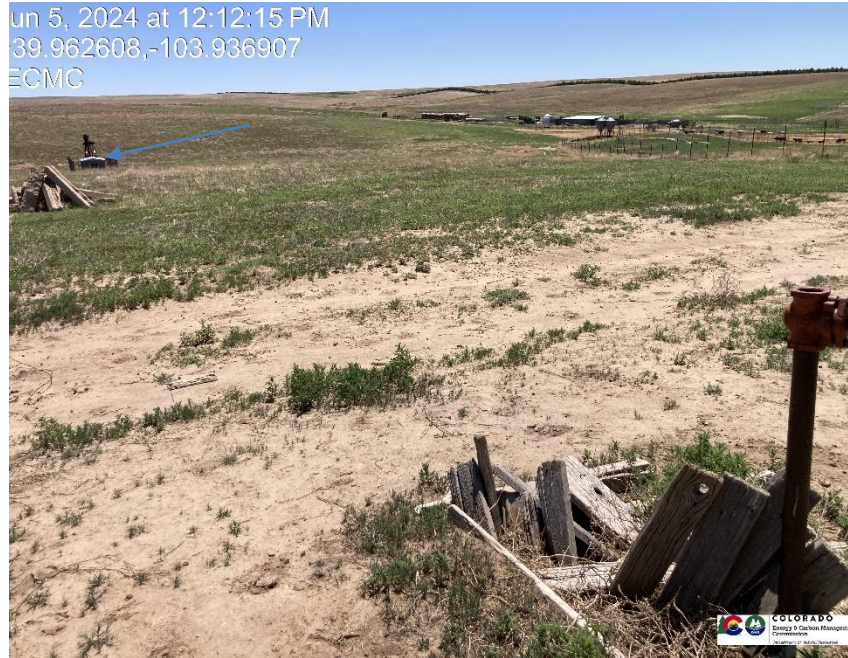
pic 7 Riser east of pump jack, arrow shows pump jack

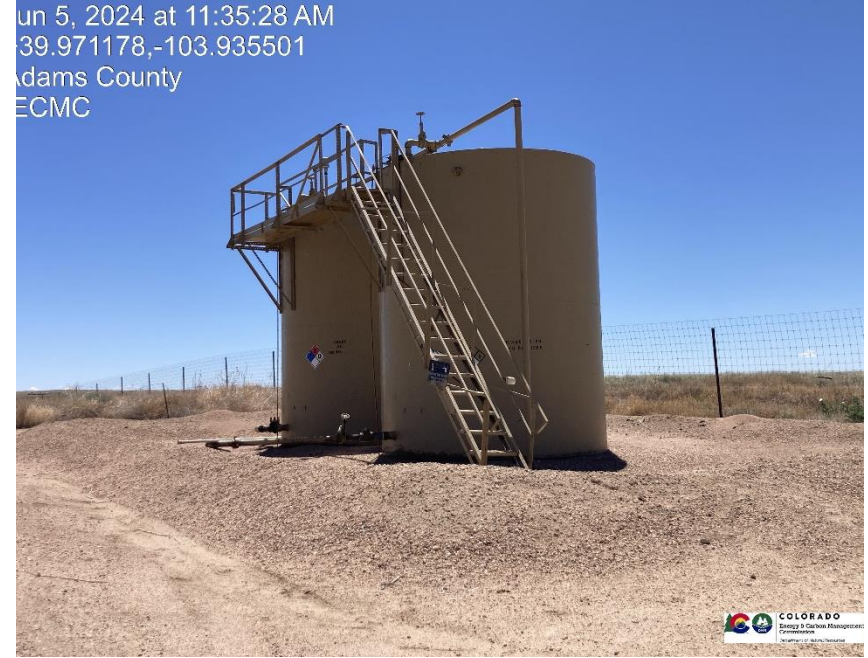
Pic 8 tanks, berms need to be repaired

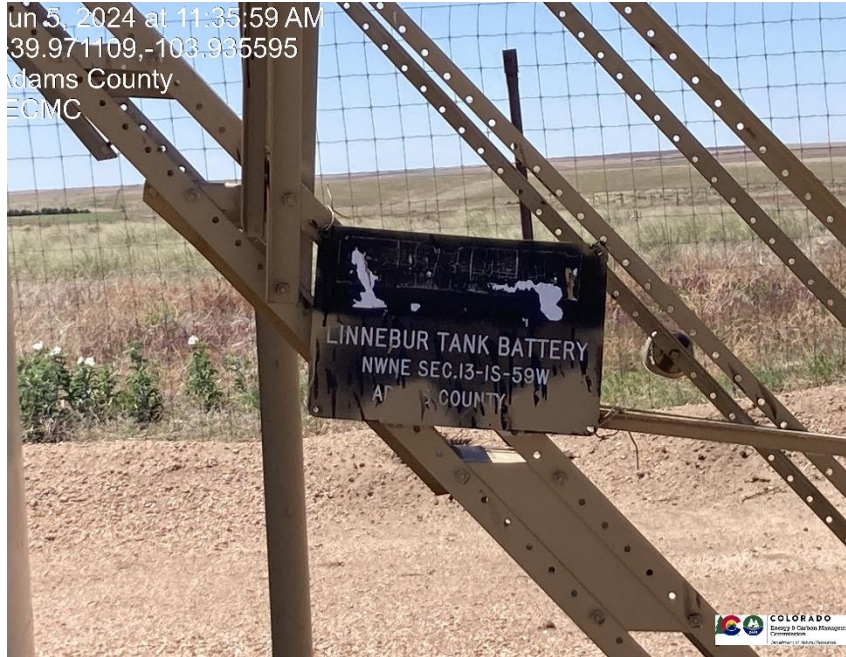
Pic 9 Sign is inadequate at tank battery.

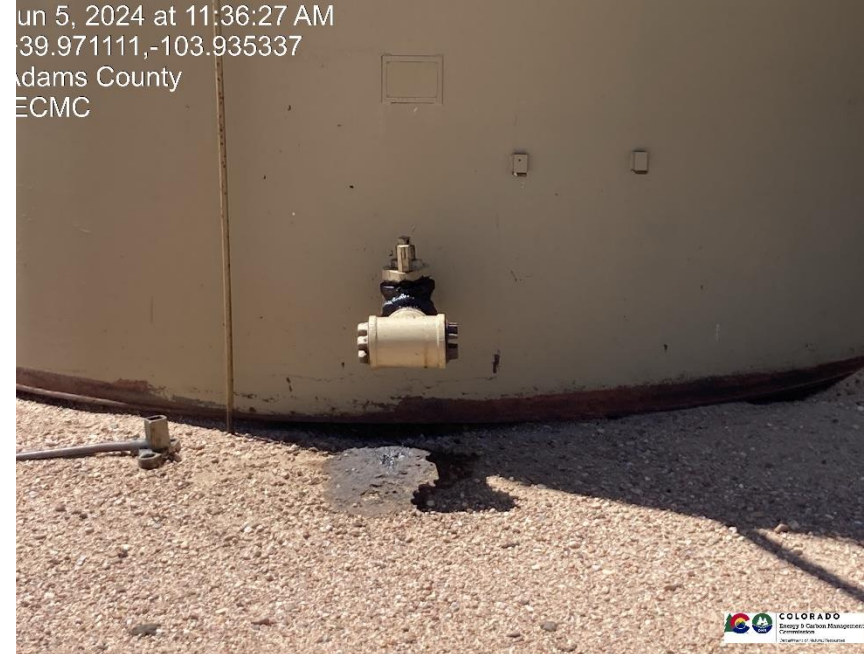
Pic 10 contaminated soil by valve on tank needs to be removed

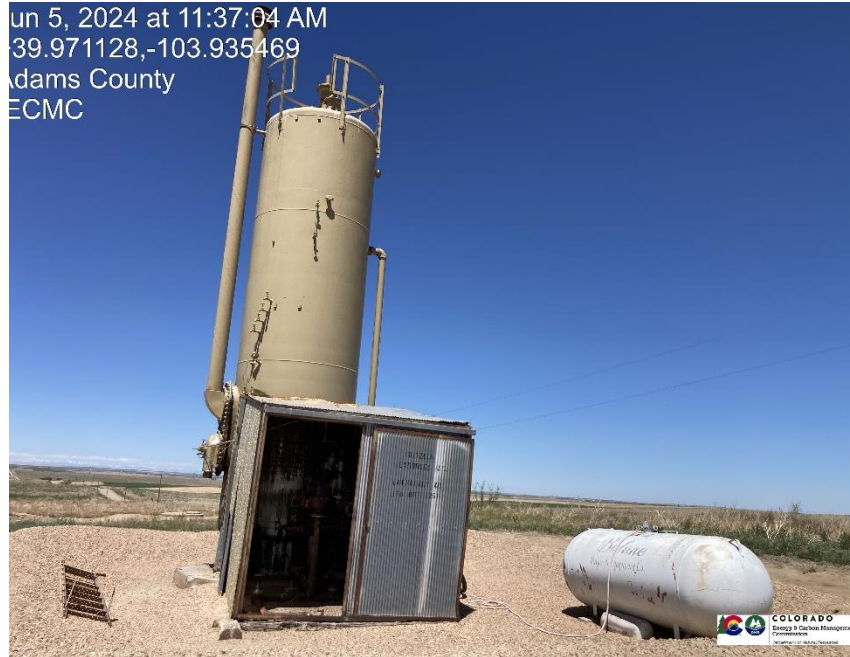
Pic 11 separator, propane tank

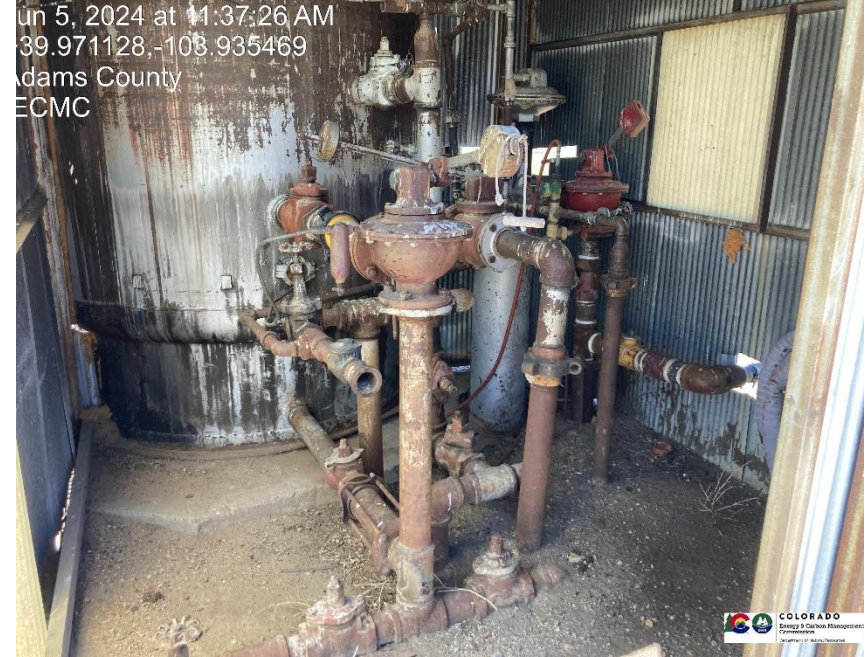
Pic 10 Separator plumbing

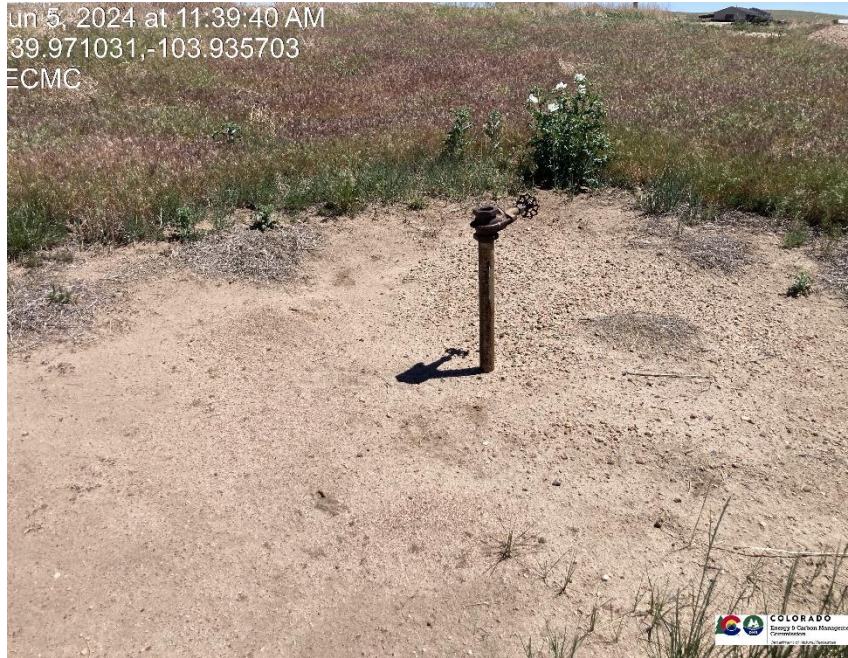
Pic 11 OOSLOT riser needs to be LOTO

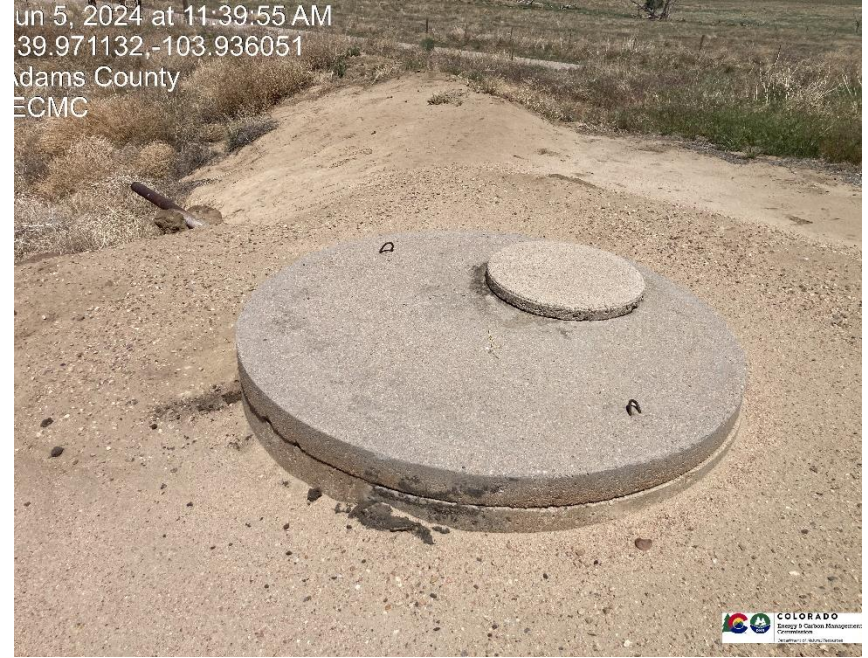
Pic 12 BV leading to pit

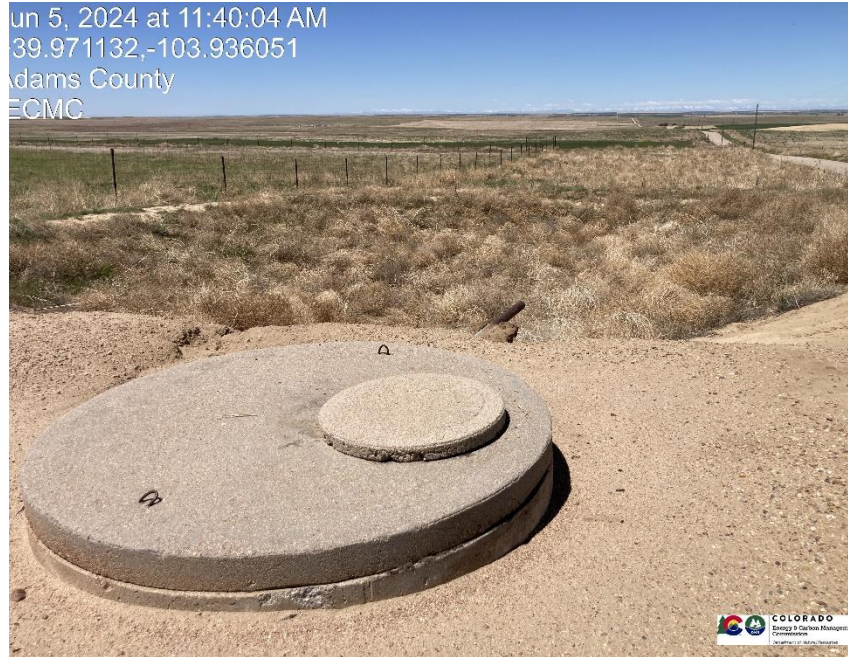
Pic 13 Pit needs weeds removed
