Inspection Photos

Location Name: TEP ROCKY MOUNTAIN LLC FOSSIL CREEK RWF 31-6 Pad

Location ID: 334988

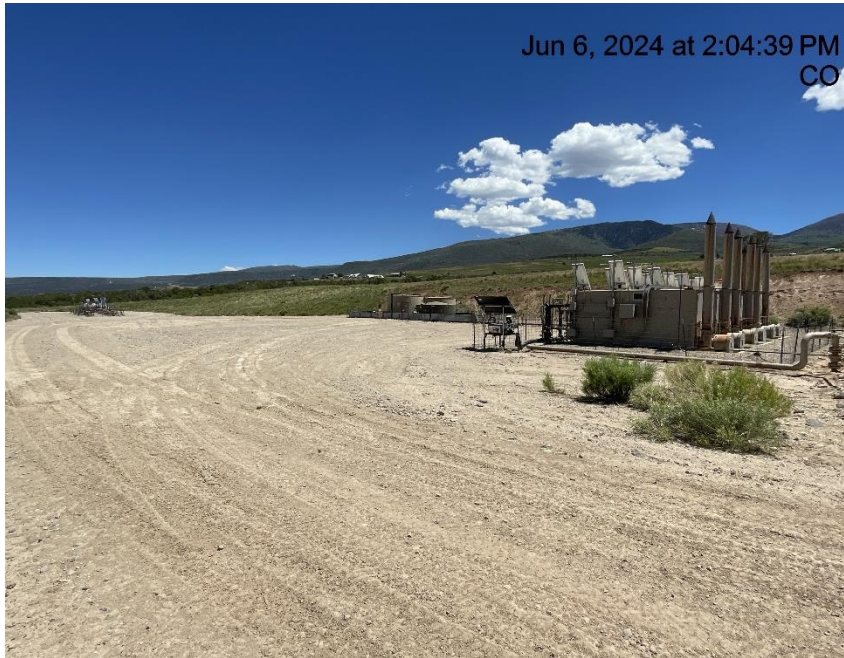
Photo # 44 From entrance to location

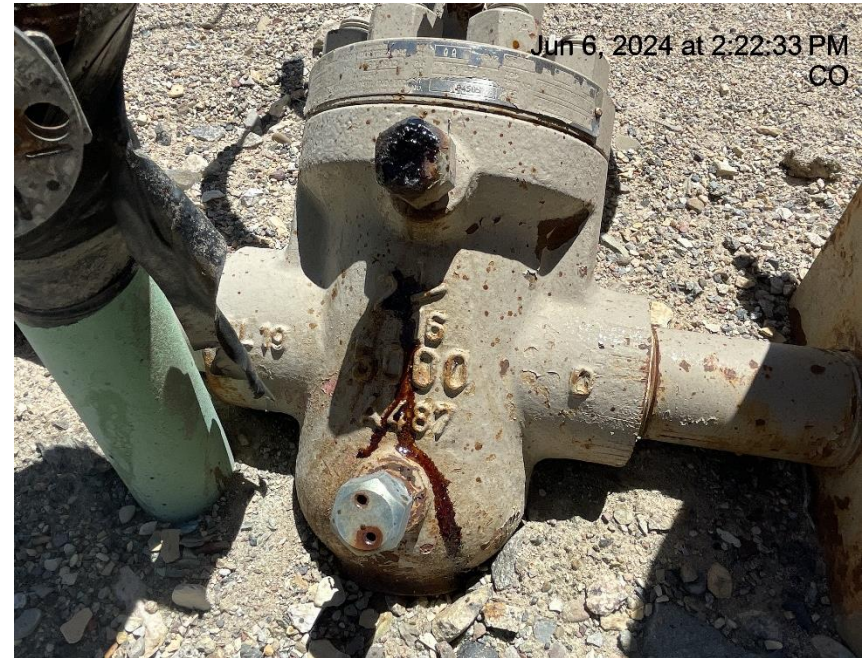
Photo # 53 Mechanical Condition - Possible leak on PA 332-6 wellhead casing valve

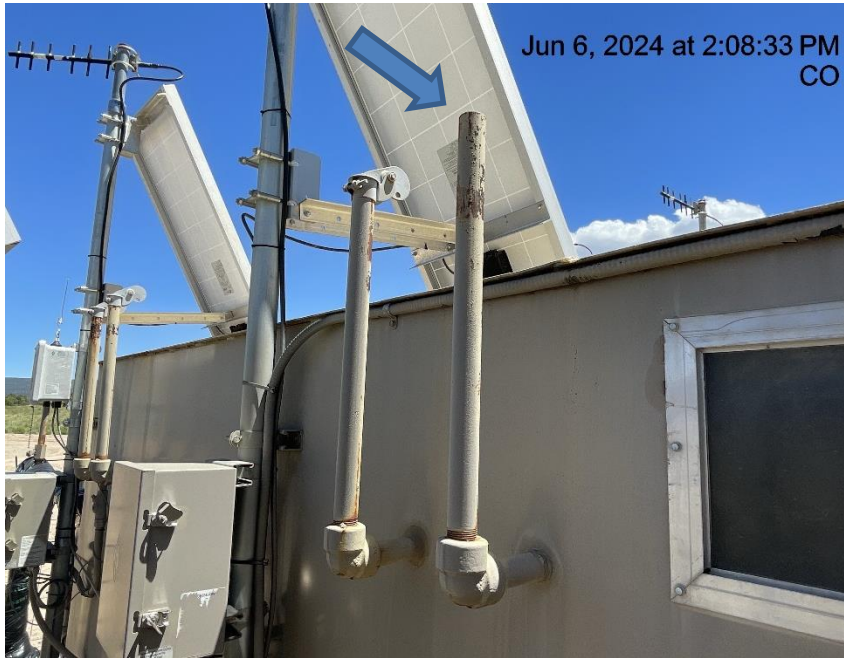
Photo # 54 PRV vent line does not comply with CECMC pressure safety device rules

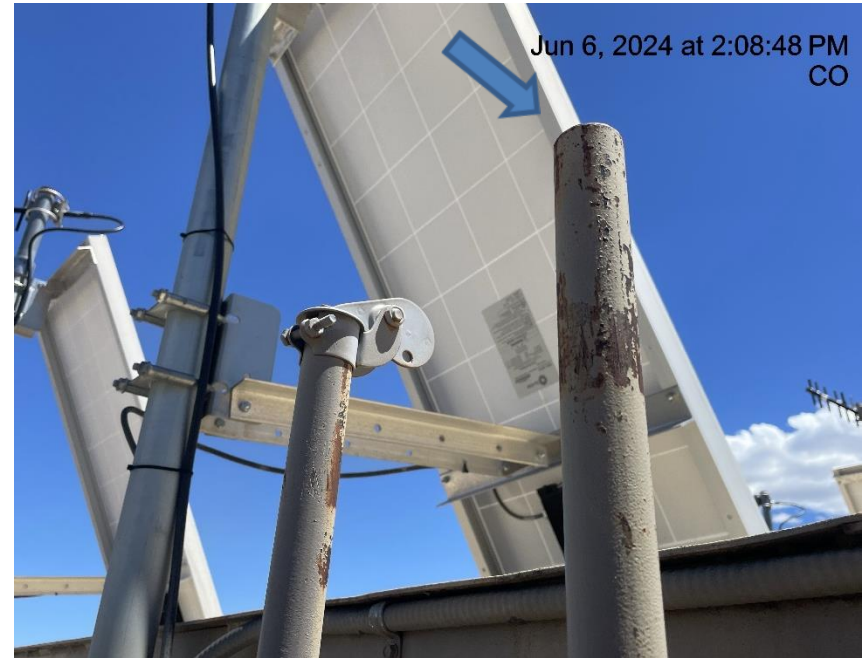
Photo # 55 PRV vent line does not comply with CECMC pressure safety device rules
