Inspection Photos

API: 017-06629

Operator: **WILLIFORD ENERGY COMPANY**

Inspection Date: 5/30/2024

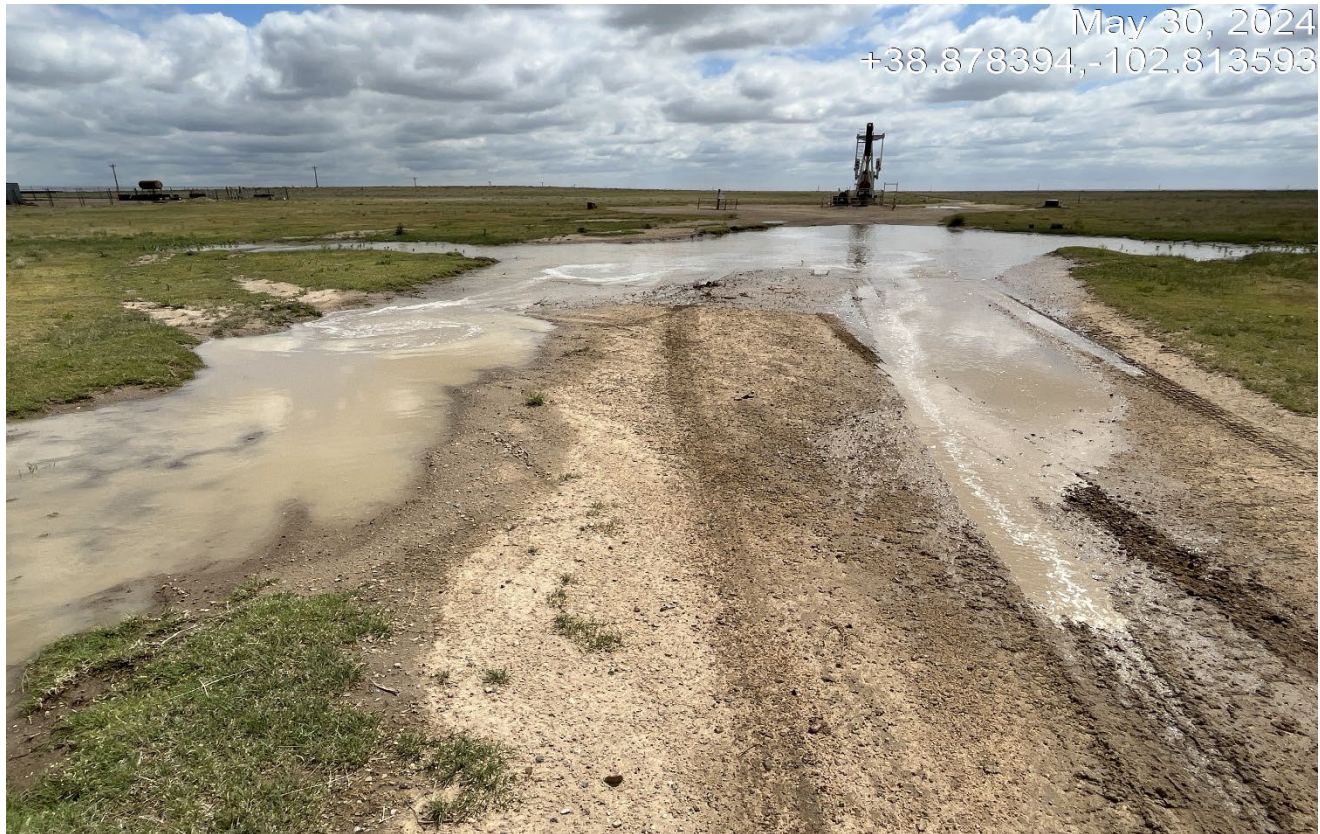
Photo 1. Facing east along the access road. Vehicles are causing unnecessary disturbance driving outside of the access road due to stormwater pooling on the road. The access road must be maintained and shall not drive outside of the access road boundary.

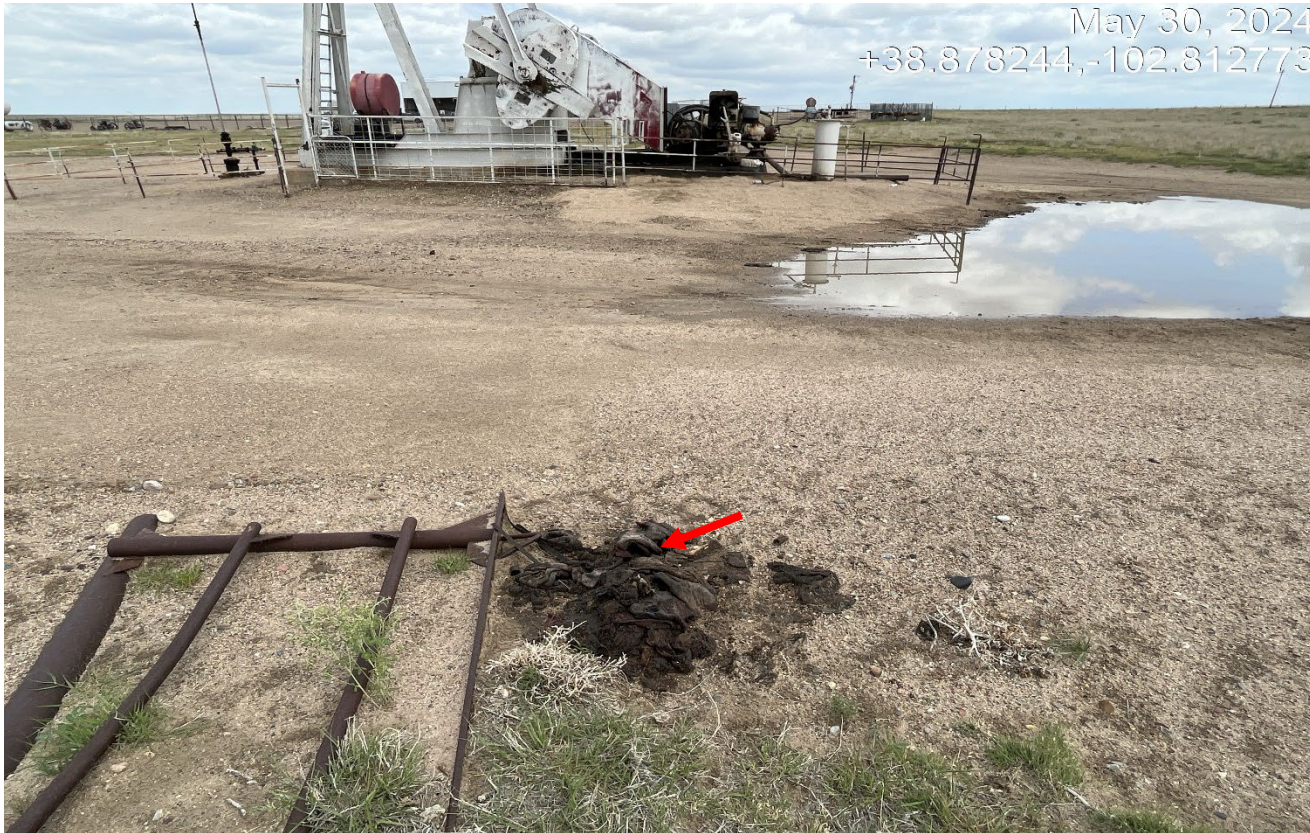
Photo 3. There is a pile of oily rags at the south side of the location. This must be removed and properly disposed.

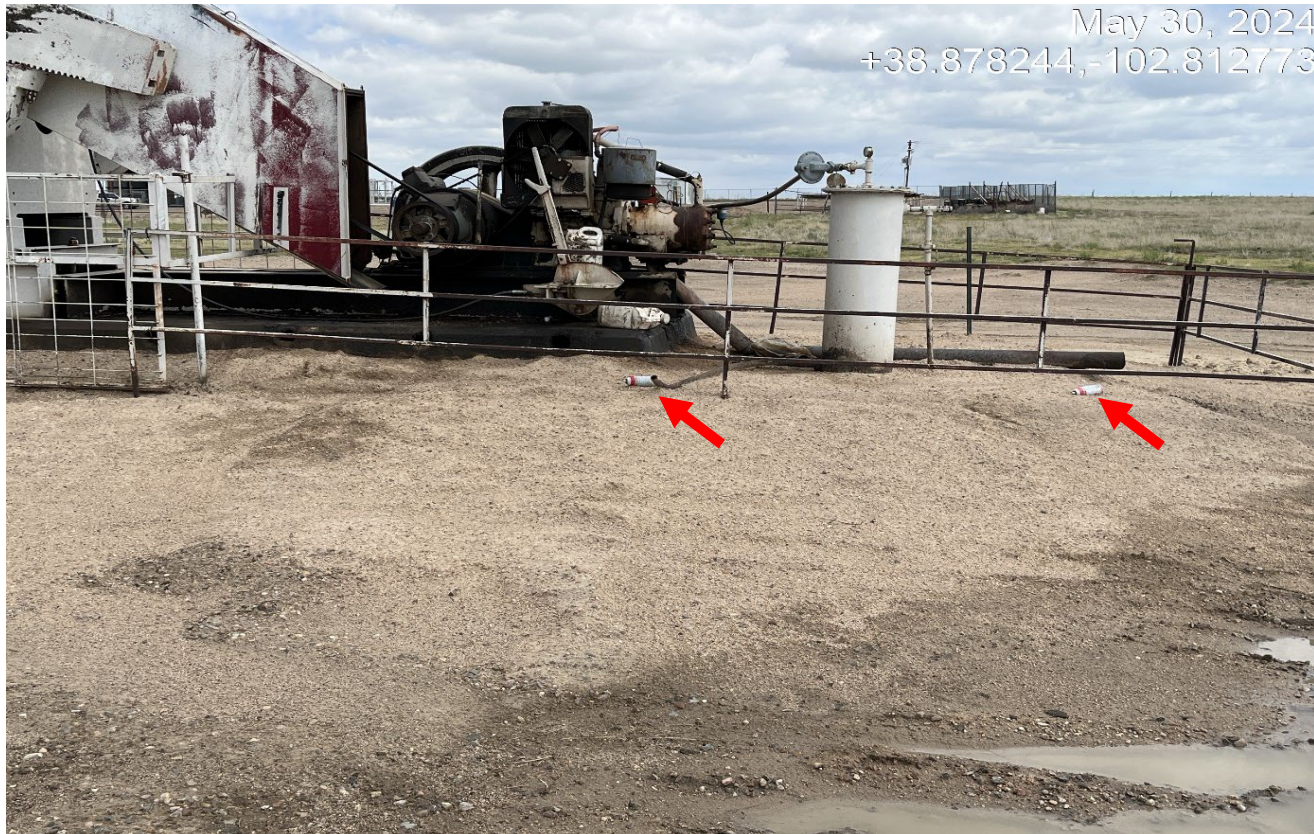
Photo 4. Facing toward the pumpjack engine. There was new sand spread around the pumpjack base. There are two cans of starting fluid that need to be removed.

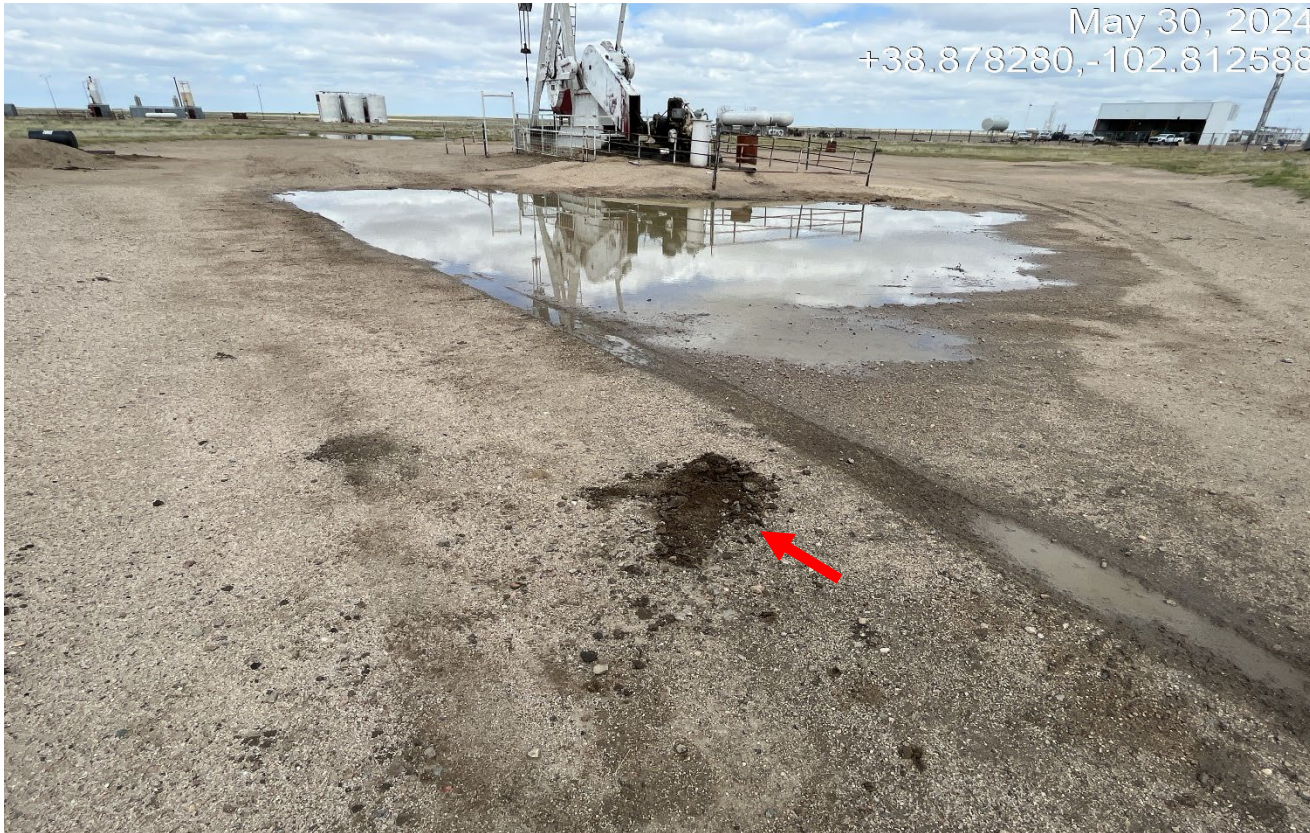
Photo 5. Facing northwest toward the wellsite. The red arrow points to oily soil spilled in this area.

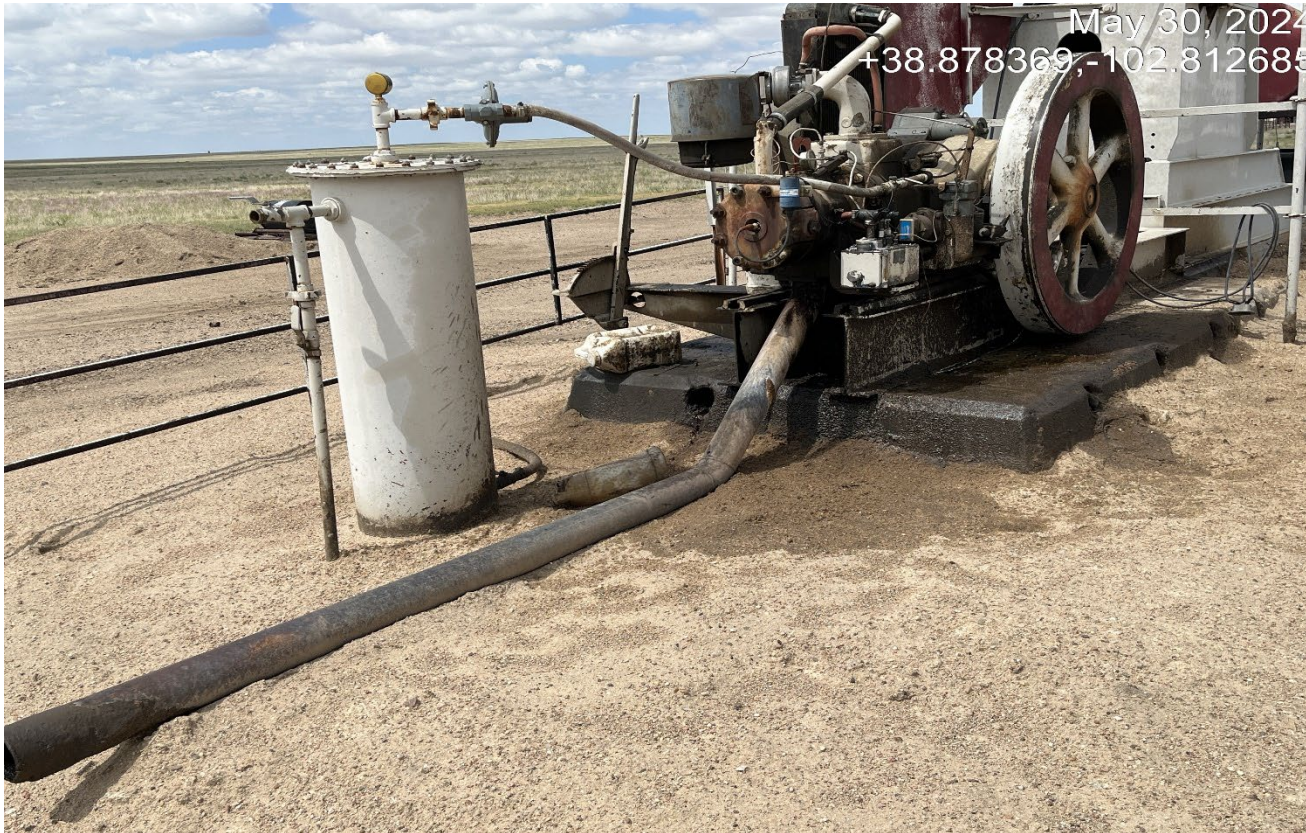
Photo 6. The pumpjack engine is still leaking oil.

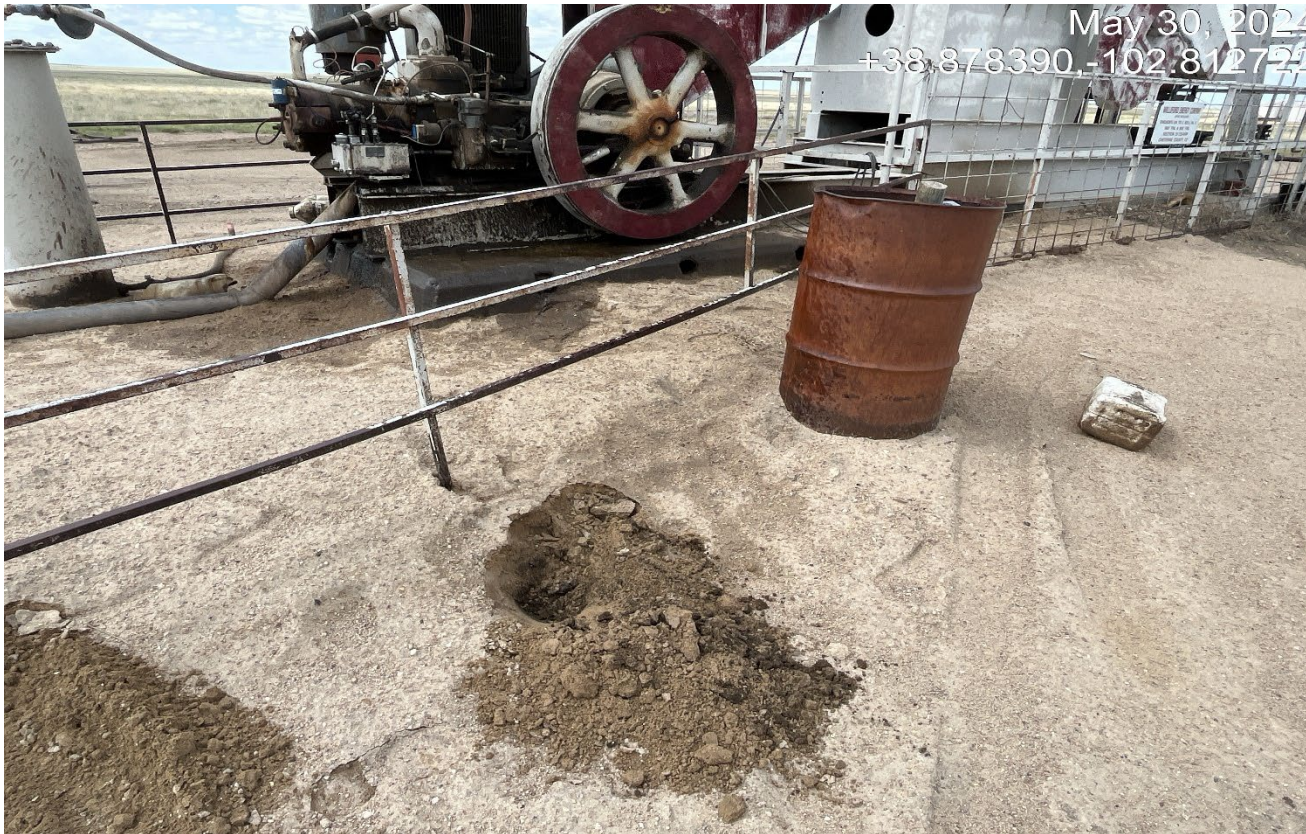
Photo 7. It appears there was sand spread on top of the spill which was not cleaned up per the rules.

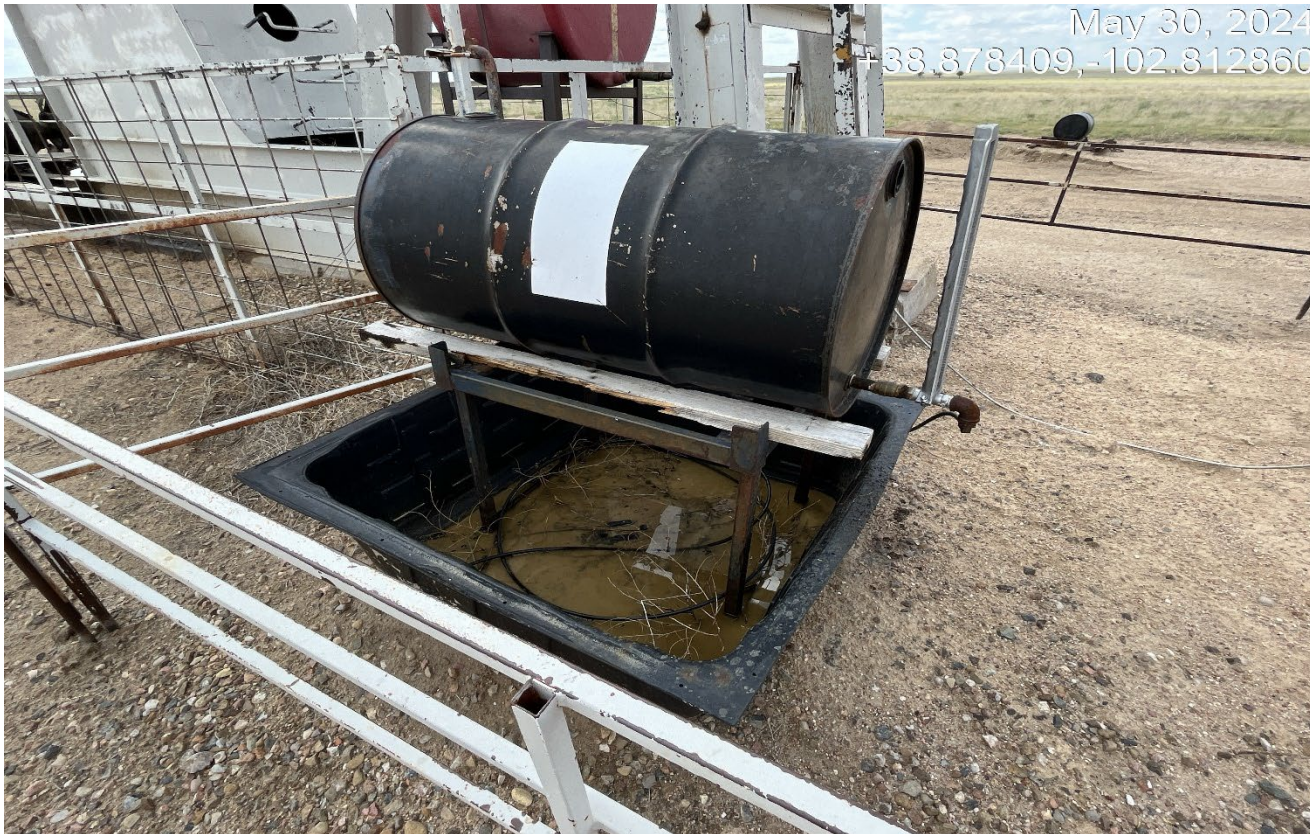
Photo 9. There is oily fluid in the secondary containment and no wildlife protection/netting is installed. The labeling on the barrel is faded and needs to be updated.
