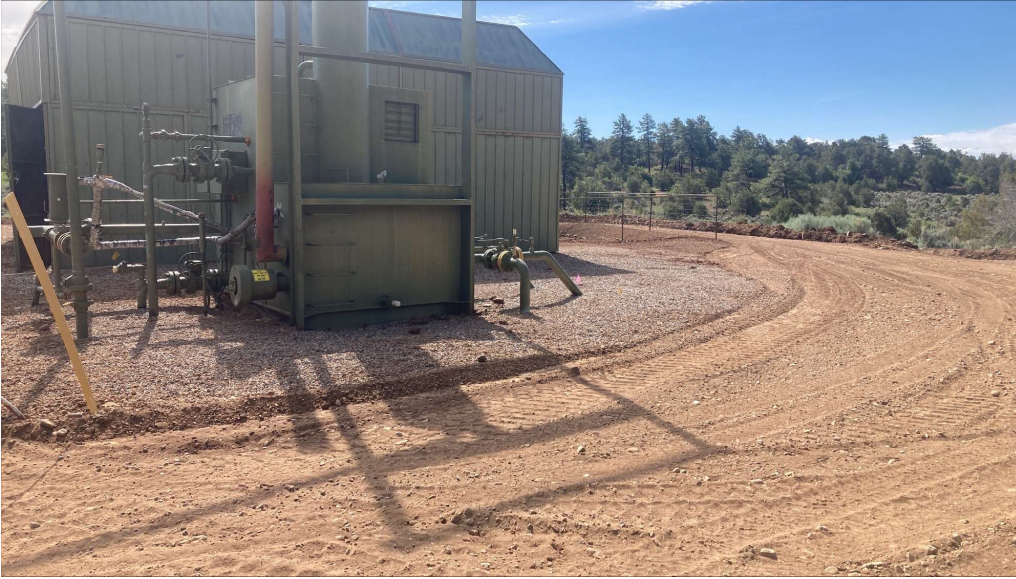
**Comment:** Unused oil and gas piping equipment observed on location.  
**Piping has been removed from location.**

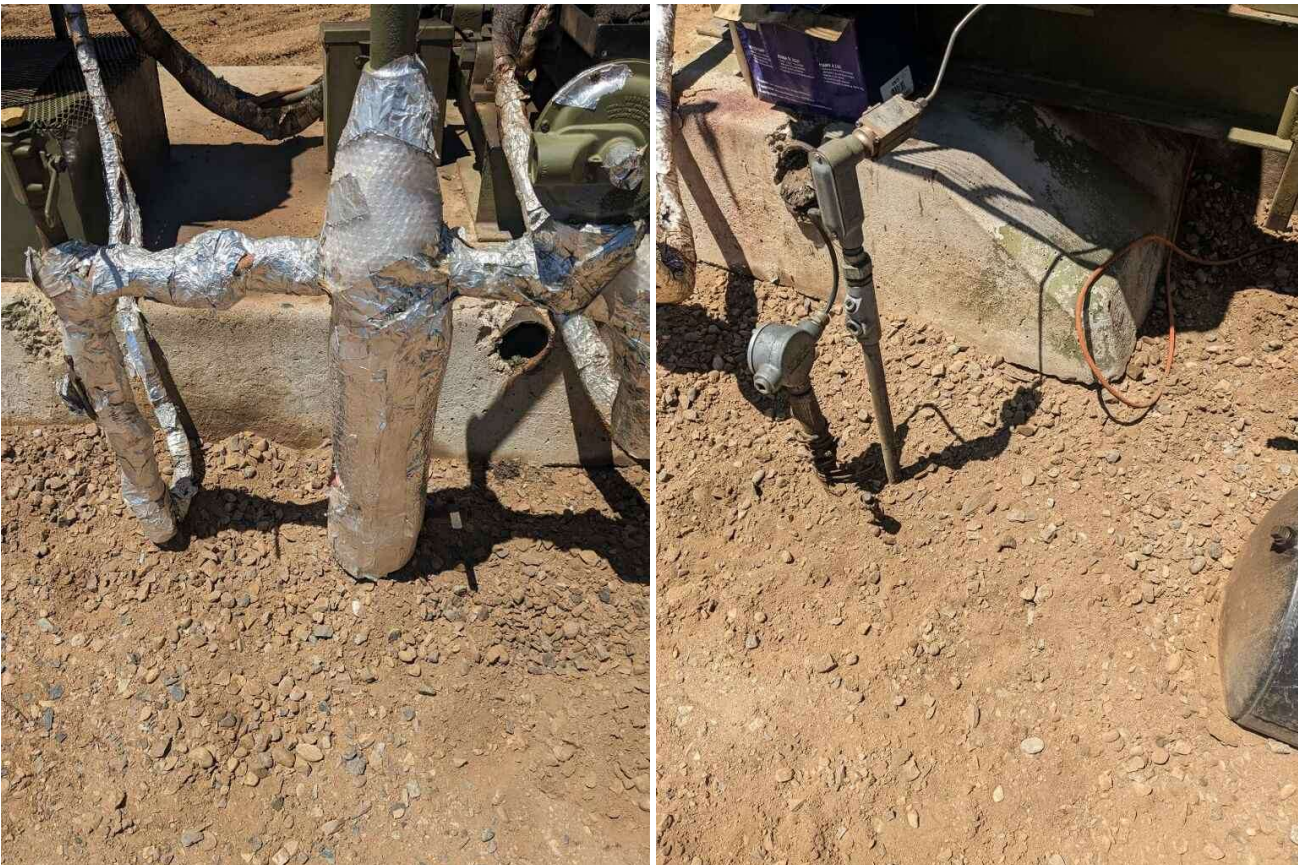
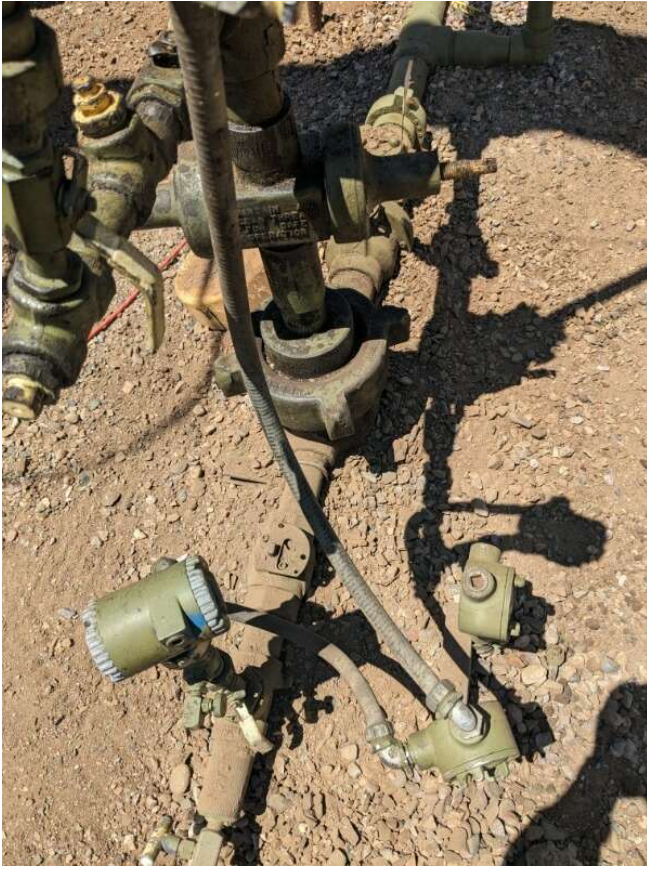
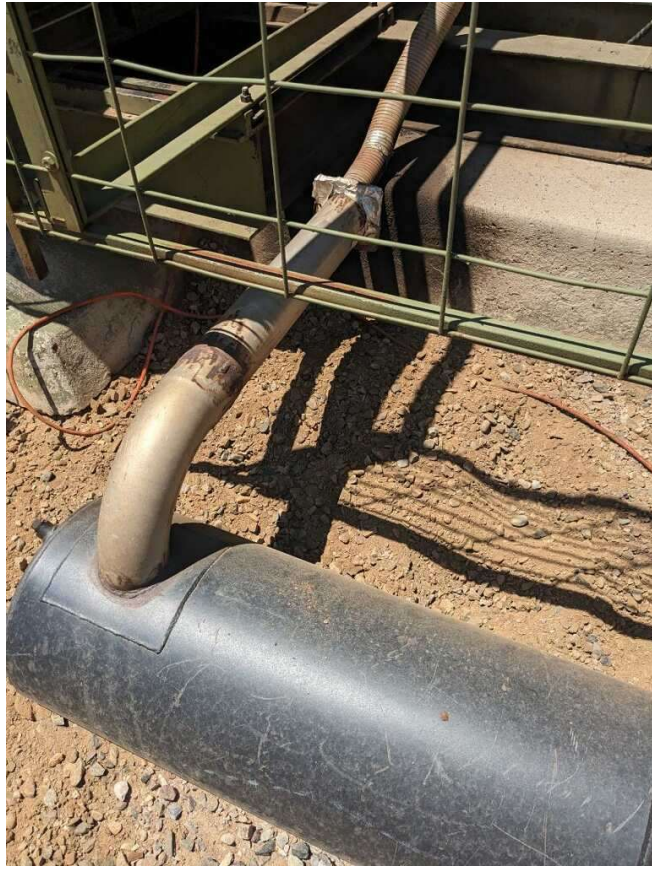
**Comment:** Impacted surface material observed at the pump jack muffler and well head.  
**Maintenance has been completed and impacted soil has been removed and disposed of.**

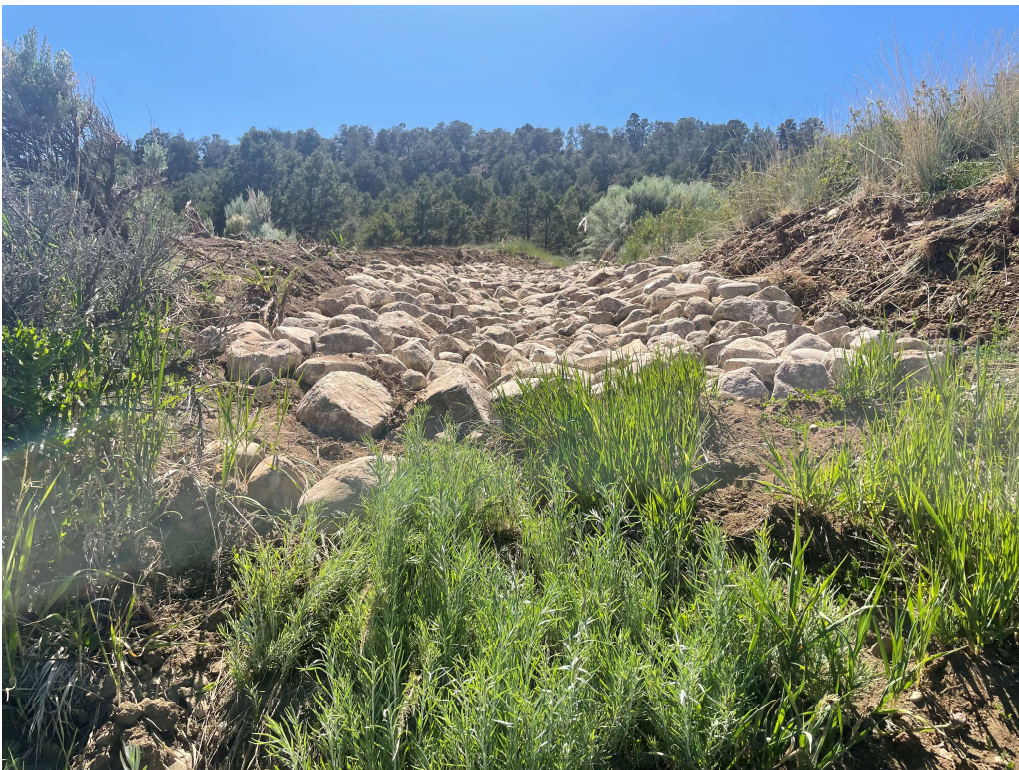
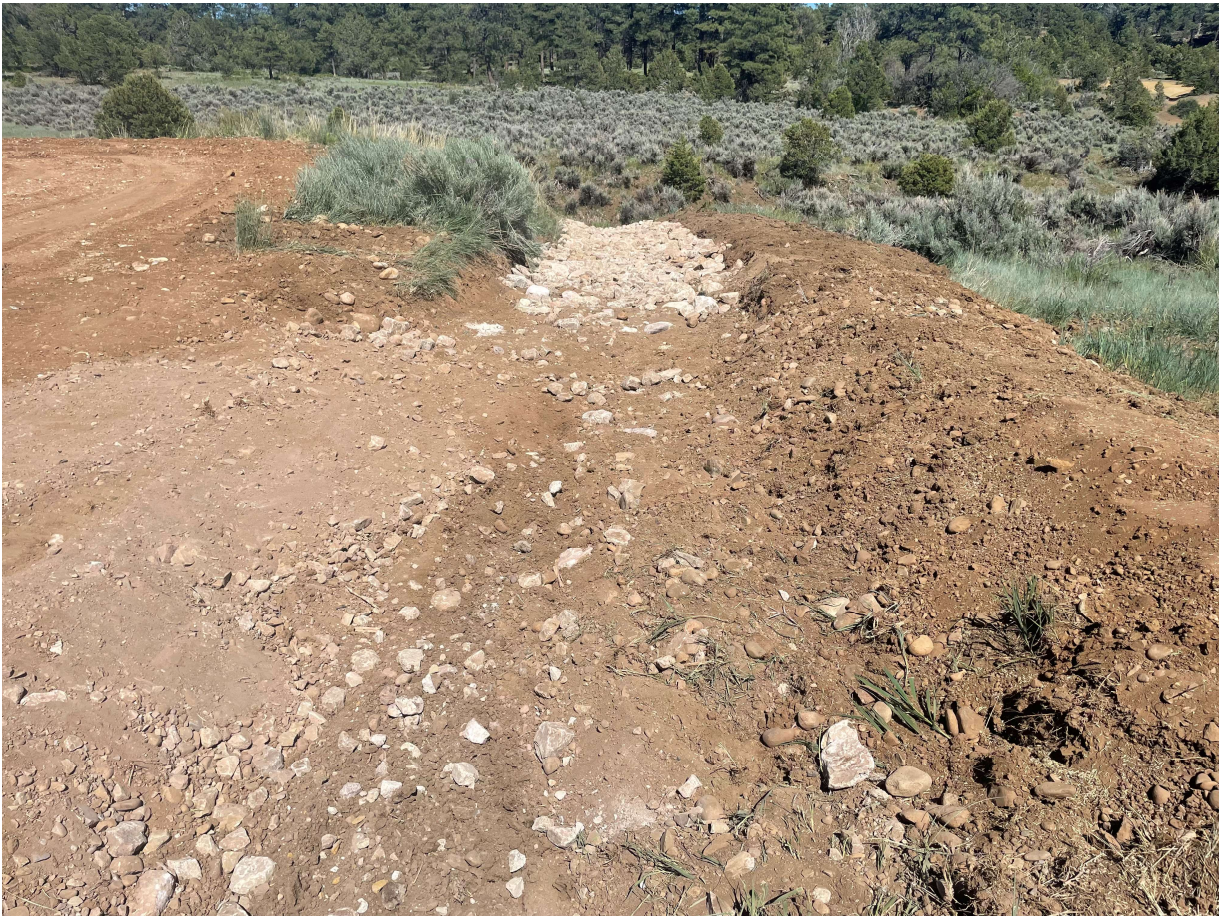
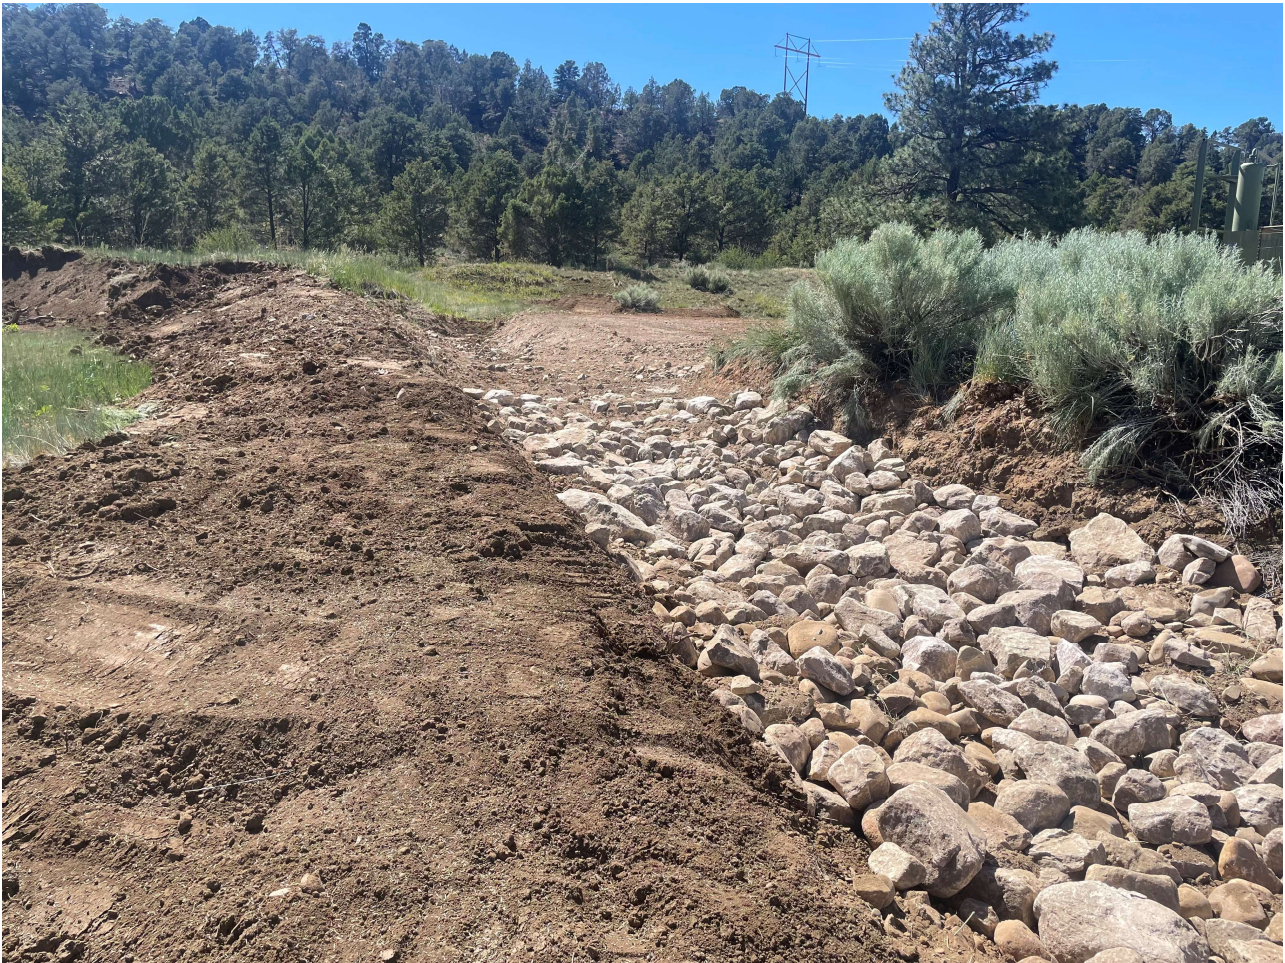
**Comment:** Storm water corrective action identified in the previous inspection doc #714000032 has only been partially addressed. New storm water divergent channel has not been installed per good engineering practices, erosion is occurring through the new channel and additional stabilization is needed.

**Storm water diversion has been stabilized with aggregate to minimize erosion in channel.**
