Inspection Photos

Location Name: TEP ROCKY MOUNTAIN LLC FOSSIL CREEK RWF 33-6 Pad

Location ID: 334999

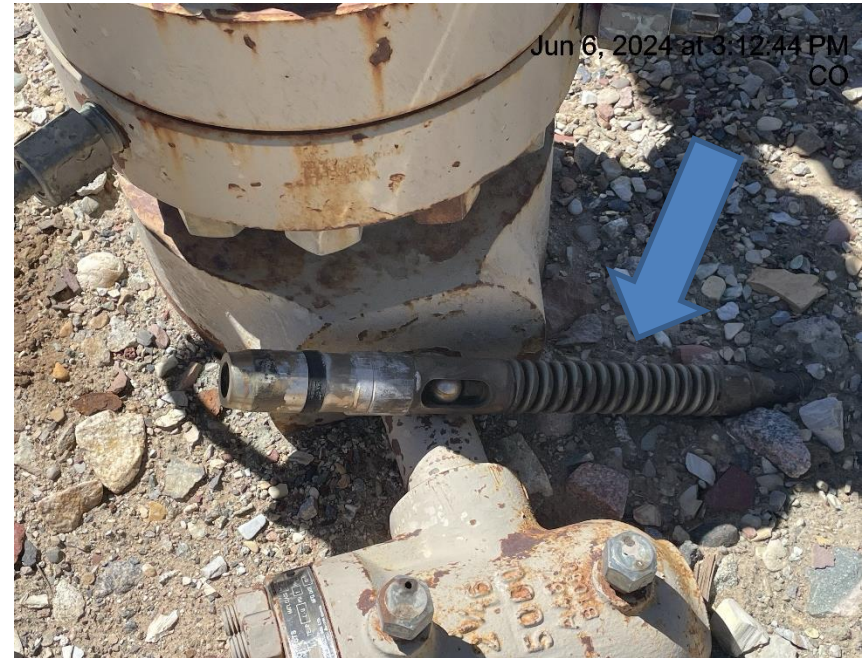
Photo # 102 Debris

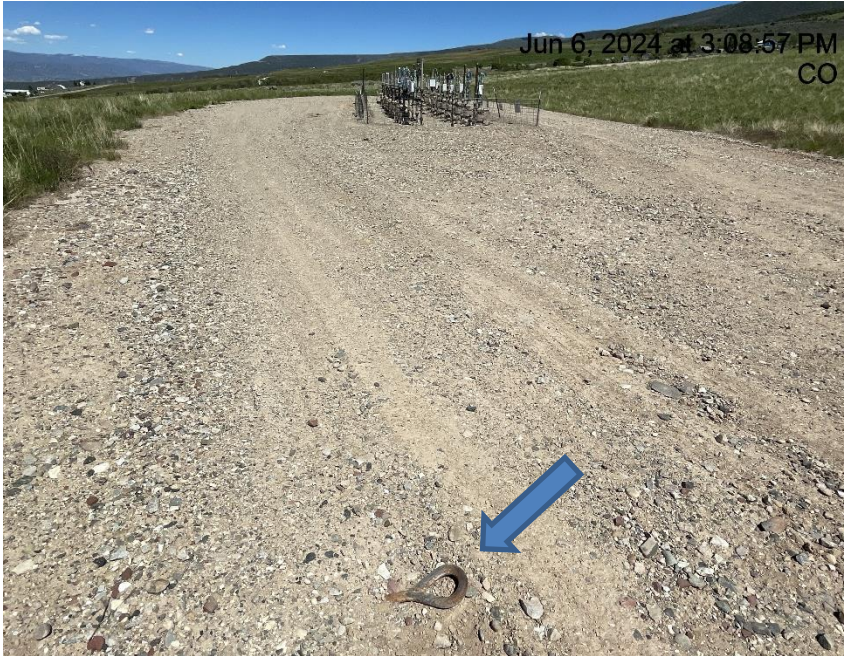
Photo # 103 Unmarked deadman

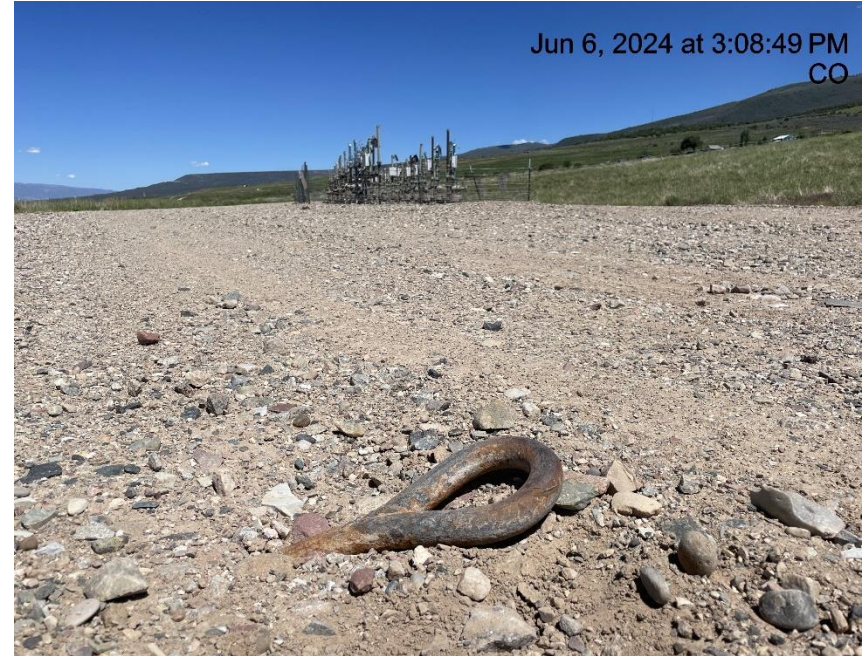
Photo # 104 Same unmarked deadman

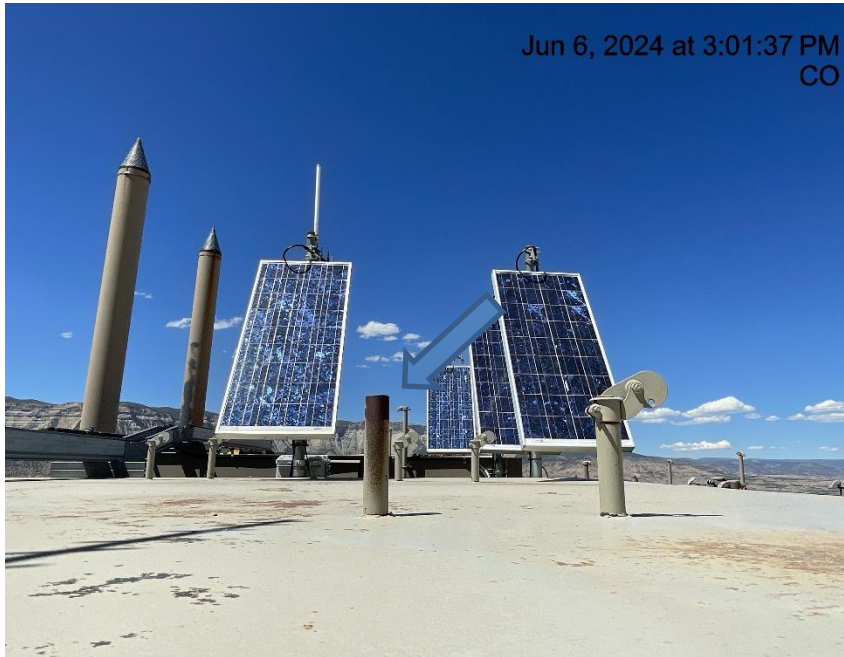
Photo # 105 PRV vent line does not comply with CECMC pressure safety device rules

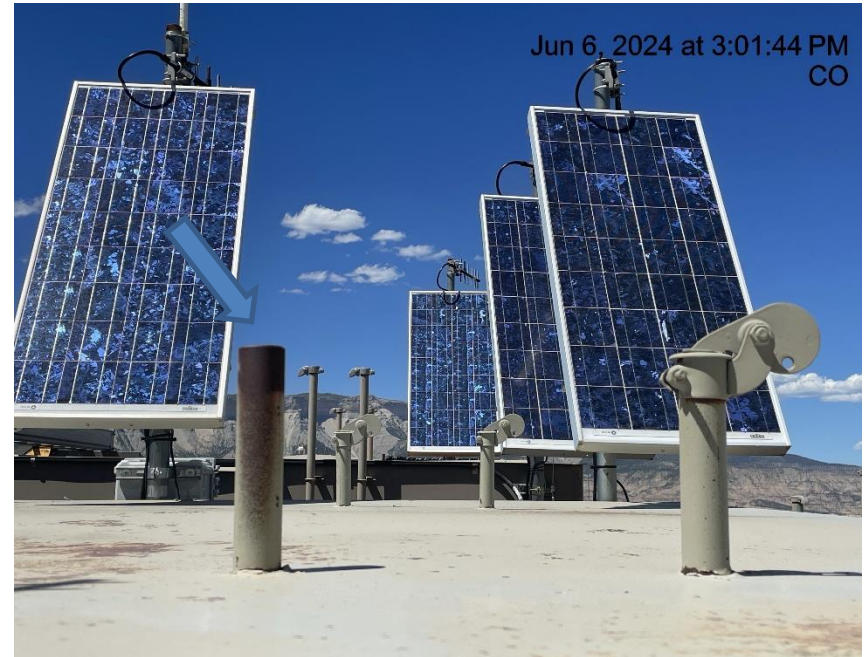
Photo # 106 PRV vent line does not comply with CECMC pressure safety device rules

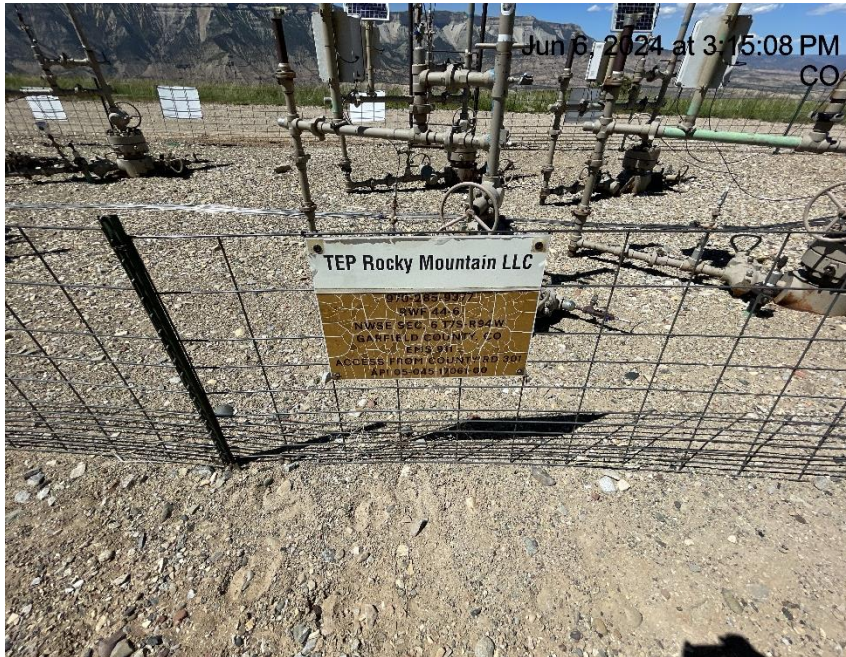
Photo # 107 Wellhead sign weathered & cracking/starting to become illegible

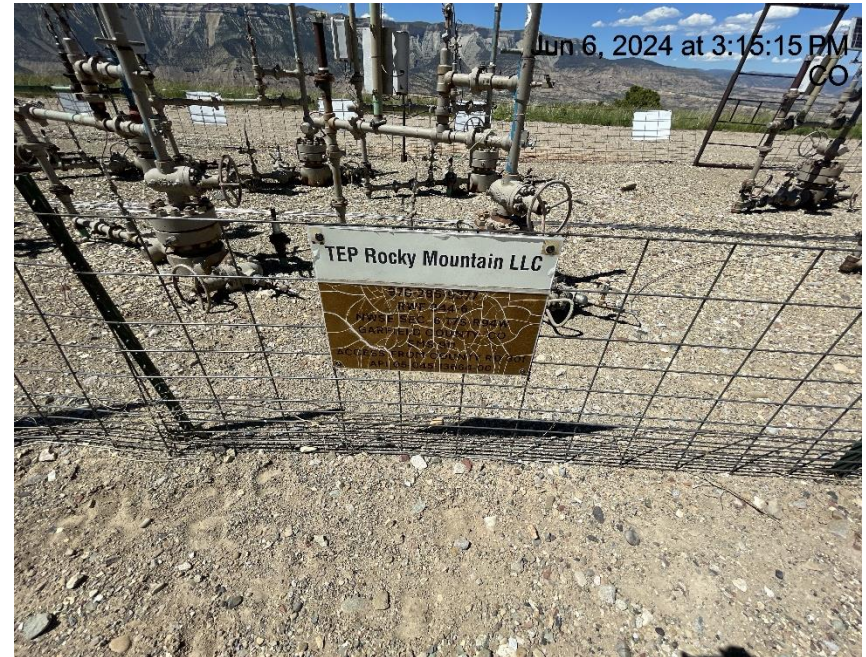
Photo # 108 Wellhead sign weathered & cracking/starting to become illegible

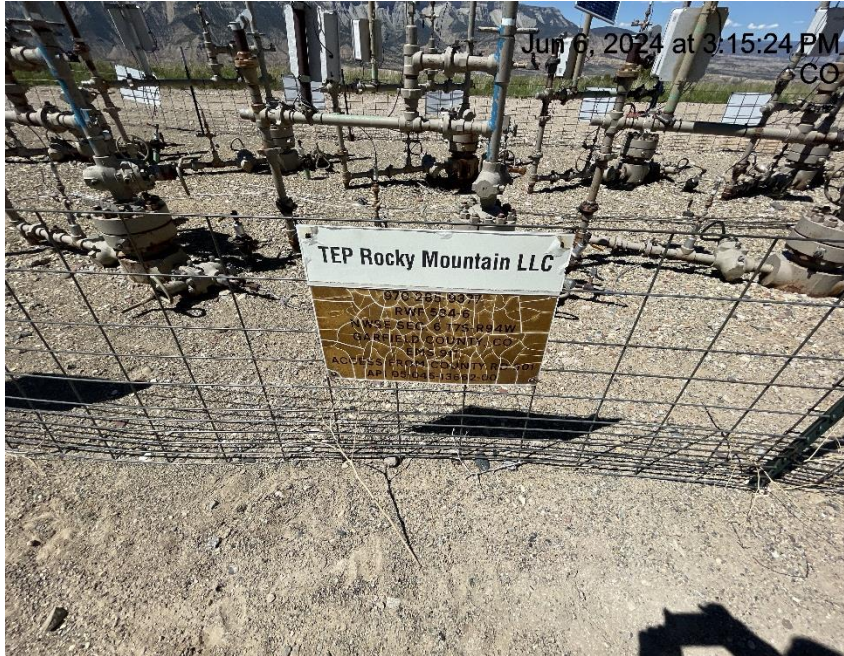
Photo # 109 Wellhead sign weathered & cracking/starting to become illegible
