Inspection Photos

Operator: TEP ROCKY MOUNTAIN LLC #96850

Location ID: 315513

Inspection Doc: 696205869

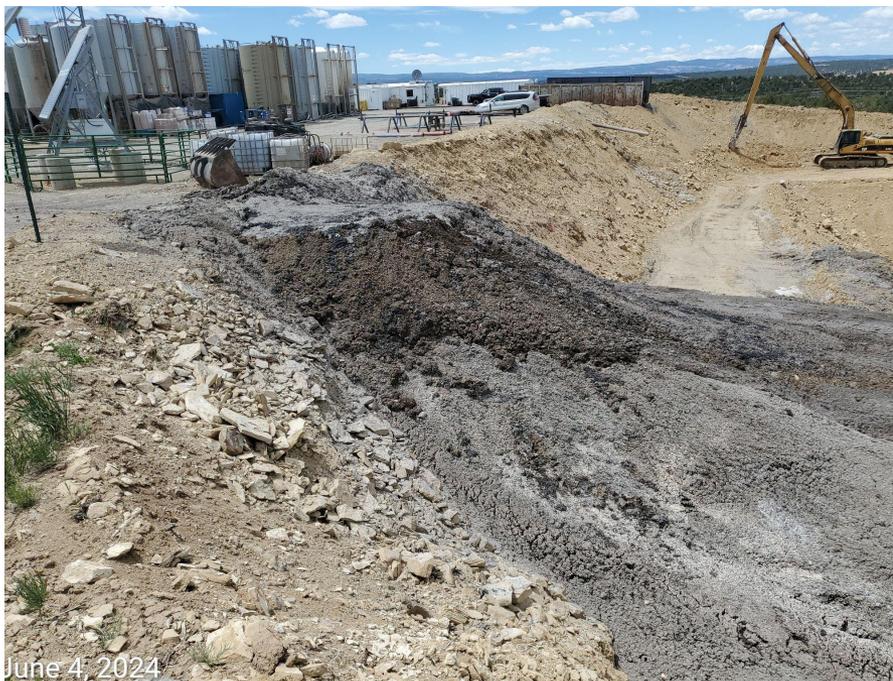
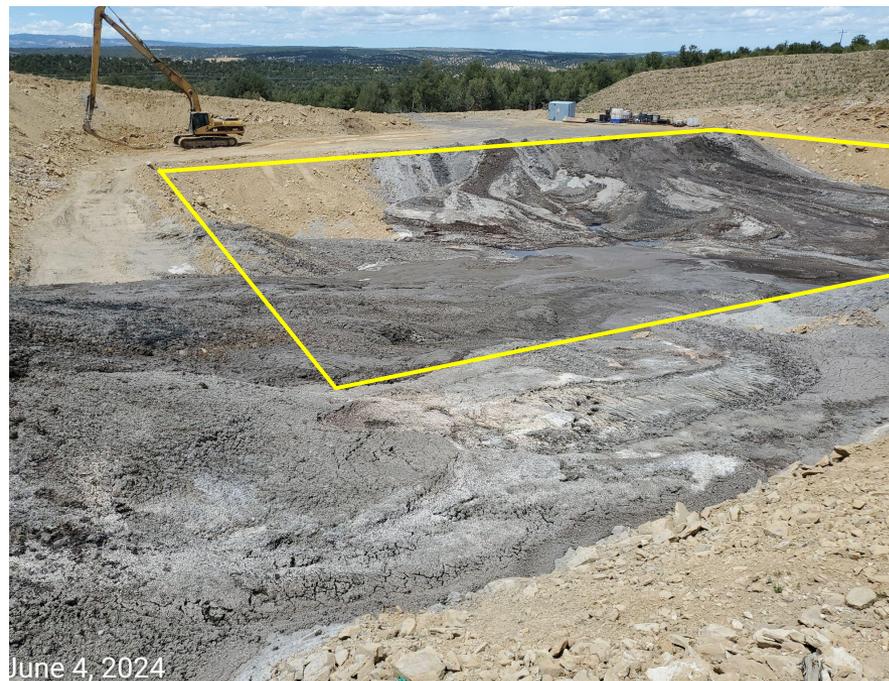
Photo 1: Photo taken from the top of the cut slope above the cuttings trench, on the south end of the Location. Cuttings are not being placed directly into the cuttings trench. Rather, cuttings are being dumped over the cutslope near the Location entrance. Yellow line polygon represents actual cuttings trench Location.

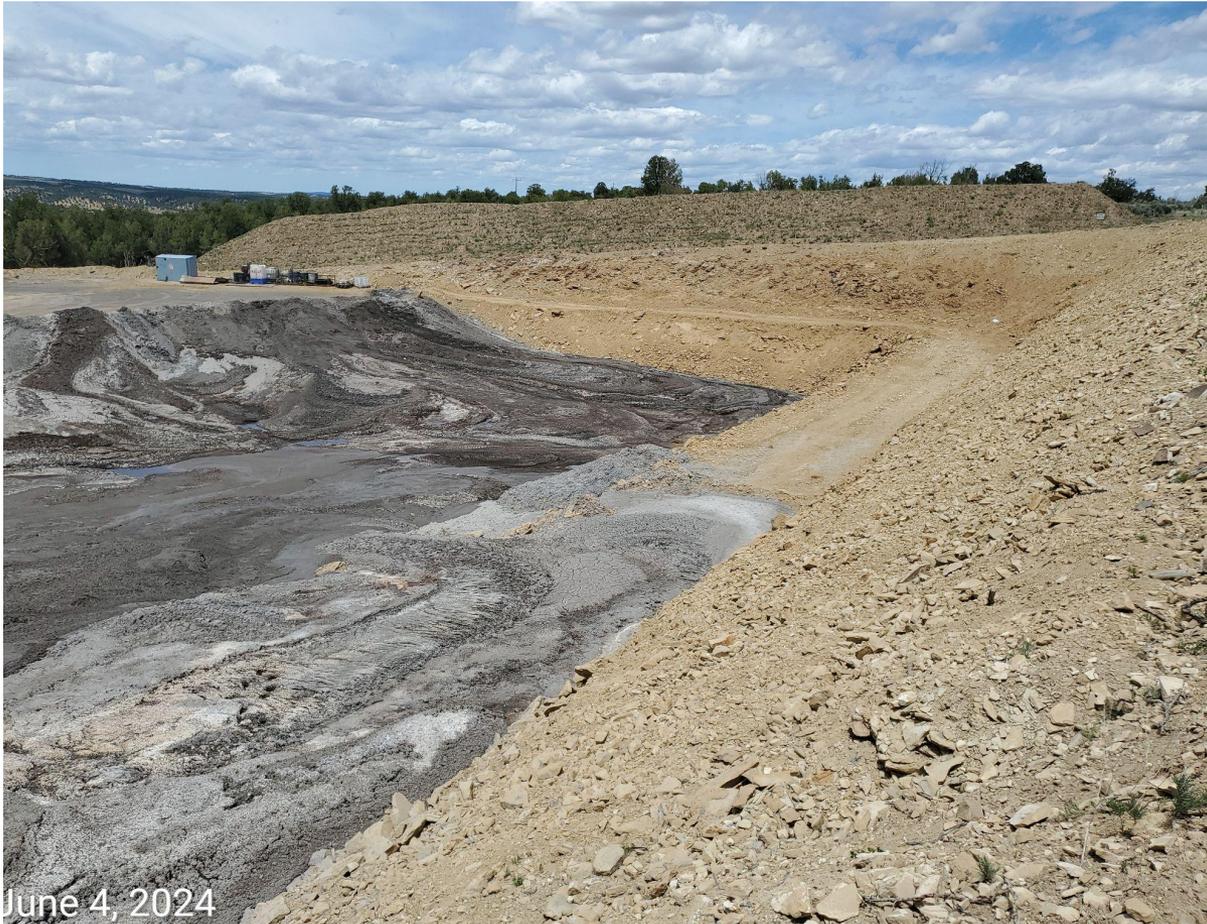
Photo 2: See comments under photo 1.

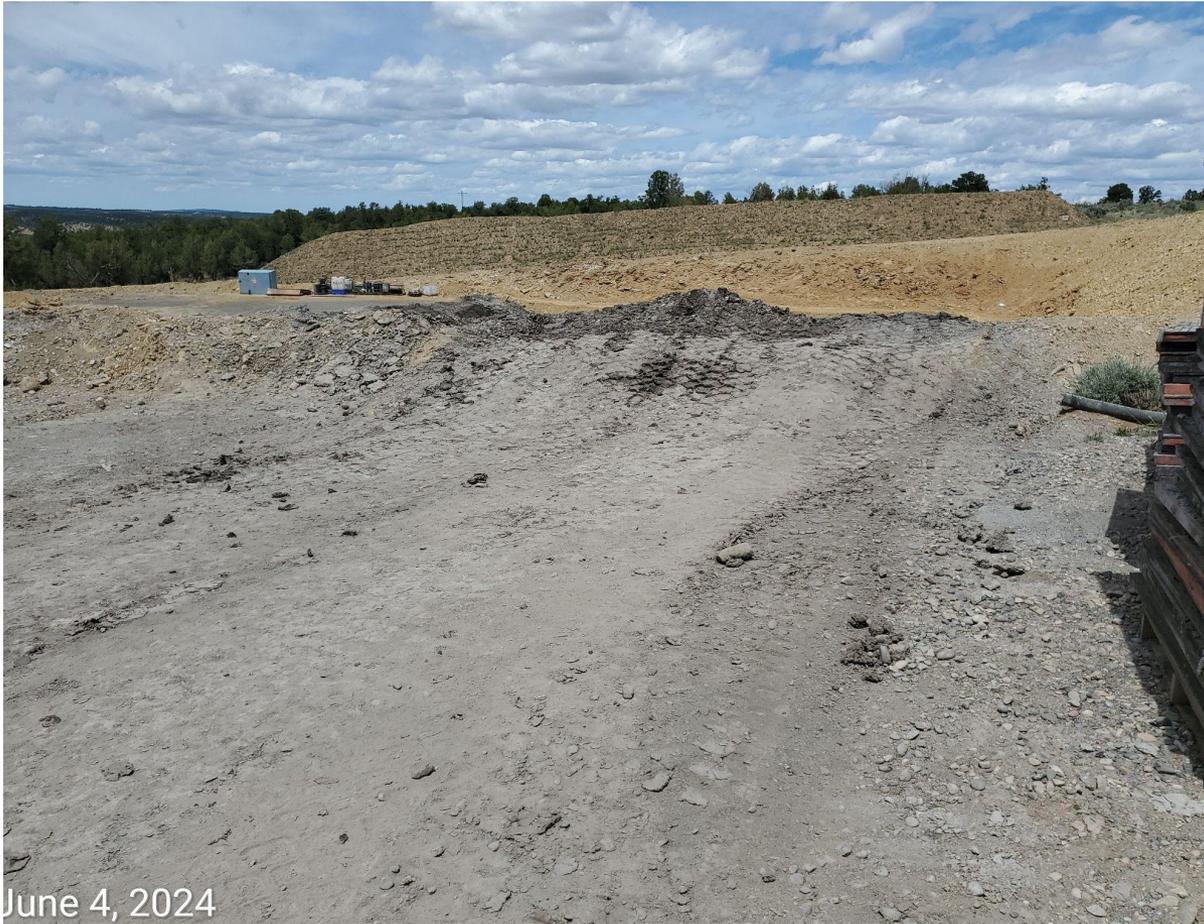
Photo 3: Continued from photo 1. Photo shows areas where drill cuttings are being dumped over the cut slope above the cuttings trench. Drill cutting material is also being spread over the WPS of the Location and tracked off-site.

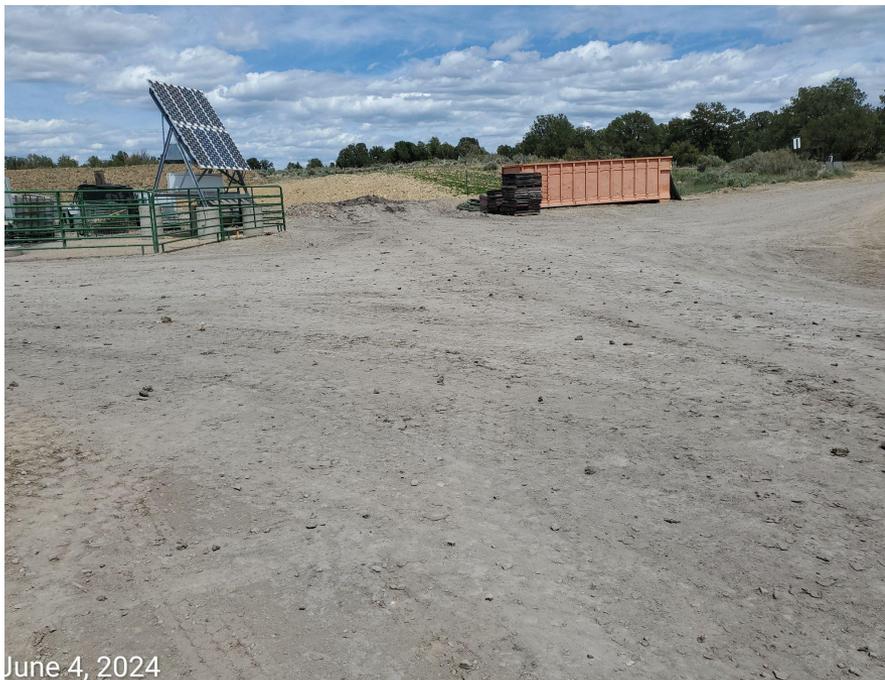
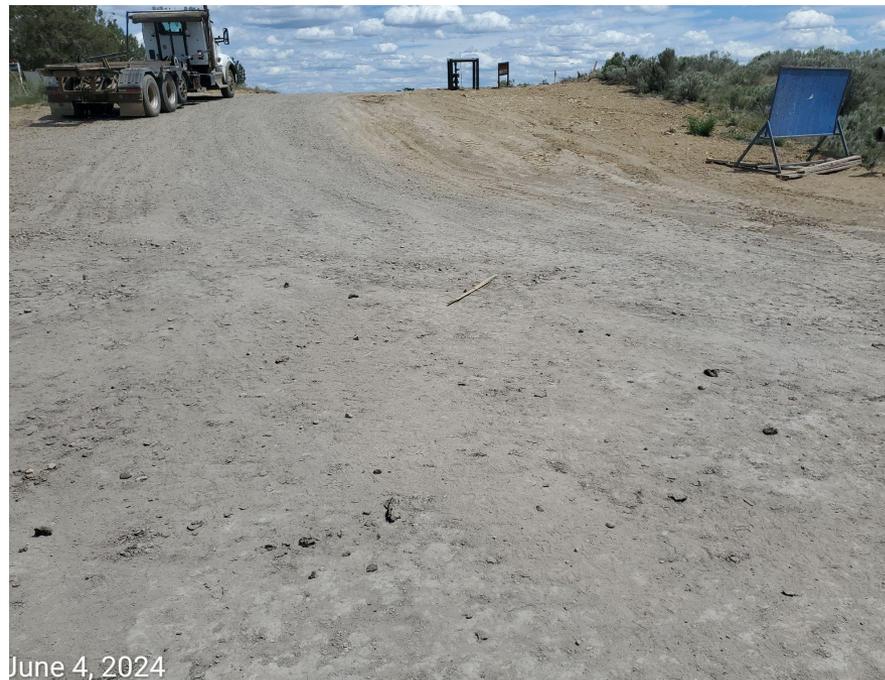
Photo 4: Photos taken from the south end of the Location. Photo left shows the dump area identified in Photo 3. Photo right shows Location entrance- cuttings material is currently being spilled throughout the Location that receives frequent vehicle traffic, resulting in vehicle tracking and off-site transport of E&P waste. Additional tracking controls required to prevent off-site transport of E&P Waste. Spills require cleanup.

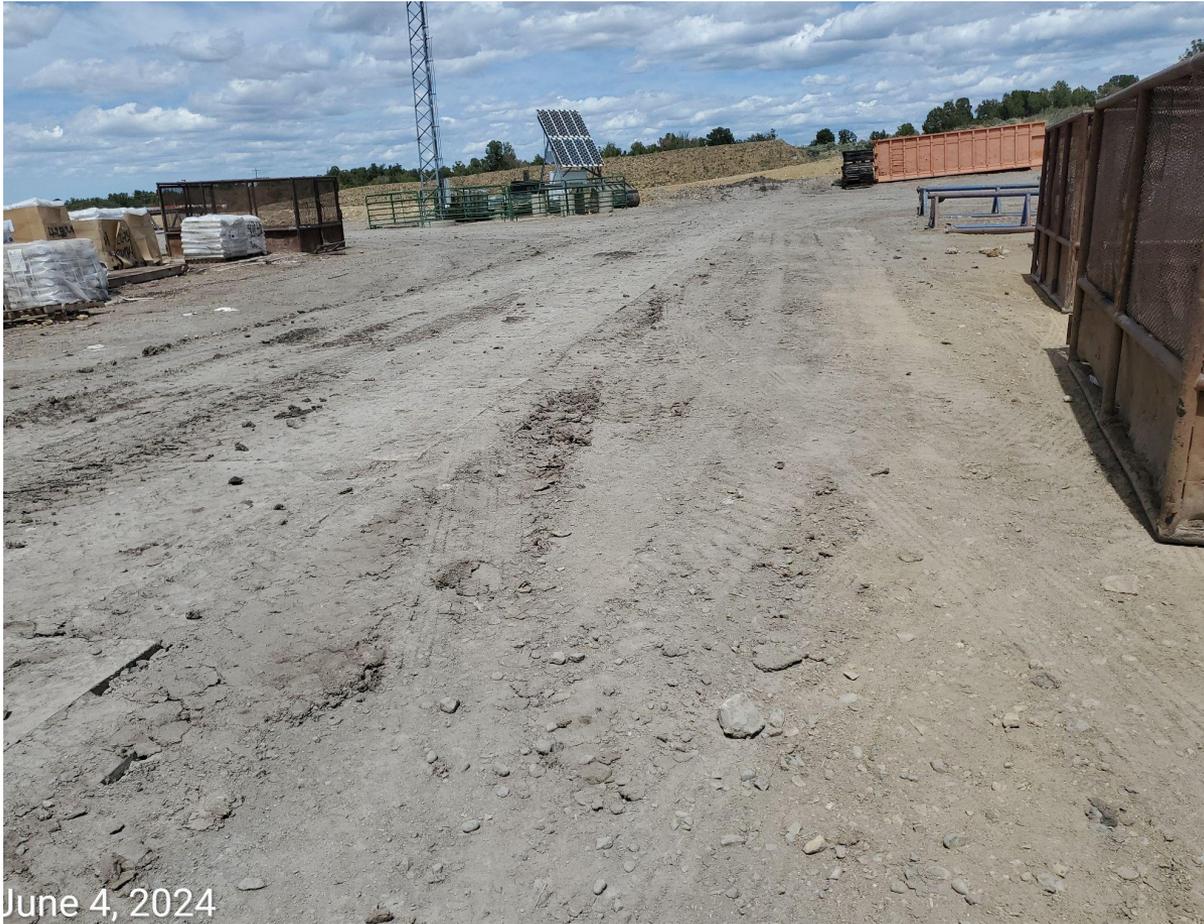
Photo 5: See comments under photo 4.

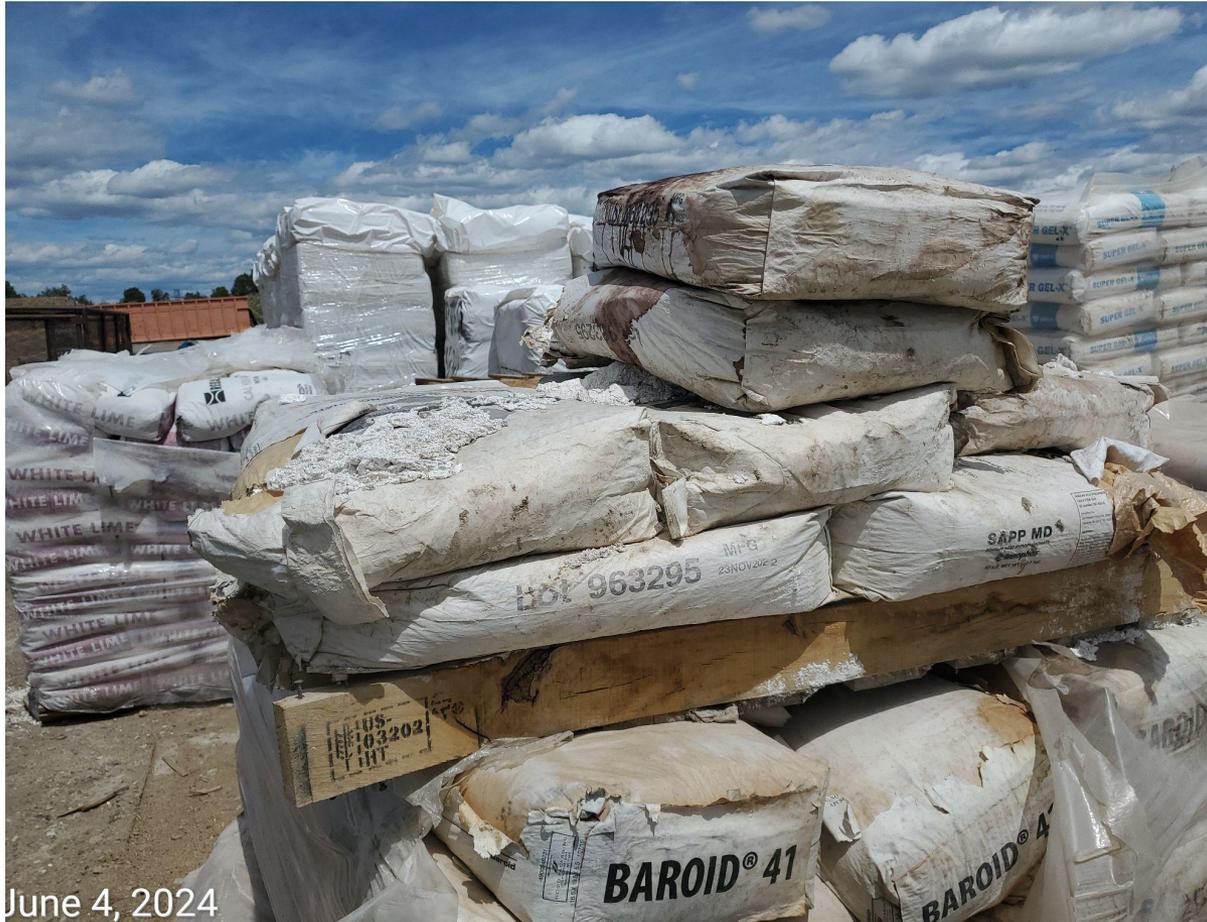
Photo 6: Photo example of pallets of materials stored on the south end of the Location missing proper material covering.

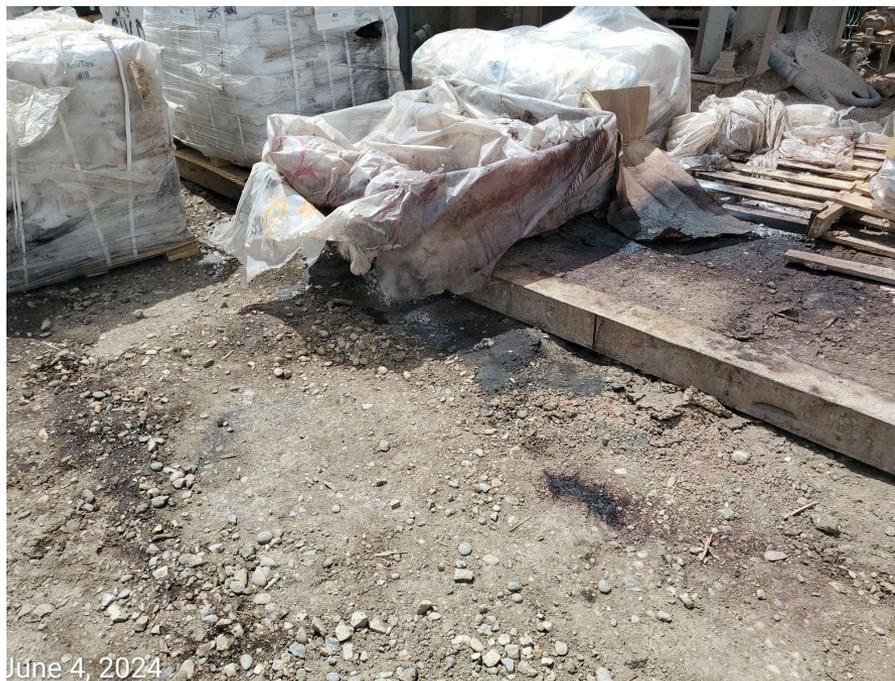
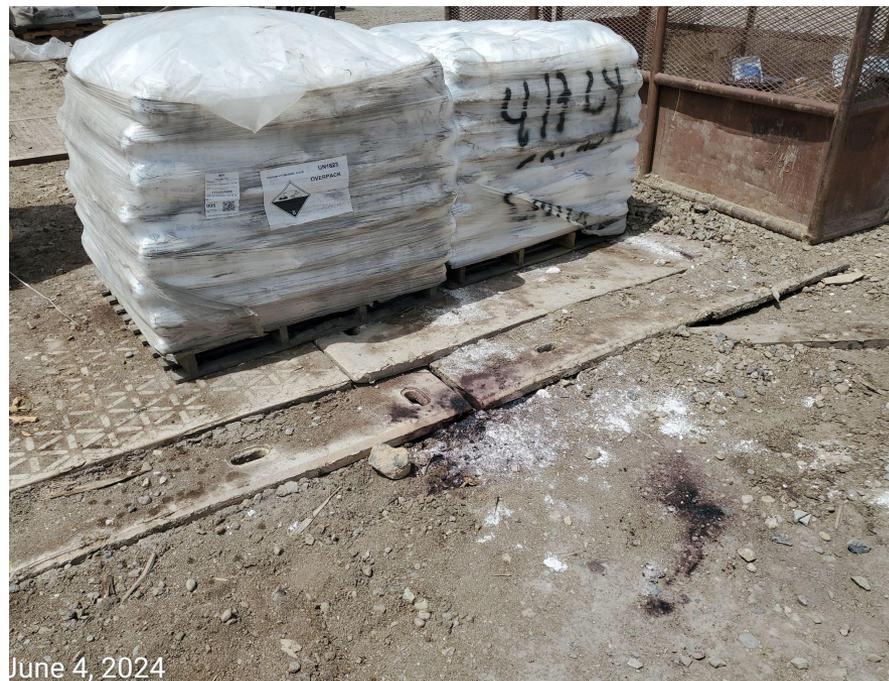
Photo 7: Photos 7-8 examples showing material spills. Spills requiring cleaning.

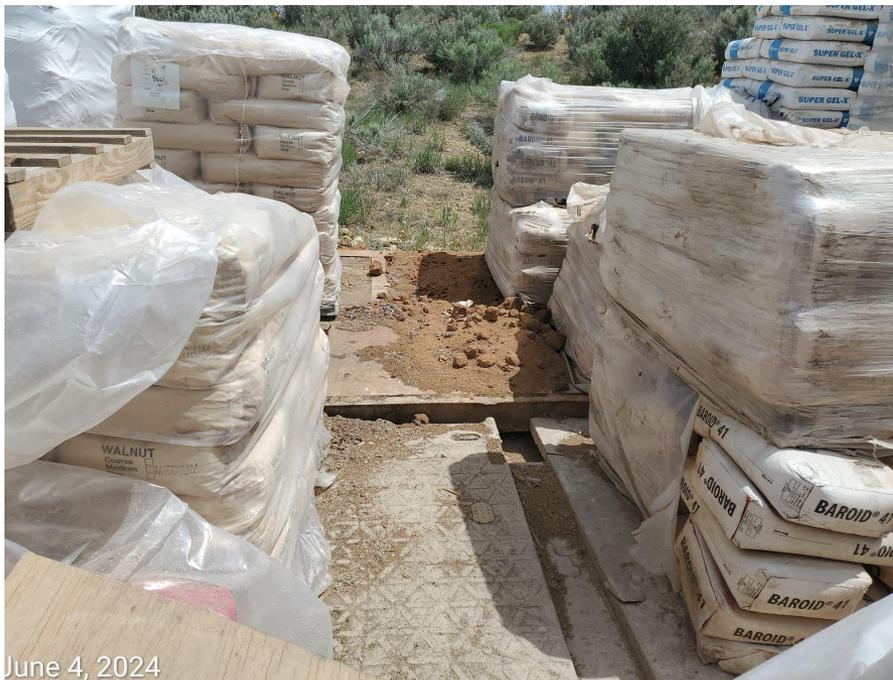
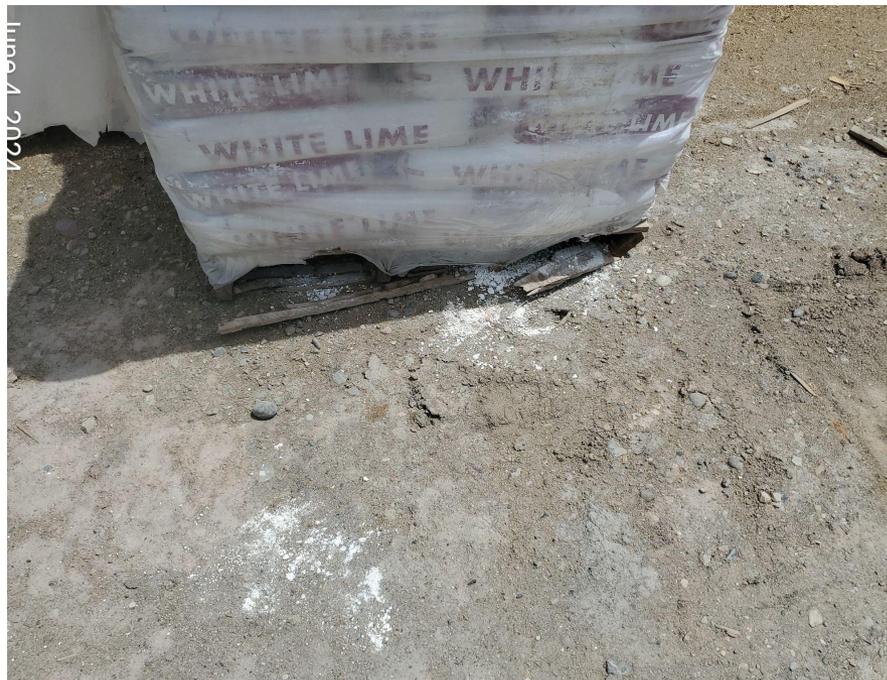
Photo 8: See comments under photo 7.

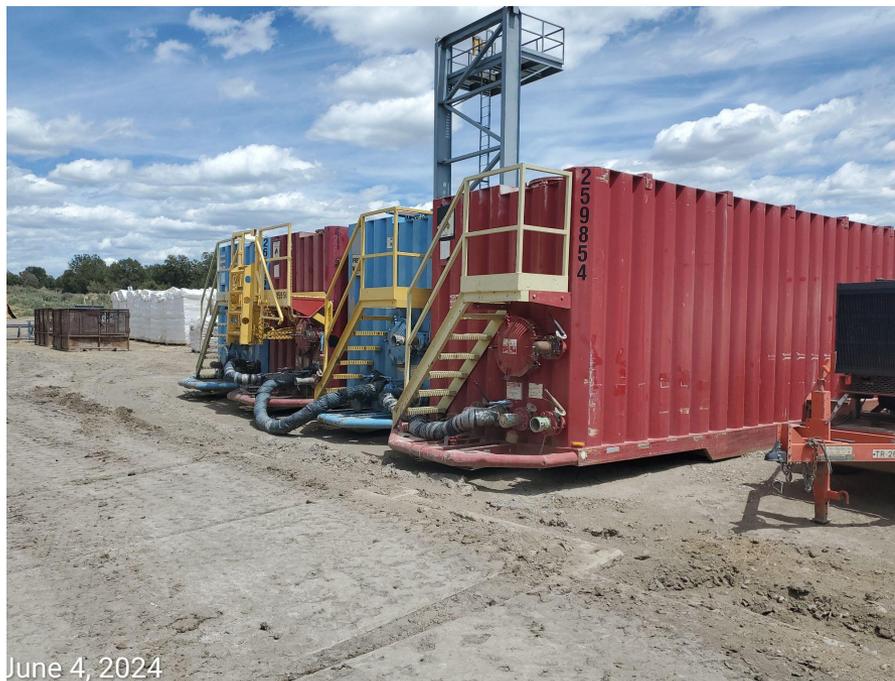
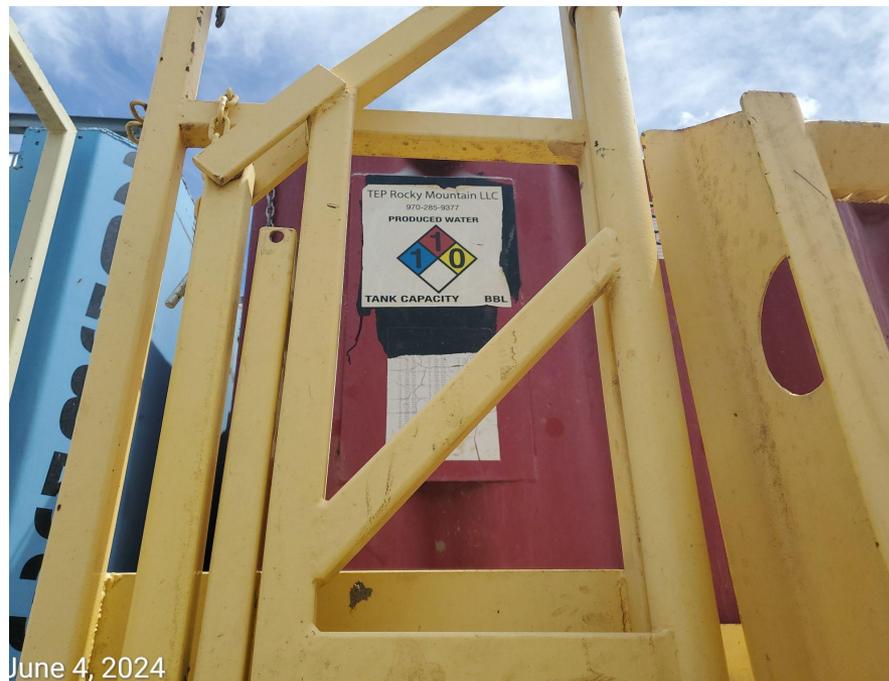
Photo 9: Tanks on the south end of the Location (including two produced water tanks). Secondary containment missing or insufficient at tanks.

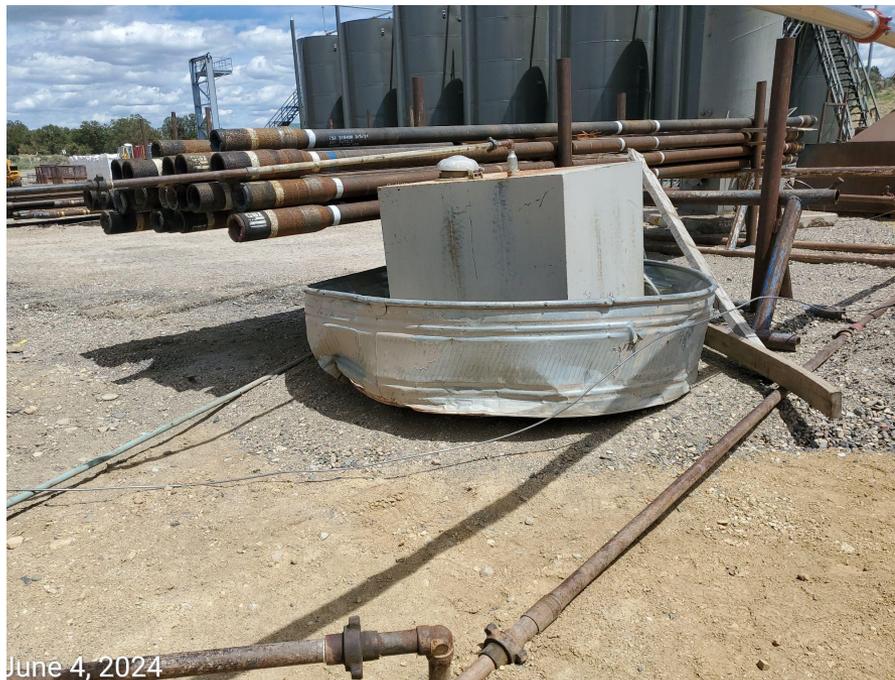
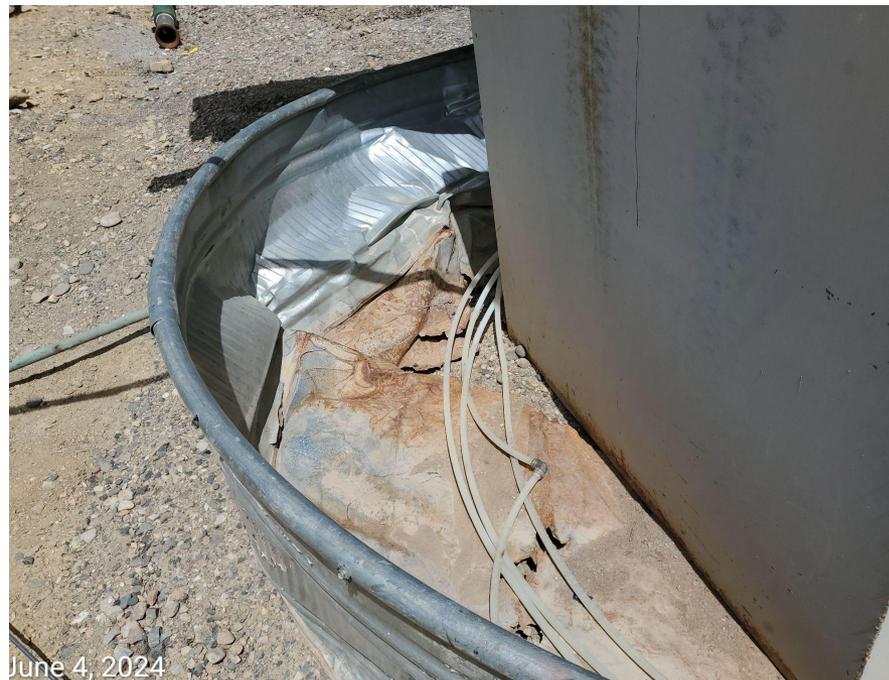
Photo 10: Secondary containment at equipment no longer in proper functioning condition to contain a spill or release.

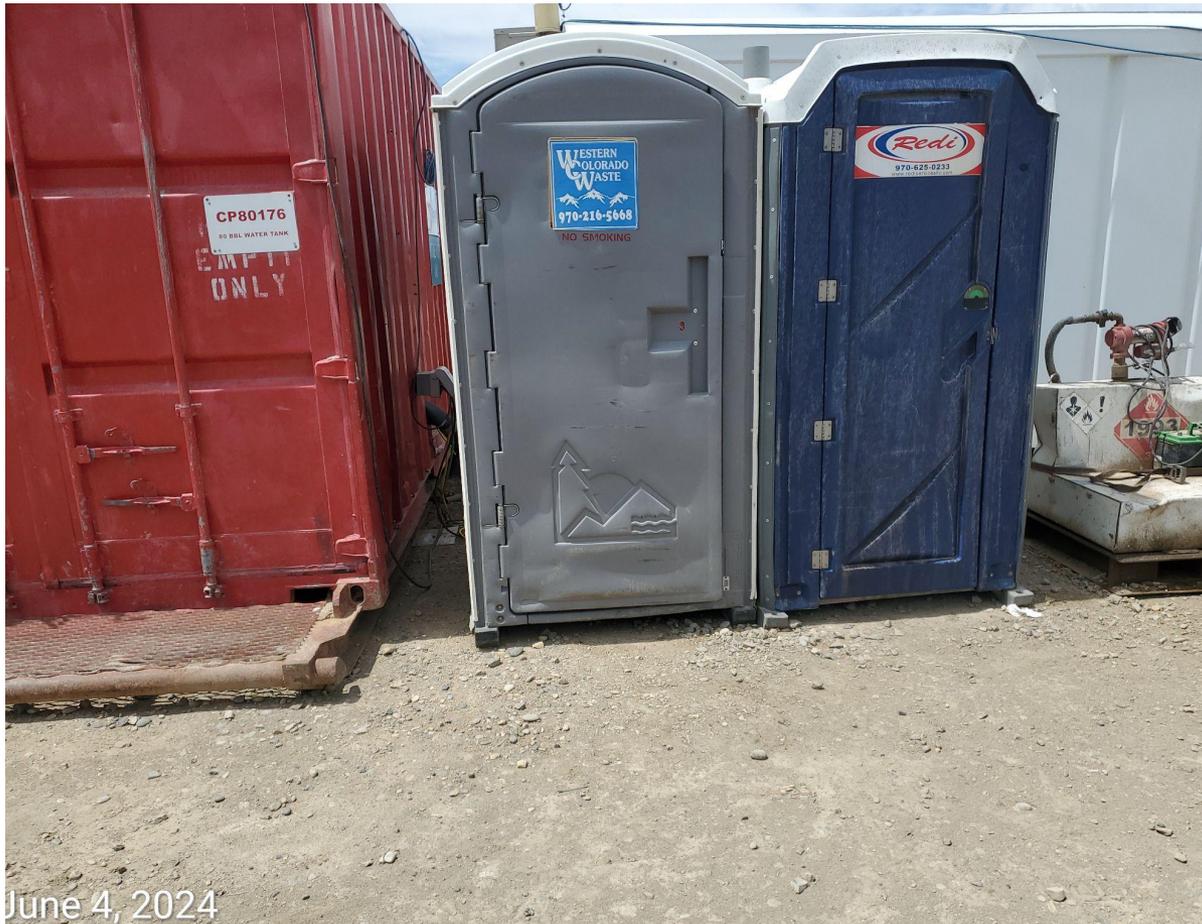
Photo 11: Example of Porta-johns on location. Facilities have not been physically secured.
