Photographic Log - 5/1/2024
Raindance FD Off-Site #20-202HNX

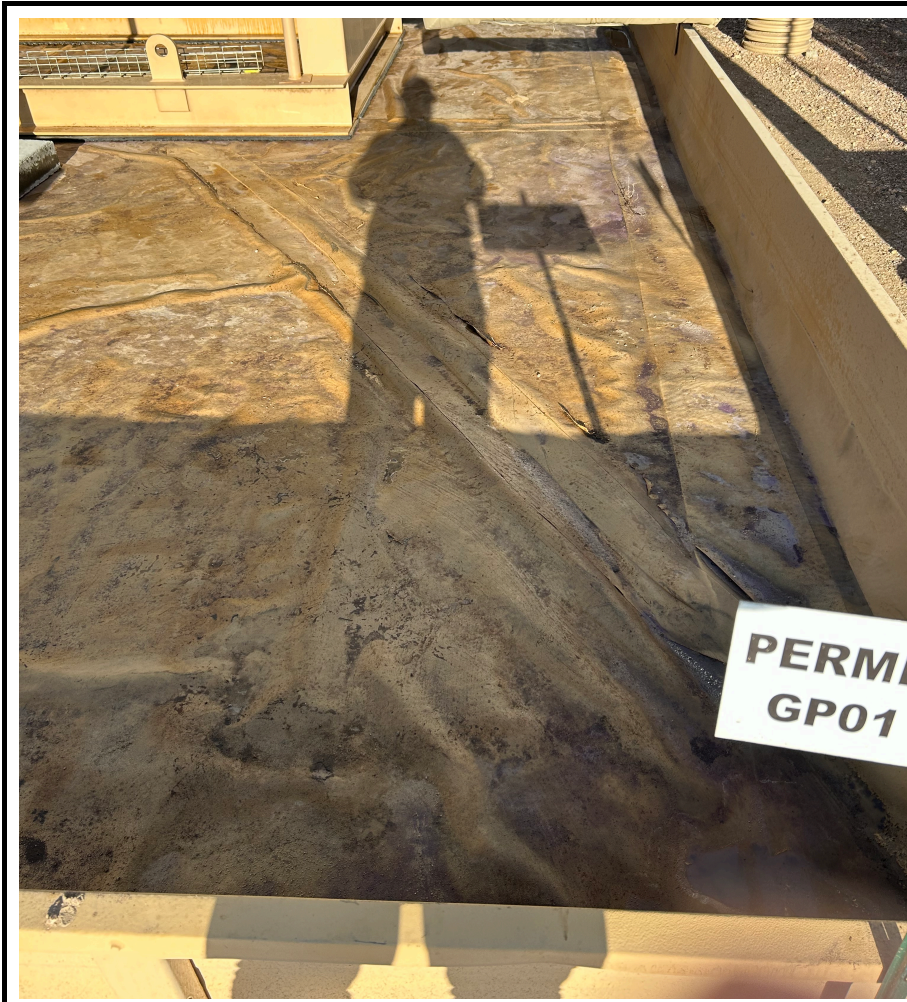
Equipment ID:		Equipment Type:	
Material:	Volume:	Contents:	
Notes/Conditions: Looking west from northeast corner of containment.

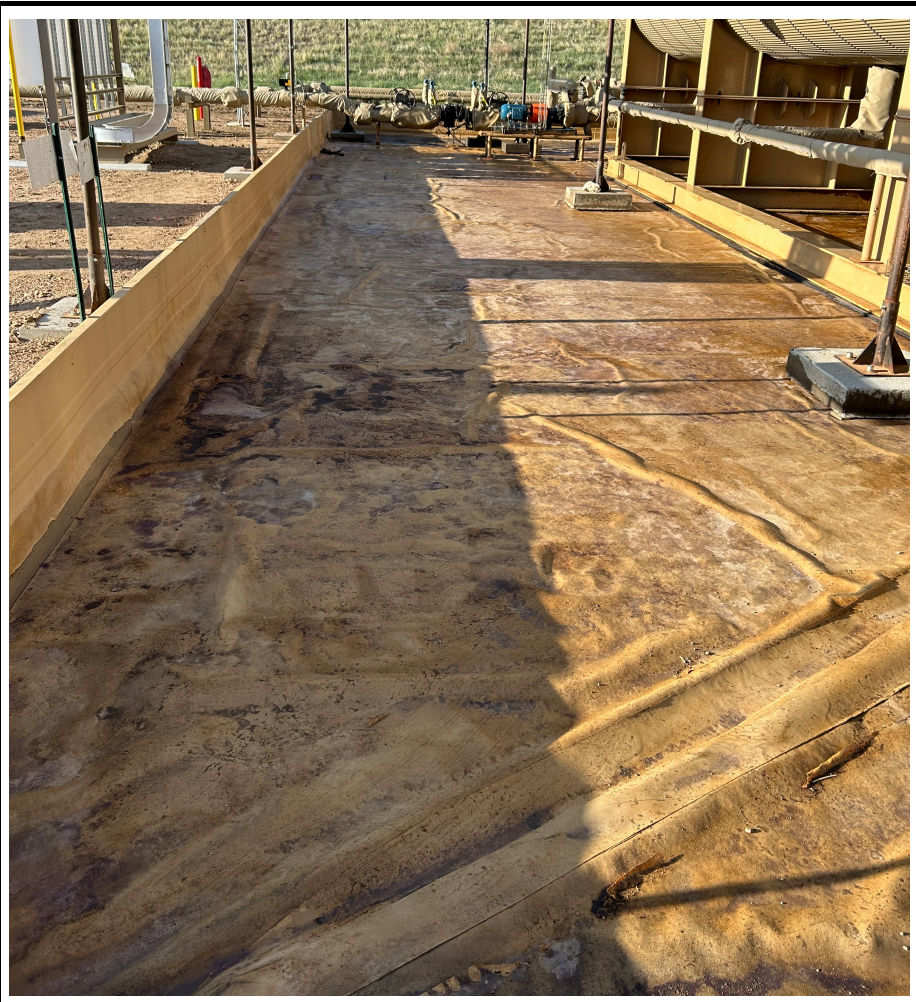
Equipment ID:		Equipment Type:	
Material:	Volume:	Contents:	
Notes/Conditions: Looking south from northeast corner of containment.

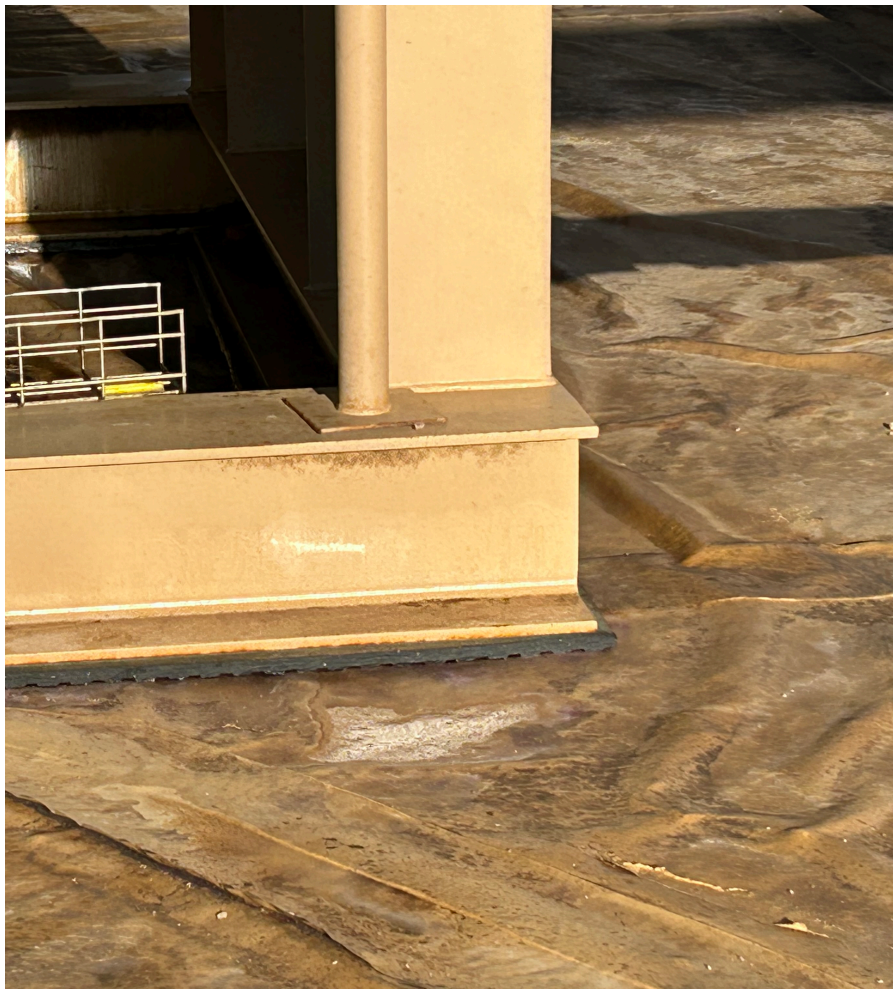
Equipment ID:		Equipment Type:	
Material:	Volume:	Contents:	
Notes/Conditions: Downward view, looking westward.

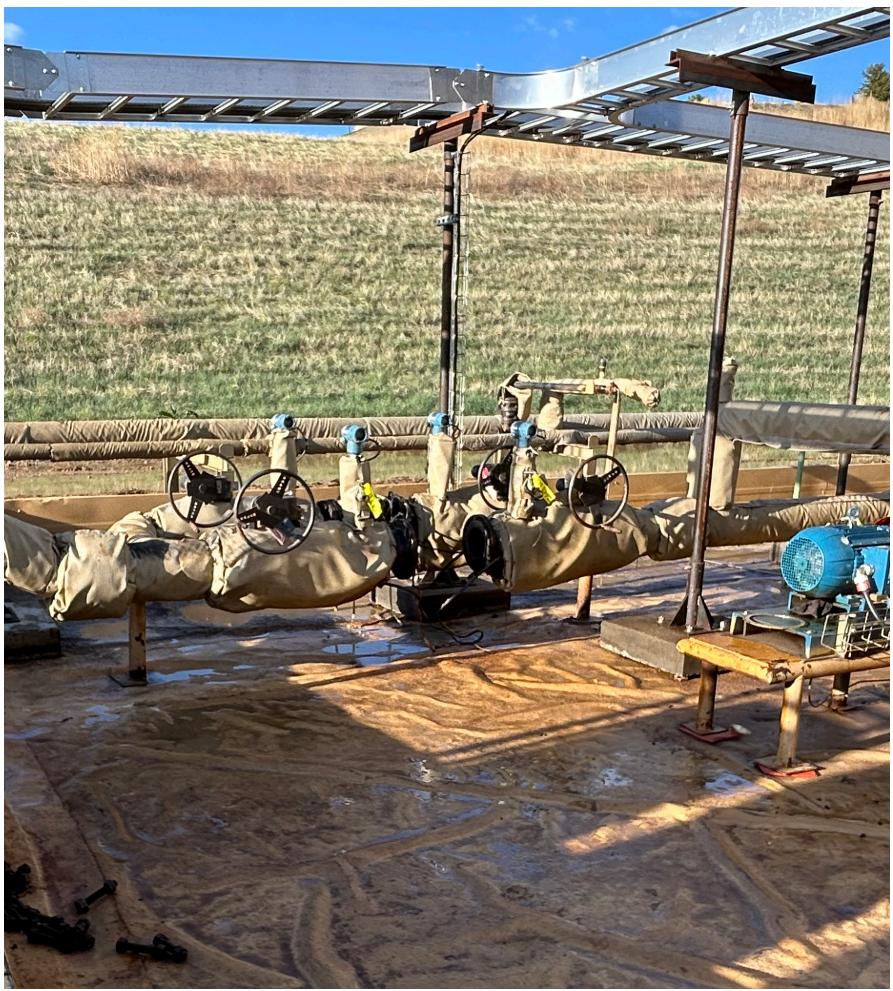
Equipment ID:		Equipment Type:	
Material:	Volume:	Contents:	
Notes/Conditions: Looking south from eastern wall of containment.

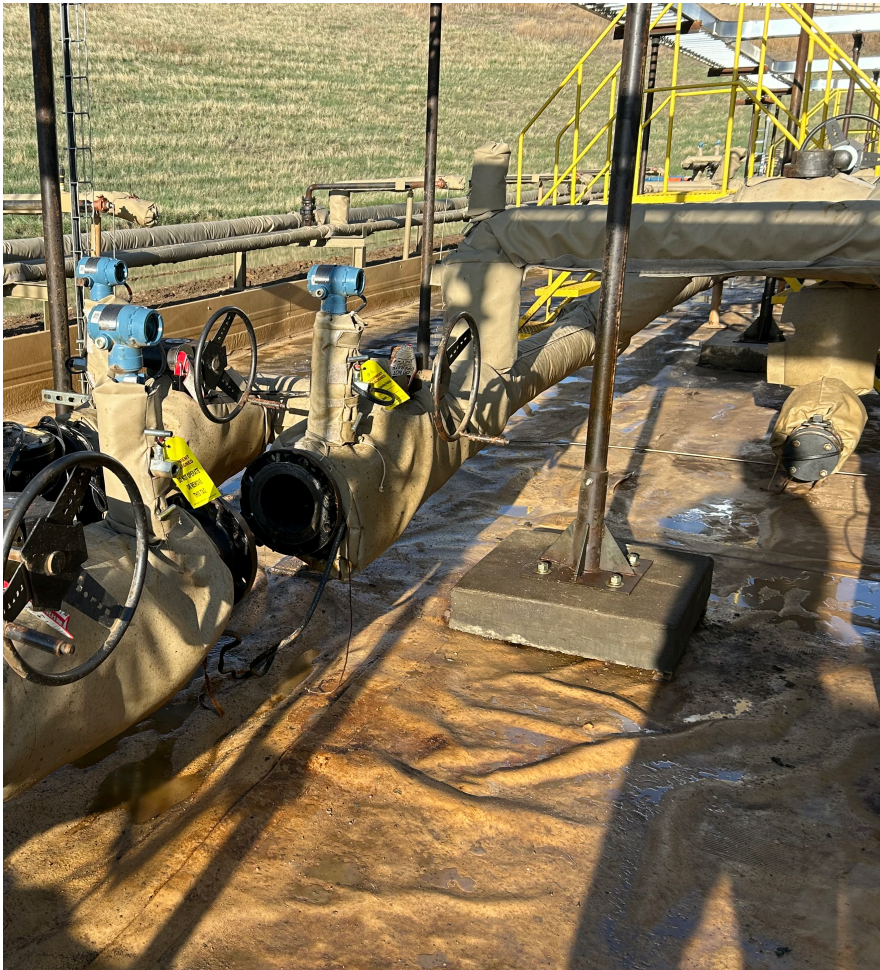
Equipment ID:		Equipment Type:	
Material:	Volume:	Contents:	
Notes/Conditions: Looking west from southeast side of containment.

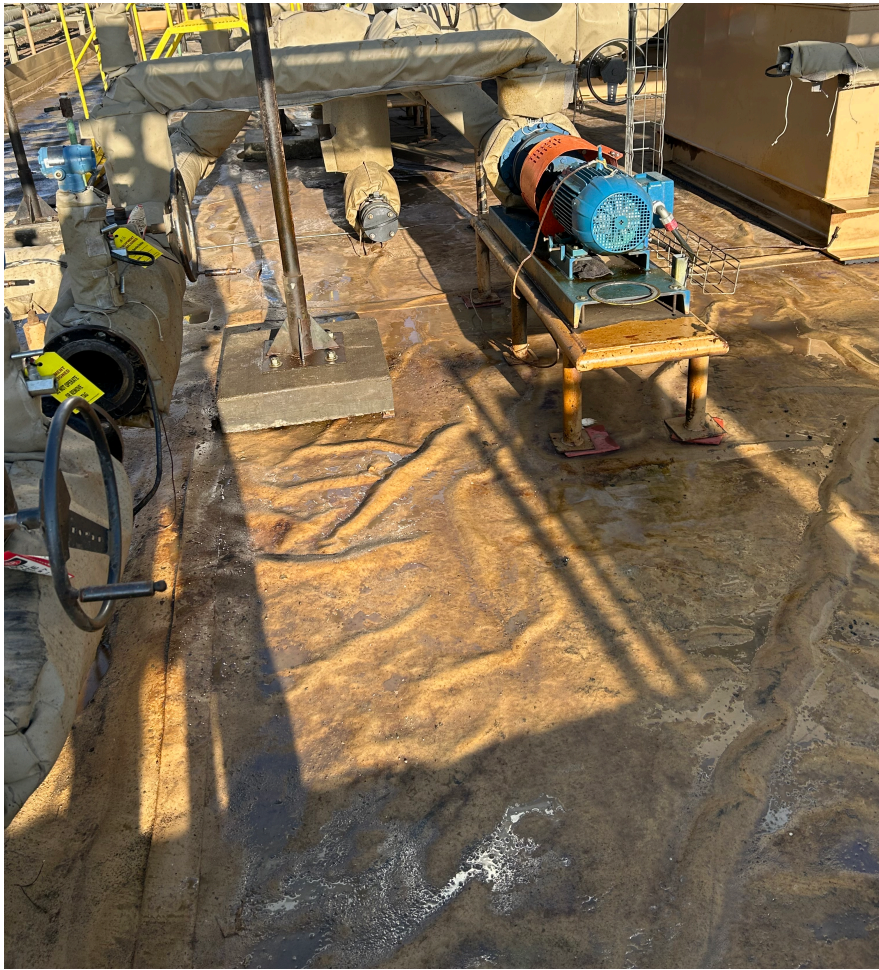
Equipment ID:		Equipment Type:	
Material:	Volume:	Contents:	
Notes/Conditions: Looking west from south wall of containment.

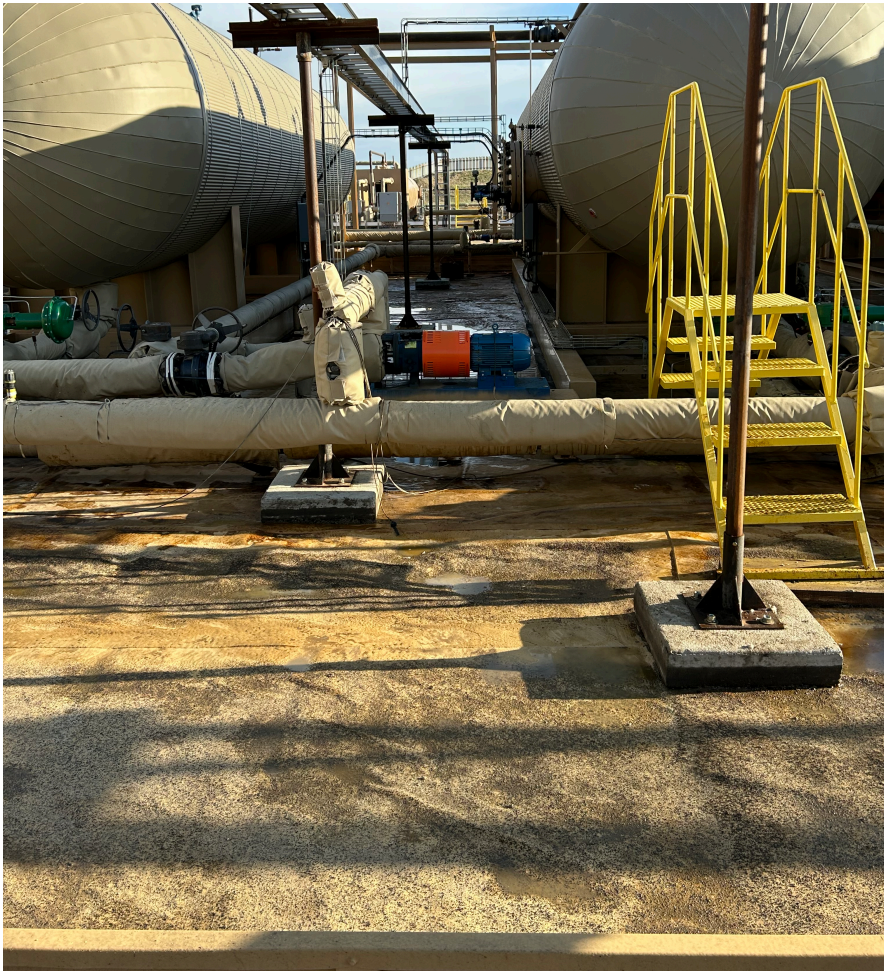
Equipment ID:		Equipment Type:	
Material:	Volume:	Contents:	
Notes/Conditions: Looking north from south wall of containment.

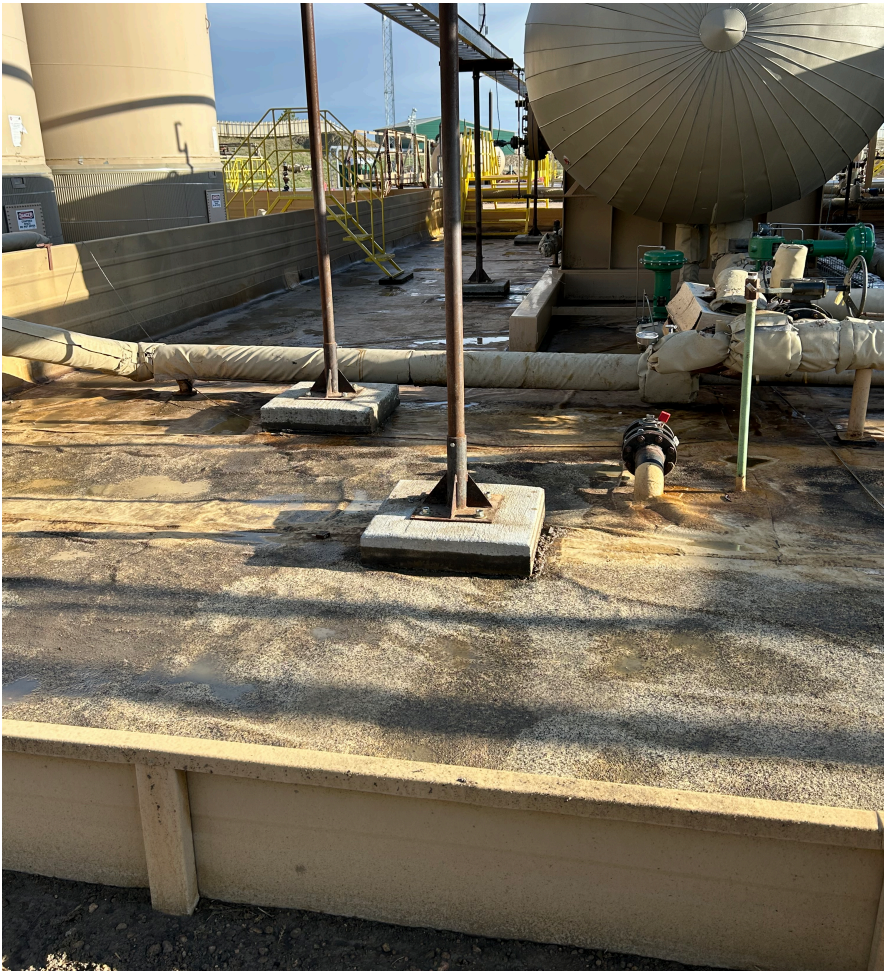
Equipment ID:		Equipment Type:	
Material:	Volume:	Contents:	
Notes/Conditions: Looking north from south wall of containment.

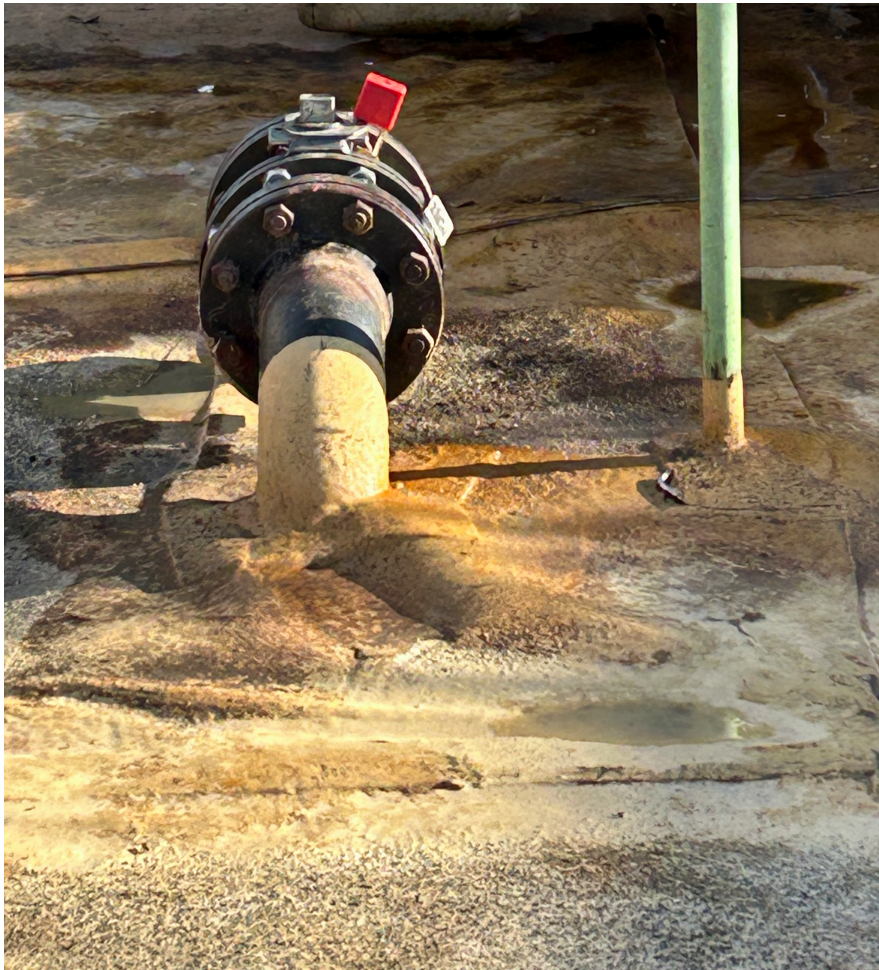
Equipment ID:		Equipment Type:	
Material:	Volume:	Contents:	
Notes/Conditions: Properly sealed liner seams.

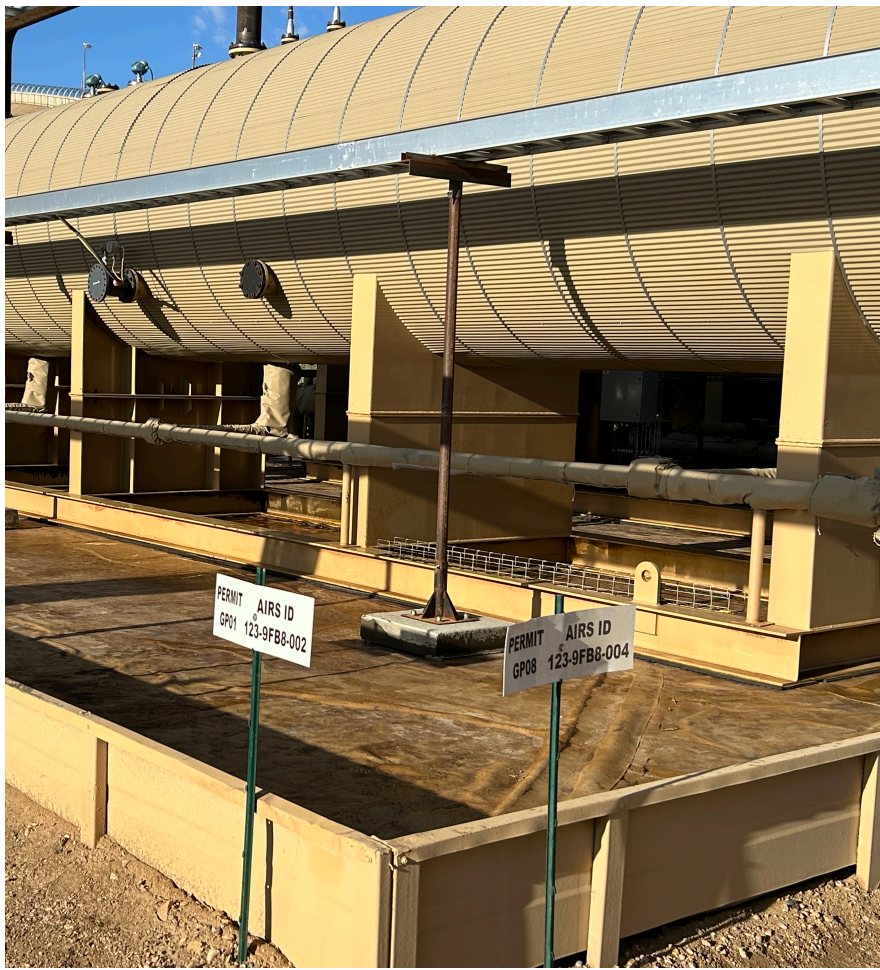
Equipment ID:		Equipment Type:	
Material:	Volume:	Contents:	
Notes/Conditions: Looking southwest from northeast corner of containment.

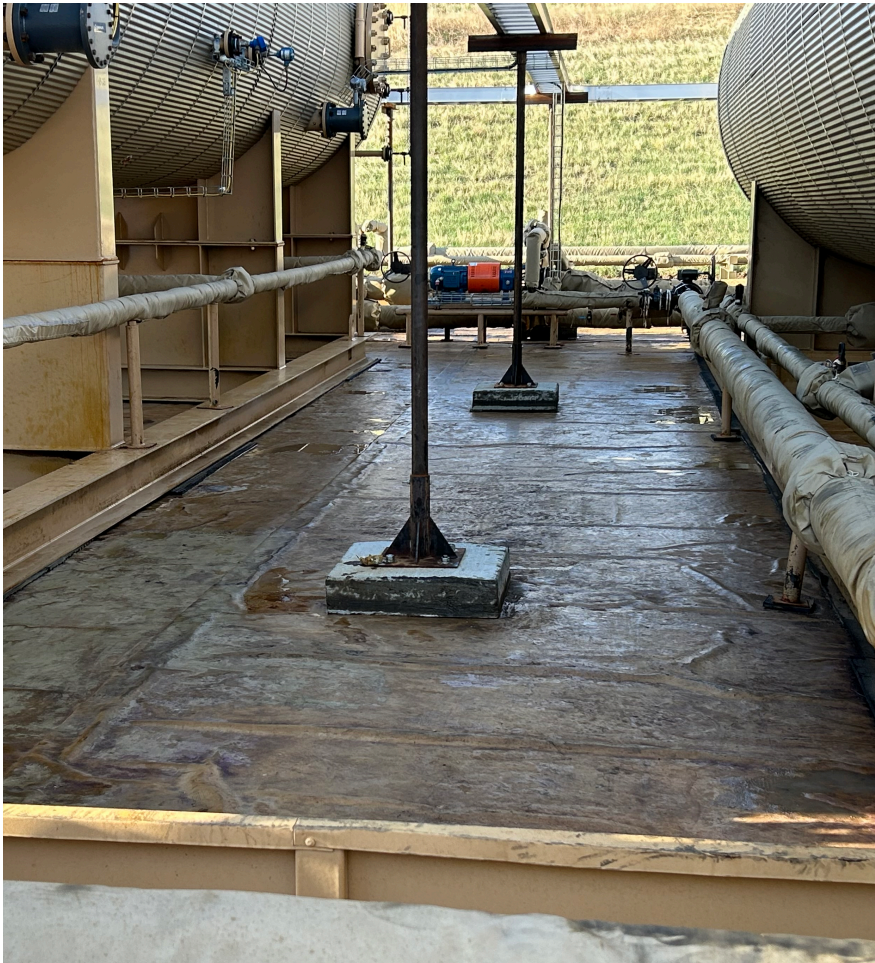
Equipment ID:		Equipment Type:		Equipment ID:		Equipment Type:	
Material:	Volume:	Contents:		Material:	Volume:	Contents:	
Notes/Conditions: Looking south from north wall.				Notes/Conditions:
