Inspection Photos
Sam Funakoshi A2 Flowline Spill
Spill ID 486562

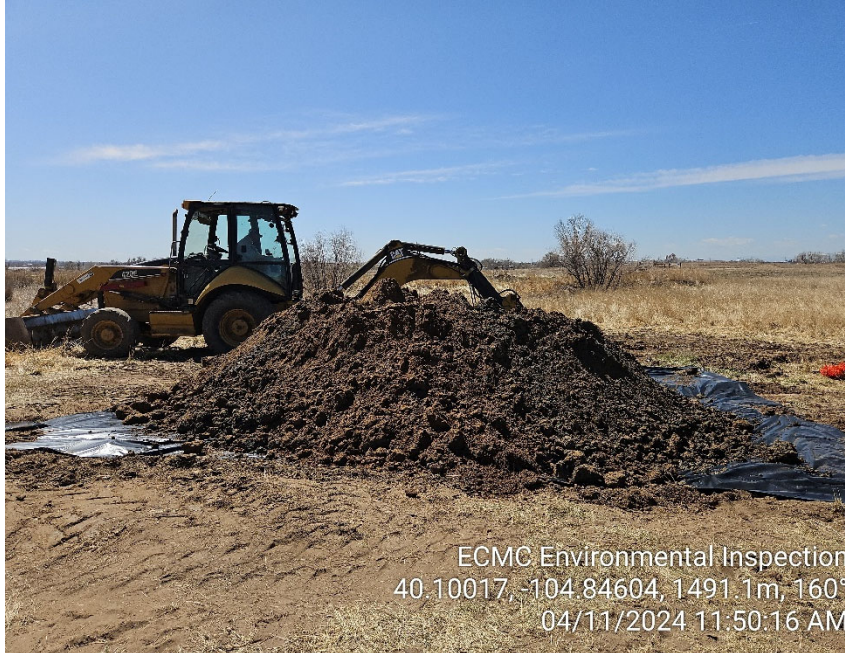
Photo 3 – Soil excavated from spill area temporarily stored on tarp. Contaminated soil beginning to overtop onto clean soil

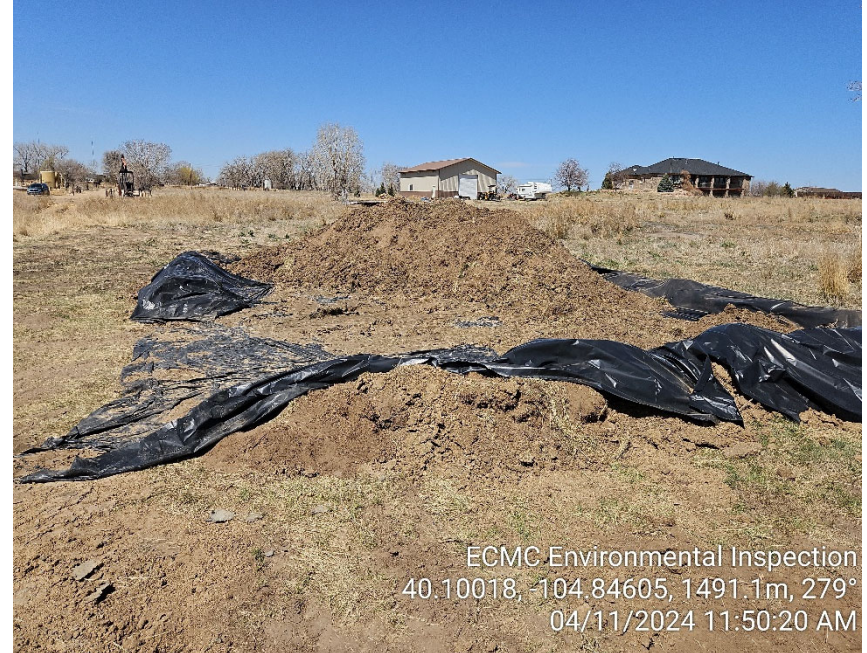
Photo 4 - Soil stockpile on liner and bermed.

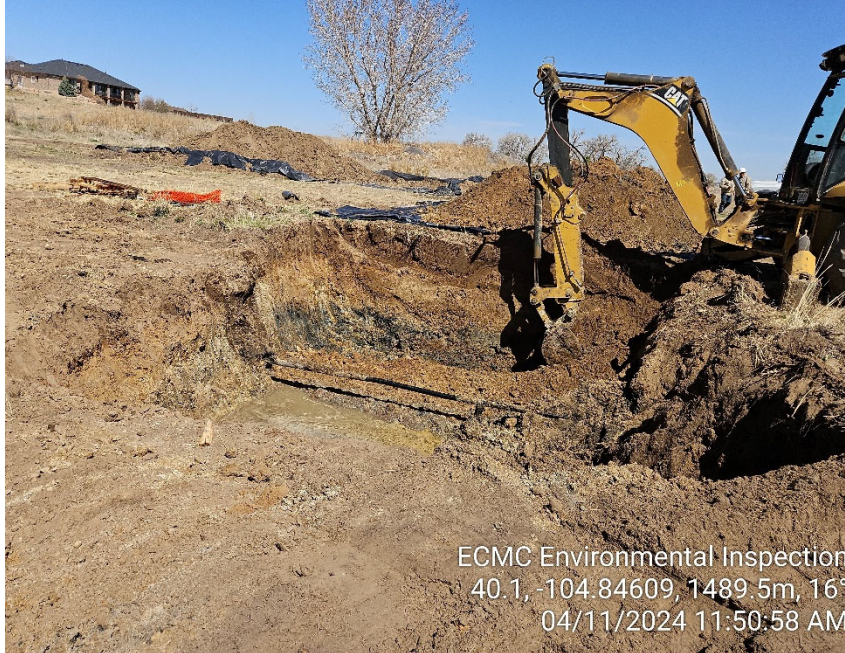
Photo 5 – Groundwater observed in open excavation. Impacts remained visible in-situ.

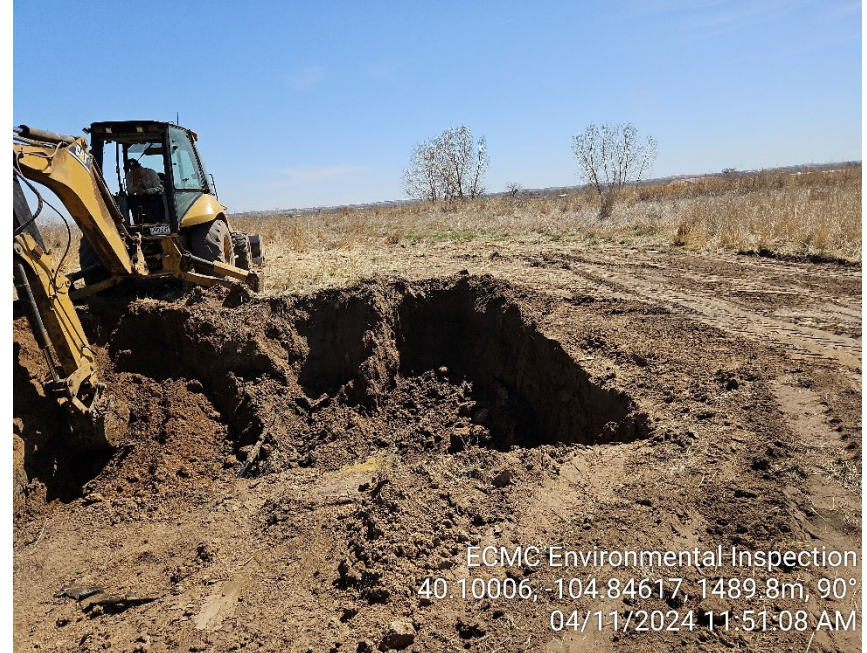
Photo 6 - Groundwater observed in open excavation. Impacts remained visible in-situ.
