ECMC
Environmental
Field Inspection

Ottesen LD Pad
© 13-Jun-24 12:37:01 PM
Weeds

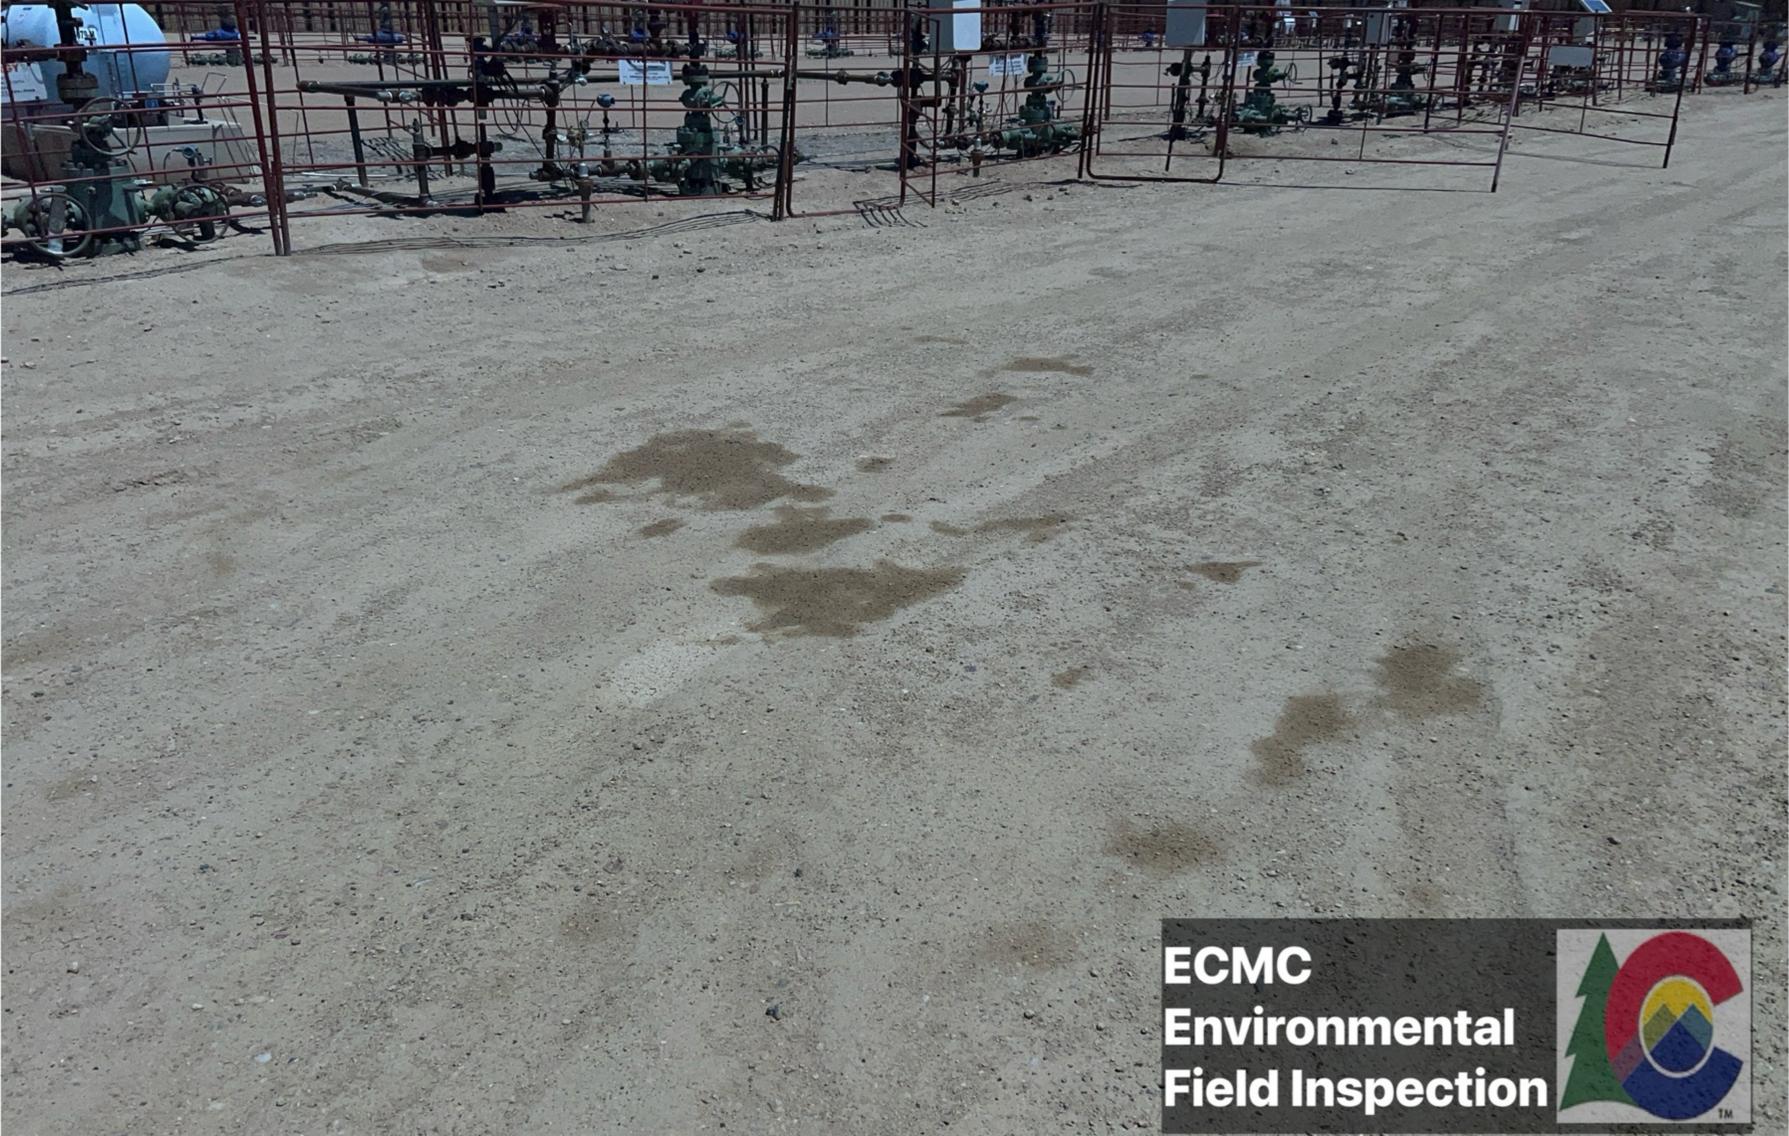
Ottesen LD Pad
© 13-Jun-24 12:37:46 PM
Stained soil

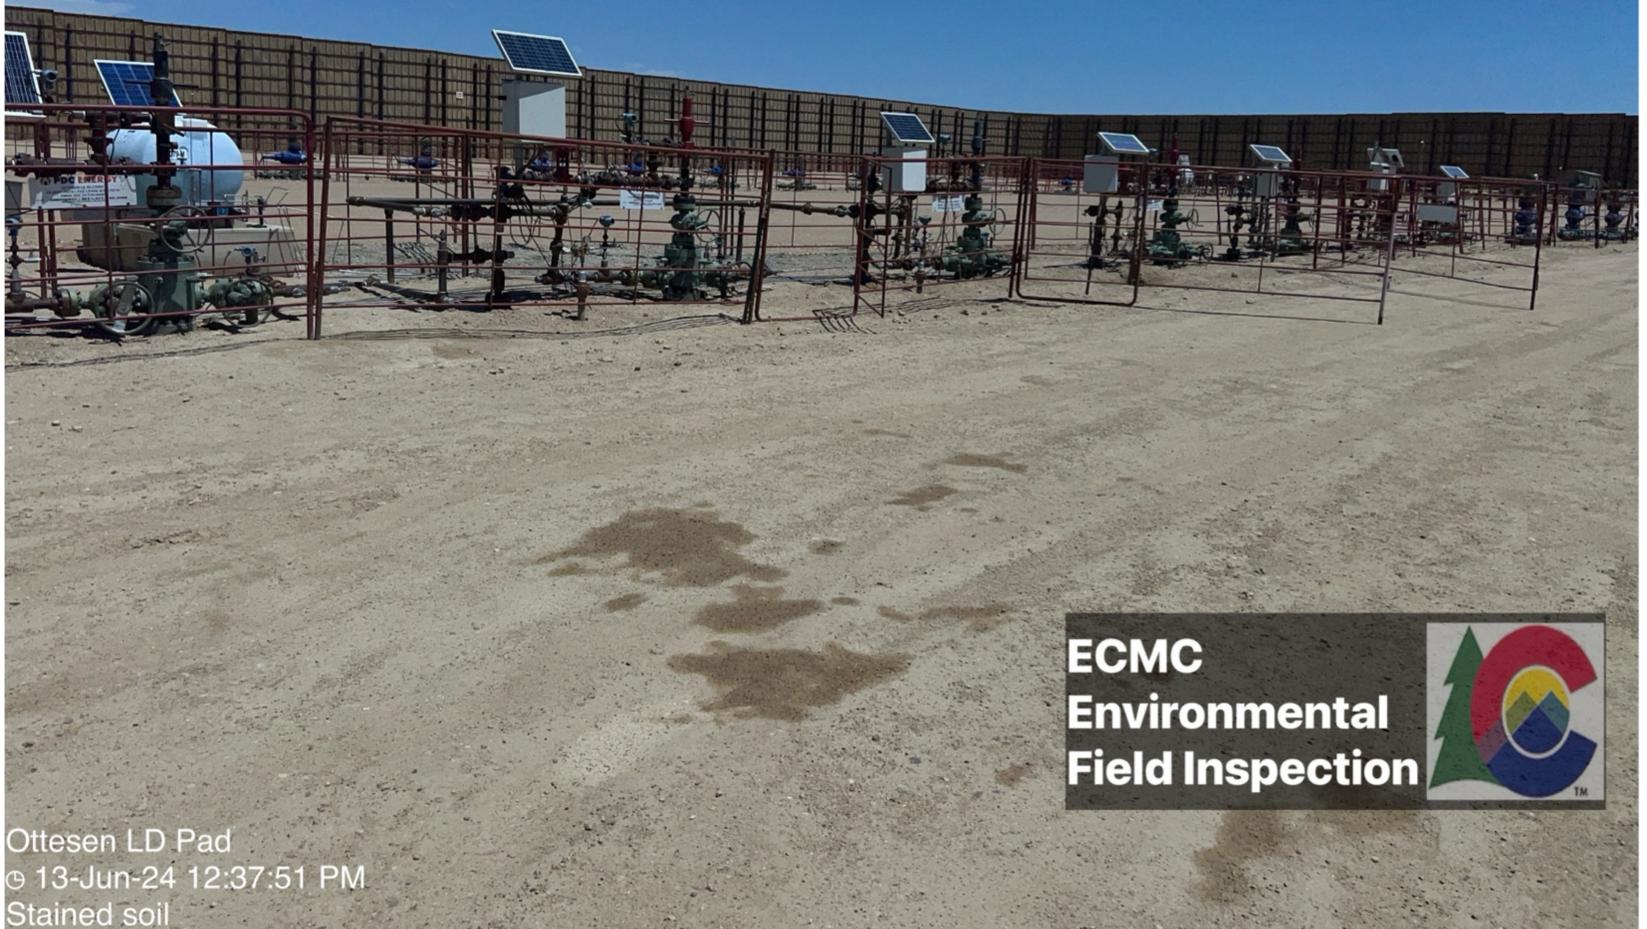
Ottesen LD Pad
© 13-Jun-24 12:37:51 PM
Stained soil

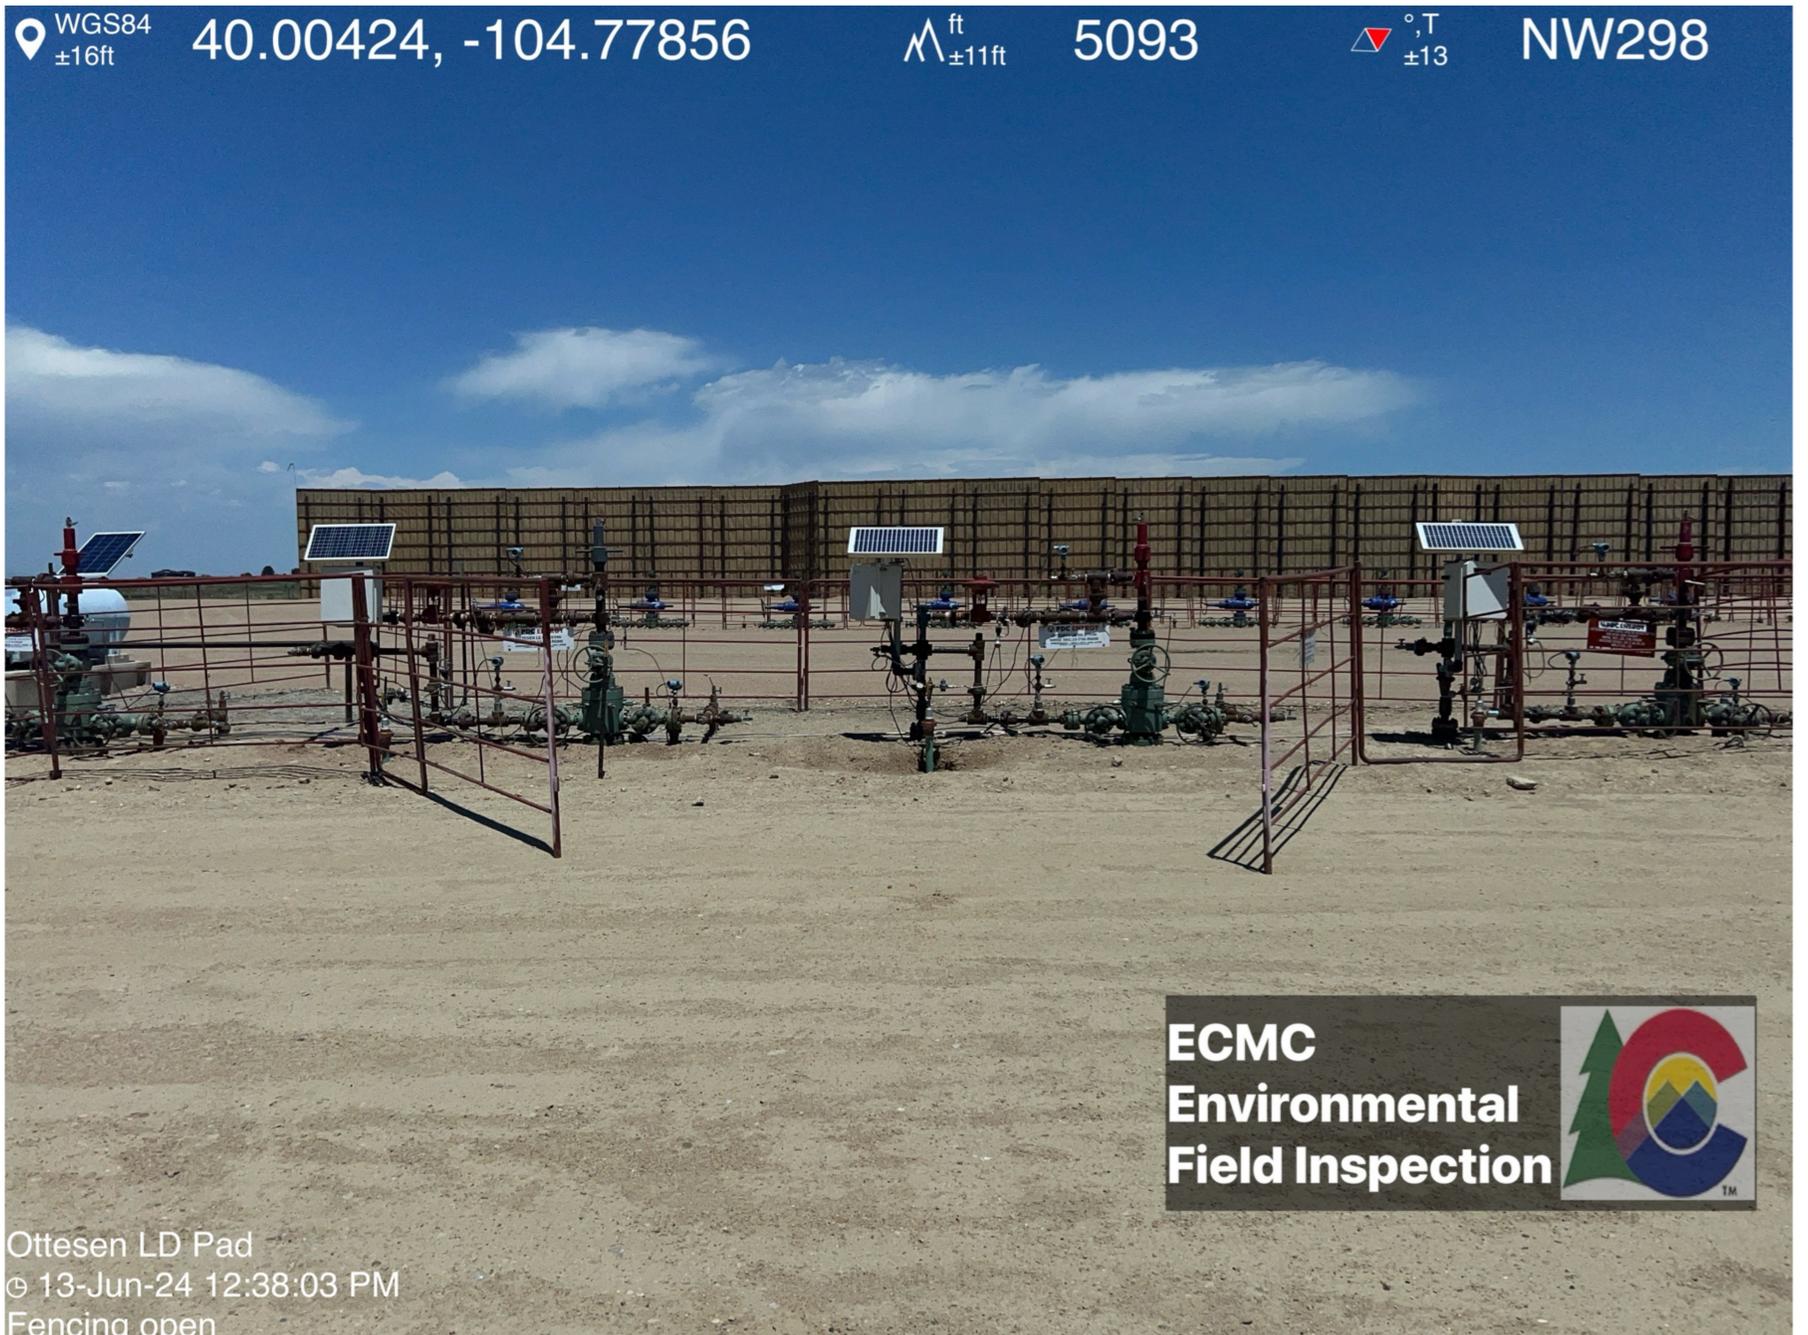
Ottesen LD Pad
© 13-Jun-24 12:38:03 PM
Fencing open

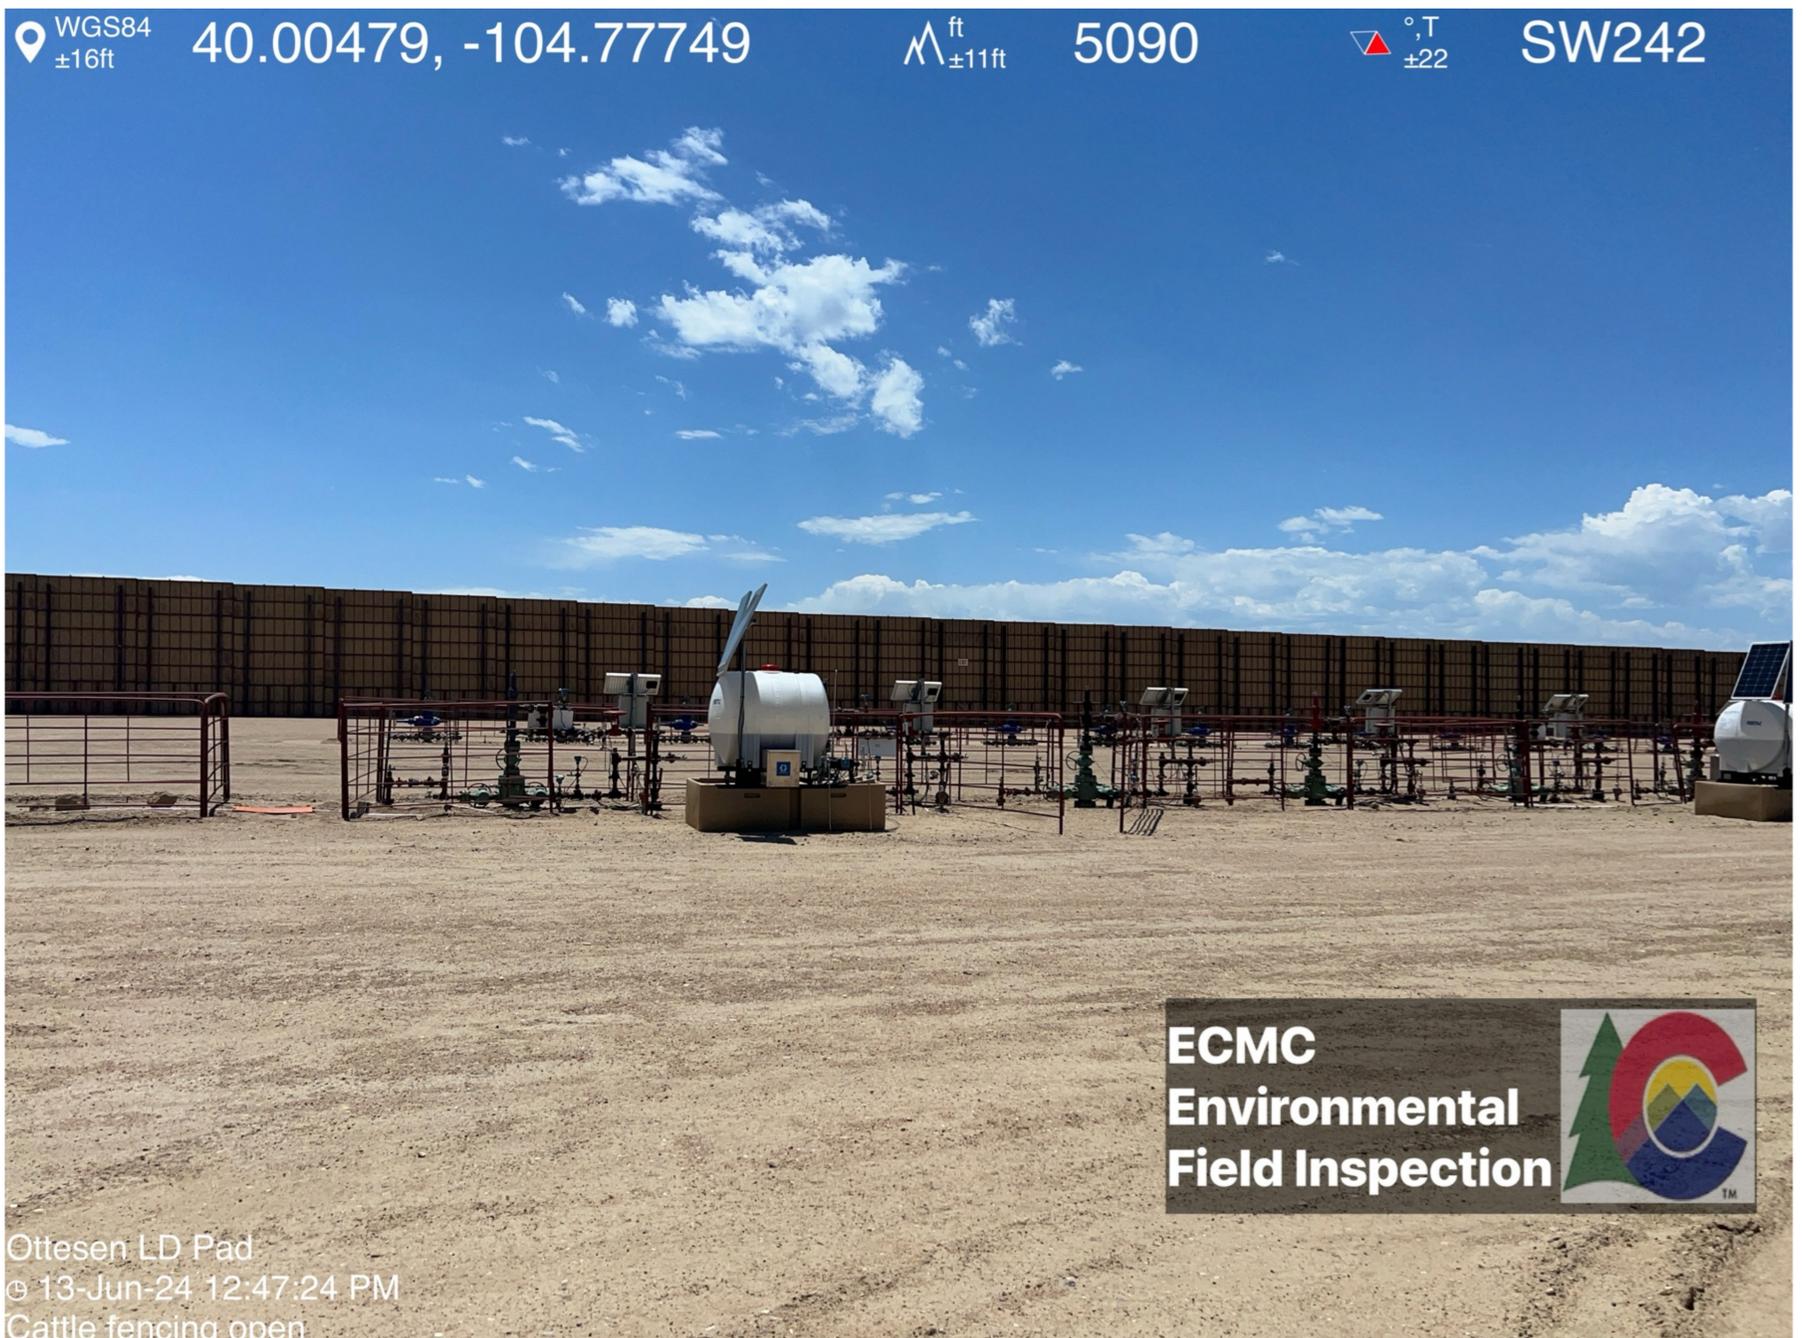
Ottesen LD Pad
© 13-Jun-24 12:47:24 PM
Cattle fencing open

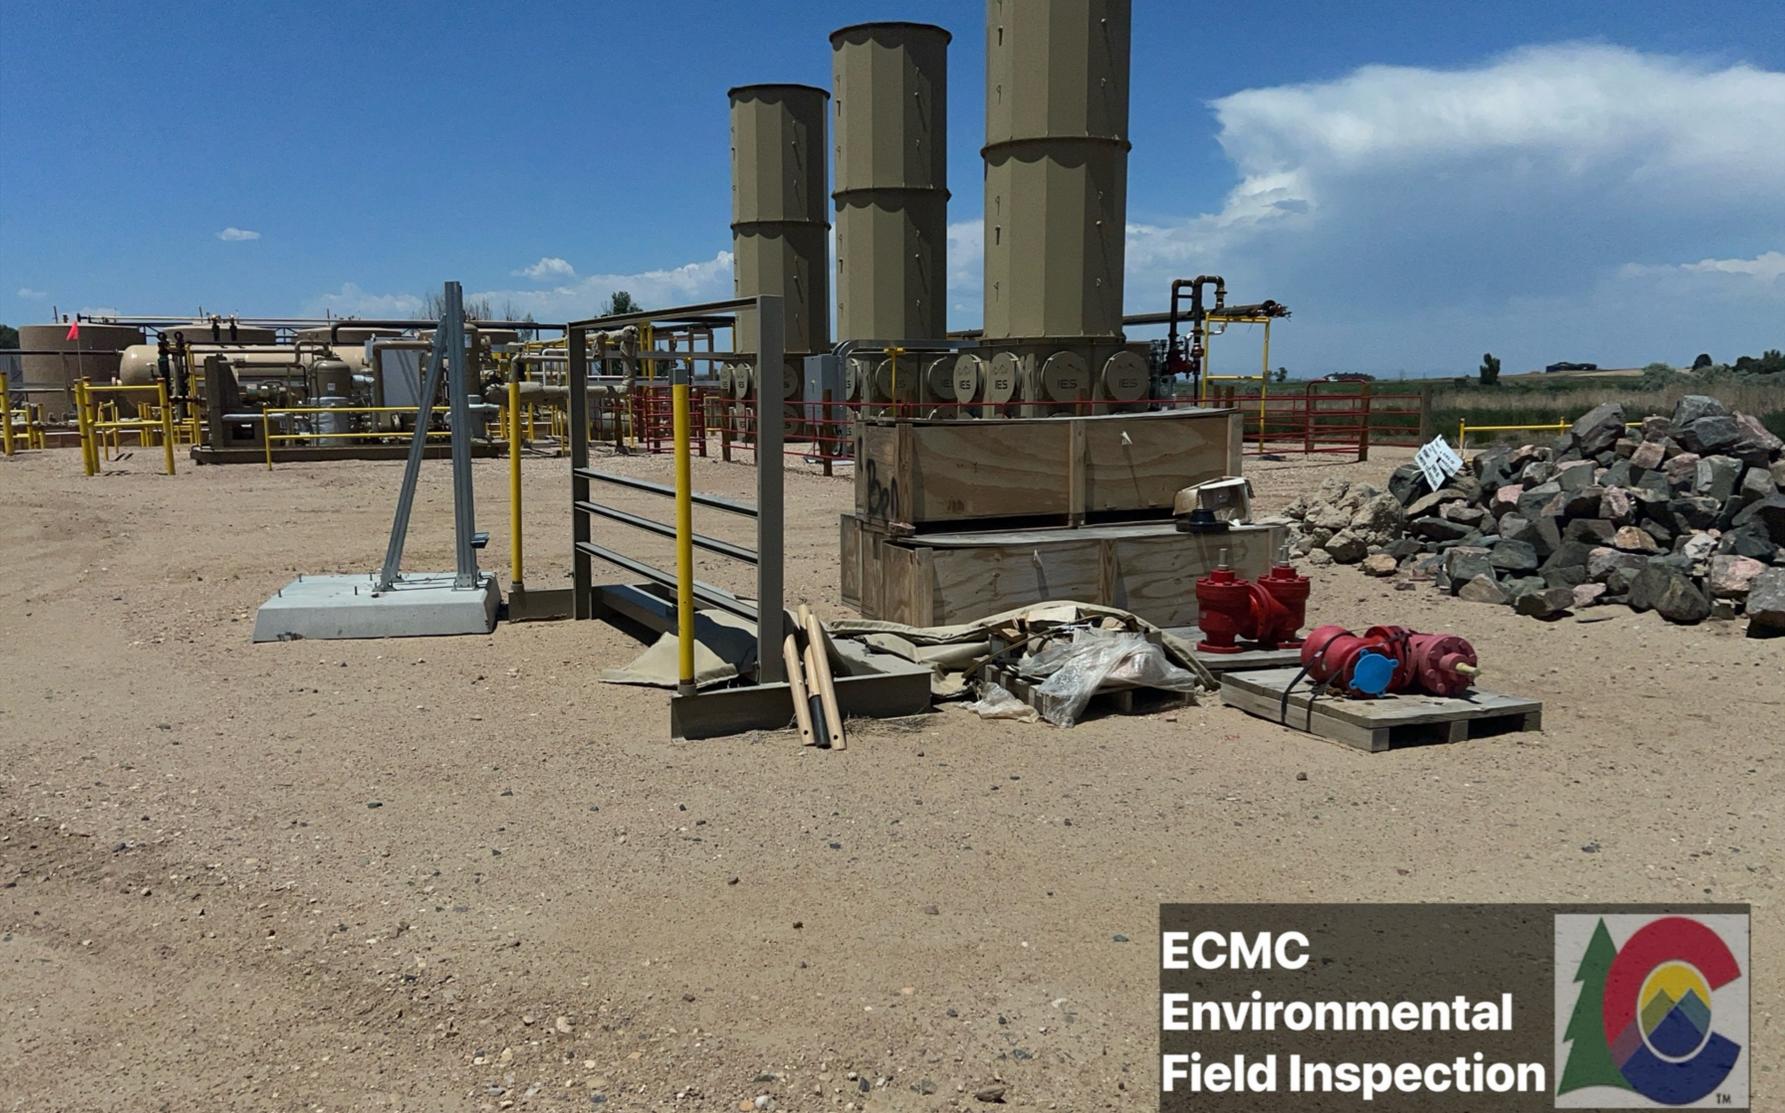
Ottesen LD Pad
© 13-Jun-24 12:48:55 PM
Unused equipment

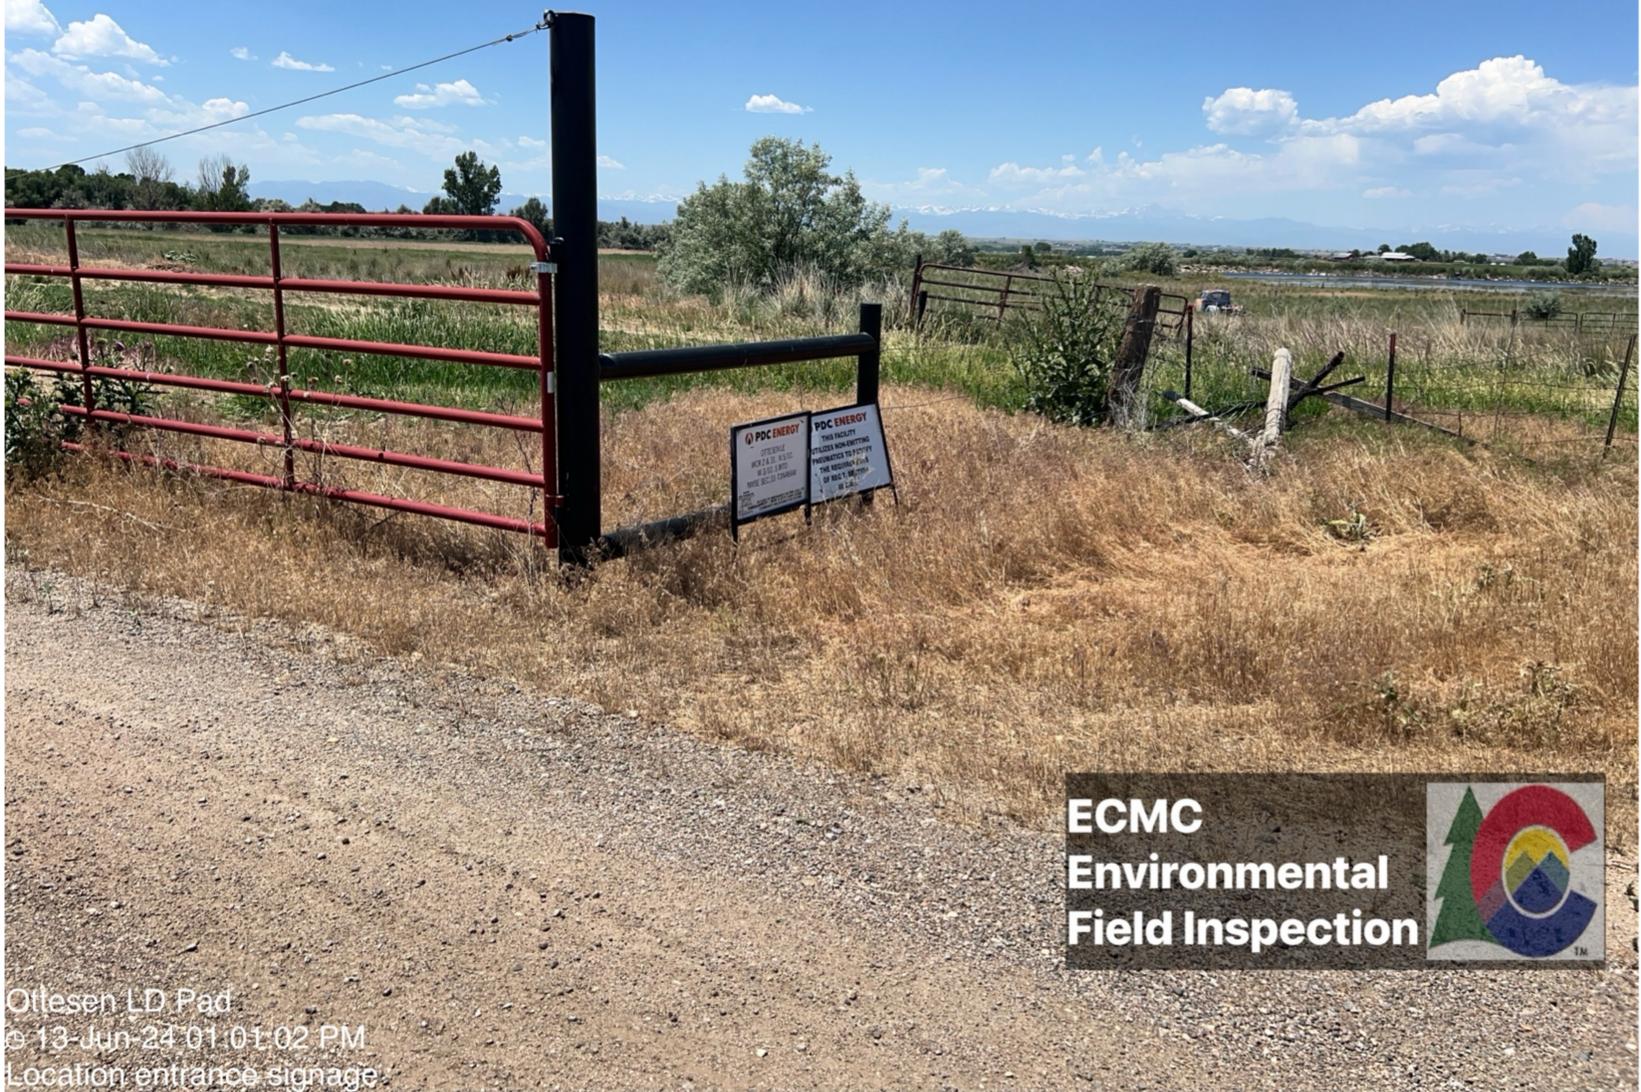
Ottesen LD Pad
© 13-Jun-24 01:01:02 PM
Location entrance signage

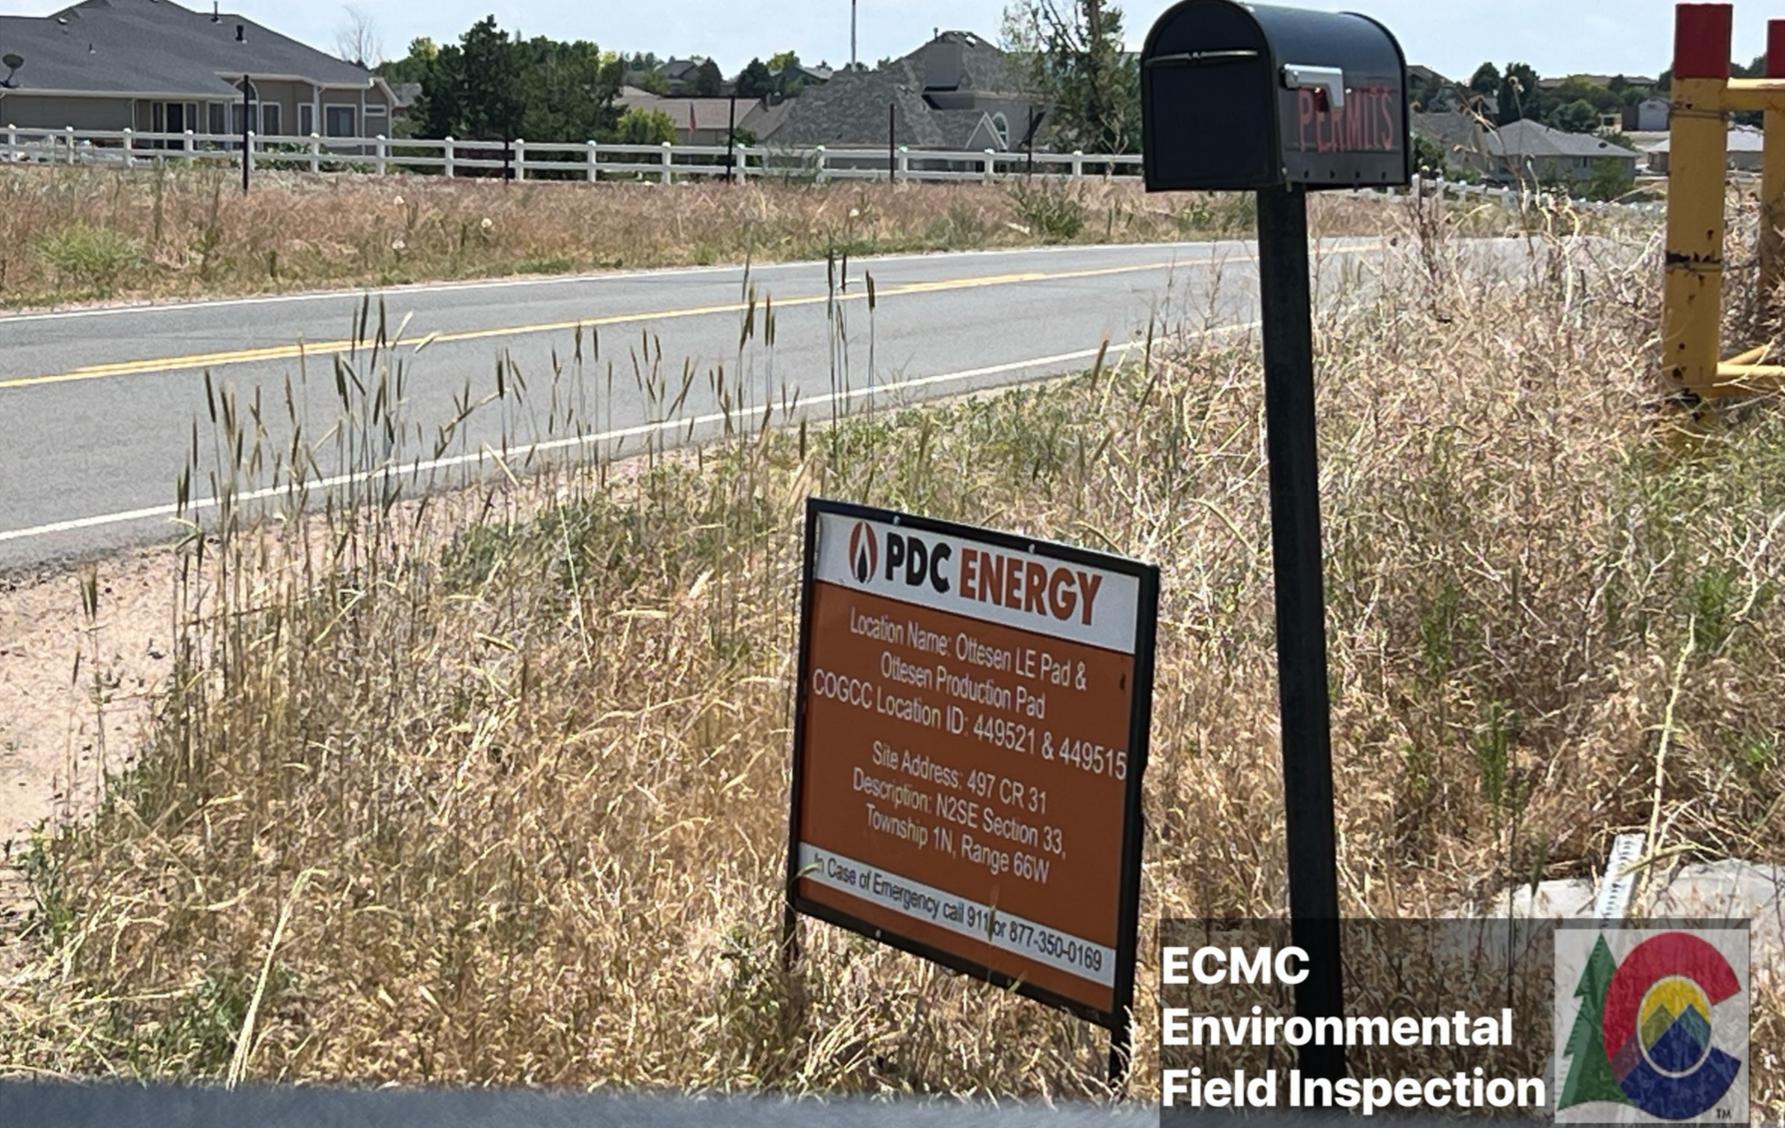
Ottesen LD Pad
© 13-Jun-24 01:03:25 PM
Location entrance signage

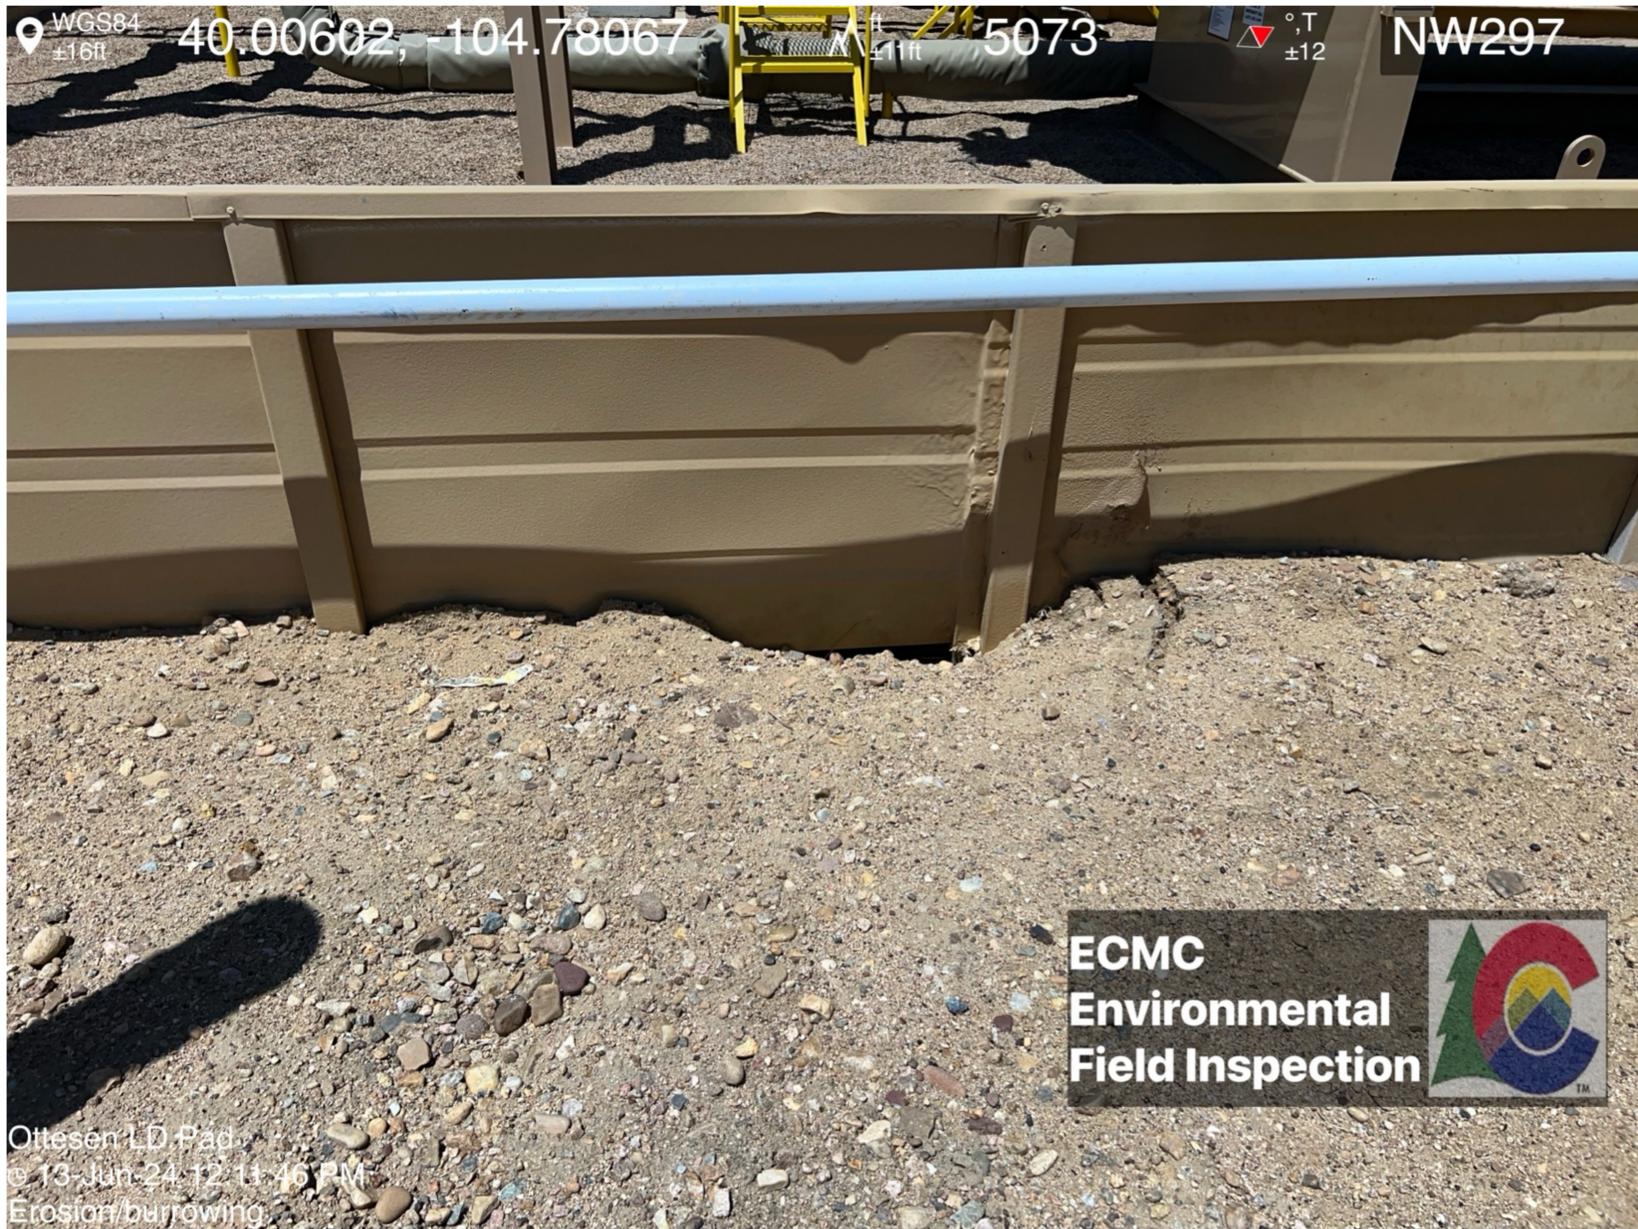
Ottesen LD Pad
© 13 Jun 24 12:11:46 PM
Erosion/burrowing

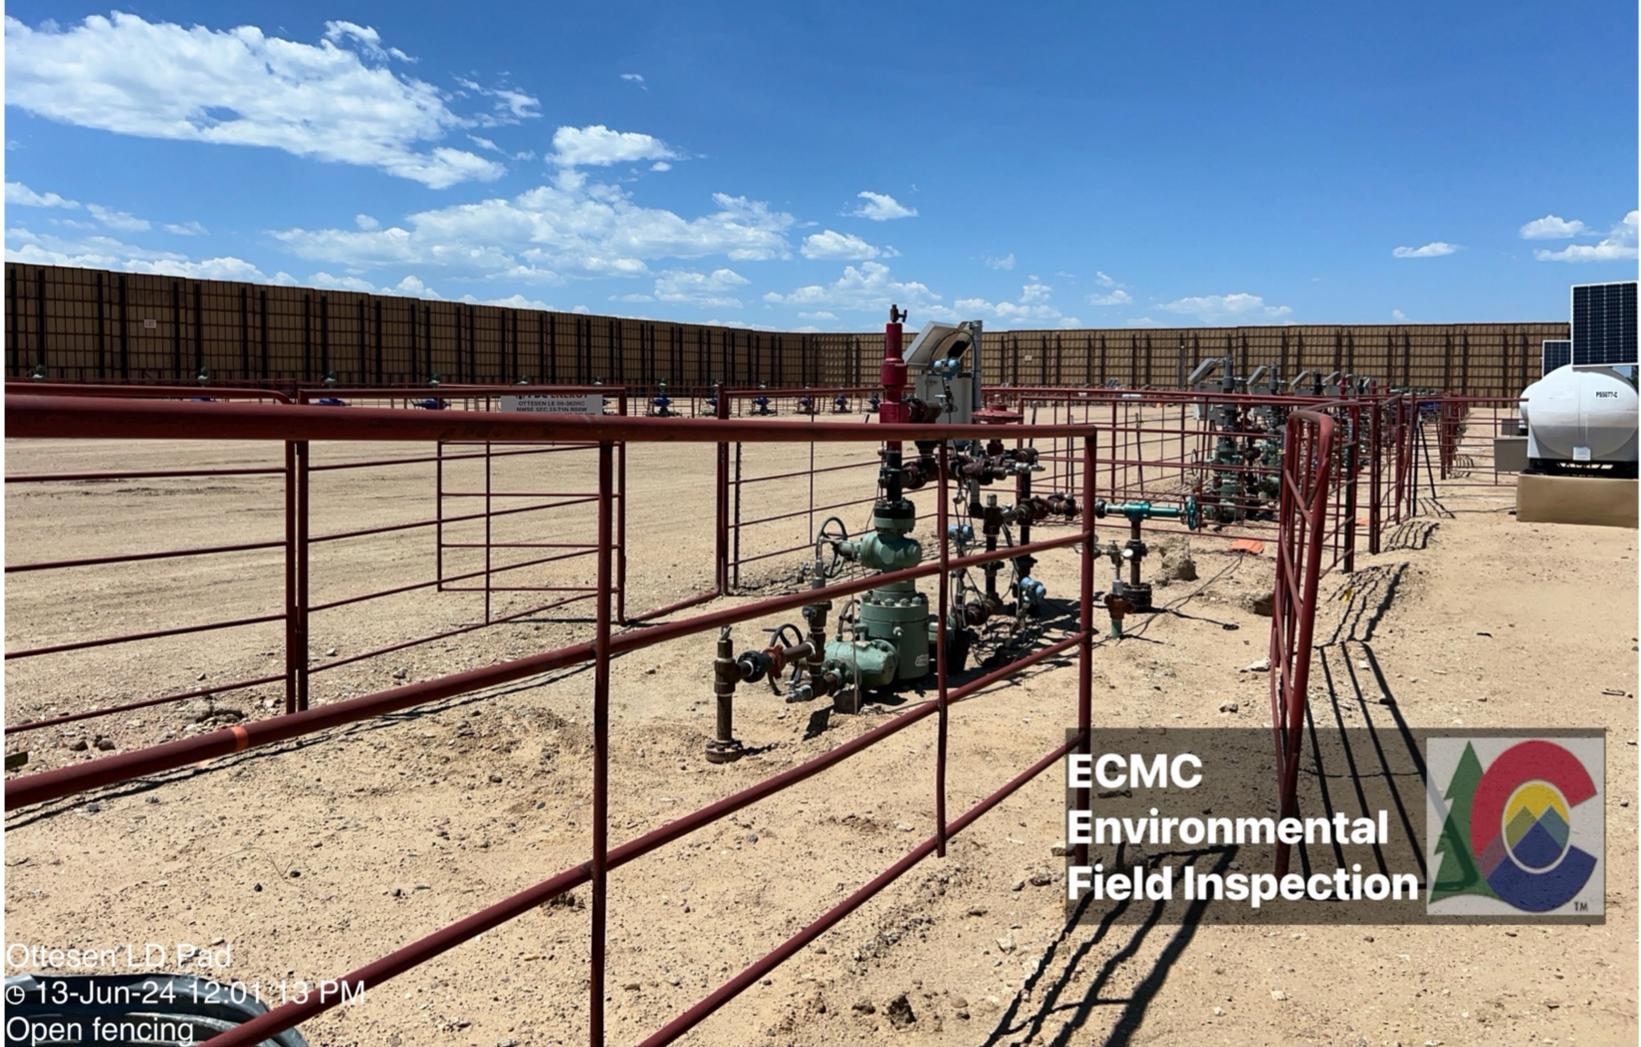
Ottesen LD Pad
© 13-Jun-24 12:01:13 PM
Open fencing

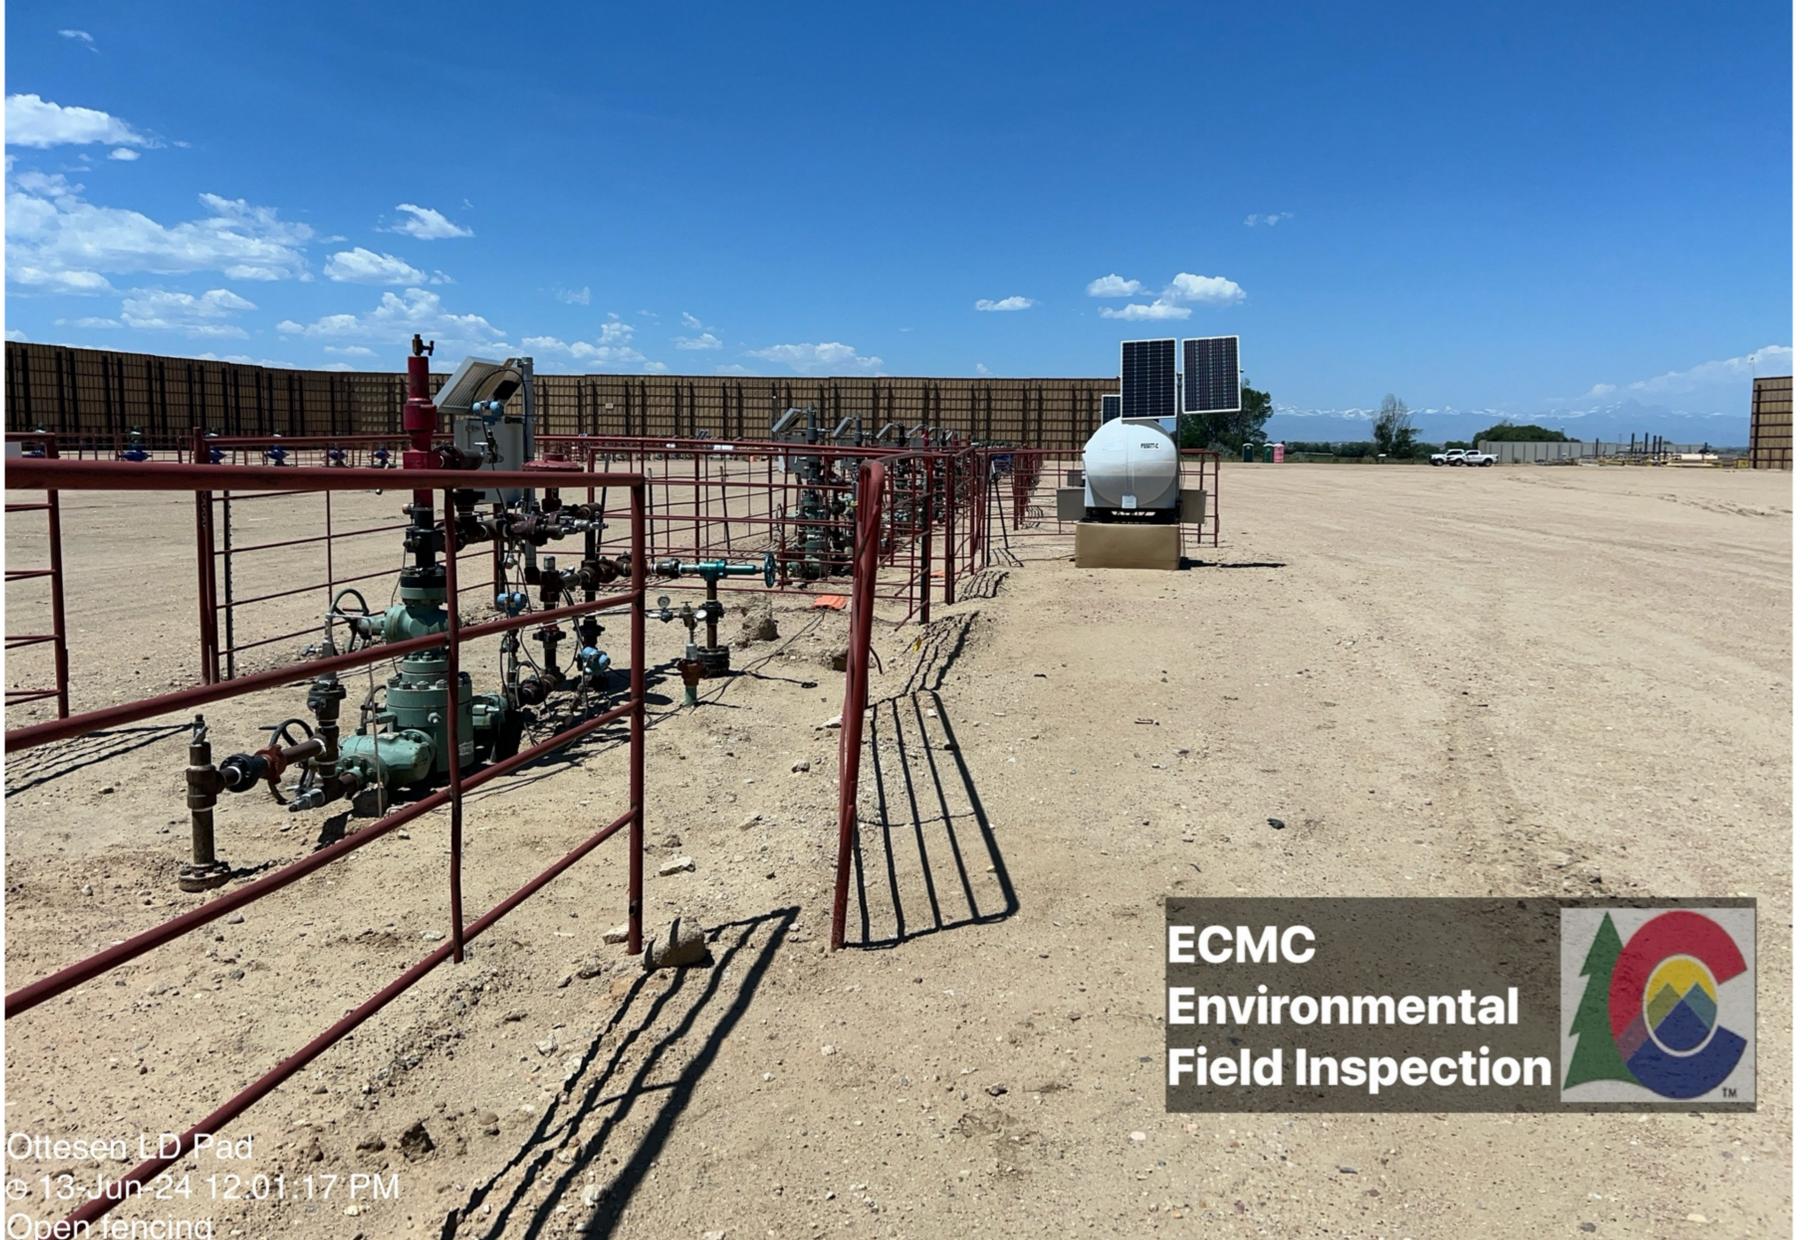
Ottesen LD Pad
© 13-Jun-24 12:01:17 PM
Open fencing

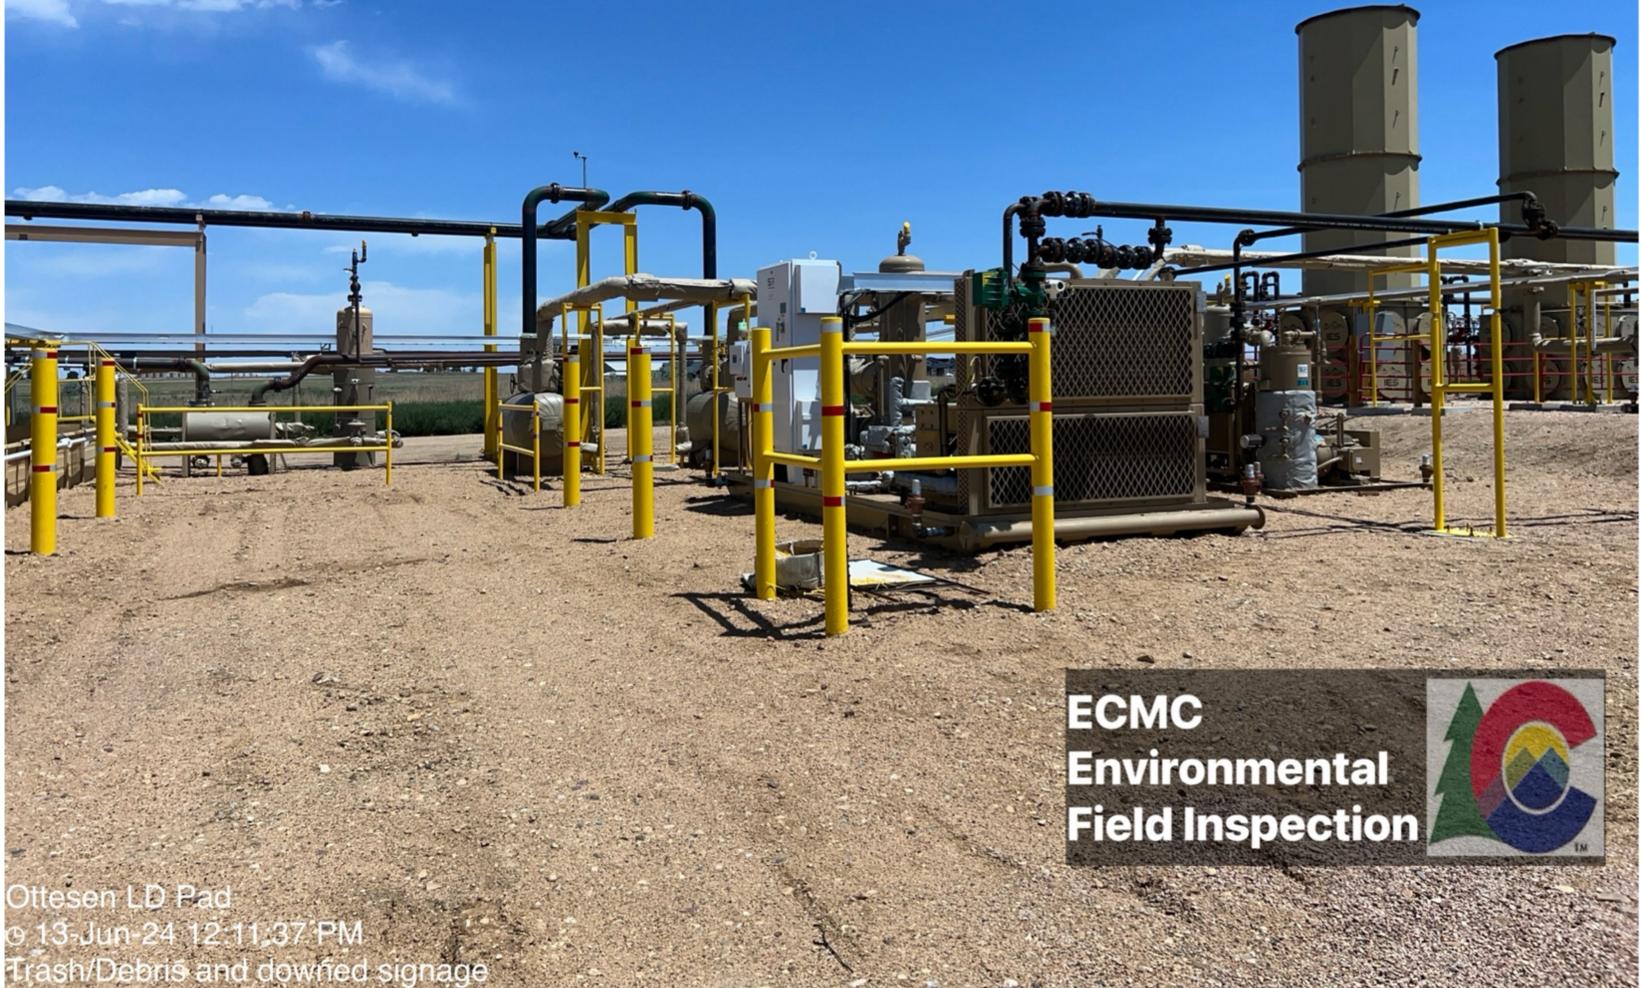
Ottesen LD Pad
© 13-Jun-24 12:11:37 PM
Trash/Debris and downed signage
