# Inspection Photos

Location Name: TEP ROCKY MOUNTAIN LLC JOHNSON RWF 434-30 Pad

Location ID: 335509

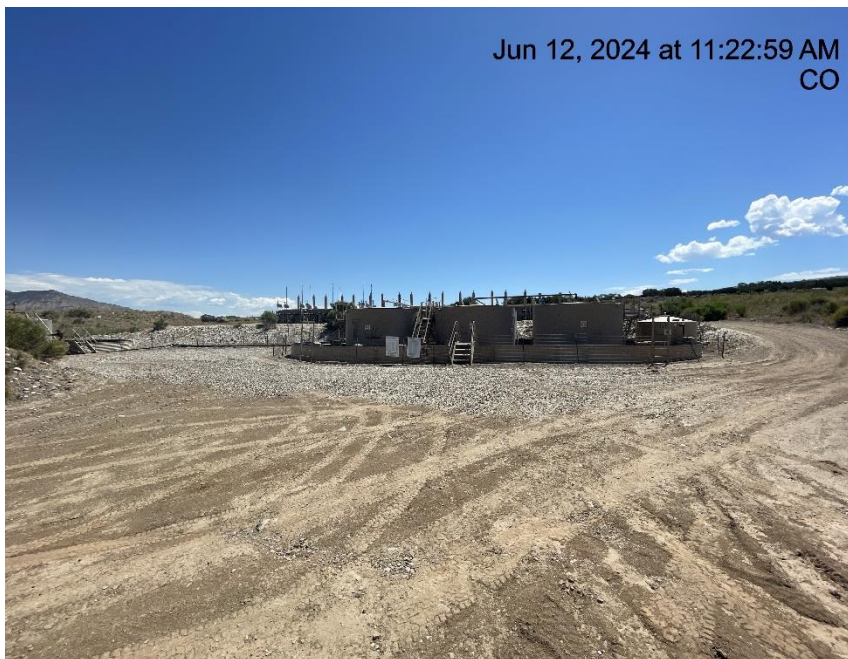
Photo # 530 From entrance to location

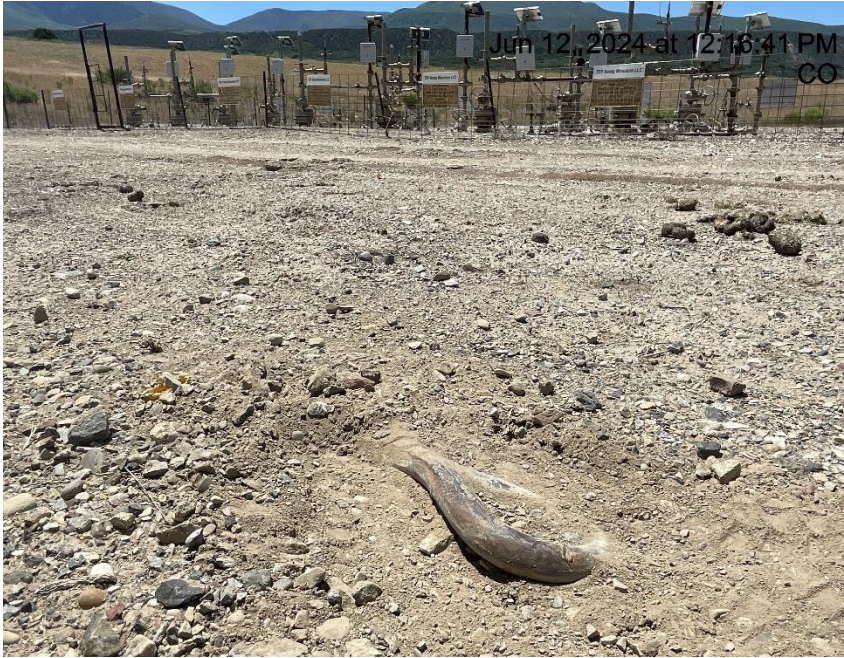
Photo # 542 Unmarked deadman

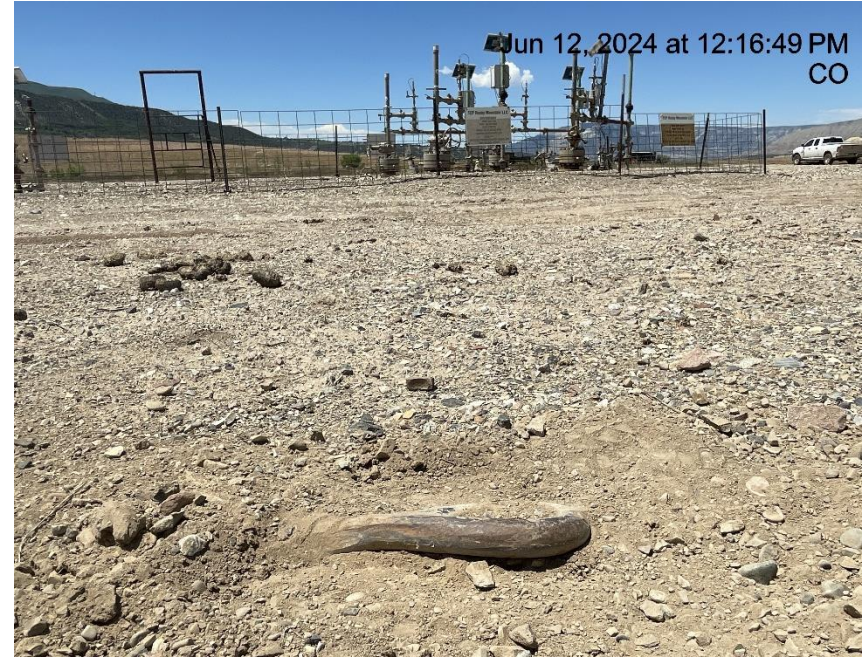
Photo # 543 Same unmarked deadman

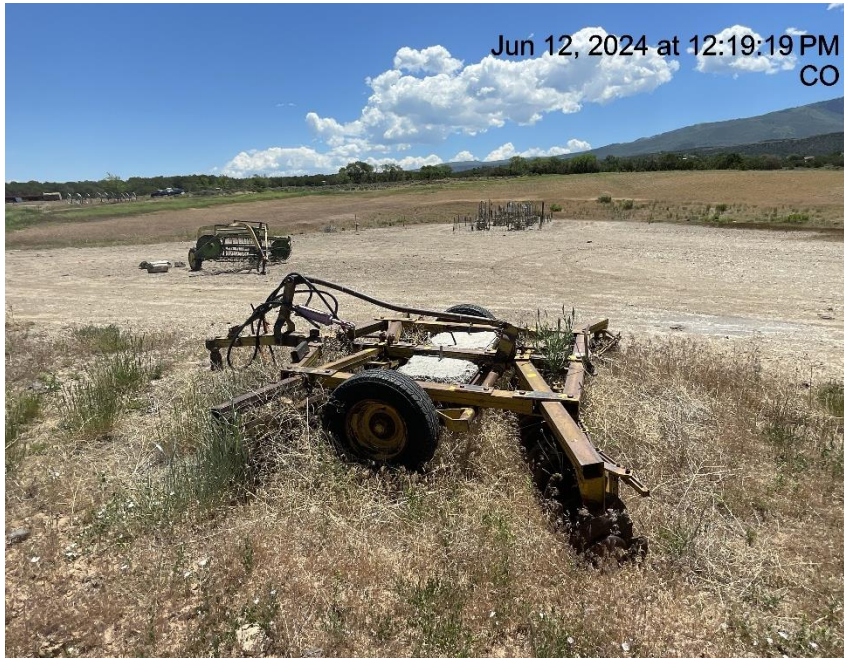
**Photo # 544 Stored farm equipment in the interim area & on location**

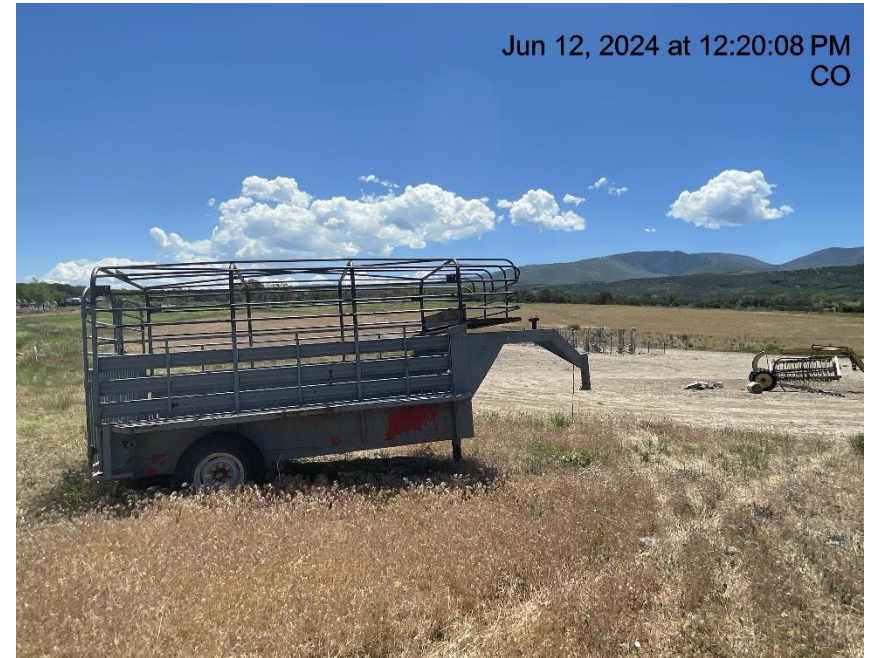
**Photo # 545 Stored farm equipment on location & stored trailer in the interim area**

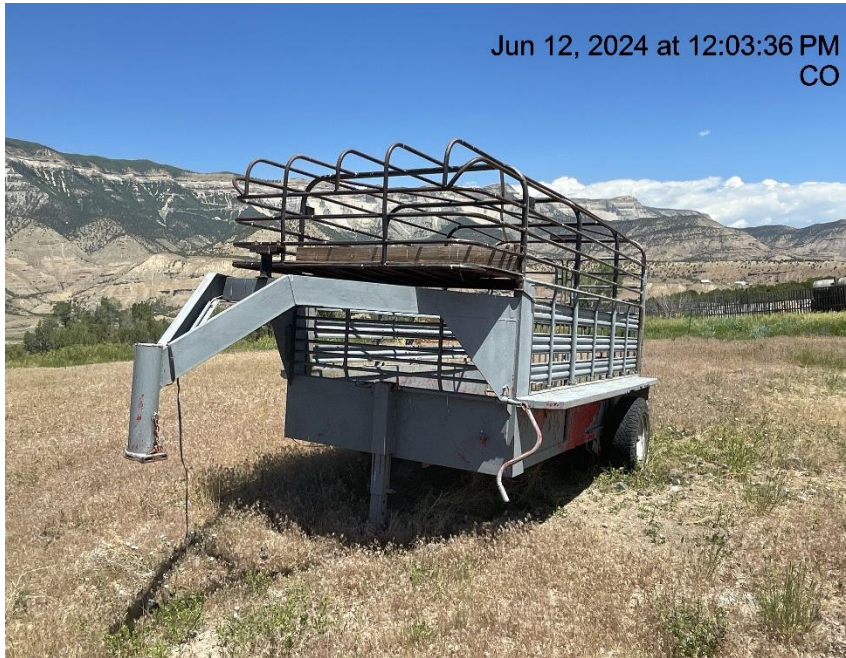
Photo # 546 Stored trailer in the interim area

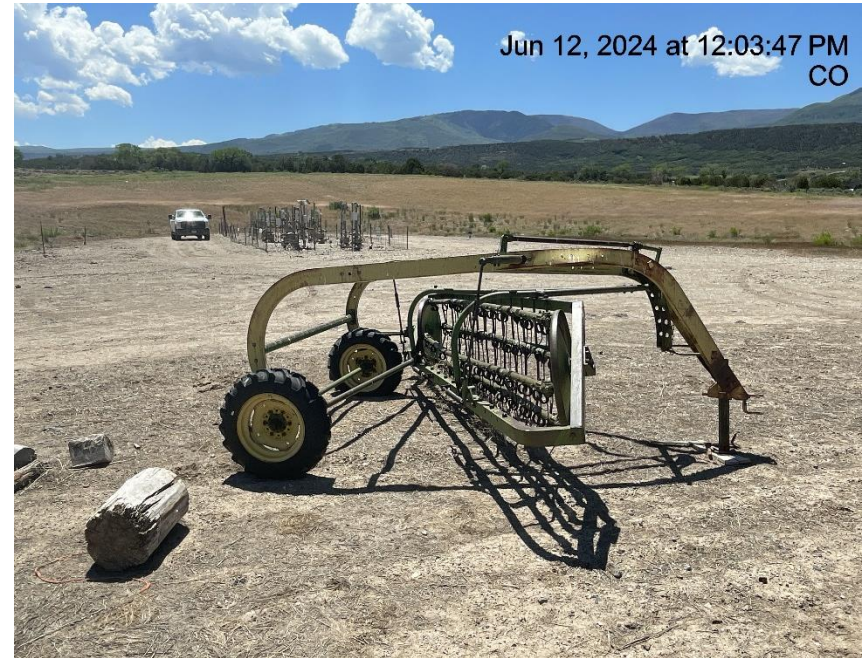
Photo # 547 Stored farm equipment on location

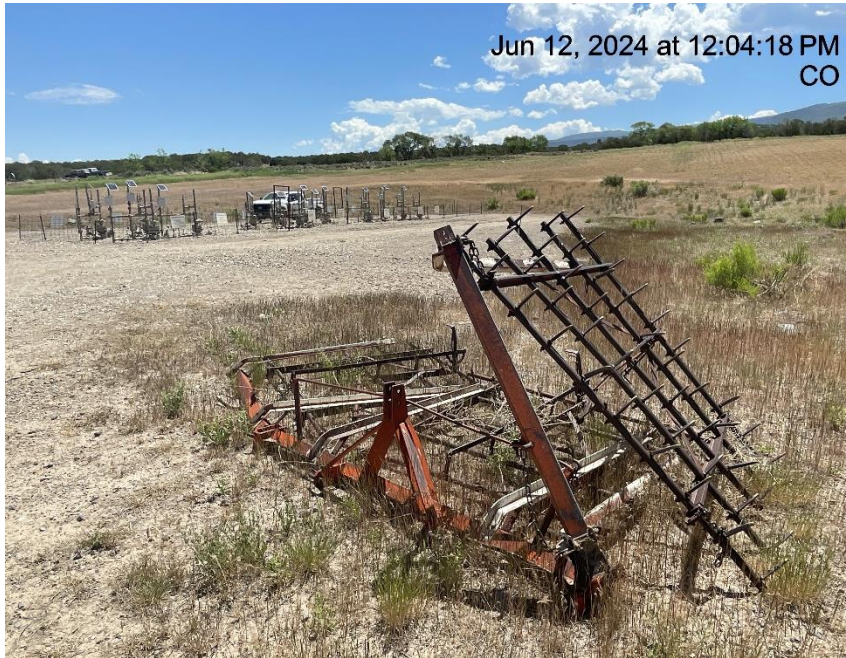
Photo # 548 Stored farm equipment in the interim area

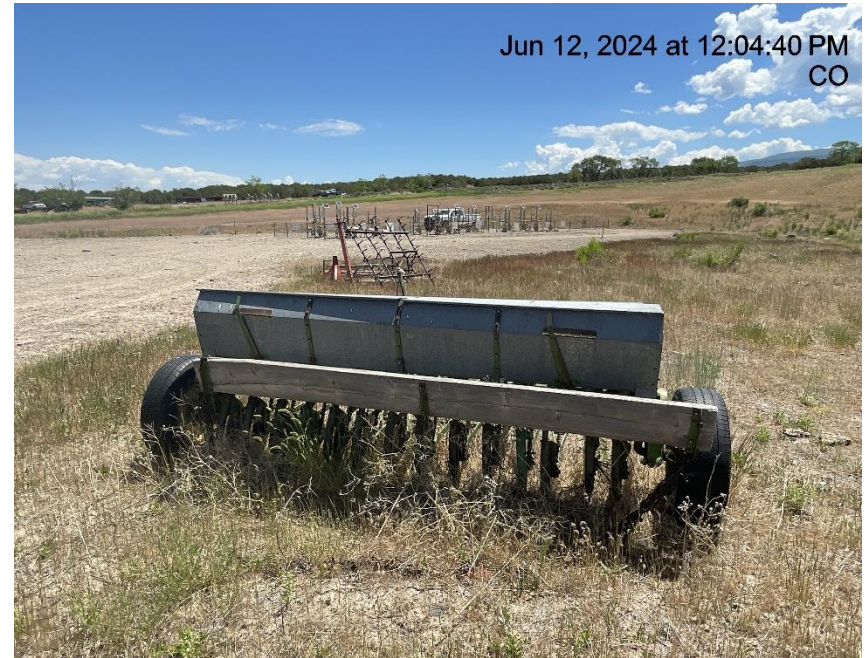
Photo # 549 Stored farm equipment in the interim area

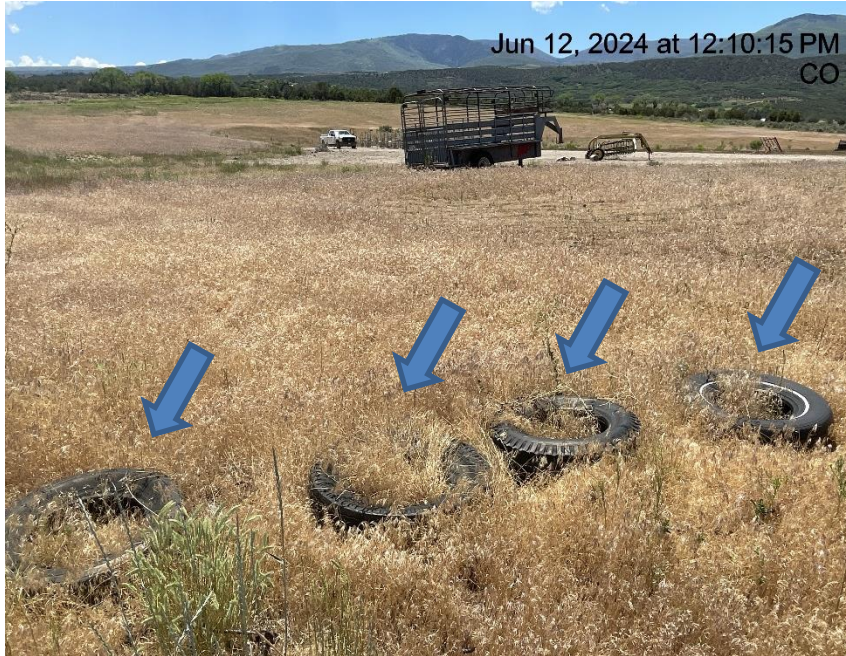
Photo # 550 Debris

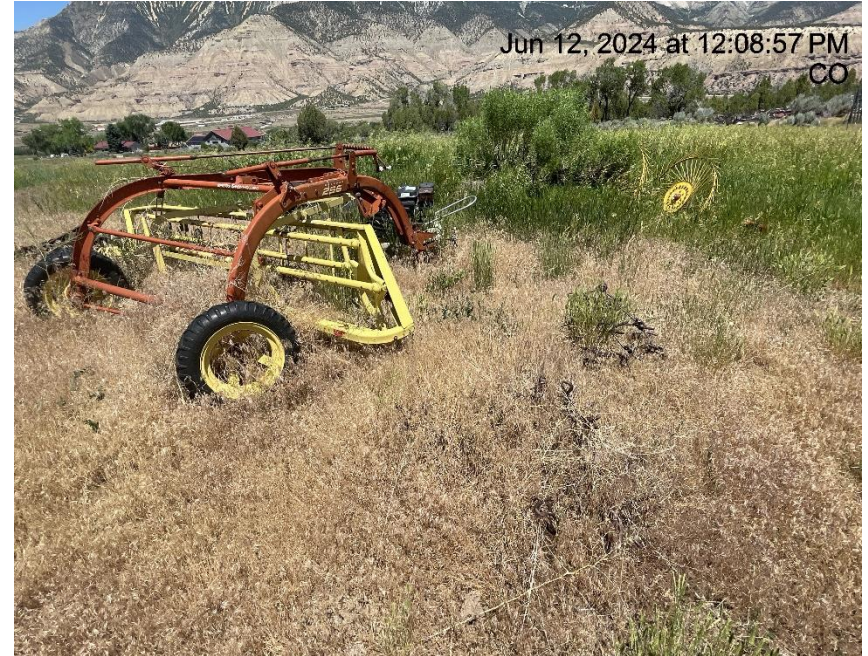
Photo # 551 Stored farm equipment in the interim area

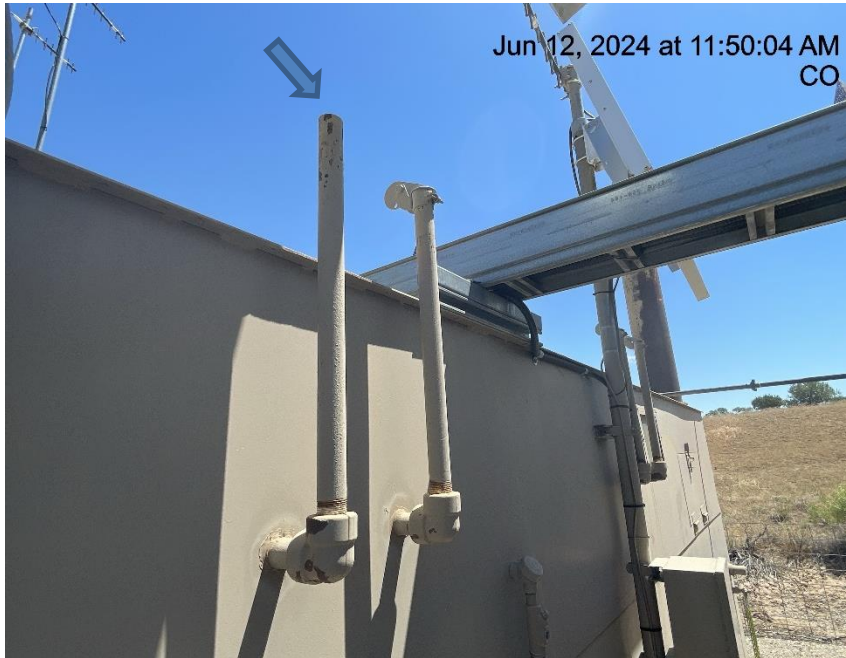
**Photo # 552 Rupture disc vent line does not comply with CECMC pressure safety device rules (RWF 533-30 separator)**

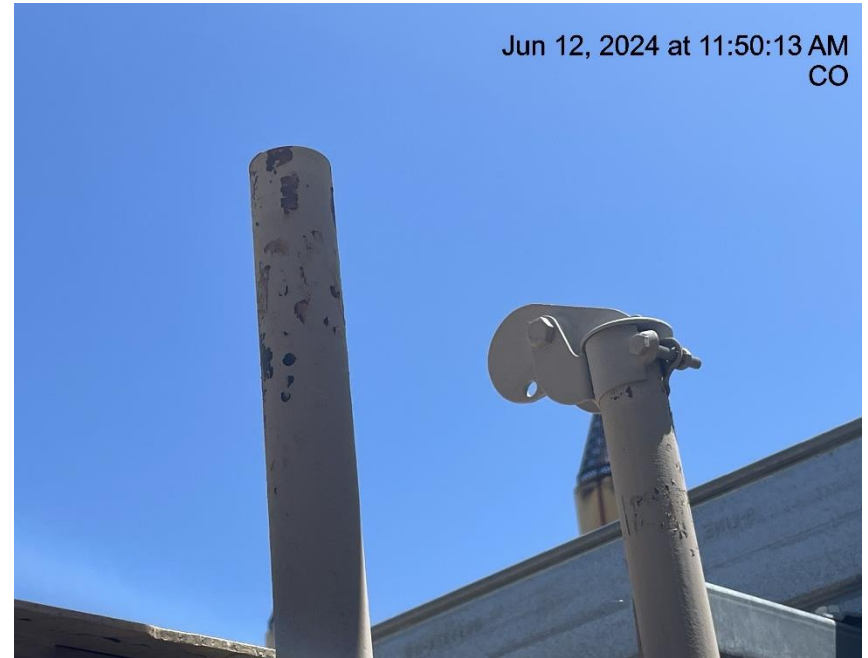
**Photo # 553 Rupture disc vent line does not comply with CECMC pressure safety device rules (RWF 533-30 separator)**

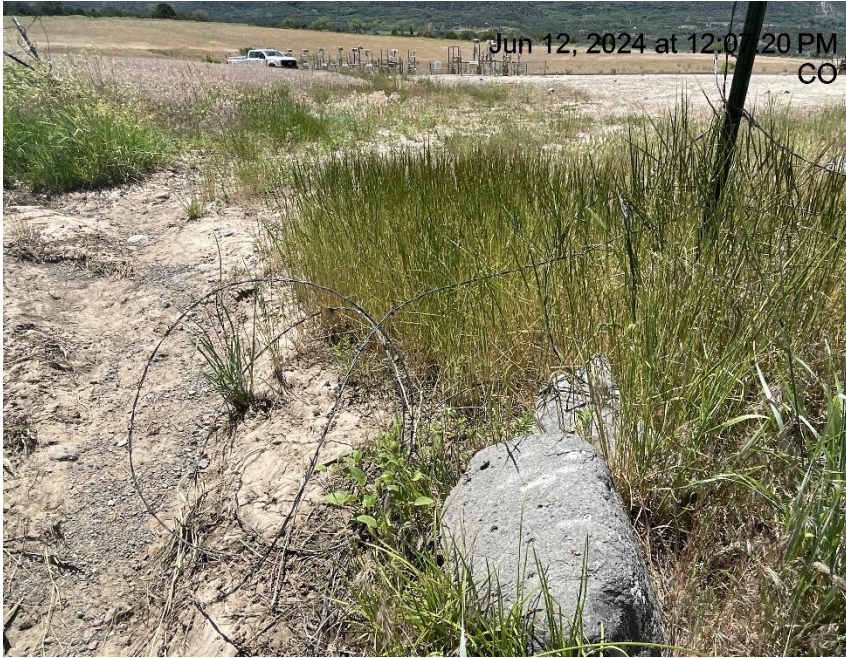
**Photo # 554 Barbed wire fence needs maintenance/wildlife hazard**

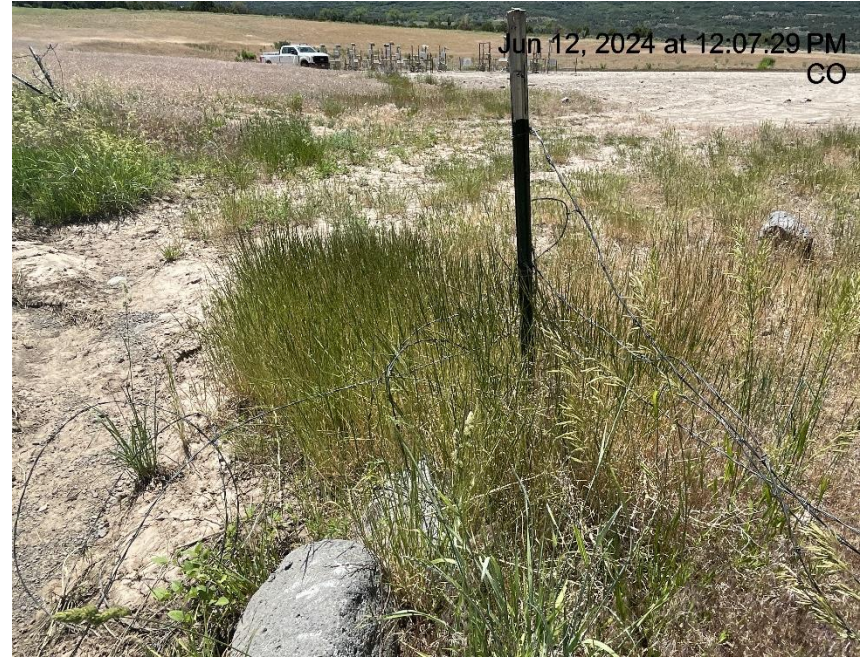
**Photo # 555 Barbed wire fence needs maintenance/wildlife hazard**

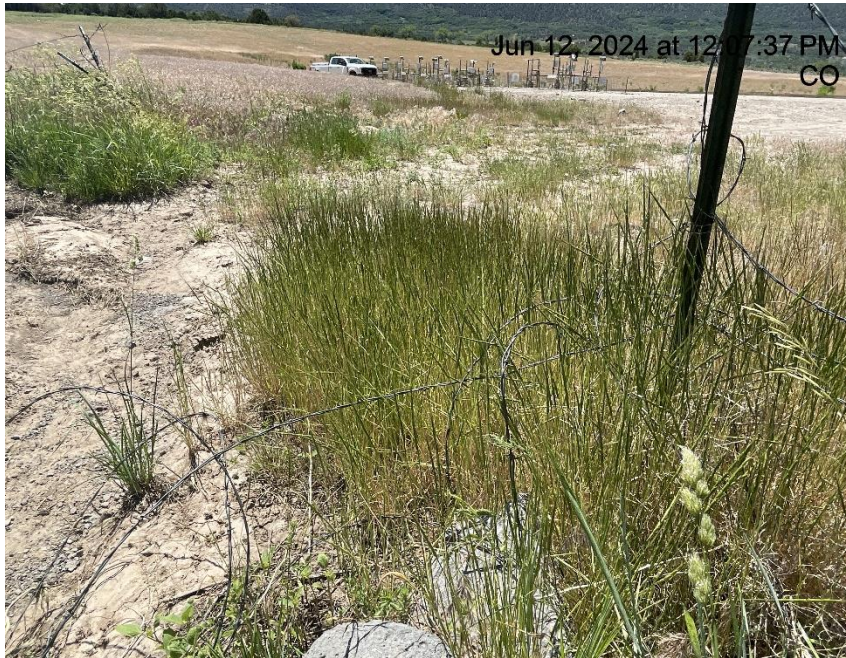
**Photo # 556 Barbed wire fence needs maintenance/wildlife hazard**

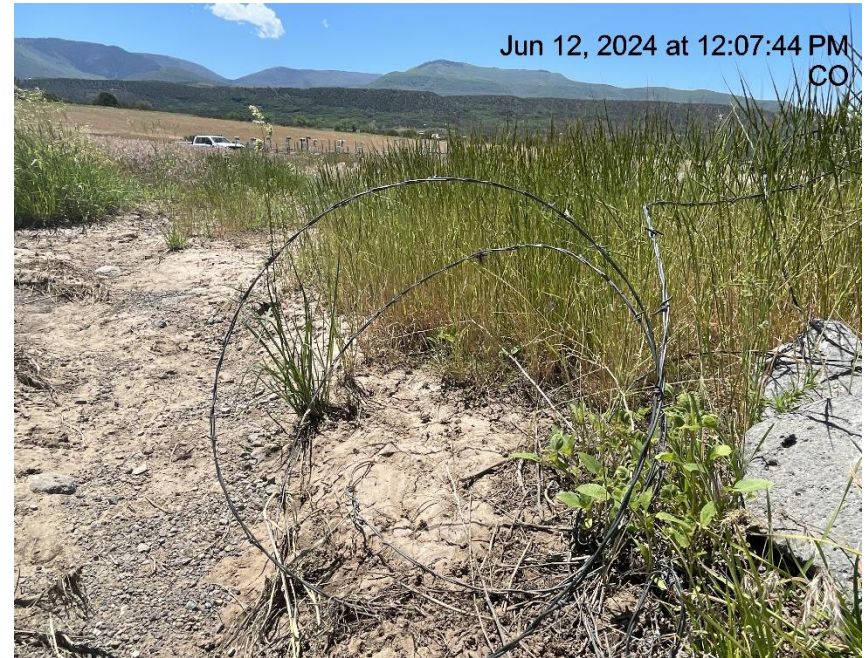
**Photo # 557 Barbed wire fence needs maintenance/wildlife hazard**

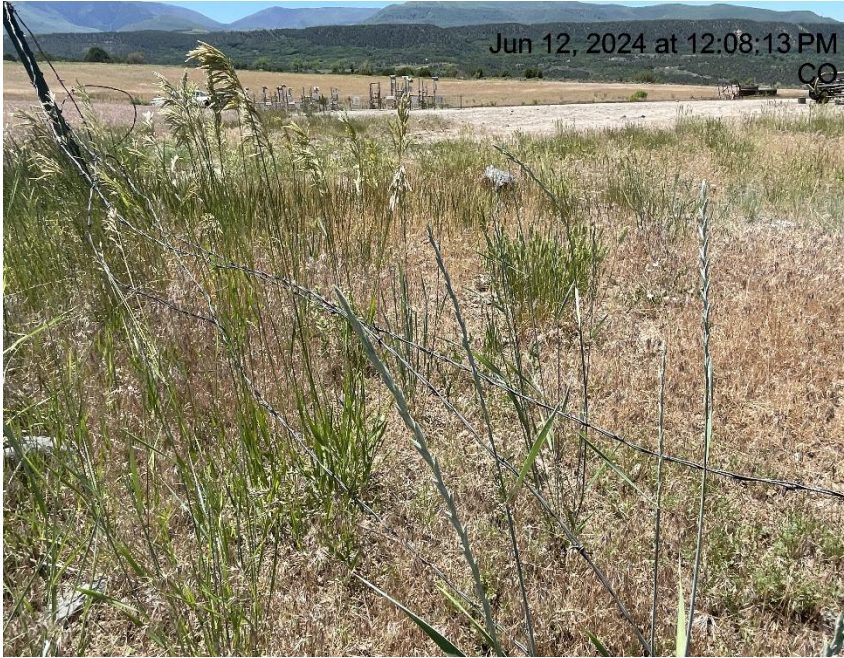
**Photo # 558 Barbed wire fence needs maintenance/wildlife hazard**

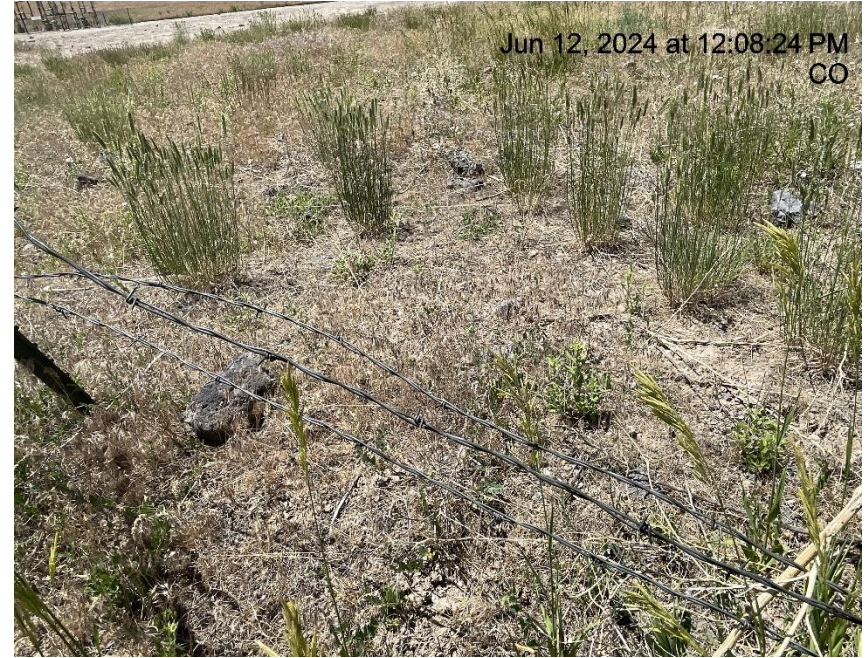
**Photo # 559 Barbed wire fence needs maintenance/wildlife hazard**

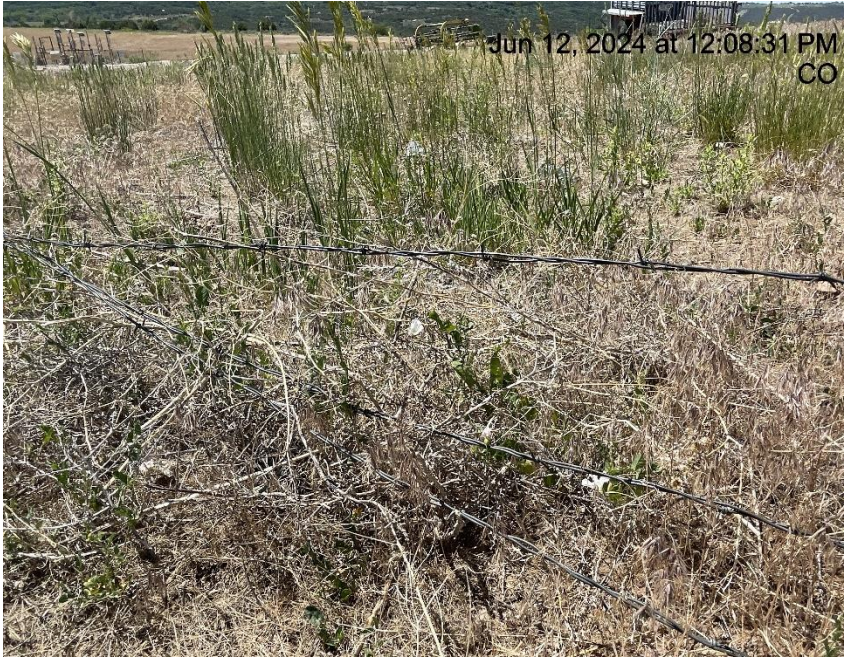
**Photo # 560 Barbed wire fence needs maintenance/wildlife hazard**

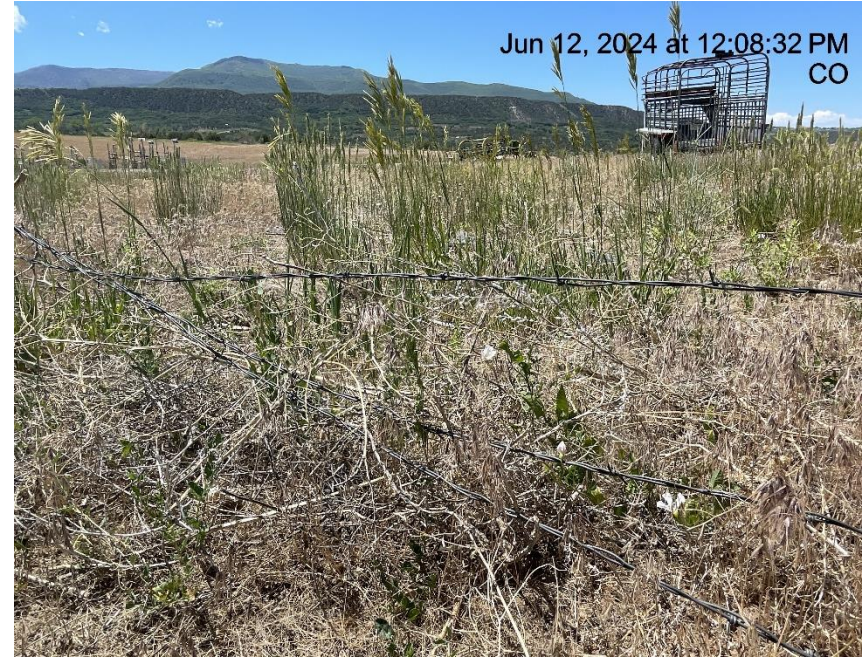
**Photo # 561 Barbed wire fence needs maintenance/wildlife hazard**

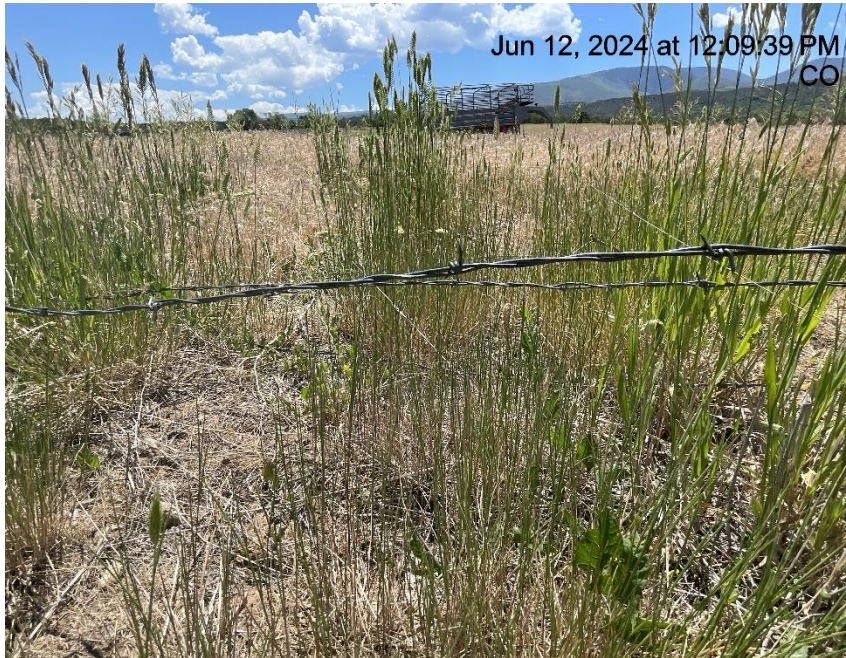
**Photo # 562 Barbed wire fence needs maintenance/wildlife hazard**

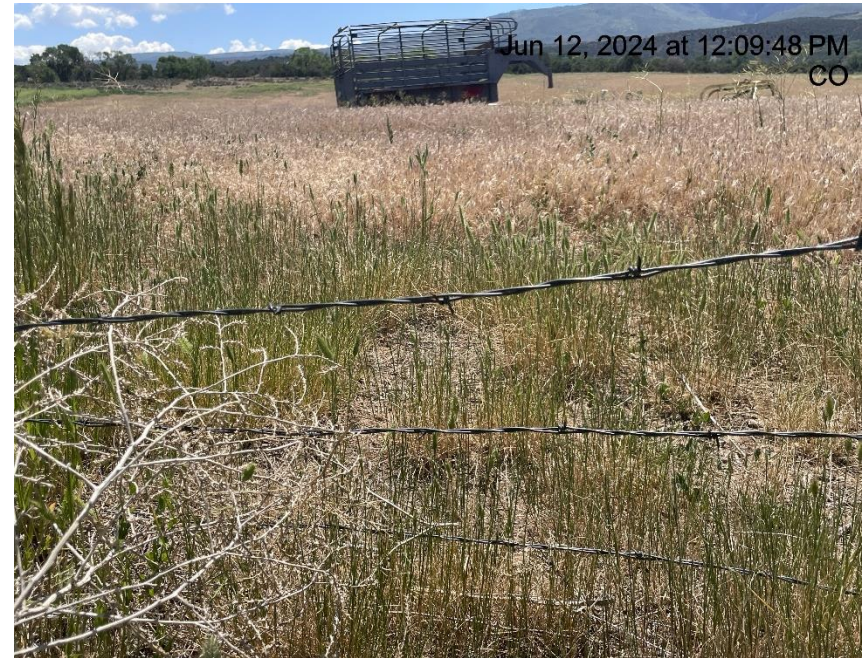
**Photo # 563 Barbed wire fence needs maintenance/wildlife hazard**

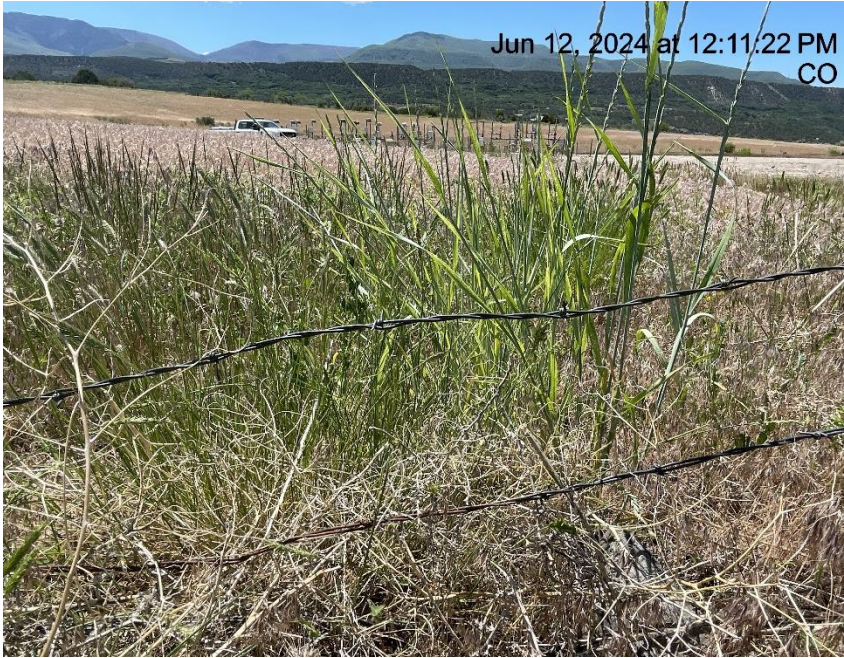
**Photo # 564 Barbed wire fence needs maintenance/wildlife hazard**

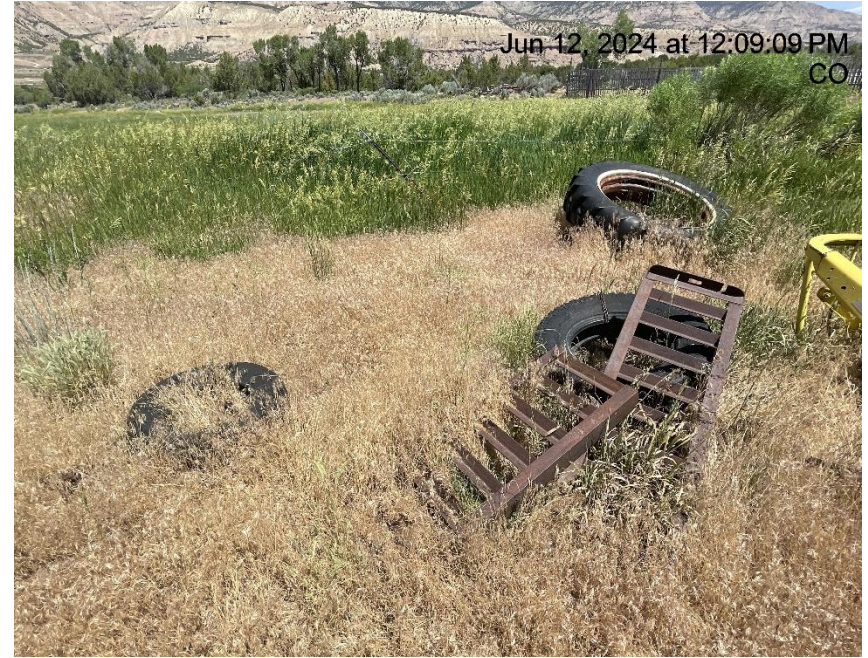
**Photo # 565 Debris**

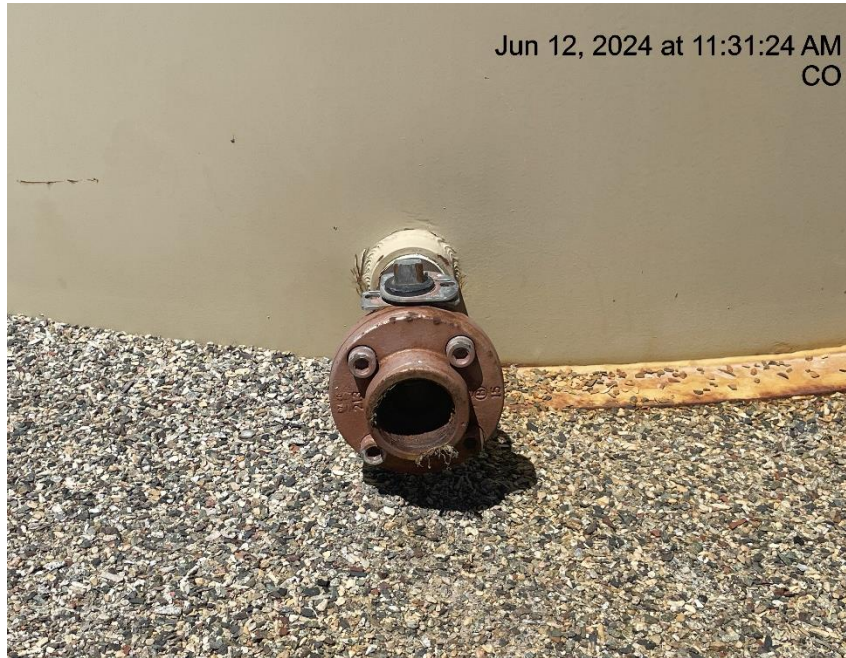
Photo # 566 Open ended load line

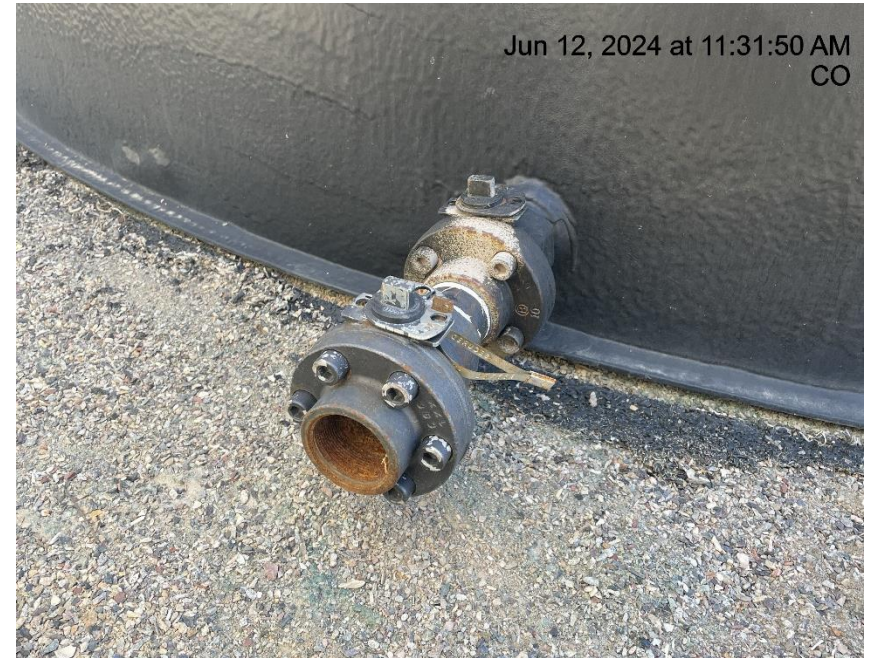
Photo # 567 Open ended load line

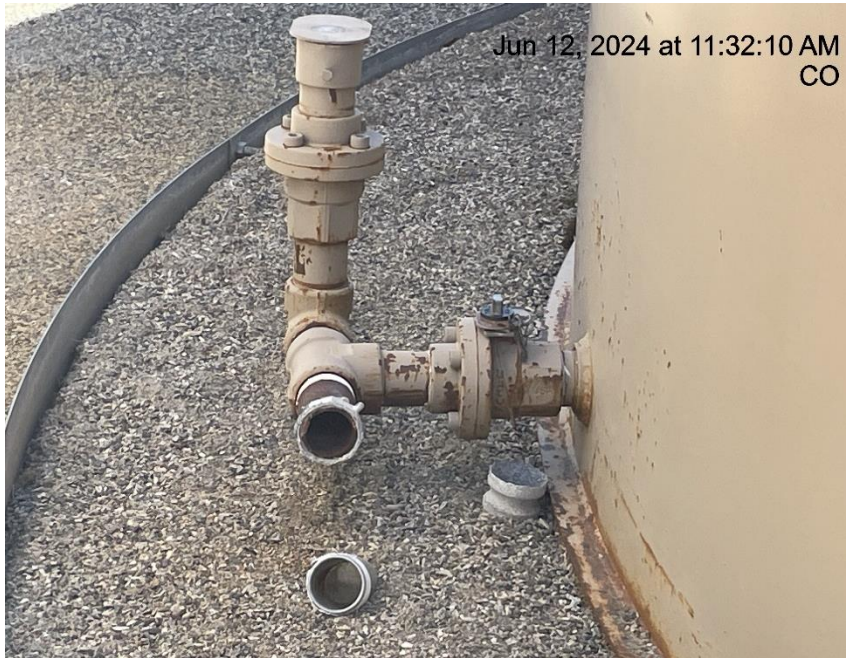
Photo # 568 Open ended load line

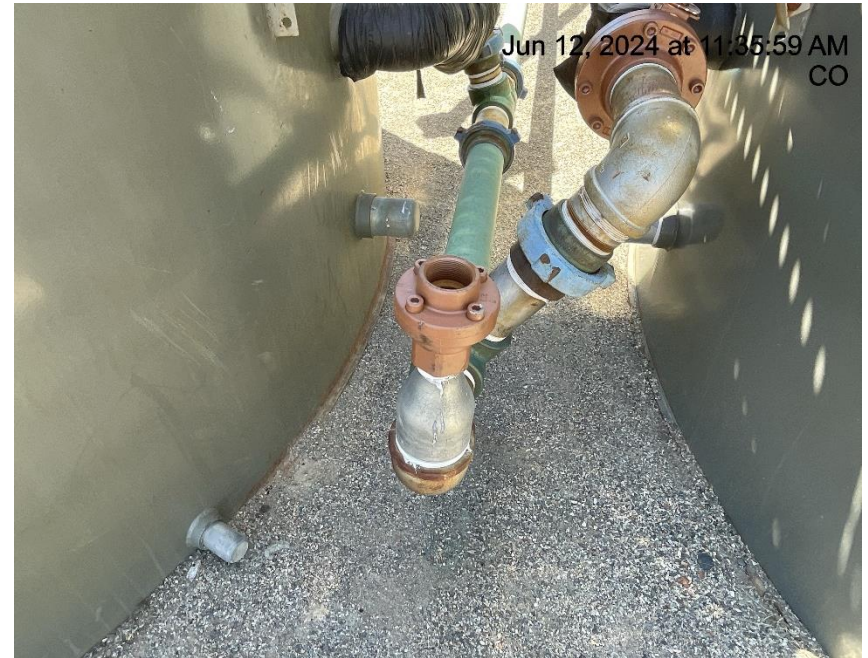
Photo # 569 Open ended load line
