Inspection Photos

Operator: Hilcorp Energy Company - 10133

Location ID: 306932

Inspection Photos
Location Name: Ute 34-101R
Location ID: 306932

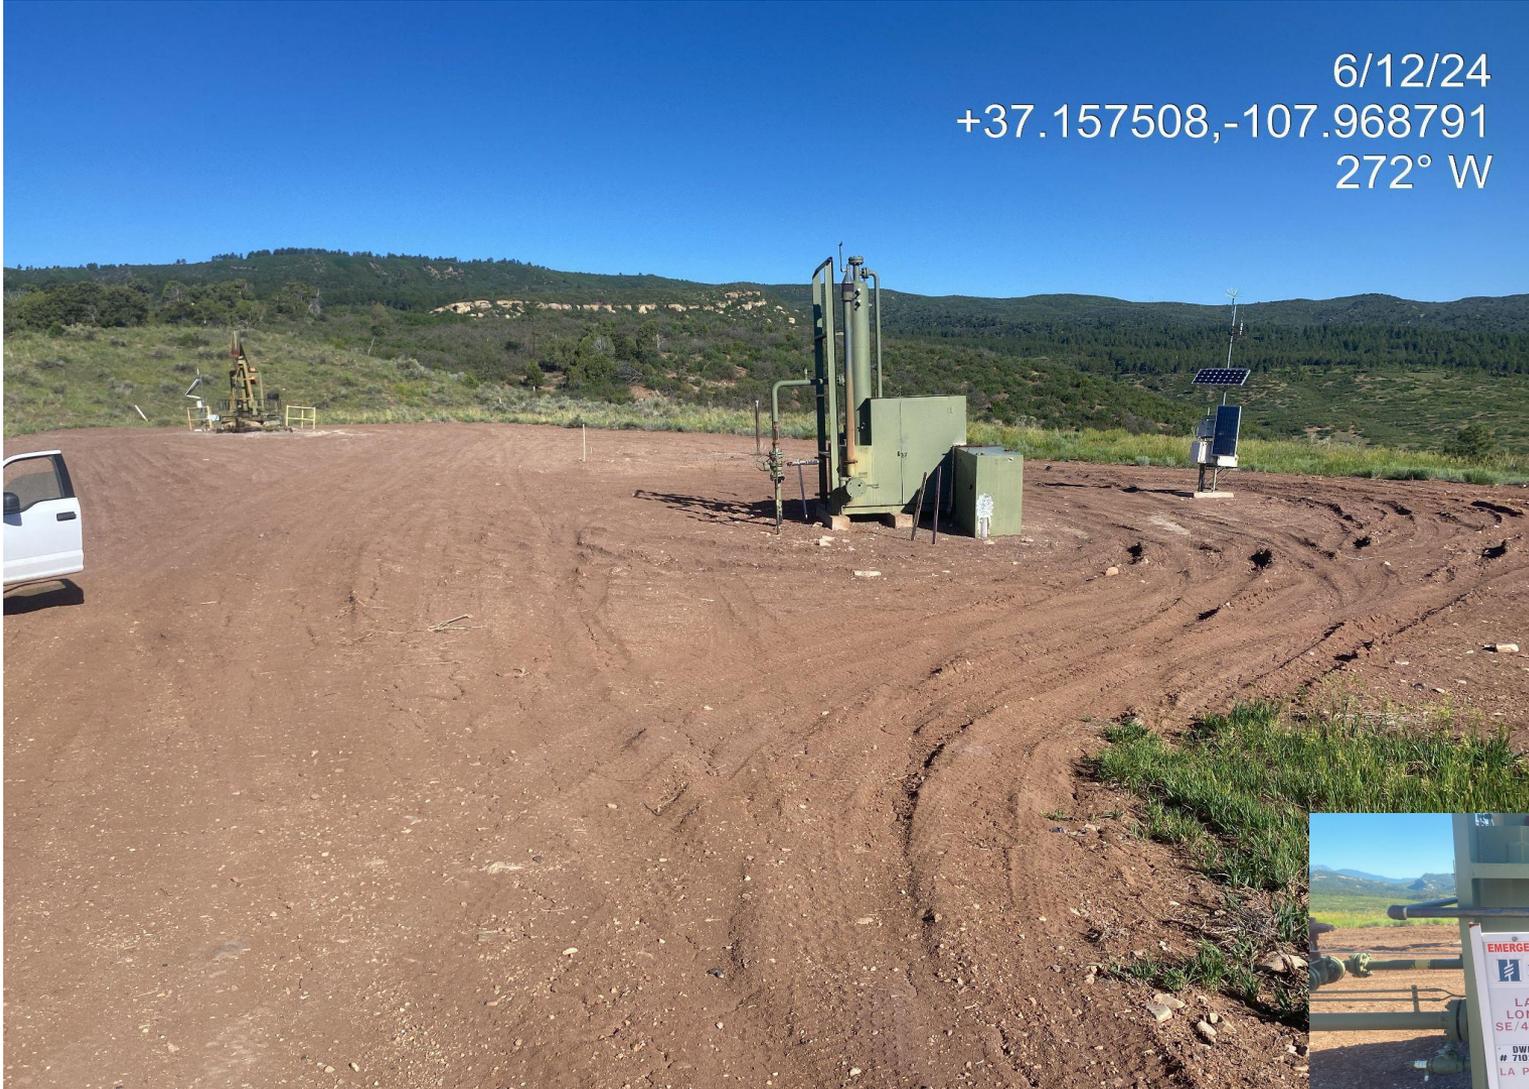
Photo 1. View of the well pad taken from the access road facing center.

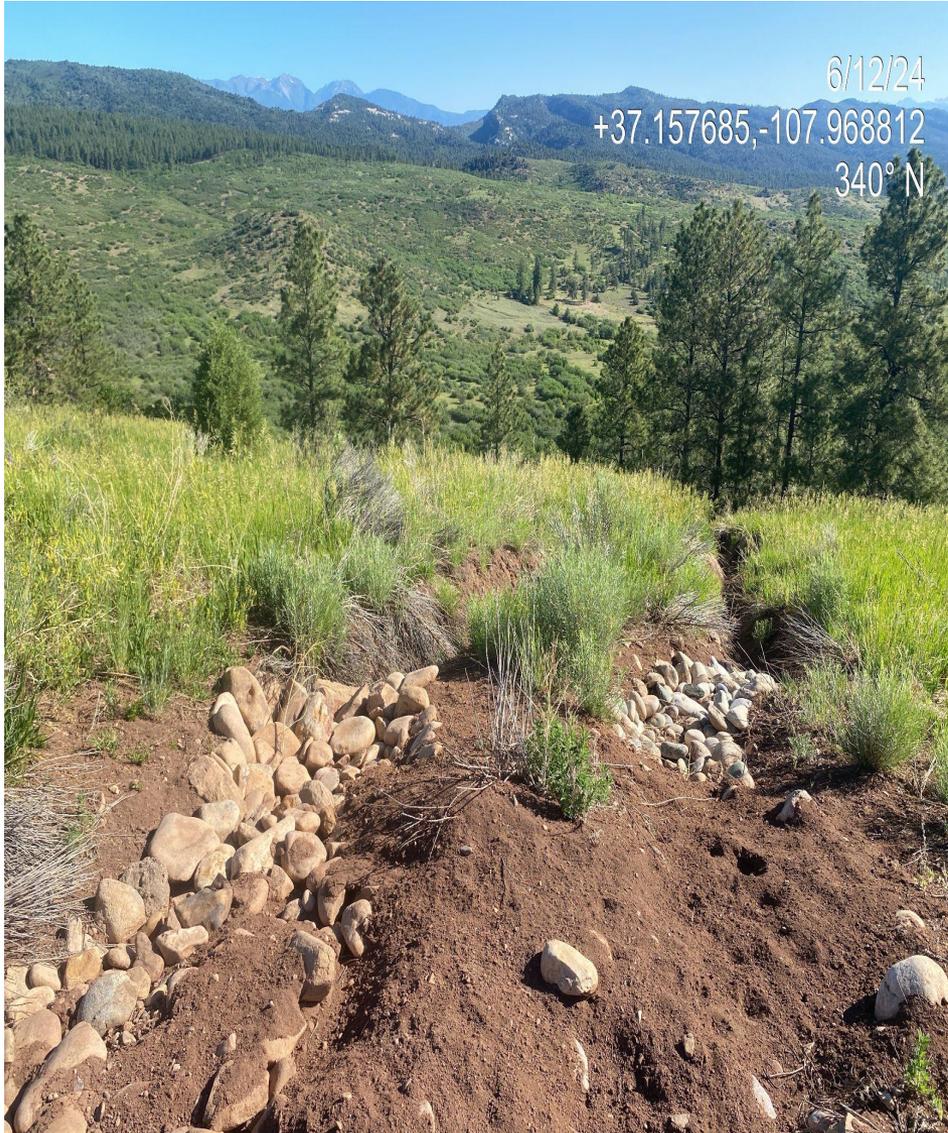
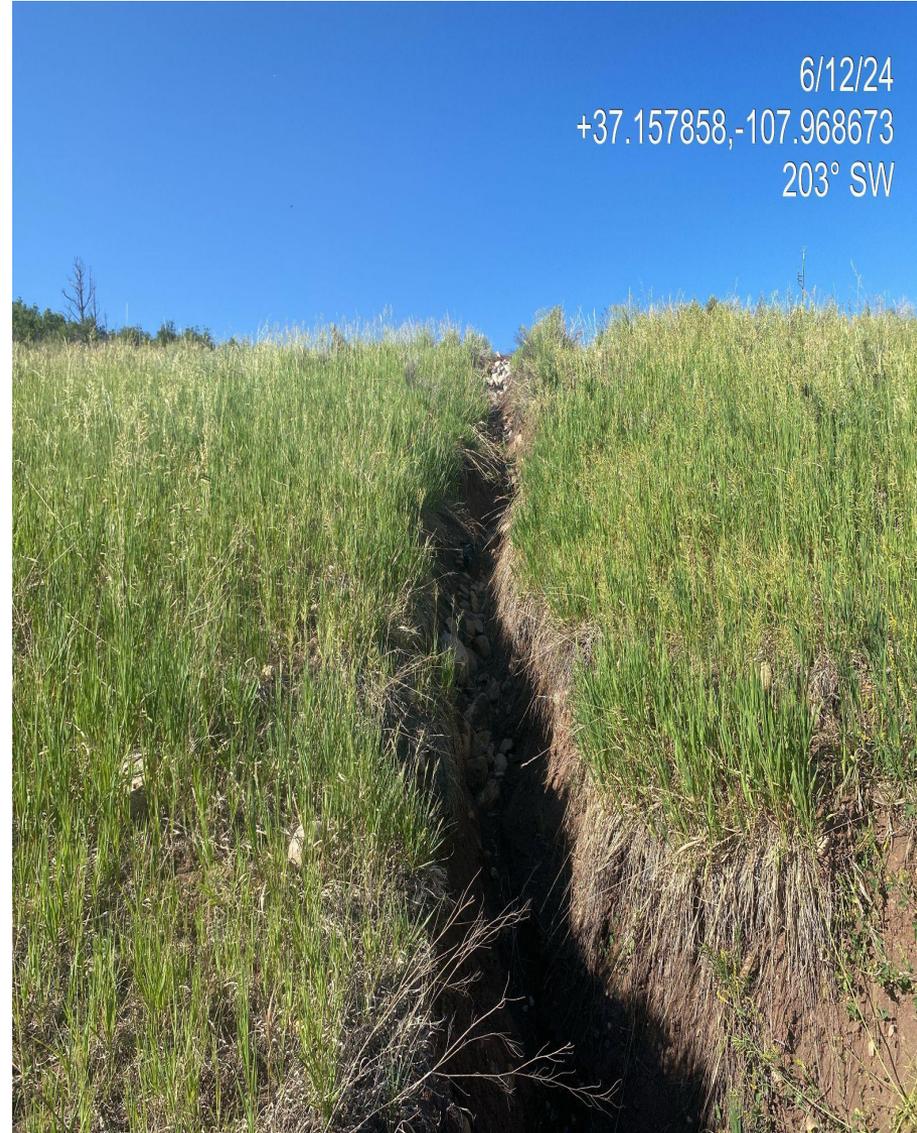
Photo 2. View of gully erosion that persists in the northern interim reclamation area. Gullies are about 2 feet wide and 2 to 3 feet deep. Current storm water BMPs are not adequate.

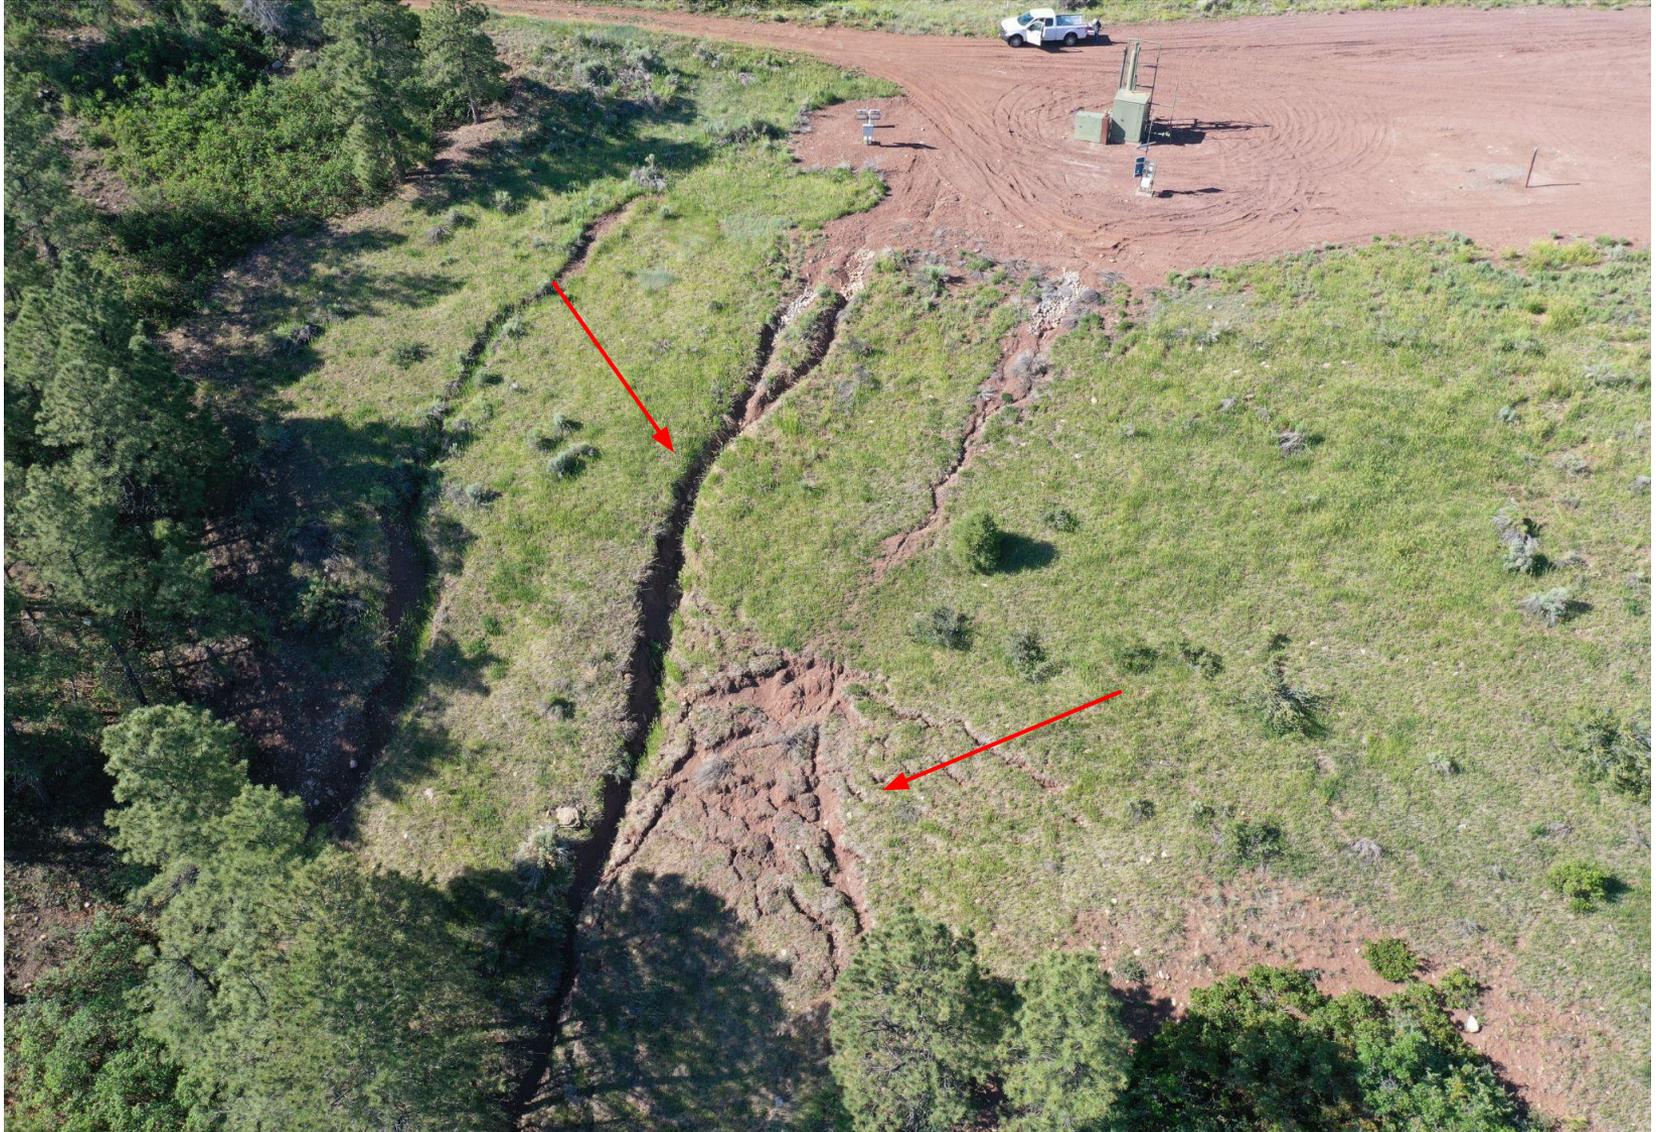
Photo 3. Additional view of gully erosion and sloughing occurring in the northern interim reclamation area. Additional stabilization is needed in this area. Photos taken with a drone from the northern edge facing south.

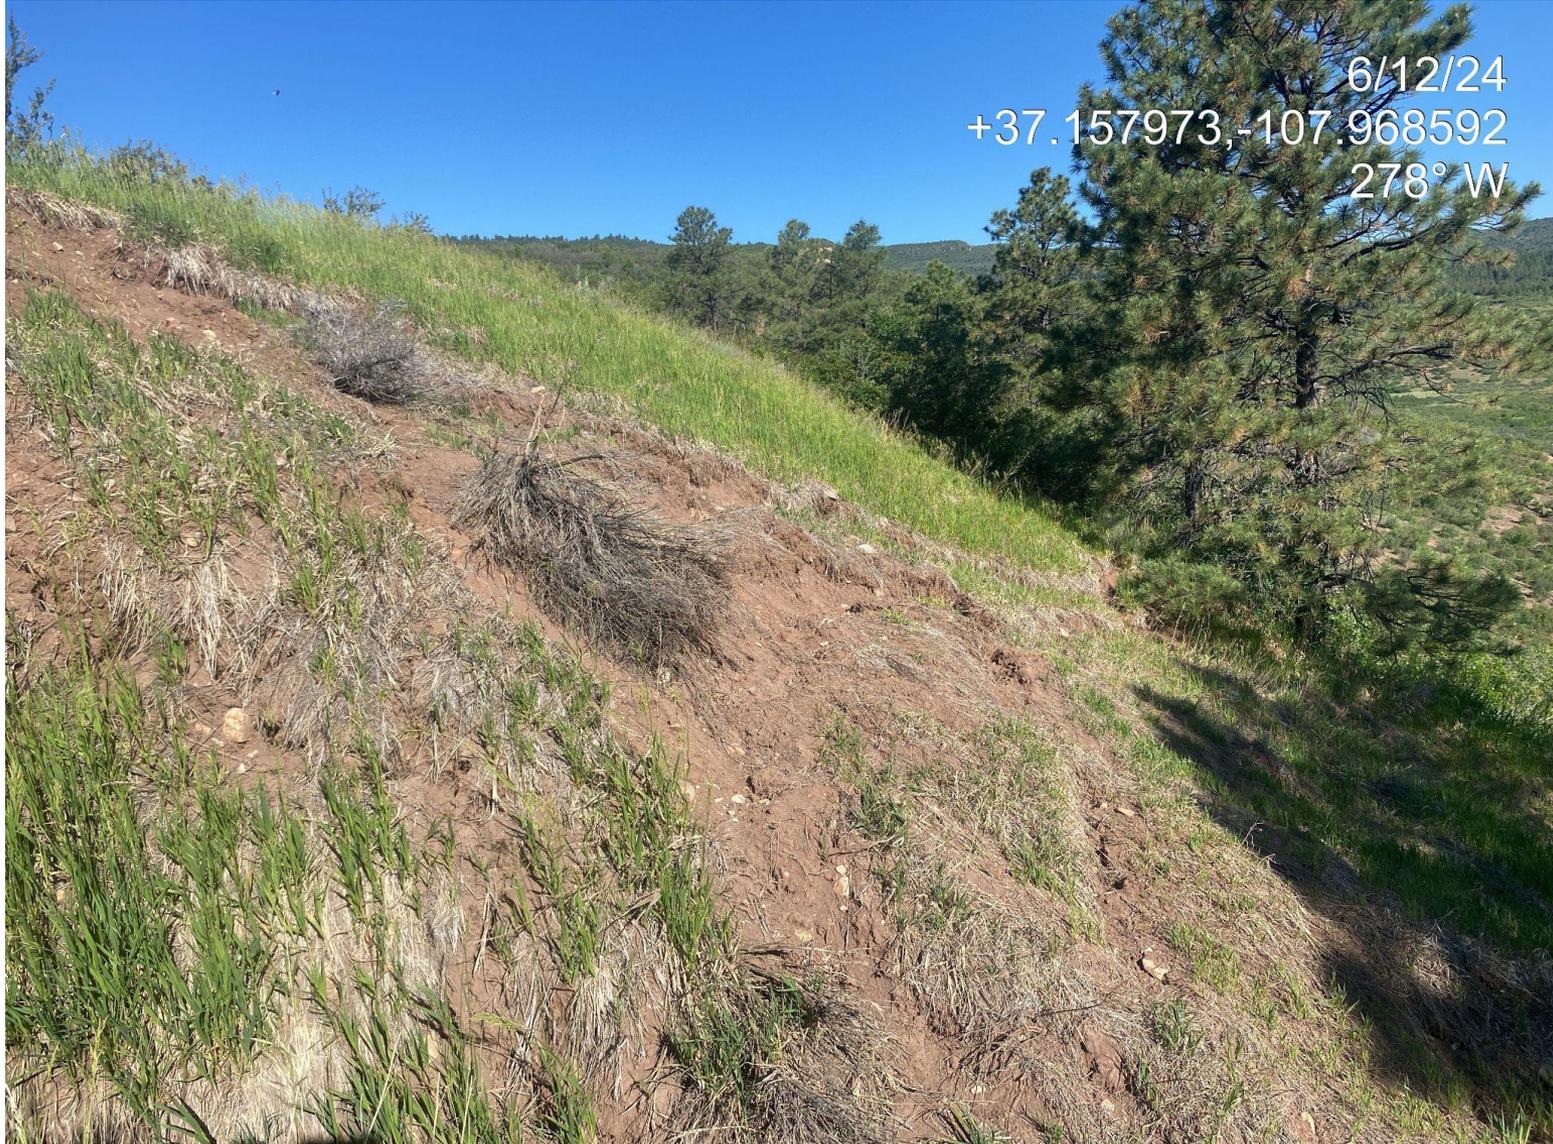
Photo 4. Ground view of sloughing occurring in the northern interim reclamation area.

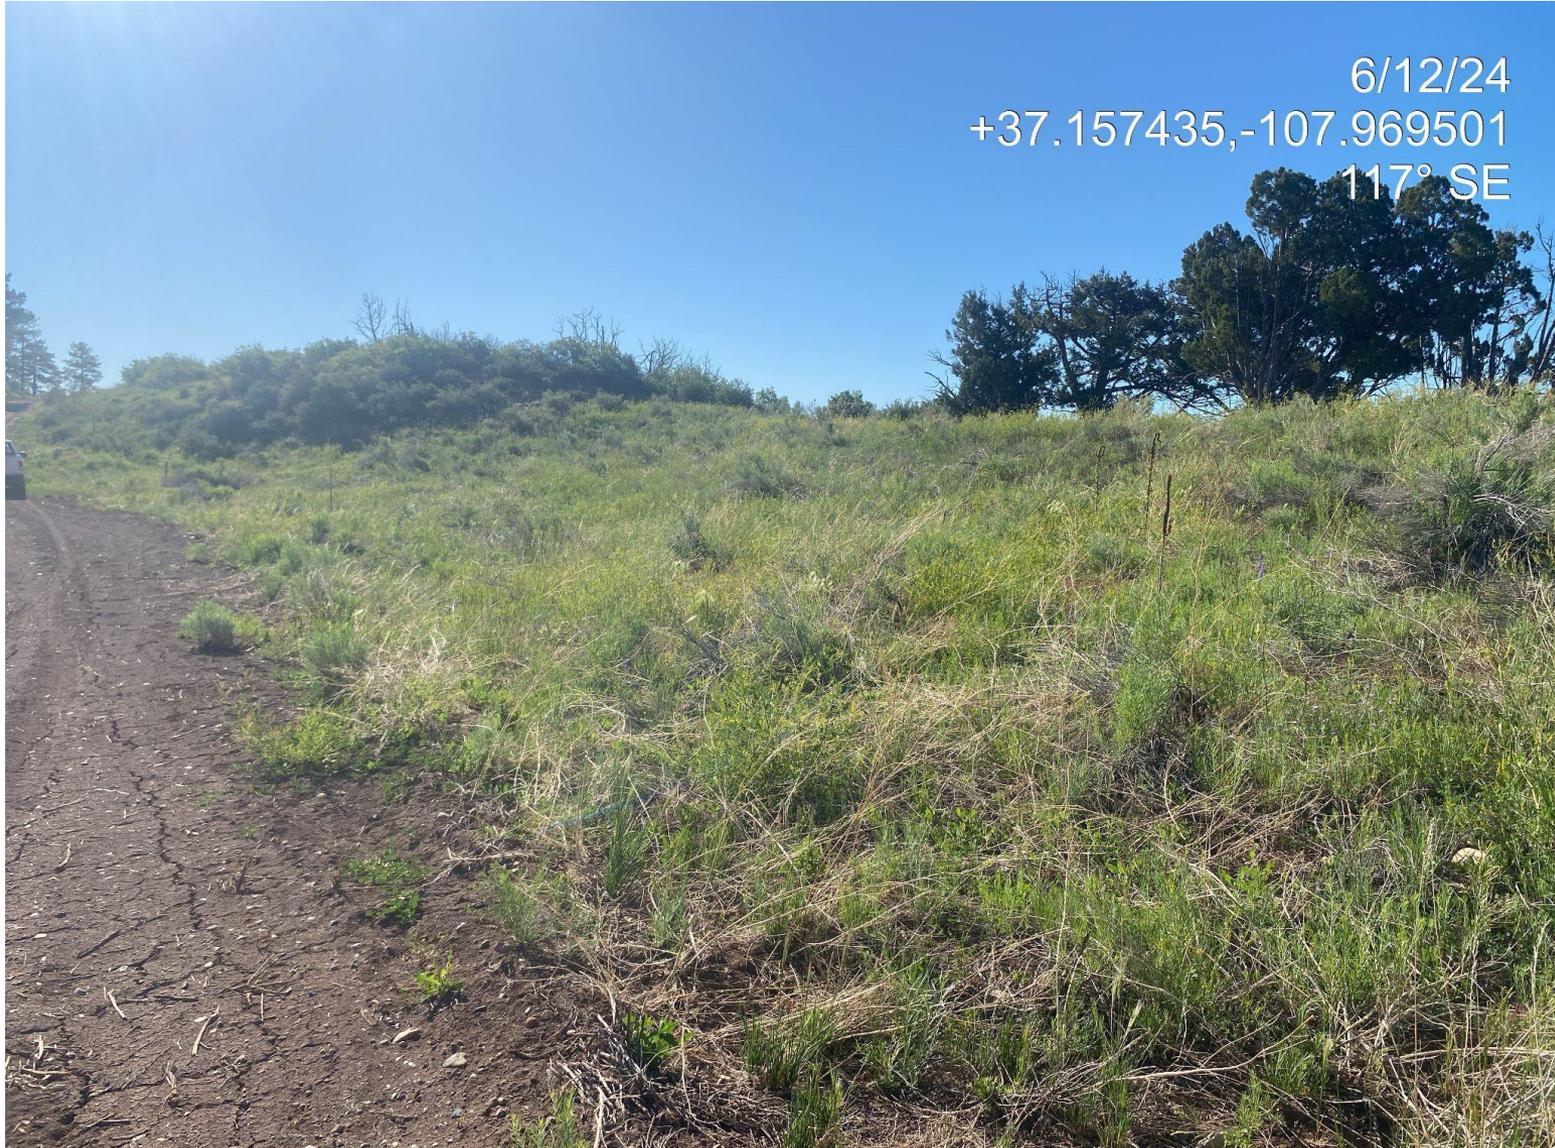
Photo 5. View of the southern interim reclamation area facing southeast.

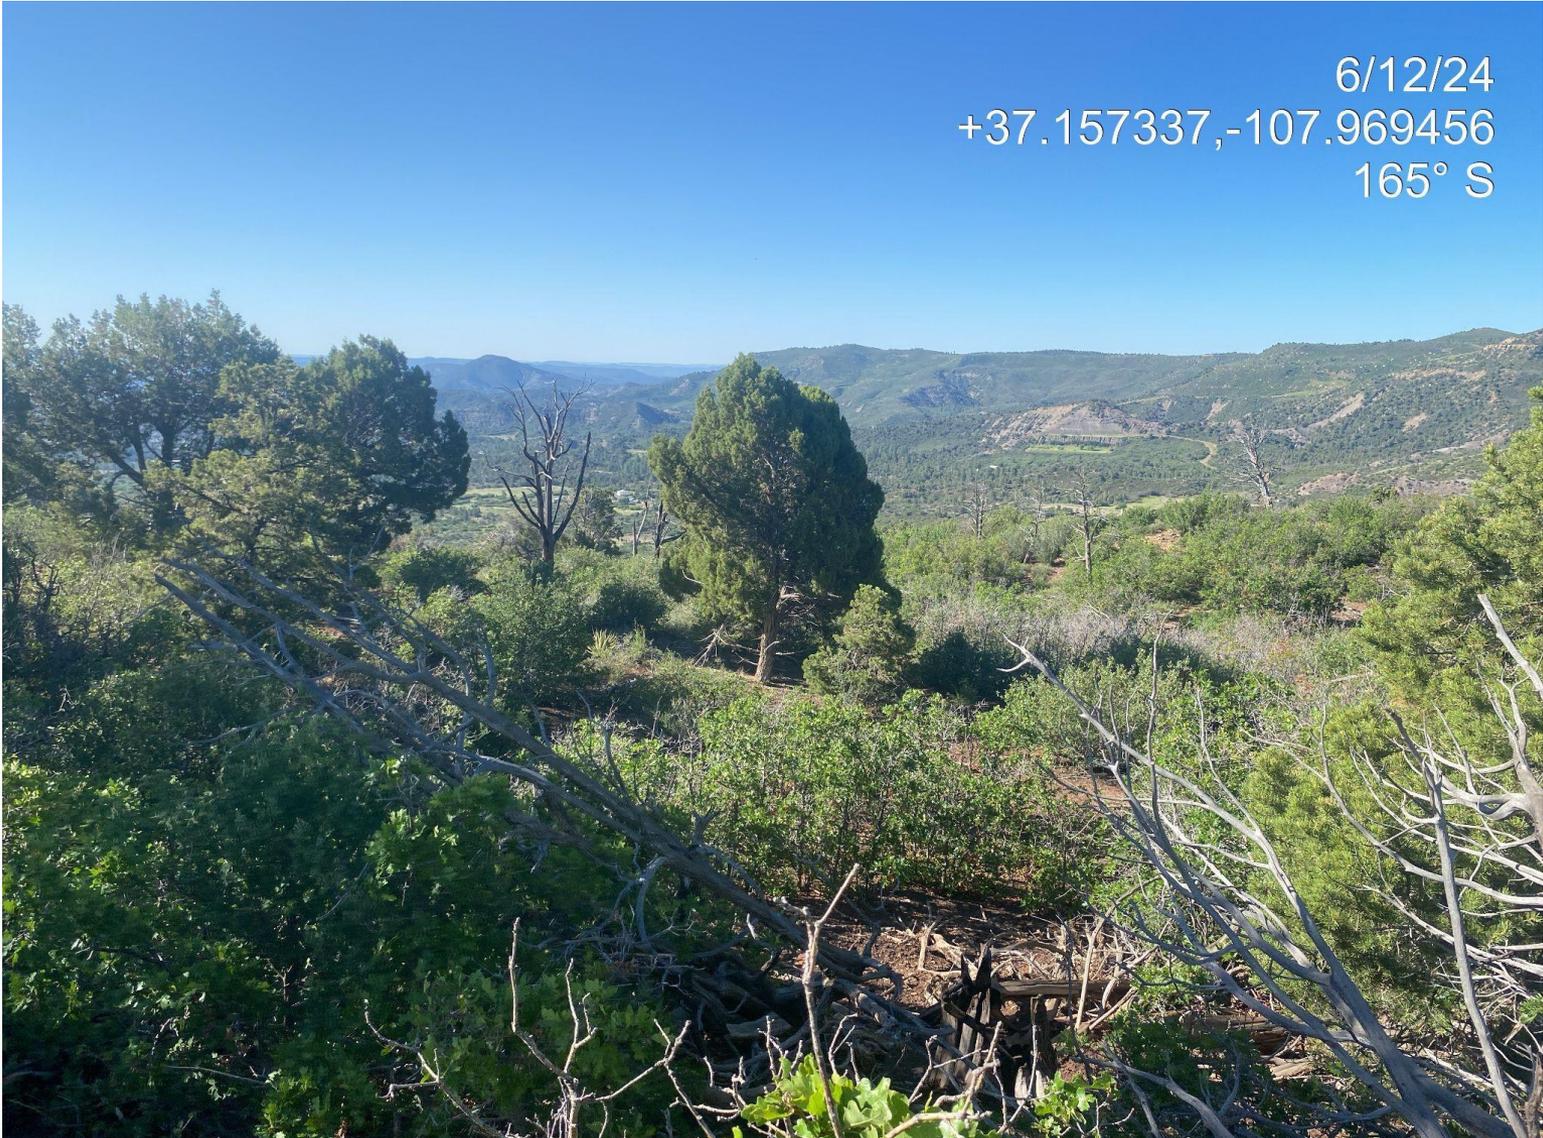
Photo 6. Reference area comprised of indian rice grass, juniper and gambel oak.
