Inspection Photos

Operator: Hilcorp Energy Company -10133

Location ID: 333494

Inspection Photos
Location Name: Argenta 34-10 32-2, 2A
Location ID: 333494

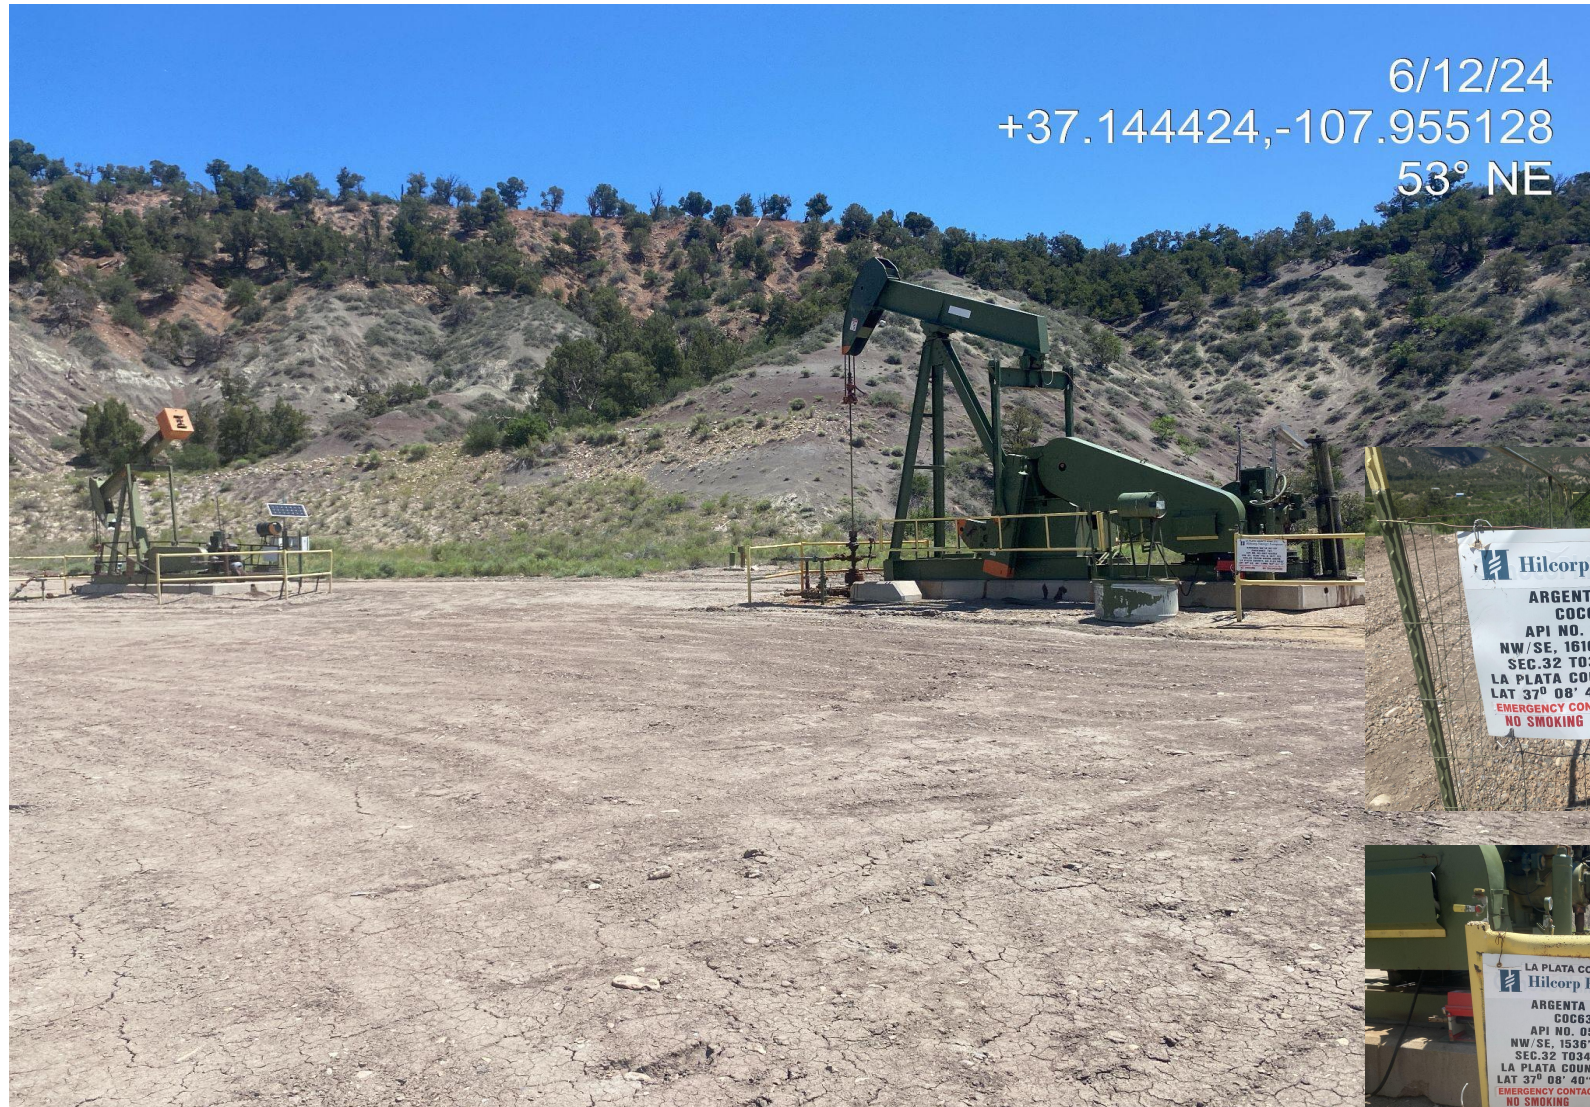
Photo 1. View of the well pad taken from the access point facing center.

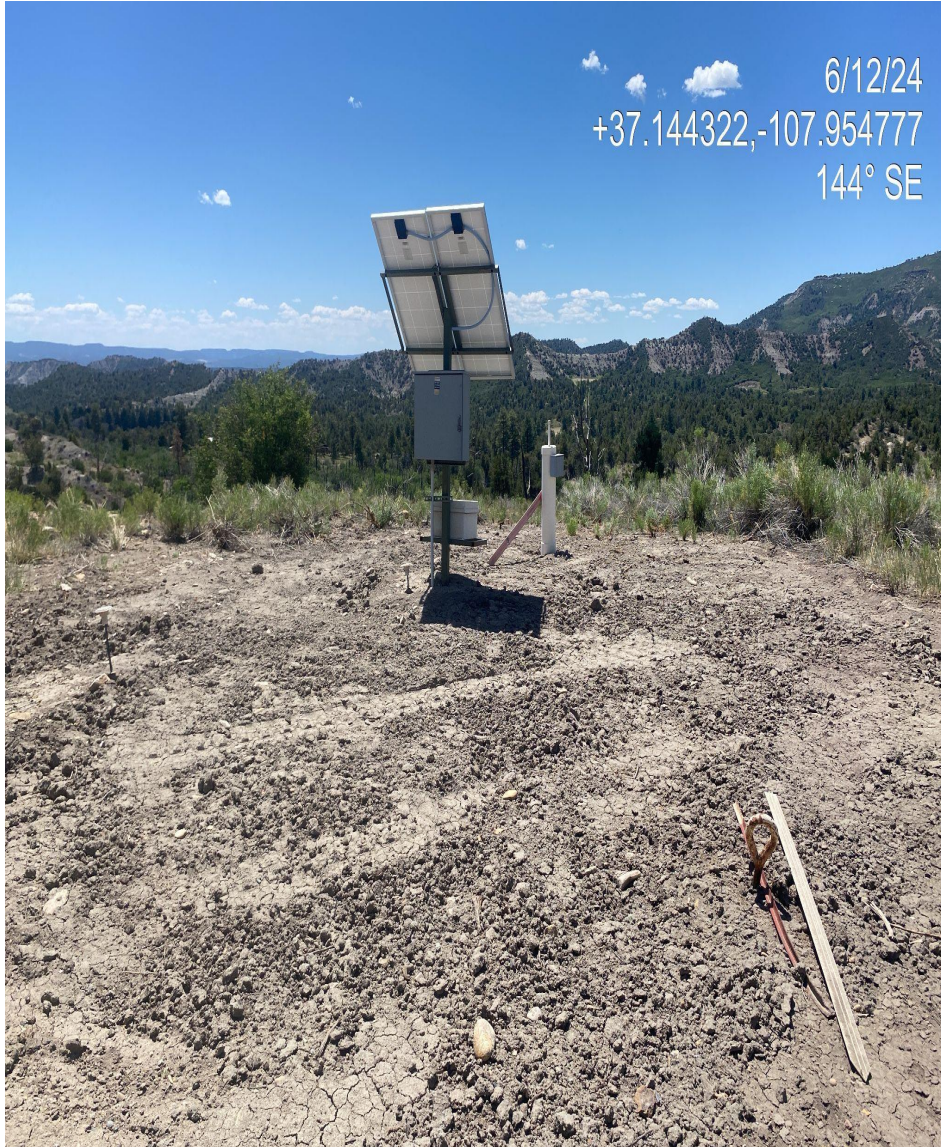
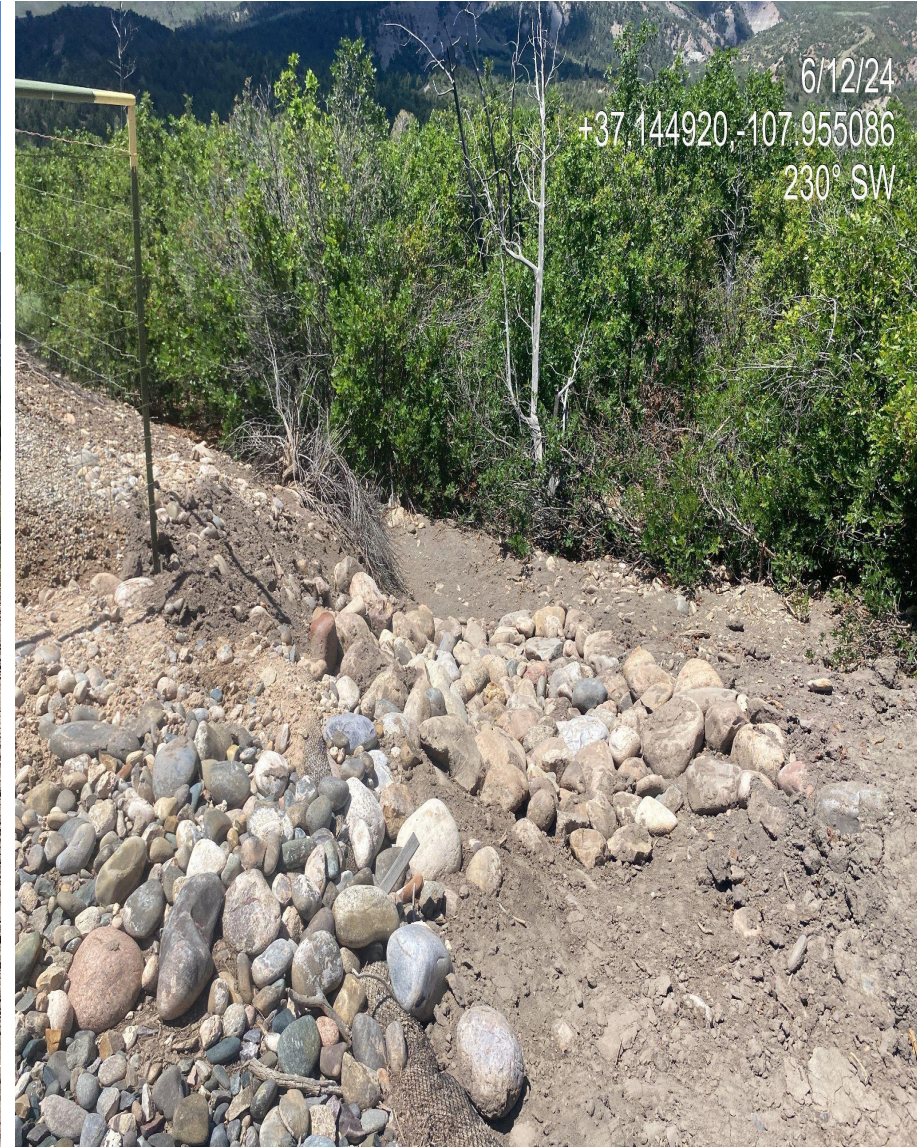
Photo 2. Storm water corrective actions identified in the previous inspection have been addressed/resolved.

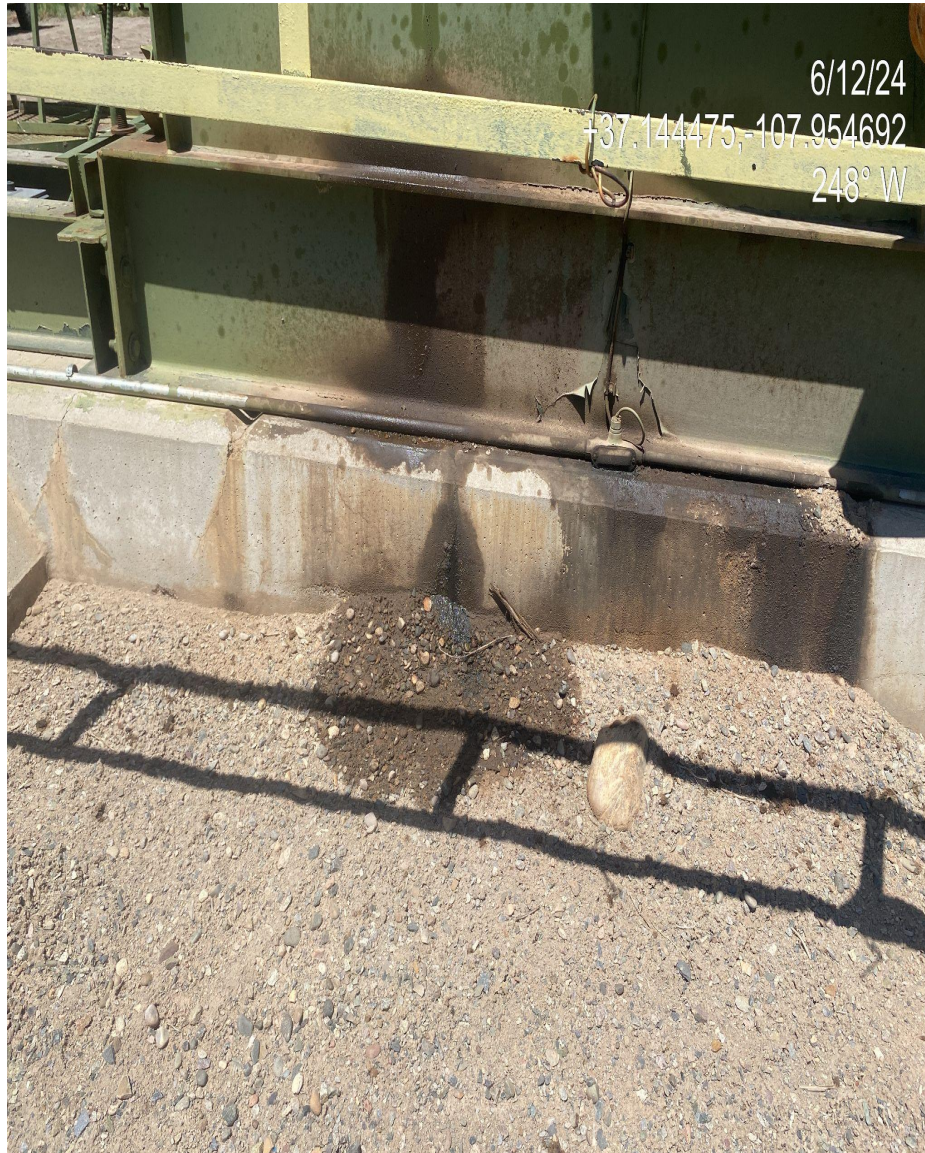
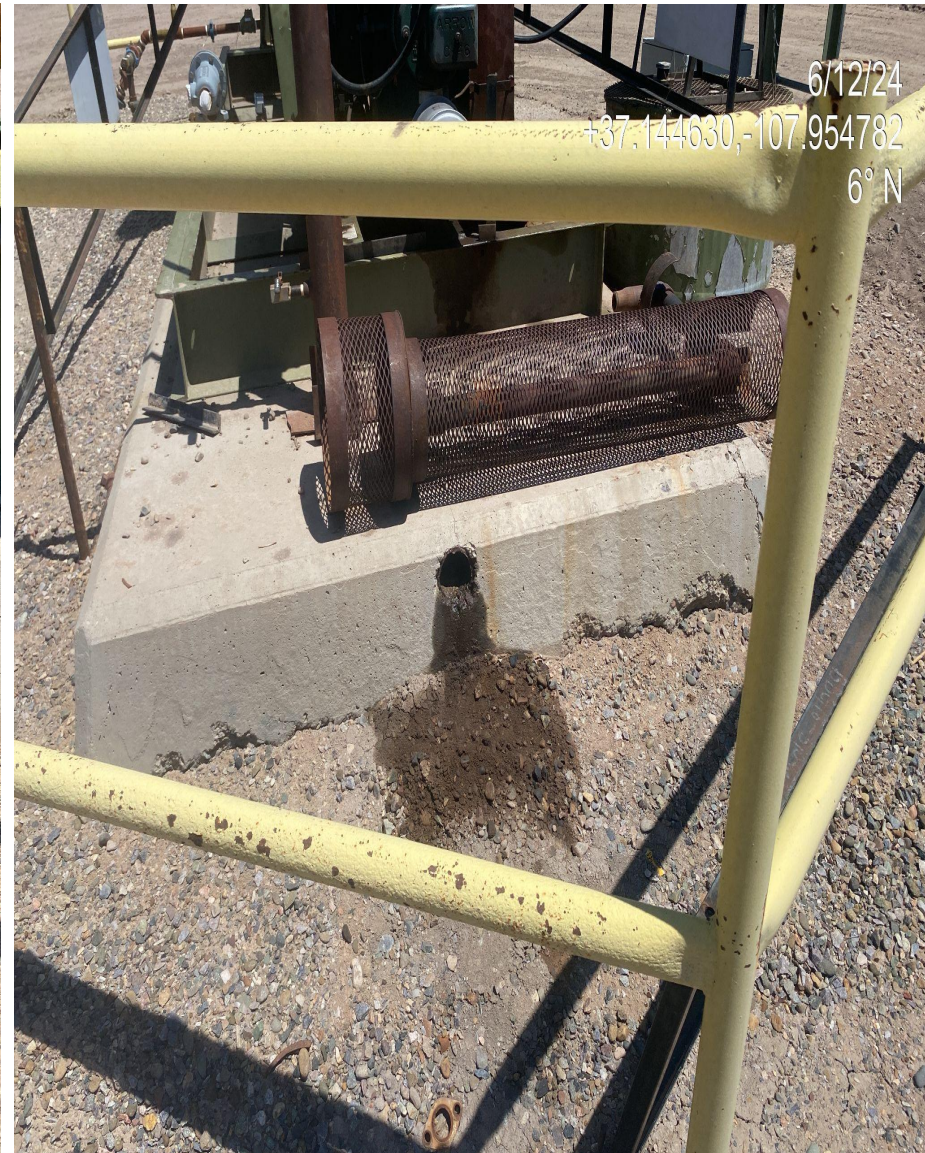
Photo 3. View of impacted surface material observed at the pump jacks.

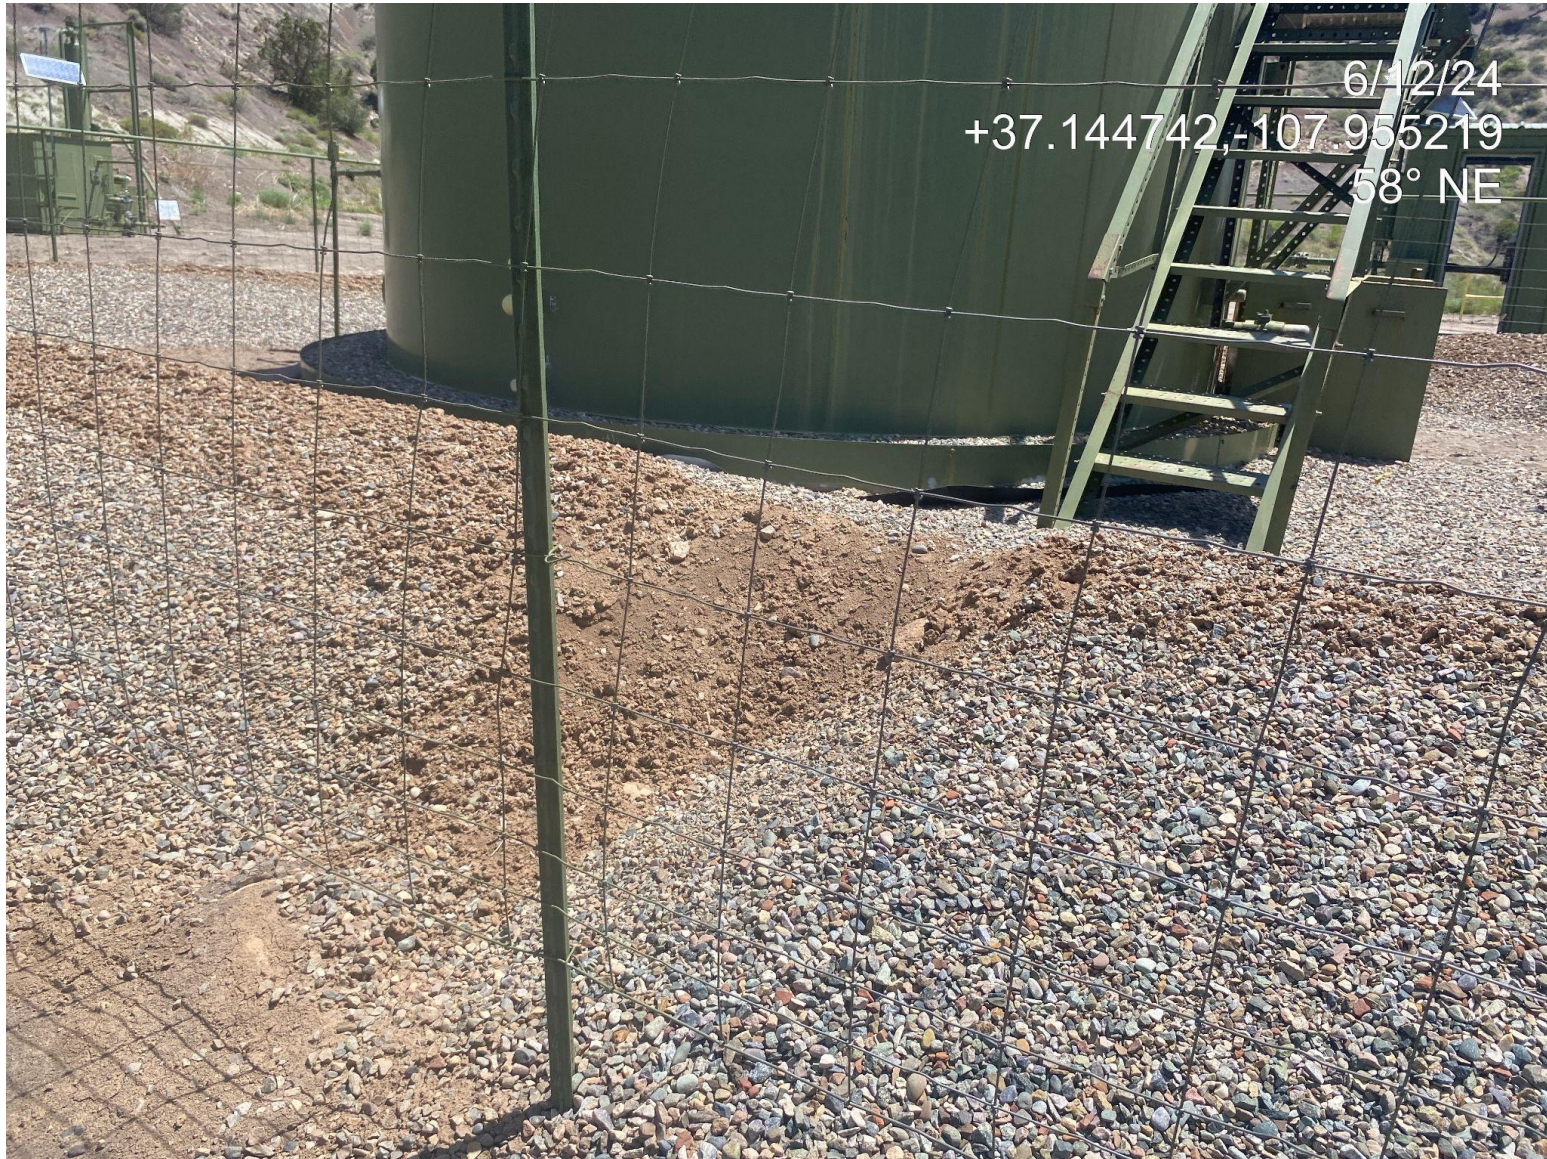
Photo 4. Tank berm remains damaged, maintenance is needed.
