Caerus Piceance LLC  
Piceance Creek Unit F23-18G  
Location ID: 315347

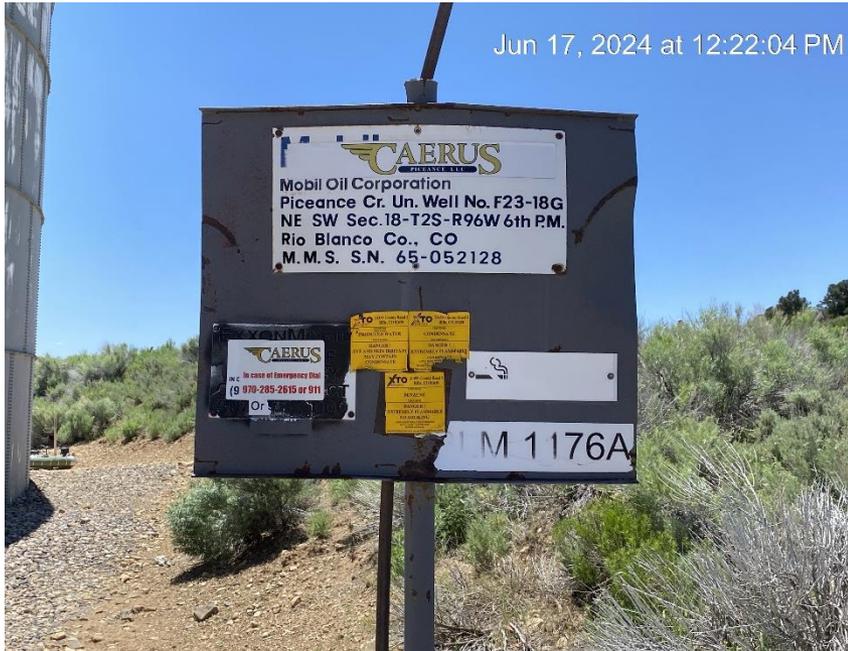
When replaced additional information will be required

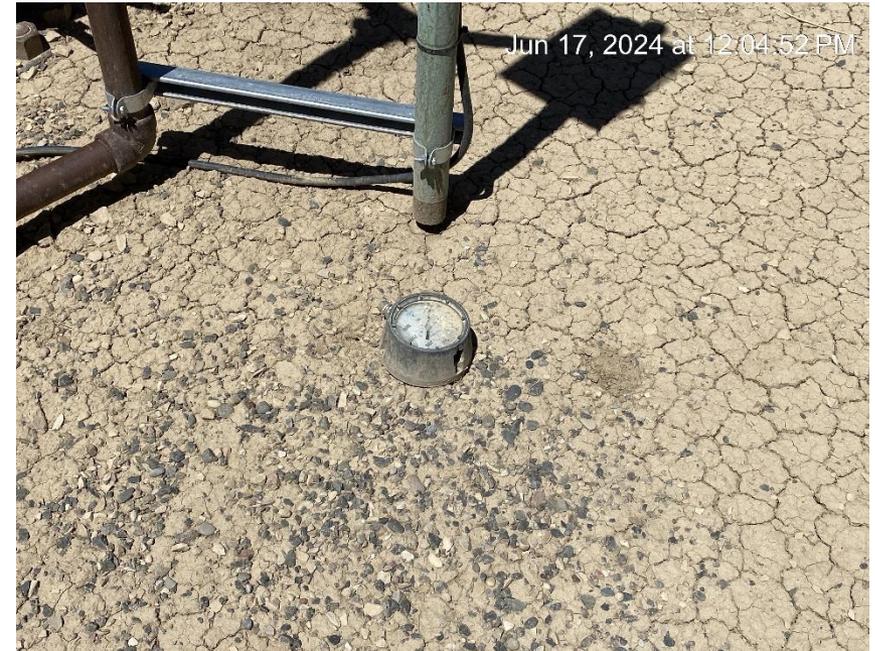
Debris

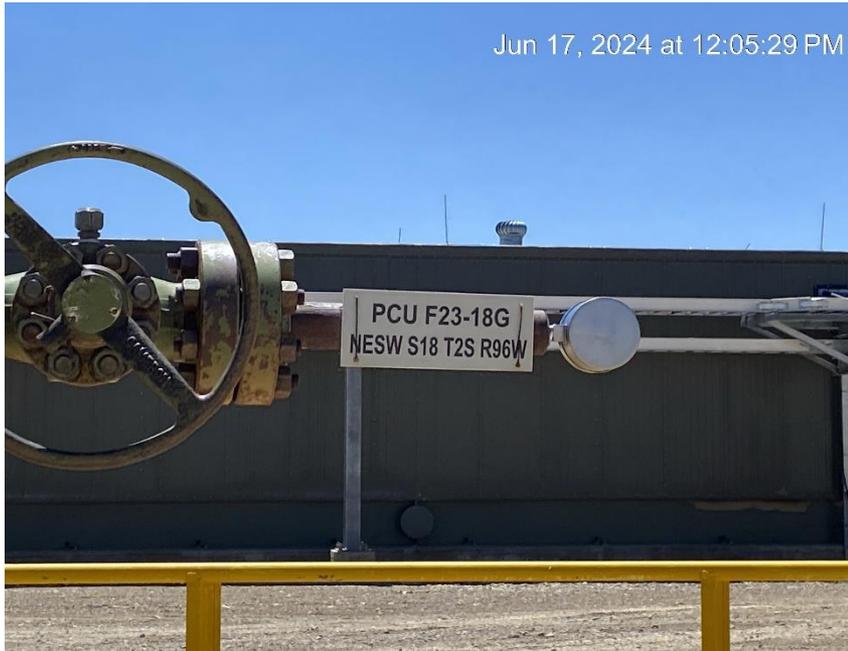
**When replaced additional information will be required**

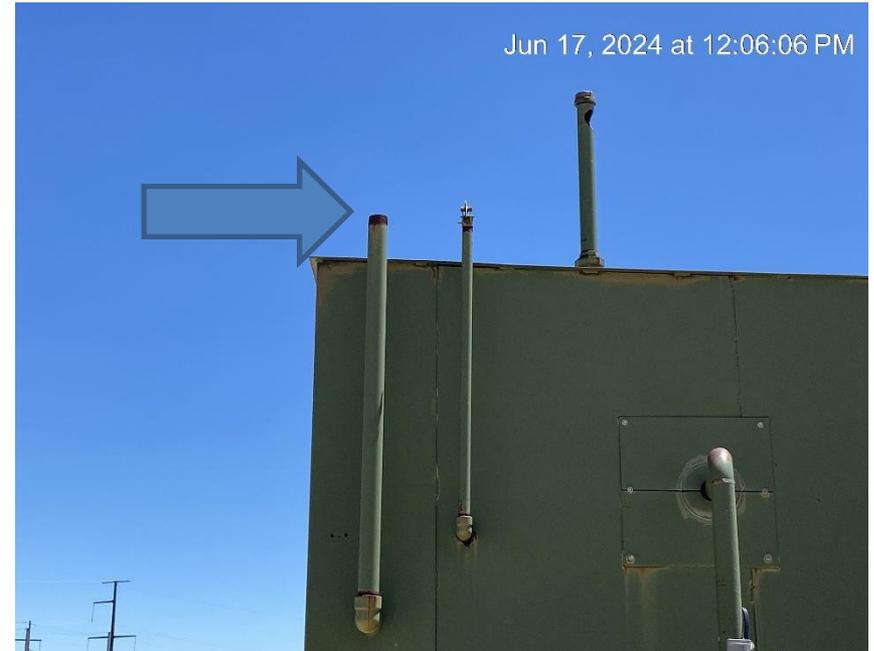
**Relief vent riser missing rain protection**

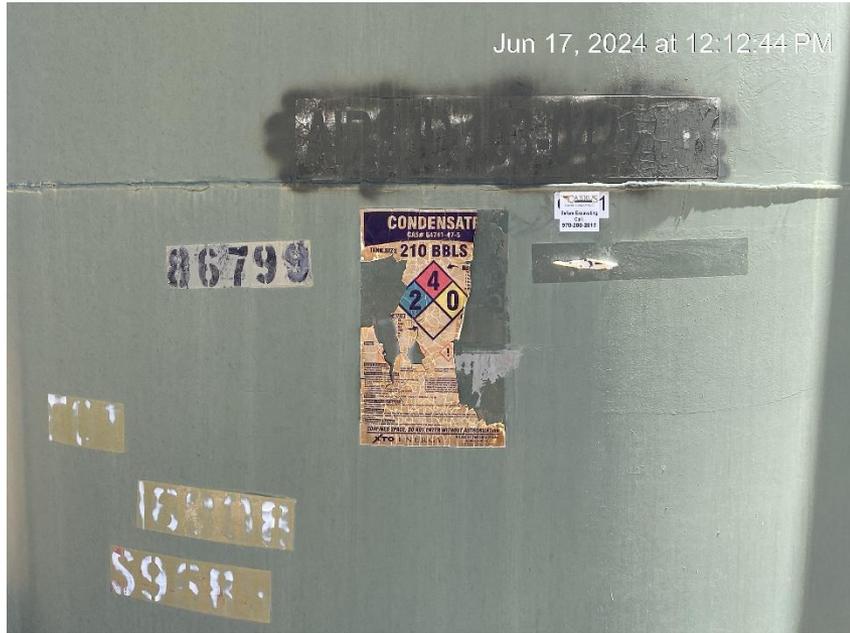
**Peeled label and required information missing**

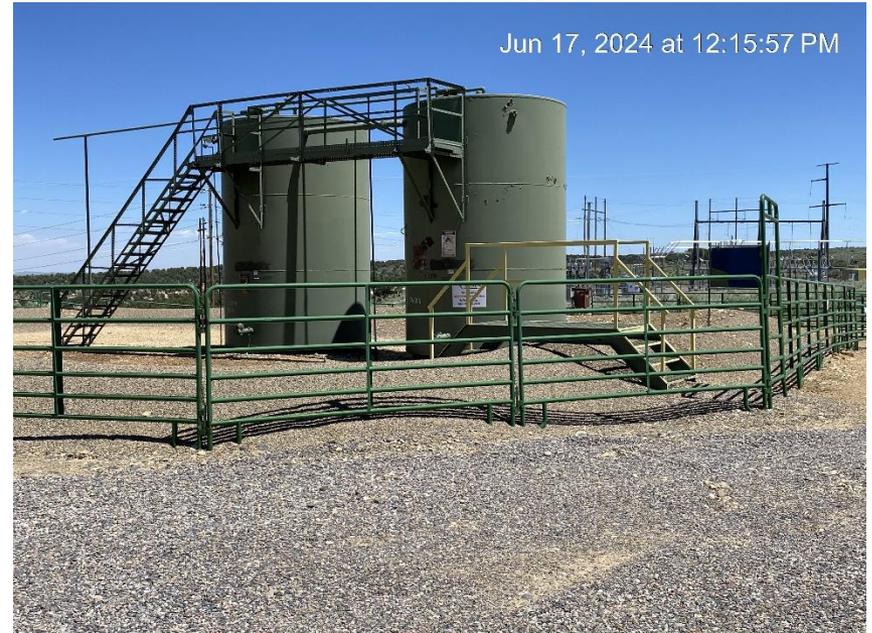
**Missing sign at tank battery**
