Inspection Photos

Operator: ANSCHUTZ EXPLORATION CORP
#3104

Location ID: 430926

Inspection Doc: 696205879

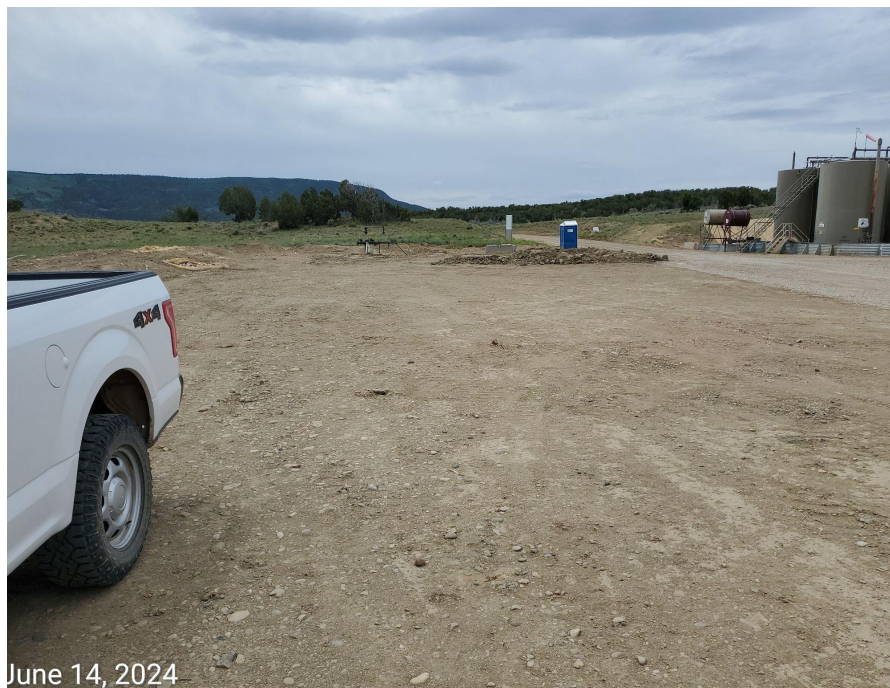
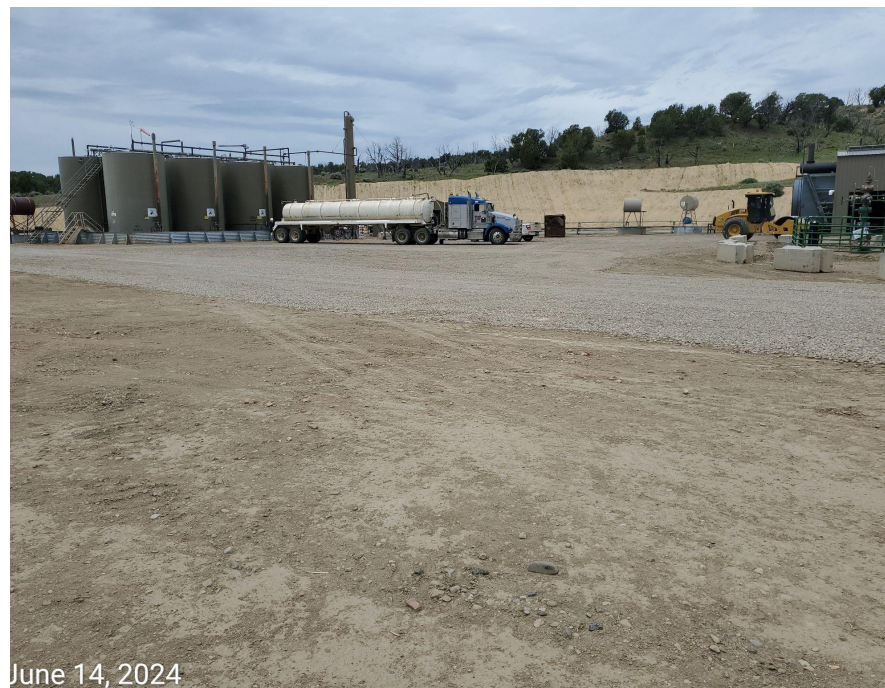
Photo 1: Photos 1-2 taken from the east end of the Location. Photos provides an overview of the Location from south, southwest, northeast to north.

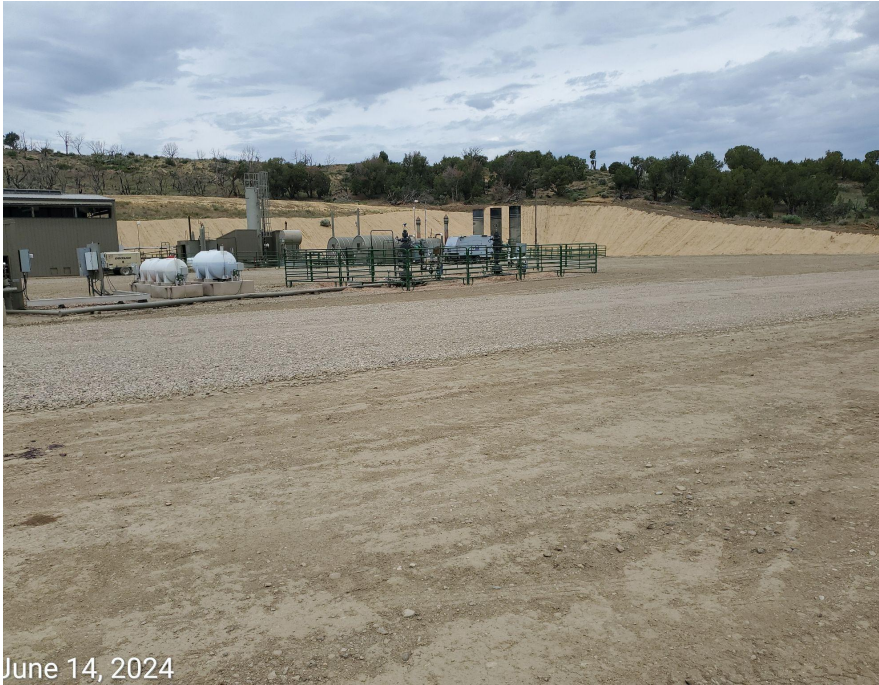
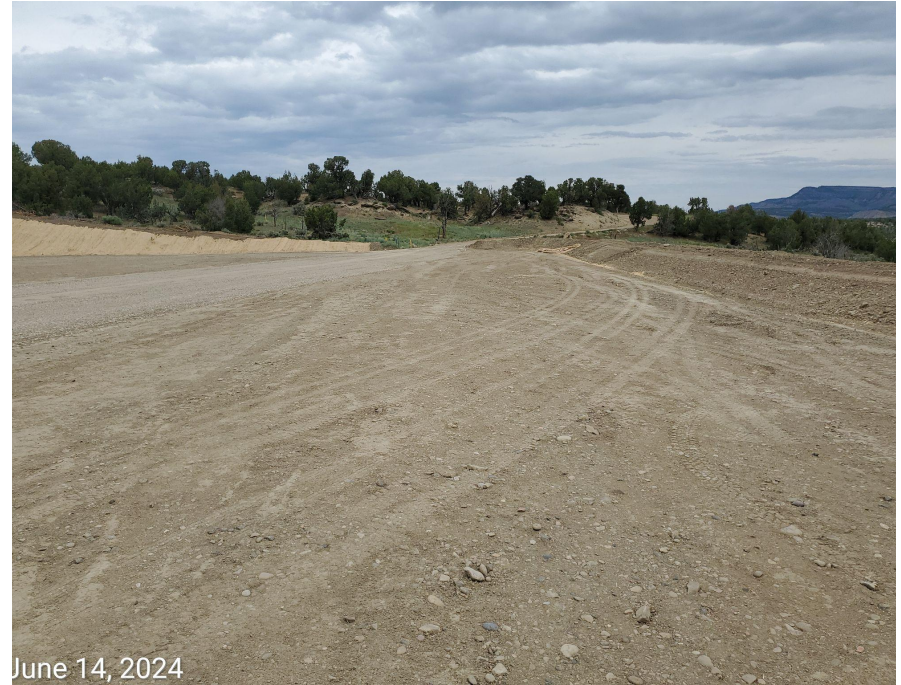
Photo 2: See comments under photo 1.

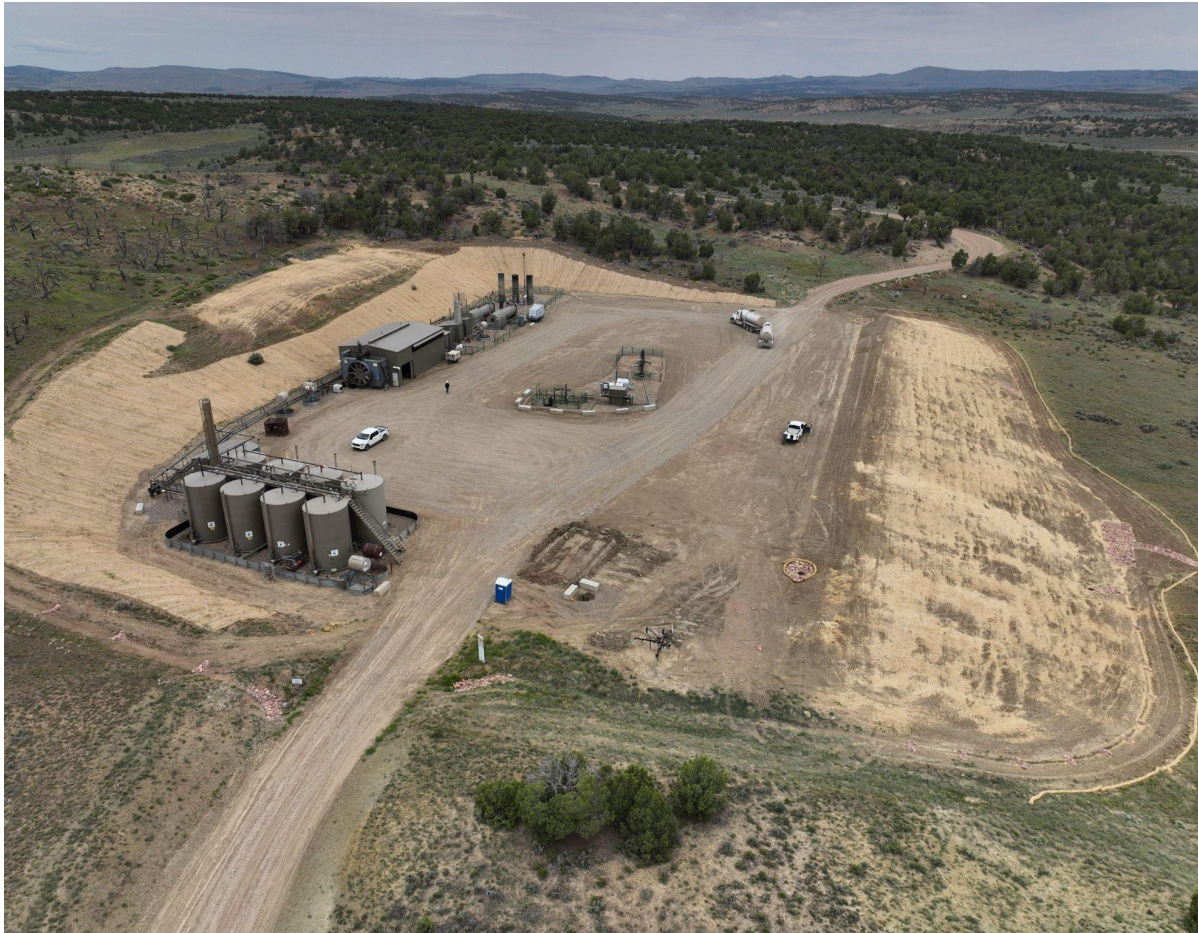
Photo 3: Drone imagery. Photo provides an overview of the Location facing north.

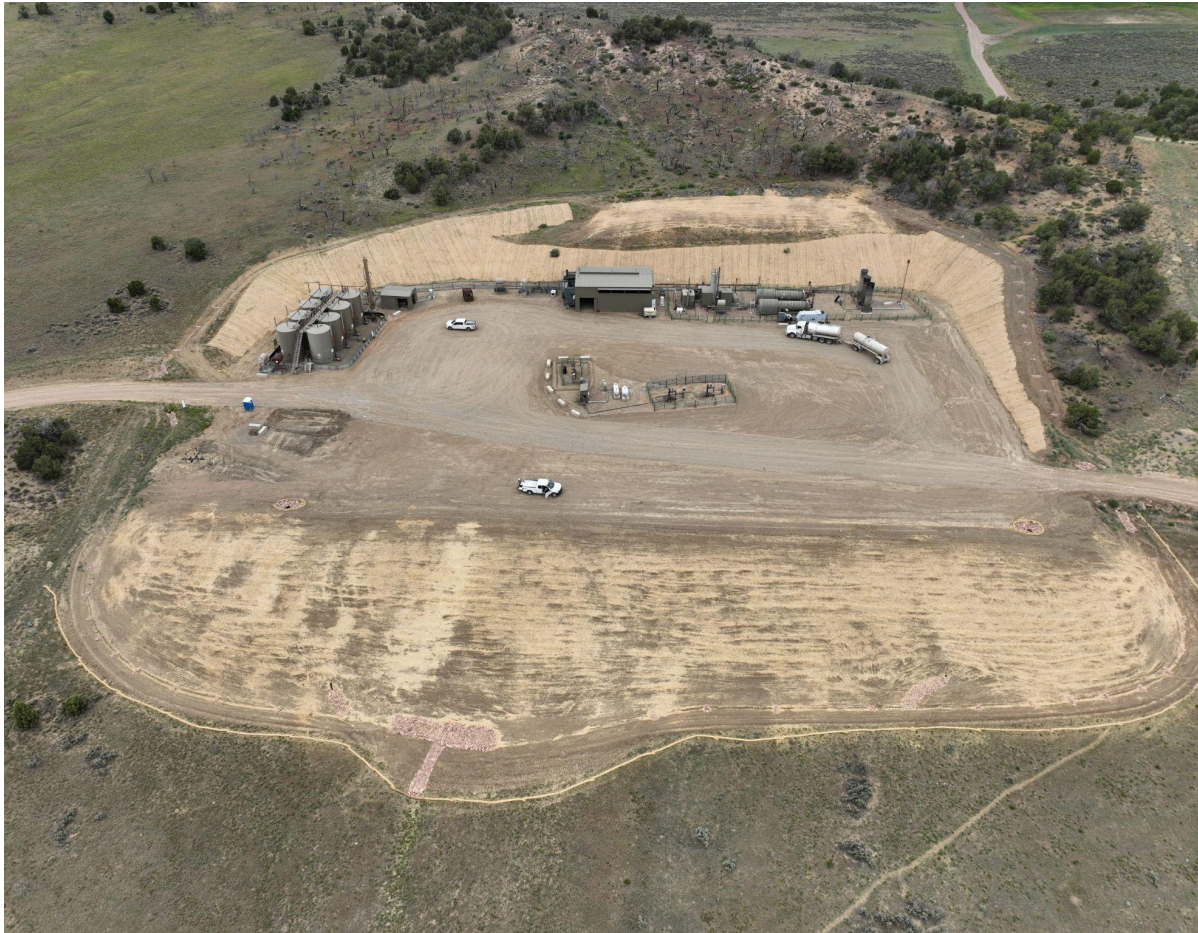
Photo 4: Drone imagery. Photo provides an overview of the Location facing west.

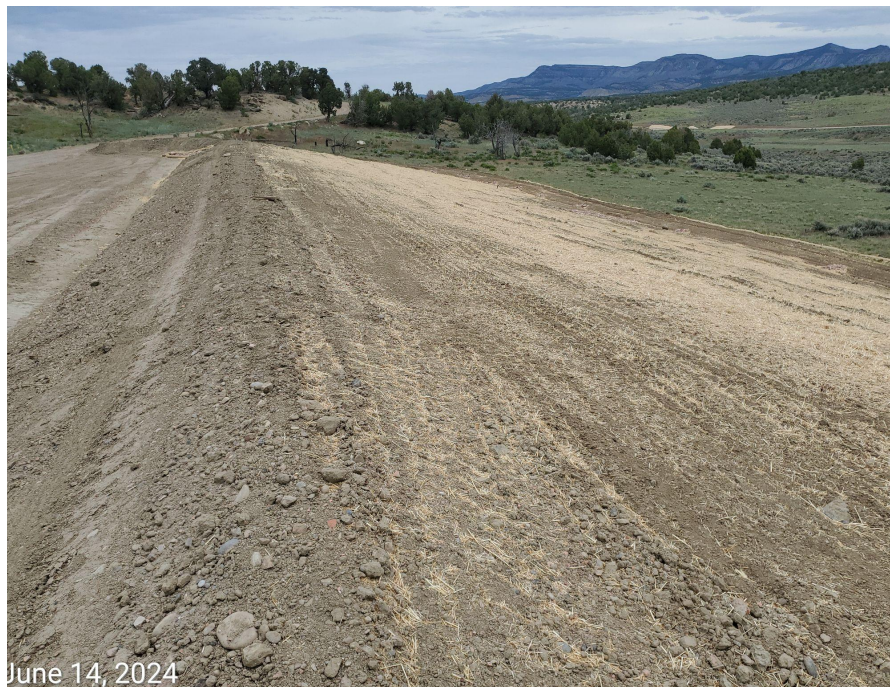
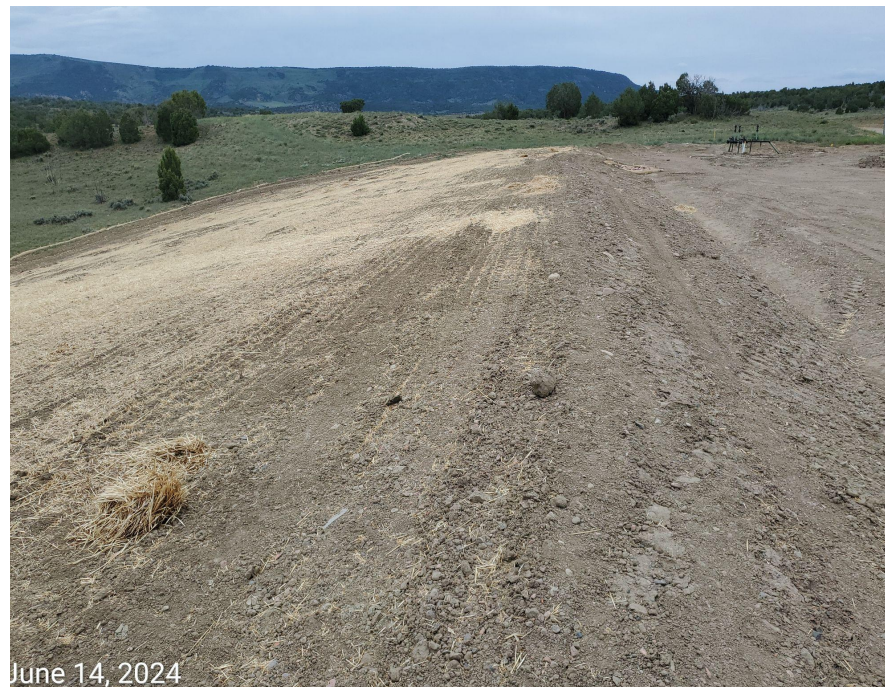
Photo 5: Photo taken from the east end of the working pad surface, facing north and south. Interim reclamation of areas not reasonably needed for production has been performed.

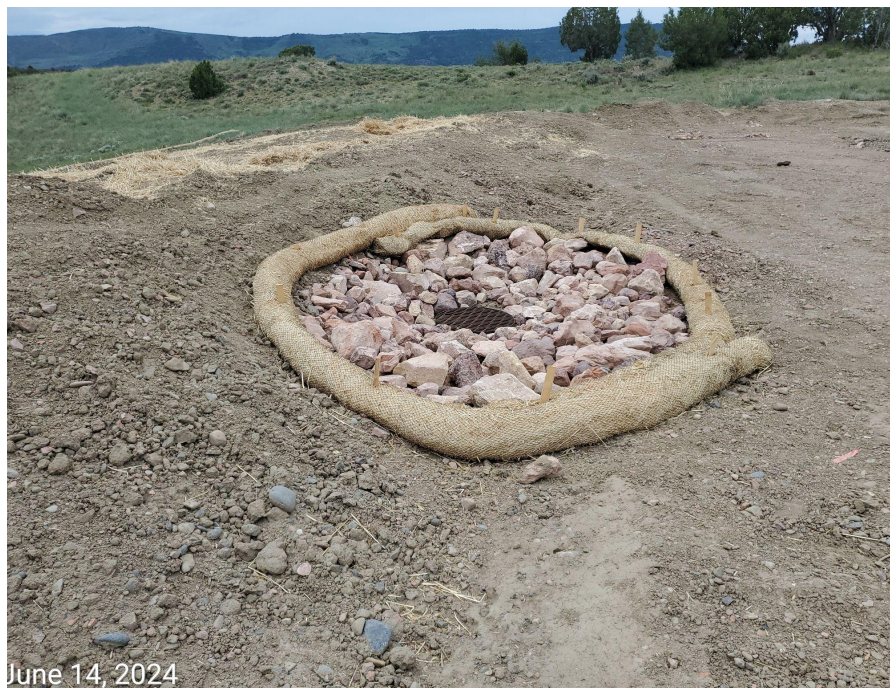
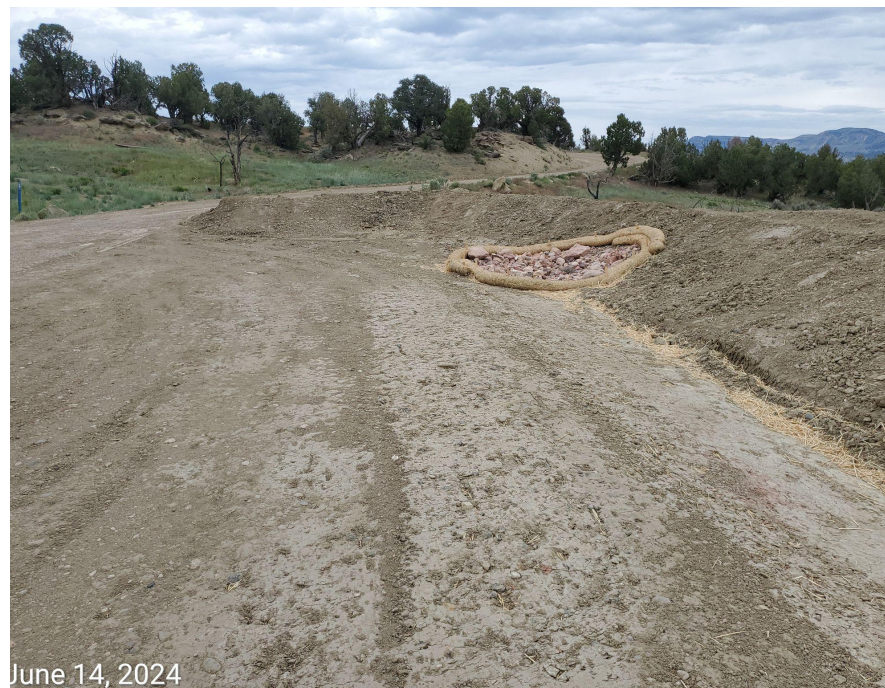
Photo 6: Photos examples showing the slope drains installed on the southeast and northeast ends of the Location.

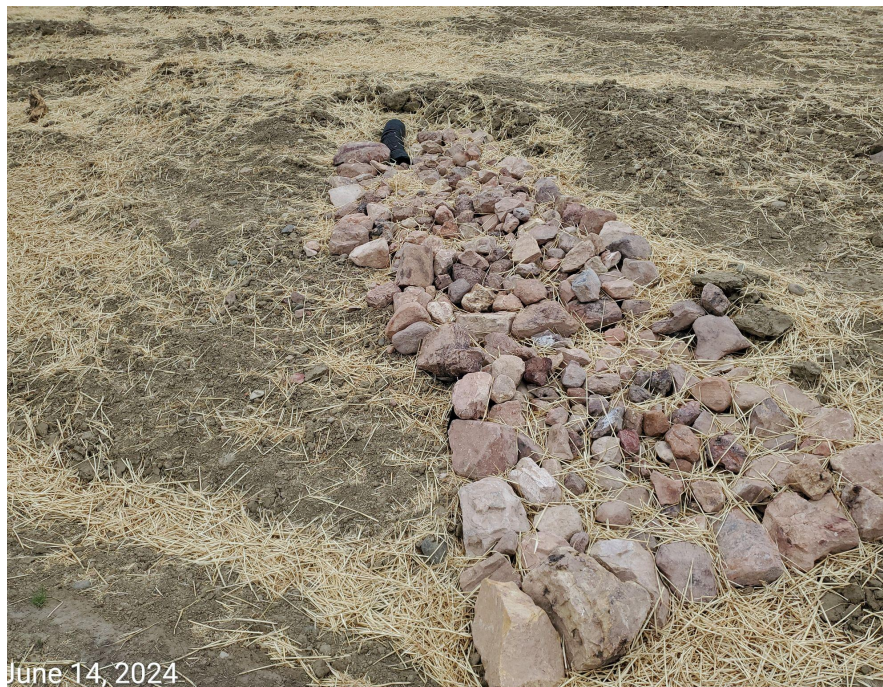
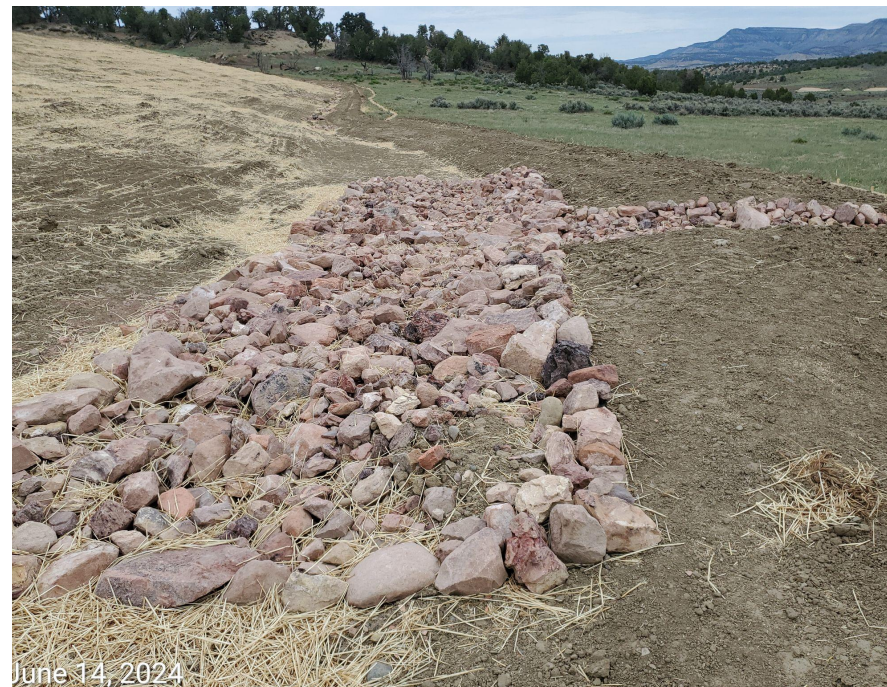
Photo 7: Photo left example of the slope drain outlets. Photo right shows sediment trap and toe of the fill slope.

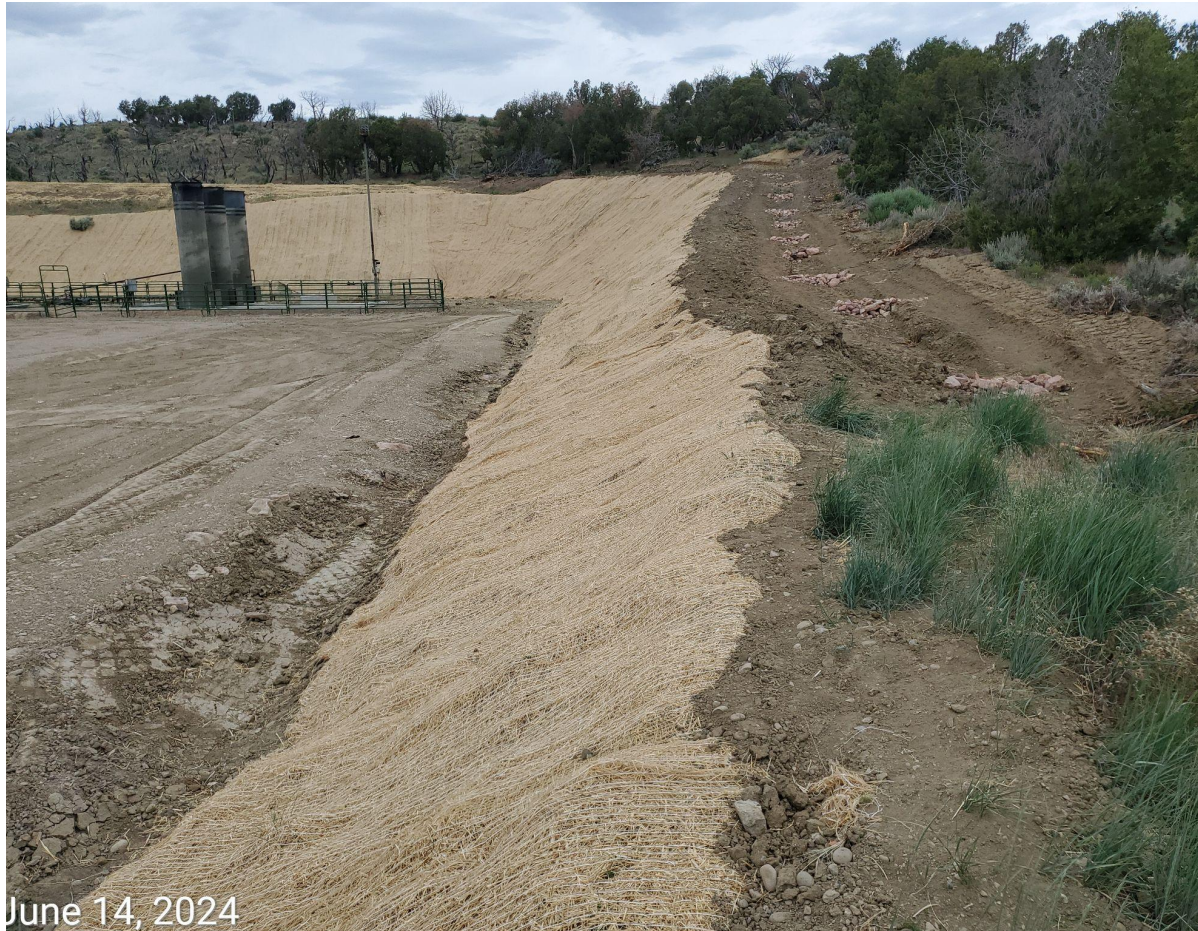
Photo 8: Erosion blankets implemented along cut slopes. Stormwater diversion ditch w/ rock checks implemented.

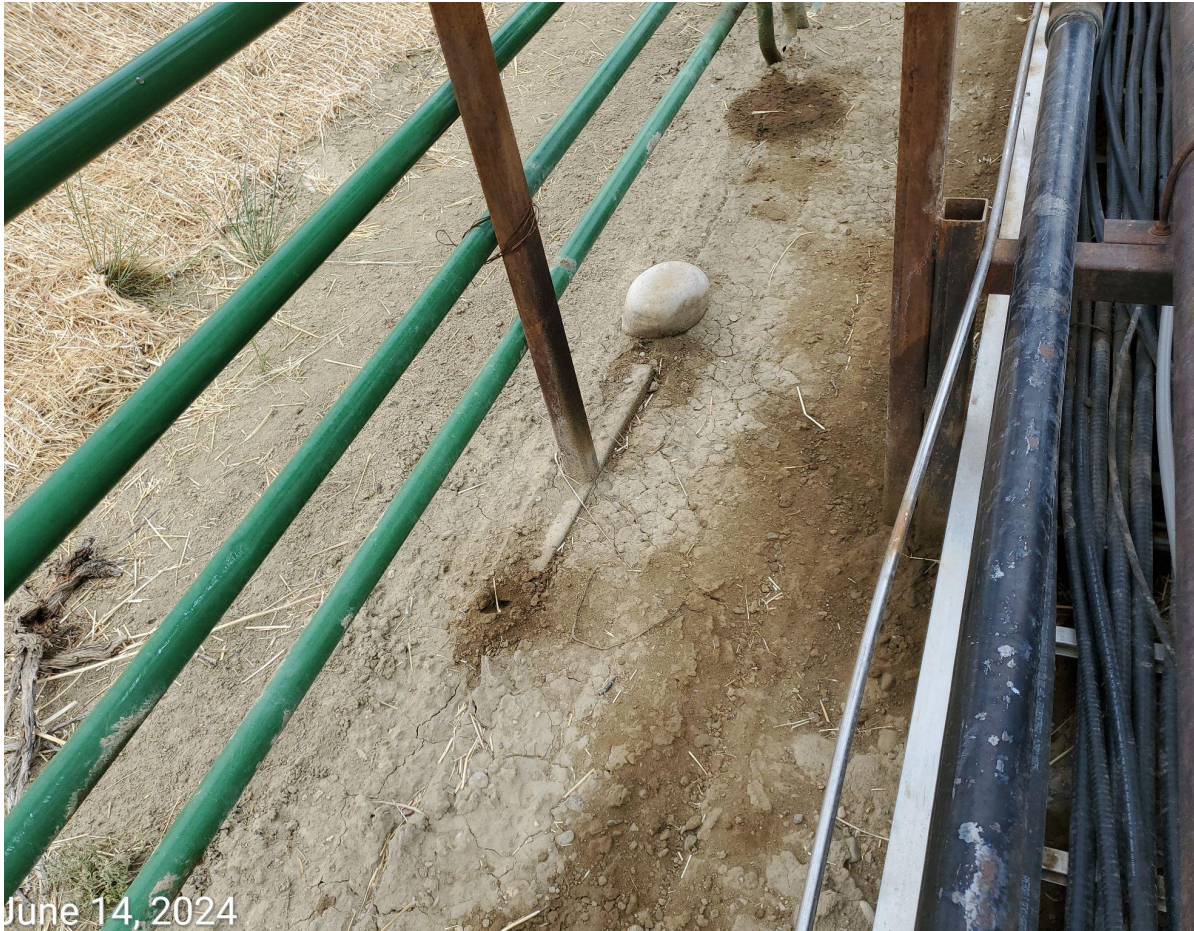
Photo 9: Photo taken from the west end of the Location. Photo shows stained soils on the Location.

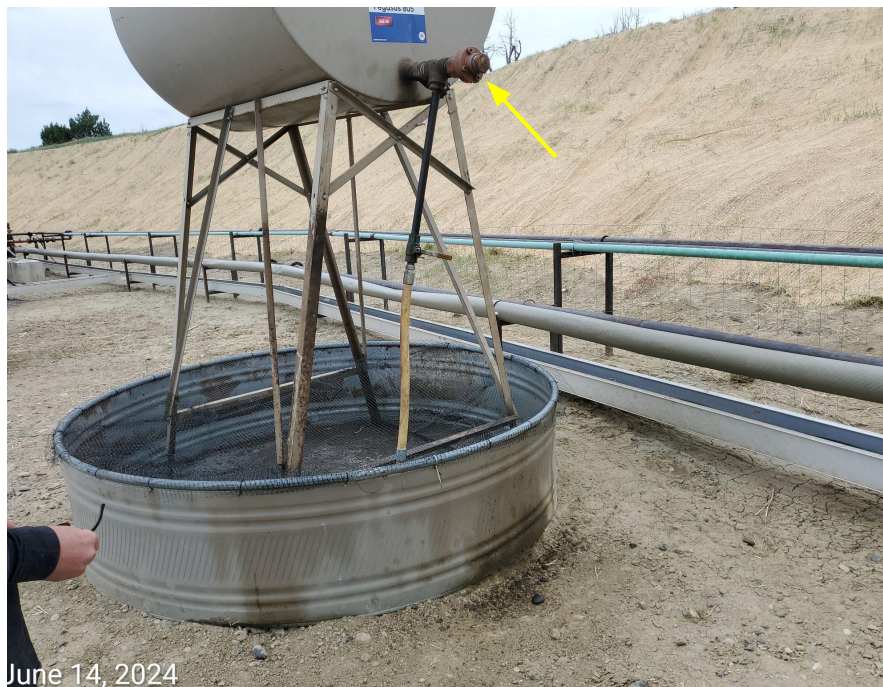
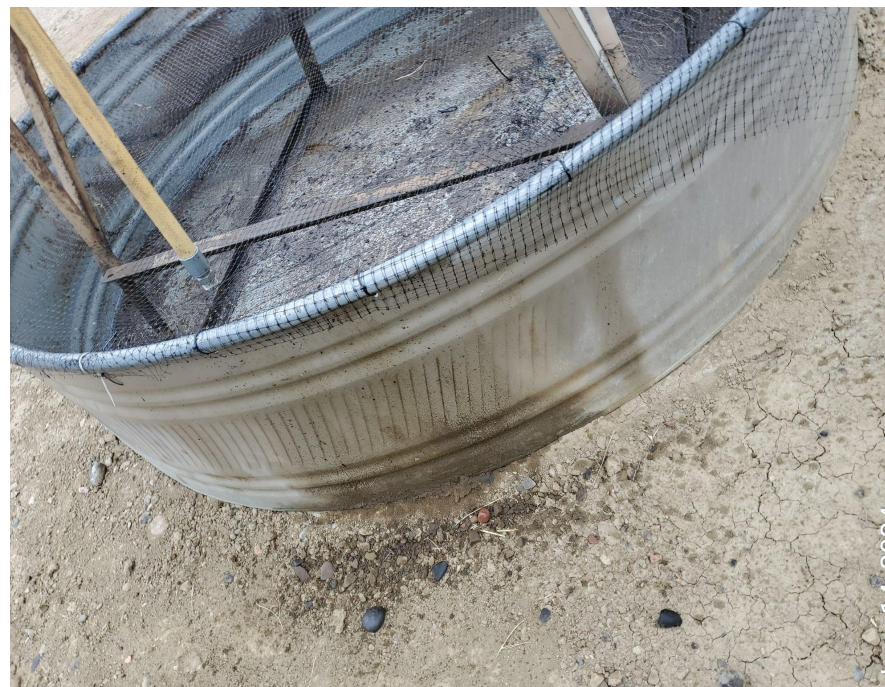
Photo 10: Photos taken from the west end of the Location. Photo shows fluids leaking from a loose cap at the methanol tank has resulted in a spill outside of containment. Operator on site tightened the valve to stop the leak.

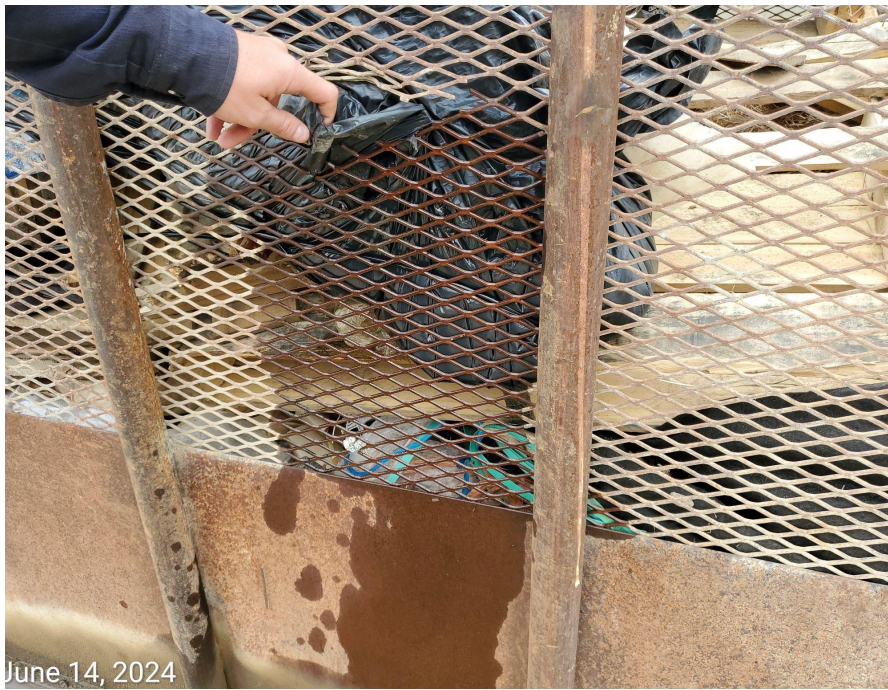
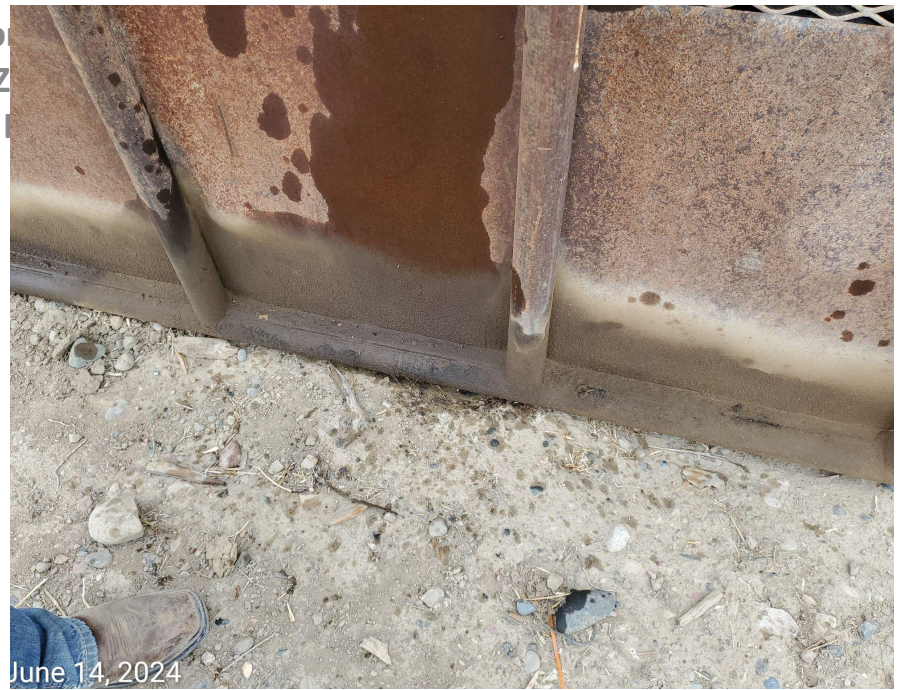
Photo 11: Photo shows improper disposal of potentially impacted materials- Operator on site indicated material to be diapers used during spill cleanup. Fluids observed spilling onto pad surface.

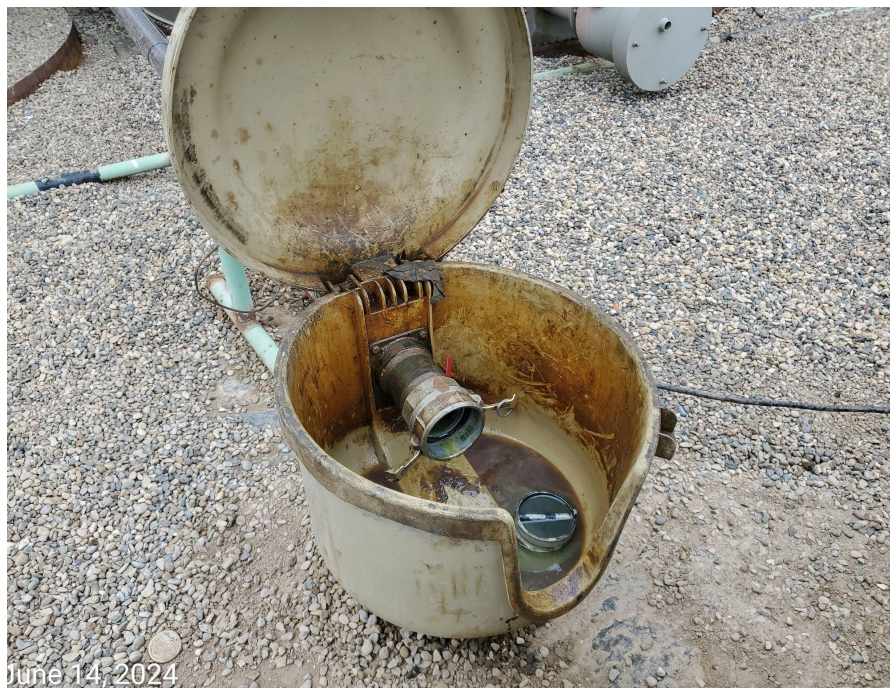
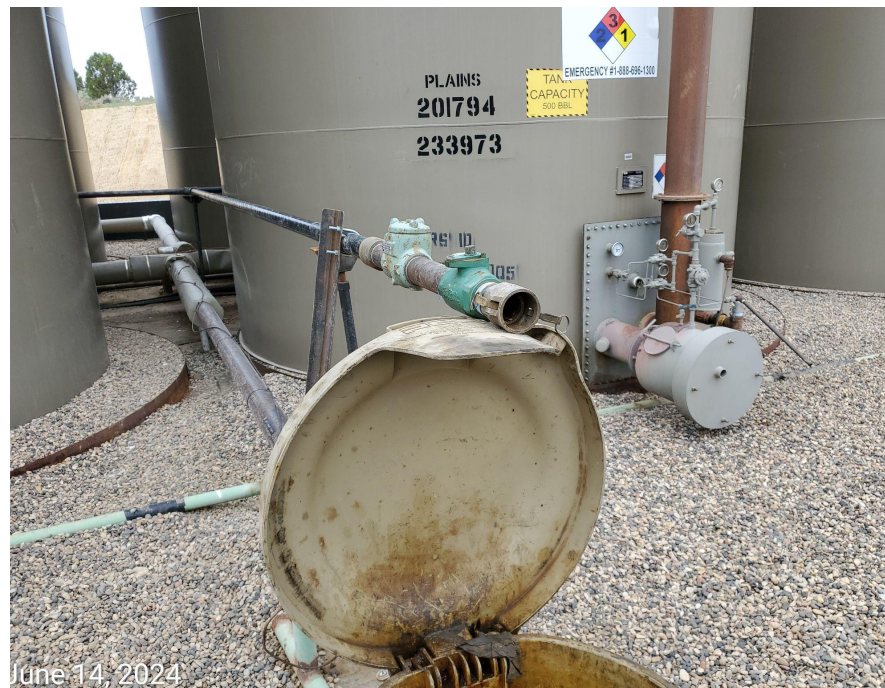
Photo 12: Photos taken from the battery facility. Photo shows caps/plugs at lines were not replaced by trucker after pumping fluids.

Photo 13: Continued from photo 12. Operator on site replaced caps at lines.
