**Storm Water Management and Erosion control**  
**Location Name: TEP ROCKY MOUNTAIN LLC CLOUGH 136 Pad**  
**Location ID: 322444**

**Location Overview: Location is within High Priority/Density  
Habitat areas. Location is approximately 22 yards from a  
drainage that contributes to the Colorado River.  
Section/Township/Range: 20 6S94W**

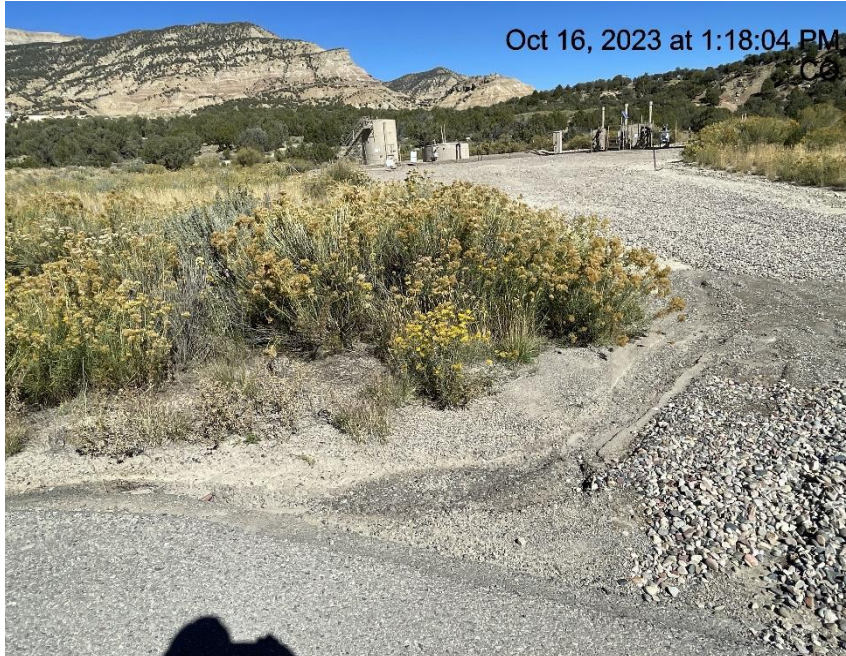
**Photo # 2884 From inspection 708901973 conducted on 10/16/2023 Sediment migrating onto gravel track pad/BMP needs maintenance**

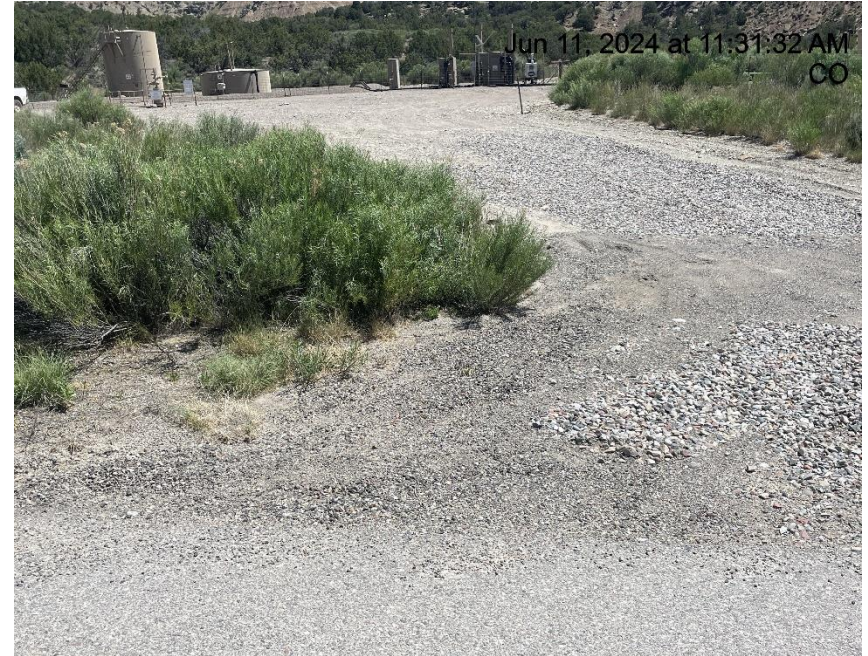
**Photo # 435 Sediment migrating onto gravel track pad/BMP needs maintenance**

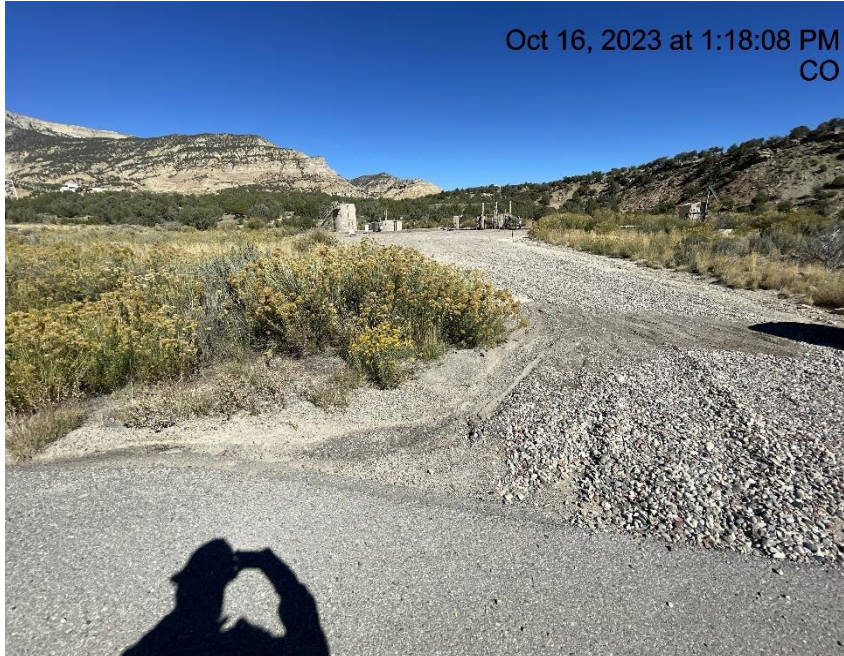
**Photo # 2885 From inspection 708901973 conducted on 10/16/2023 Sediment migrating onto gravel track pad/BMP needs maintenance**

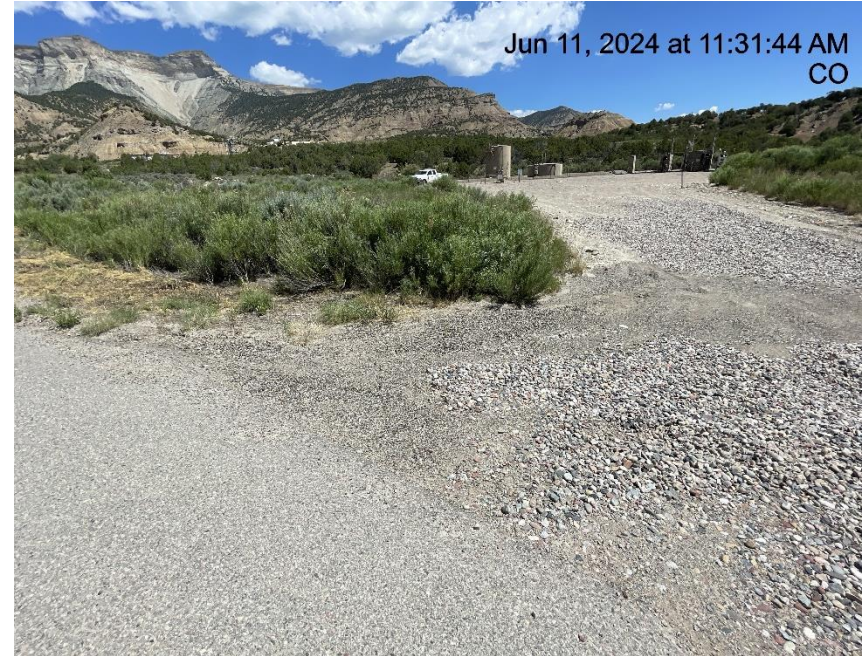
**Photo # 436 Sediment migrating onto gravel track pad/BMP needs maintenance**

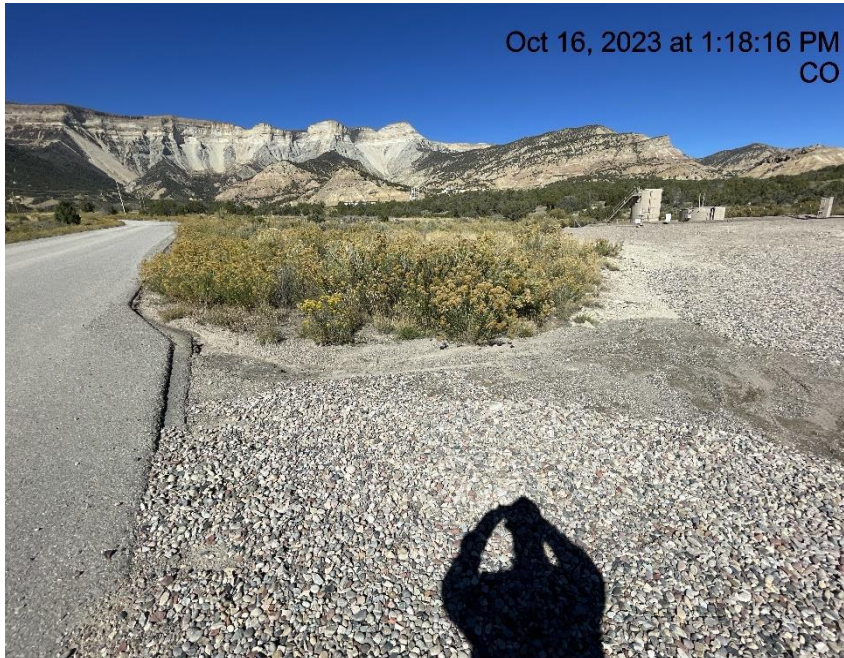
**Photo # 2886 From inspection 708901973 conducted on 10/16/2023 Sediment migrating onto gravel track pad/BMP needs maintenance**

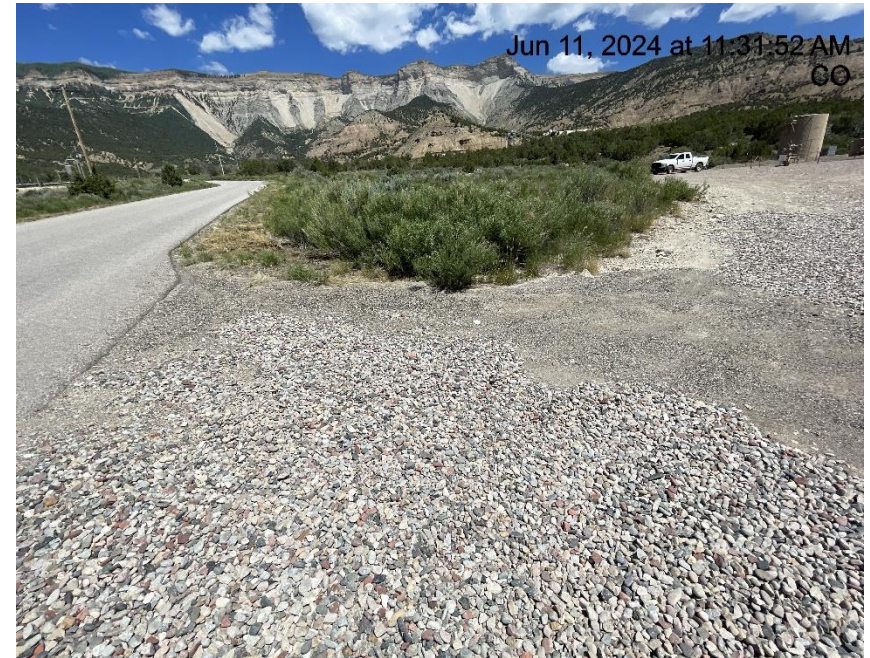
**Photo # 437 Sediment migrating onto gravel track pad/BMP needs maintenance**

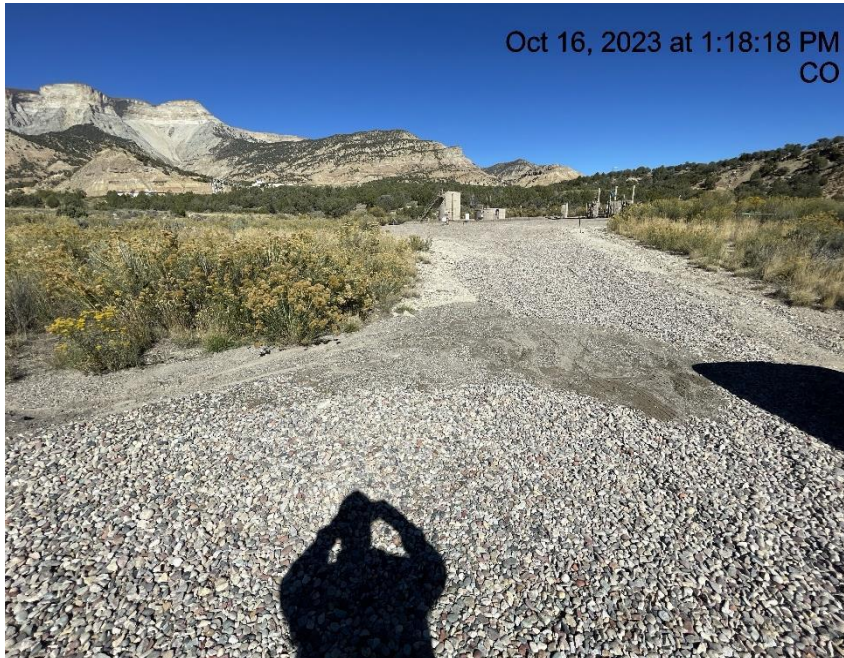
**Photo # 2887 From inspection 708901973 conducted on 10/16/2023 Sediment migrating onto gravel track pad/BMP needs maintenance**

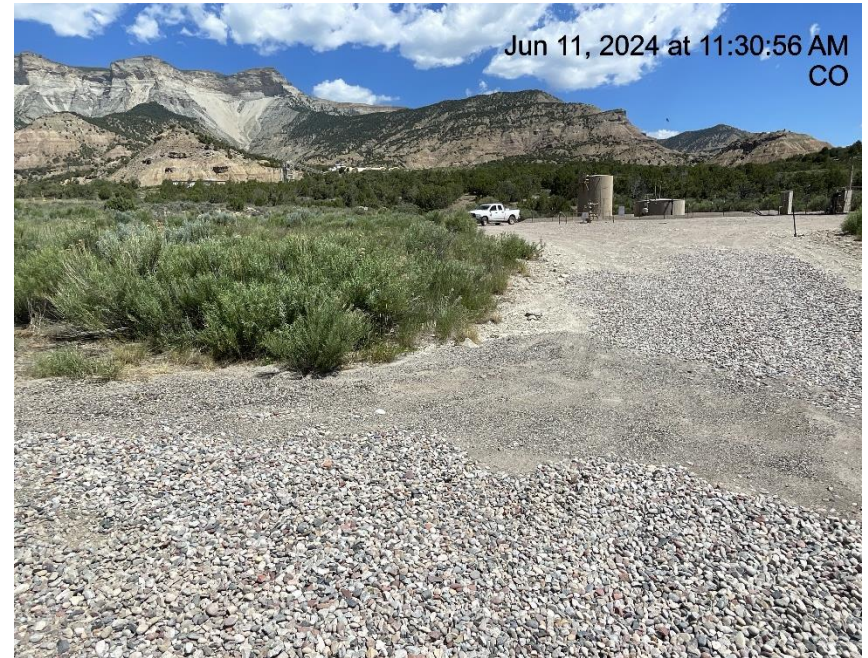
**Photo # 438 Sediment migrating onto gravel track pad/BMP needs maintenance**

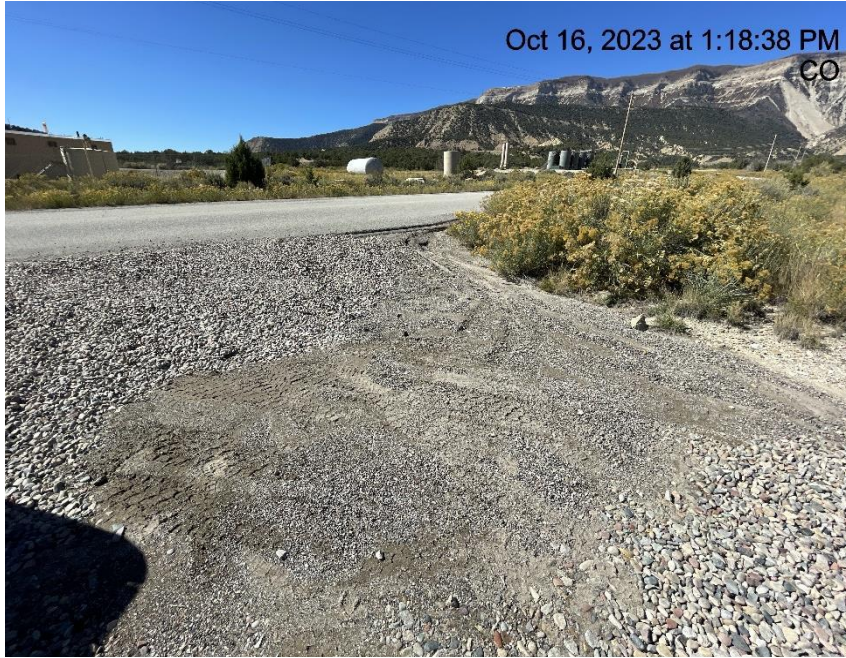
**Photo # 2889 From inspection 708901973 conducted on 10/16/2023 Sediment migrating onto gravel track pad/BMP needs maintenance**

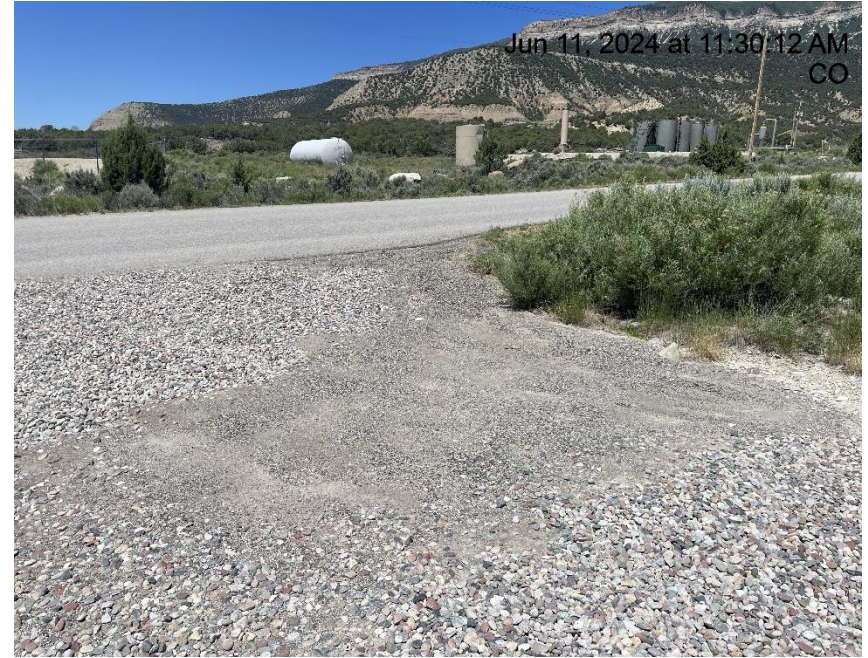
**Photo # 439 Sediment migrating onto gravel track pad/BMP needs maintenance**

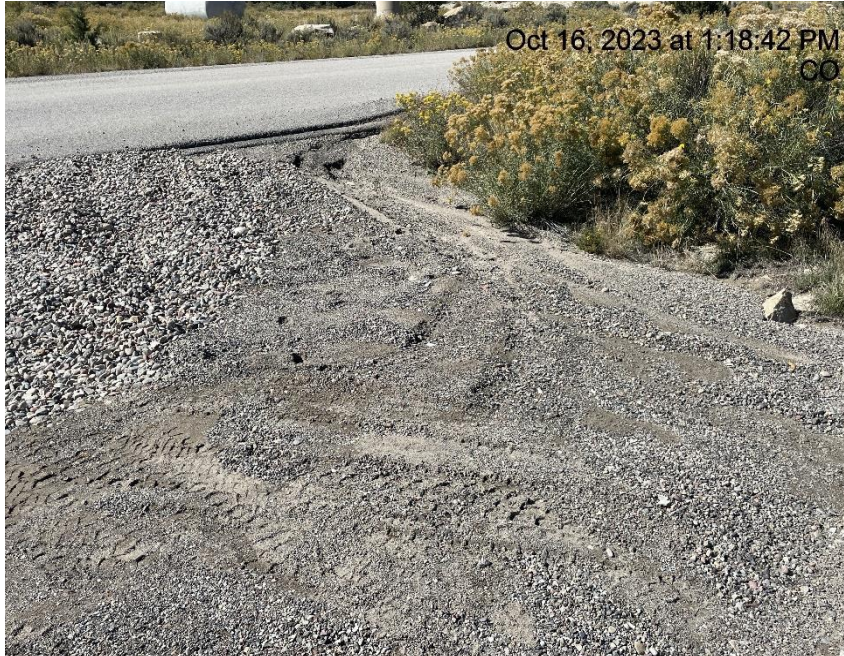
**Photo # 2890 From inspection 708901973 conducted on 10/16/2023 Sediment migrating onto gravel track pad/BMP needs maintenance**

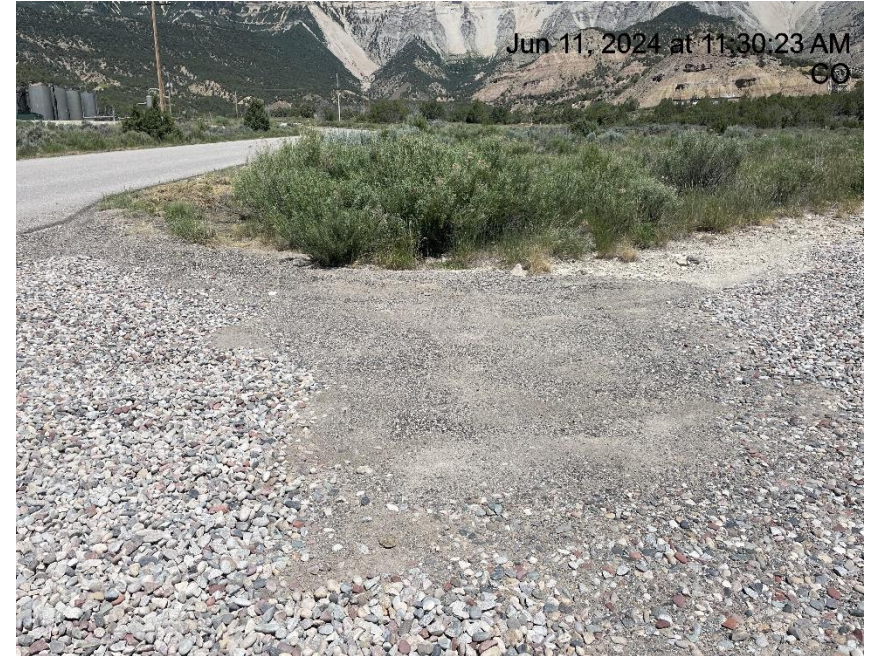
**Photo # 440 Sediment migrating onto gravel track pad/BMP needs maintenance**

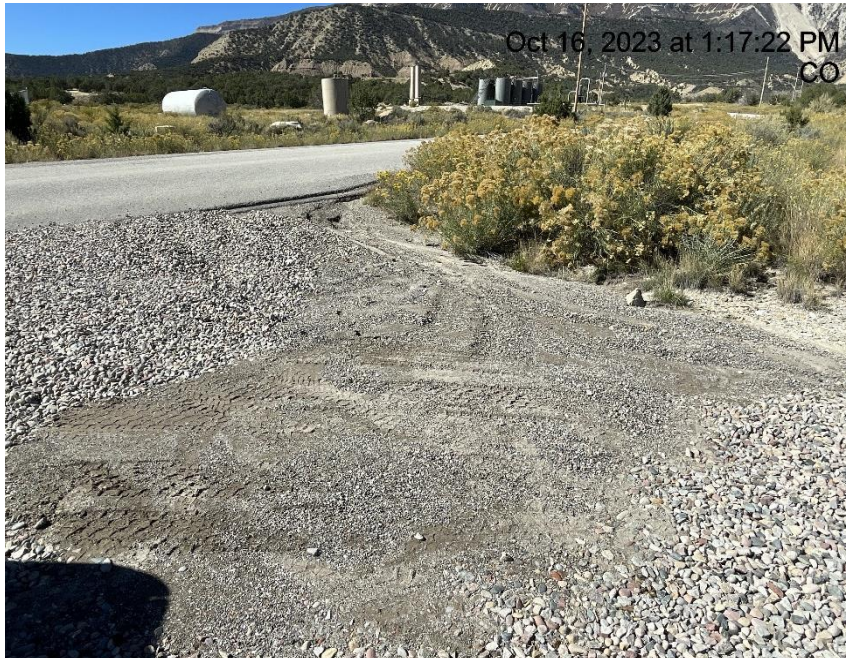
**Photo # 2891 From inspection 708901973 conducted on 10/16/2023 Sediment migrating onto gravel track pad/BMP needs maintenance**

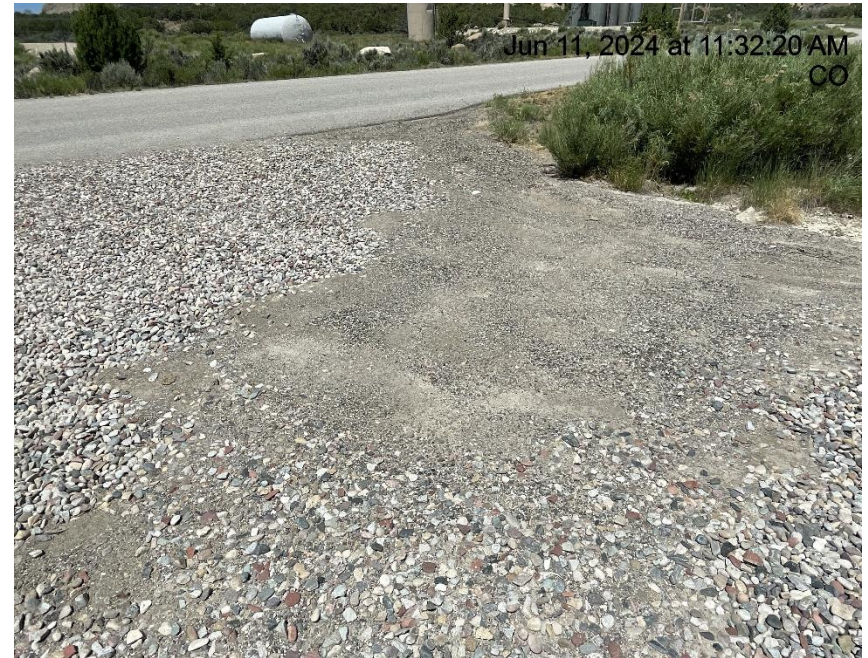
**Photo # 441 Sediment migrating onto gravel track pad/BMP needs maintenance**

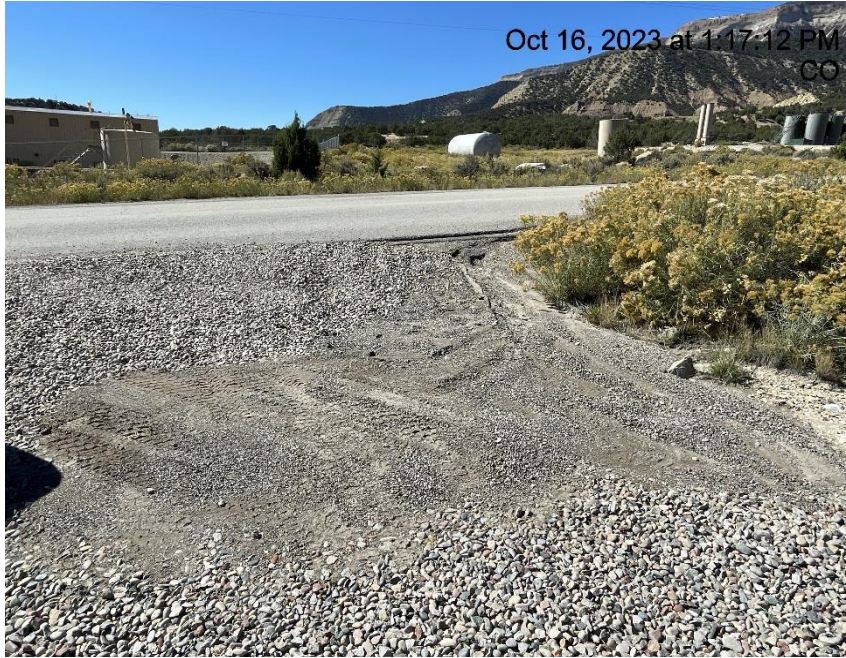
**Photo # 2892 From inspection 708901973 conducted on 10/16/2023 Sediment migrating onto gravel track pad/BMP needs maintenance**

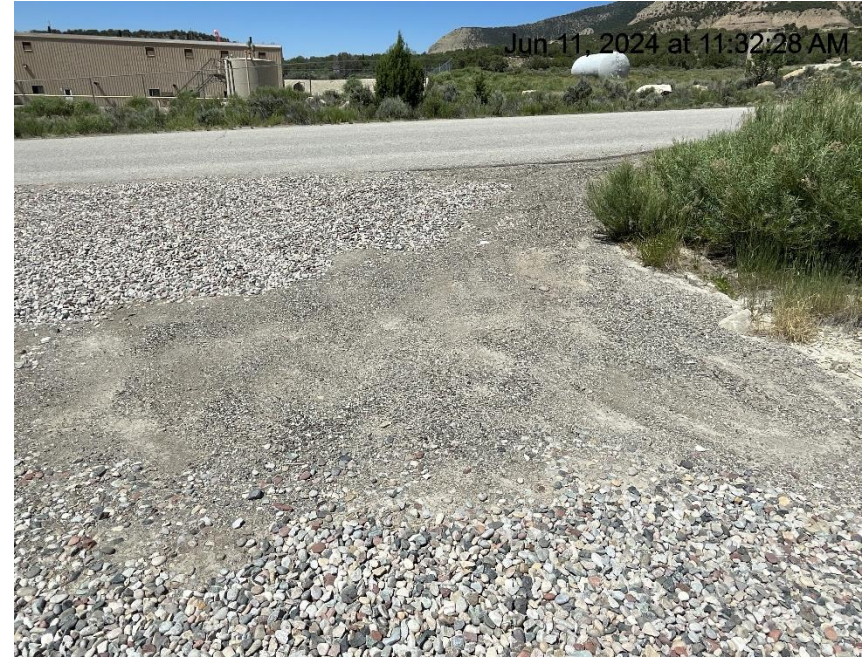
**Photo # 442 Sediment migrating onto gravel track pad/BMP needs maintenance**

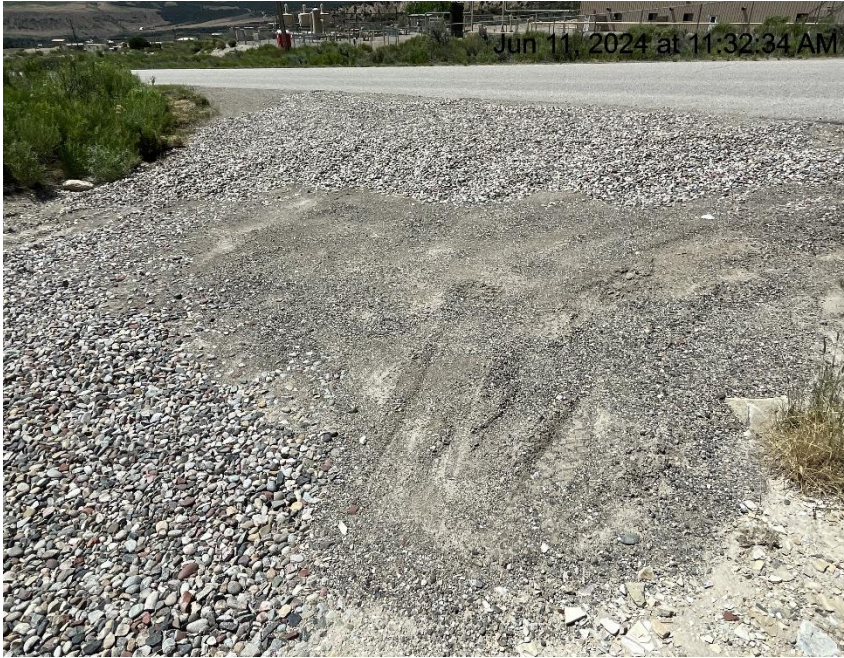
**Photo # 443 Sediment migrating onto gravel track pad/BMP needs maintenance**

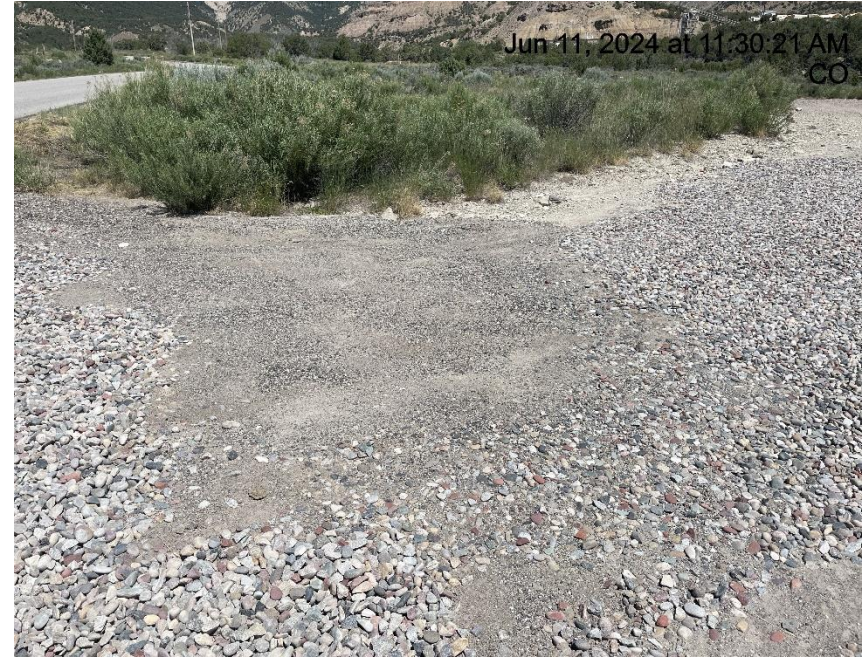
**Photo # 444 Sediment migrating onto gravel track pad/BMP needs maintenance**
