Inspection Photos

Location: TEP Rocky Mountain LLC GV/33-22 frac pad

Location ID: 334730

Date: 6/18/2024

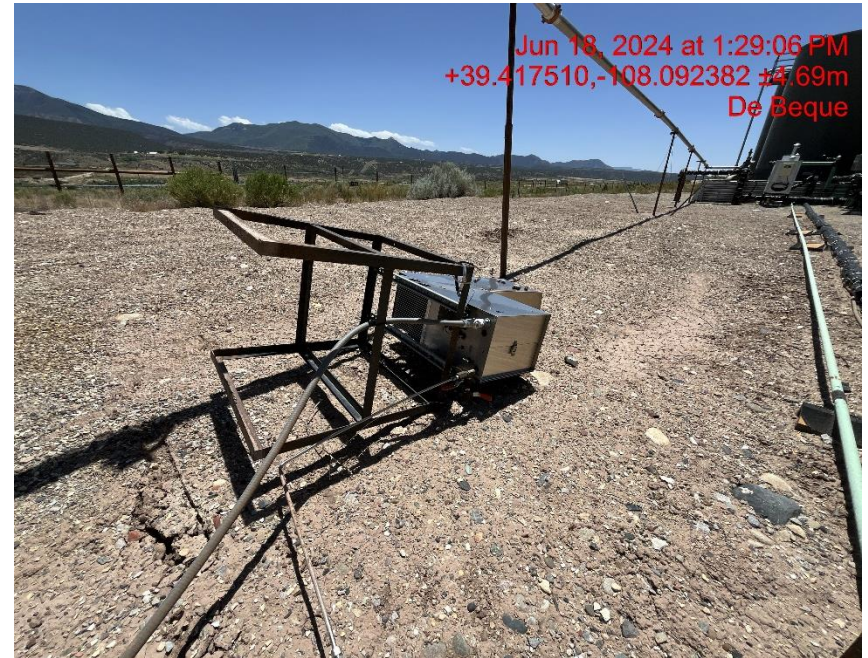
Fire/Safety Hazard - Photo #02628

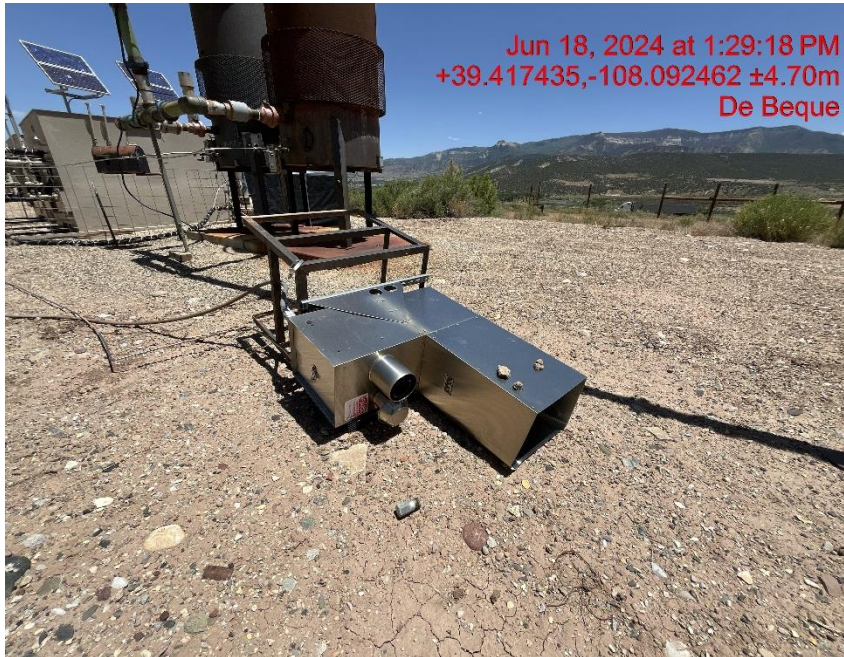
Fire/Safety Hazzard - Photo #02630
