Site Specific Final Reclamation Completion Notice – Cropland Drone Imagery

Permit Closure Report – Cropland

Location ID: 306515

Location Name: DALTON #24-24 Well Head

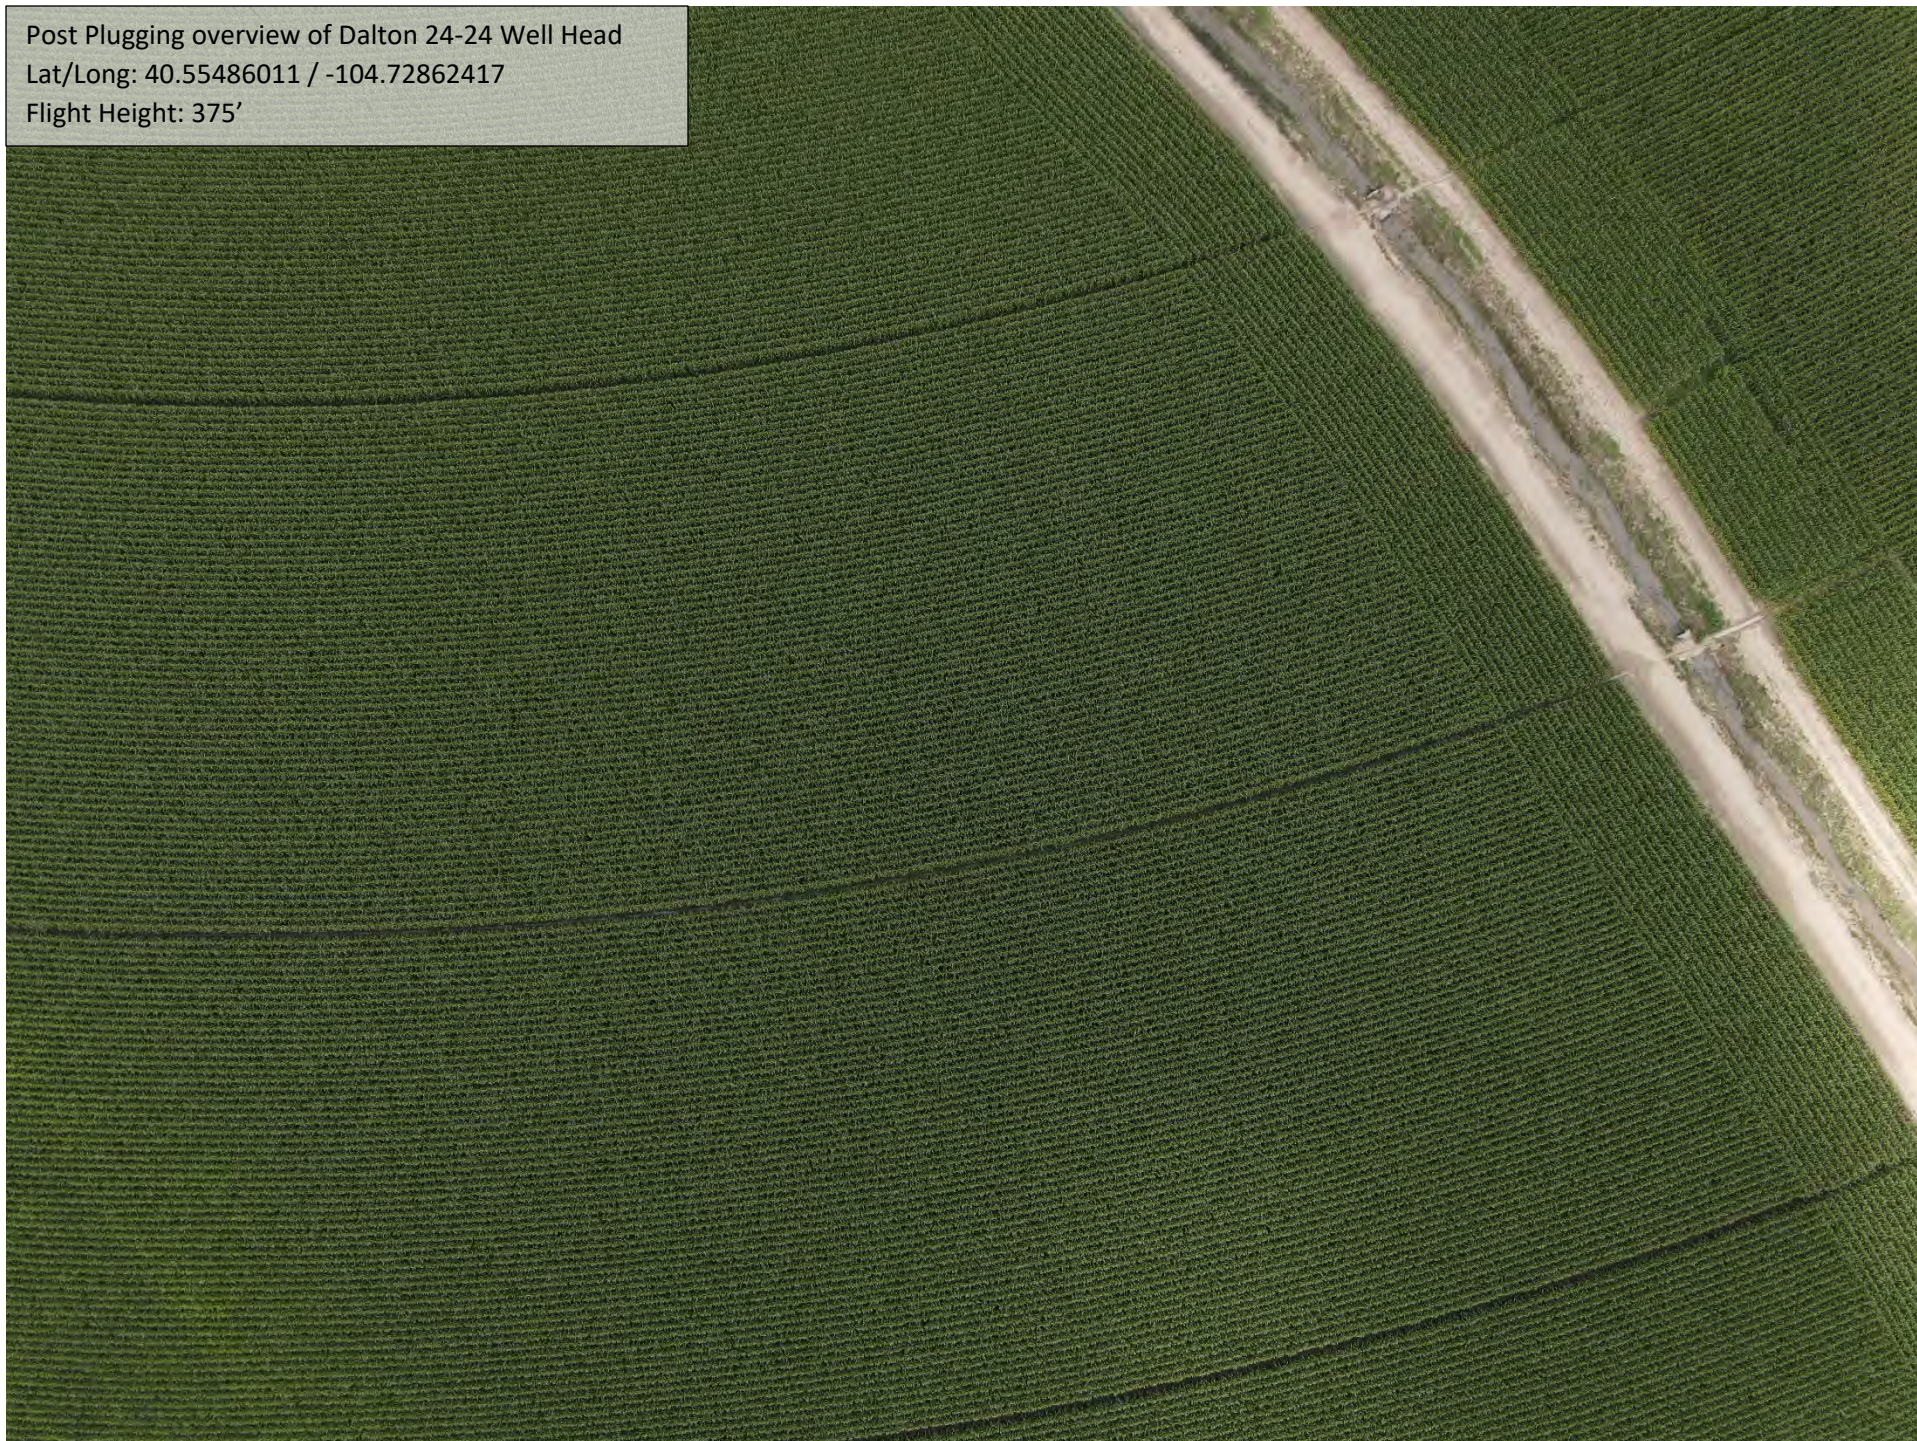
Drone imagery confirms that no equipment was left on site at this location after reclamation activities occurred.

Post Plugging overview of Dalton 24-24 Well Head
Lat/Long: 40.55486011 / -104.72862417
Flight Height: 375'
