Site Specific Final Reclamation Completion Notice – Cropland Drone Imagery

Permit Closure Report – Cropland

Location ID: 305351

Location Name: HAZEN-67N65W/28SWSW

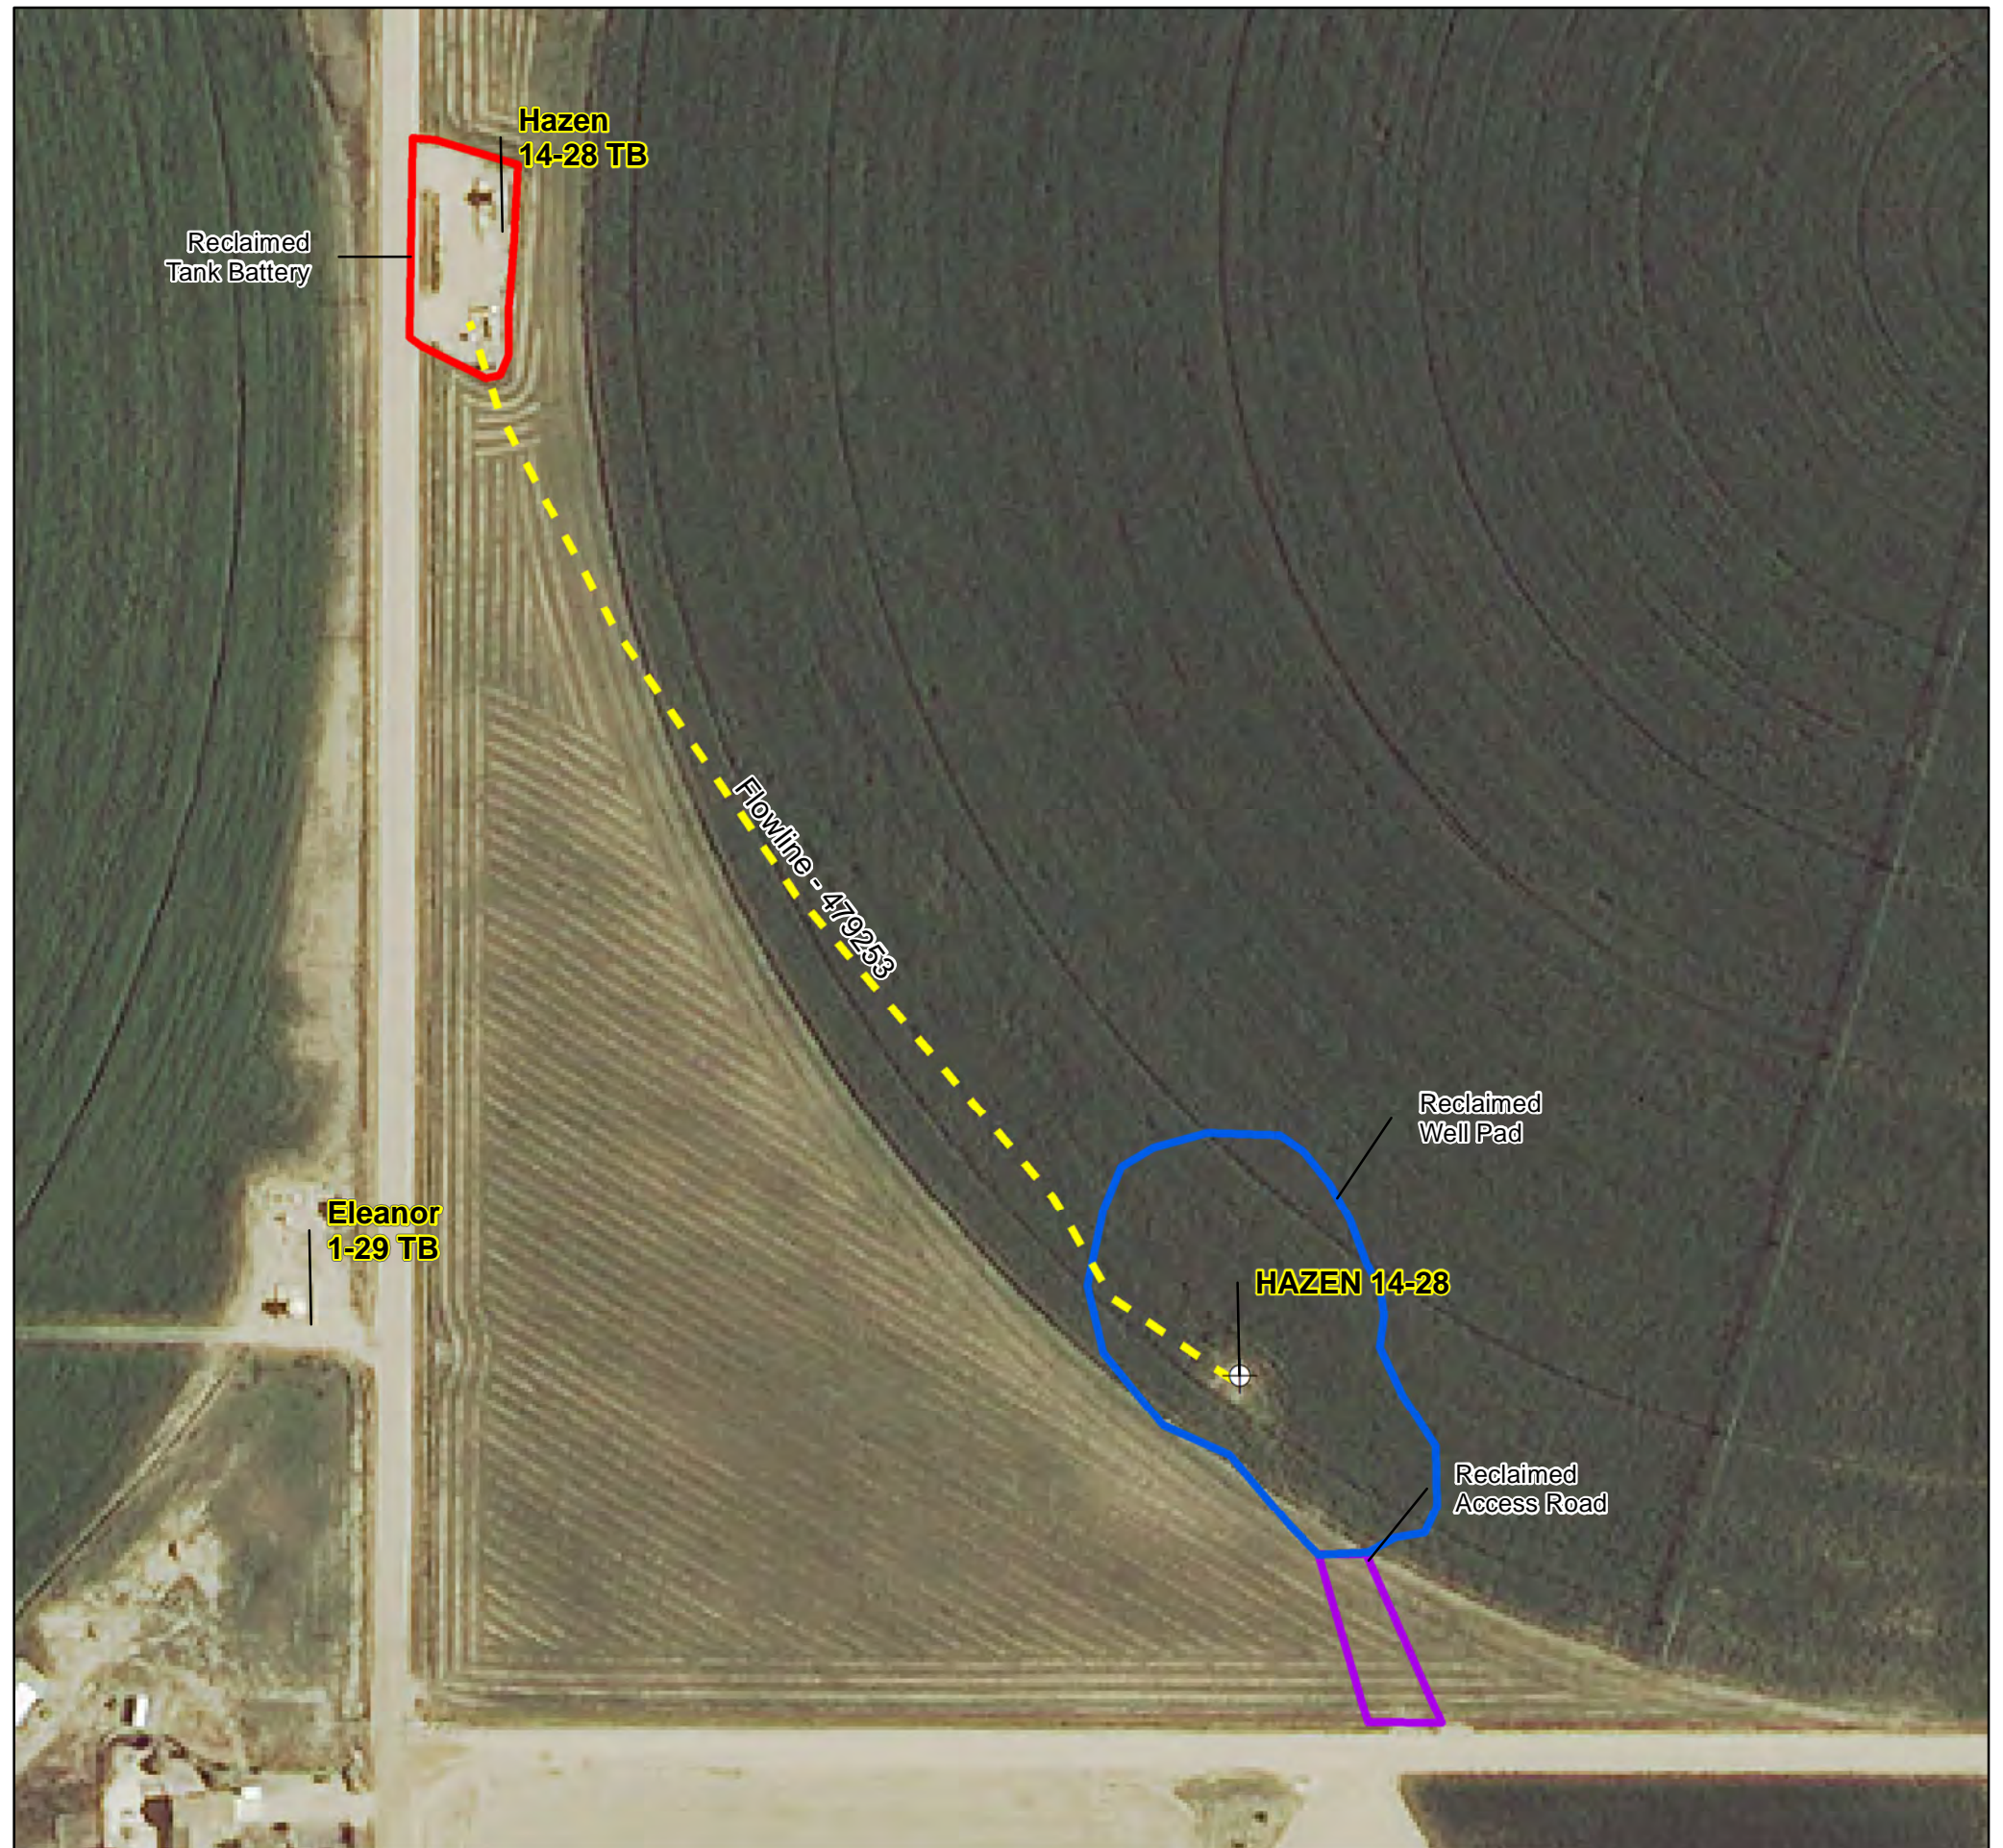
Pre-Plugging Active Operations Location Overview

PDC Form 4 Final Reclamation - Pre Plugging Overview

NAIP 2013 Imagery

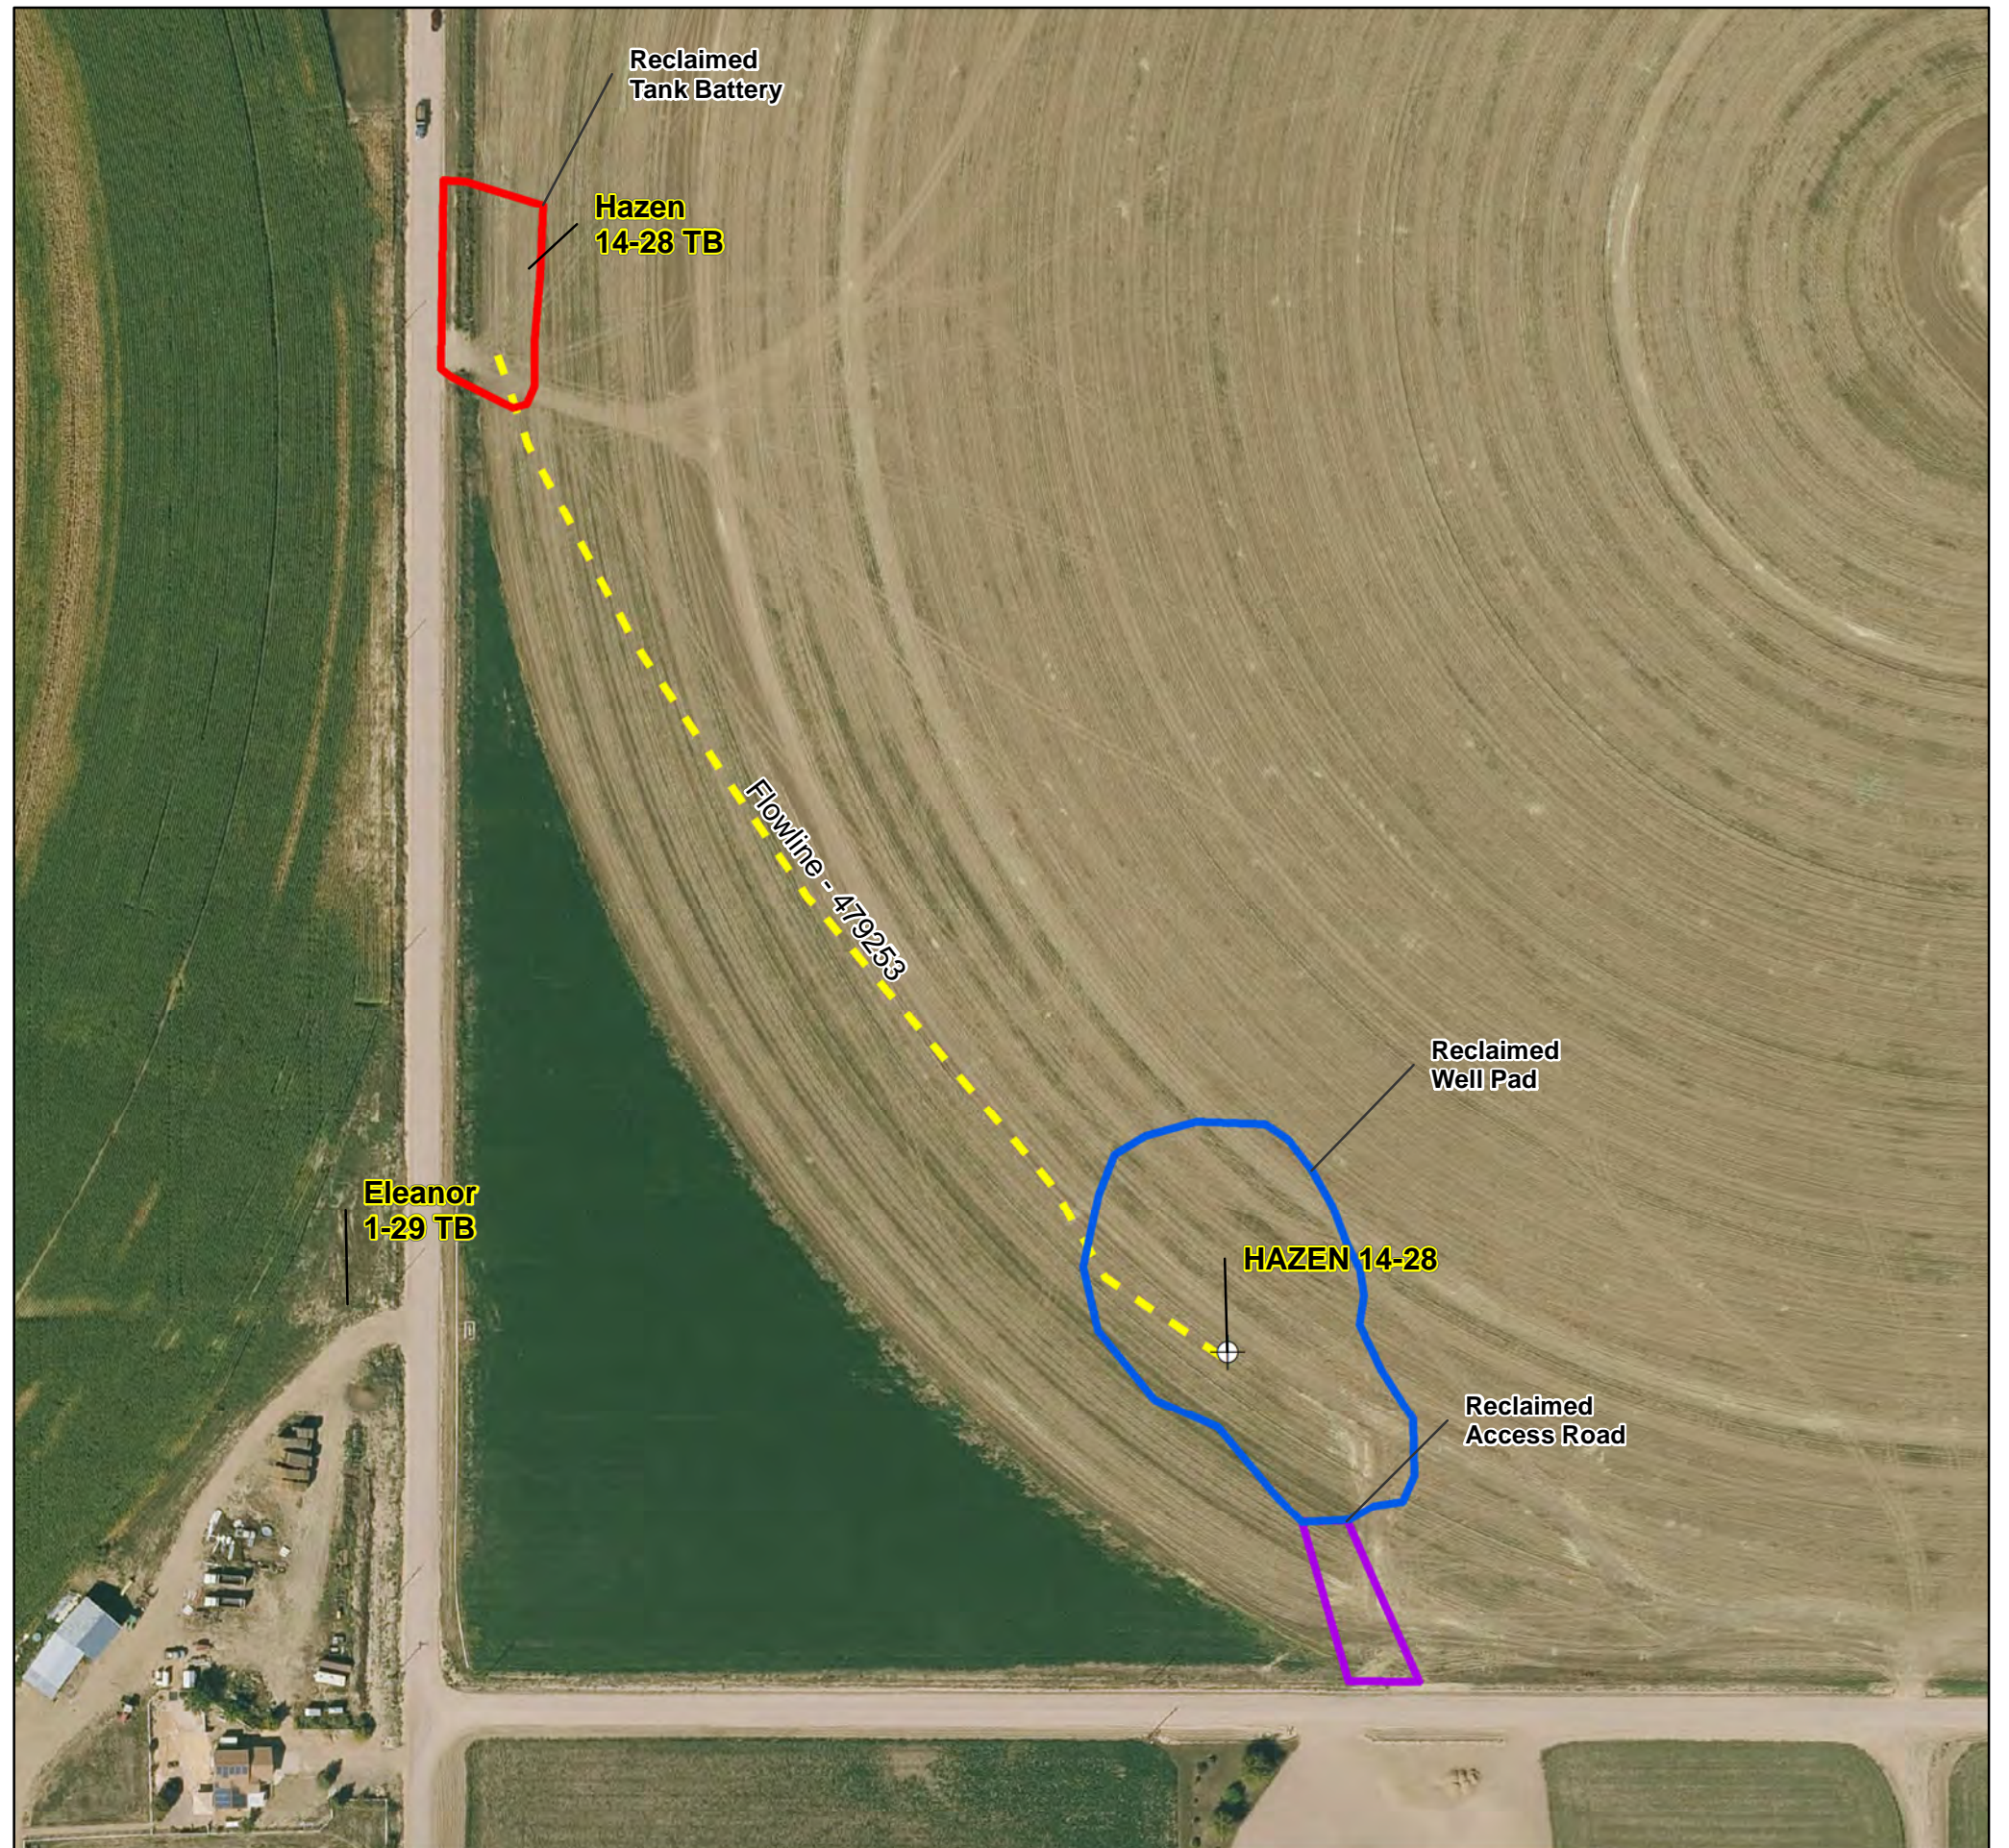
Drone imagery confirms that no equipment was left on site at this location after reclamation activities occurred.

Post-Plugging and Abandonment Location Overview

PDC Form 4 Final Reclamation - Post Plugging Overview

NAIP 2023 Imagery

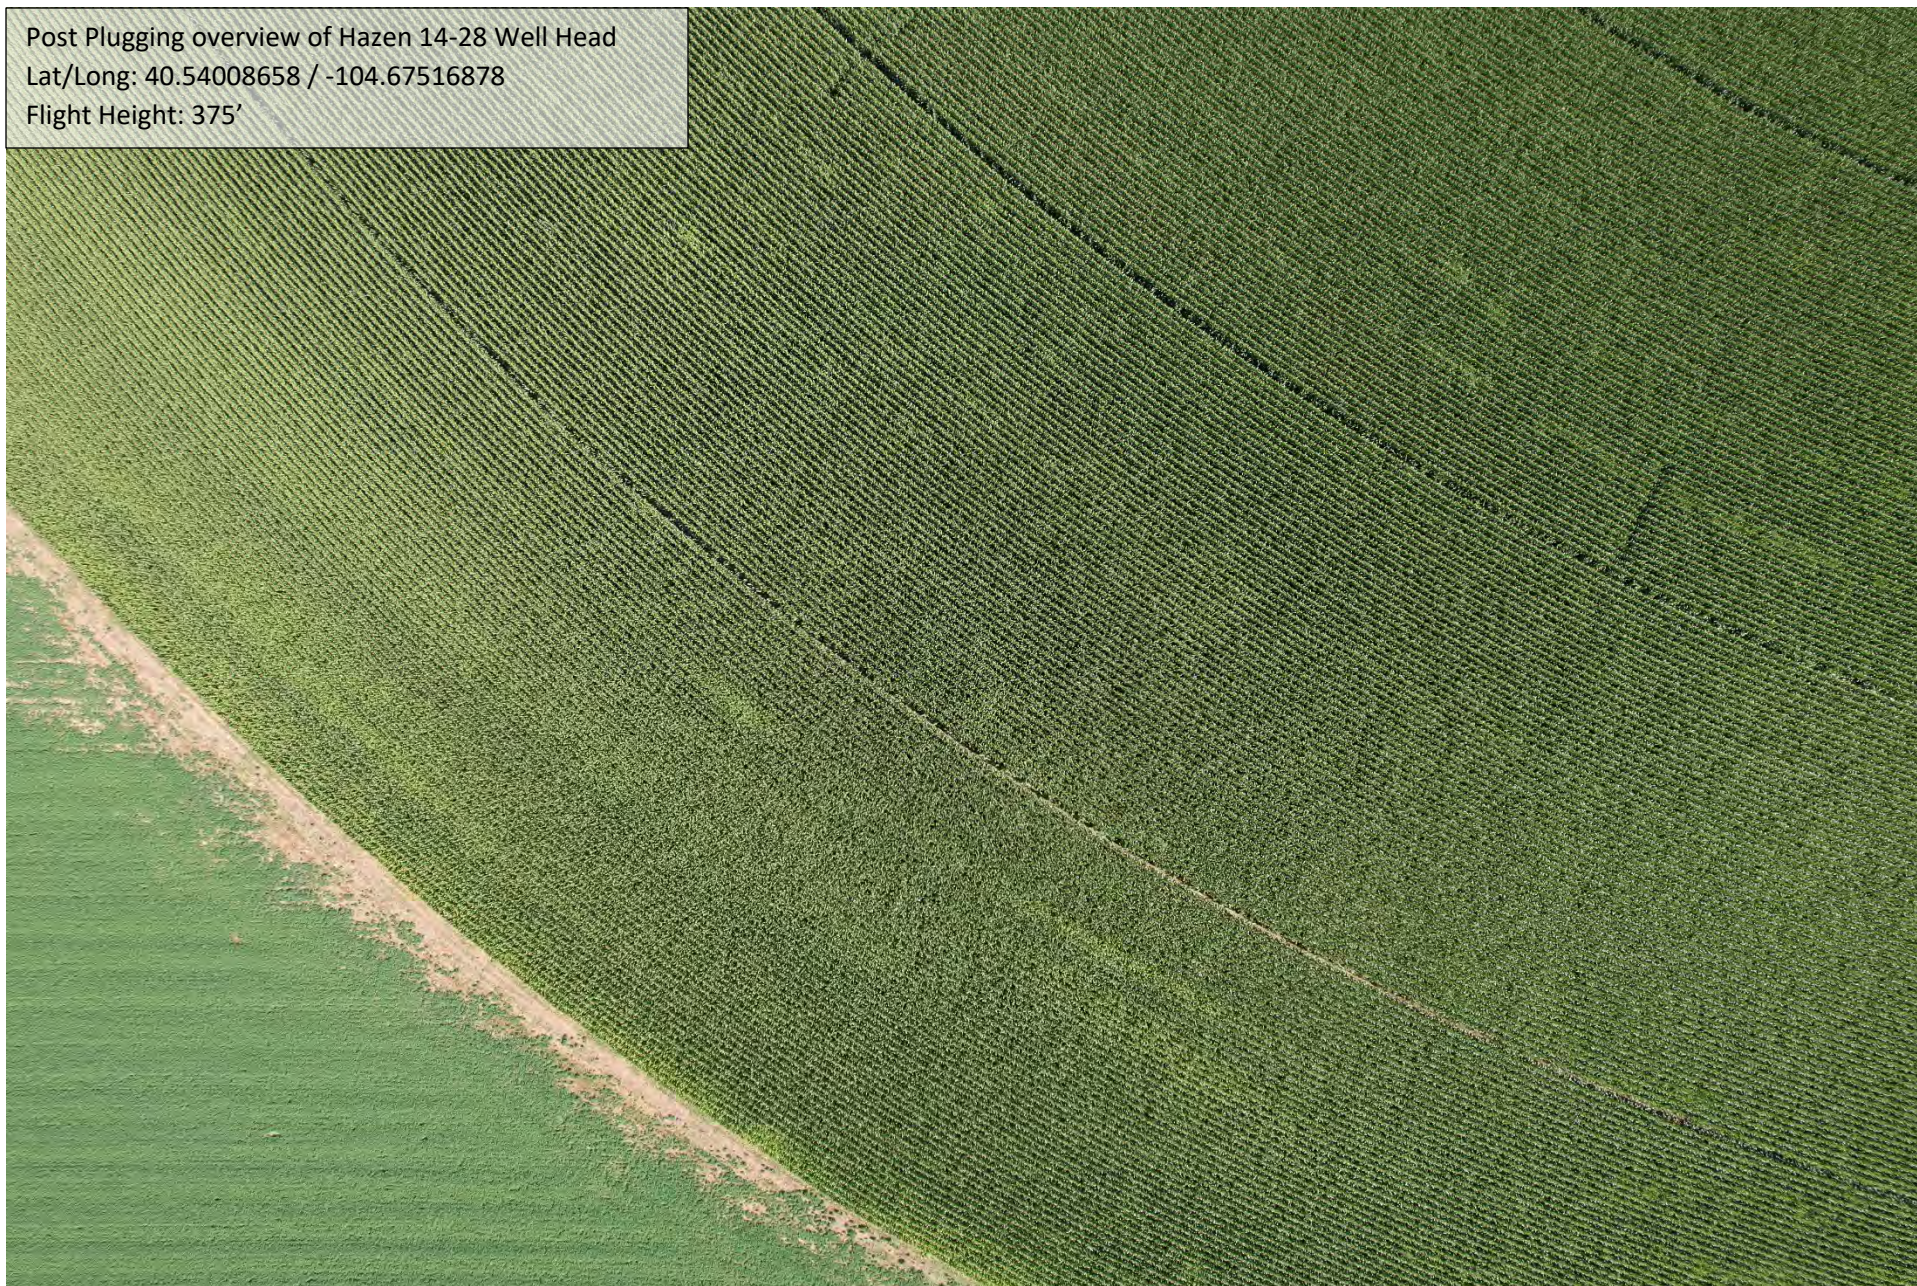
Post Plugging overview of Hazen 14-28 Well Head
Lat/Long: 40.54008658 / -104.67516878
Flight Height: 375'

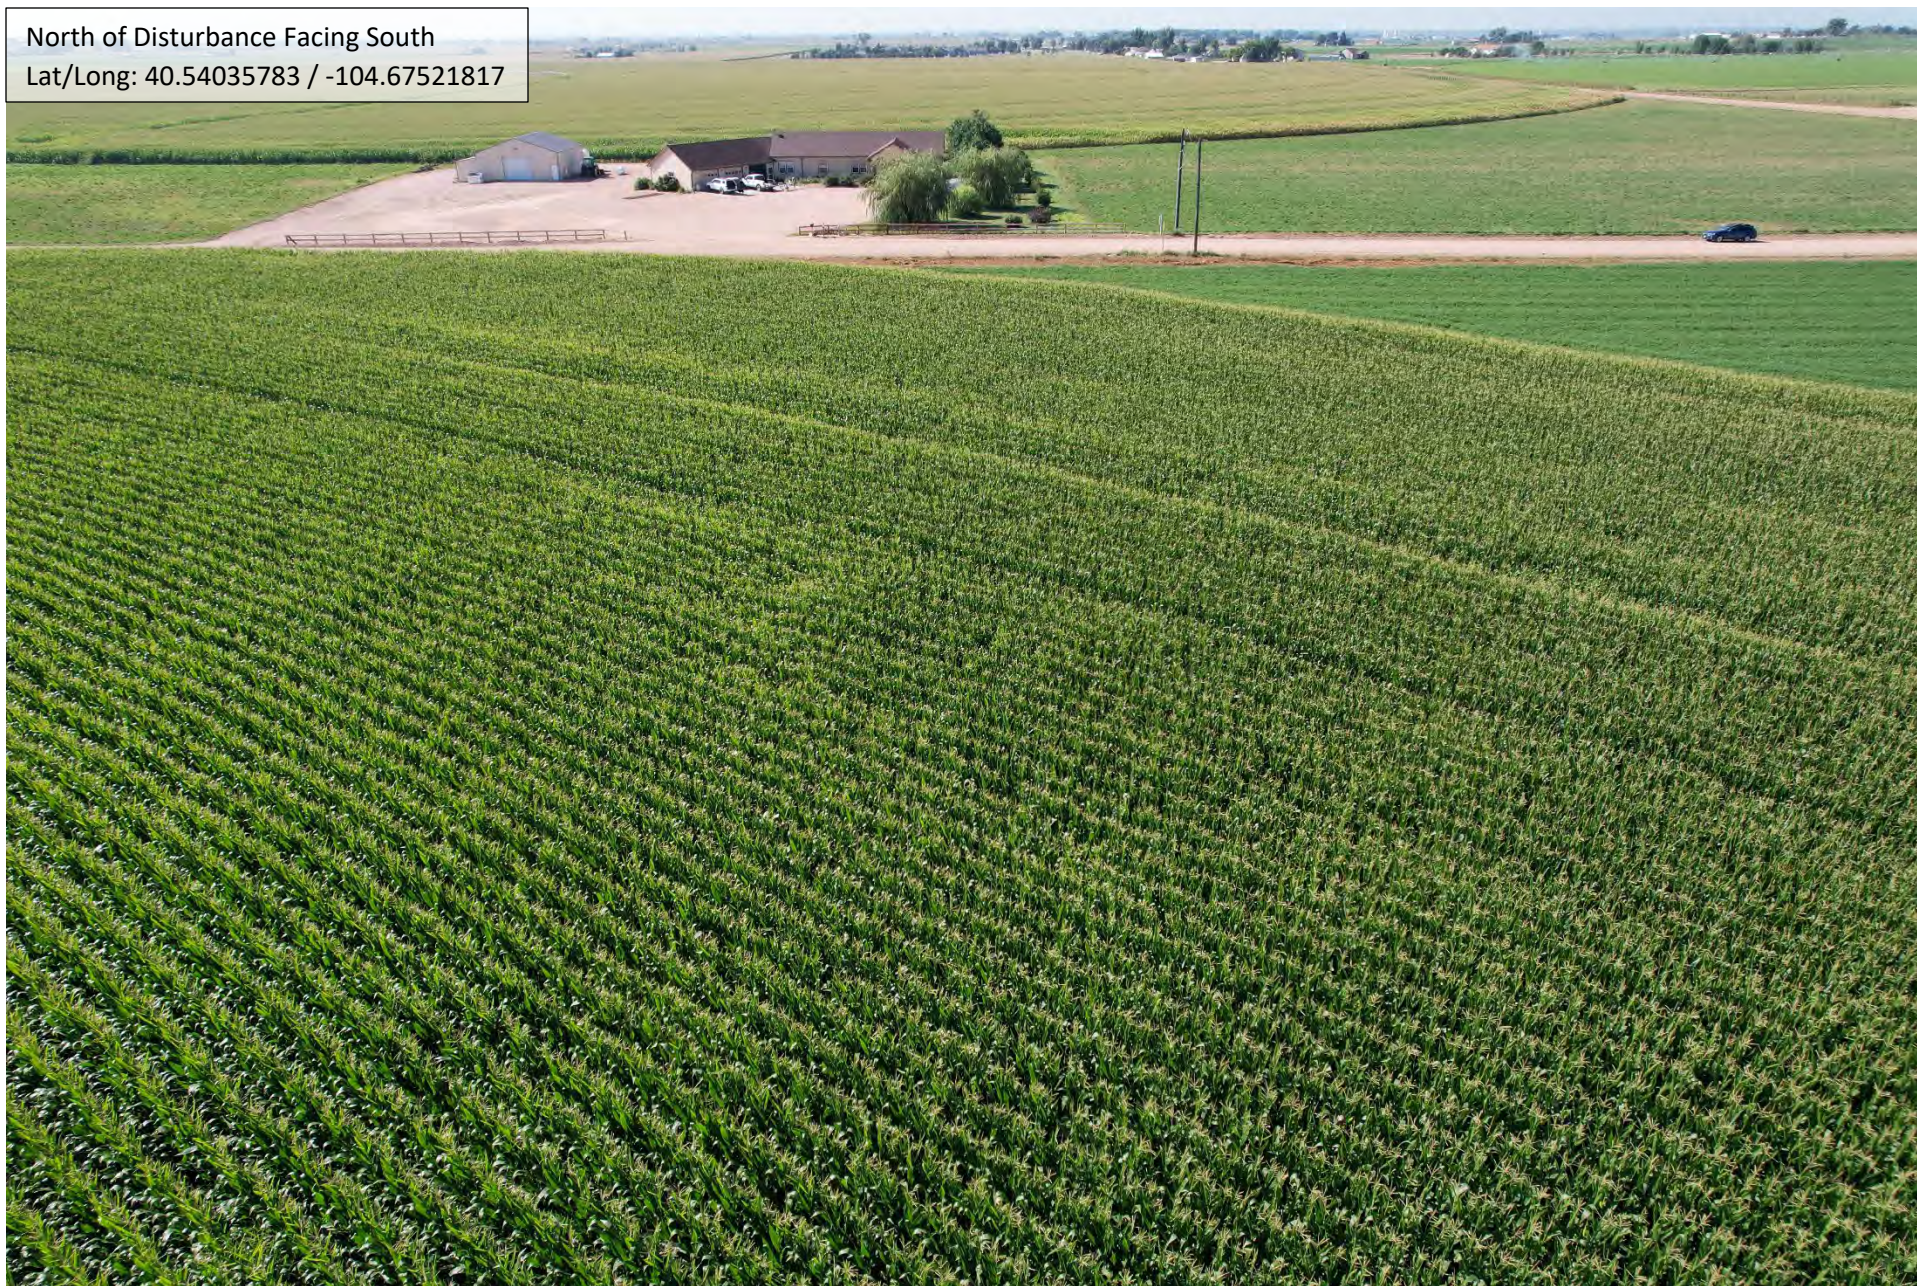
North of Disturbance Facing South
Lat/Long: 40.54035783 / -104.67521817

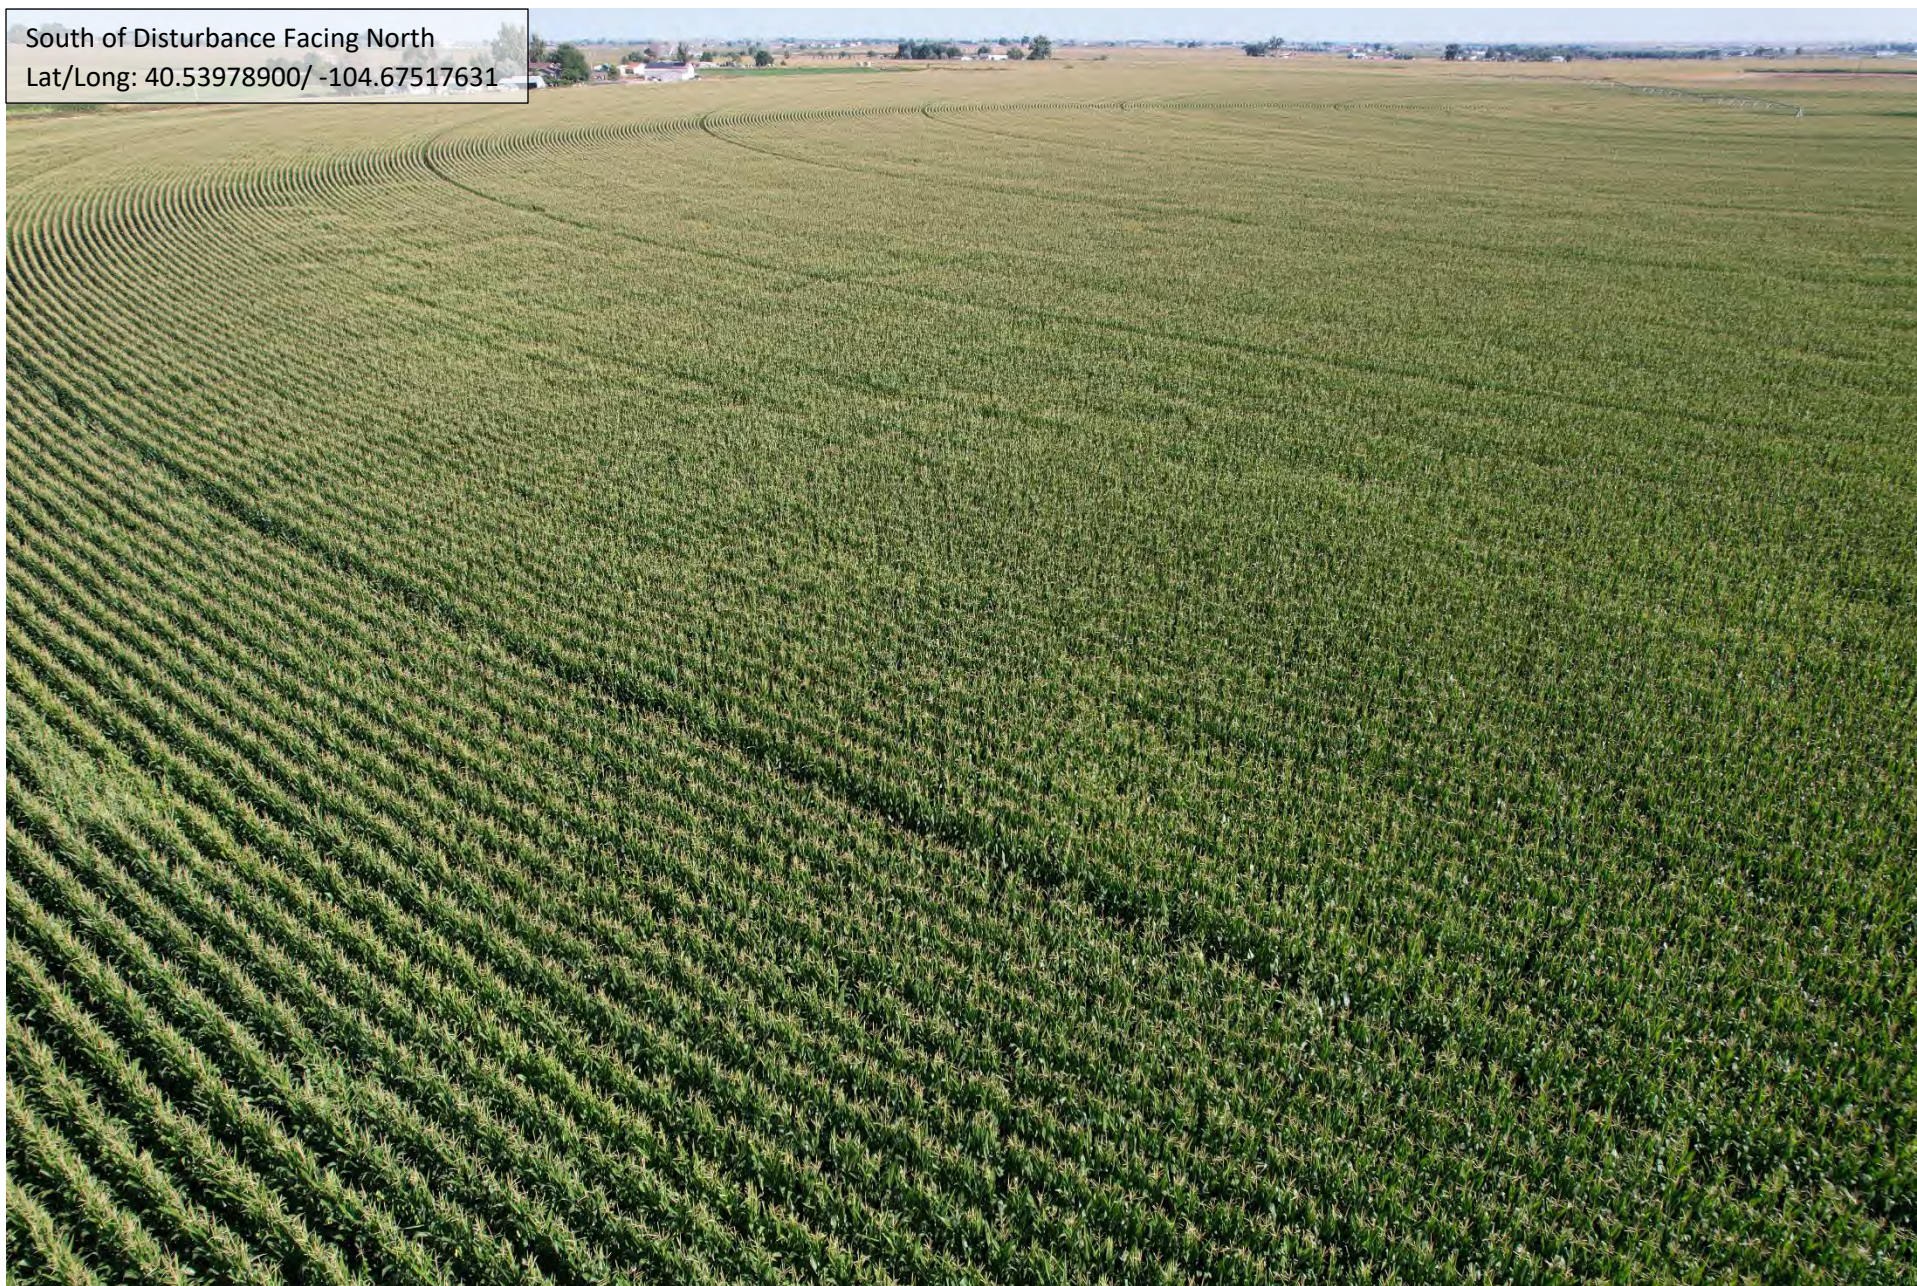
South of Disturbance Facing North
Lat/Long: 40.53978900/ -104.67517631

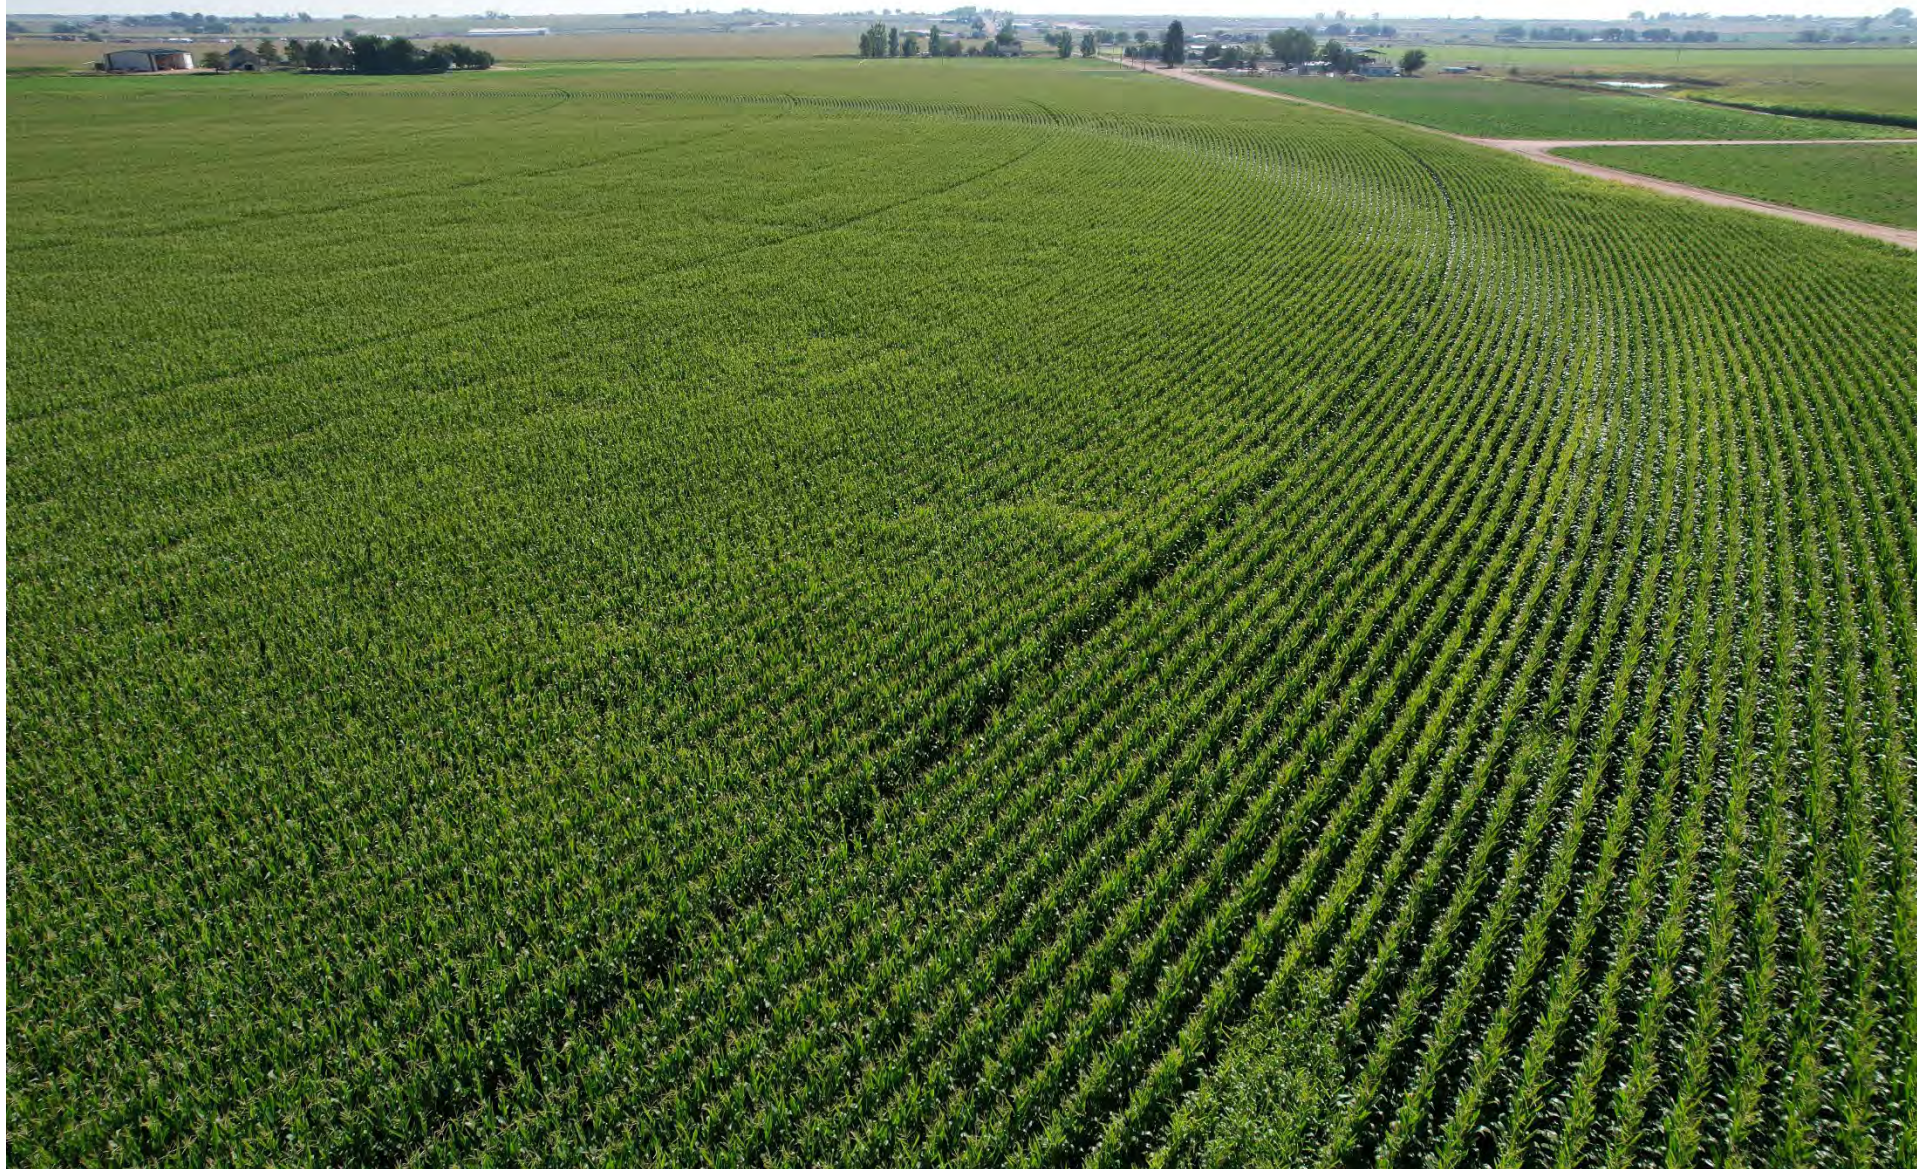
West of Disturbance Facing East
Lat/Long: 40.54006433 / -104.67562394

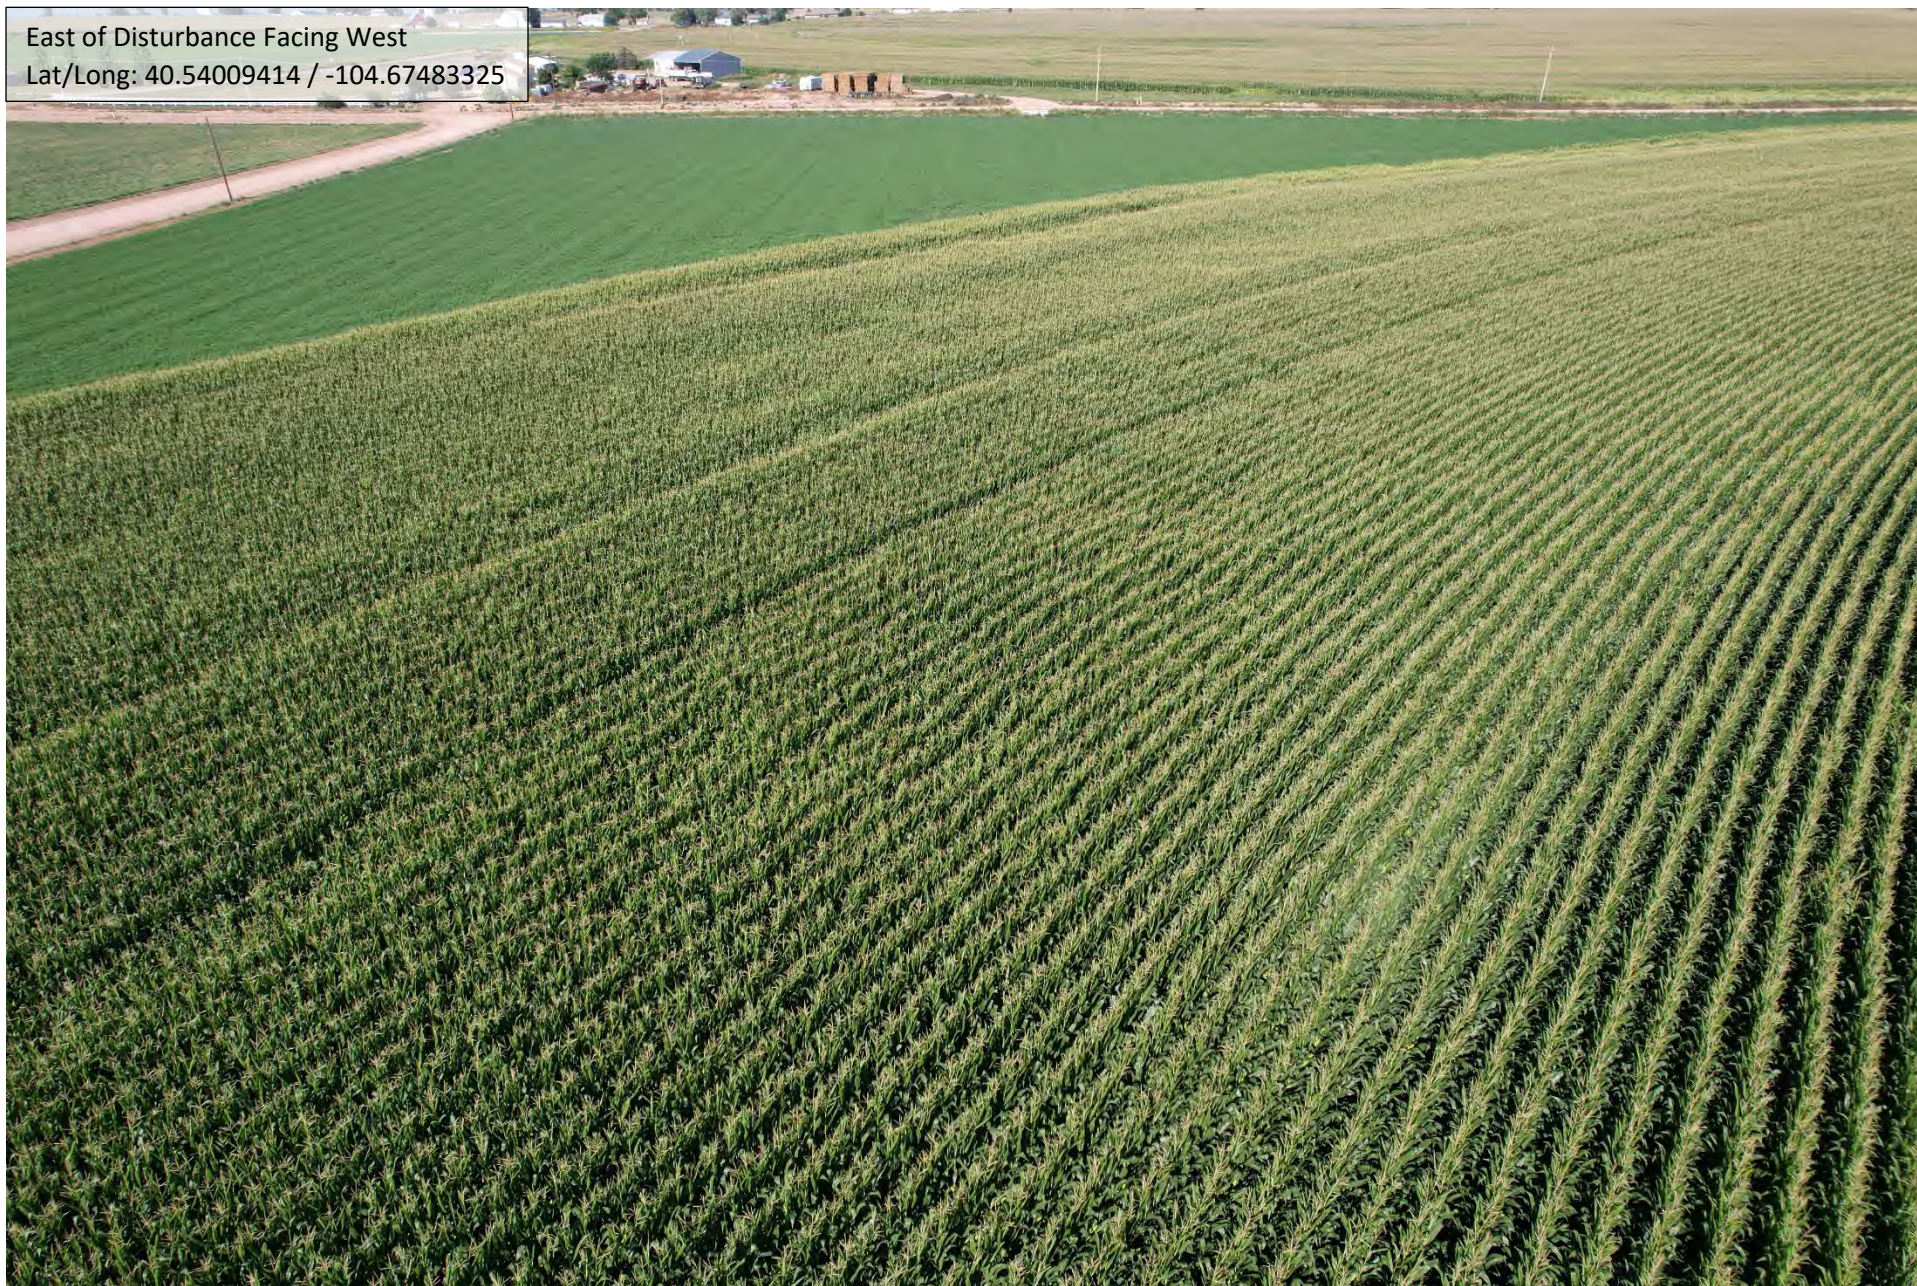
East of Disturbance Facing West
Lat/Long: 40.54009414 / -104.67483325

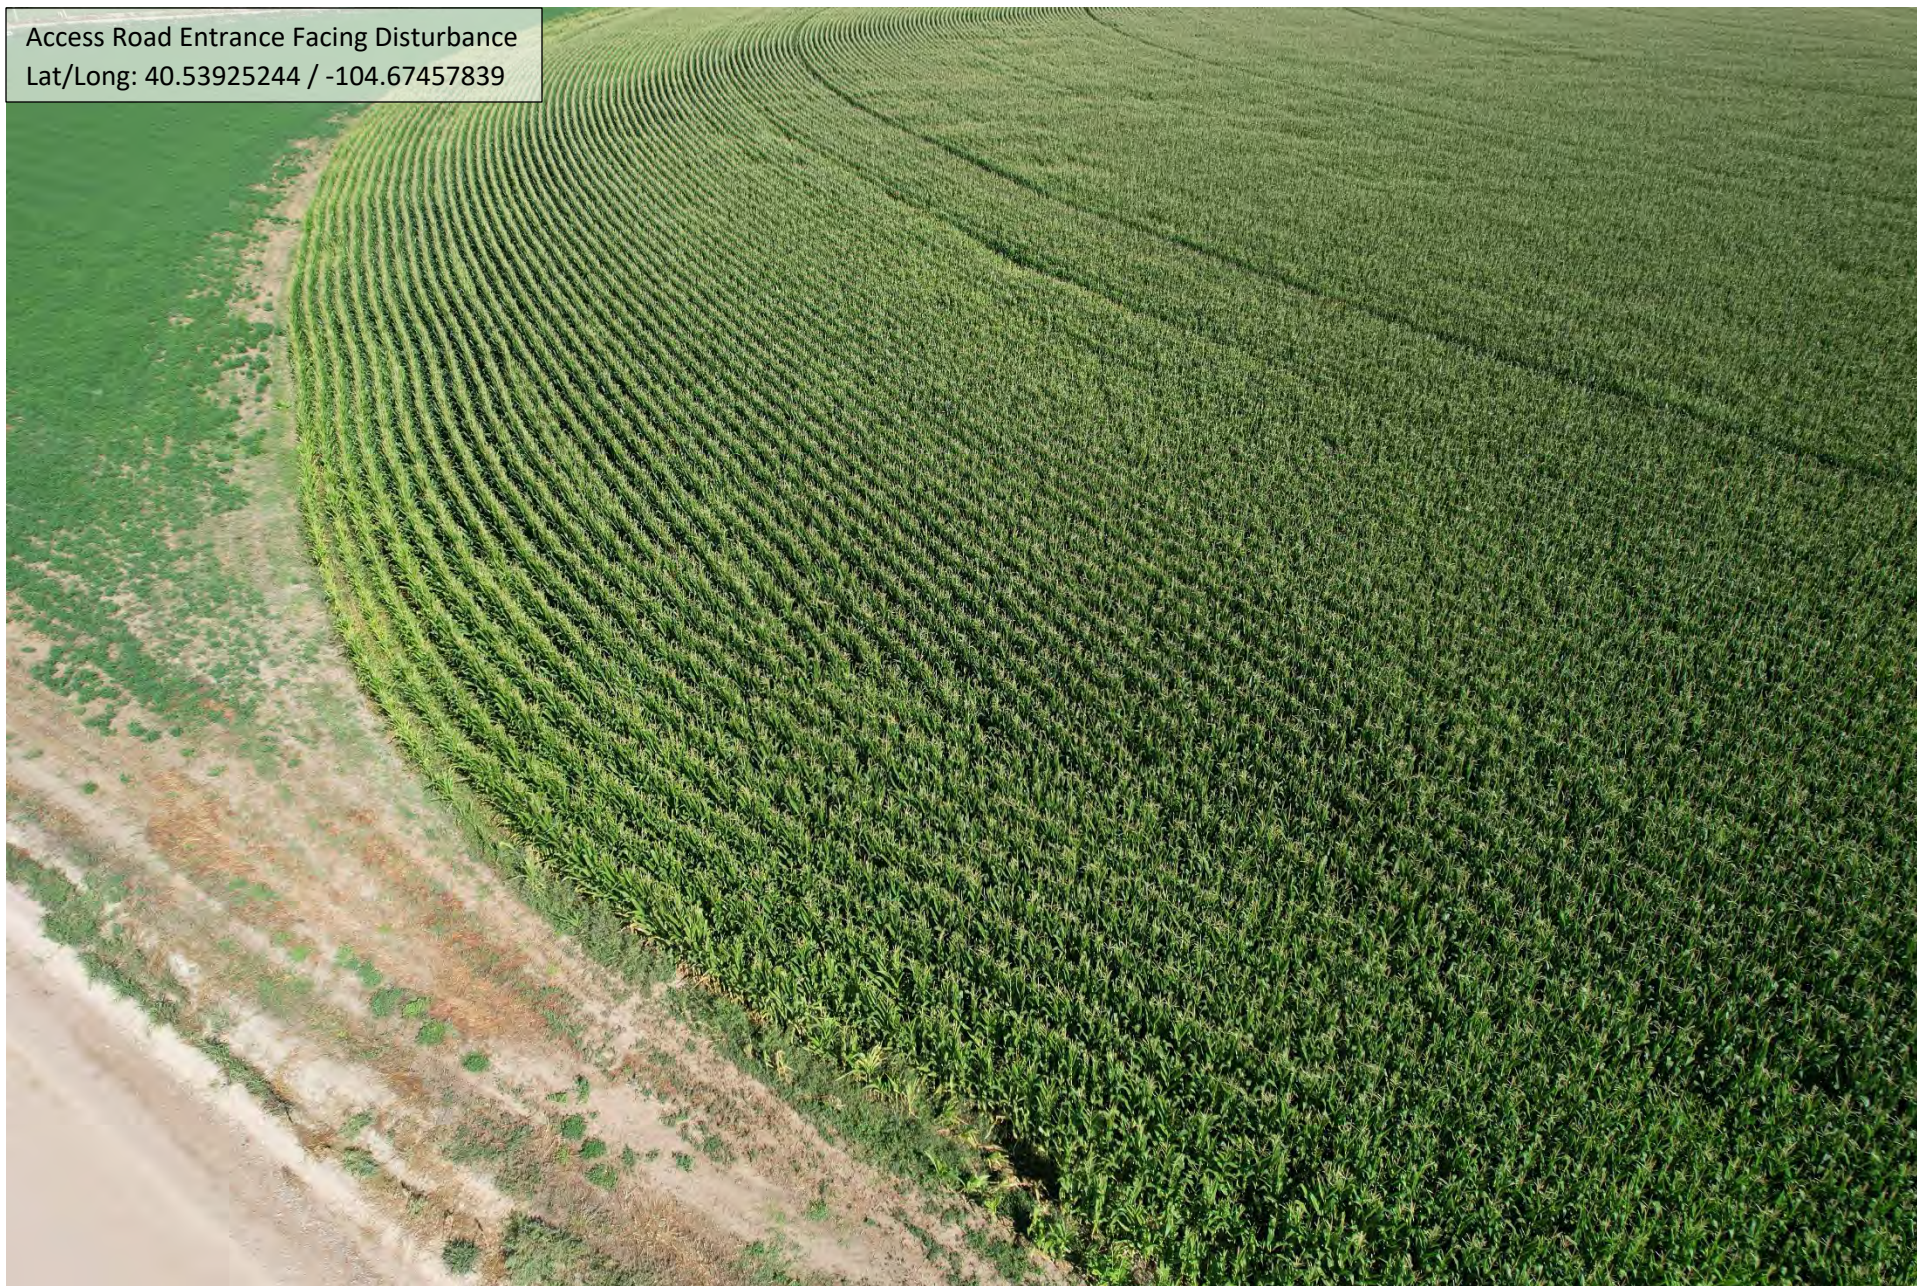
Access Road Entrance Facing Disturbance
Lat/Long: 40.53925244 / -104.67457839
