Site Specific Final Reclamation Completion Notice – Cropland Drone Imagery

Permit Closure Report – Cropland

Location ID: 305351

Location Name: HAZEN-67N65W/28SWSW

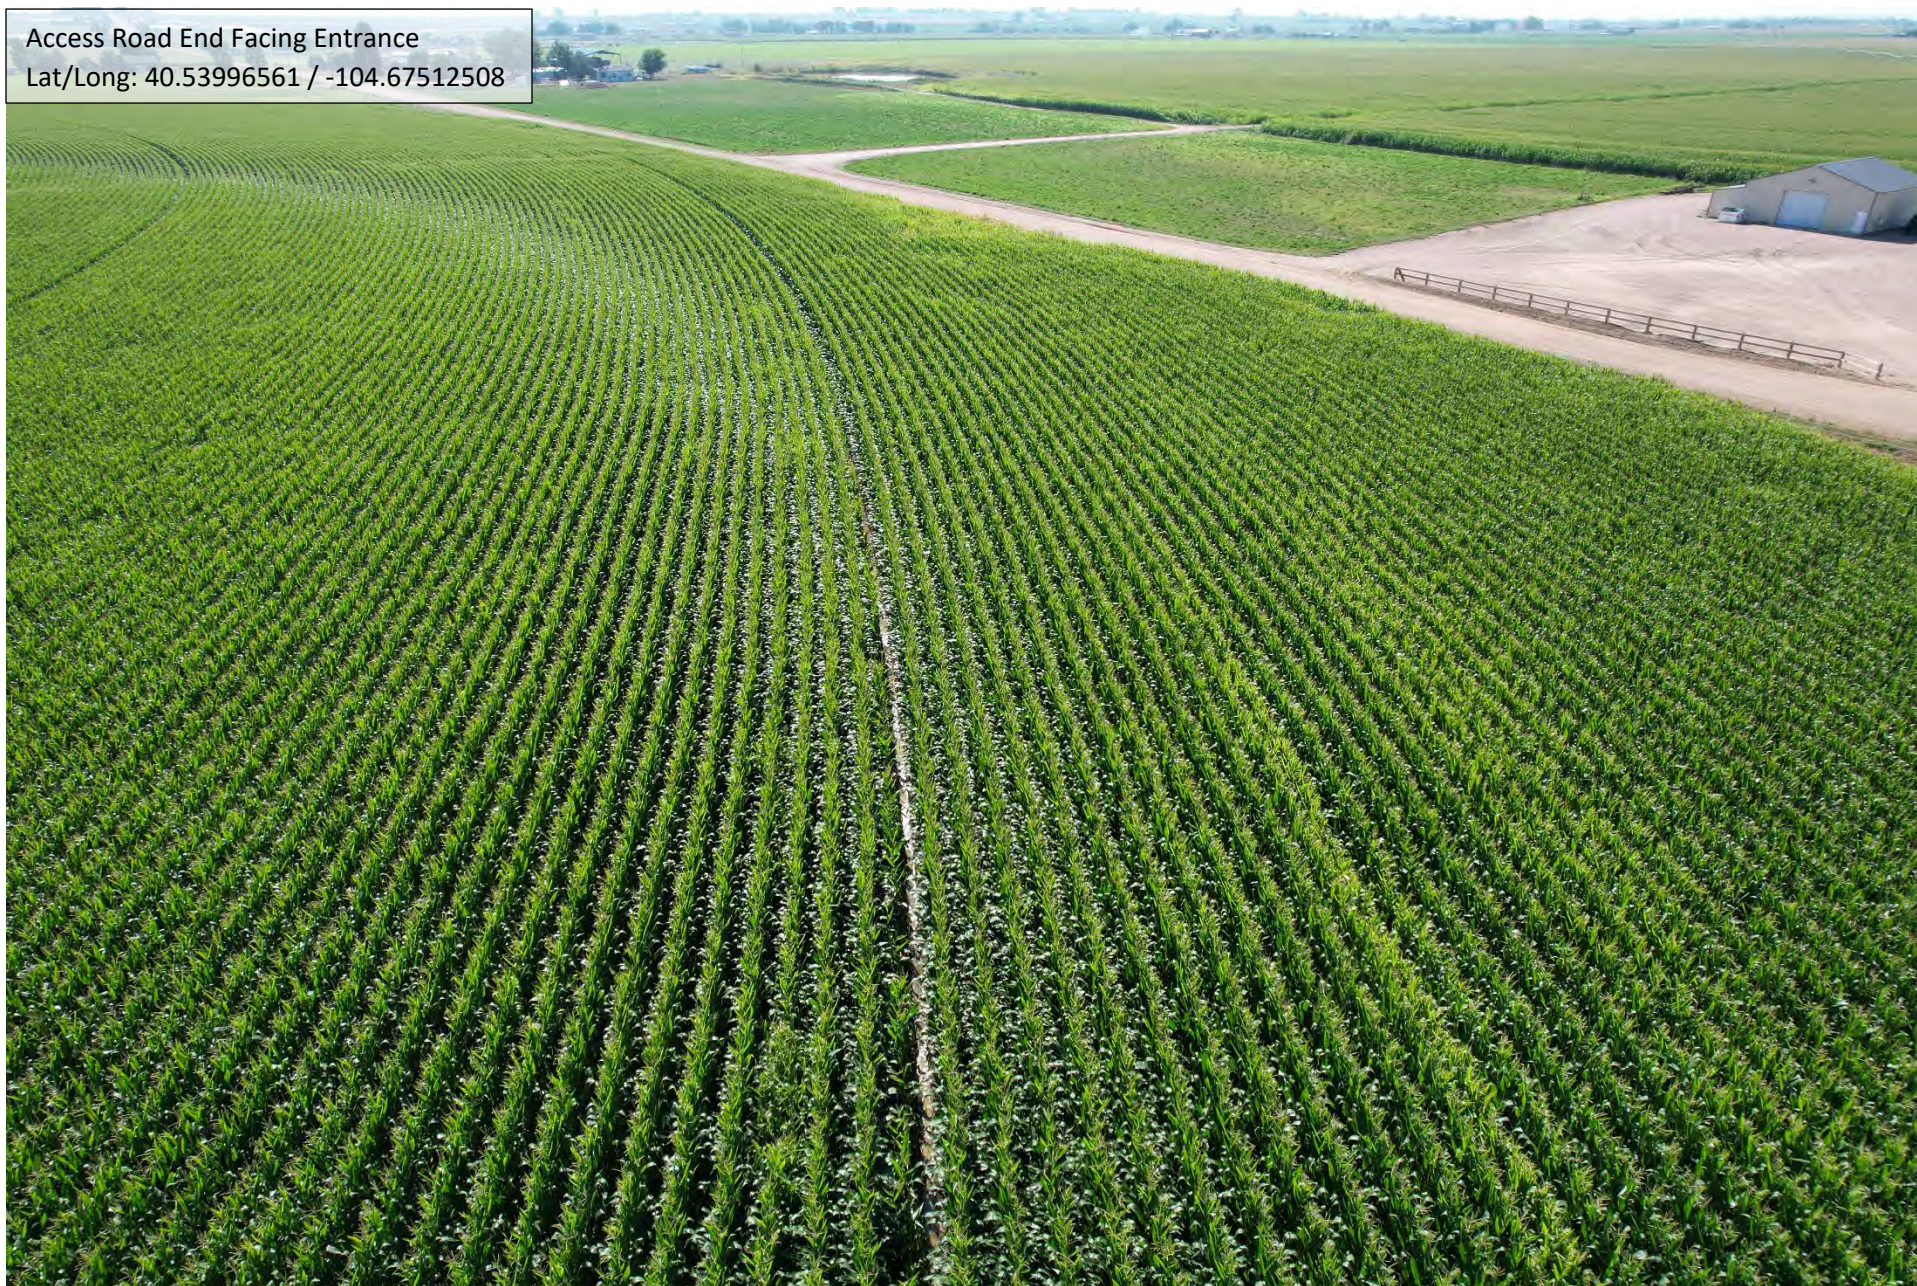
Access Road End Facing Entrance
Lat/Long: 40.53996561 / -104.67512508

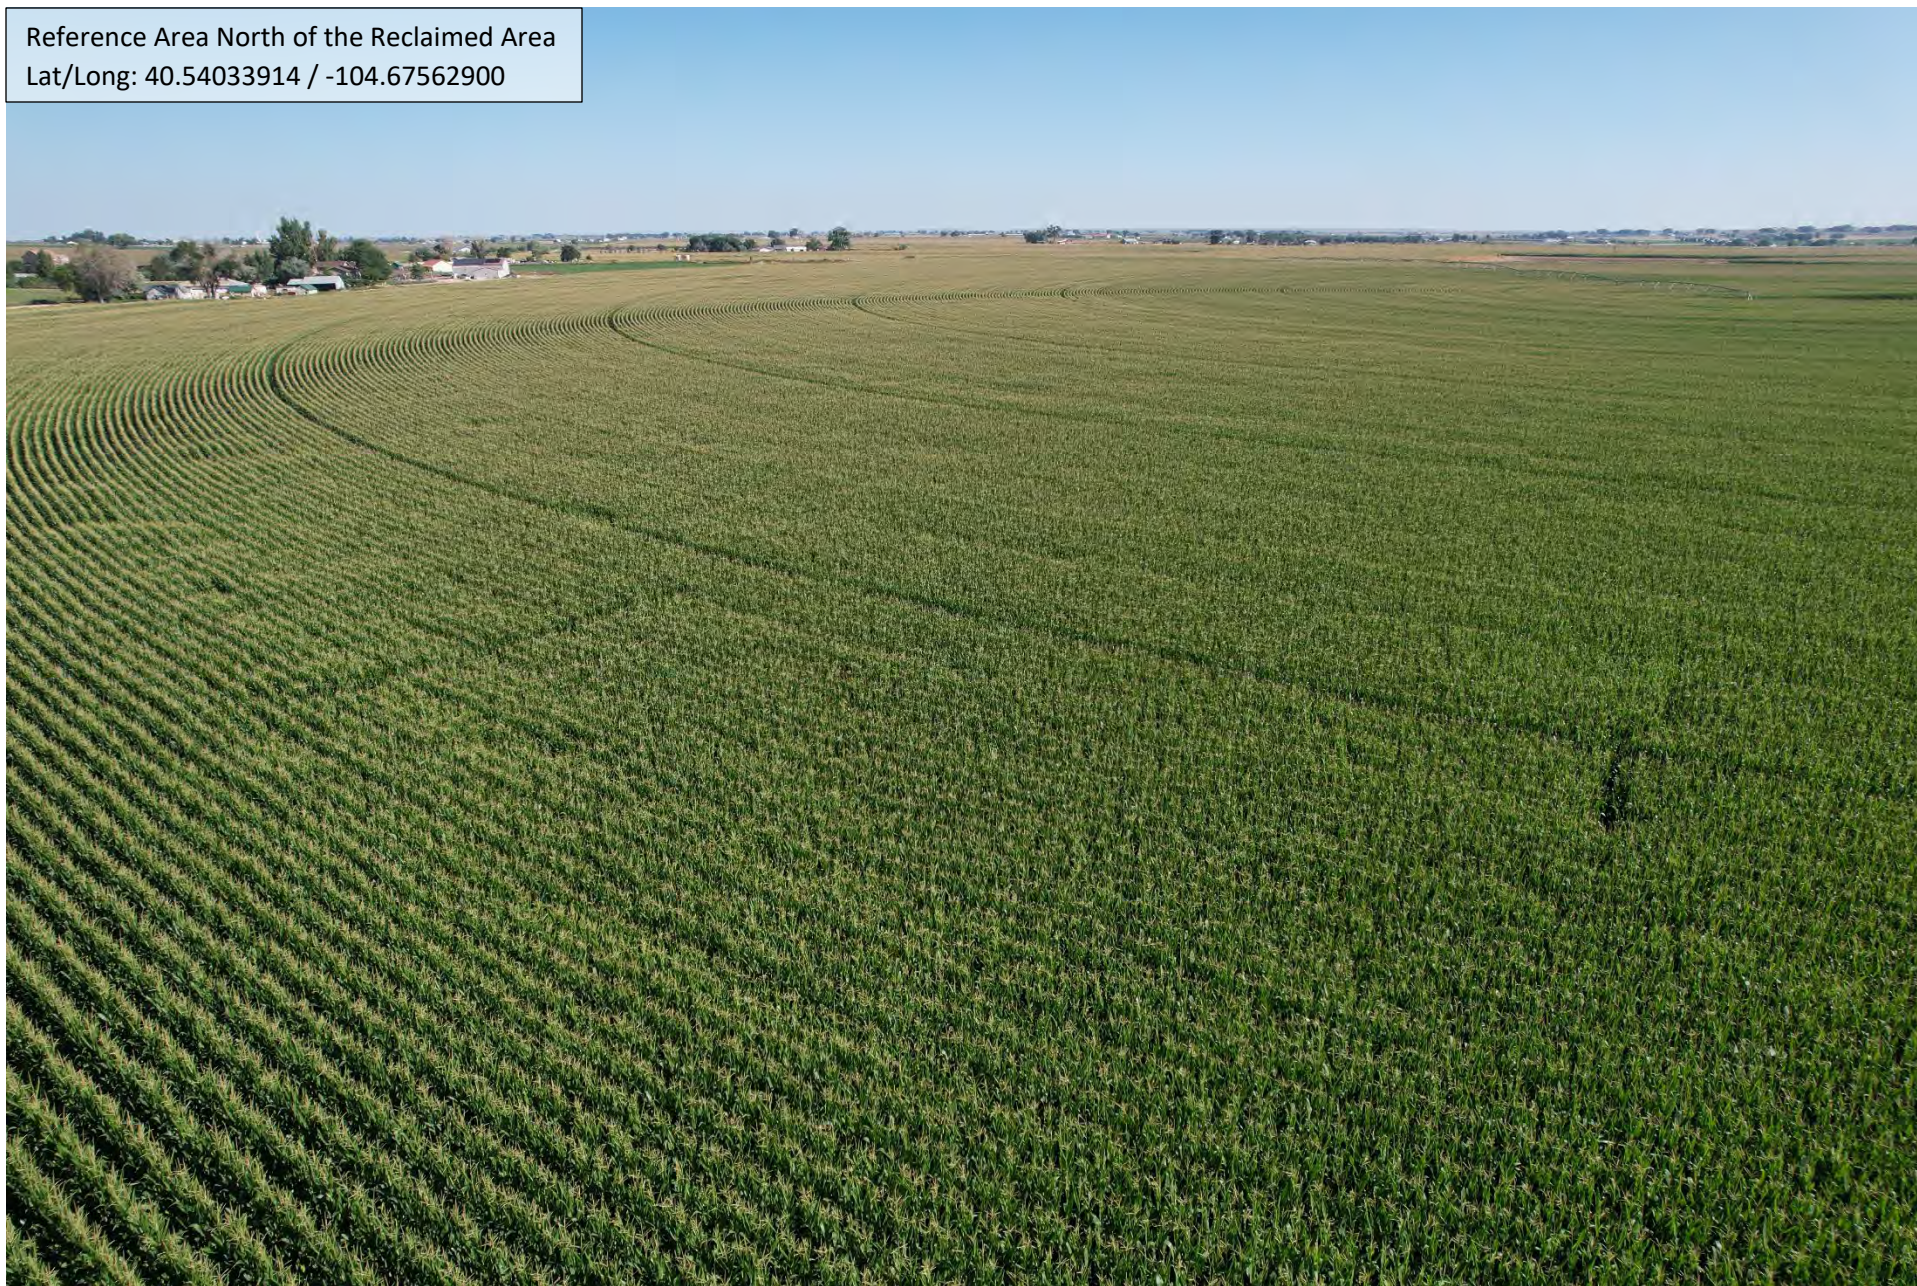
Reference Area North of the Reclaimed Area
Lat/Long: 40.54033914 / -104.67562900

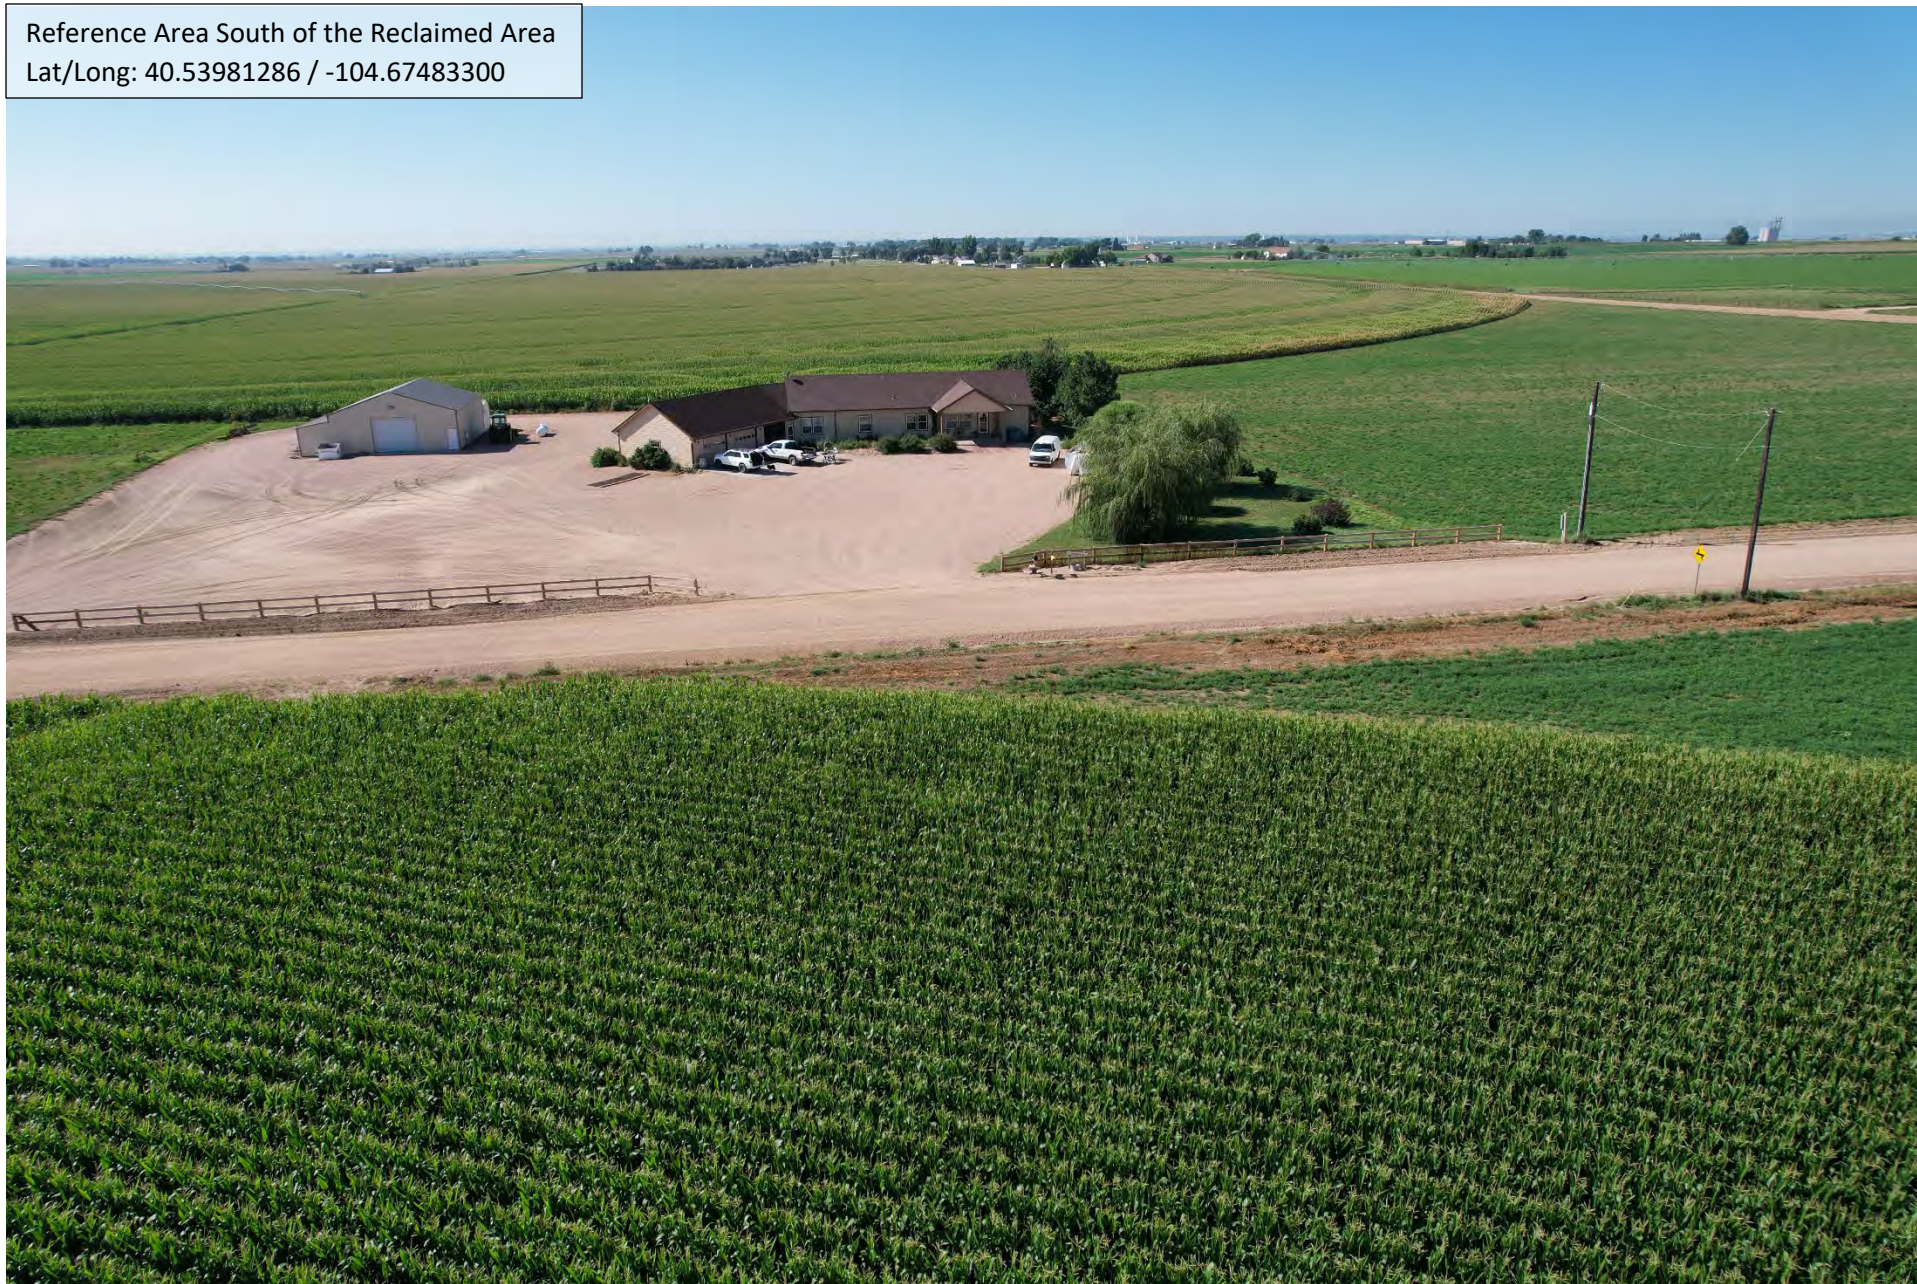
Reference Area South of the Reclaimed Area
Lat/Long: 40.53981286 / -104.67483300

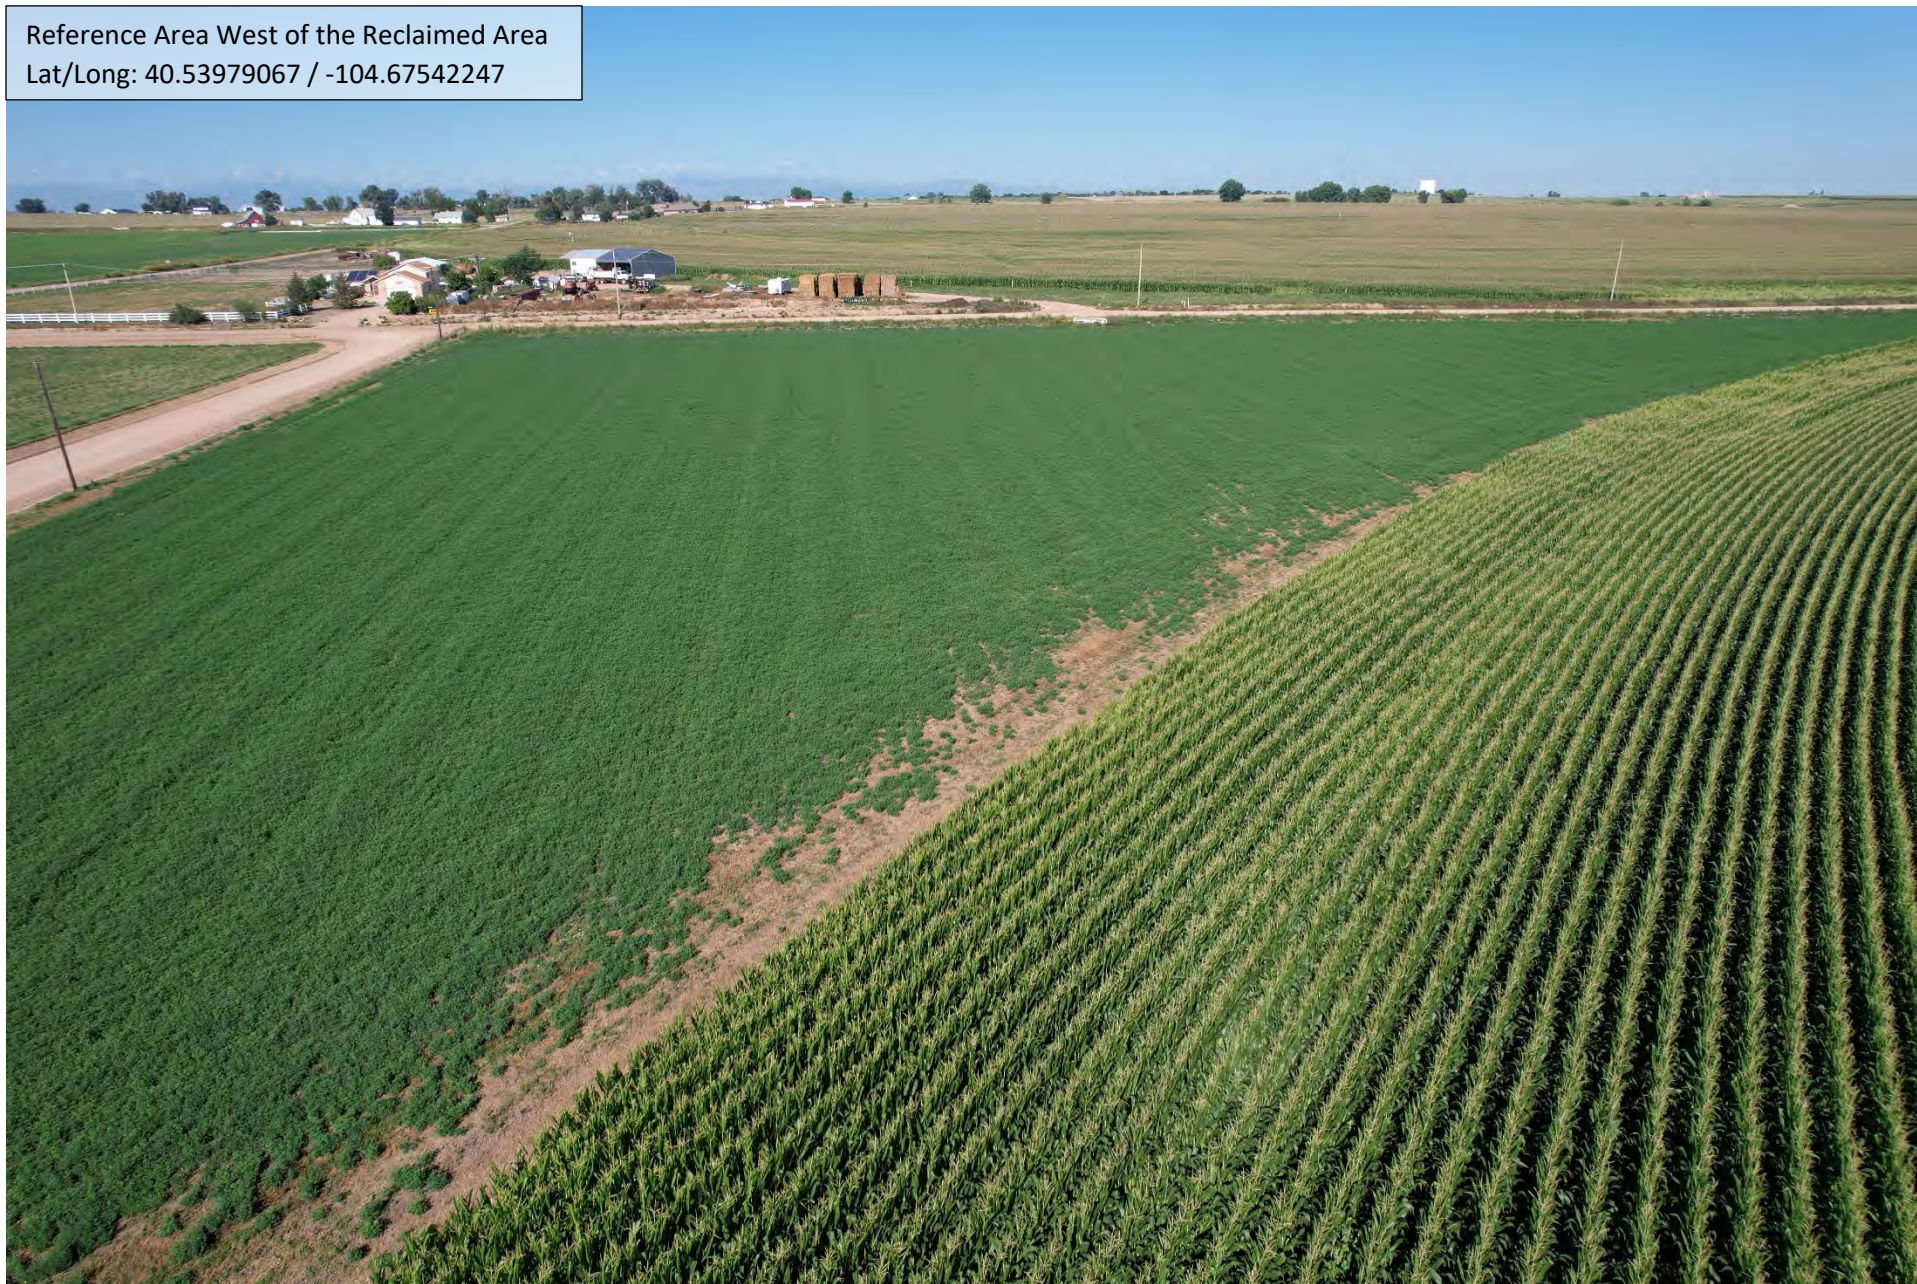
Reference Area West of the Reclaimed Area
Lat/Long: 40.53979067 / -104.67542247

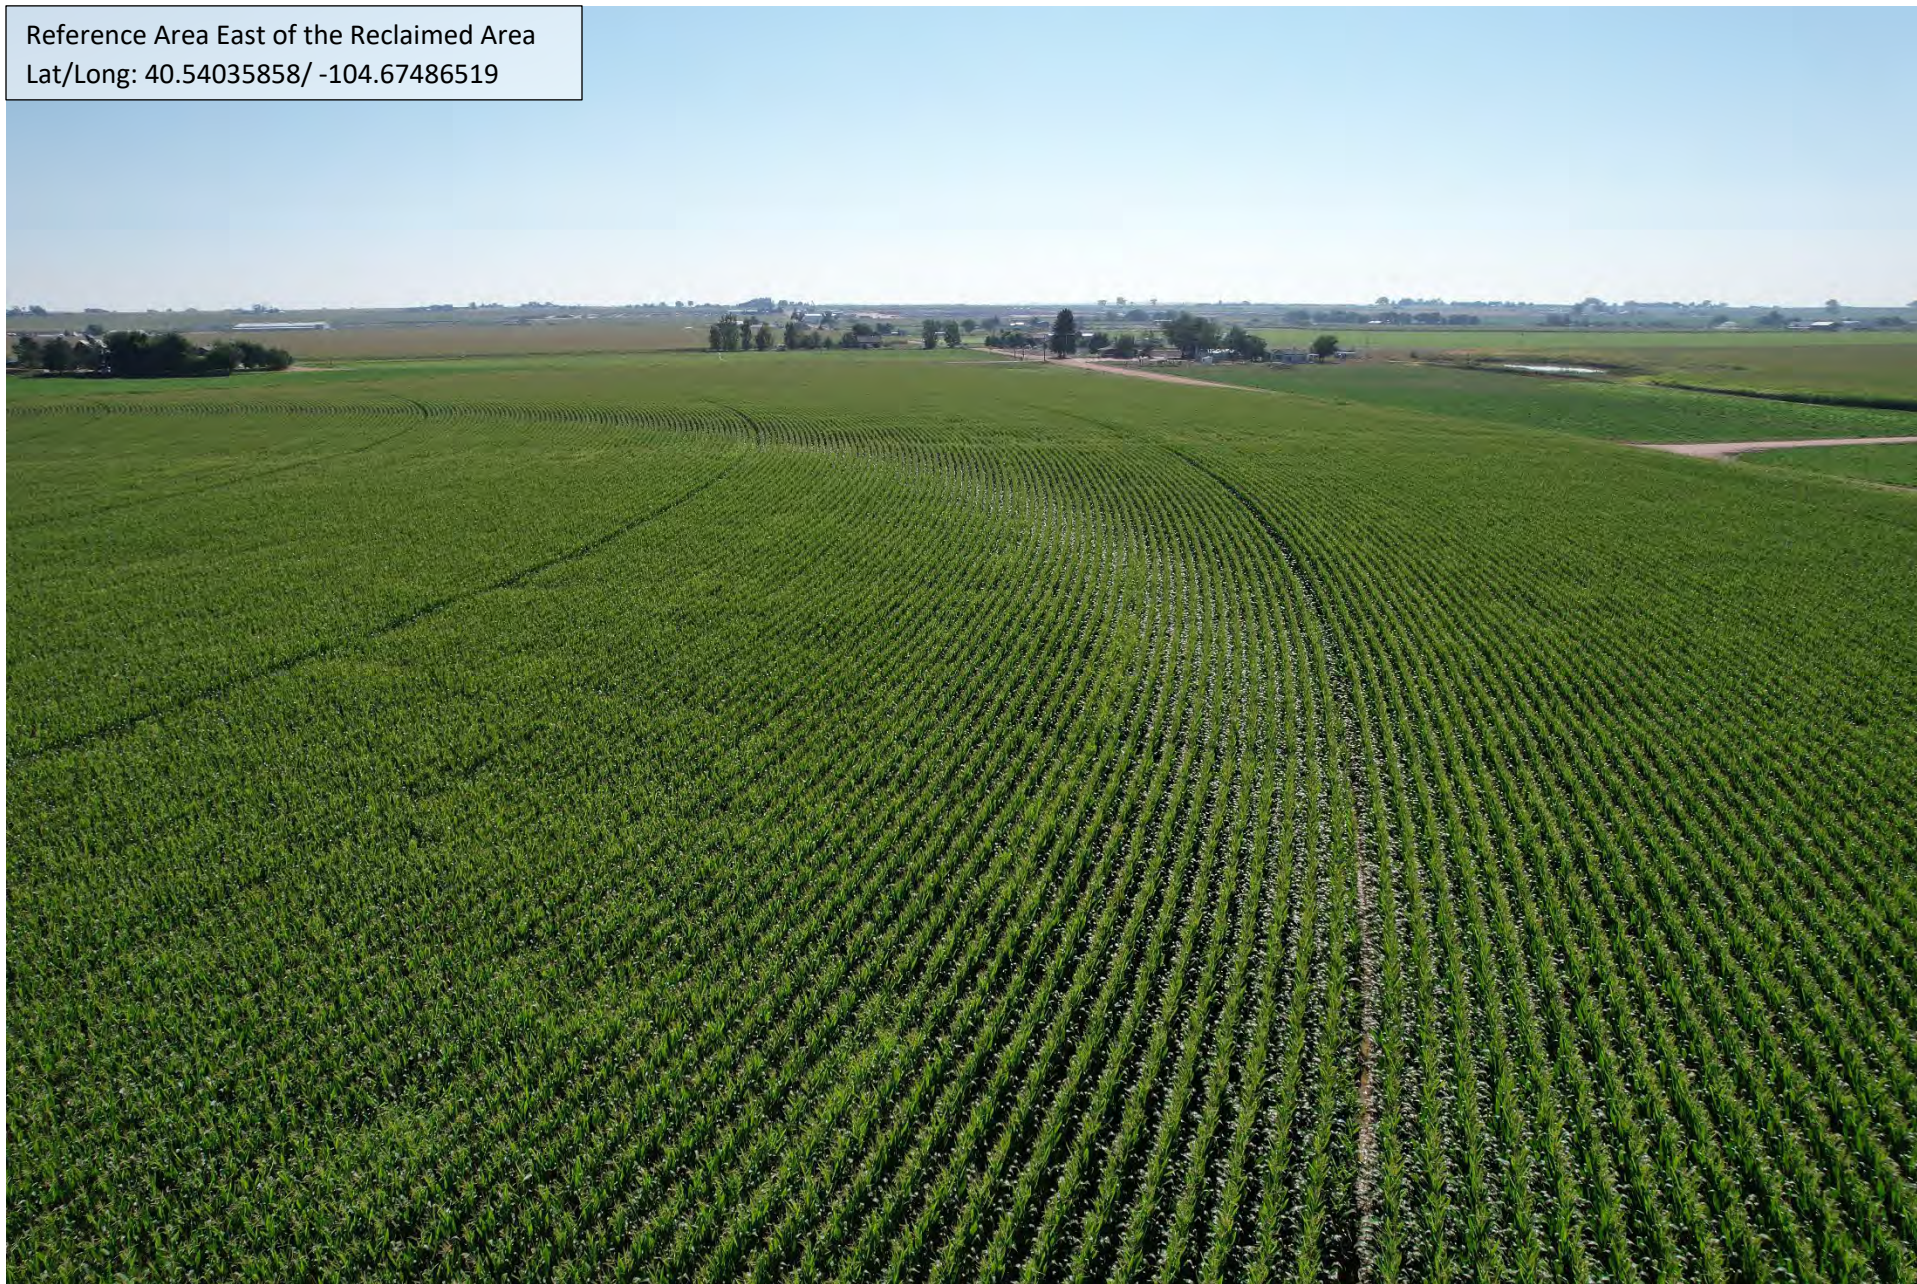
Reference Area East of the Reclaimed Area
Lat/Long: 40.54035858/ -104.67486519

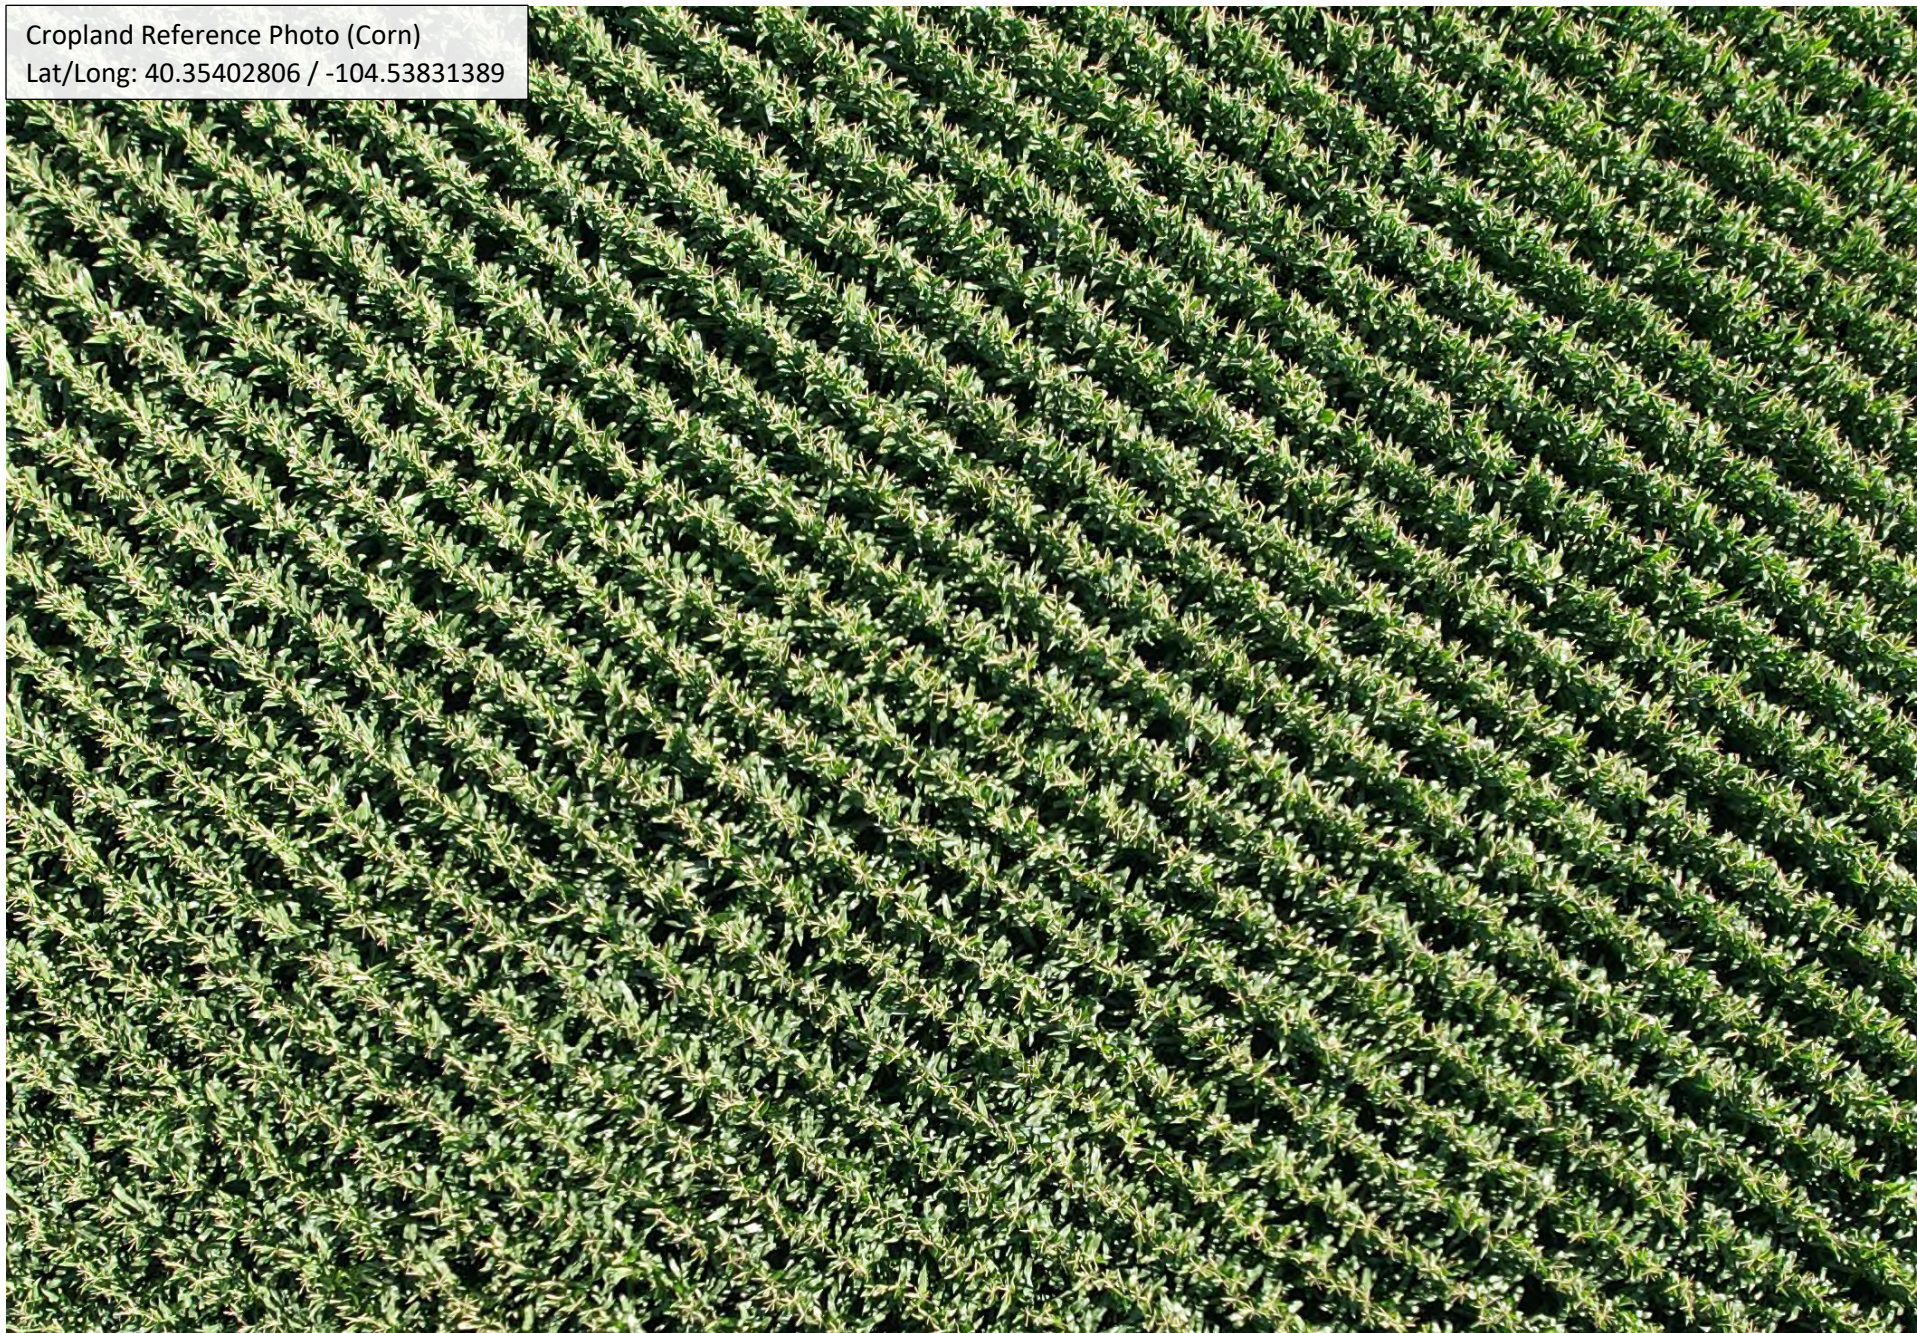
Cropland Reference Photo (Corn)
Lat/Long: 40.35402806 / -104.53831389
