KP Kauffman - ECMC Inspection Photos
Location: UPRR 42 Pan Am E 2 Flowline Release
Spill ID #487060 Date 06/19/2024

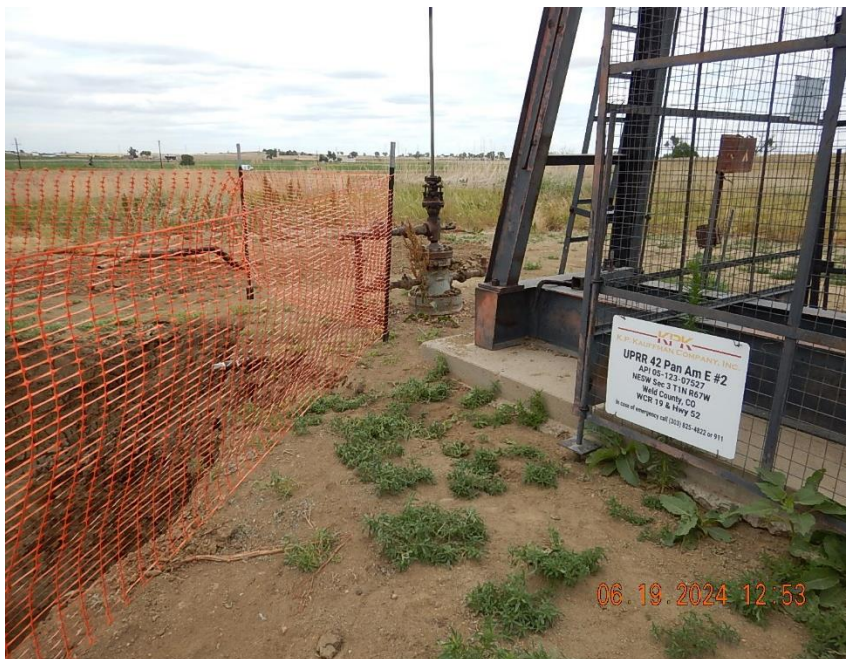
Signage at wellhead
Fenced excavation at spill id #487060

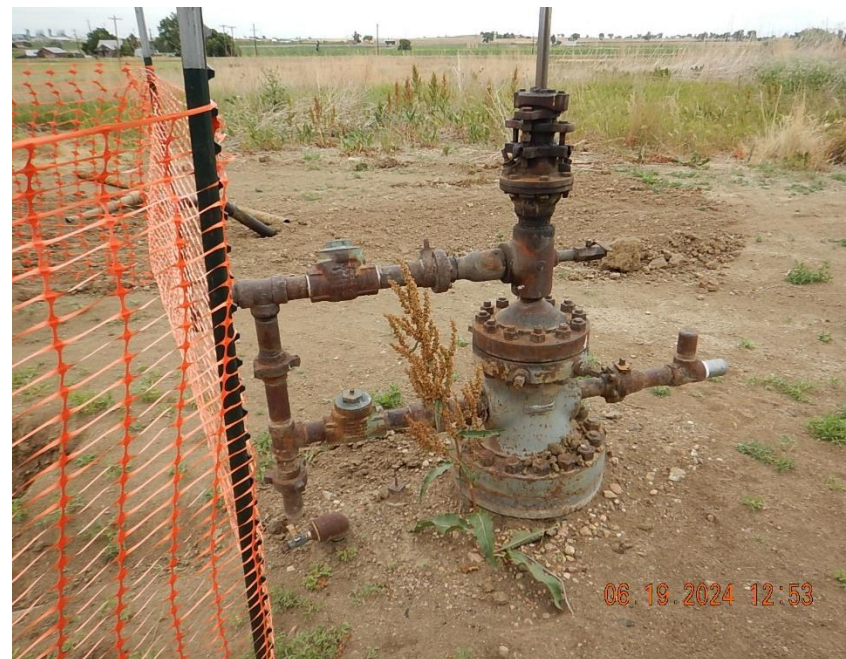
Close up view of wellhead; No OOSLAT observed at WH

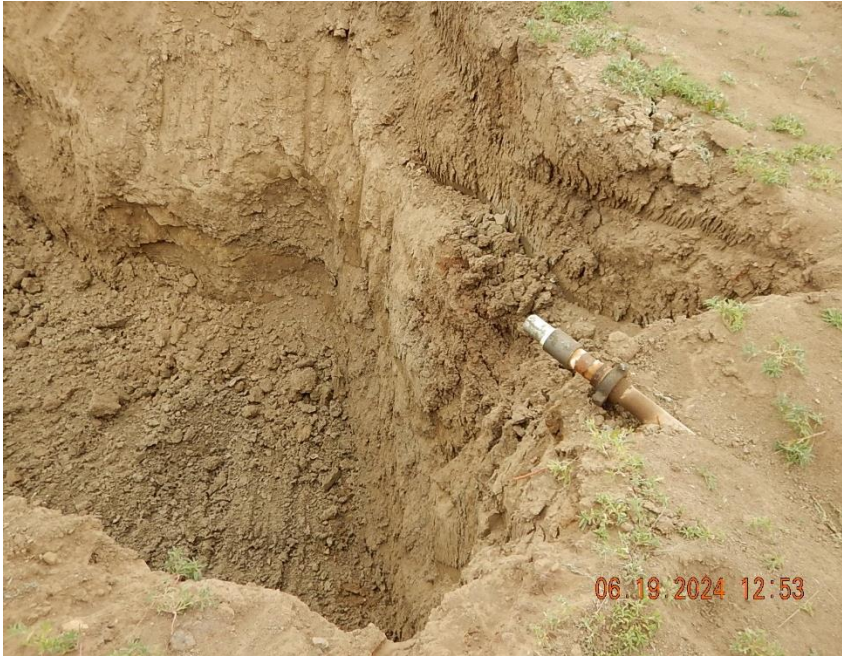
East side of excavation adjacent to wellhead. Flowline (2" CS OLF) cut end is bull plugged (end sealed).

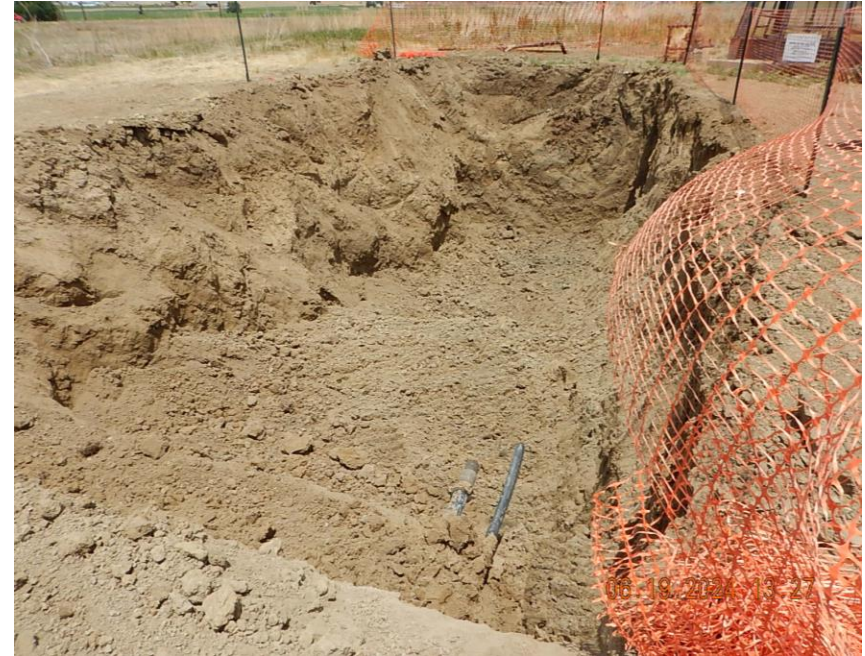
West side of fenced excavation looking east to wellhead. Flowlines exposed in excavation include (1) 3" fiberglass multiphase flowline (end bull plugged) and (1) 1.5" HDPE gas flowline.

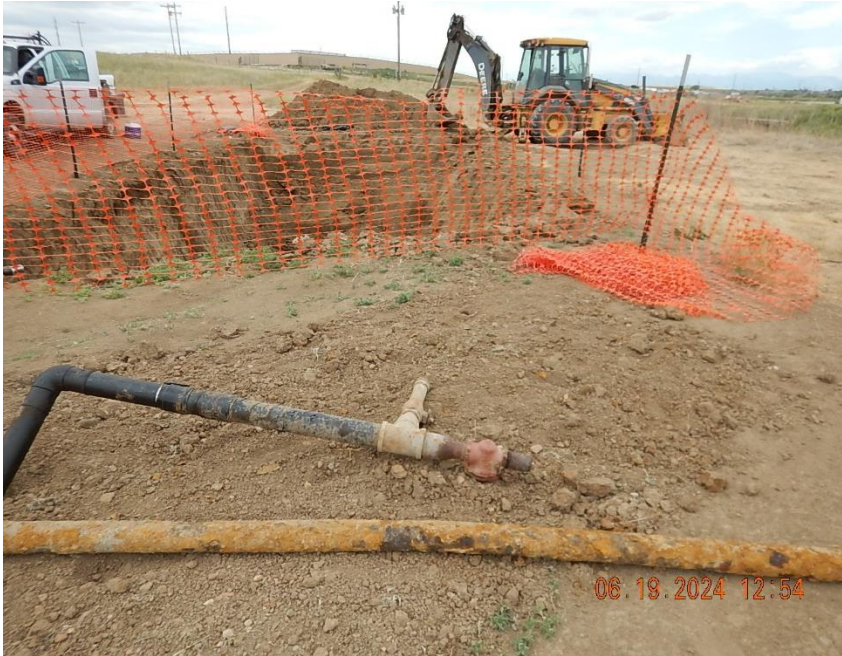
Flowline pipe and riser removed from excavation; mixed materials were observed that included CS, HDPE and fiberglass flowline pipe.

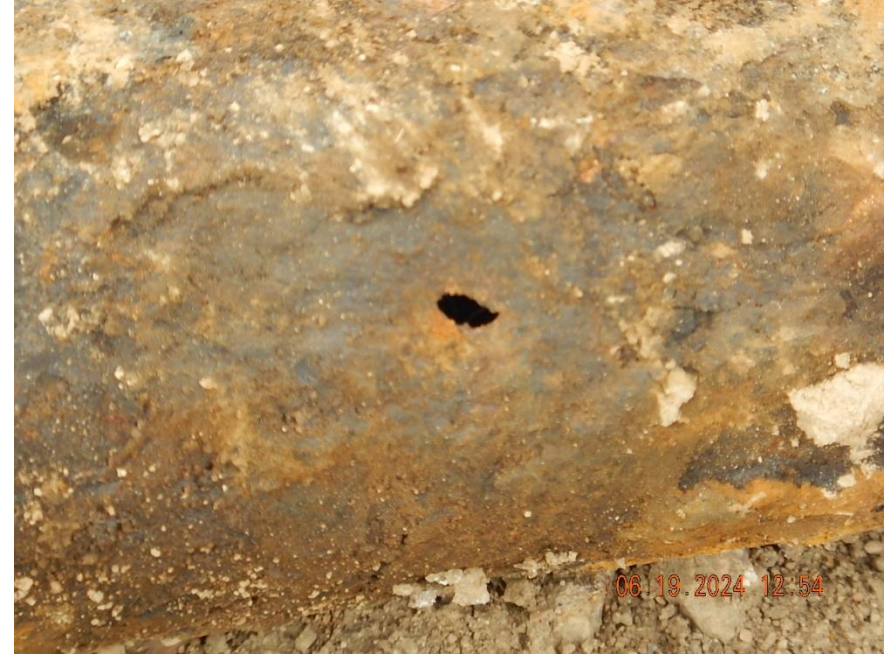
External corrosion pitting identified on the 3" CS flowline pipe segment. It appears external coating deterioration over a long period of time resulted in the failure.
