Interim Reclamation and Stormwater Inspection

Date: 06/13/2024

Operator: WESTERN OPERATING COMPANY -95620

Location ID: 312292

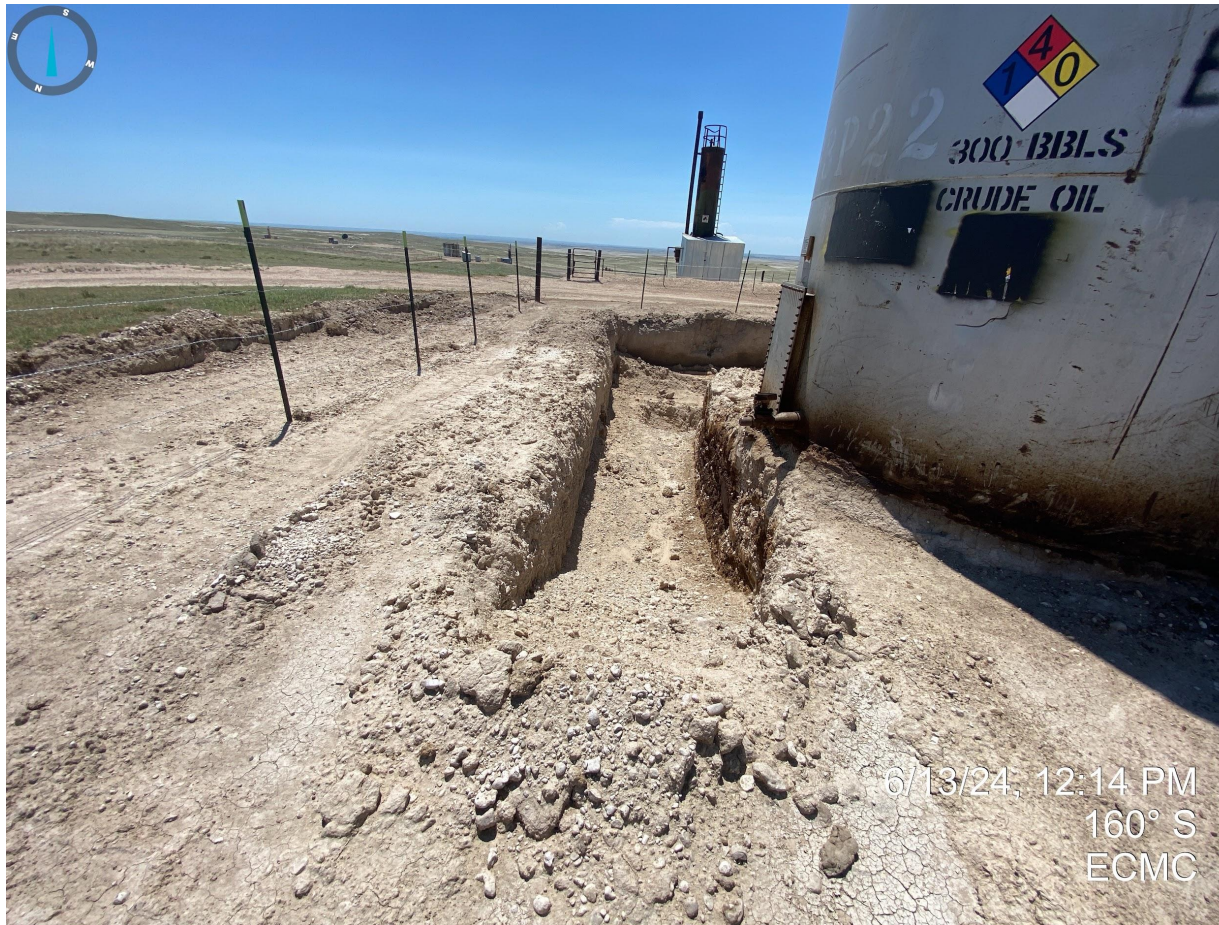
Photo 1. The open excavation at the tank battery has been fenced to exclude entry.

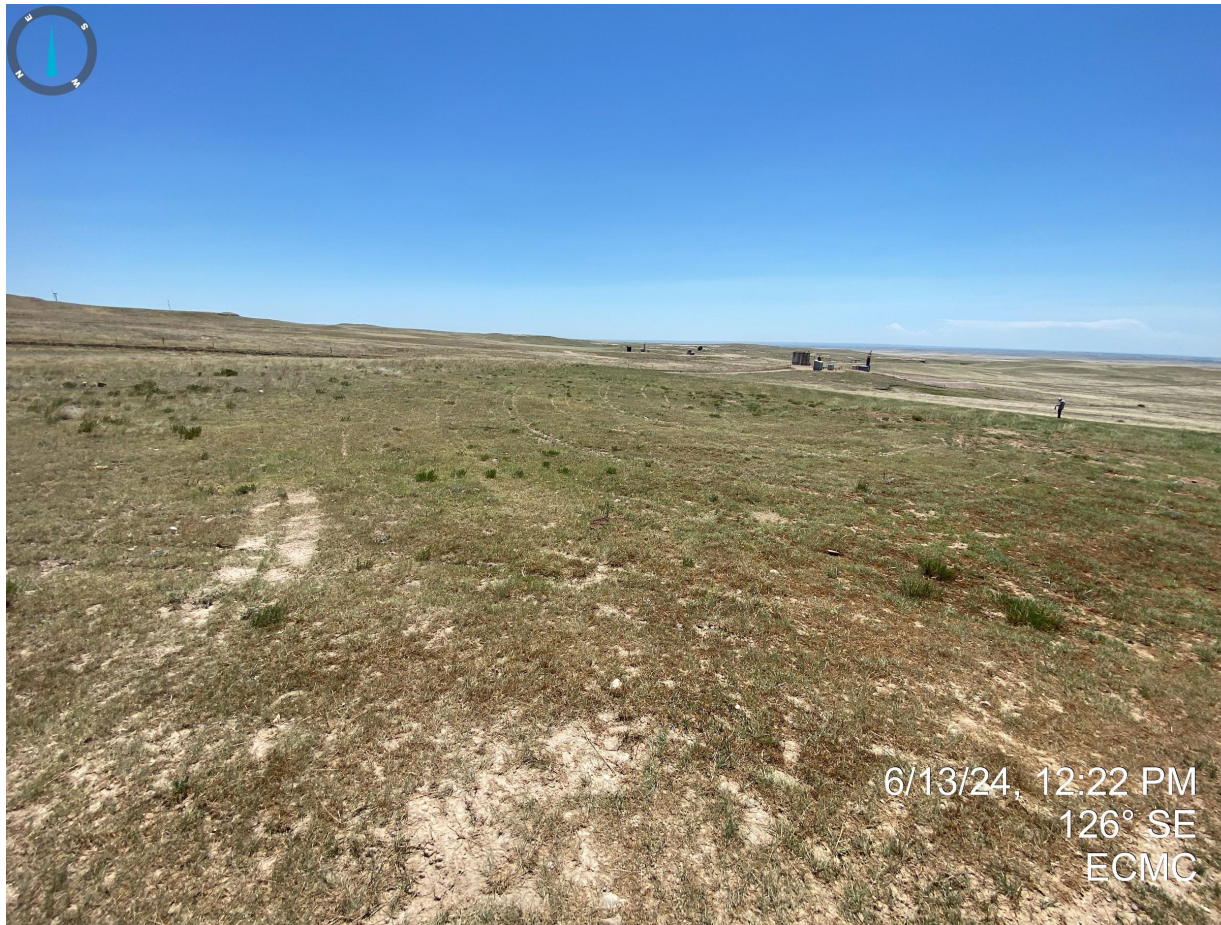
Photo 2. Facing southeast towards the spill/release area where misting occurred on adjacent lands on April 29th, 2024.

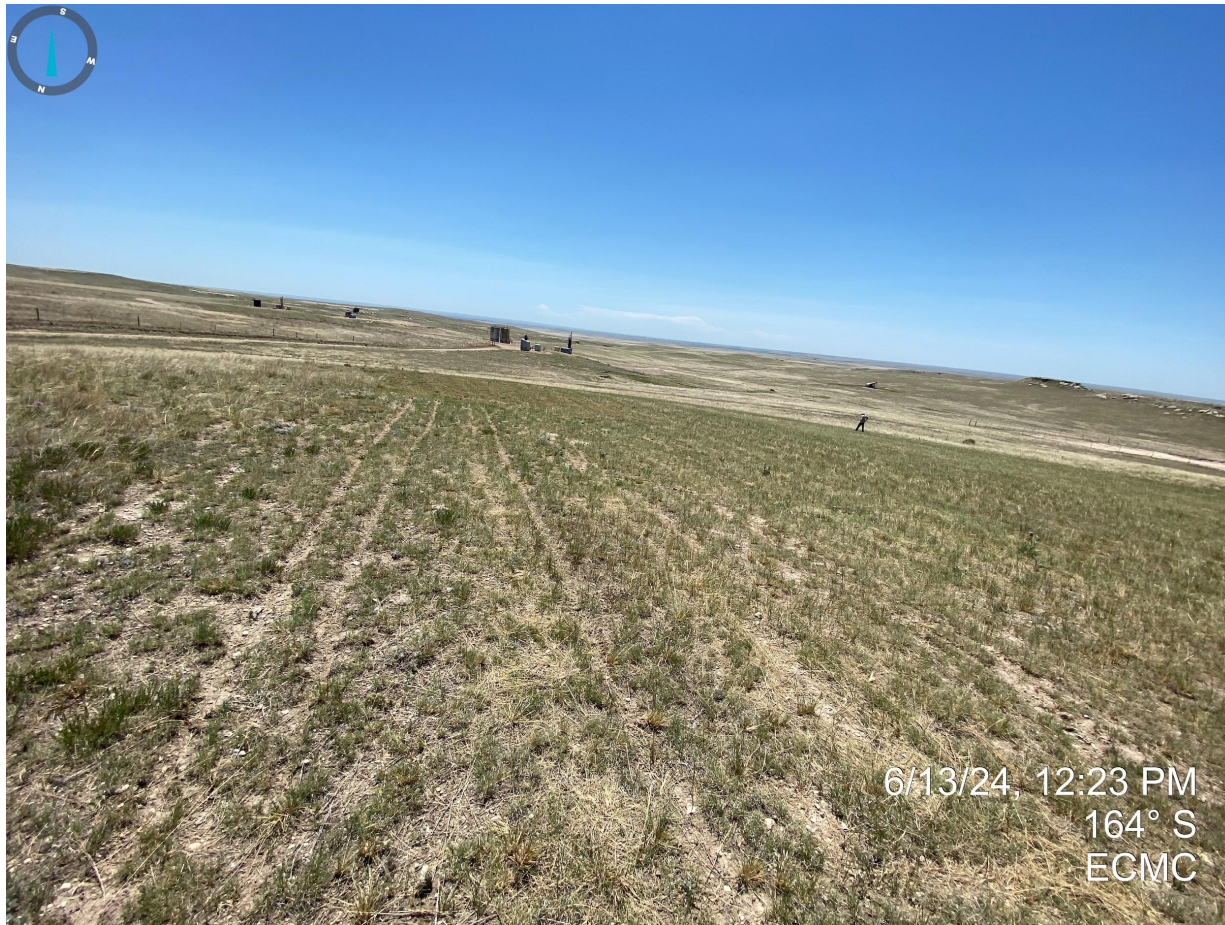
Photo 3. Facing south; see comments in Photo 2.

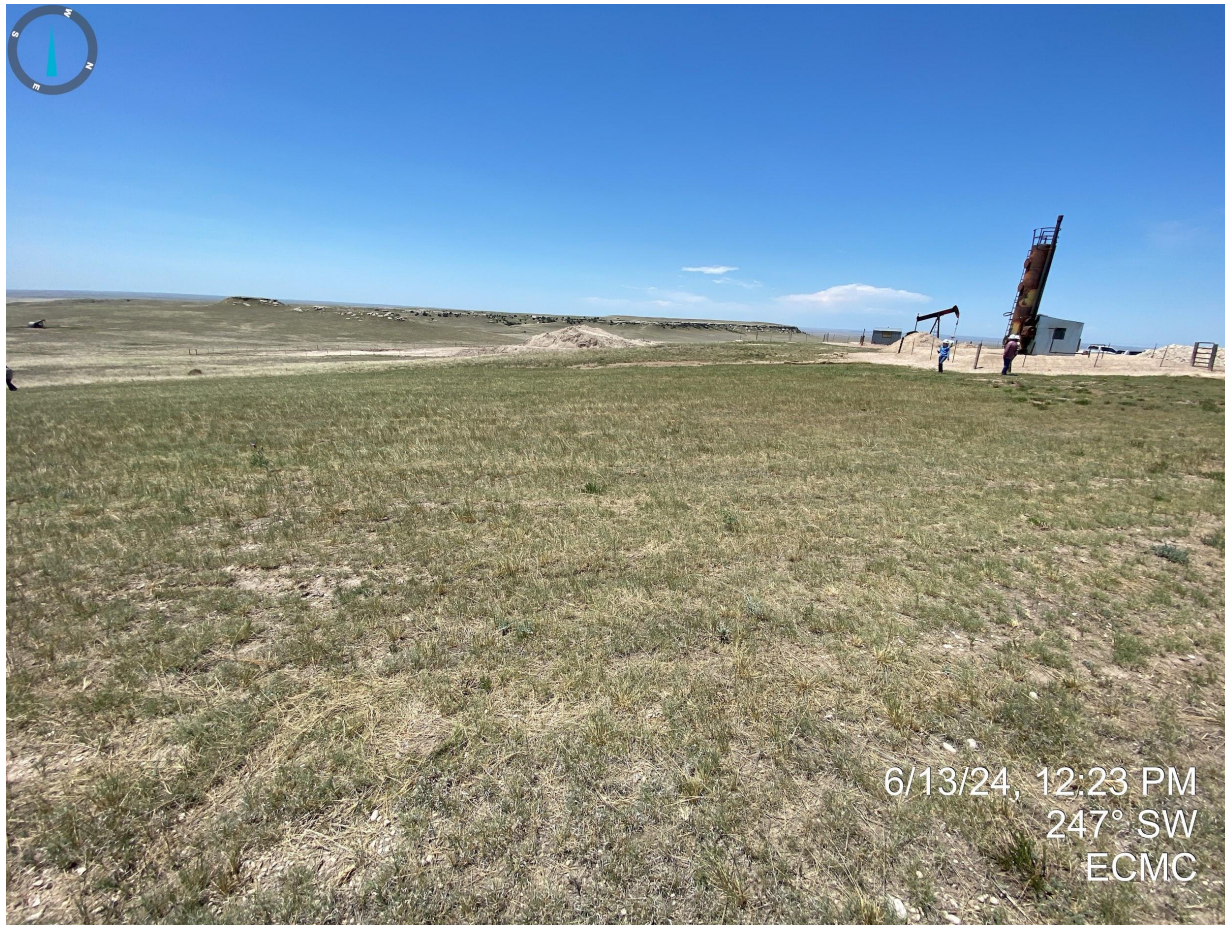
Photo 4. Facing southwest; see comments in Photo 2.

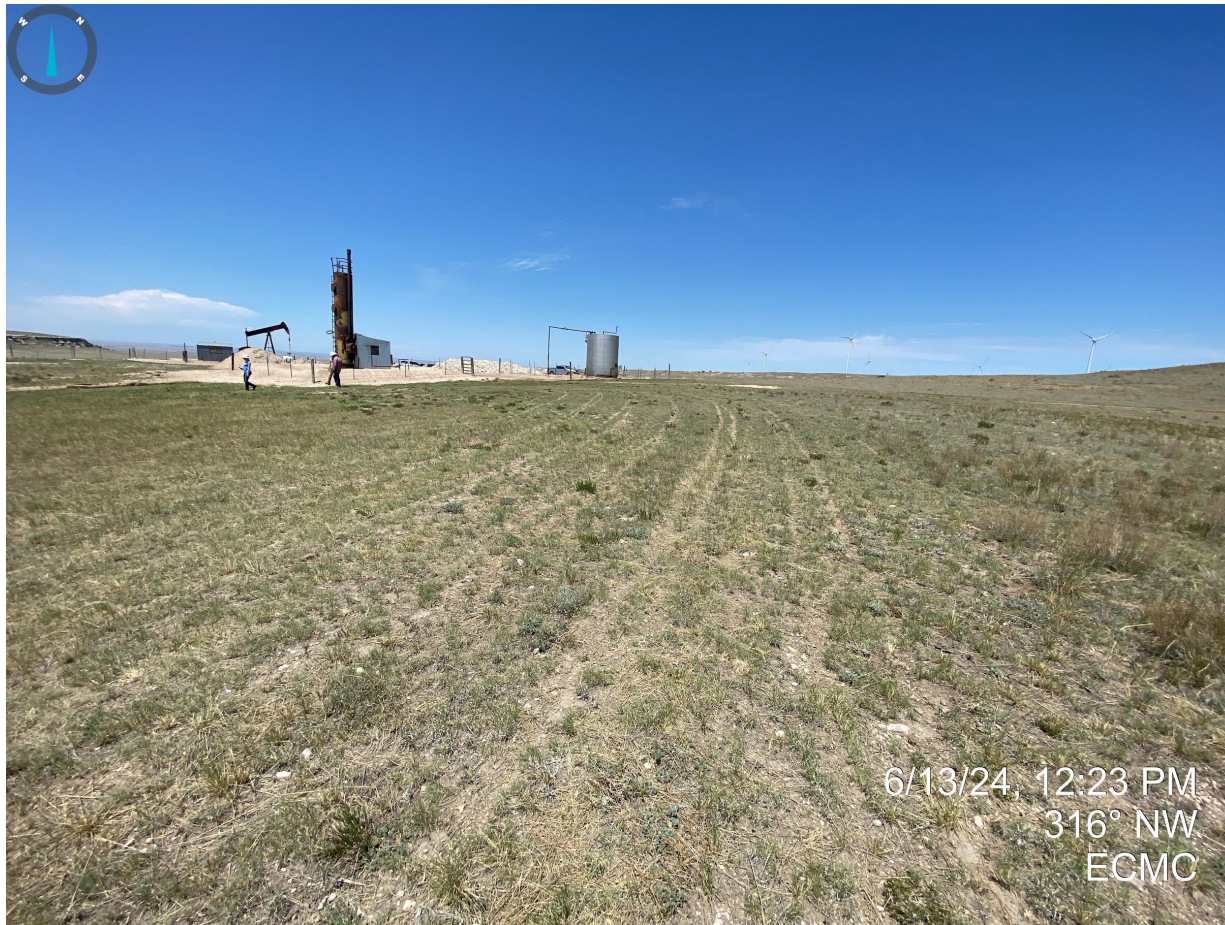
Photo 5. Facing northwest; see comments in Photo 2.

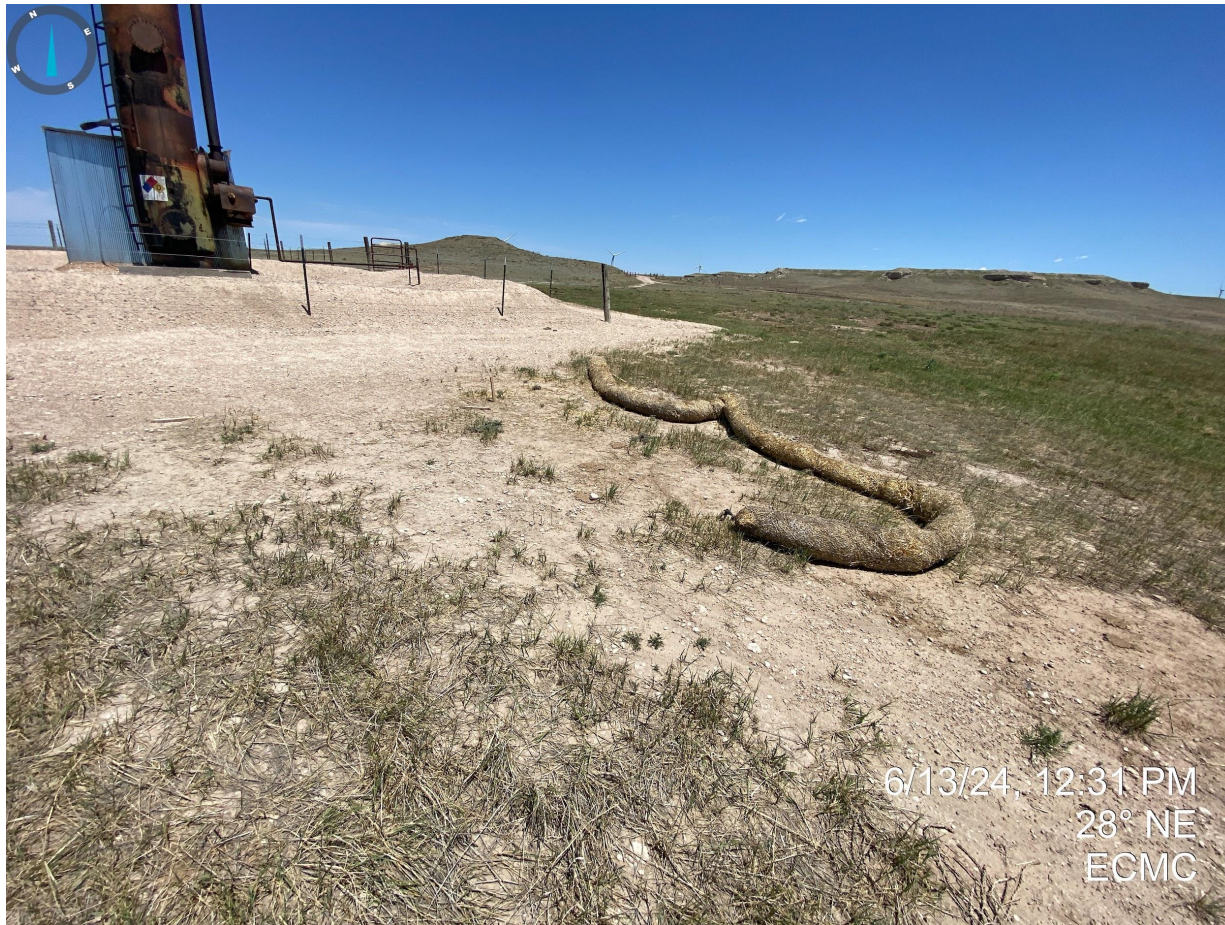
Photo 6. Facing northeast at the heater treater. Stormwater control measures (straw wattles) do not appear to be installed per good engineering practices (trenched and backfilled) and require maintenance.

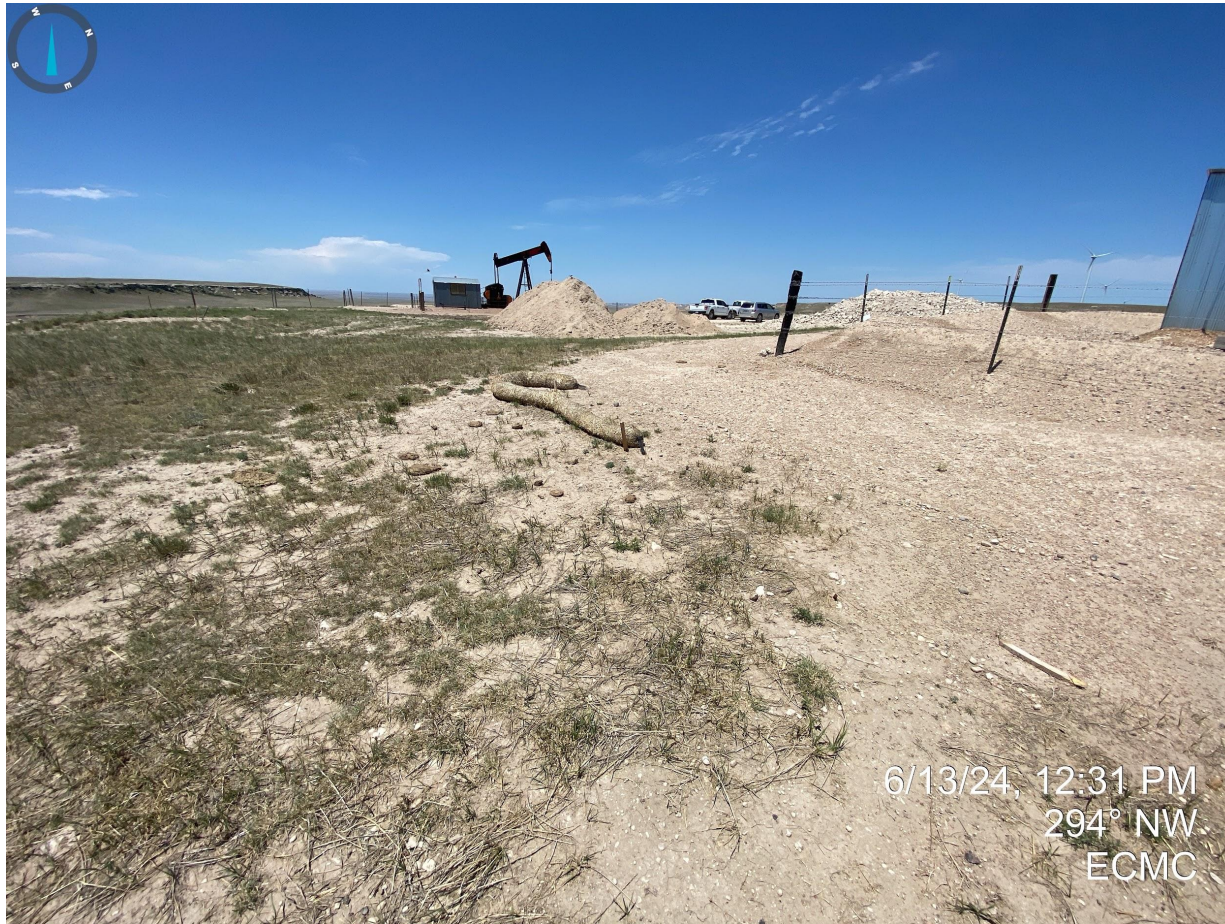
Photo 7. Continued from Photo 6, facing northwest.

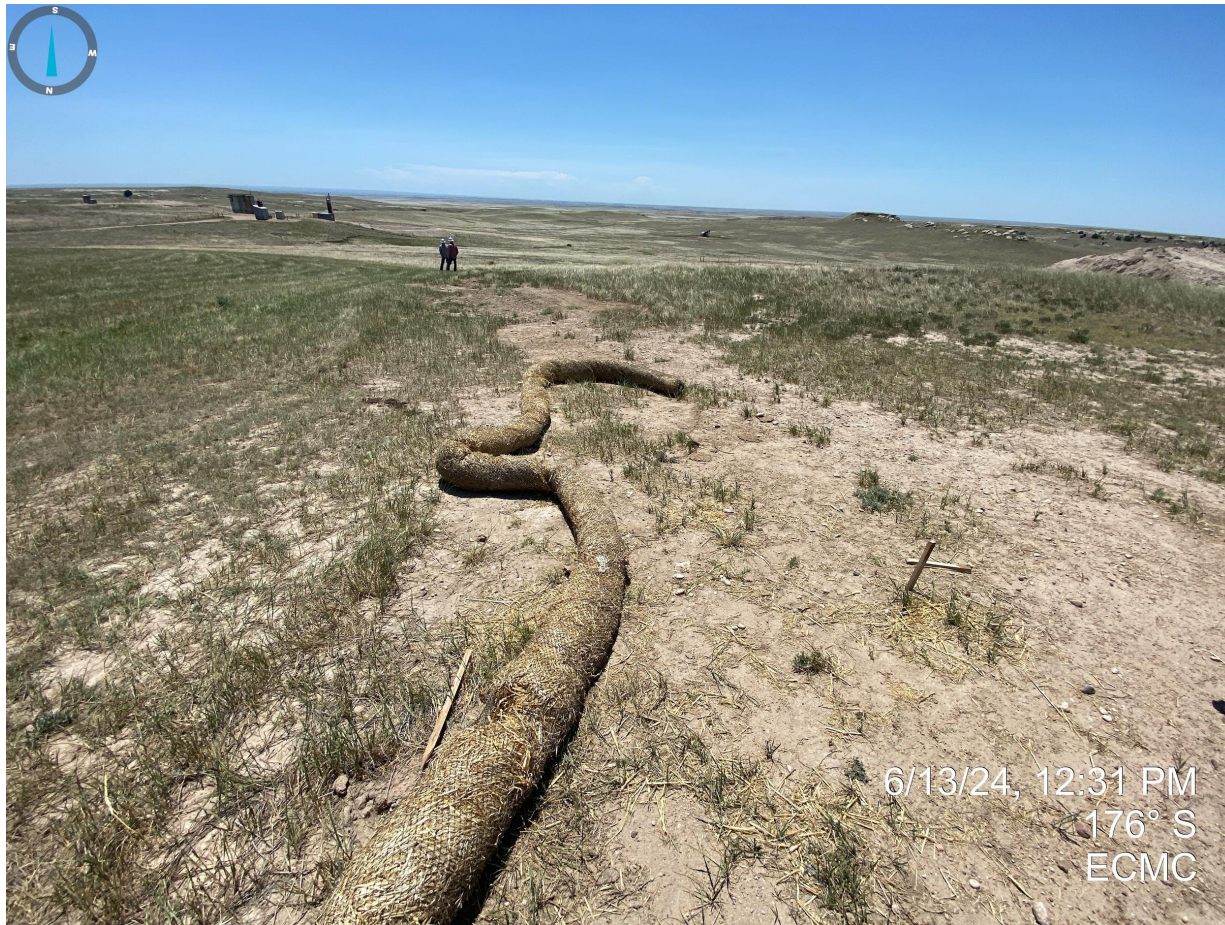
Photo 8. Continued from Photo 6, facing south.

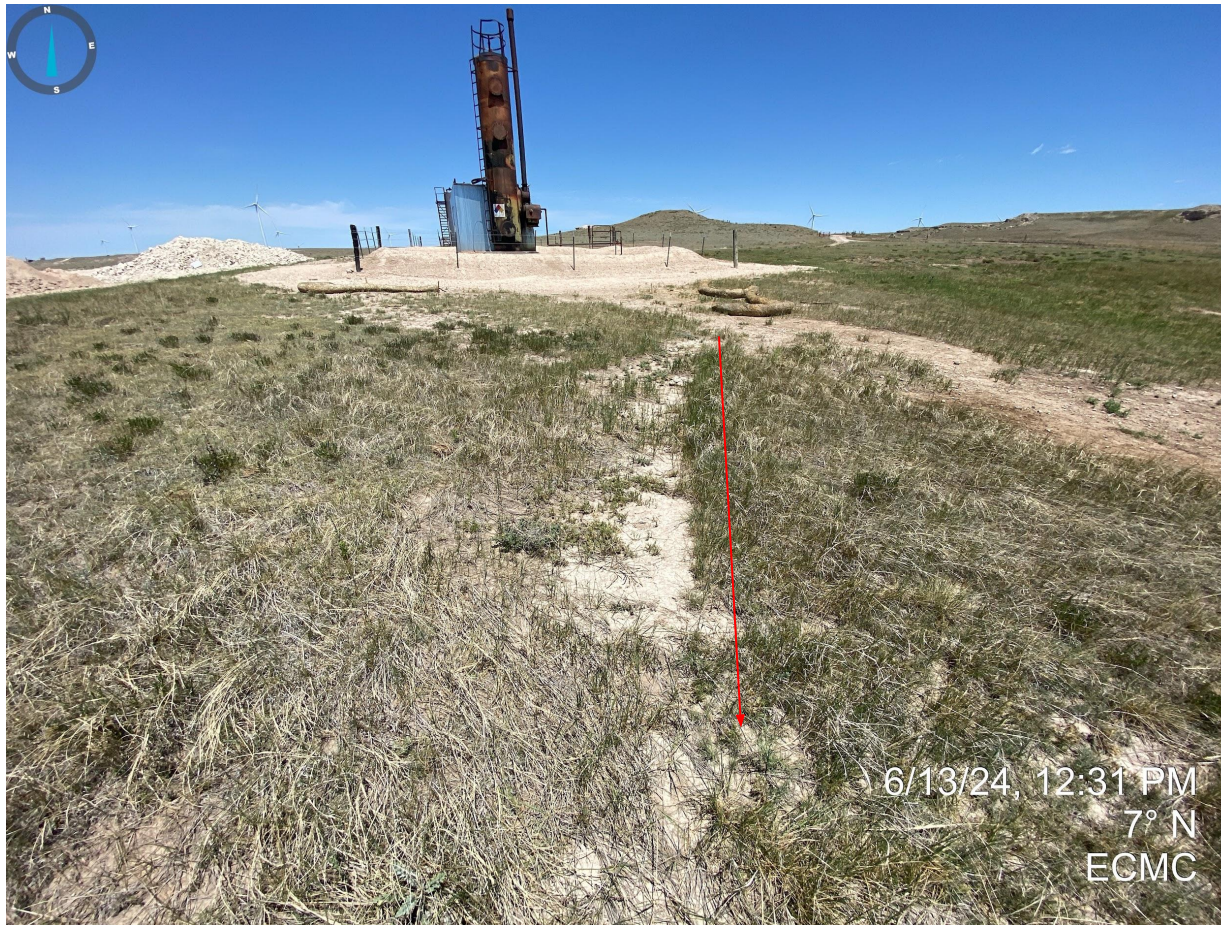
Photo 9. Sediment deposition observed south of the vertical heater treater. Stormwater control measures remain inadequate to prevent continued erosion degradation.

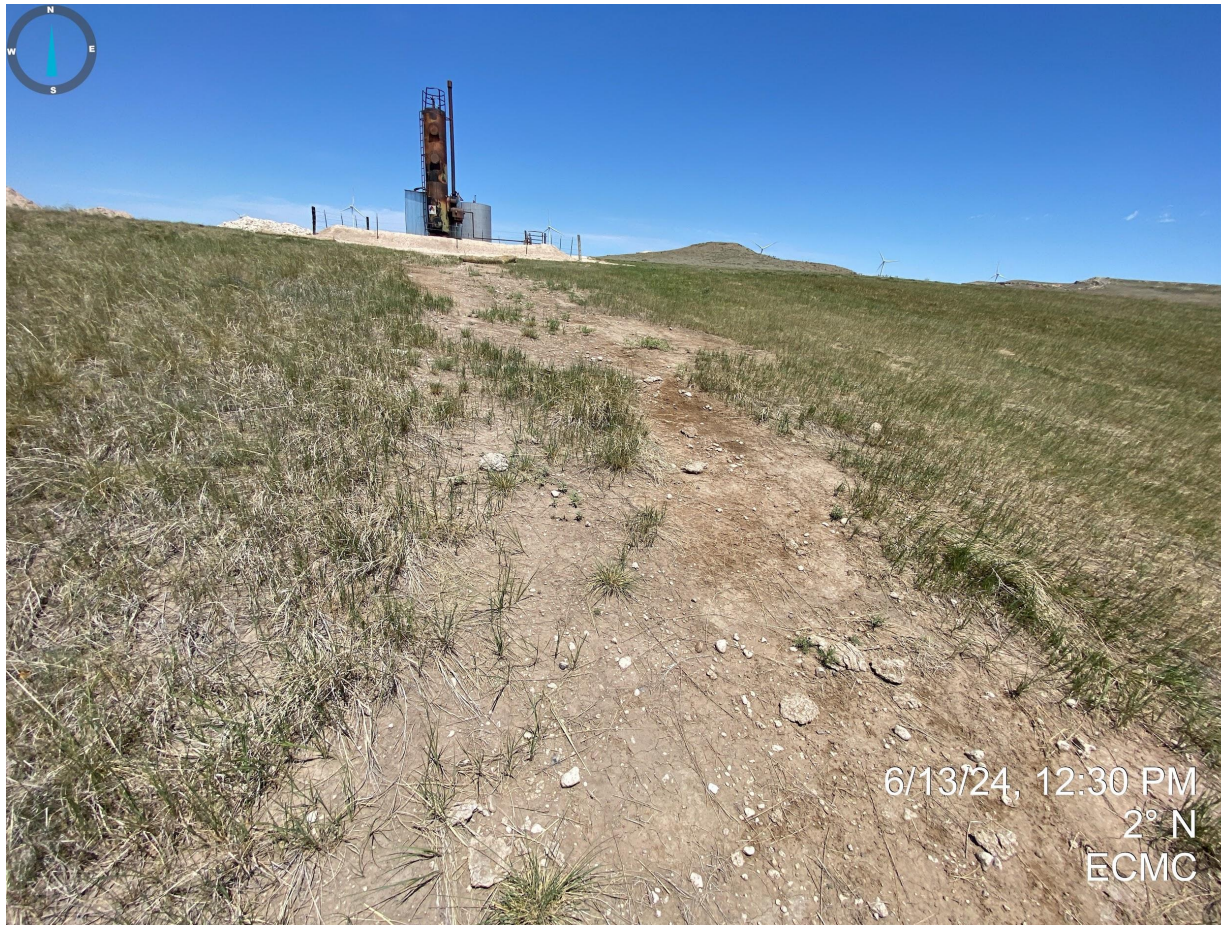
Photo 10. South of vertical heater treater. Photo illustrates unstabilized soils and lack of proper stormwater controls measures that would prevent erosion degradation.

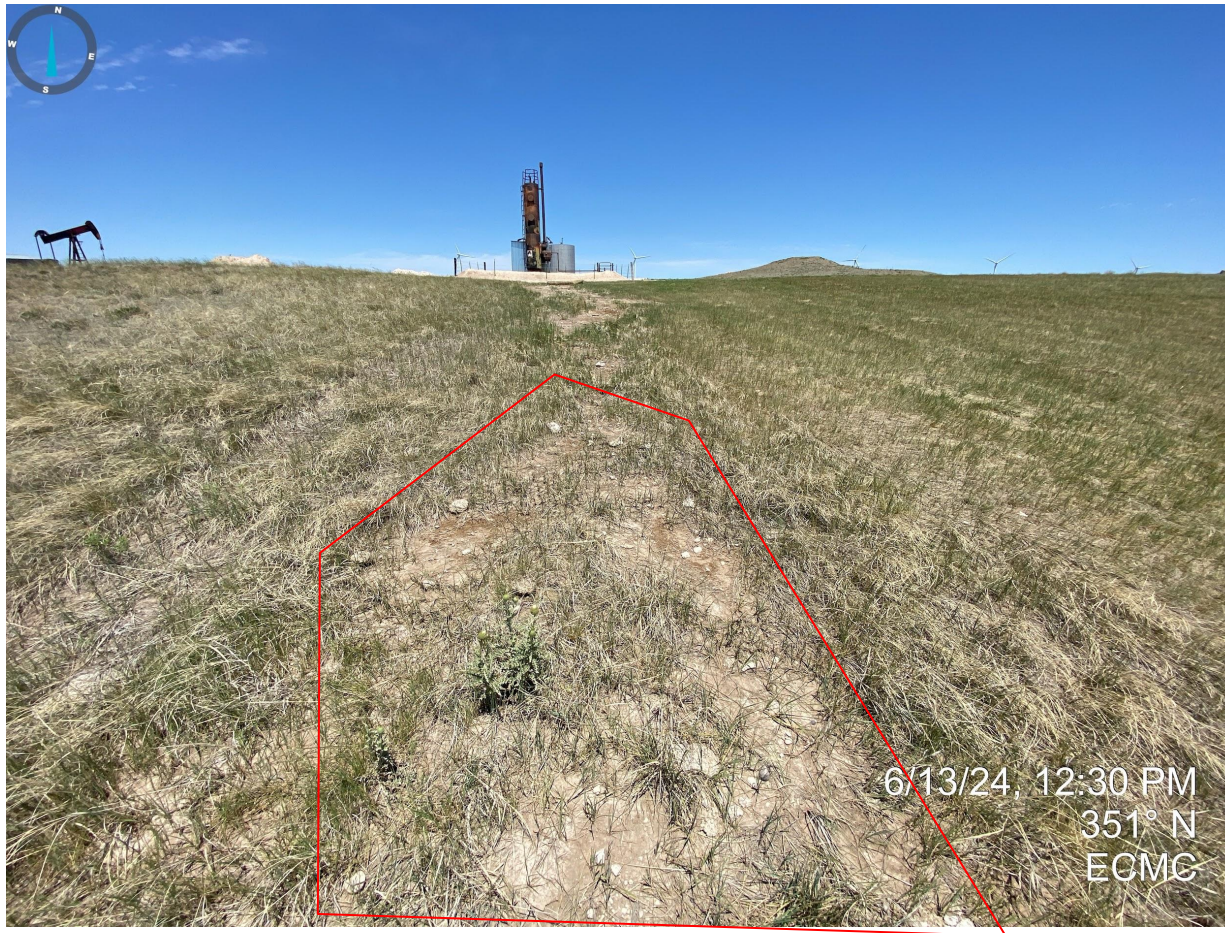
Photo 11. Continued from Photo 10. Red polygon illustrates sediment deposition.

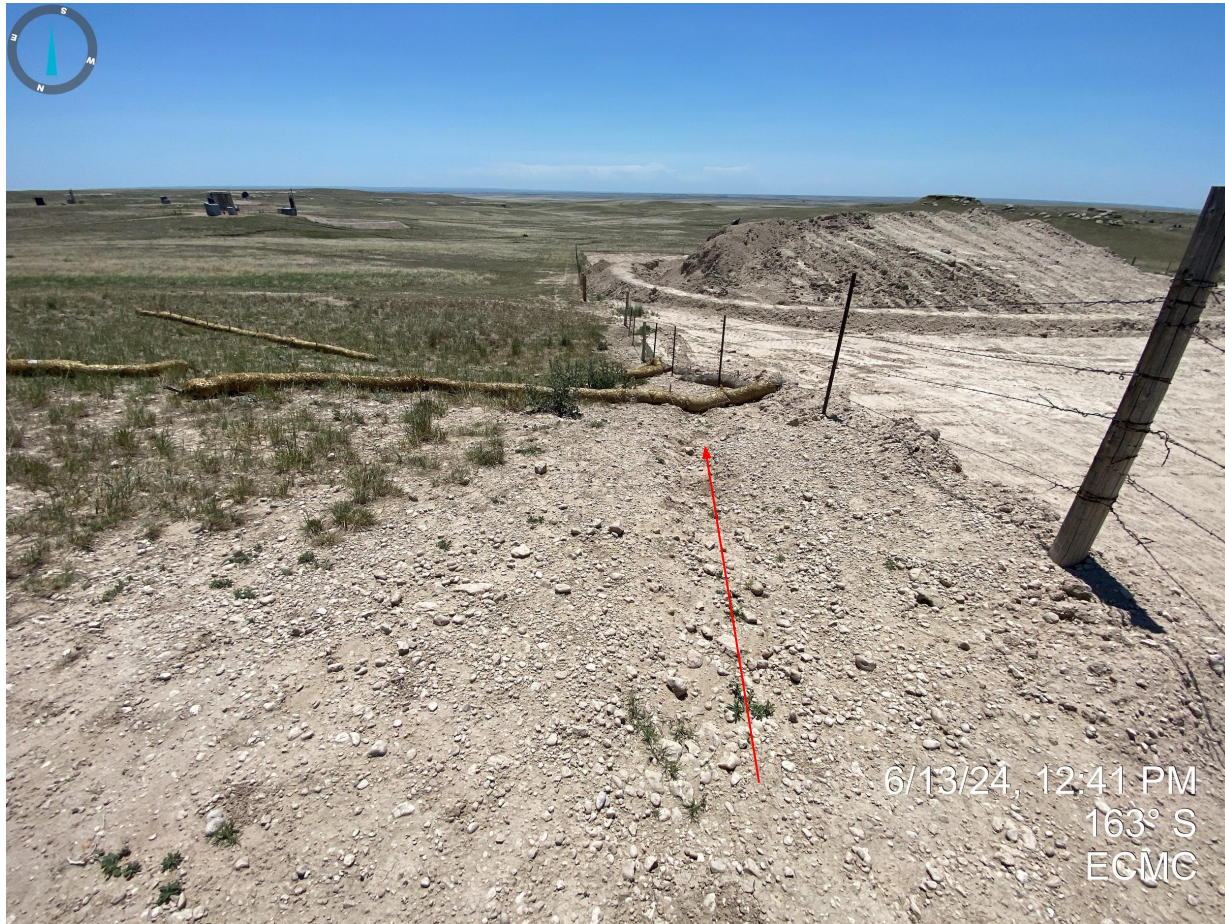
Photo 12. Erosion degradation identified in previous inspection does not appear to have been repaired and stabilized. Degraded straw wattles appear to have been replaced with new wattles, however, the control measures do not appear to have been installed per good engineering practices.

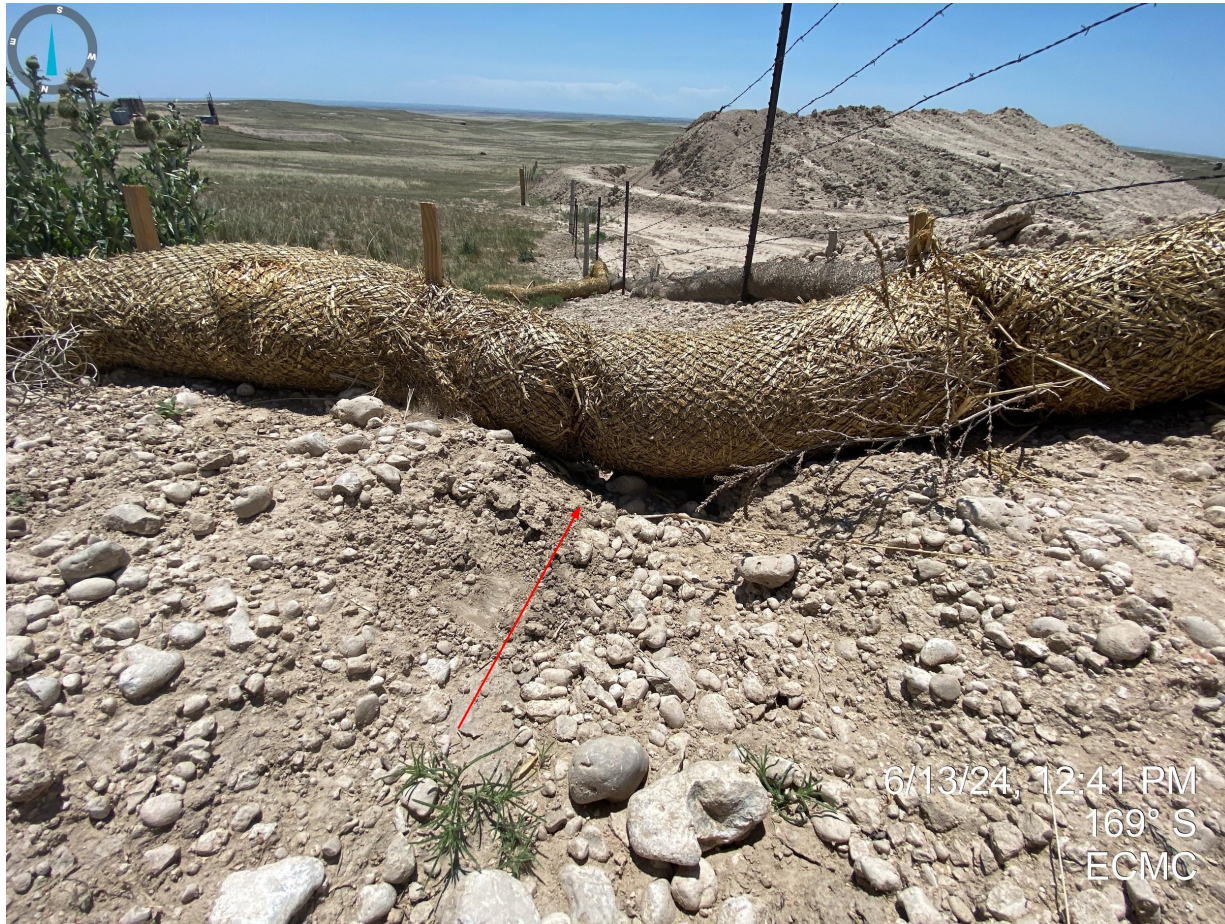
Photo 13. Close up of straw wattles not trenched and backfilled; daylight observed.

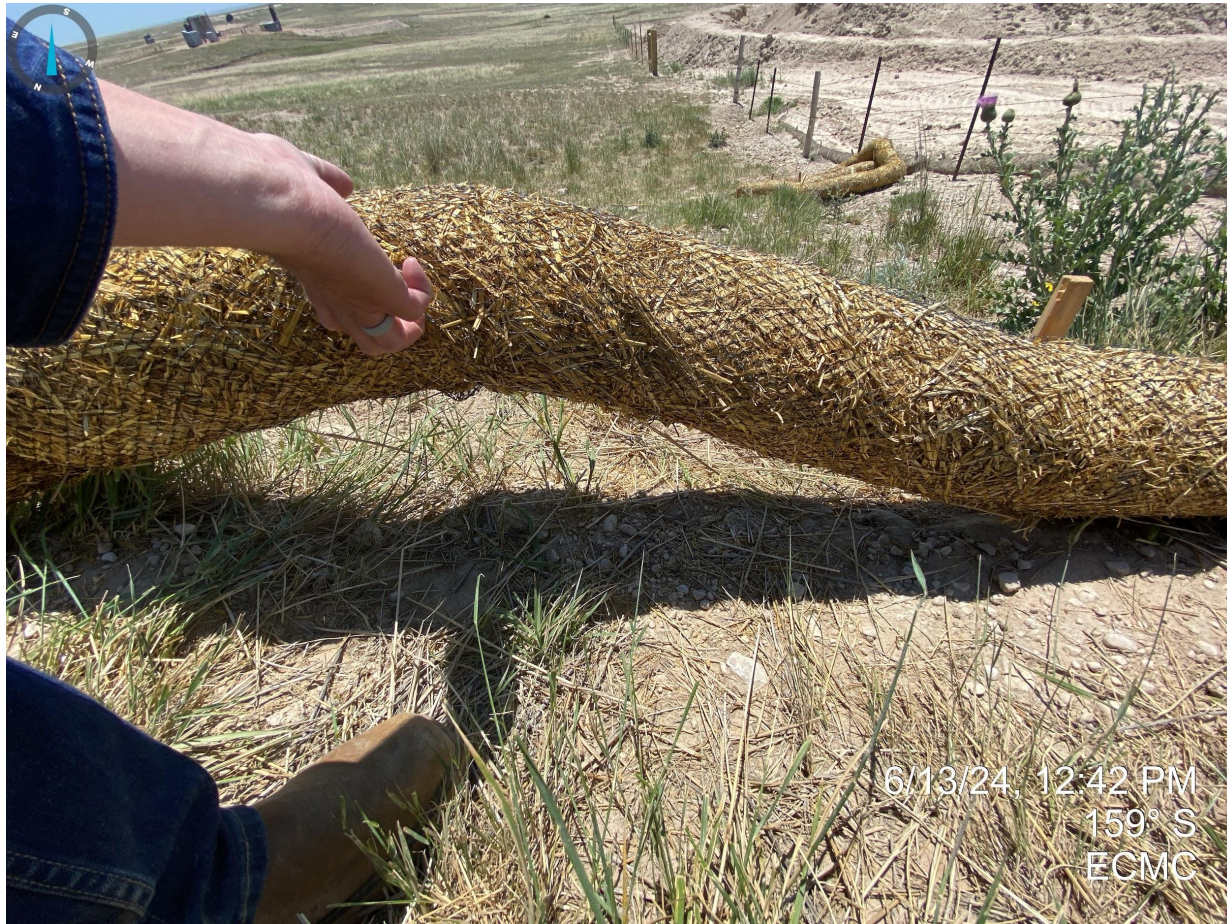
Photo 14. Continued from Photo 13.

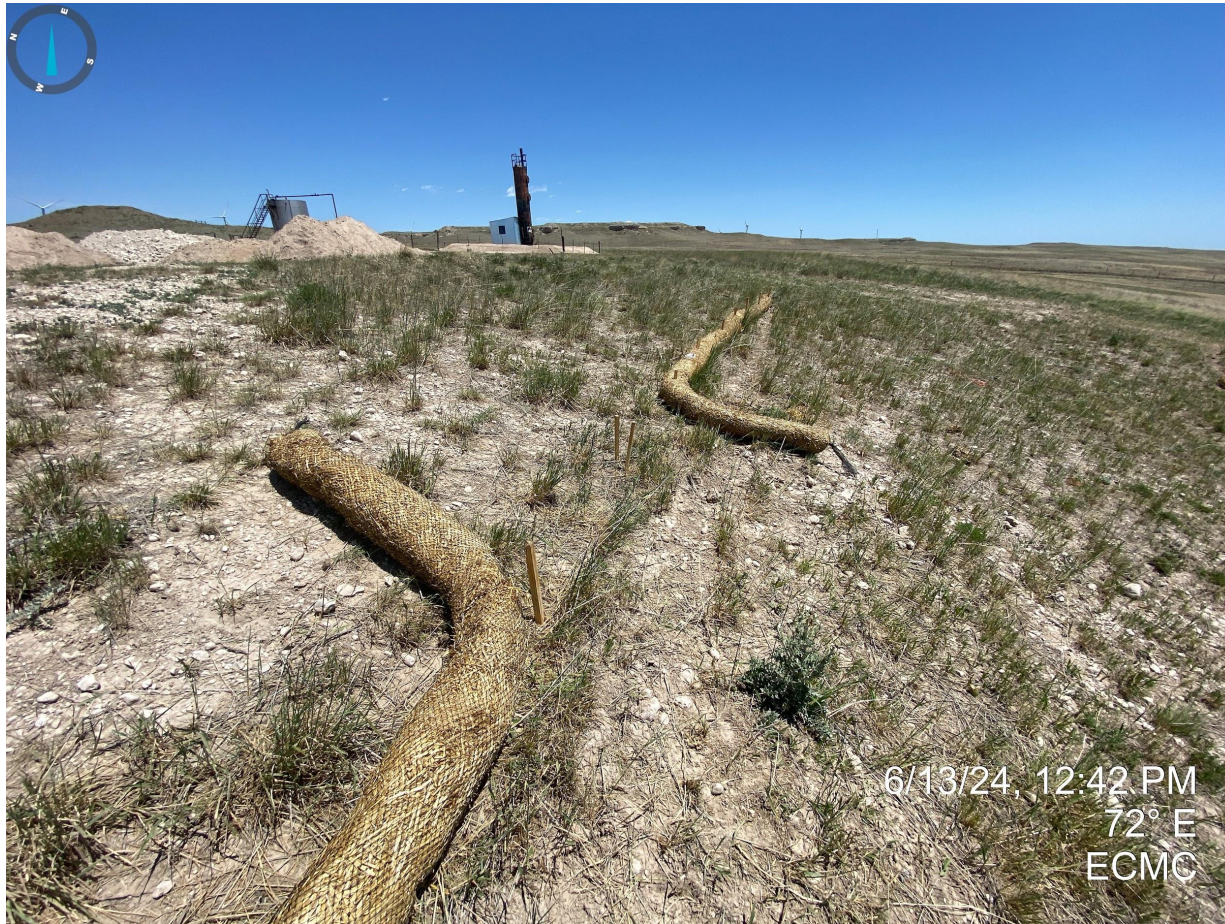
Photo 15. Straw wattles not properly installed.

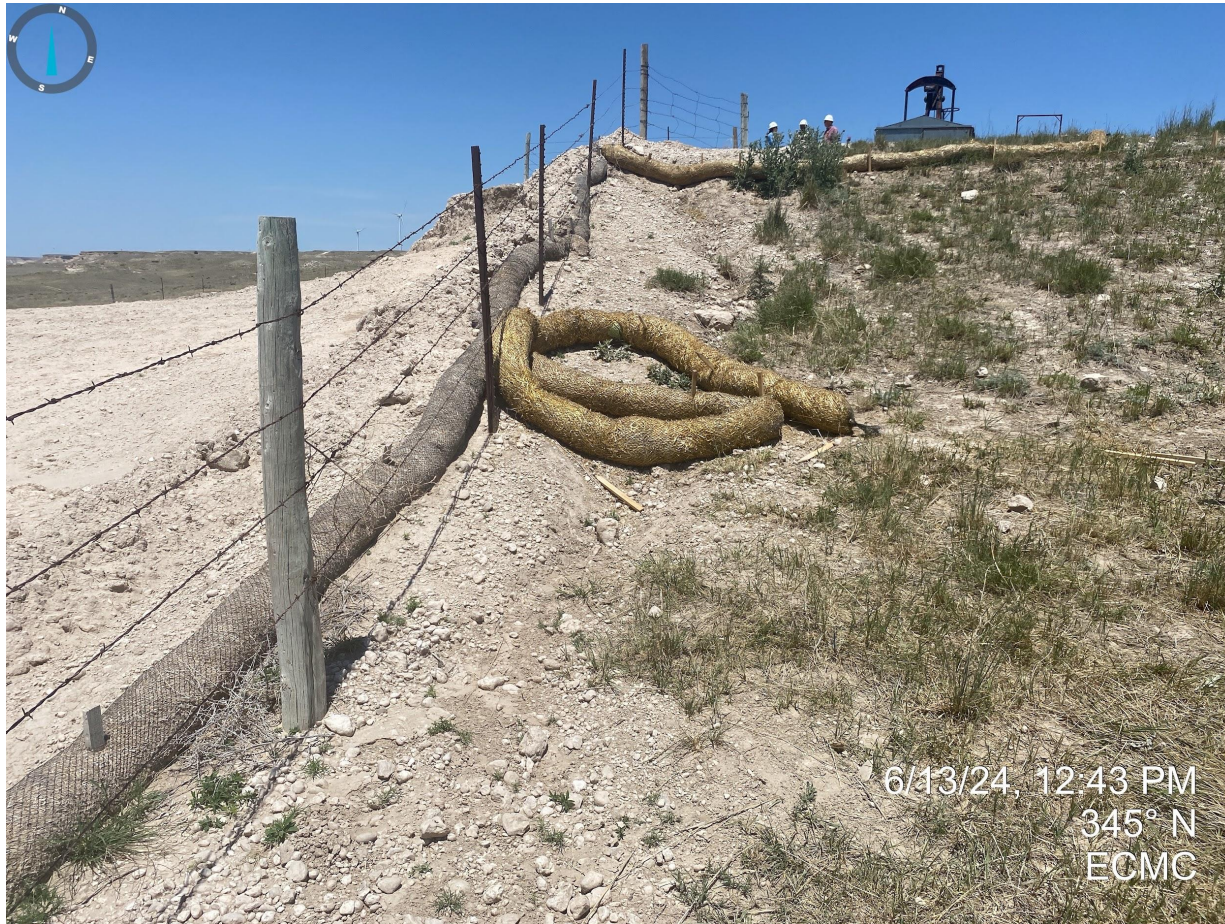
Photo 16. Erosion degradation doesn't appear to have been repaired and stabilized and straw wattles are not adequate.

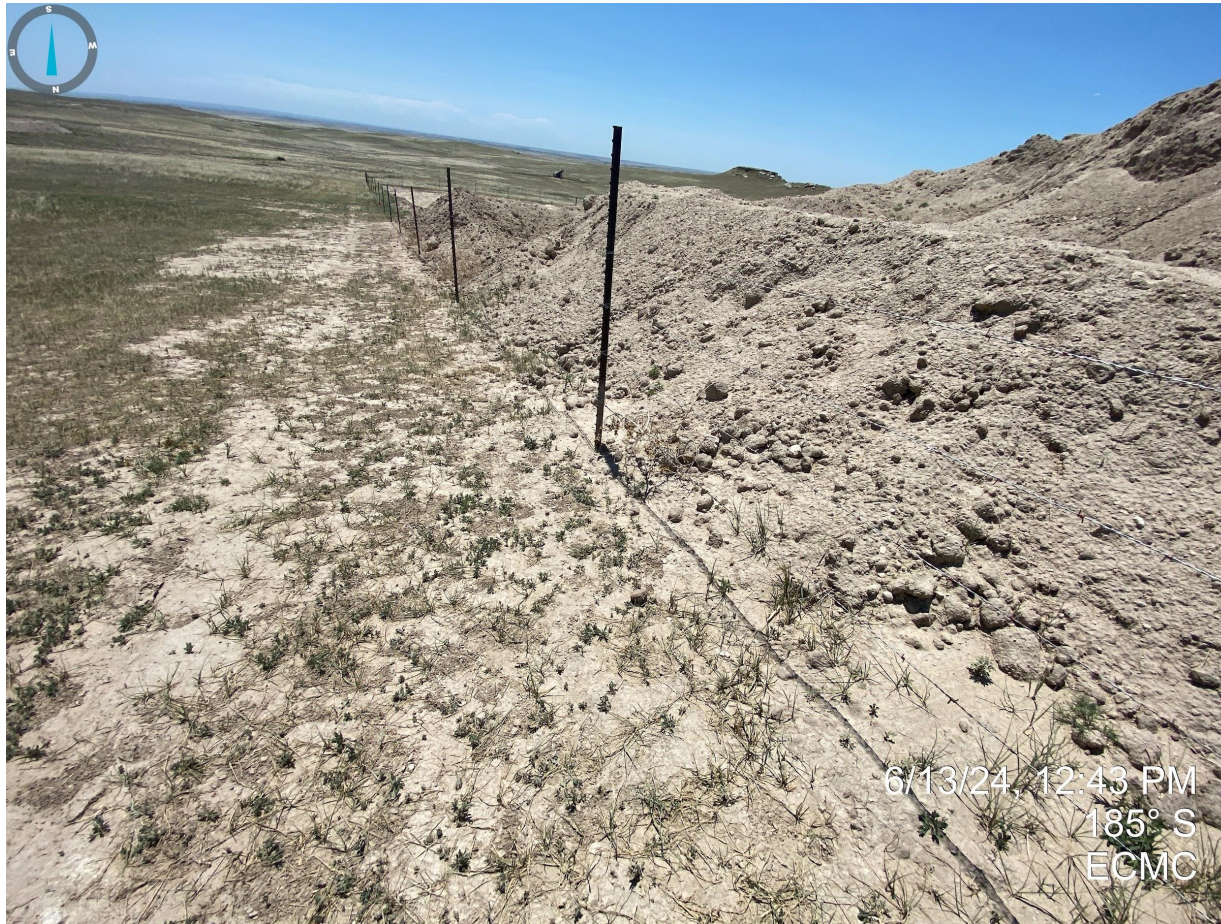
Photo 17. East side of stockpiled pit soils. Photo illustrates that both the stockpile and berms have been left unconsolidated. Unconsolidated materials can become a potential pollution source as it is not properly stabilized. Berms also appear to be built out of impacted material from the salt kill/pit excavation.

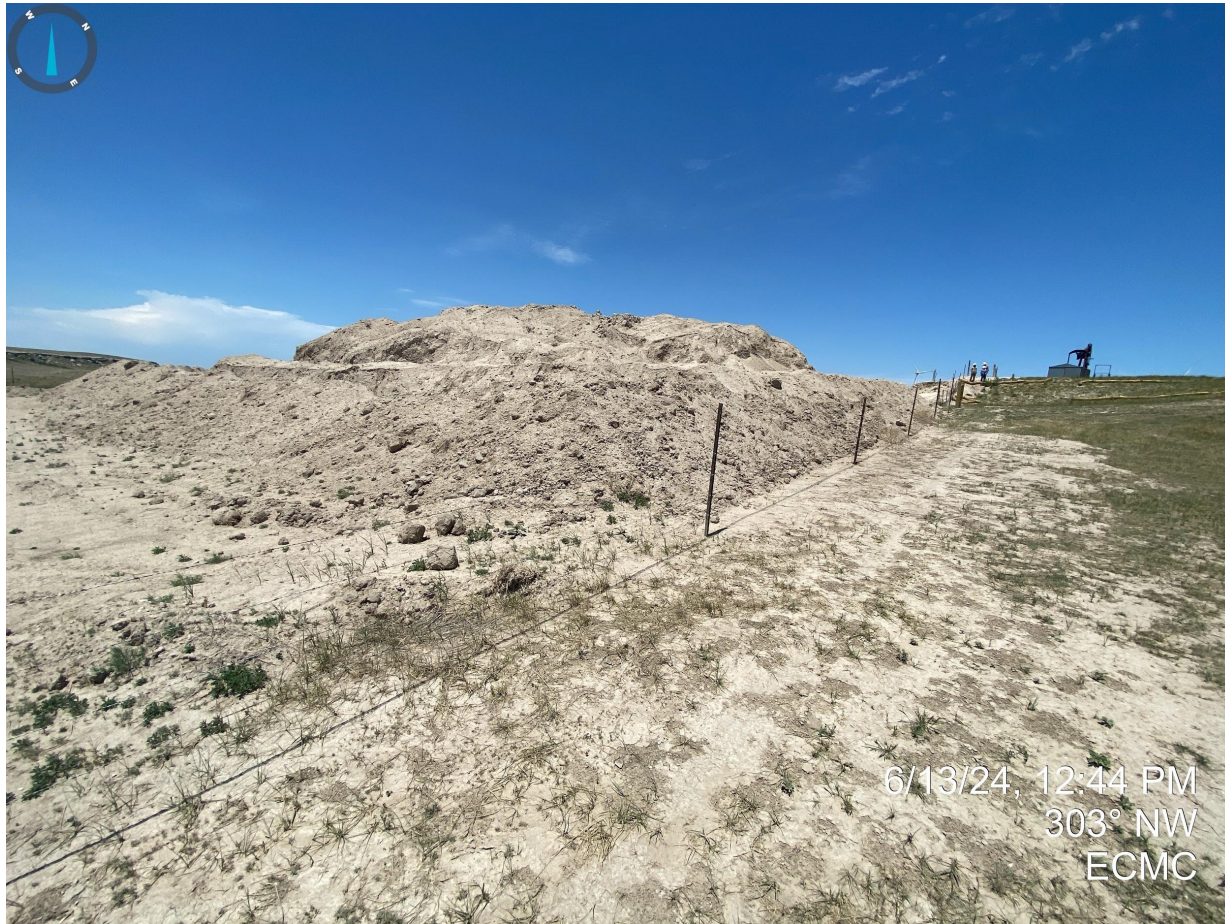
Photo 18. Fencing has been installed around the perimeter of the excavation and stockpiled soils. No perimeter stormwater controls/BMPS observed around the stockpiled soils or excavated areas.

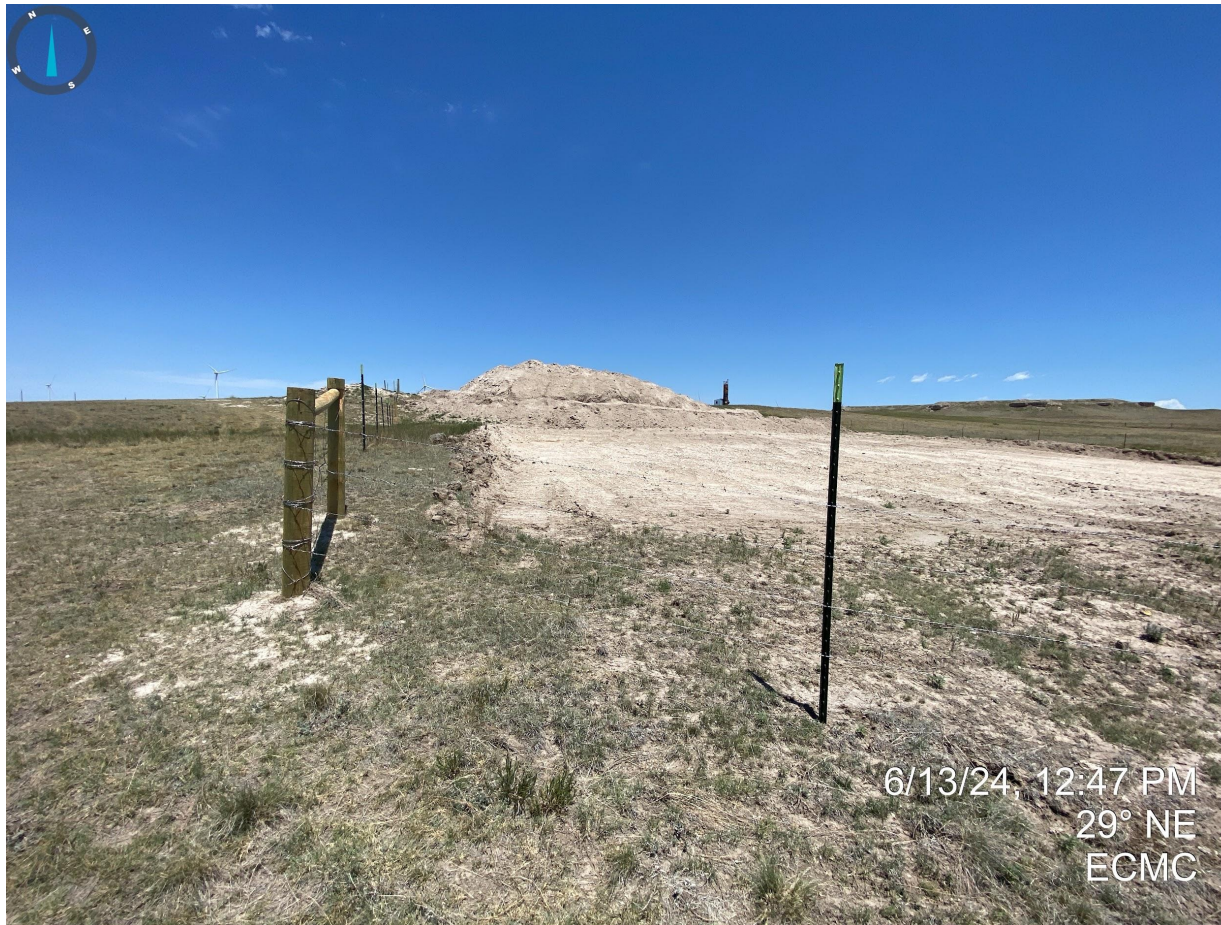
Photo 19. Fencing has been installed around the perimeter of the excavation and stockpiled soils. No perimeter stormwater controls/BMPS observed around the stockpiled soils or excavated areas.

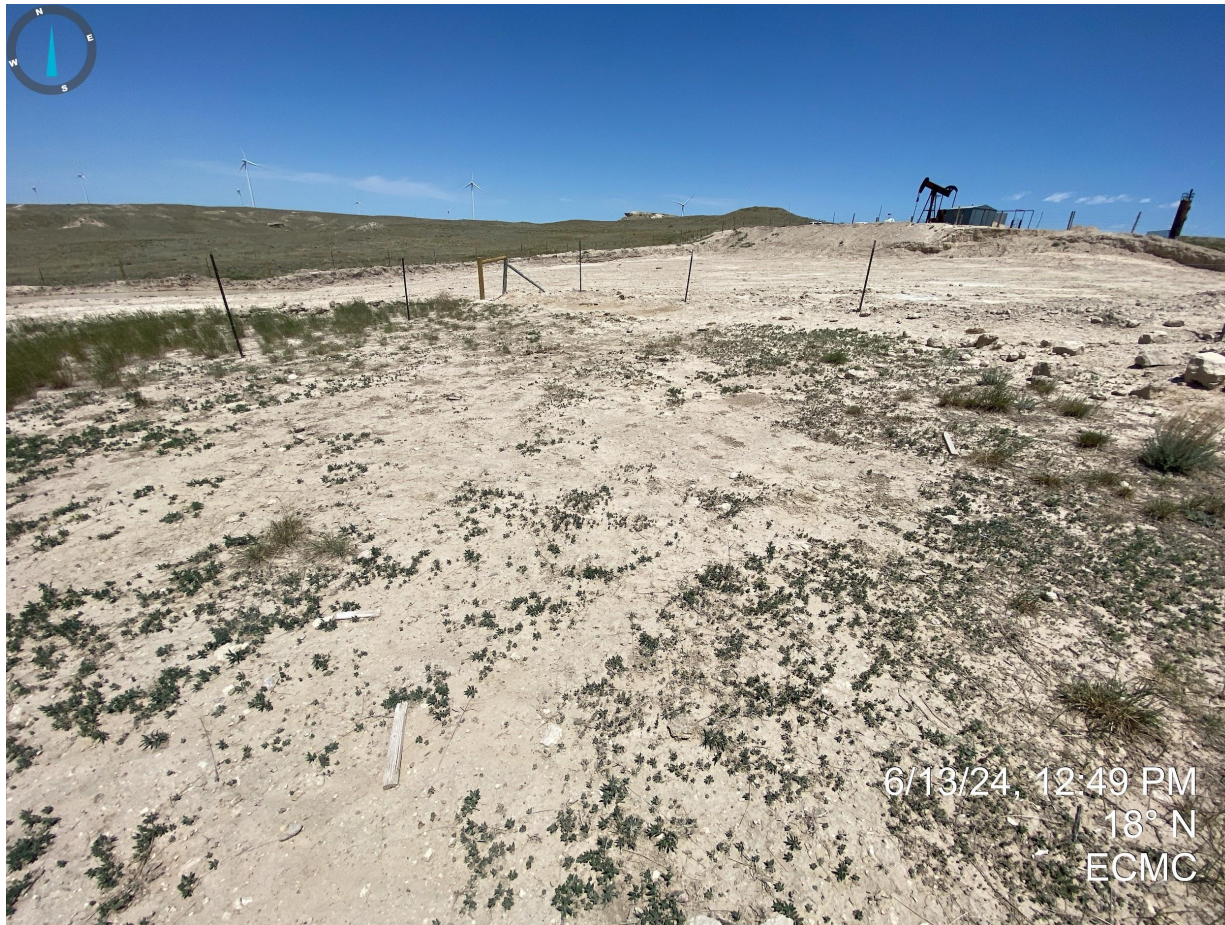
Photo 20. Additional disturbance observed south of the salt kill impacted areas. Any disturbance will need to be reclaimed per the reclamation rules as the area is now susceptible to wind and water erosion degradation.
