Interim Reclamation and Stormwater Inspection

Date: 06/13/2024

Operator: WESTERN OPERATING COMPANY -95620

Location ID: 312292

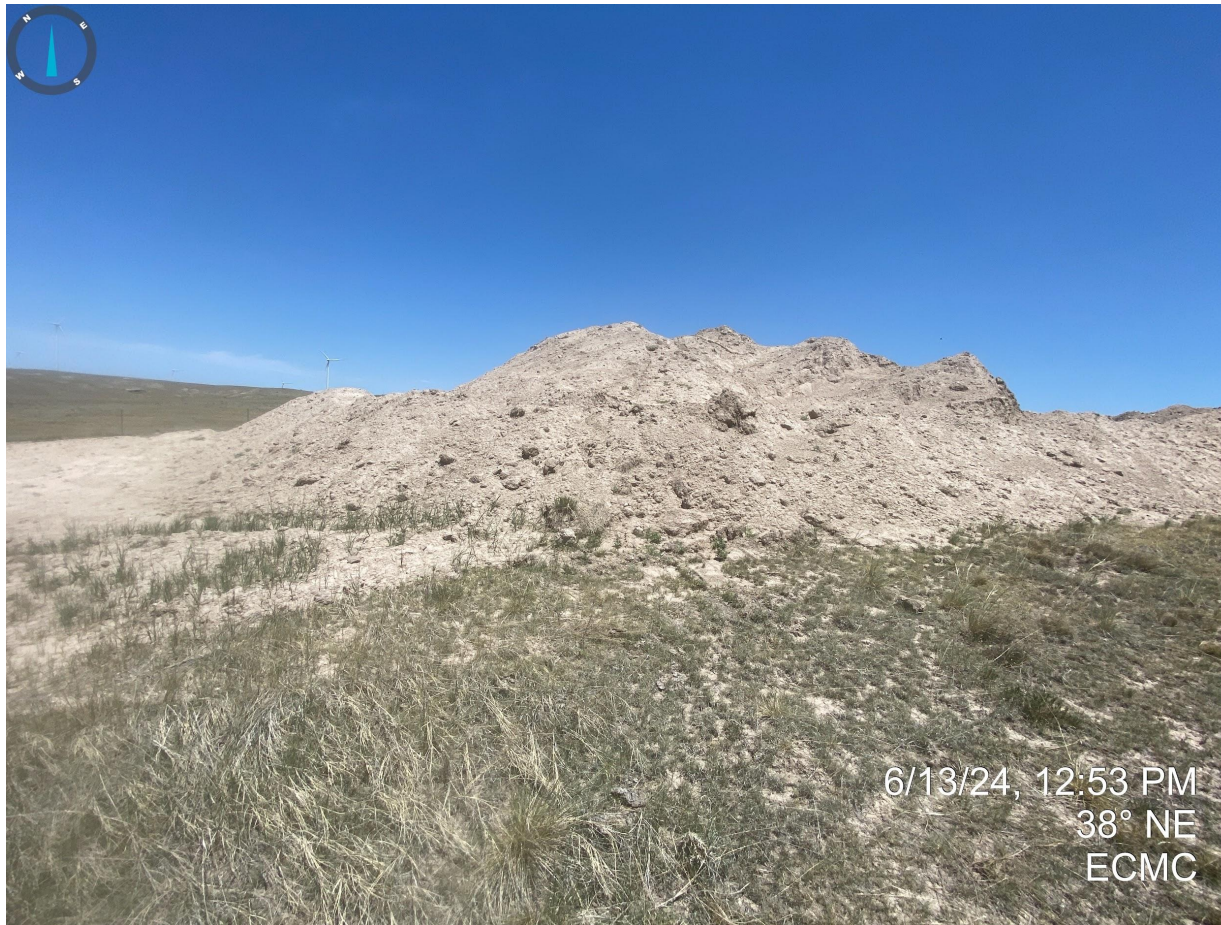
Photo 21. Western stockpiled material is not properly stabilized with evidence of unconsolidated materials. No perimeter stormwater control measures observed.

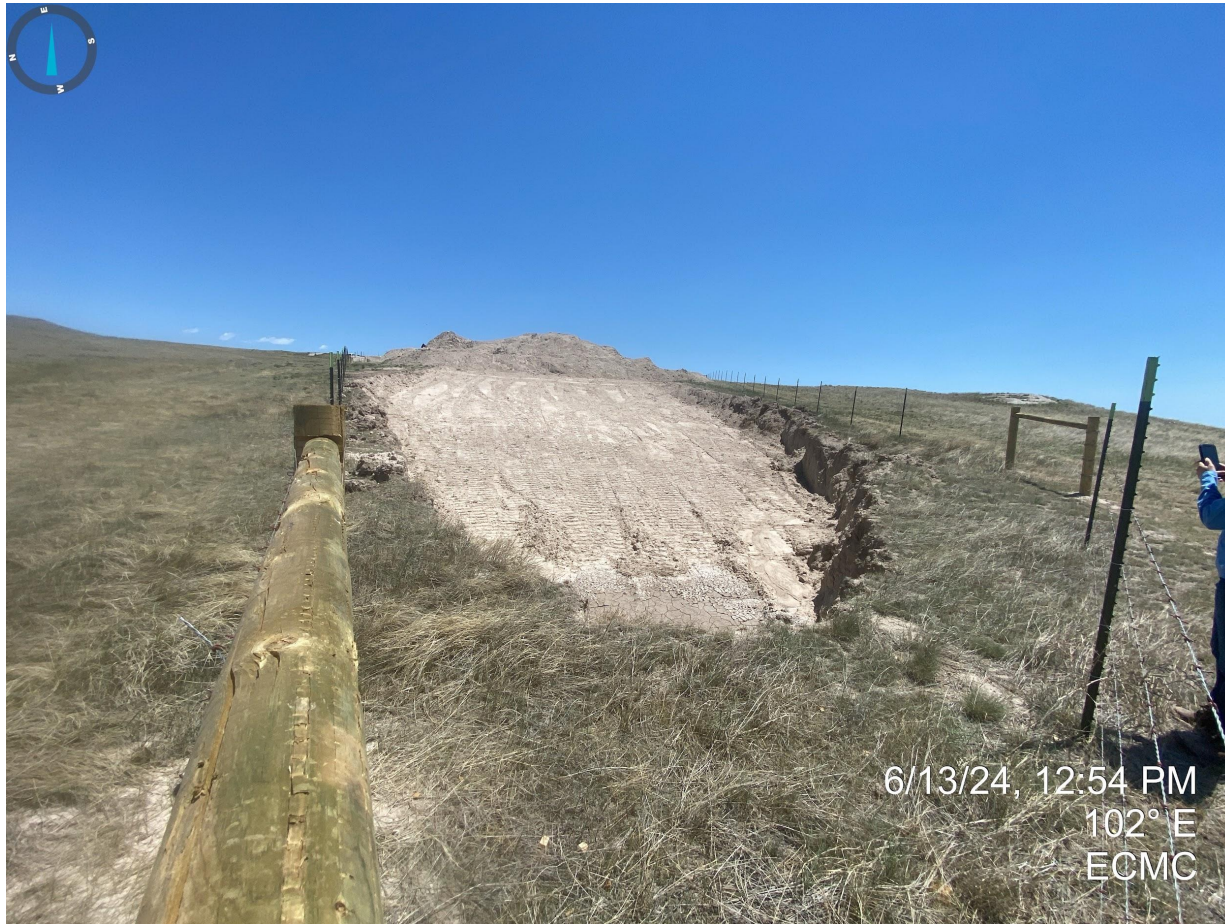
Photo 22. Overview of western most excavation area; the open excavation has been fenced around the perimeter.

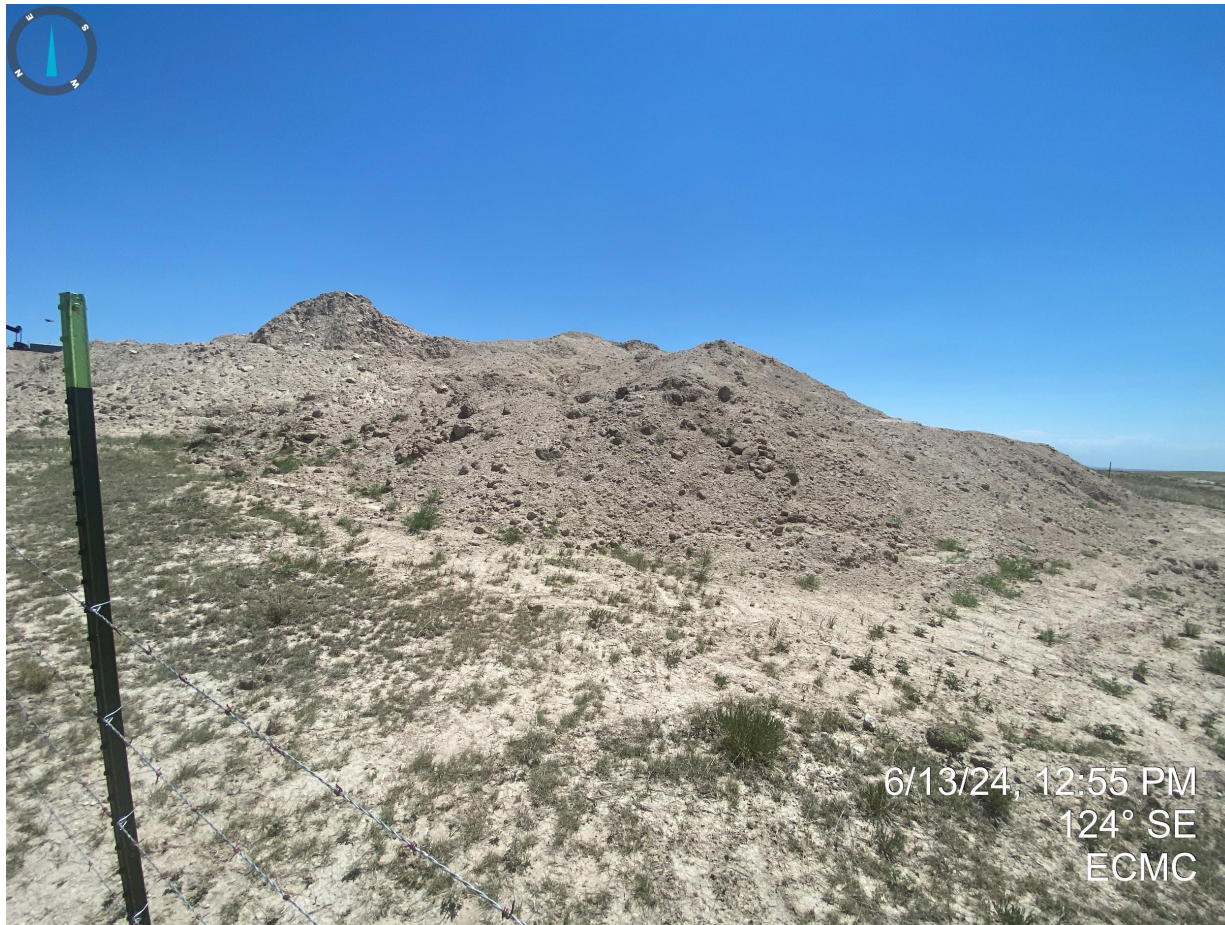
Photo 23. North side of excavation. No stormwater control measures/BMPs were observed around the perimeter of the excavated area or stockpiles that would prevent off location stormwater discharge from entering nearby drainage.

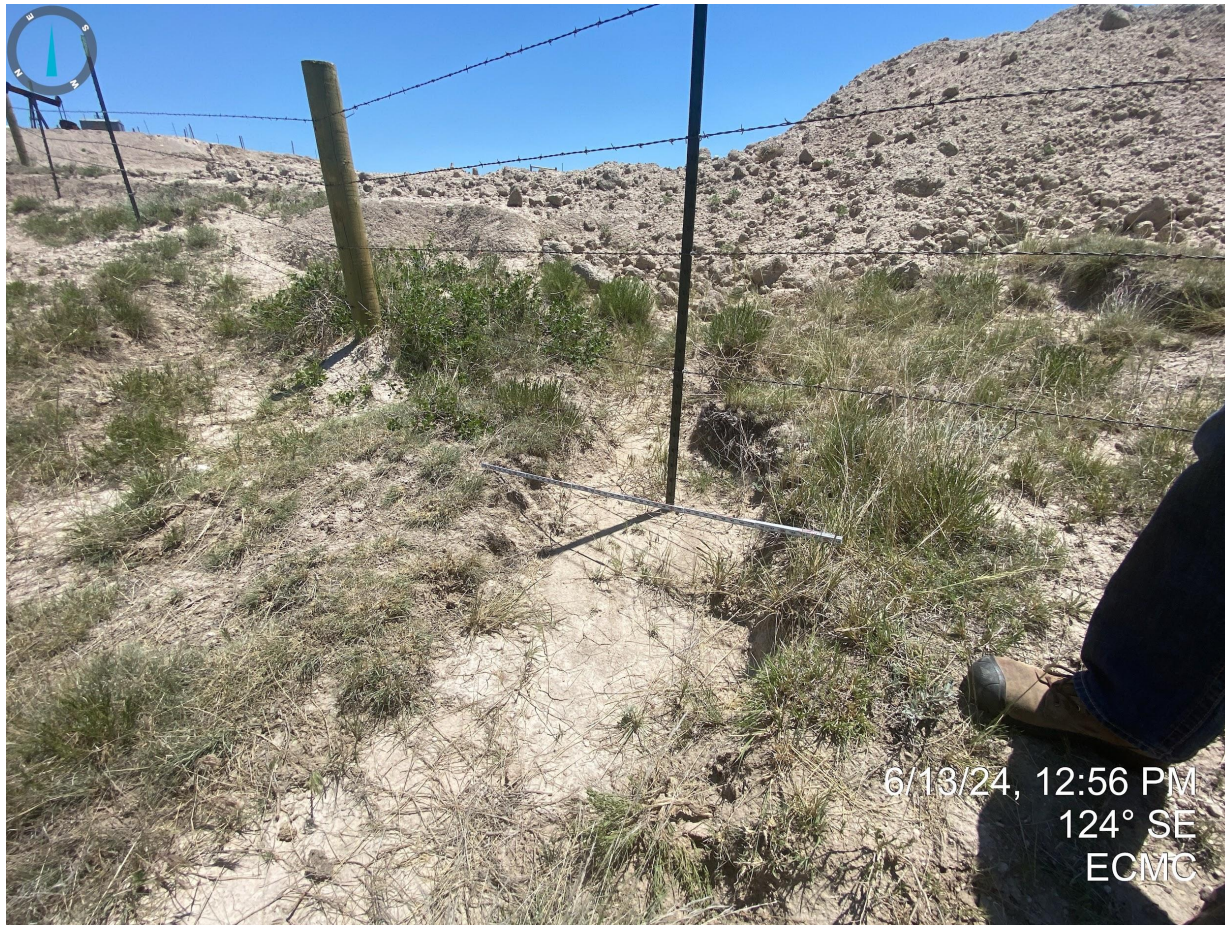
Photo 24. Continued from Photo 23. No apparent perimeter stormwater control measures observed. Erosion degradation evident.

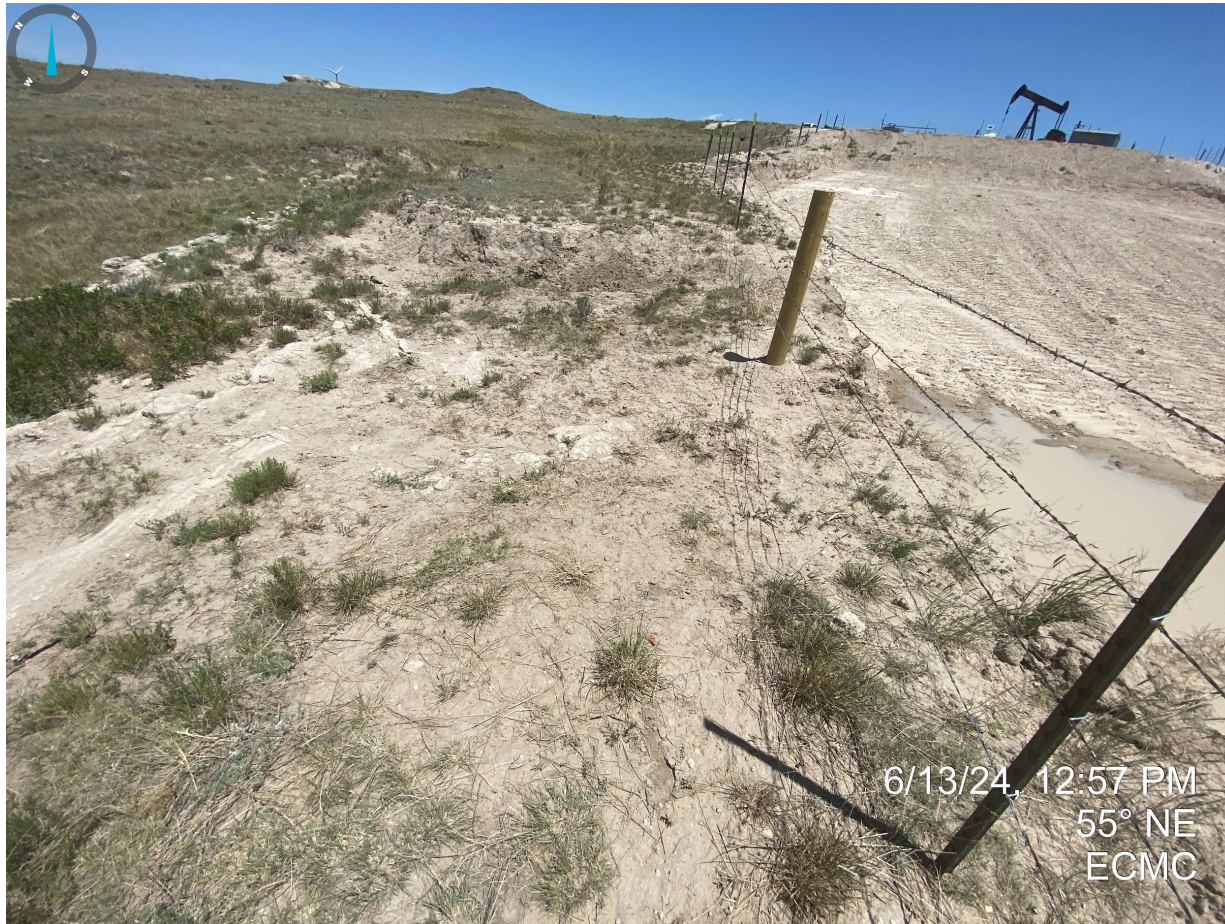
Photo 25. Continued from Photo 23. No apparent perimeter stormwater control measures observed.

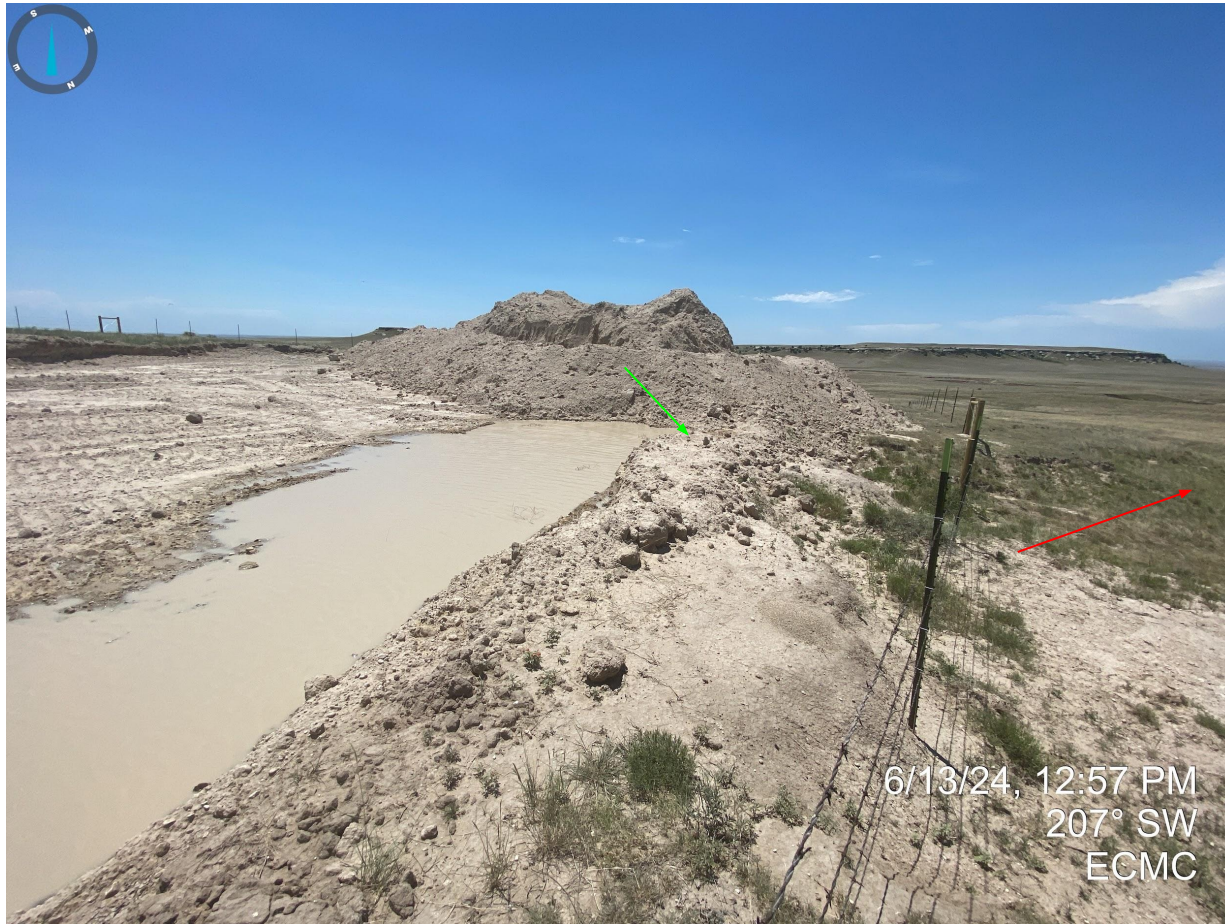
Photo 26. Continued from Photo 23. No stormwater control measures/BMPs were observed around the perimeter of the excavated area or stockpiles that would prevent off location stormwater discharge from entering nearby drainage (indicated by red arrow). Stormwater is close to spilling over the excavated area, indicated by green arrow.

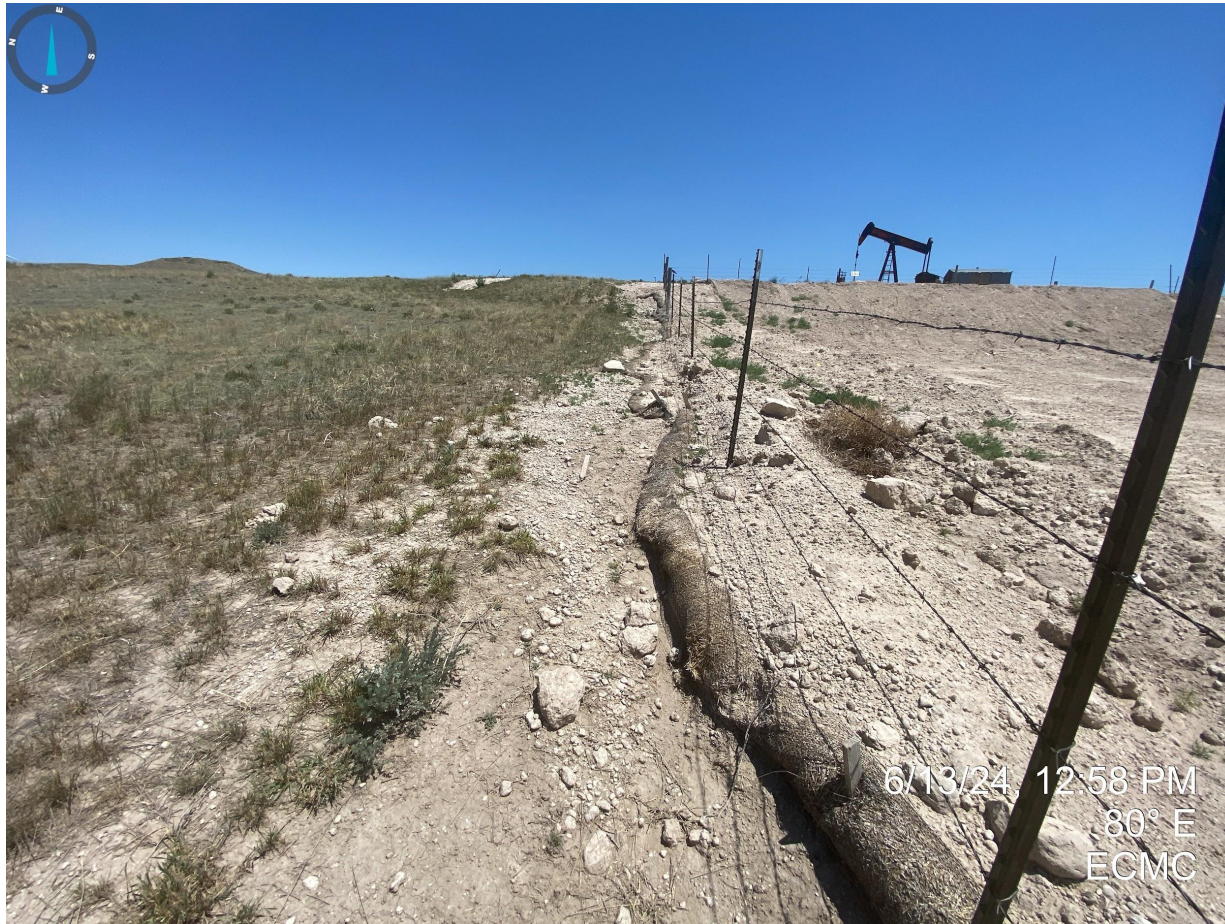
Photo 27. Taken from the north side of the pit. It does not appear that any erosion degradation has been properly stabilized or repaired, and stormwater control measures remain inadequate as the straw wattles are degraded and not properly functioning.

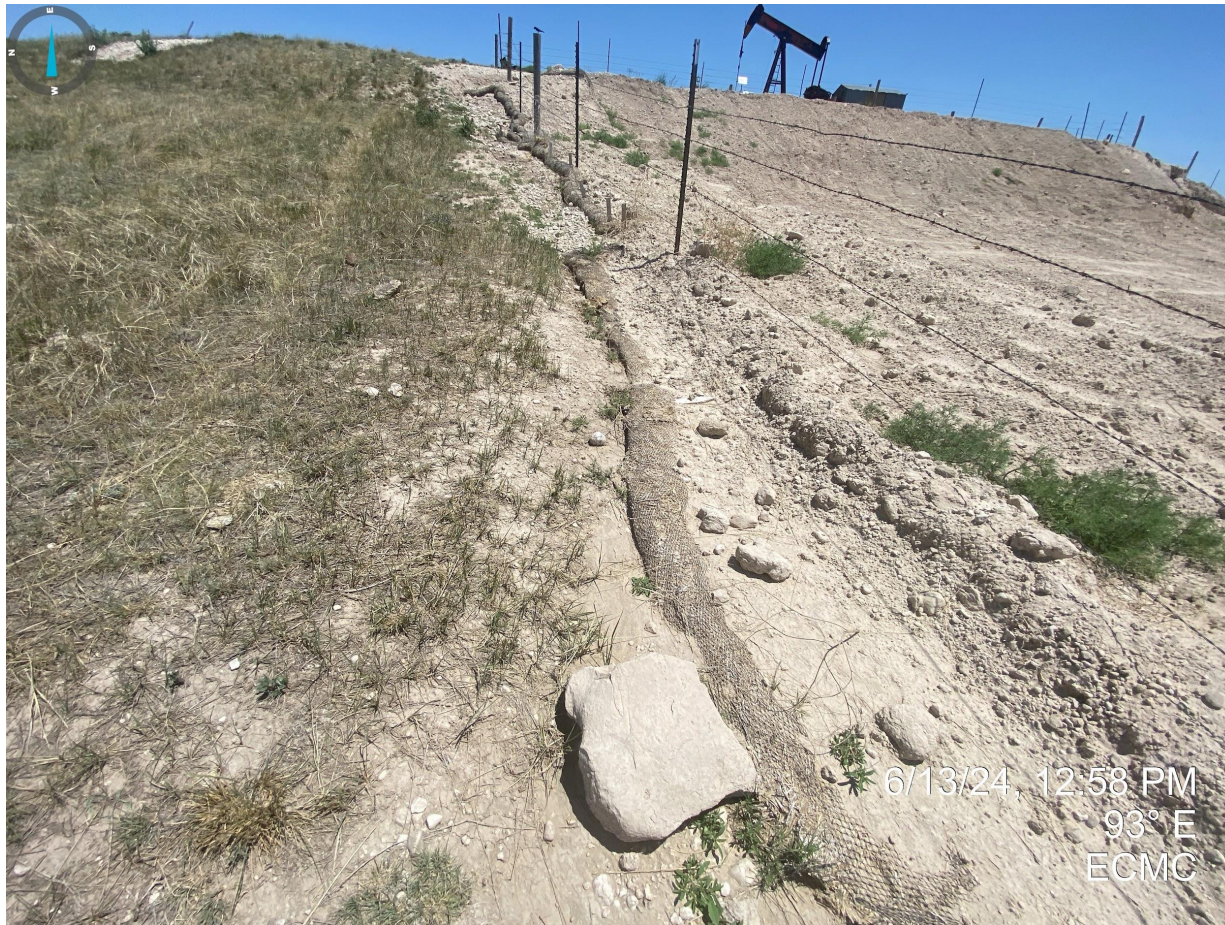
Photo 28. Continued from Photo 27.

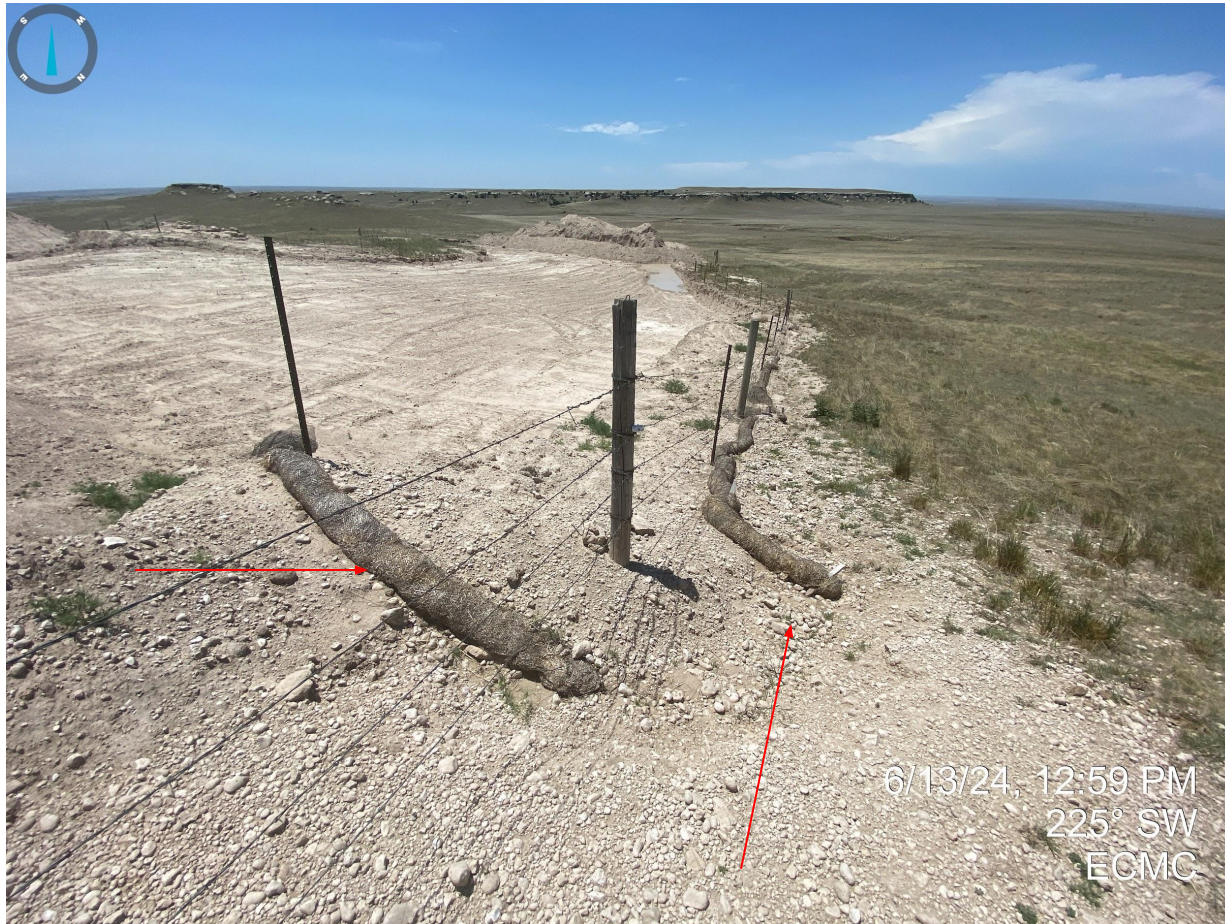
Photo 29. Continued from Photo 27.
