# Interim Reclamation and Stormwater Inspection

Operator: WESTERN OPERATING COMPANY - 95620

Location ID: 312291

Inspection Document #: 708201332

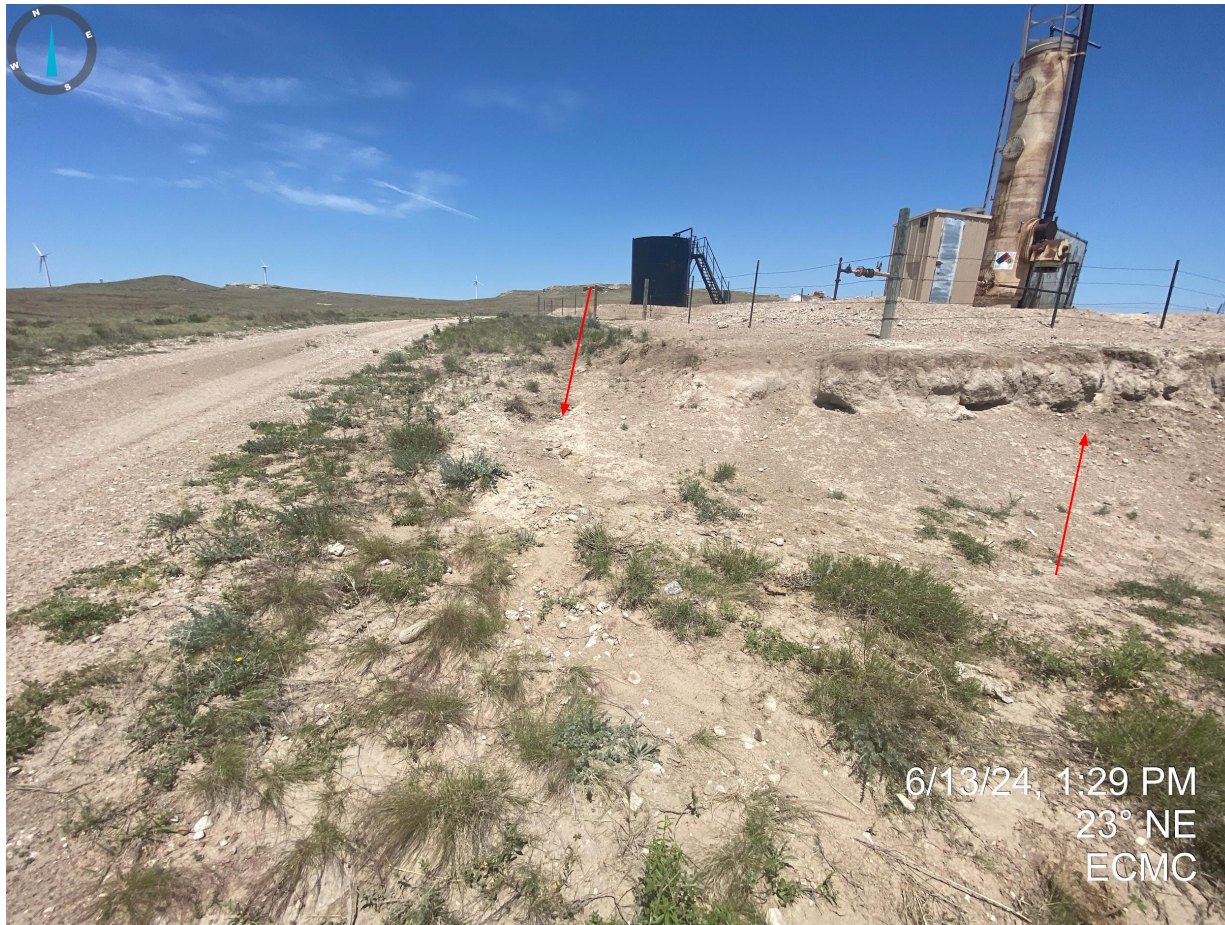
**Photo 1.** Areas experiencing erosion degradation throughout the production areas do not appear to have been repaired/stabilized and there is no evidence of stormwater controls measures/BMPs having been implemented.

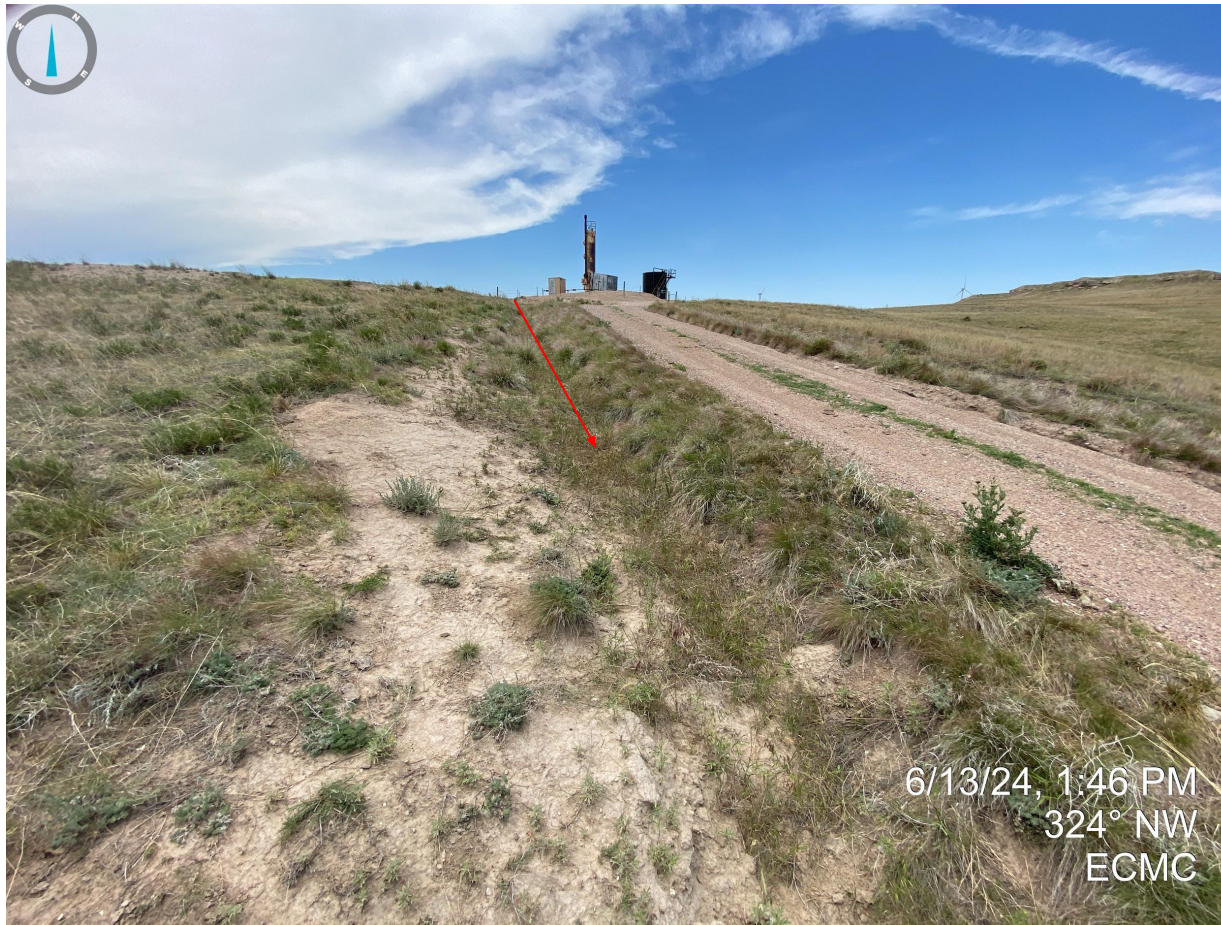
**Photo 2.** Taken from the access road east of the pit. Evidence of erosion degradation, previously documented, does not appear to have been repaired/stabilized with no evidence of control measures/BMPs observed that would prevent further erosion of the access road.

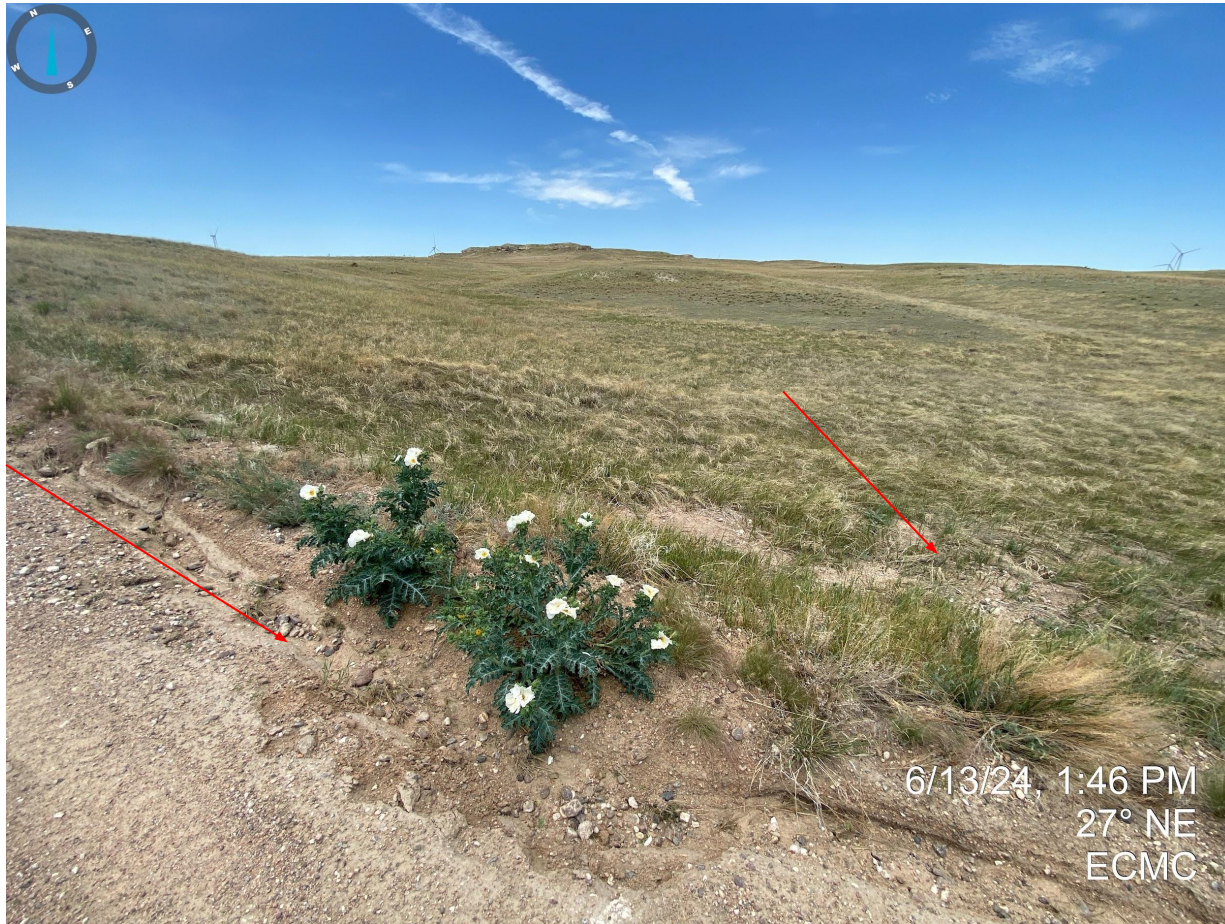
**Photo 3.** Taken from the access road, facing northeast; see comments in Photo 2.

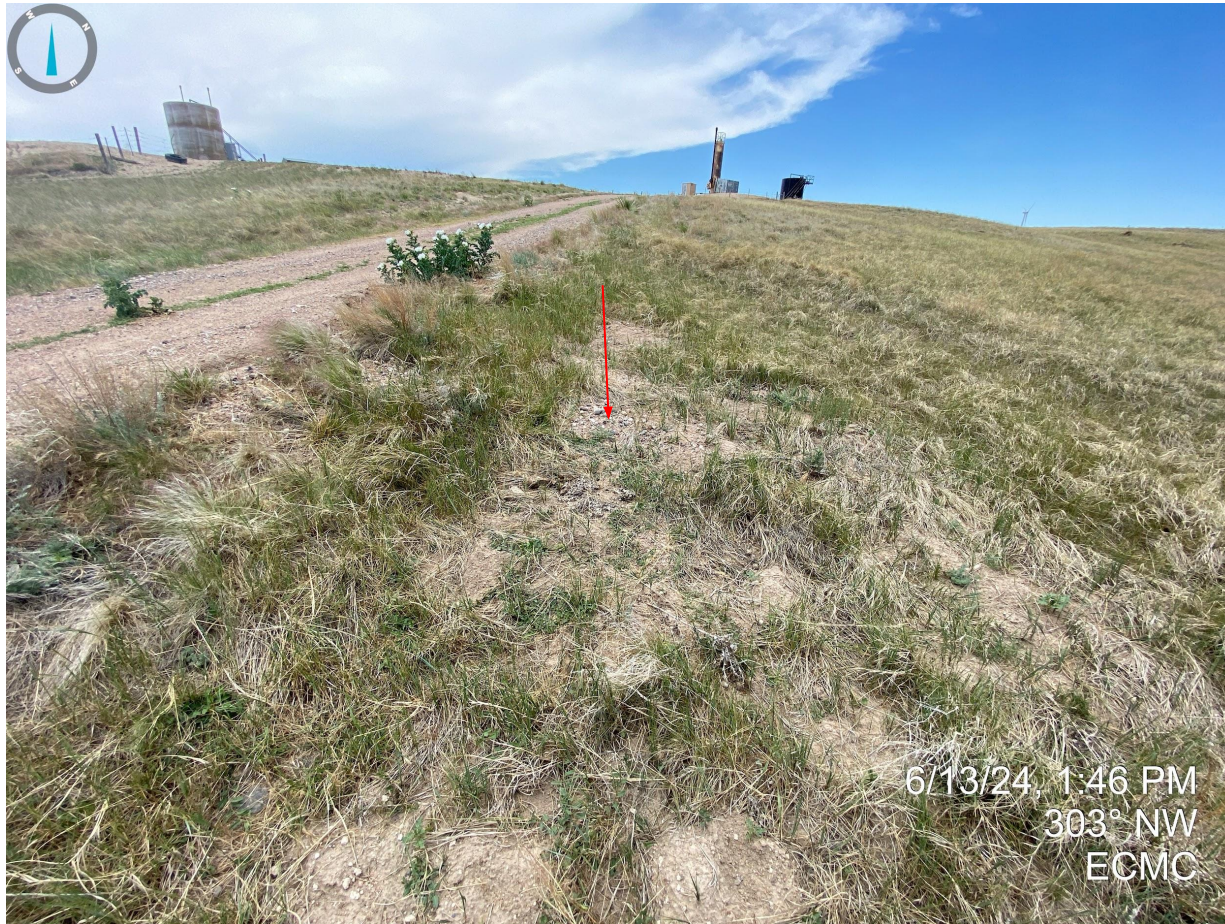
**Photo 4.** Continued from Photo 3. Sediment deposition pictured.

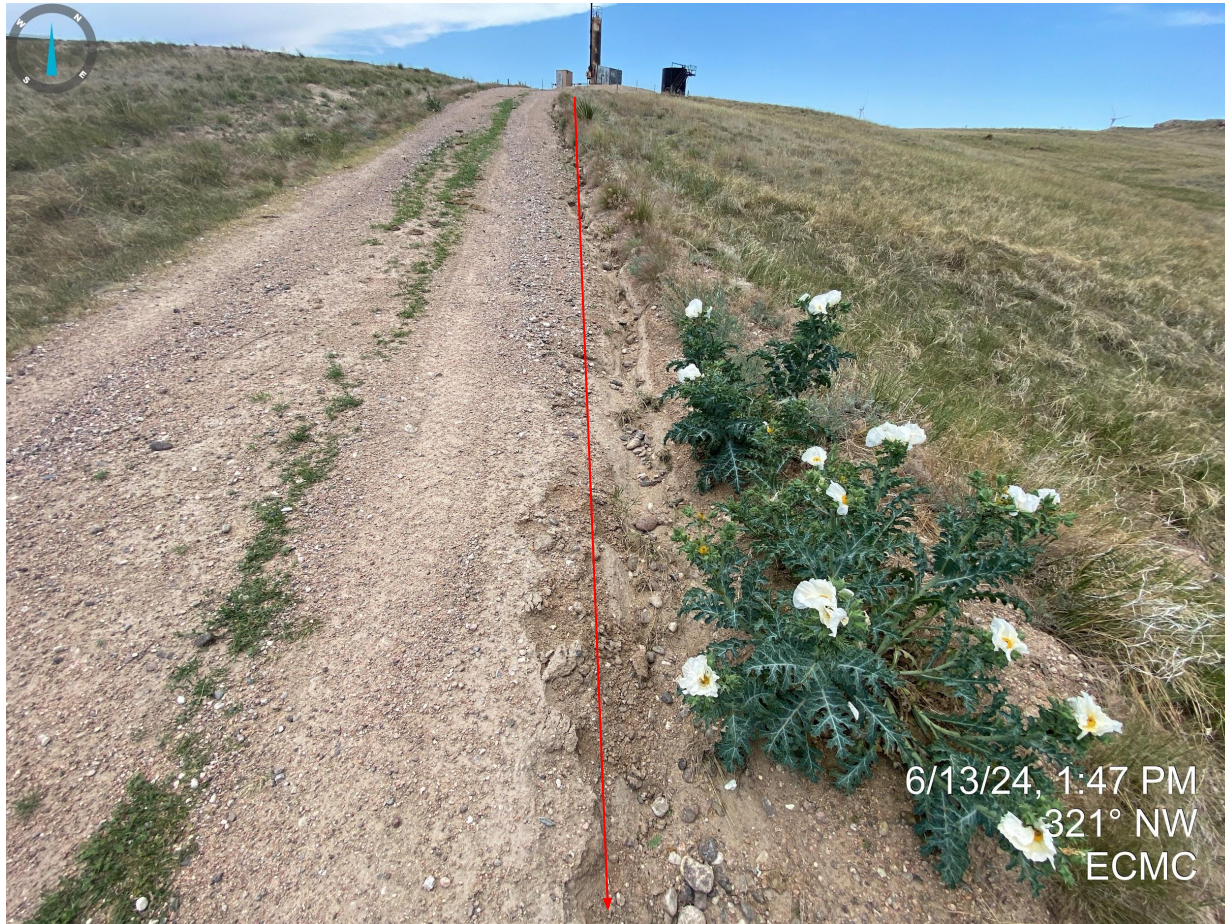
**Photo 5.** Taken from the access road, facing northwest; see comments in Photo 2.

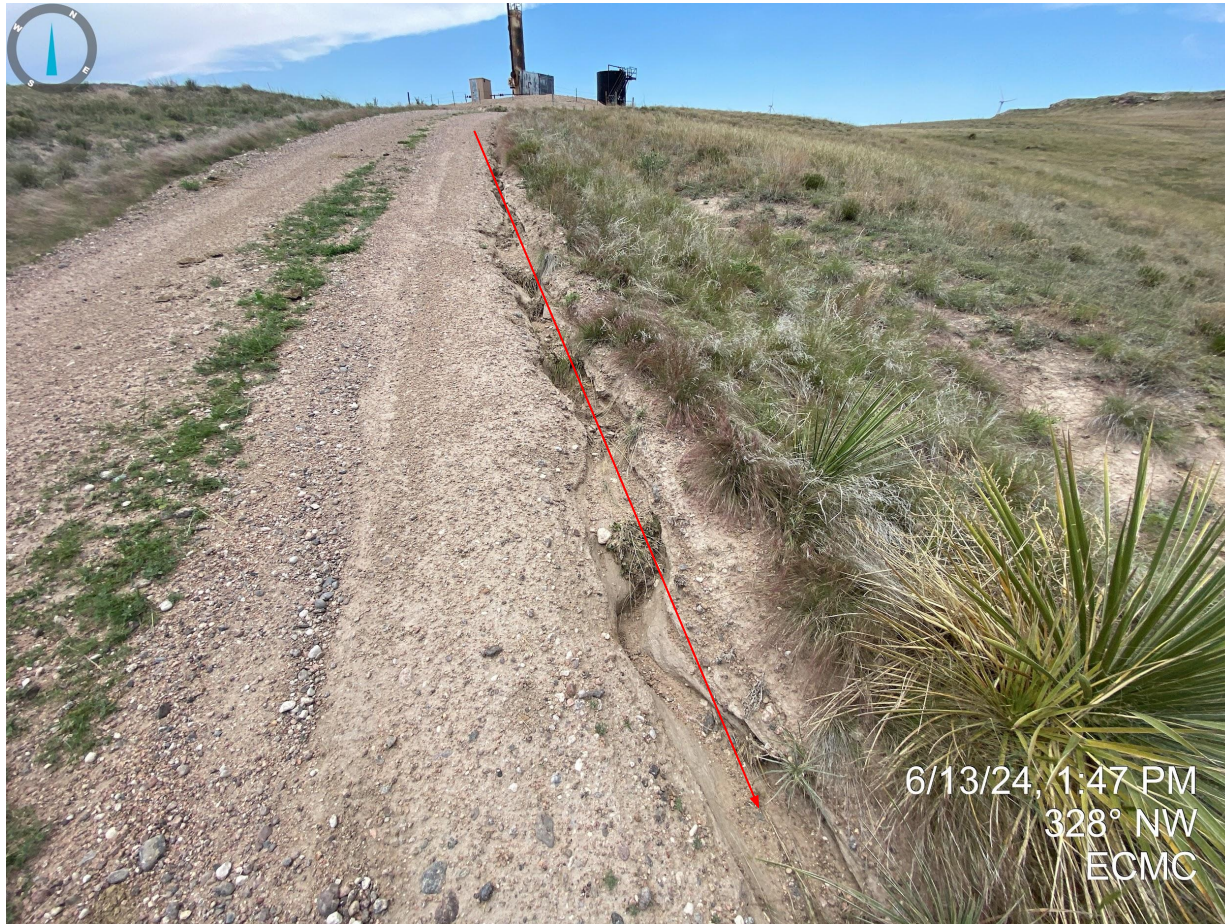
**Photo 6.** Taken from the access road, facing northwest; see comments in Photo 2.

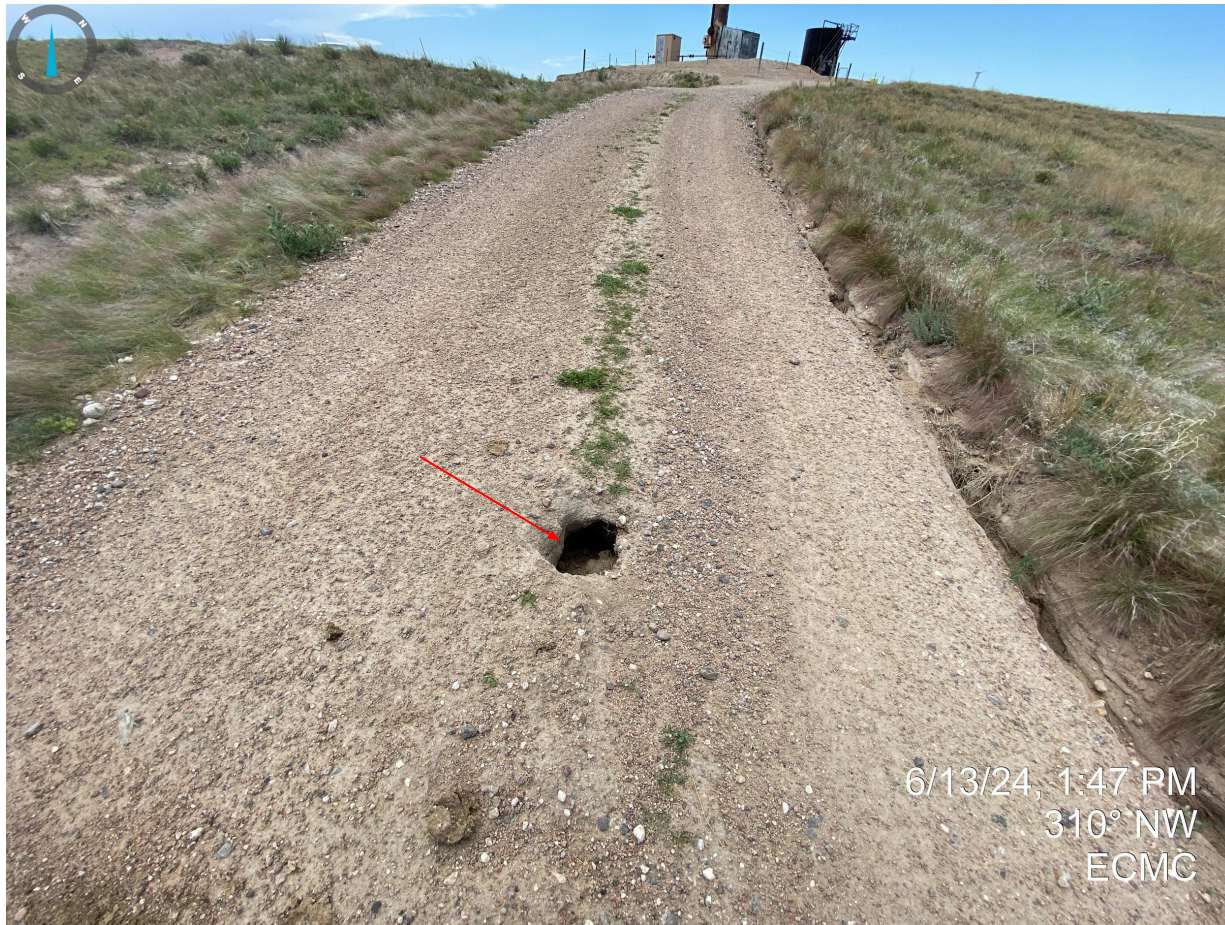
**Photo 7.** Taken from the access road, facing northwest; see comments in Photo 2. Subsidence pictured.

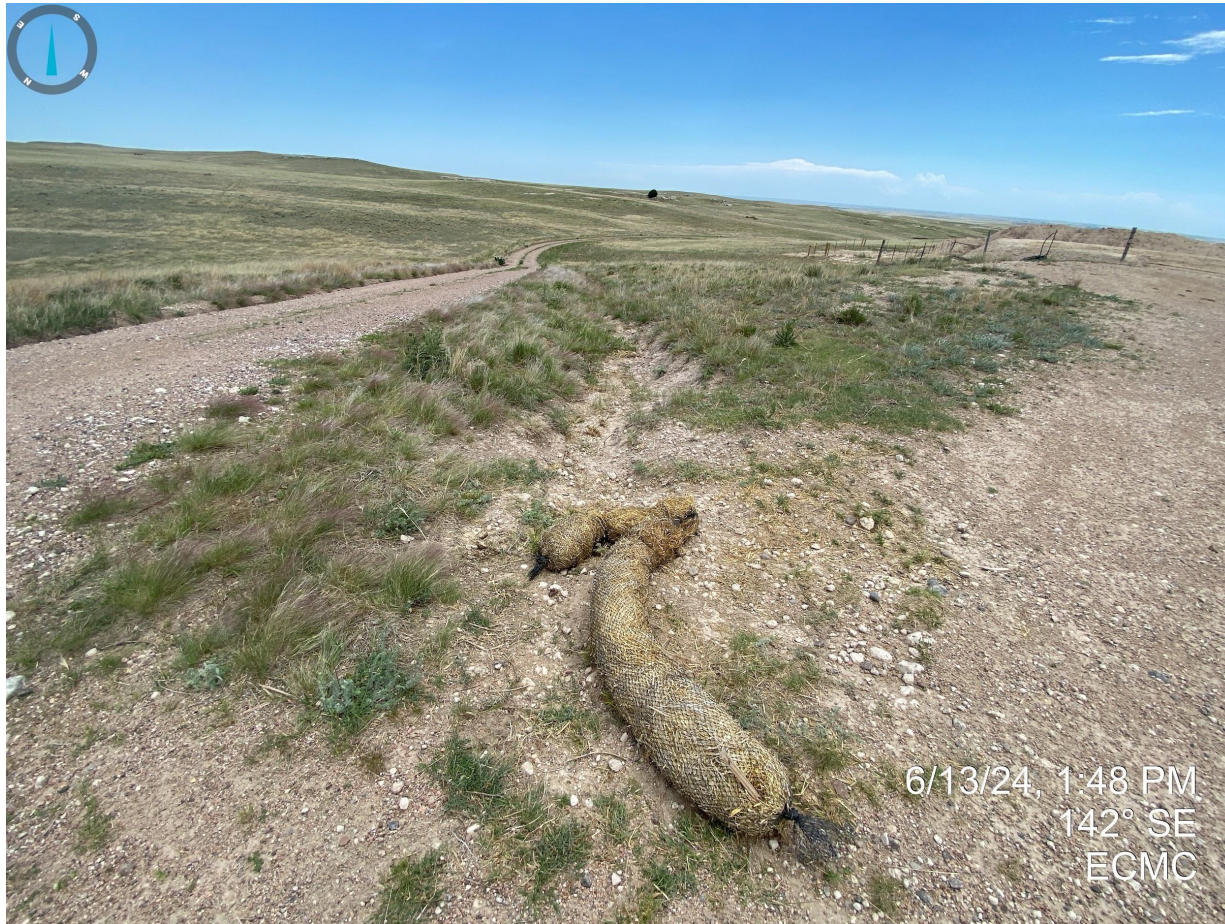
**Photo 8.** Taken from the production area, facing southeast along the access road; see comments in Photo 2.

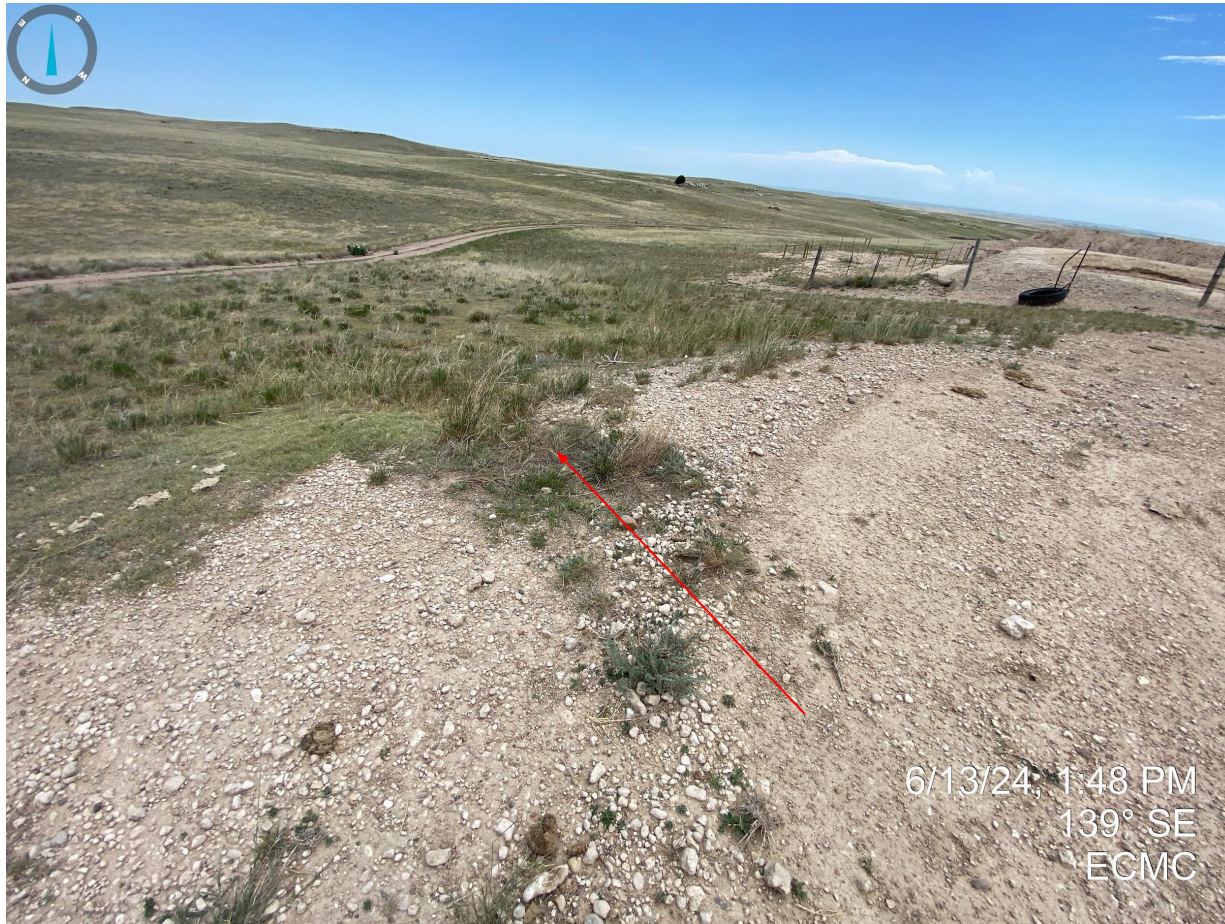
**Photo 9.** Erosion degradation occurring along the production areas; see comments in Photo 2.

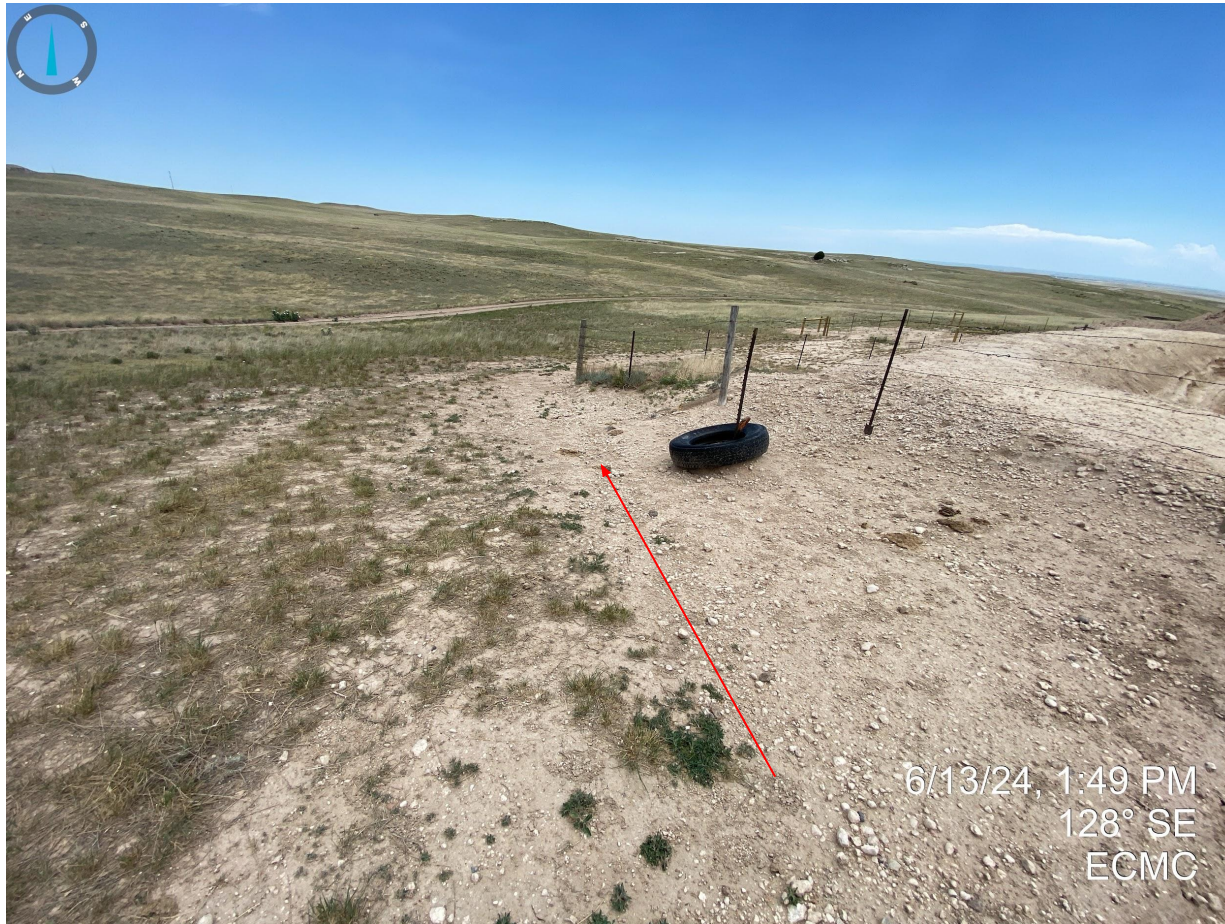
**Photo 10.** Erosion degradation occurring along the production areas; see comments in Photo 2.

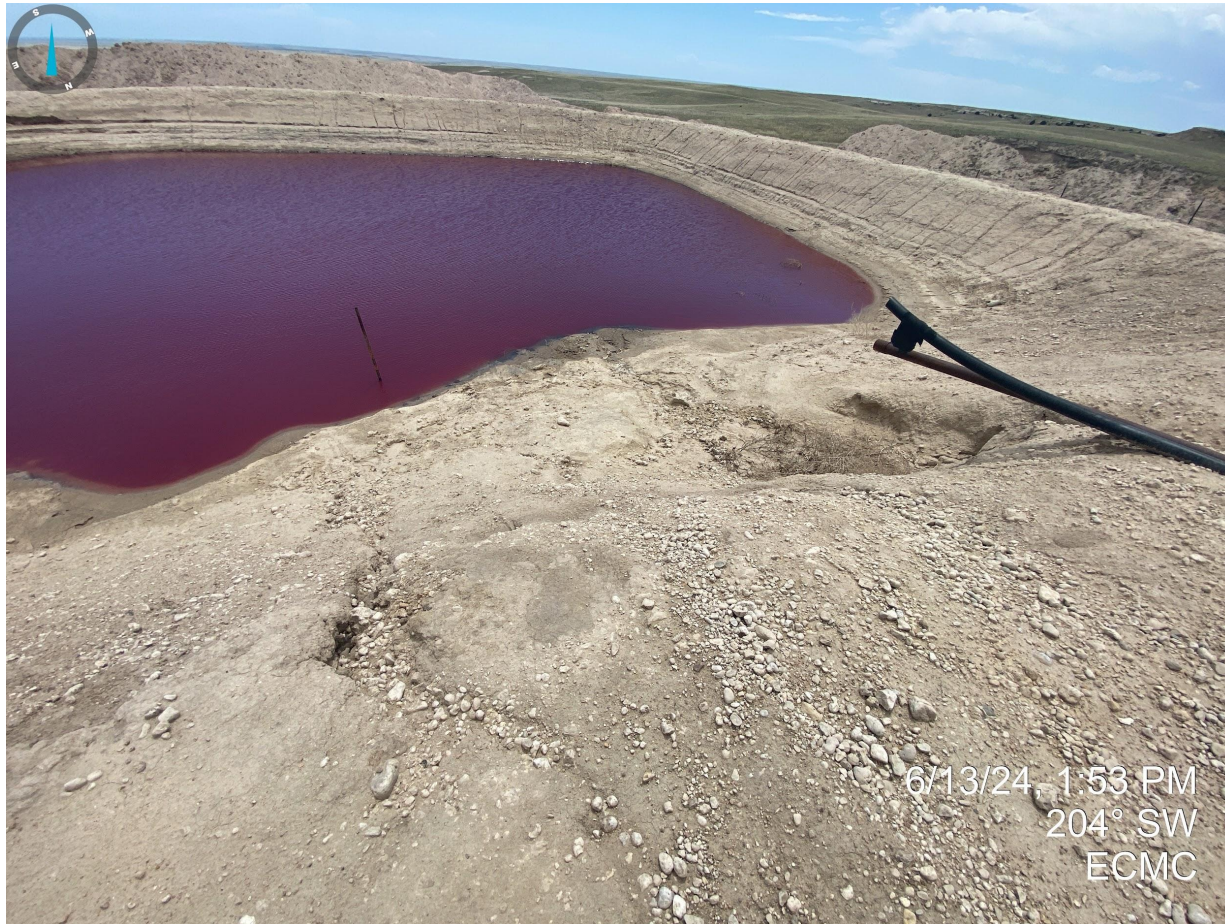
**Photo 11.** No wildlife netting covering the pit was observed during this inspection.

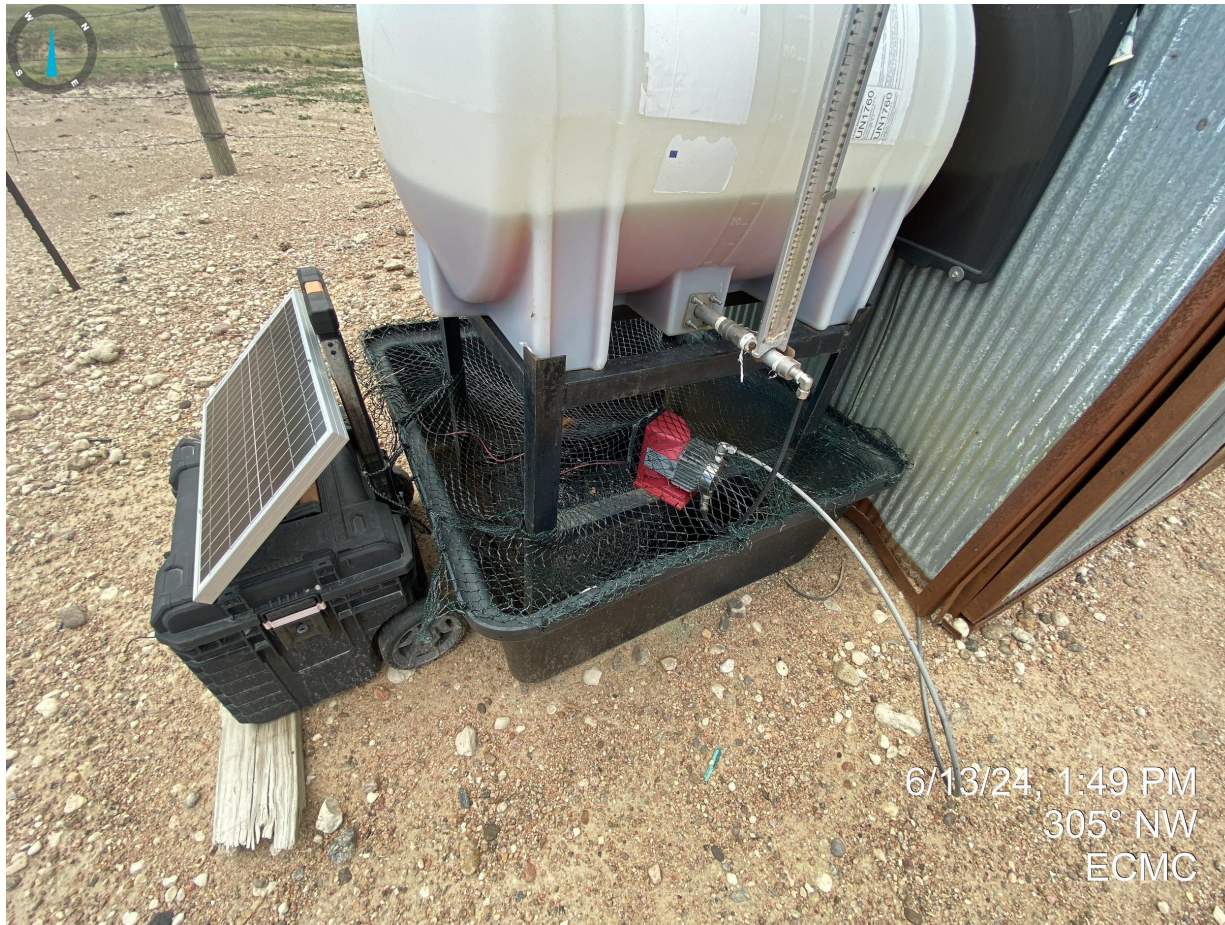
**Photo 12.** Free fluids observed within secondary containment have not been properly disposed of.

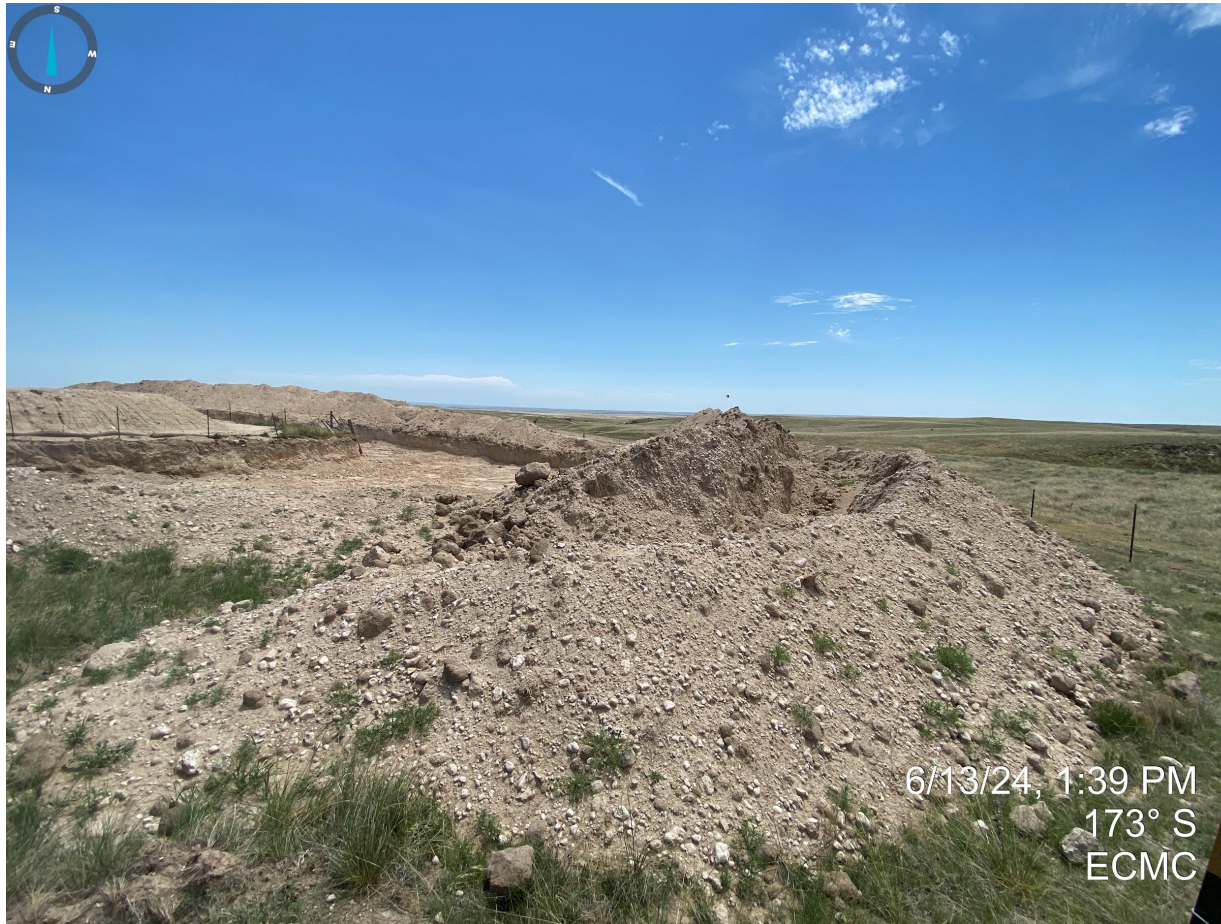
**Photo 13.** Taken from the north side of the stockpiled soils. No perimeter stormwater control measures/BMPs, or impermeable liners underneath the stockpile were observed during this inspection. Impacted soils appear to have been placed directly on top of undisturbed lands. Additionally, it does not appear that topsoil has been salvaged Per Rule 1002.b prior to stockpiling the soil on undisturbed portions of land.

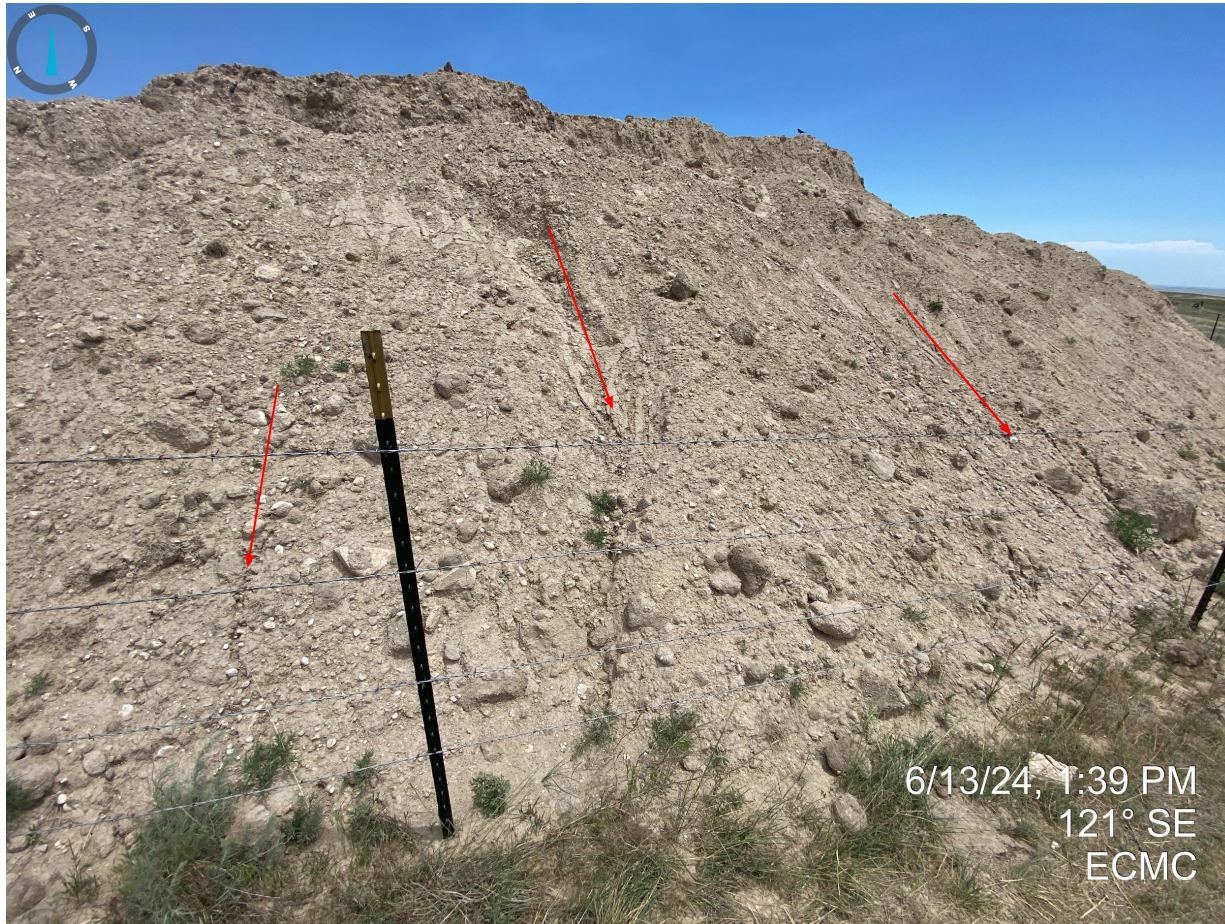
**Photo 14.** Riling observed on the stockpiled materials; see comments in Photo 13.

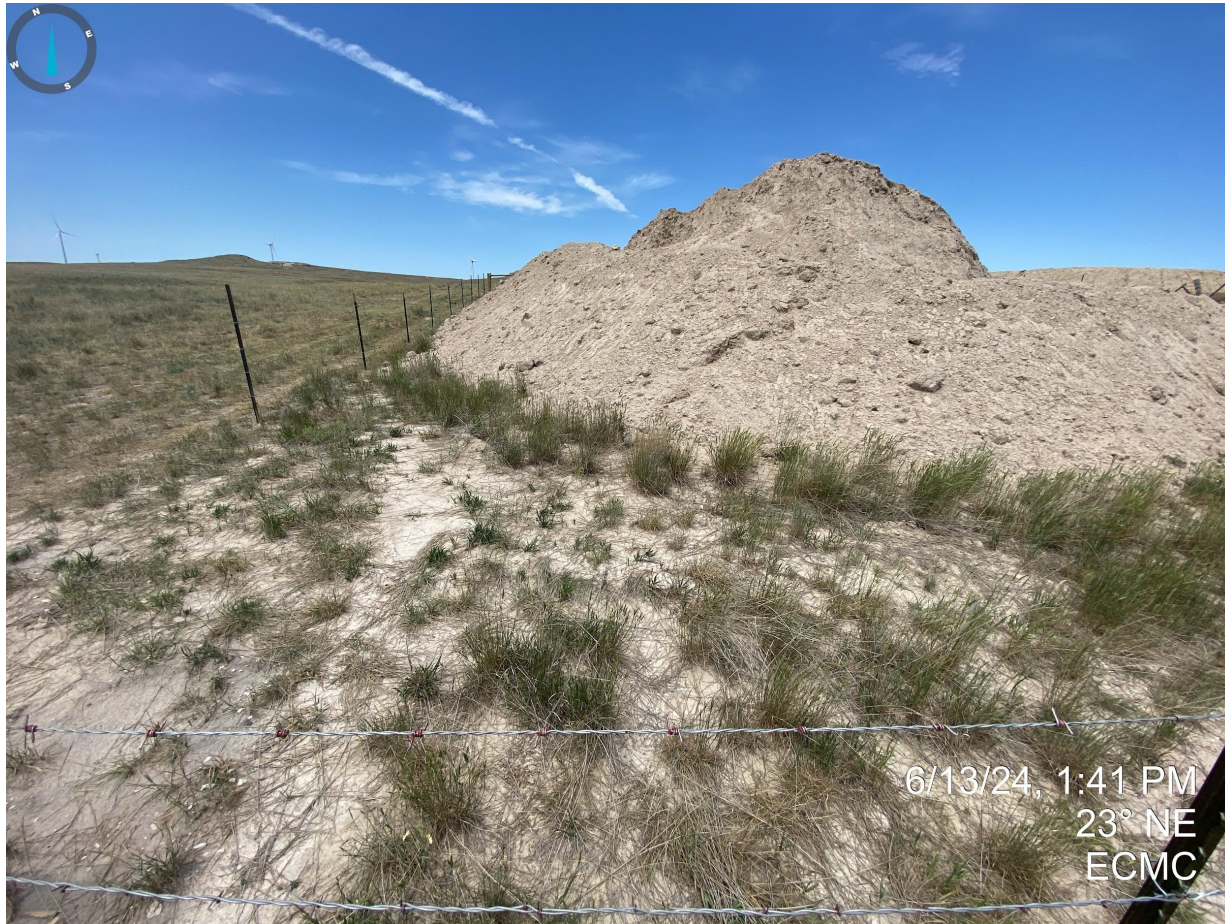
**Photo 15.** Taken southwest of the excavated area and stockpiled material; see comments in Photo 13.

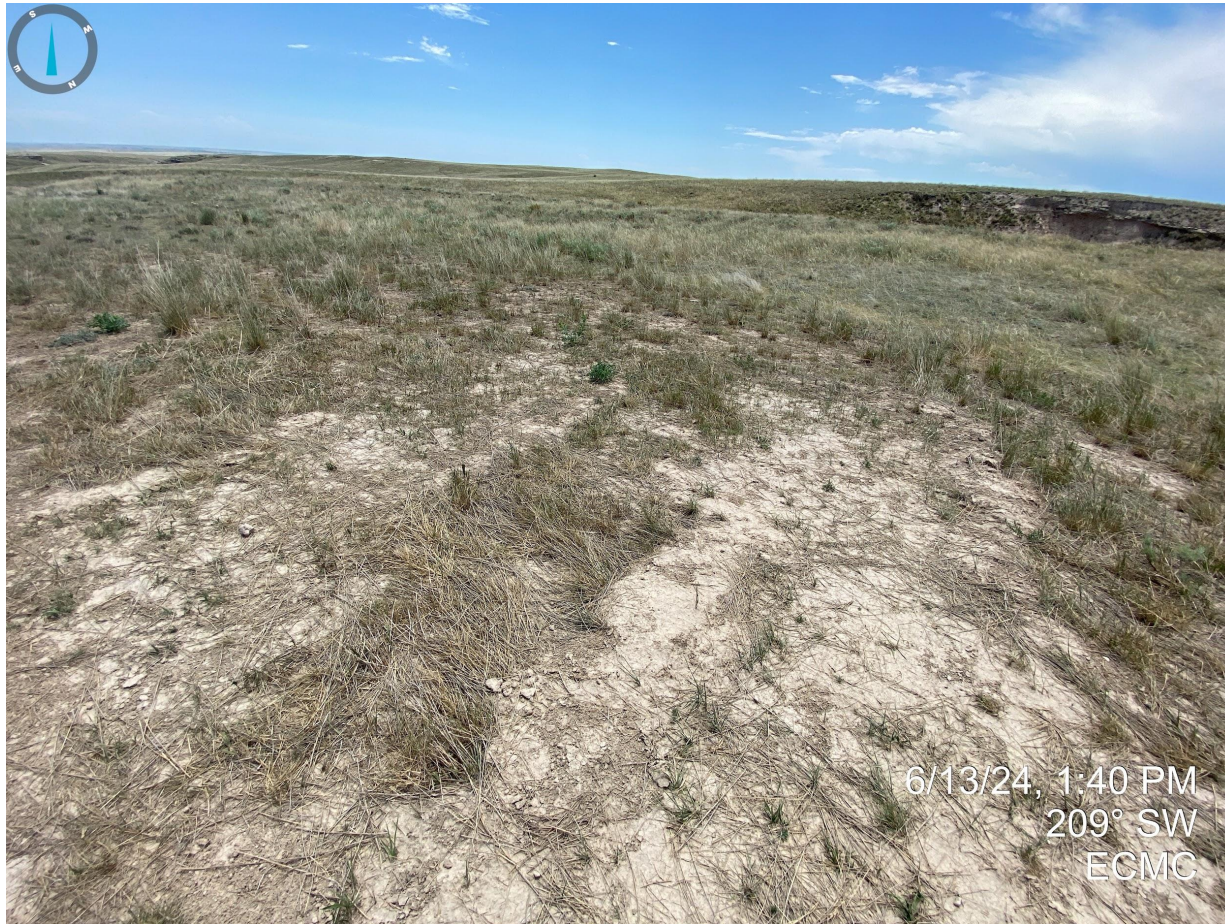
**Photo 16.** Continued from Photo 15, facing southwest. Sediment deposition pictured.

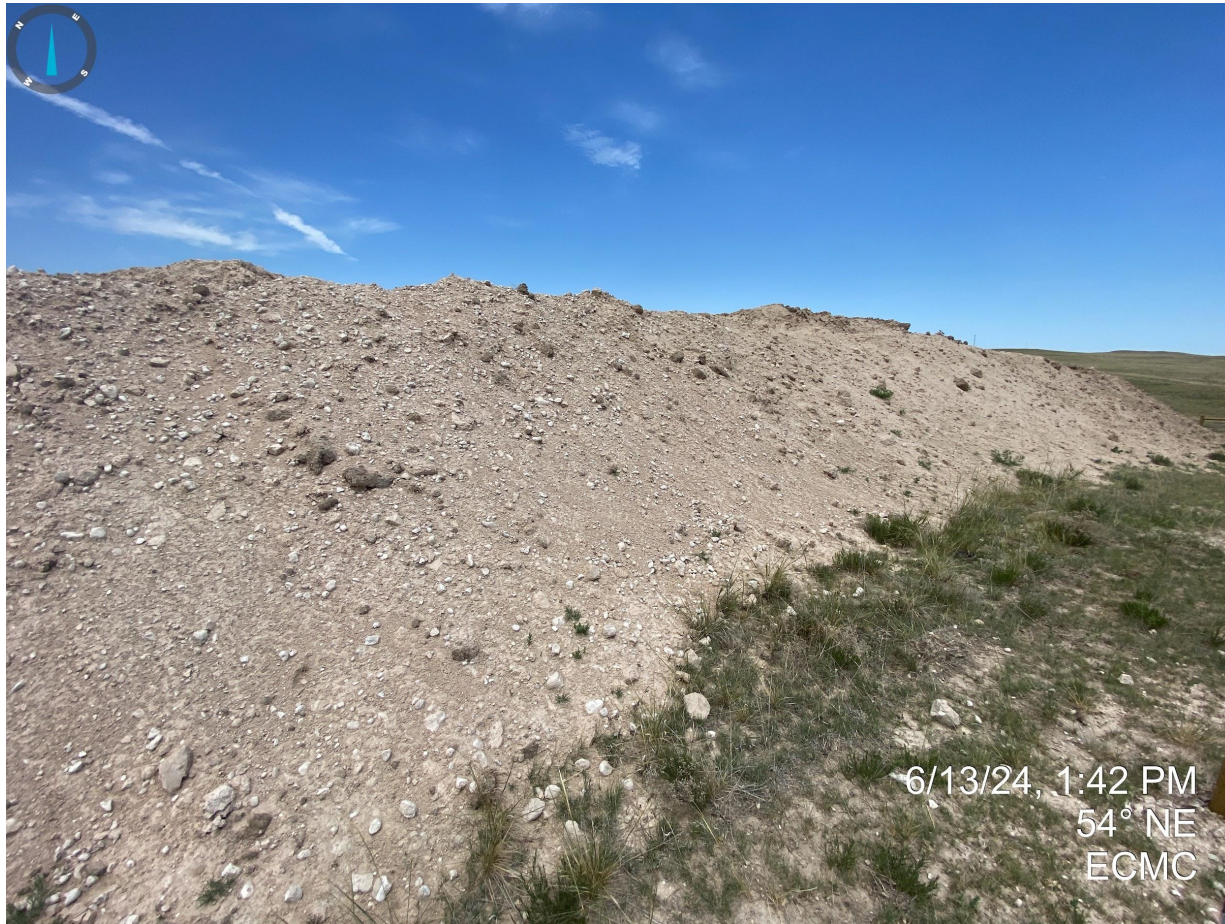
**Photo 17.** Taken from the southern portion of the stockpiled material; see comments in Photo 13.

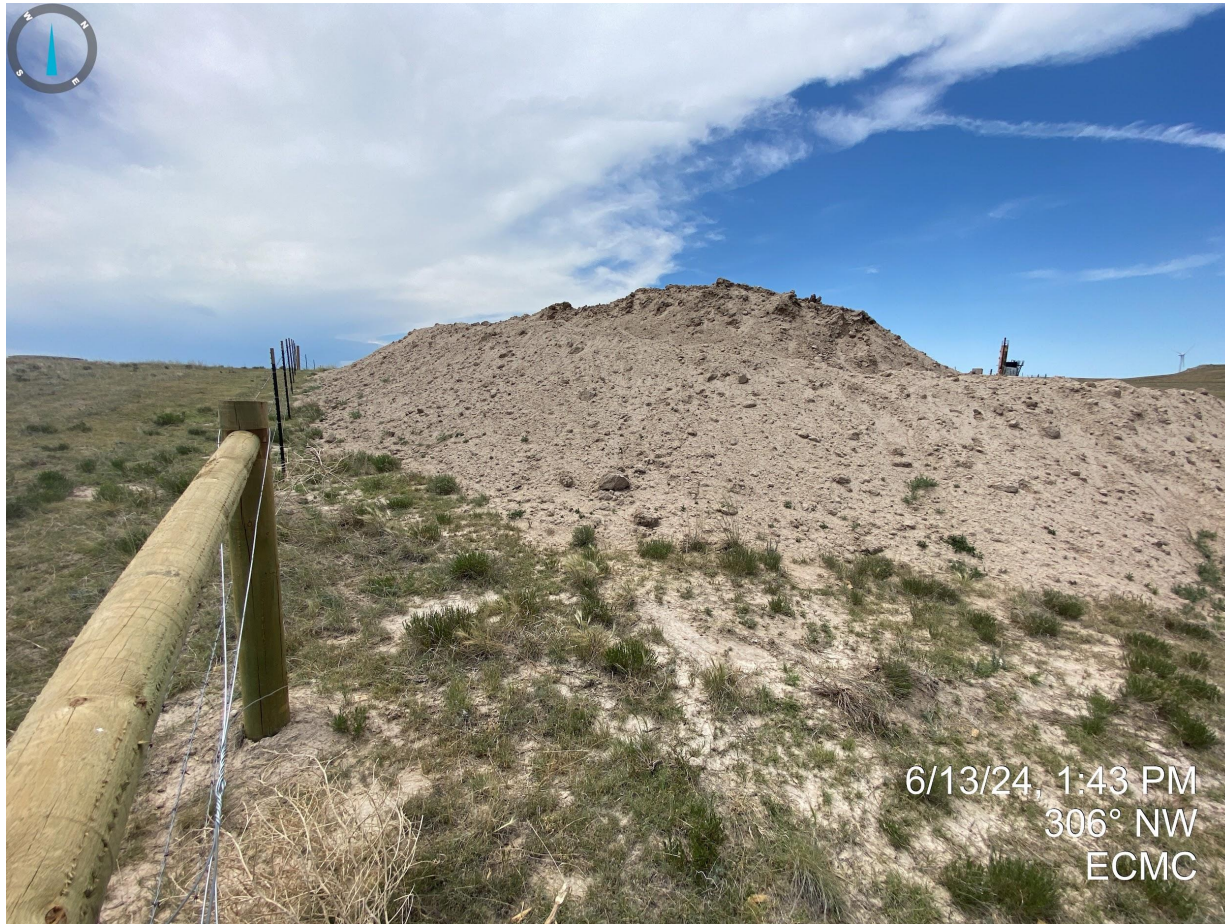
**Photo 18.** Taken from the southeast corner of the stockpiled material; see comments in Photo 13.

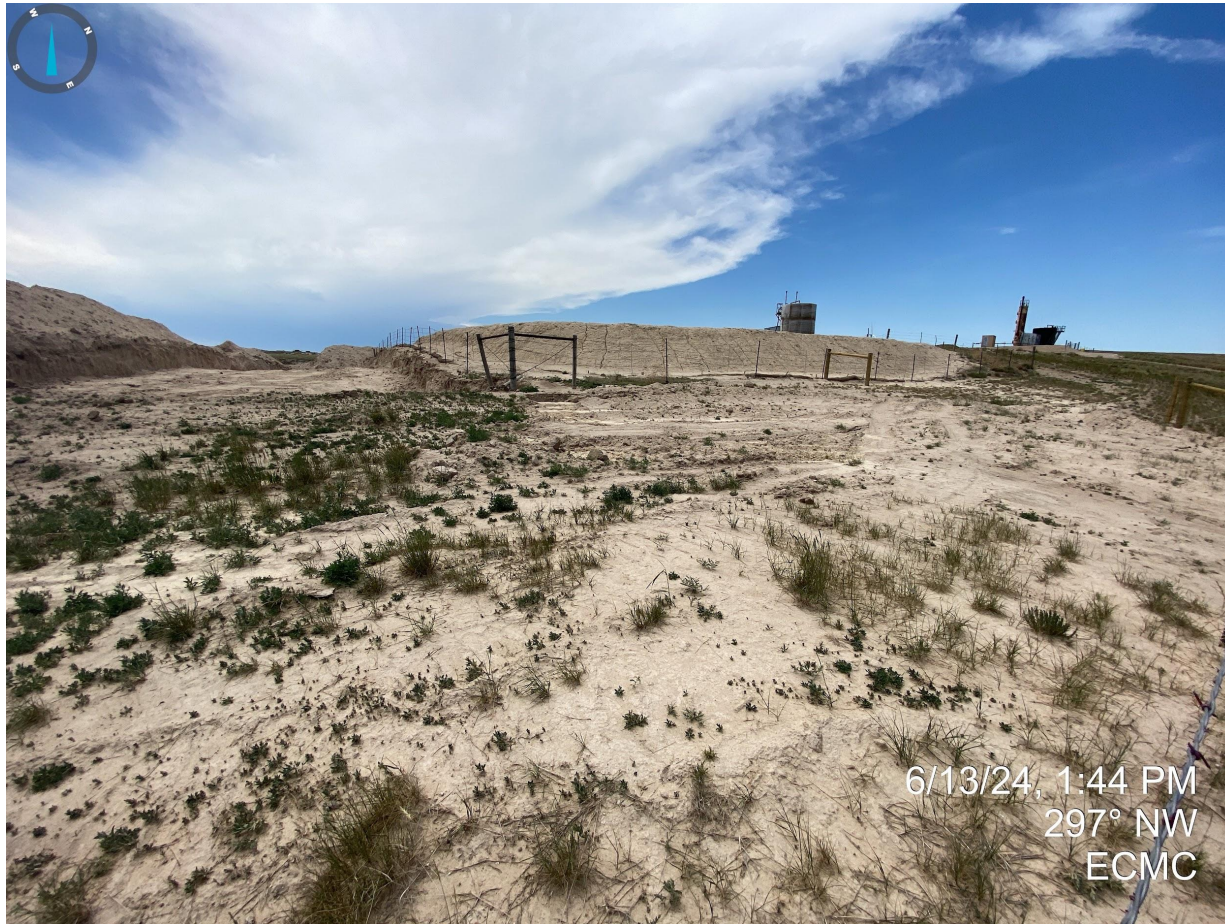
**Photo 19.** Taken southeast of the excavated area and stockpiled material; see comments in Photo 13.
