# Interim Reclamation and Stormwater Inspection

Operator: WESTERN OPERATING COMPANY - 95620

Location ID: 312291

Inspection Document #: 708201332

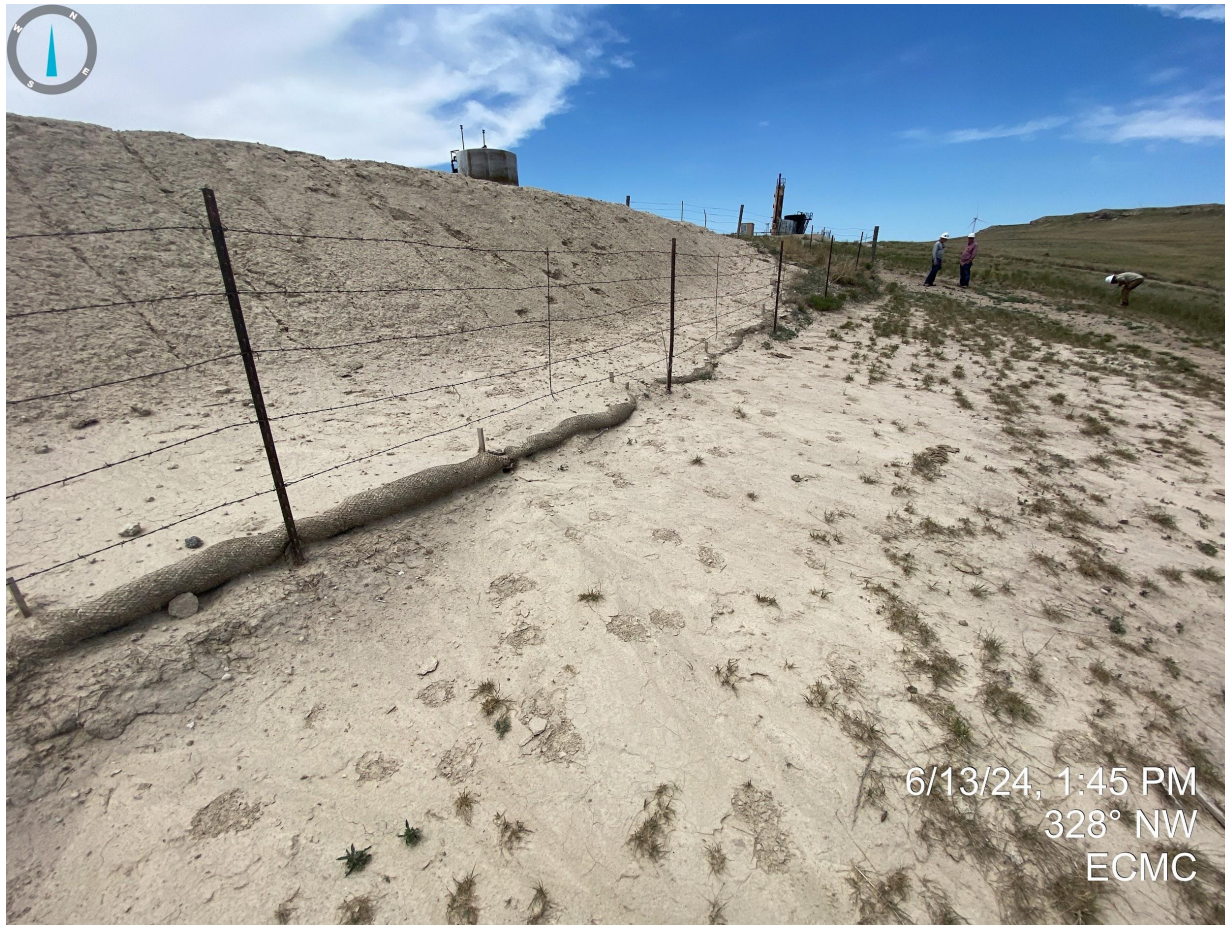
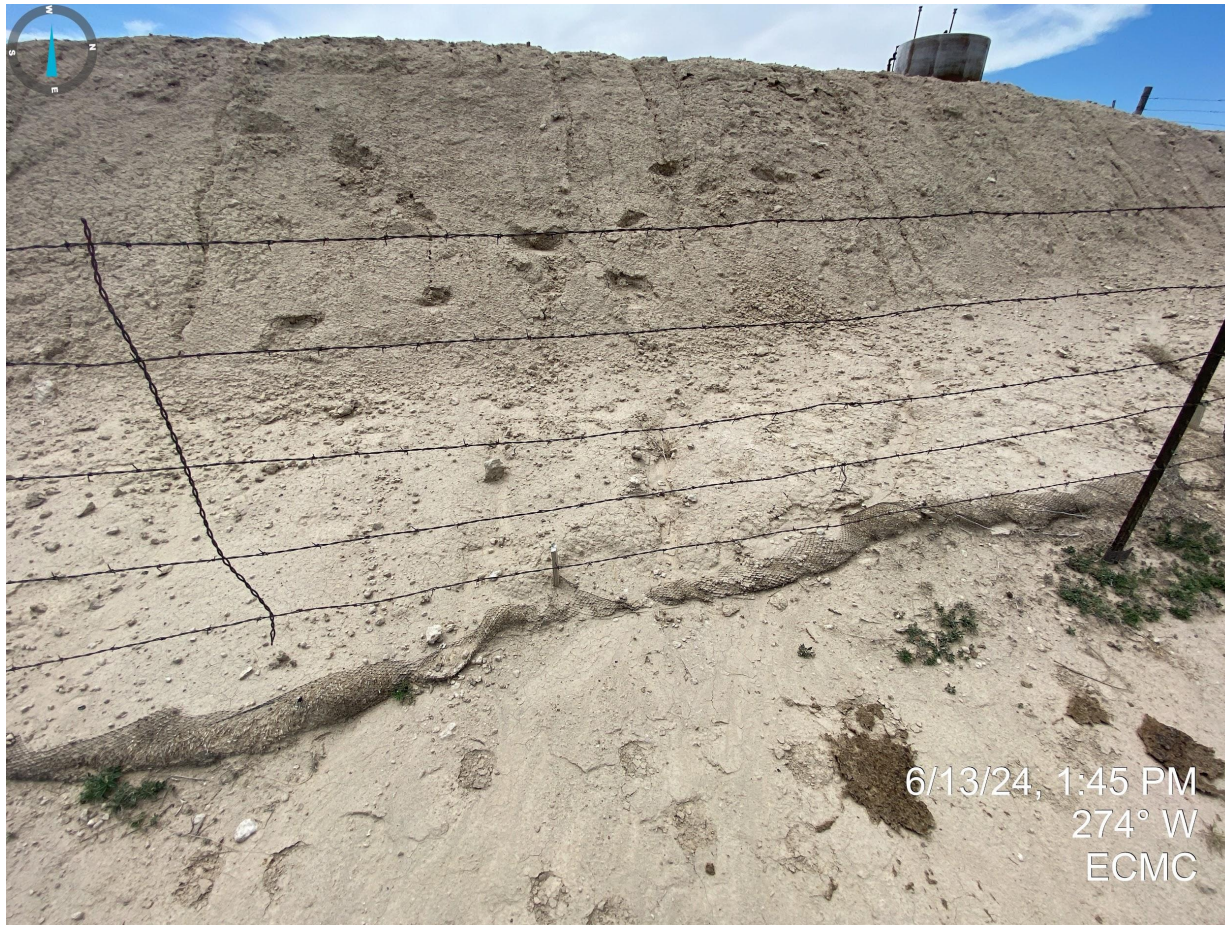
**Photo 21.** East side of pit; Stormwater control measures around the pit remain inadequate.

**Photo 22.** Continued from Photo 21.

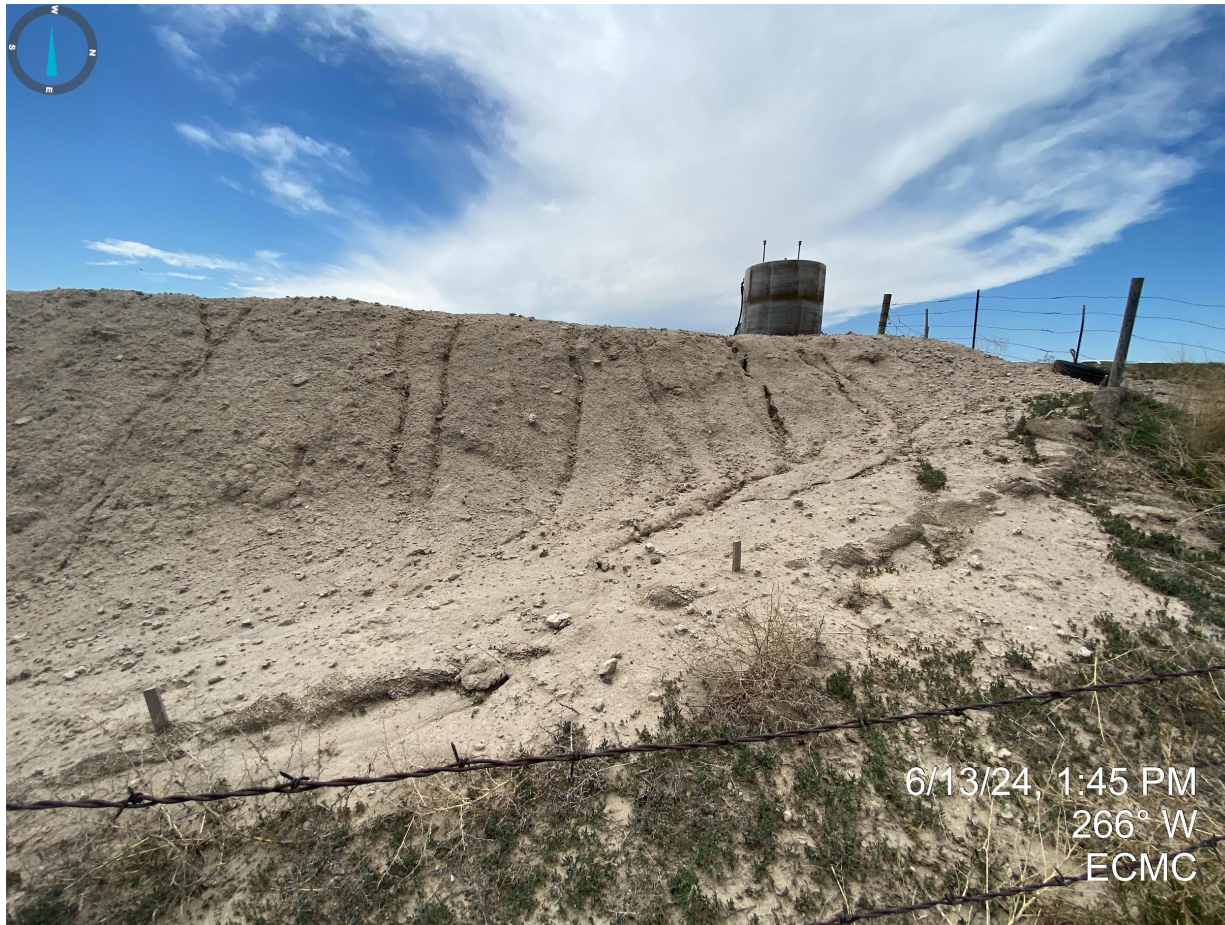
**Photo 23.** Northeast corner of the pit; erosion degradation pictured. Stormwater control measures around the pit remain inadequate.

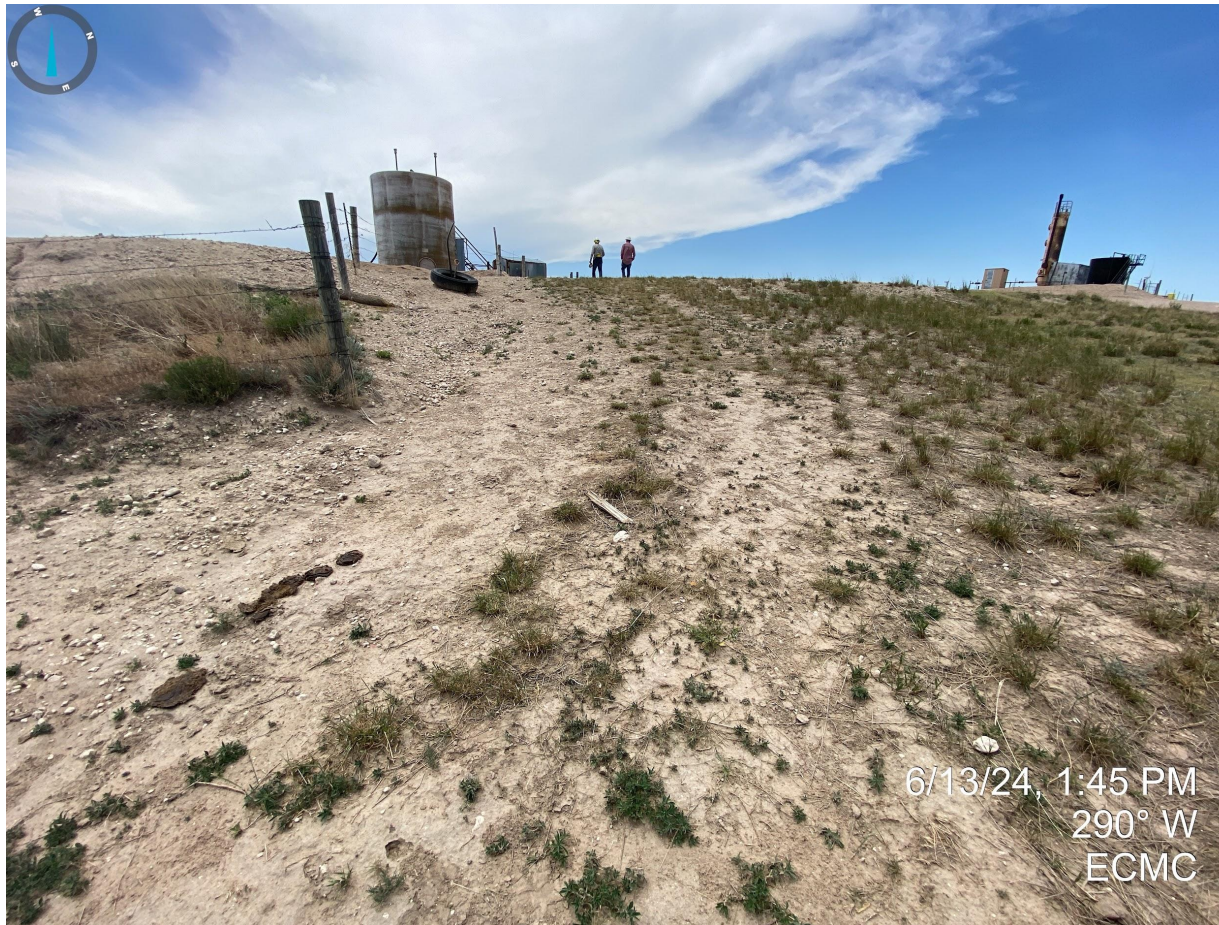
**Photo 24.** Northeast corner of the pit; erosion degradation pictured. Stormwater control measures around the production areas remain inadequate.
