Construction and Stormwater Inspection

Date: 06/18/2024

Operator: PDC ENERGY INC - 69175

Location ID: 485814

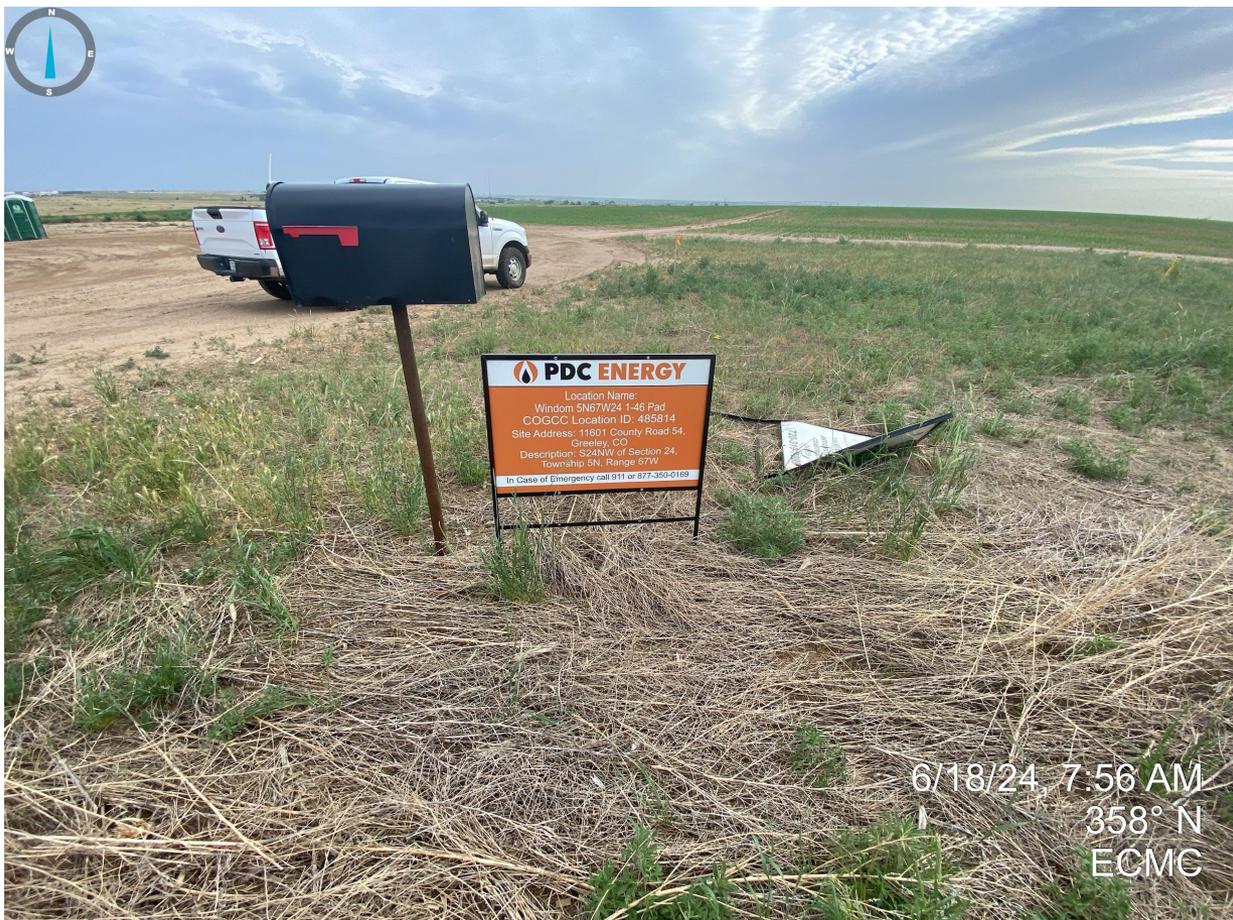
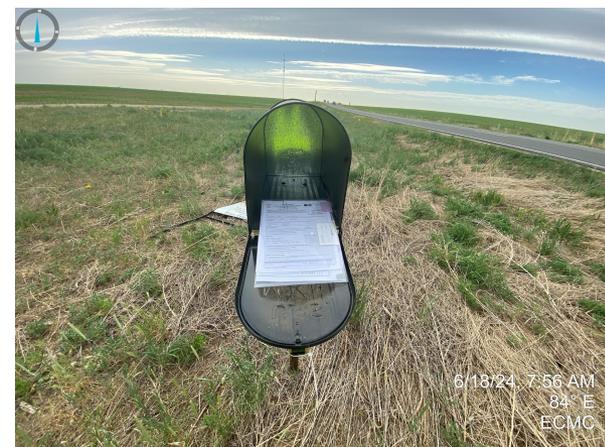
Photo 1. Per Rule 406.c. a copy of the approved Form 2A was posted on location.

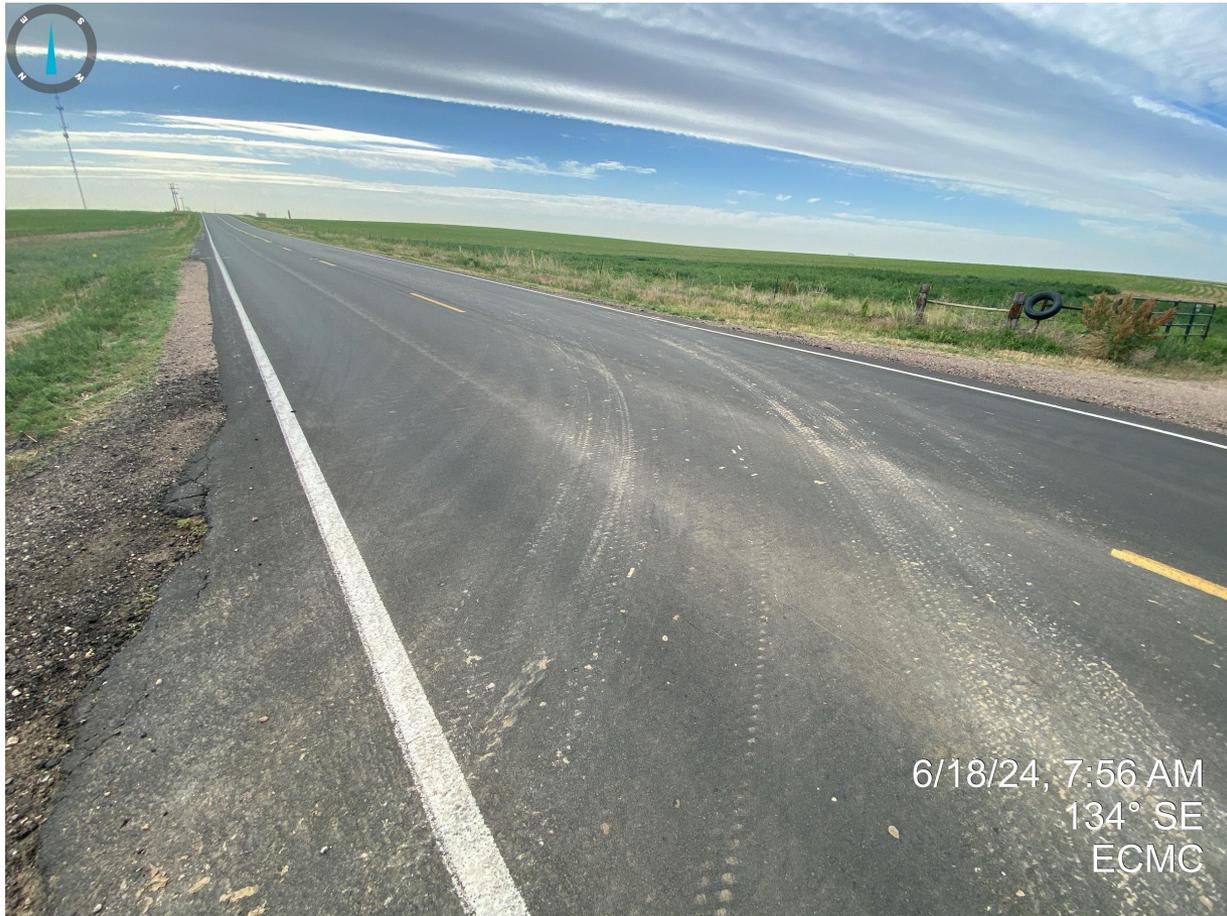
Photo 2. Vehicle track out onto eastbound WCR 54.

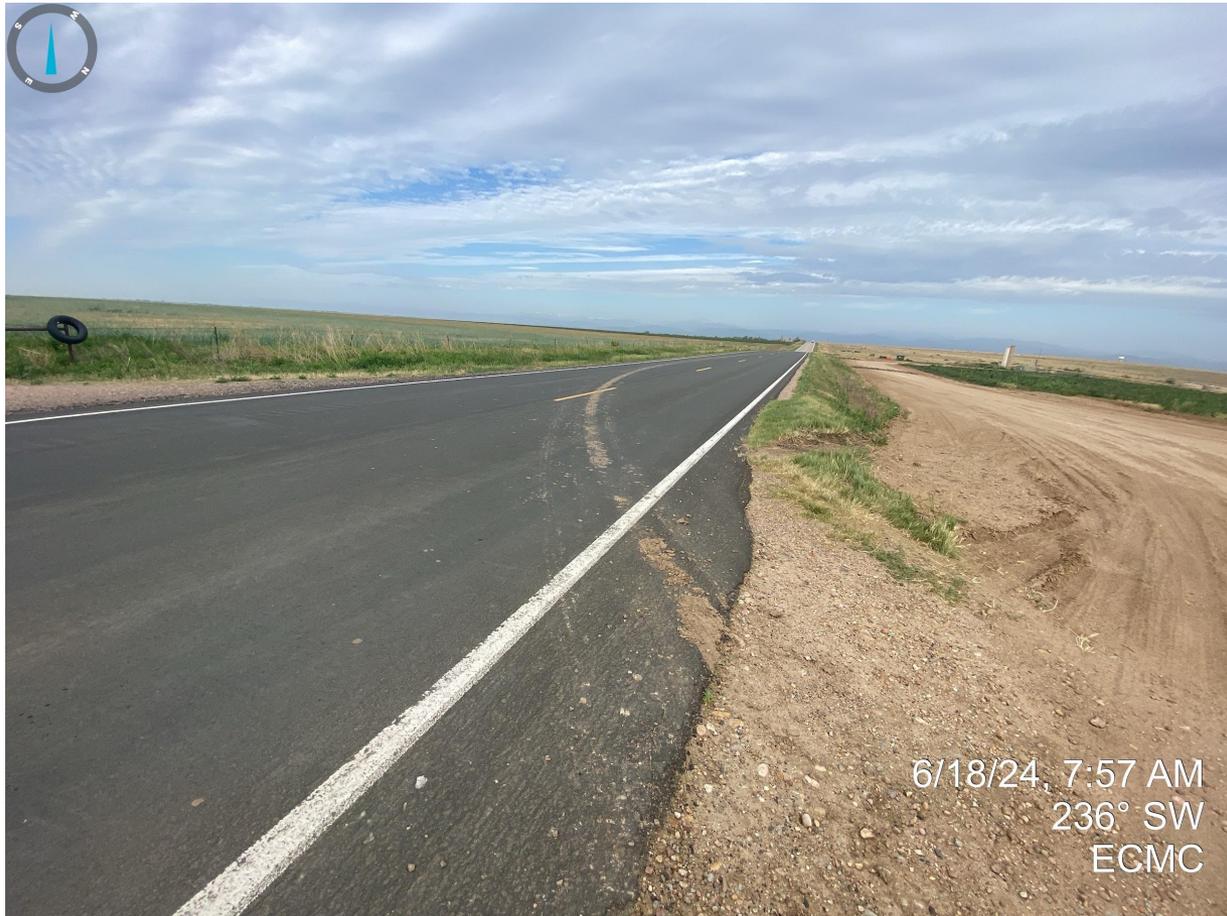
Photo 3. Vehicle track out onto westbound WCR 54.

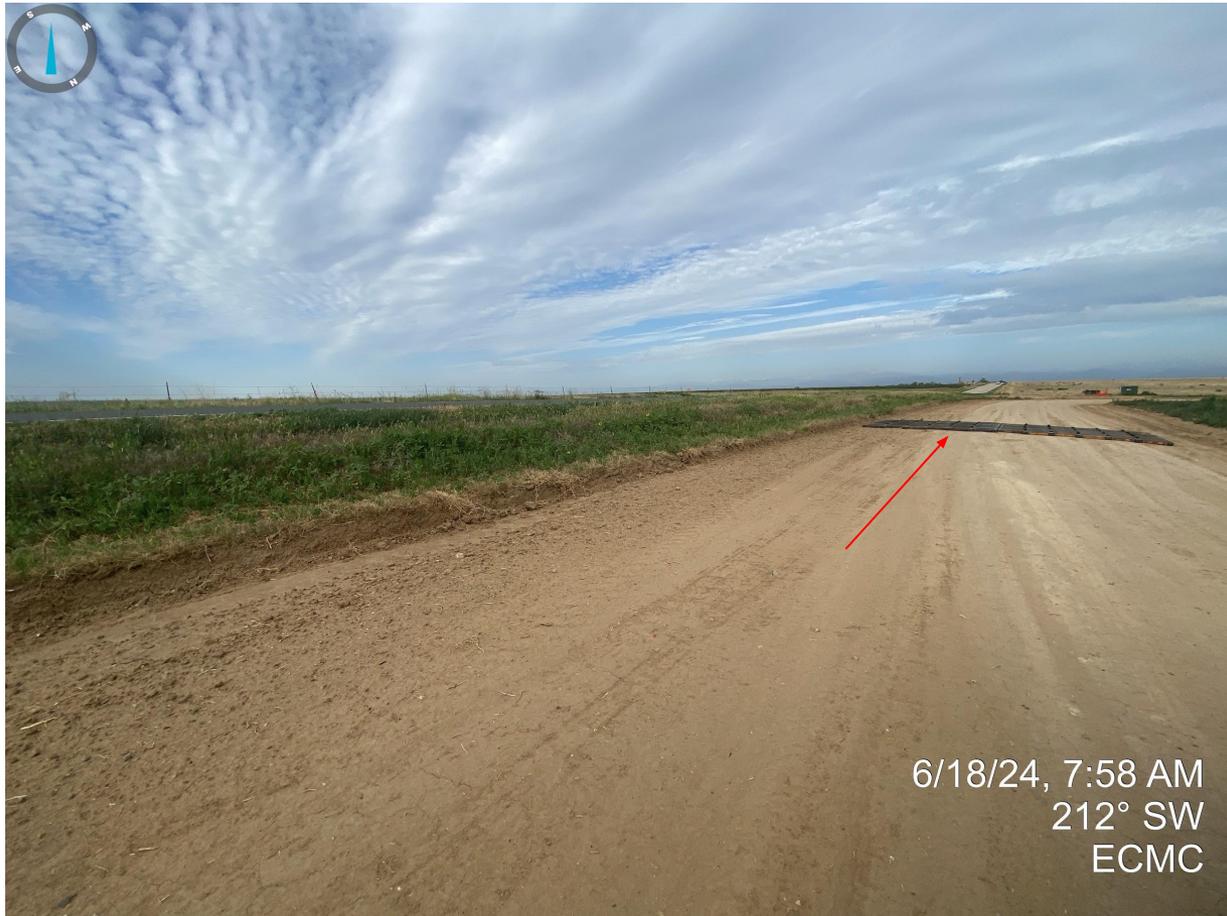
Photo 4. Taken near the locations access road; track out pad indicated by red arrow.

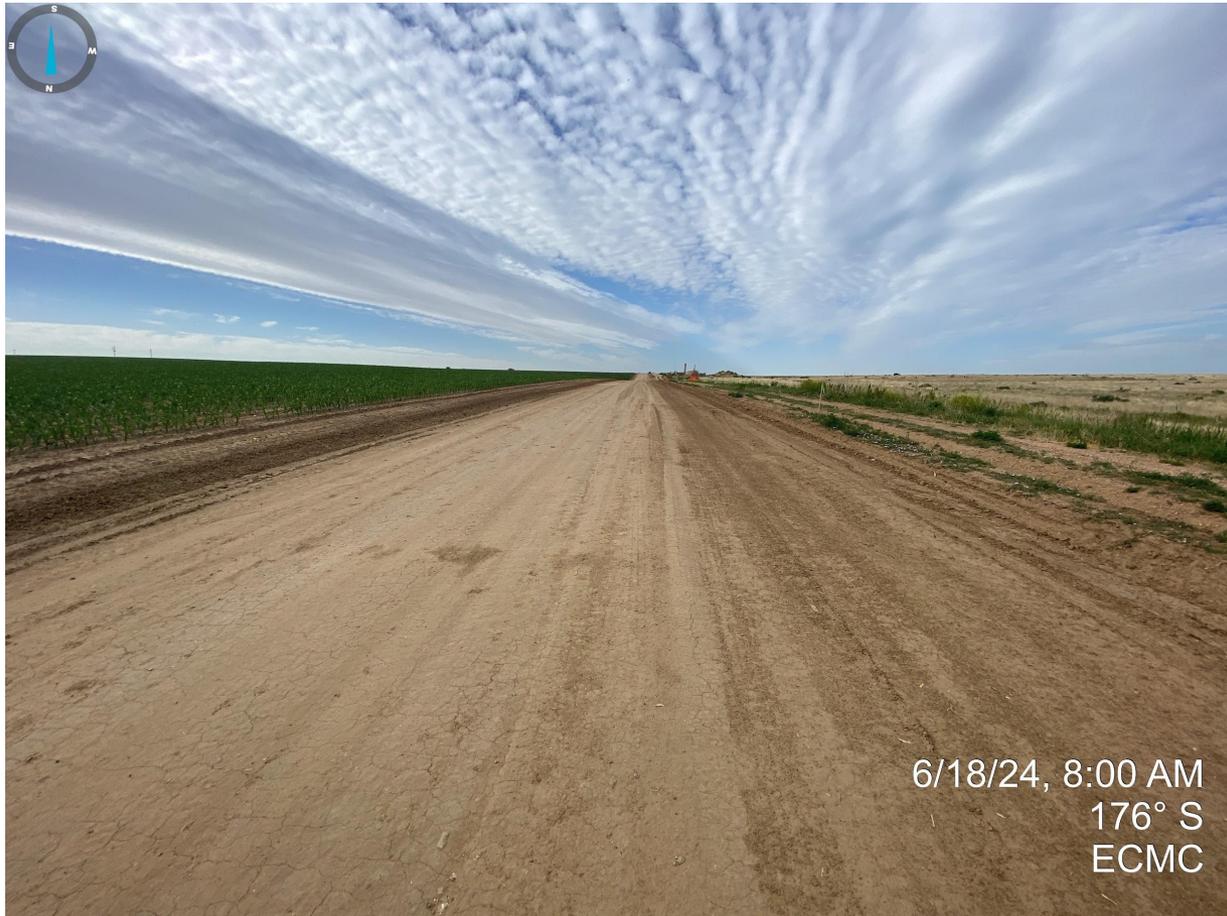
Photo 5. Facing south along the access road, south of the construction area. It appears that topsoil has been salvaged from the new access road.

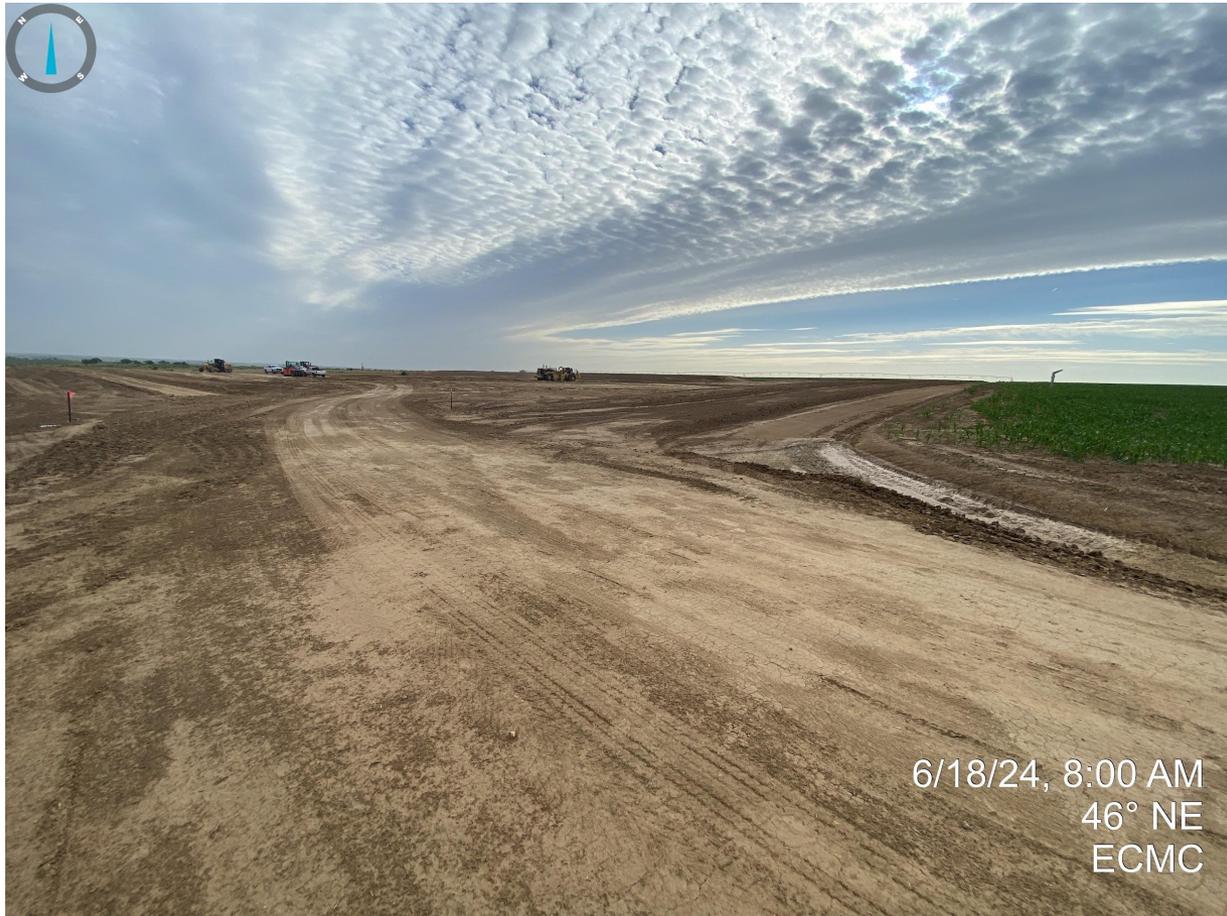
Photo 6. Southwest corner of the construction area.

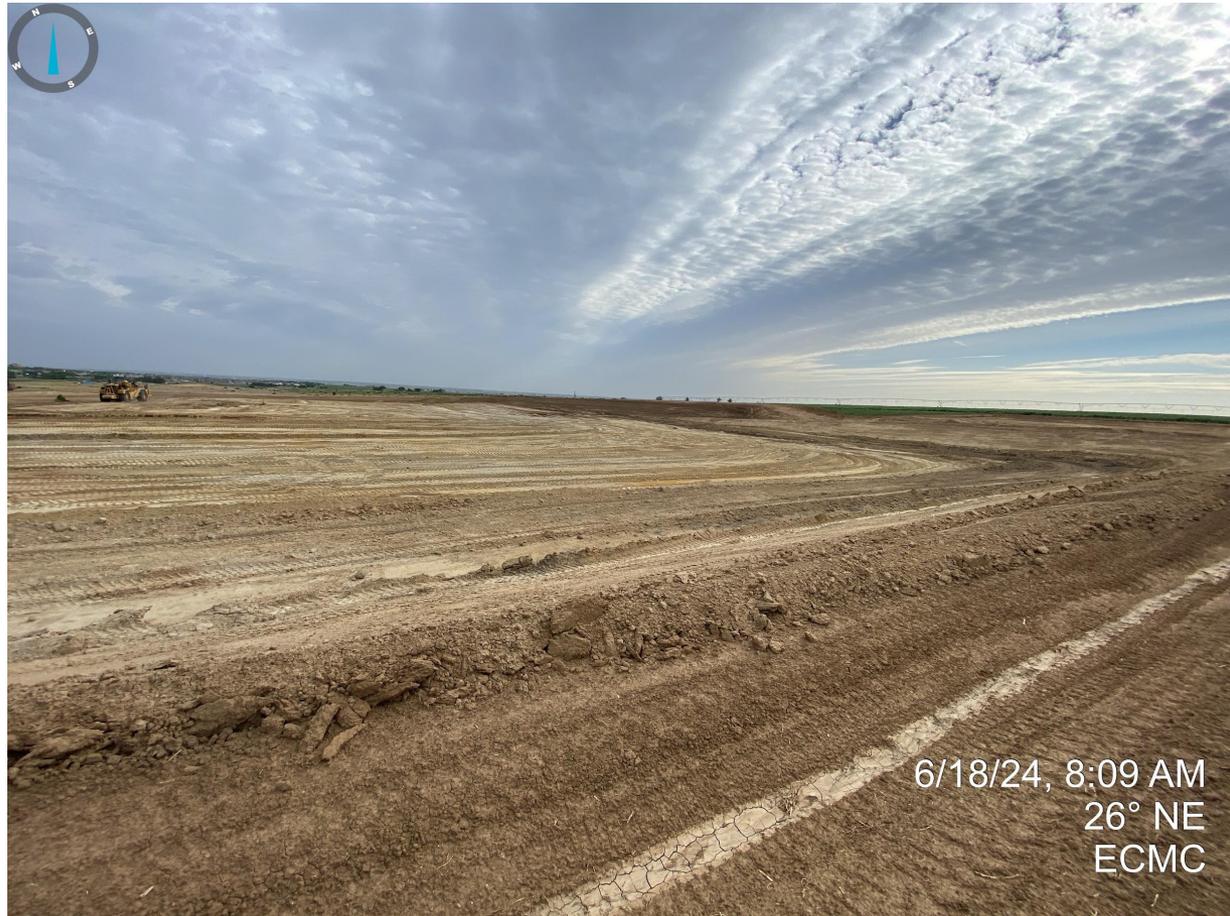
Photo 8. Facing northeast from the southern portion of the construction area. Cut and fill operations were ongoing at the time of this inspection.

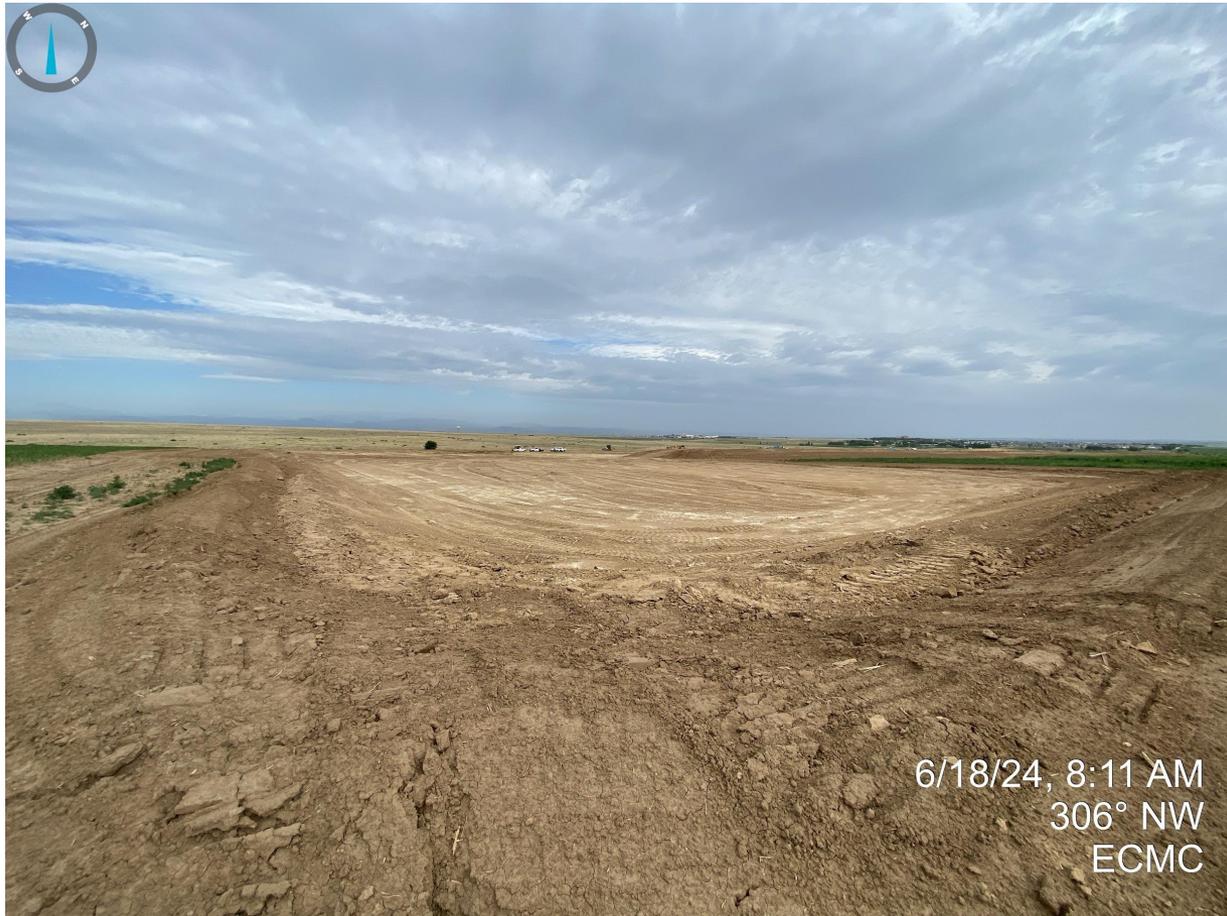
Photo 8. Taken from the southeast corner near the MLVT area. Perimeter stormwater control measures (ditch and berm) have been installed.

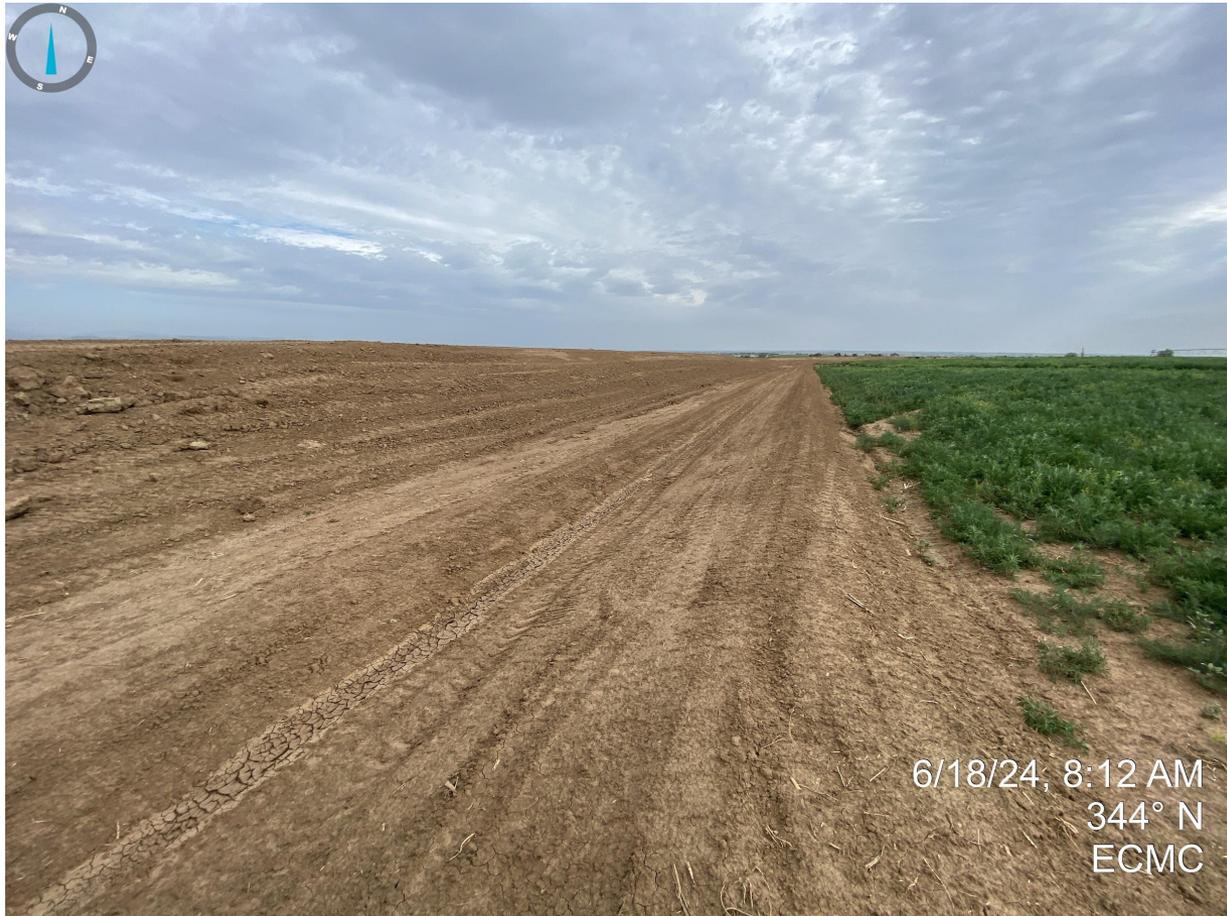
Photo 9. Taken from the east side of the construction area, facing north. Photo illustrates perimeter stormwater control measures (ditch and berm) and the topsoil stockpile area.

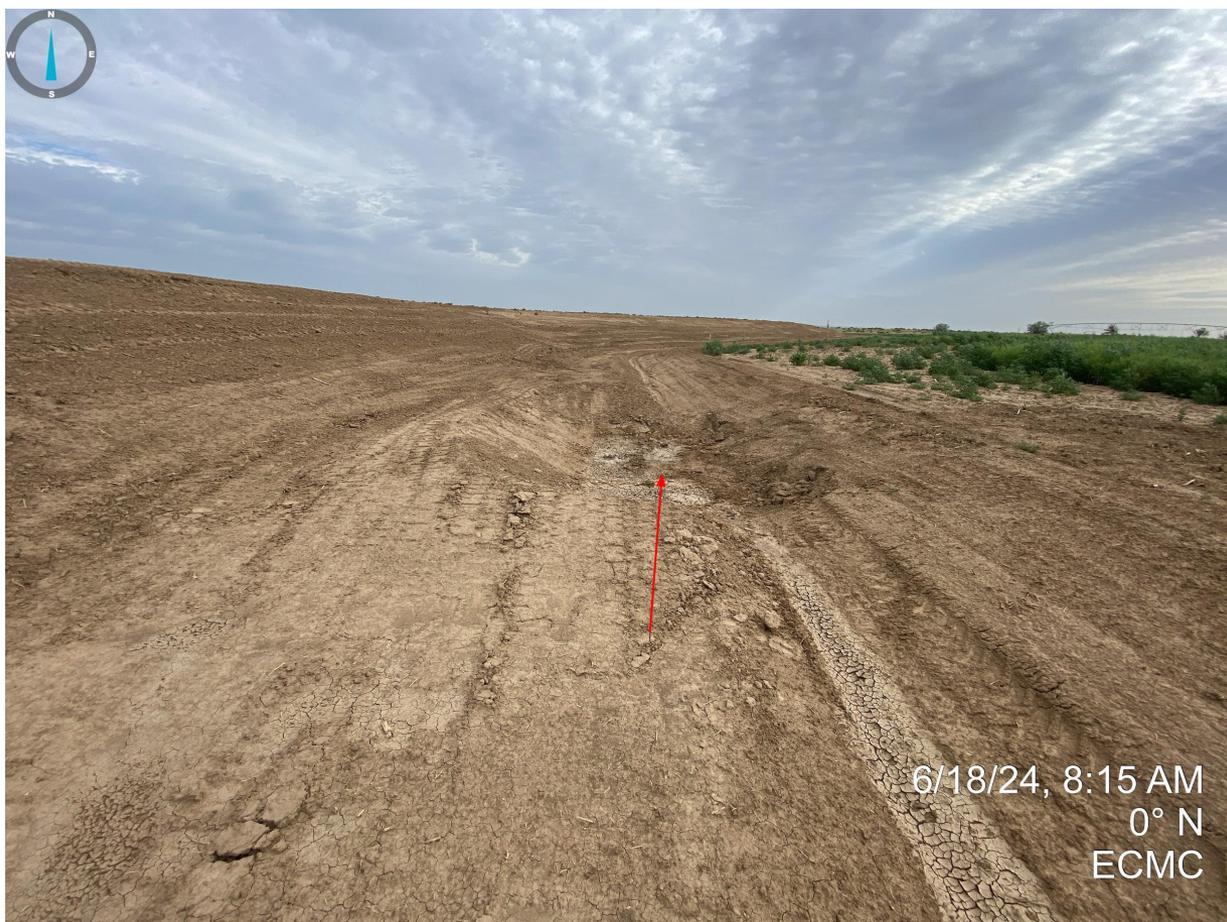
Photo 10. East side of construction area, facing north. Photo illustrates sediment trap that appears to be under construction.

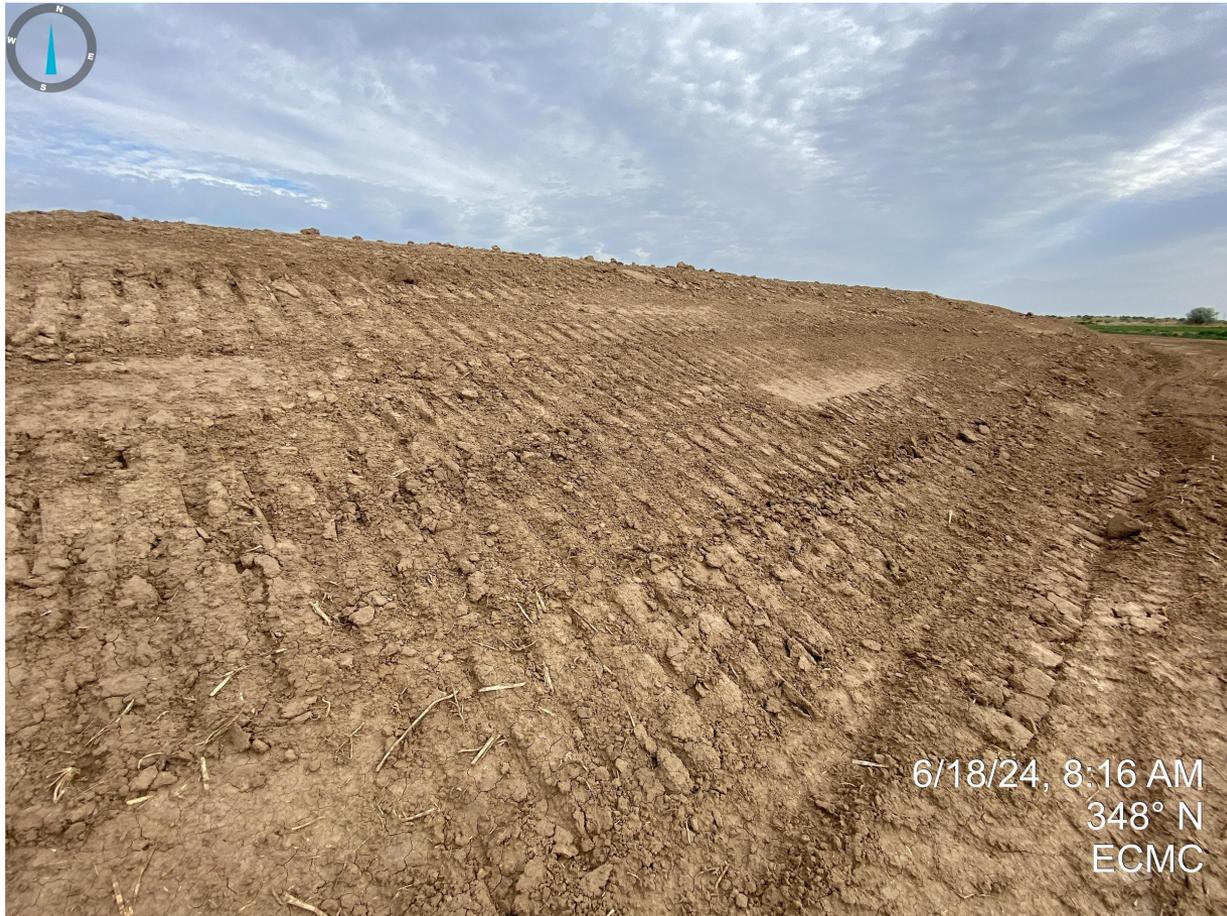
Photo 11. Eastside of construction area, facing north. Topsoil stockpile has been temporarily stabilized with equipment tracking, however, it has been installed parallel to grade. Long term stabilization techniques should be implemented (e.g. seeding).

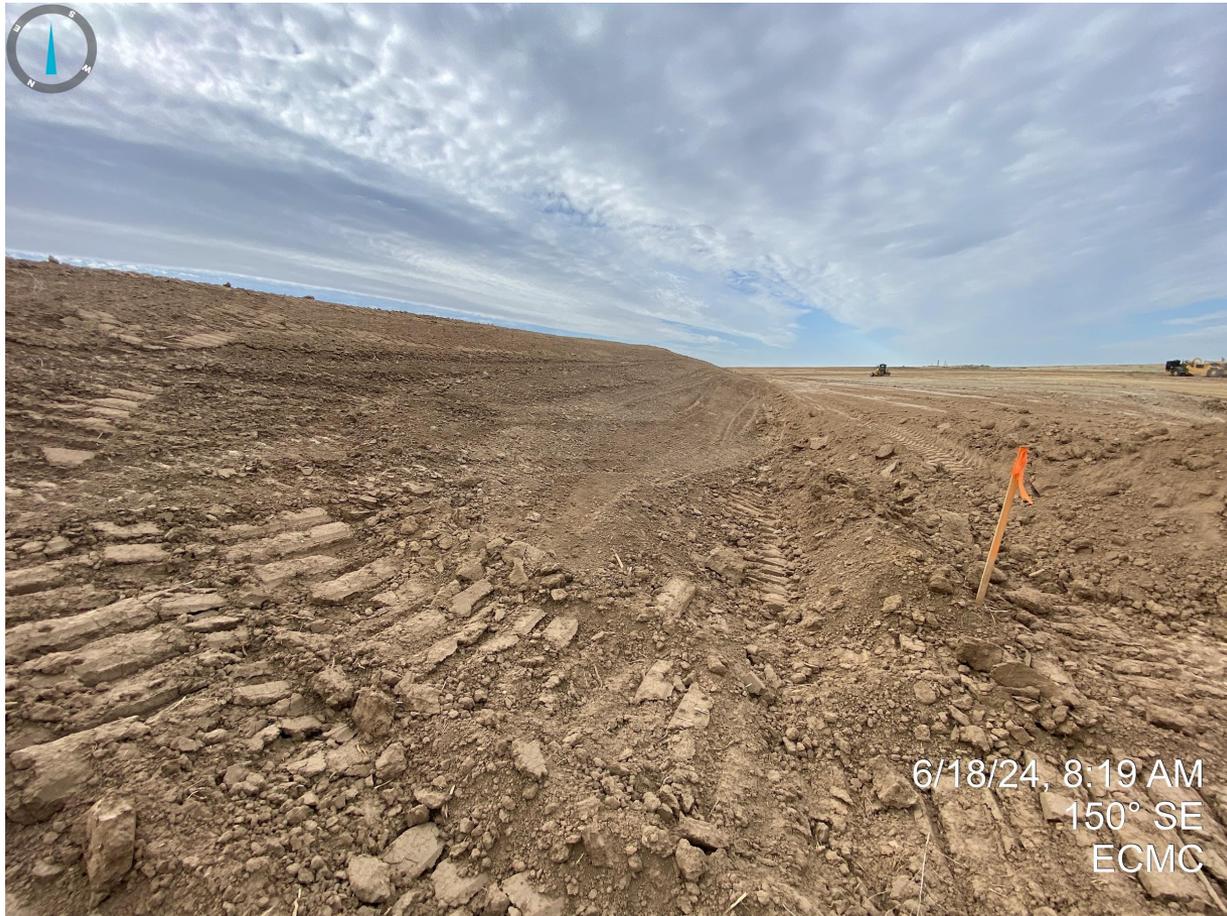
Photo 12. Northwest side of topsoil stockpile; see comments in Photo 11.

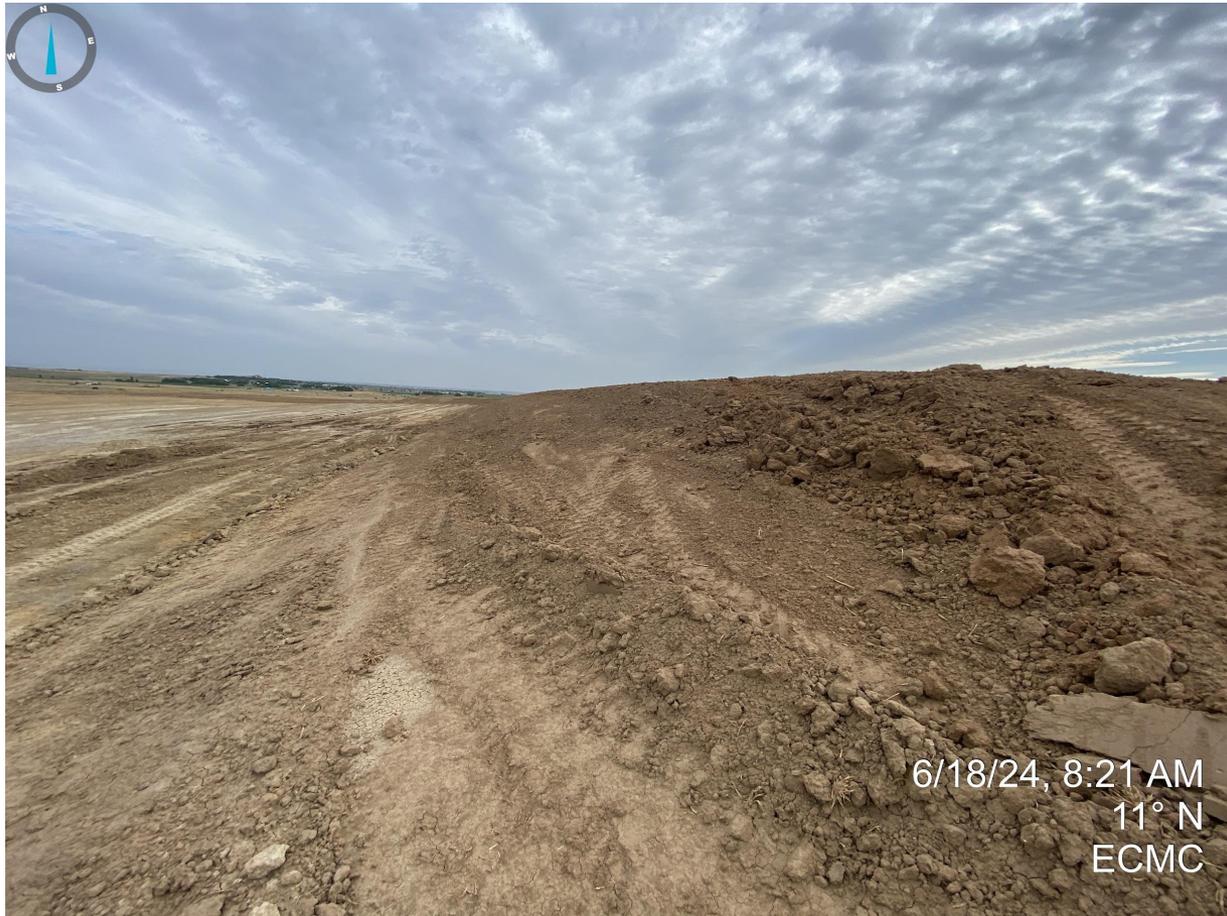
Photo 13. Southwest side of topsoil stockpile; see comments in Photo 11.

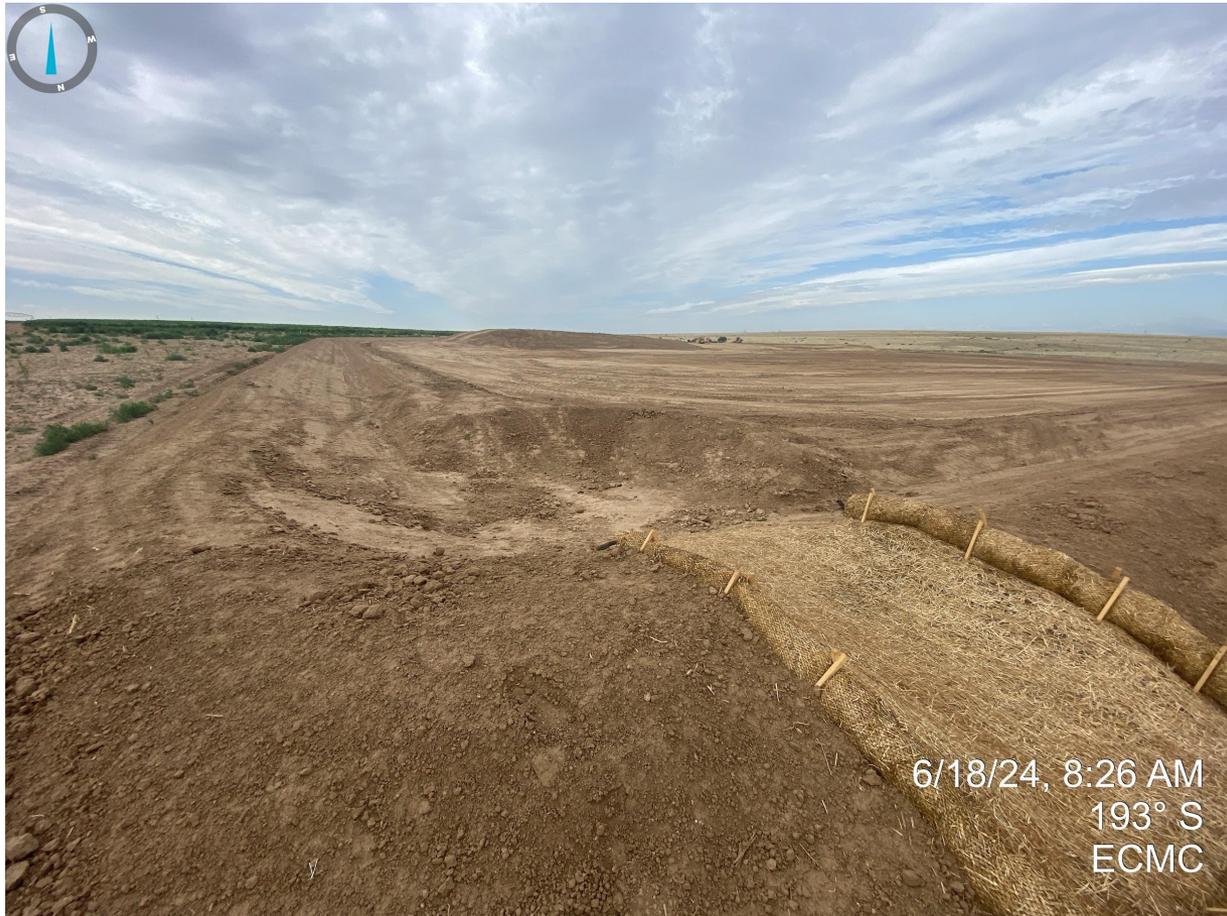
Photo 14. Northeast corner of the construction area; photo illustrates perimeter stormwater control measures (ditch and berm) have been installed around the entire location and sediment trap with temporarily stabilized outlet protection.

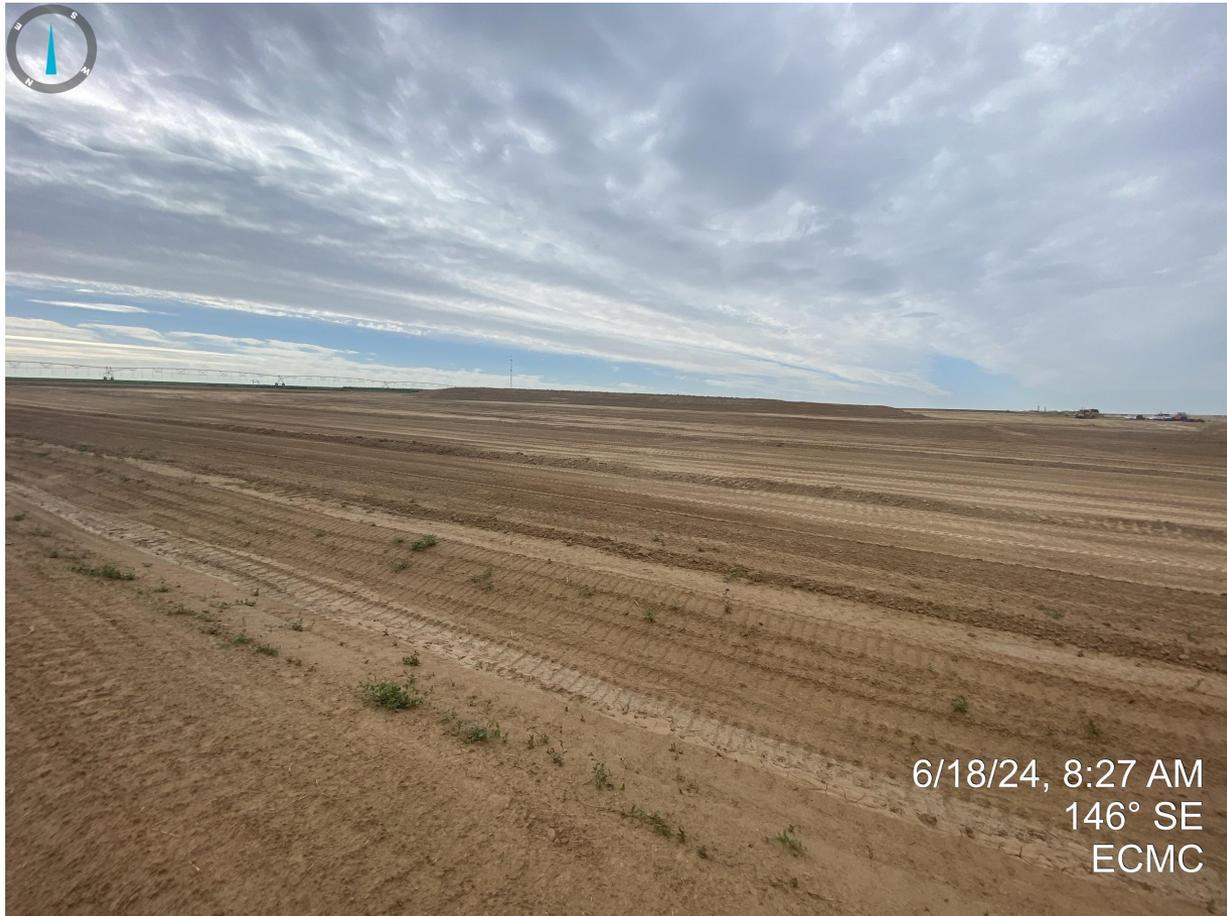
Photo 15. Facing southeast from the northern portion of the construction area. Cut and fill operations were ongoing at the time of this inspection.

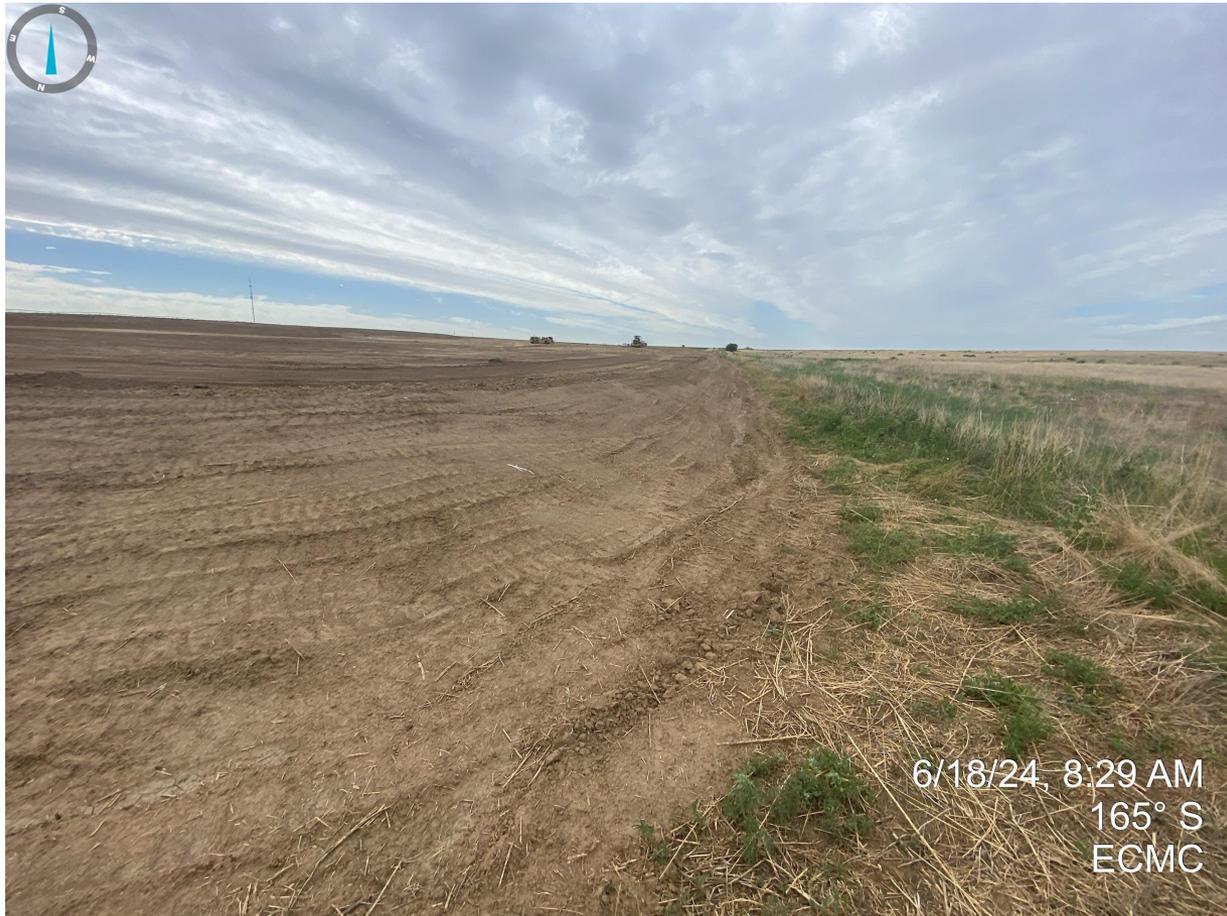
Photo 16. Northwest corner of the construction area; photo illustrates perimeter stormwater control measures (ditch and berm) have been installed around the entire location.

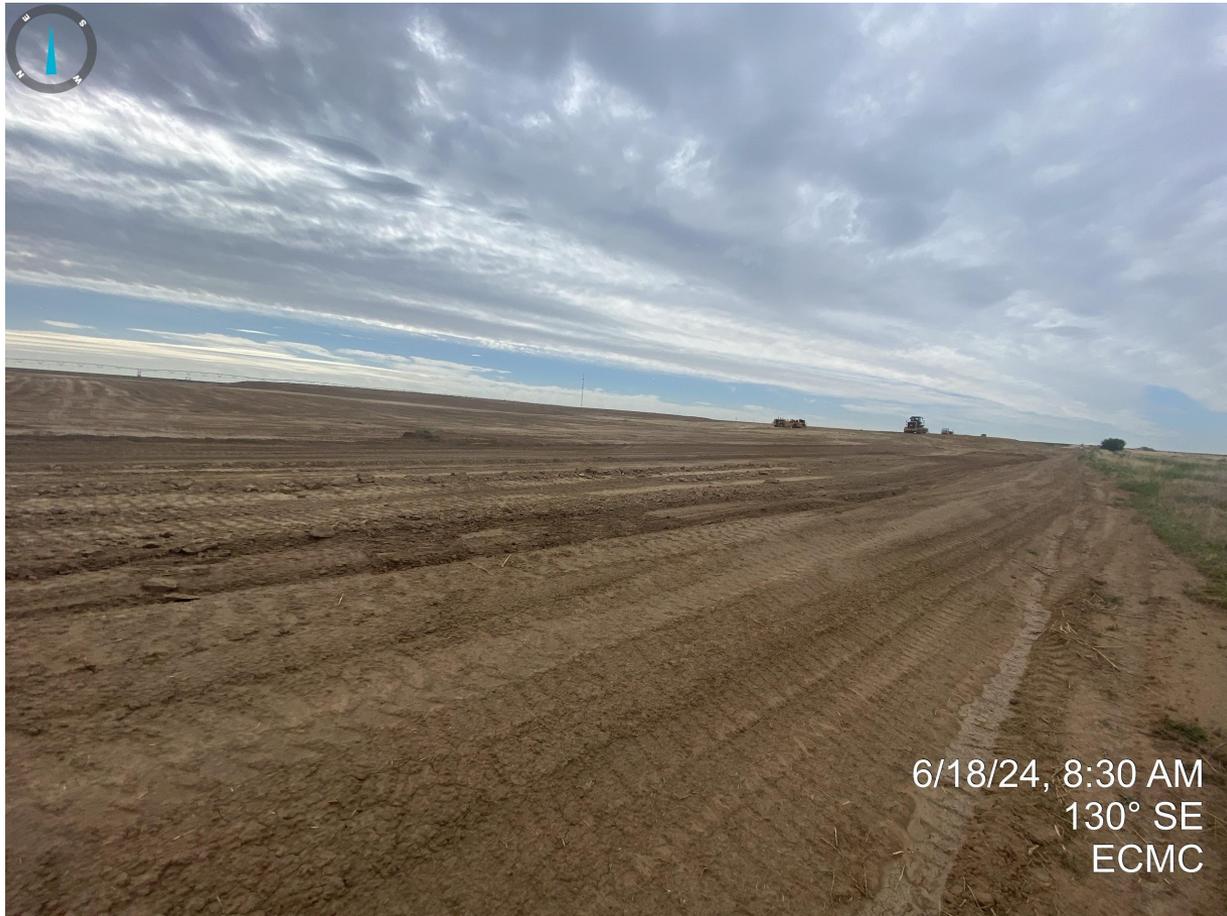
Photo 17. Facing southeast towards the future stormwater detention basin area, which is still being constructed at the time of this inspection.

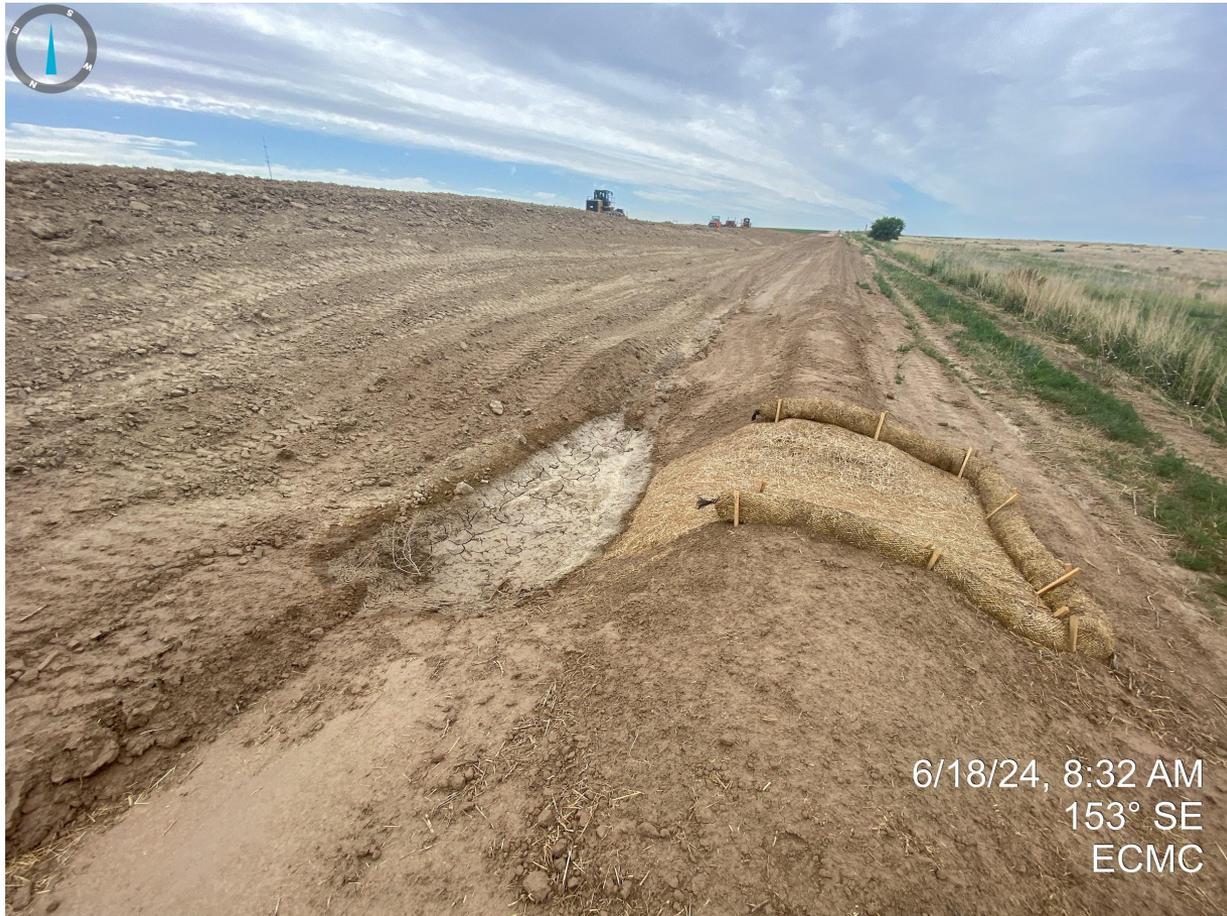
Photo 18. Ditch and berm with a sediment trap located on the west side of the location.
