Inspection Photos

Location Name: TEP ROCKY MOUNTAIN LLC MOBILE 11-20 Pad

Location #: 322510

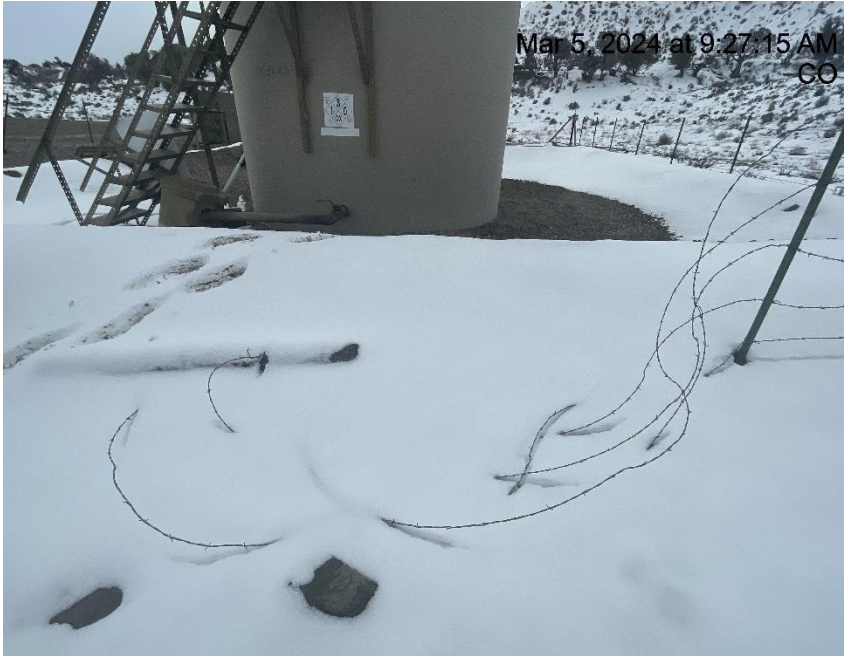
Photo # 8201 From inspection 708903205 conducted on 03/05/2024 Barbed wire fence needs maintenance/barbed wire laying on ground/wildlife hazard

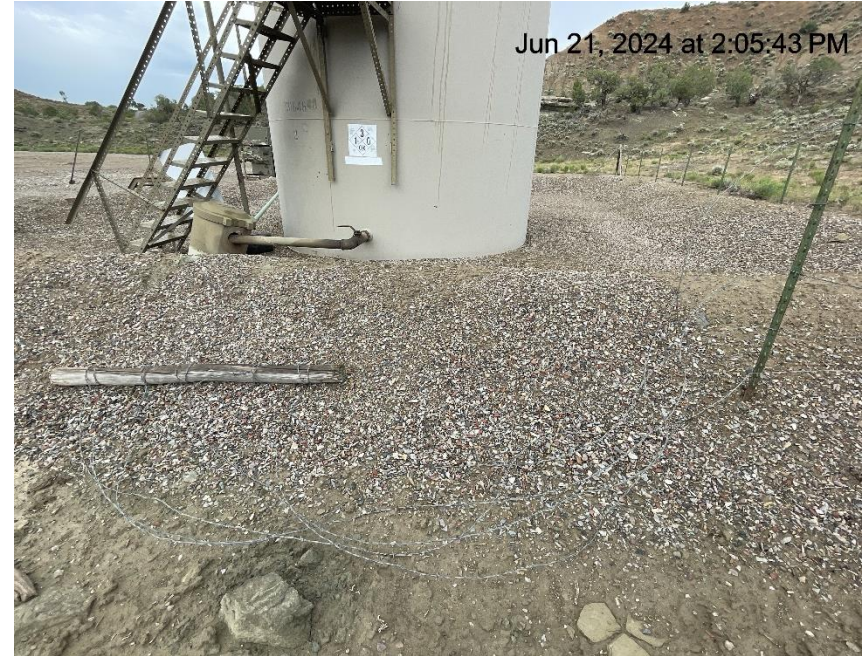
Photo # 1125 Barbed wire fence needs maintenance/barbed wire laying on ground/wildlife hazard

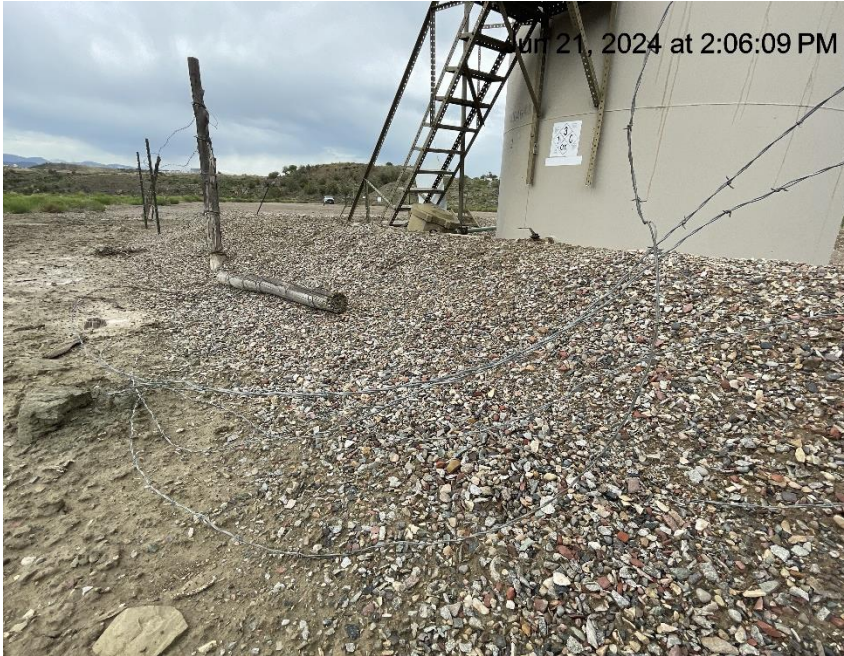
Photo # 1126 Barbed wire fence needs maintenance/barbed wire laying on ground/wildlife hazard

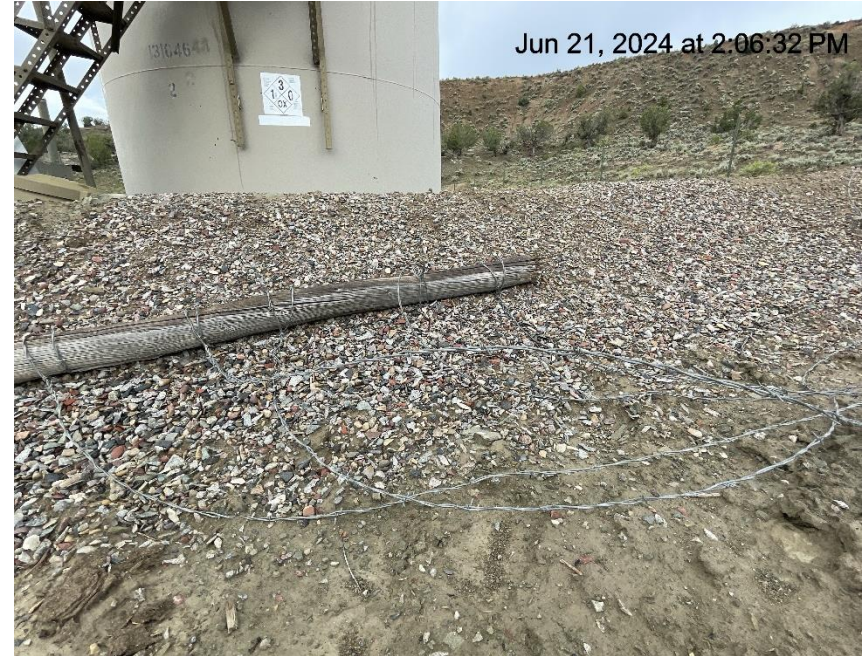
Photo # 1127 Barbed wire fence needs maintenance/barbed wire laying on ground/wildlife hazard

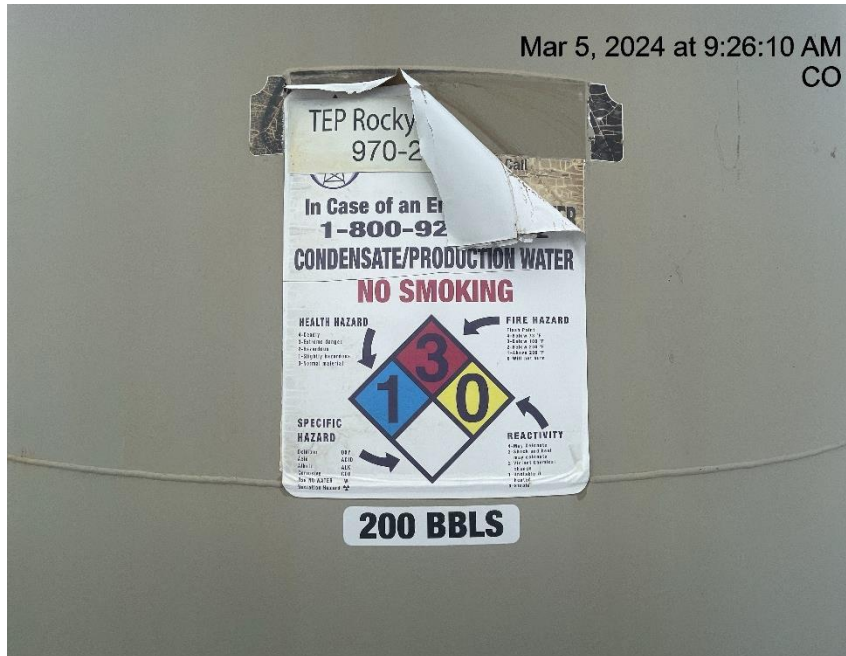
Photo # 8198 From inspection 708903205 conducted on 03/05/2024 Tank label losing adhesion & some required info is not visible

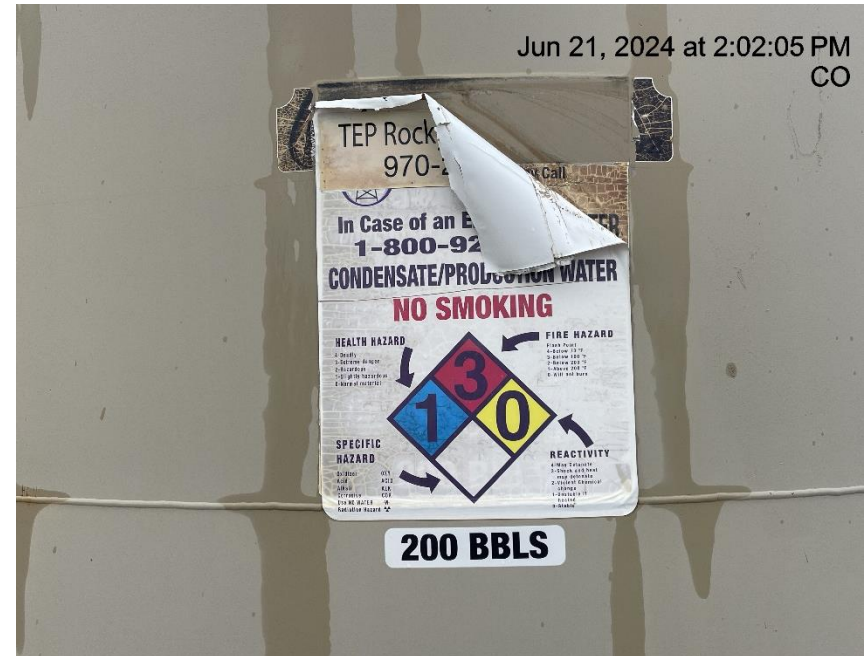
Photo # 1128 Tank label losing adhesion & some required info is not visible

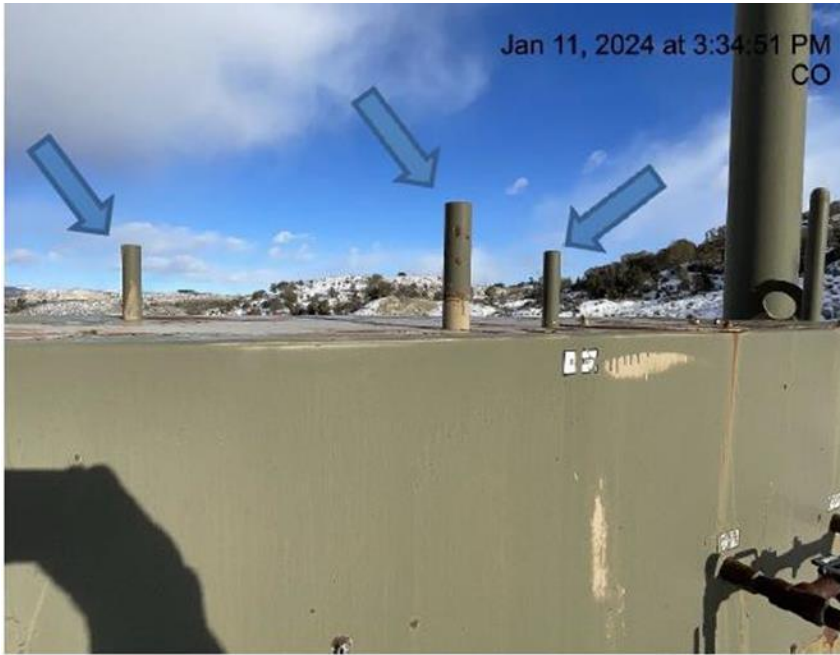
Photo # 2673 From inspection 708902787 conducted on 01/11/2024 PRV & rupture disc vent lines lack caps

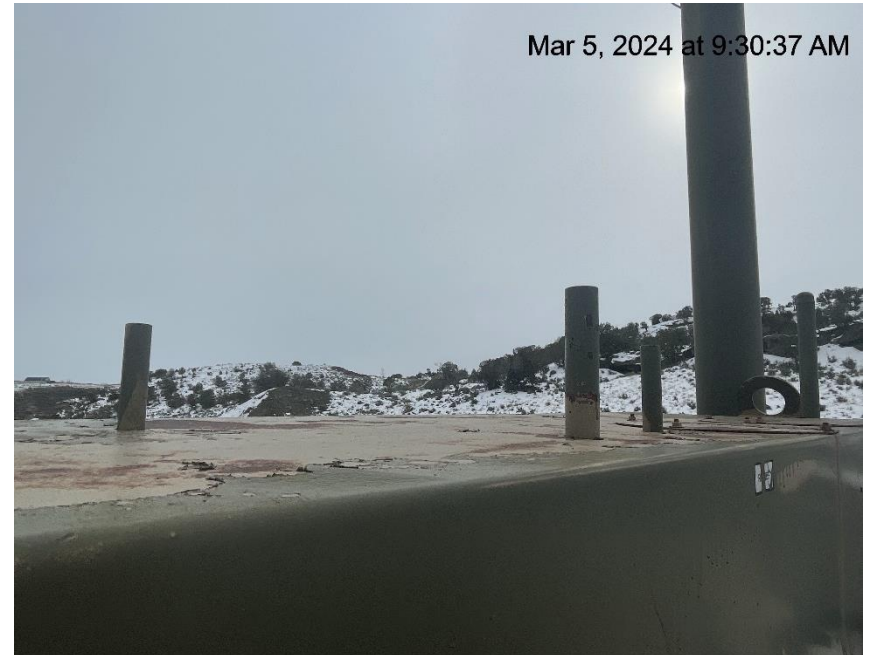
Photo # 8199 From inspection 708903205 conducted on 03/05/2024 PRV & rupture disc vent lines lack caps

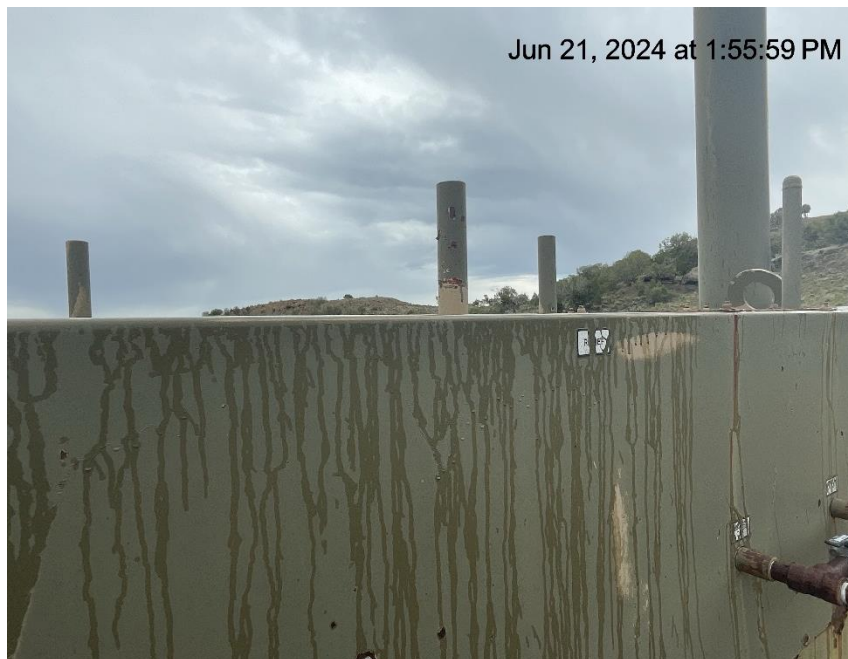
Photo # 1129 PRV & rupture disc vent lines lack caps

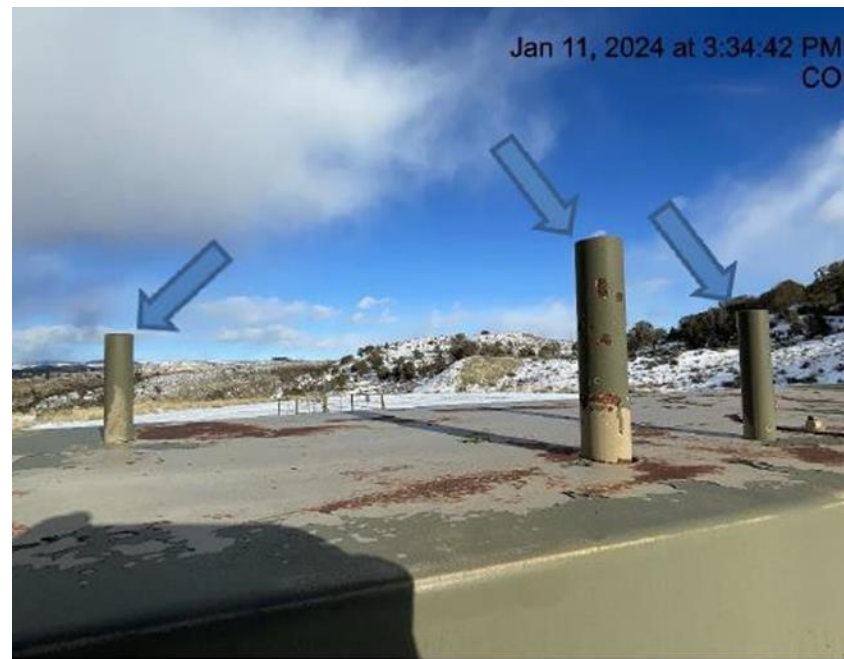
Photo # 2674 From inspection 708902787 conducted on 01/11/2024 PRV & rupture disc vent lines lack caps

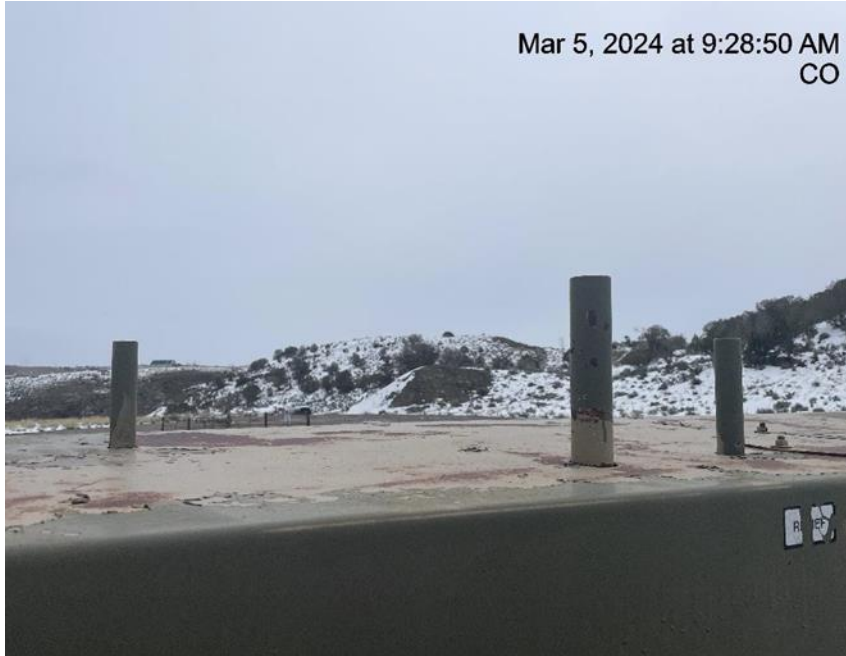
Photo # 8200 From inspection 708903205 conducted on 03/05/2024 PRV & rupture disc vent lines lack caps

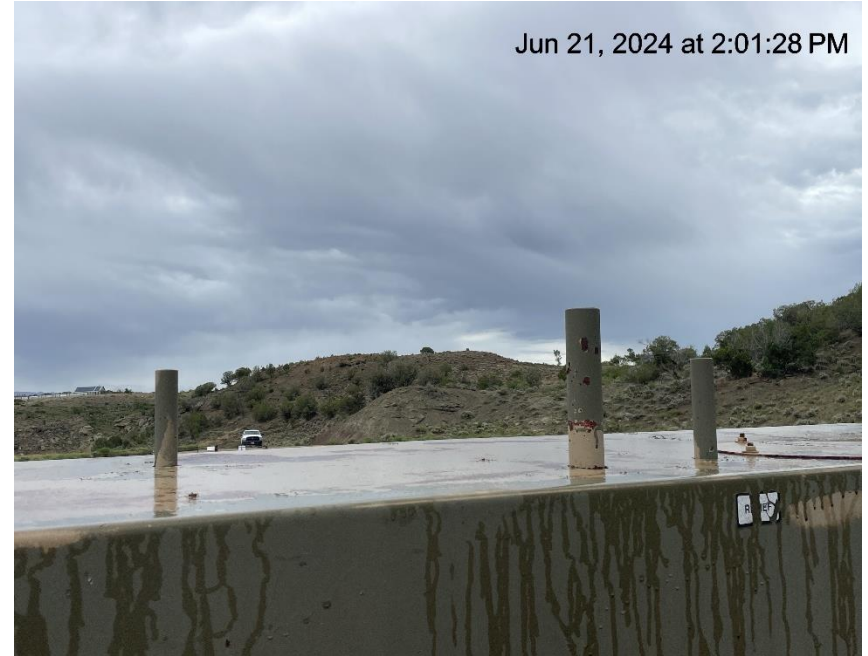
Photo # 1130 PRV & rupture disc vent lines lack caps
