Construction and Stormwater Inspection

Operator: Crestone Peak Resources Operating LLC -
10633

Location ID: 486500

Inspection Photos
Location Name: Lussing Trust 4-64
Location ID: 486500

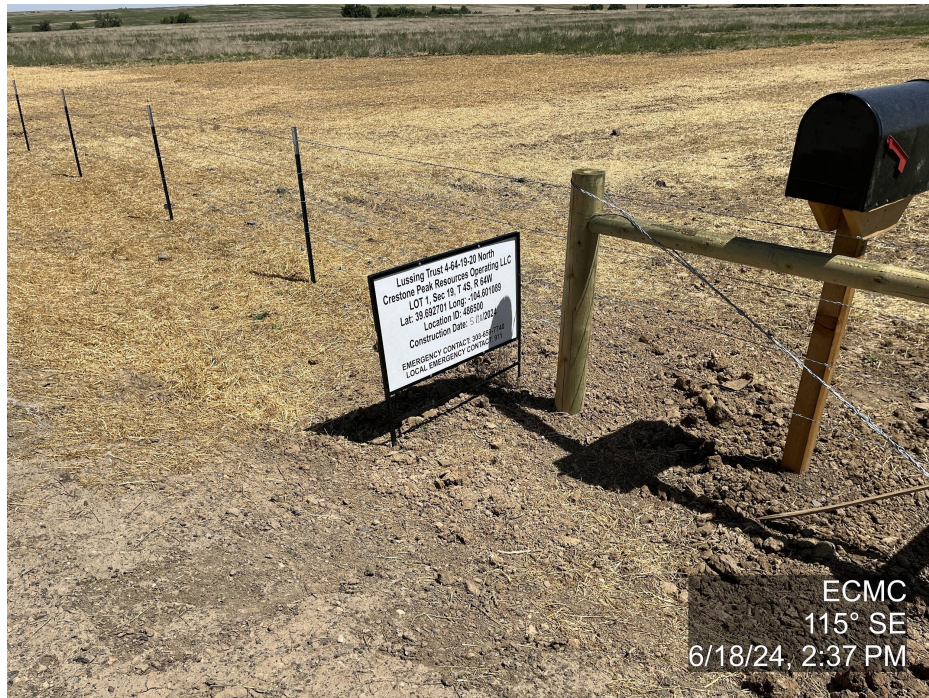
Photo 1. The photo was taken at the entrance to the well location facing Southeast. The photo illustrates the location sign and Form 2A mailbox.

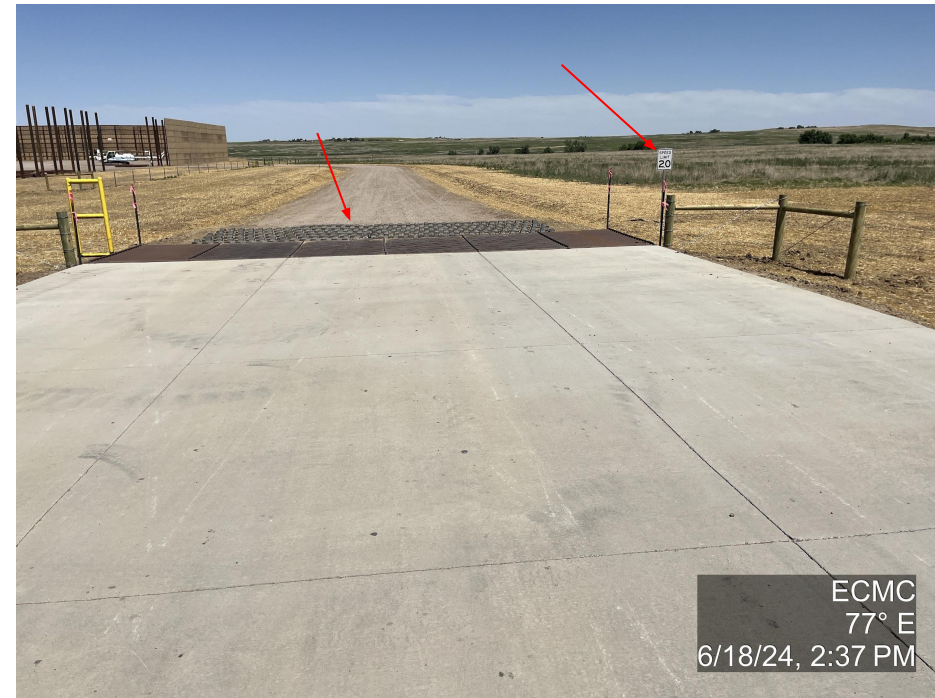
Photo 2. The photo was taken at the entrance to the well location facing East. The photo illustrates the sediment track out device, wind erosion BMP and concrete entrance.

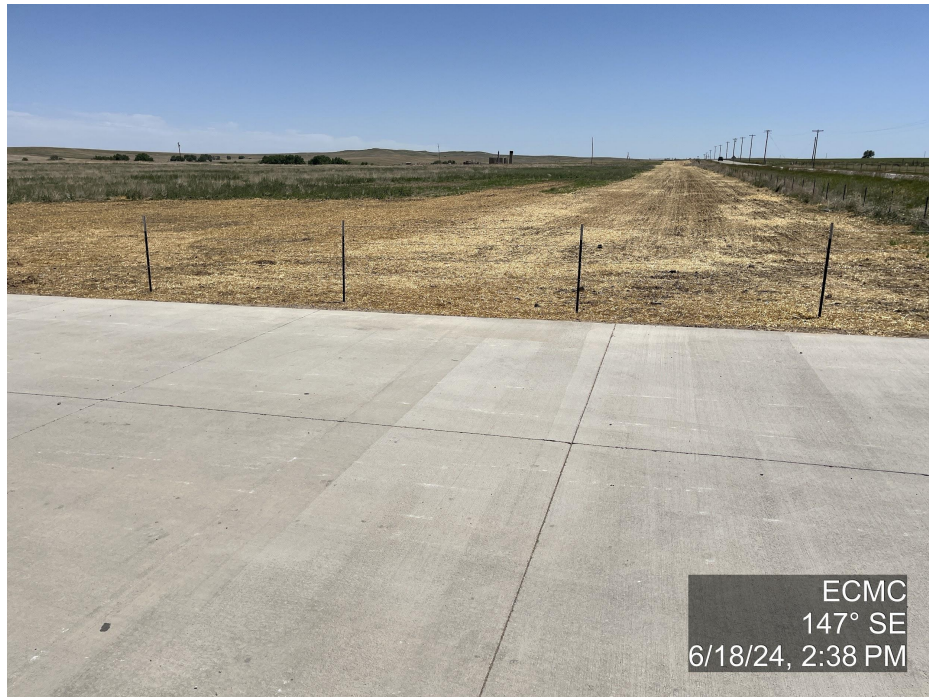
Photo 3. The photo was taken at the entrance to the well location facing Southeast. The photo illustrates the temporary access has been reclaimed.

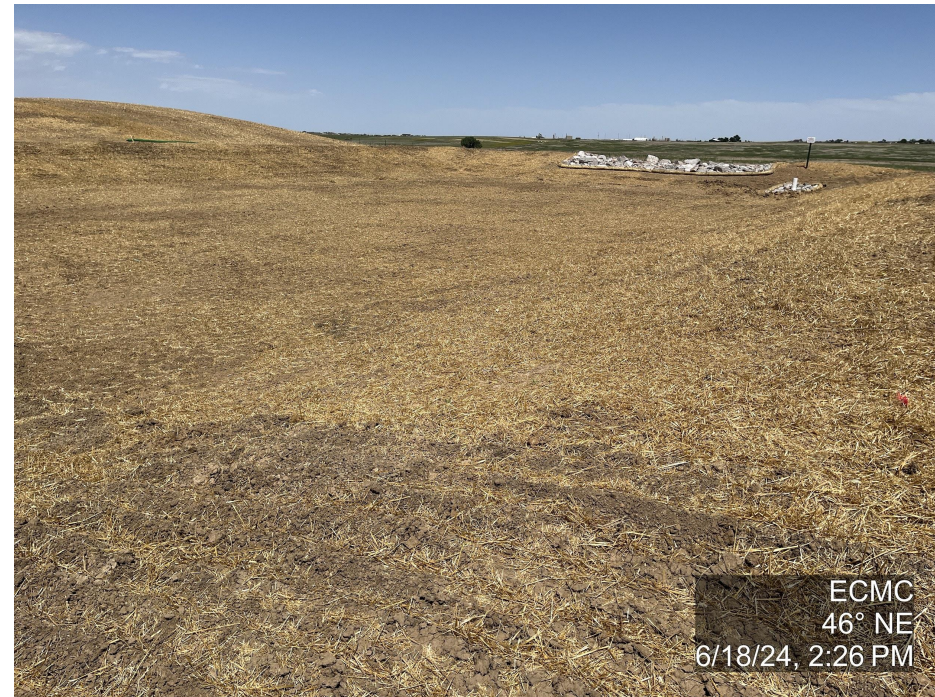
Photo 4. The photo was taken at the well location facing Northeast. The photo illustrates the sediment basin has been crimped and has an armored outlet/spillway per the stormwater plan.

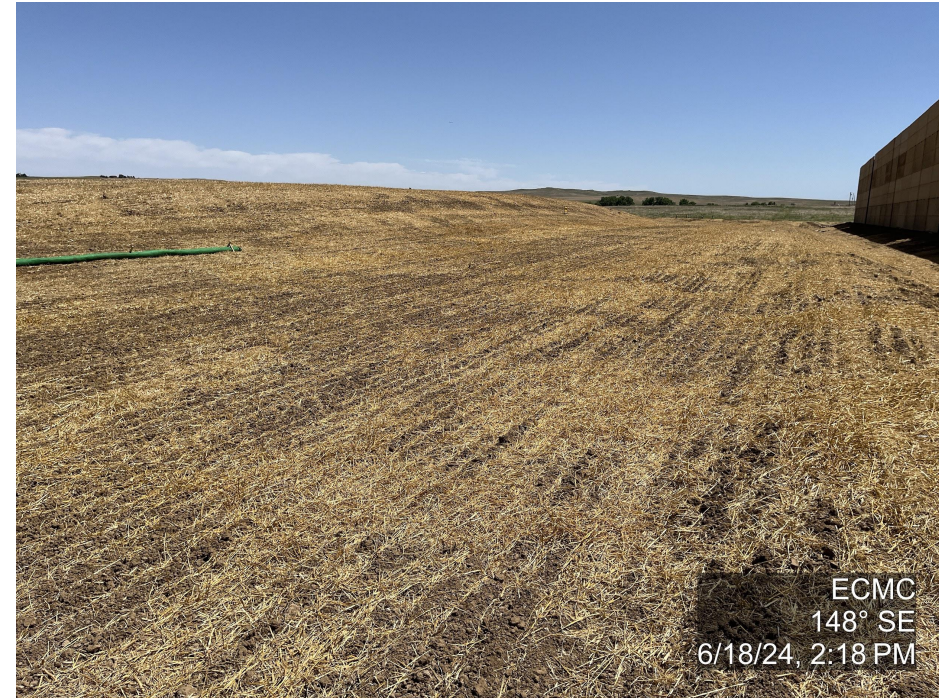
Photo 5. The photo was taken at the well location facing Southwest. The photo illustrates the stormwater ditch around the South and West side of the location has been crimped and culverts have been armored with rip-rap and straw wattles.

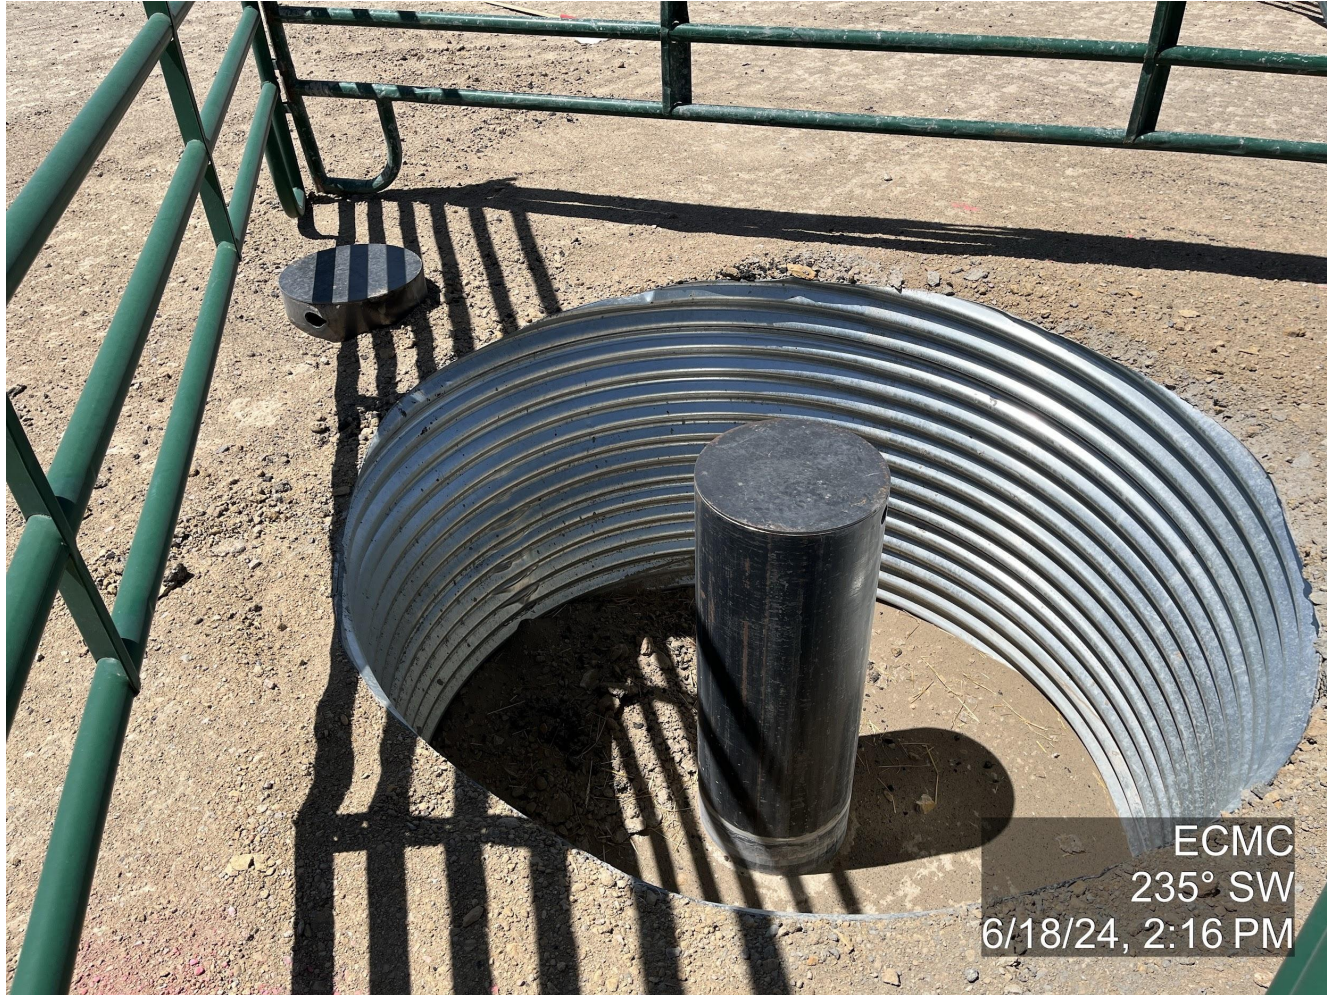
Photo 7. The photo was taken at the well location facing Southwest. The photo illustrates no wildlife protection on surface casings.
