Inspection Photos
Location: UPRR 42 PAN AM E 2 Flowline
Spill ID: 487060

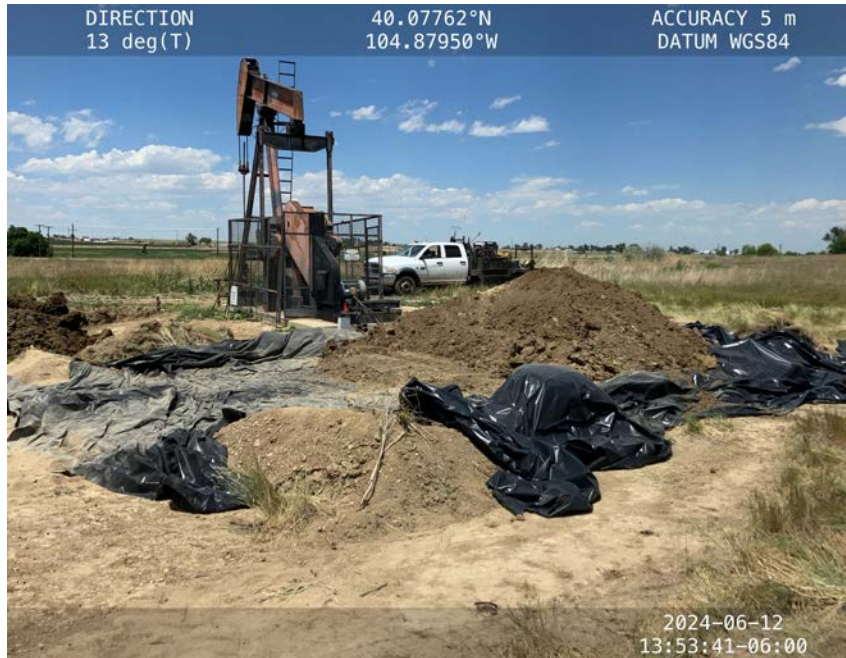
Photo 3 – Stockpile w/ liner

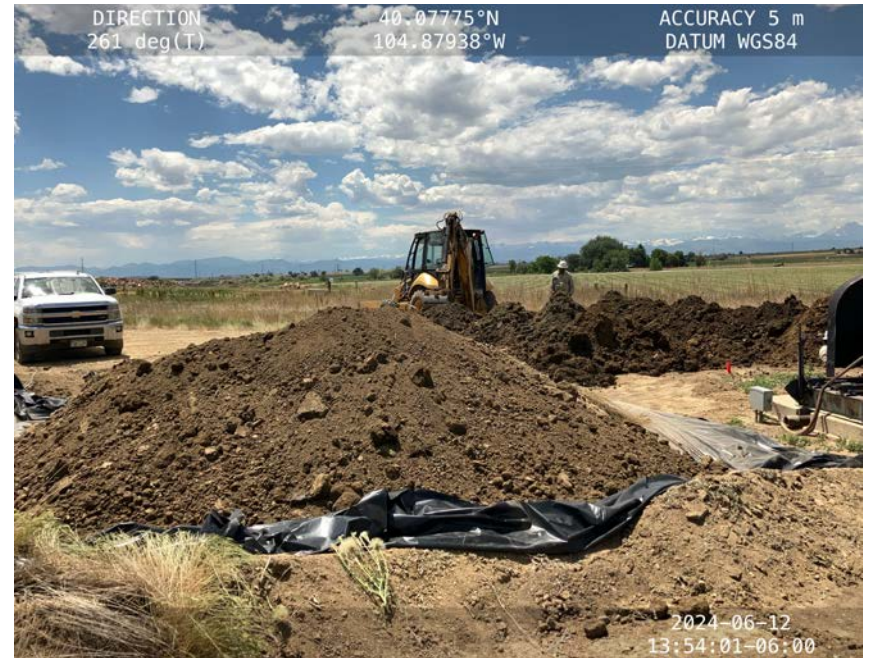
Photo 4 – Stockpile w/ liner

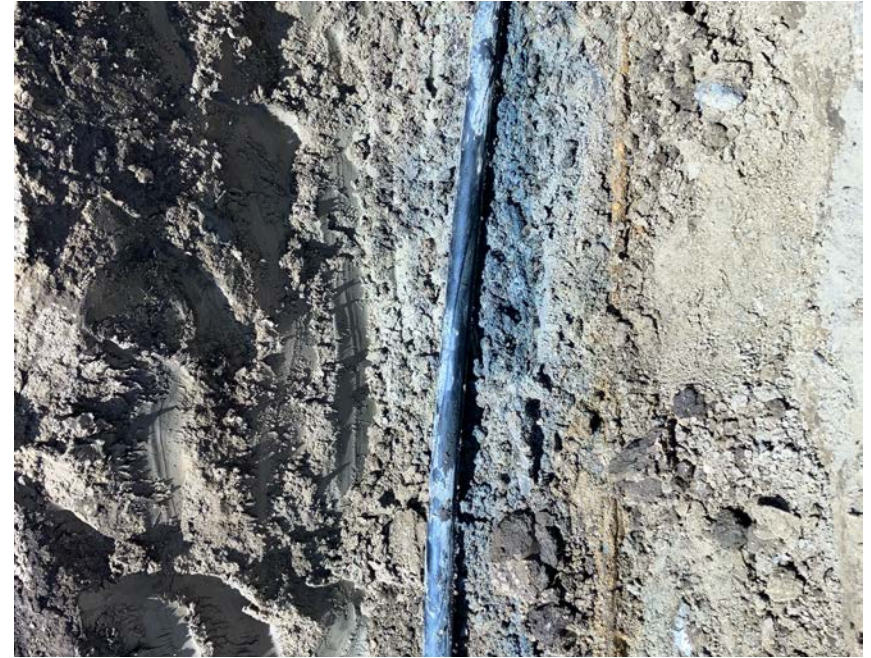
Photo 6 – Stained soil within the excavation

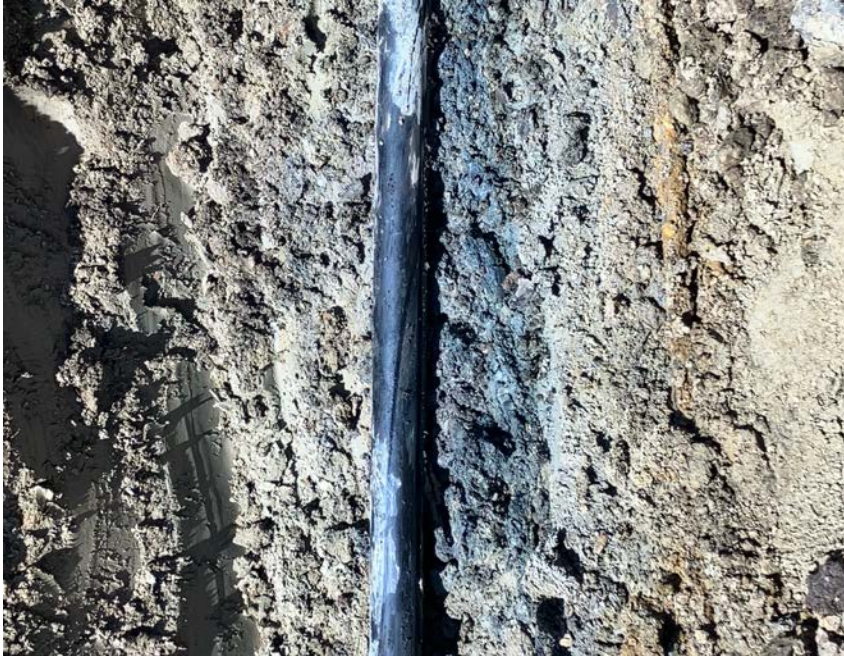
Photo 7 – Stained soil within the excavation

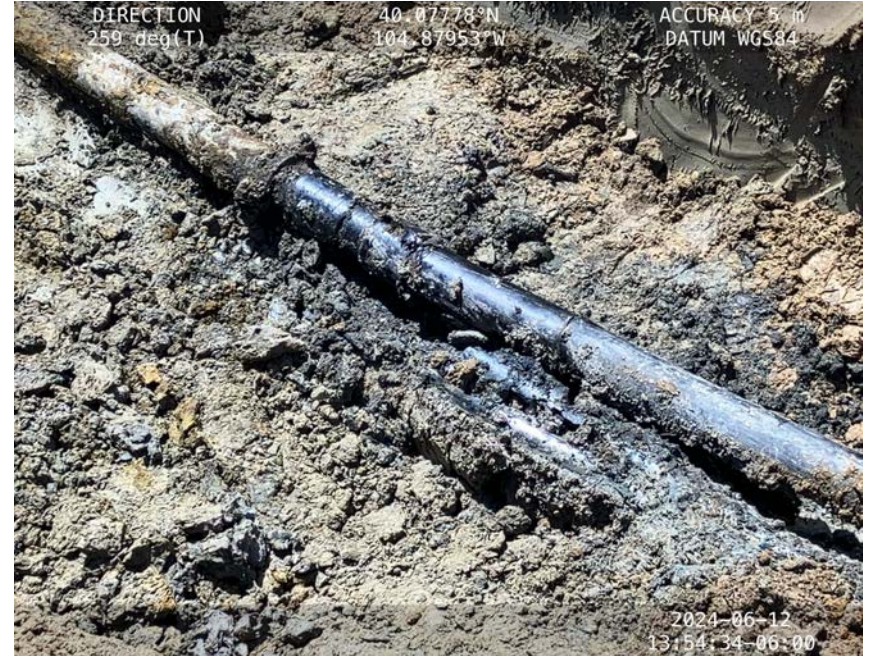
Photo 8 – Release point

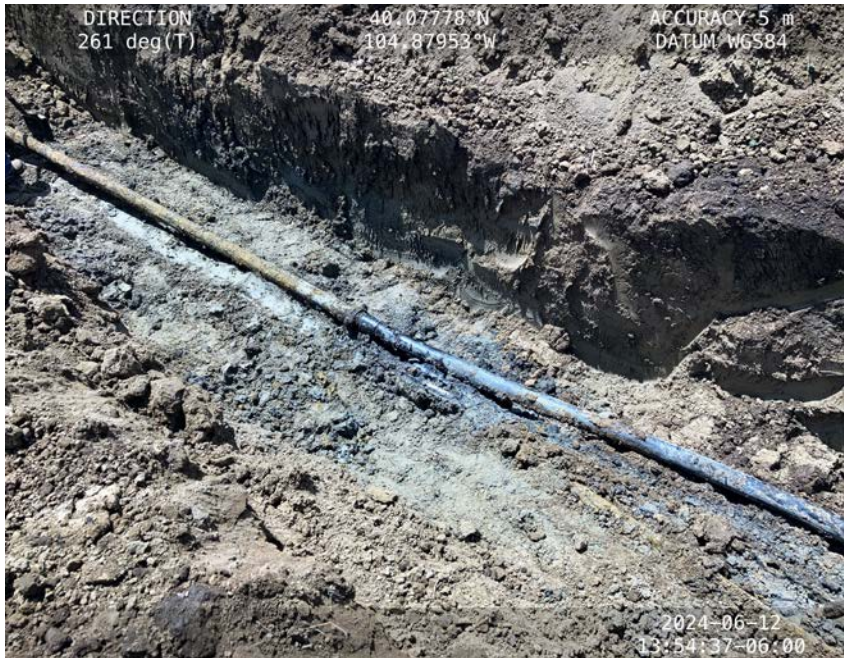
Photo 9 – Stained soil within the excavation.
Release point

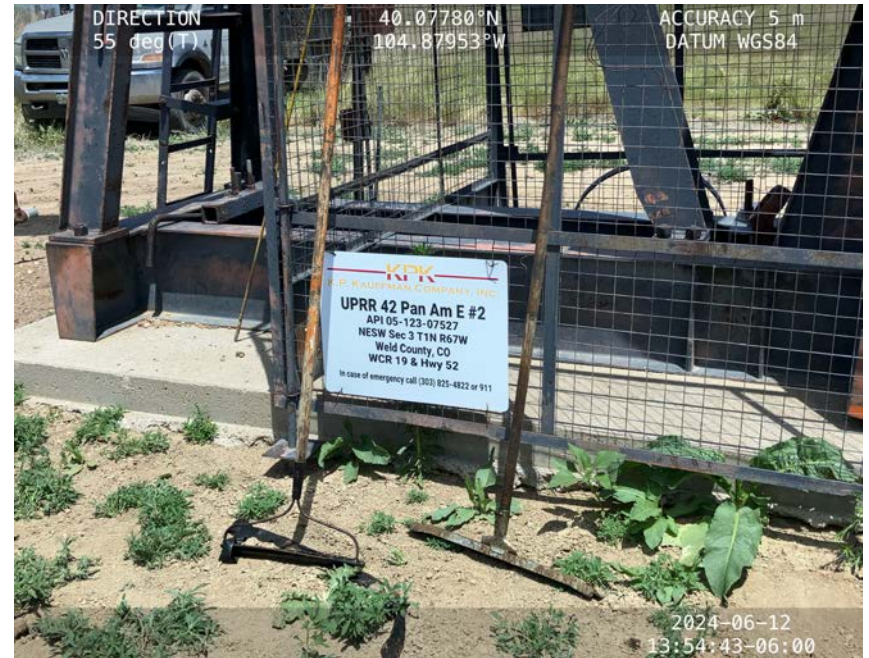
Photo 10 – Wellhead signage
