Inspection Photos

Loc: 484357

Operator: DESERT EAGLE OPERATING LLC

Inspection Date: 6/24/2024

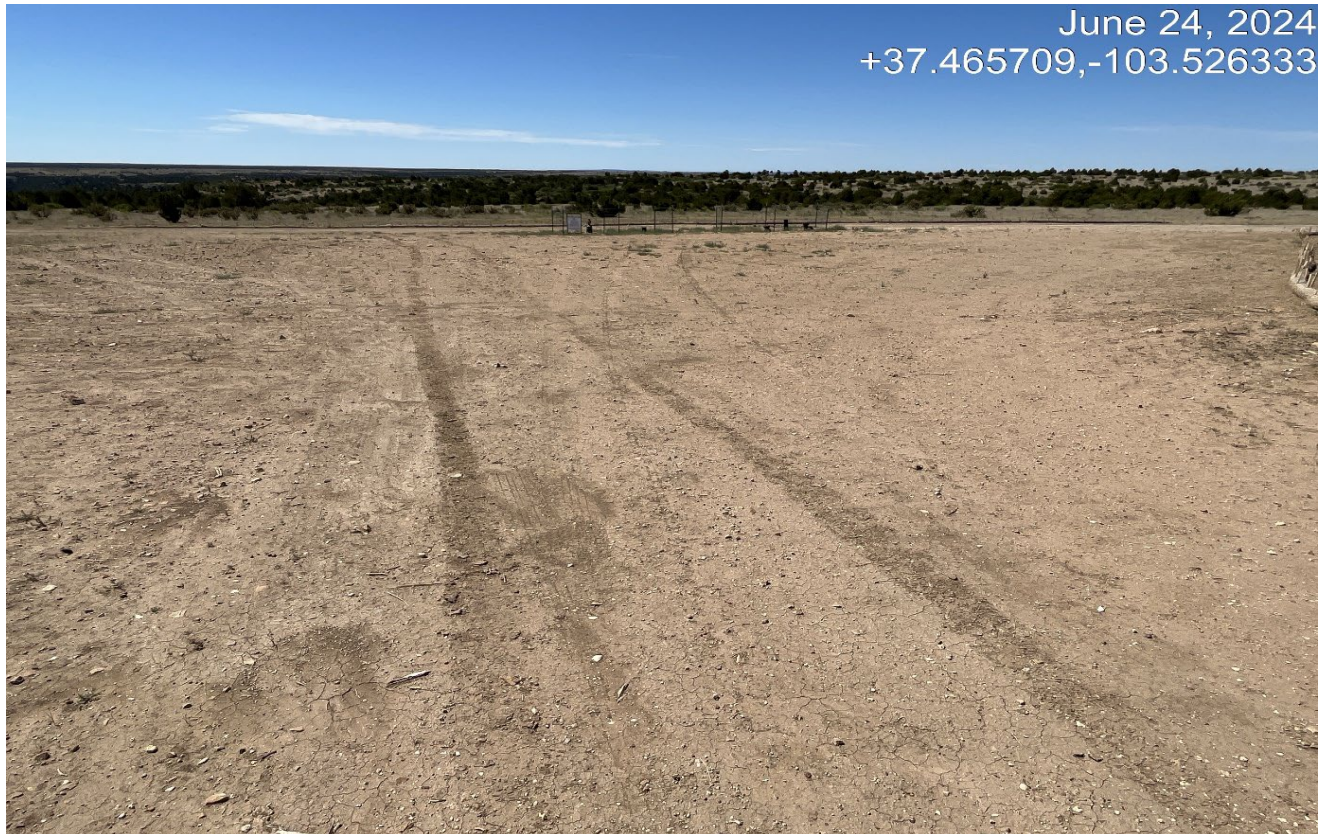
Photo 1. Facing south toward the location.

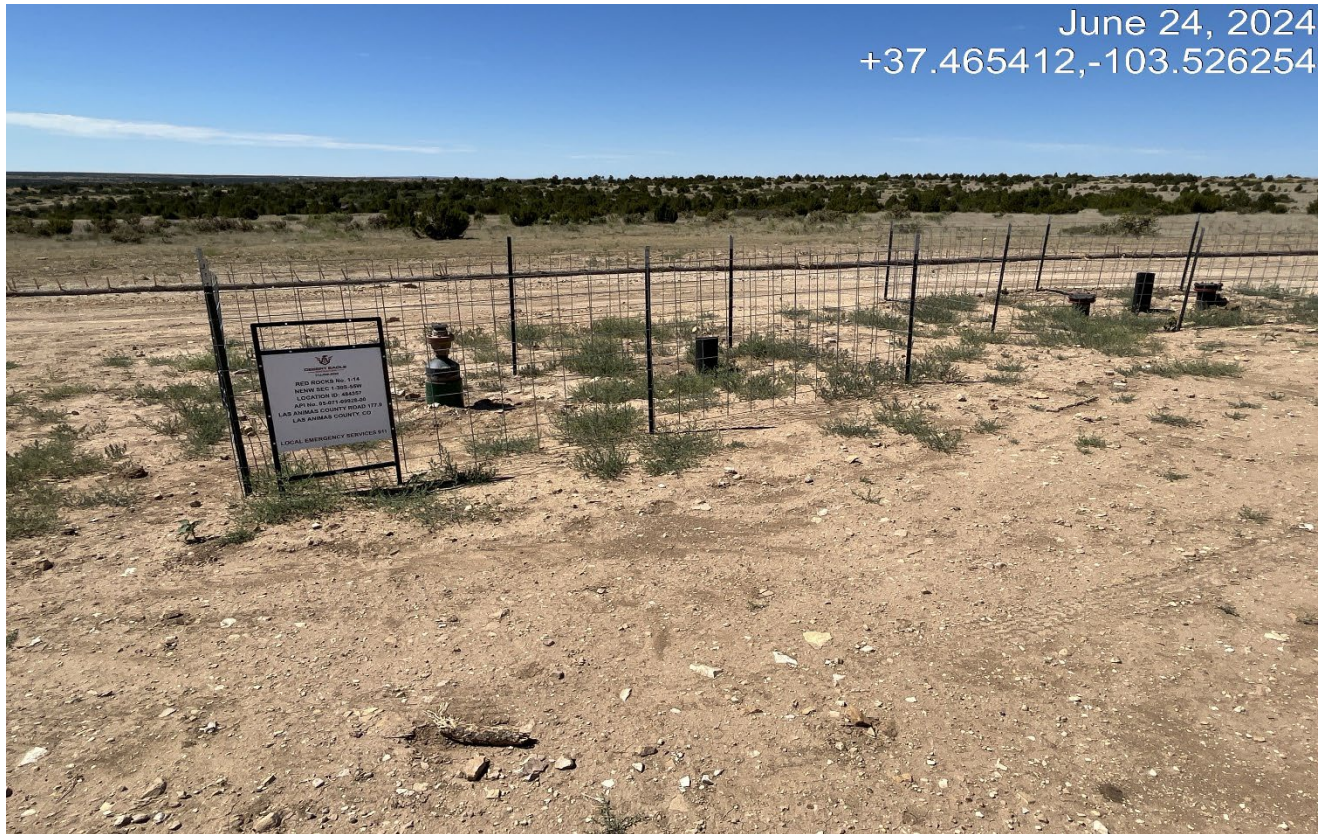
Photo 2. Facing east toward along the access road near the location. There are area where soils are very compacted. Seeding was performed in this area however vegetation will not grow well in compacted soils.

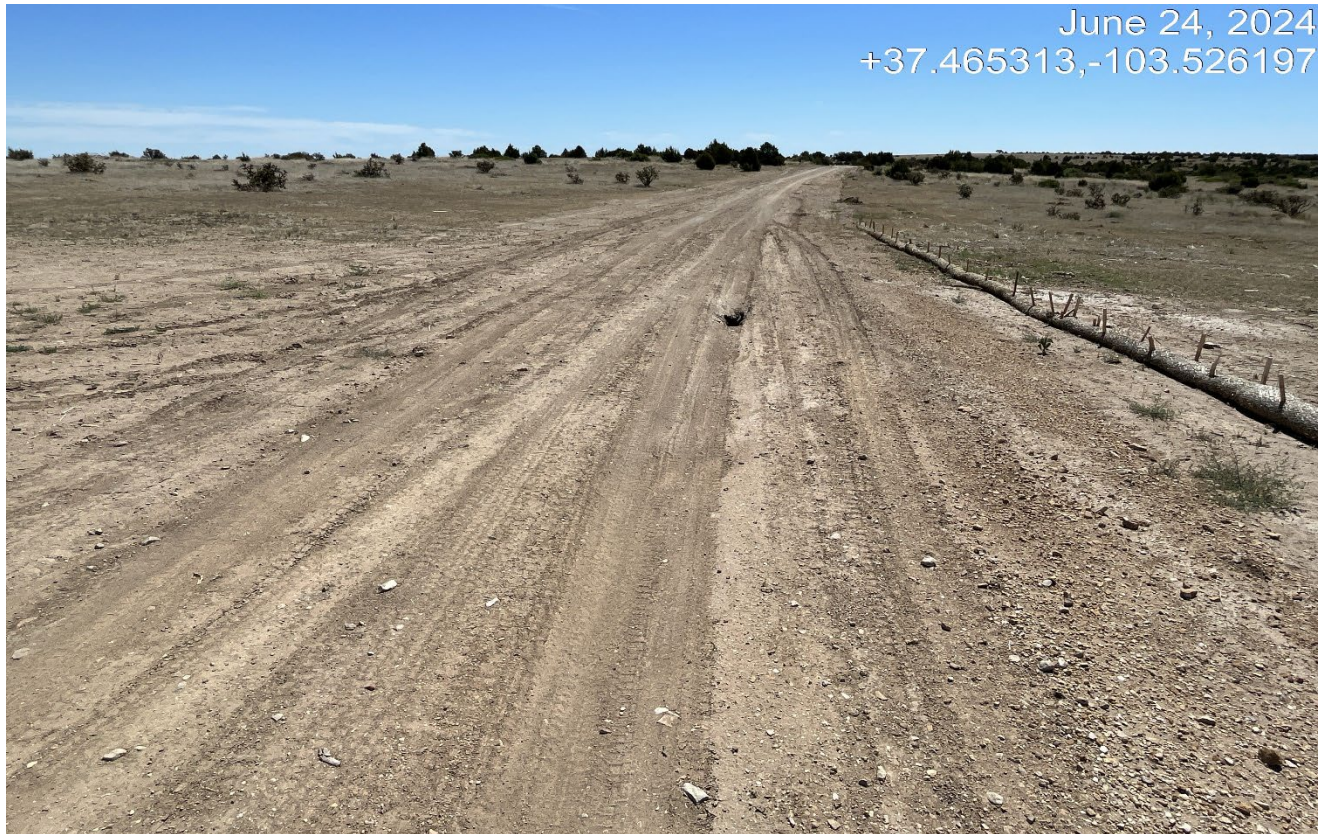
Photo 3. Facing east toward the flowline disturbance. The vegetation is not establishing along the flowline and there are vehicle tracks which are causing unnecessary disturbance. The flowline must be reclaimed and stabilized.

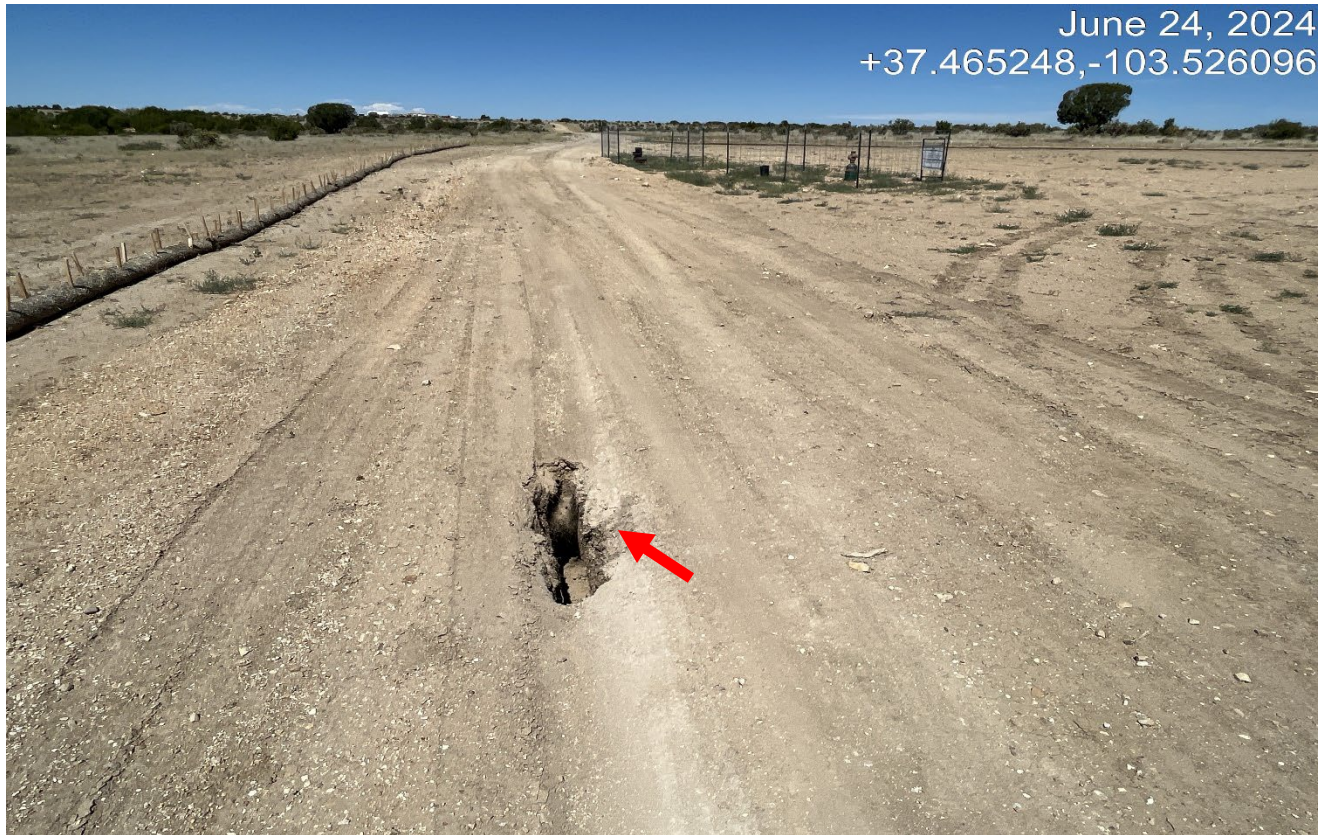
Photo 4. Facing west toward the flowline disturbance. There is an area of subsidence that needs to be filled in.

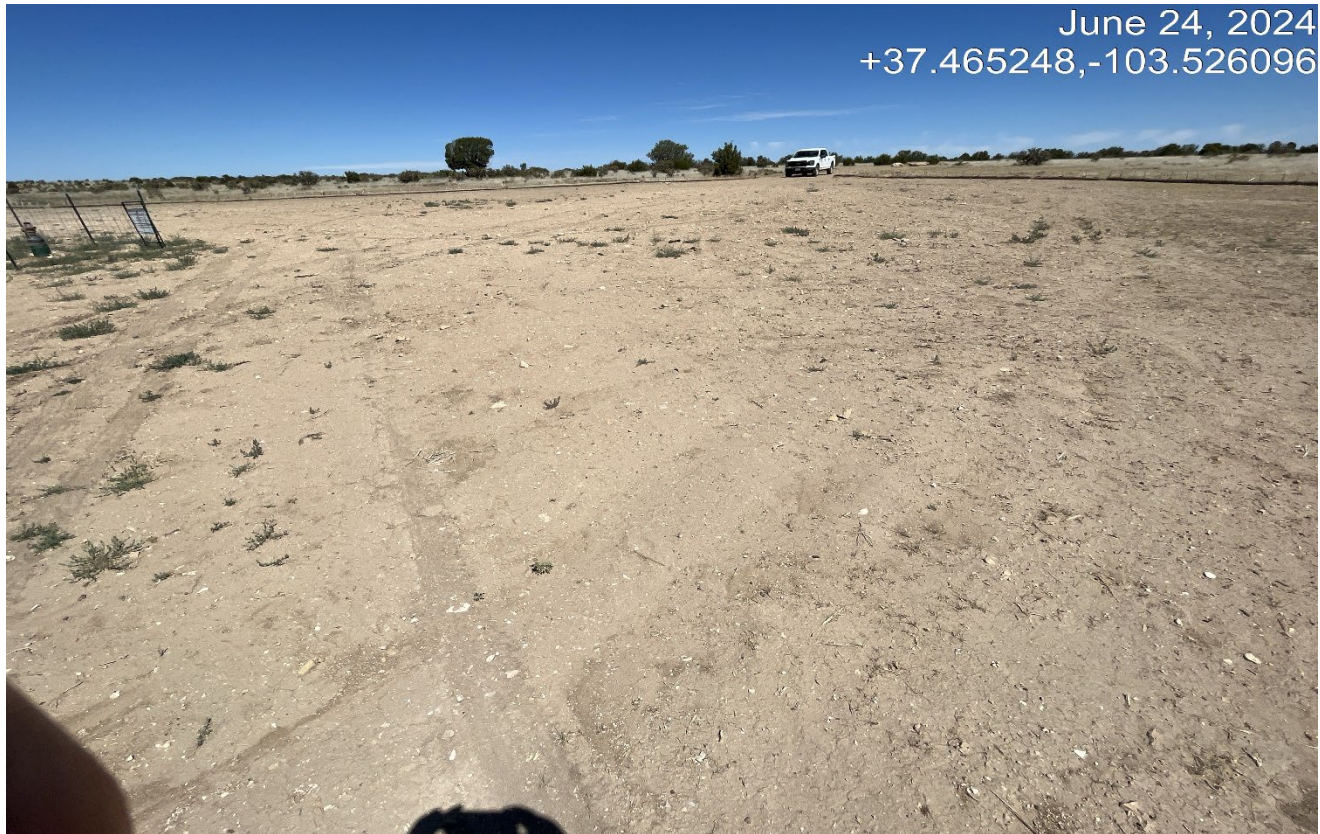
Photo 5. Facing north at the location. The vegetation has not yet established in the disturbed areas.

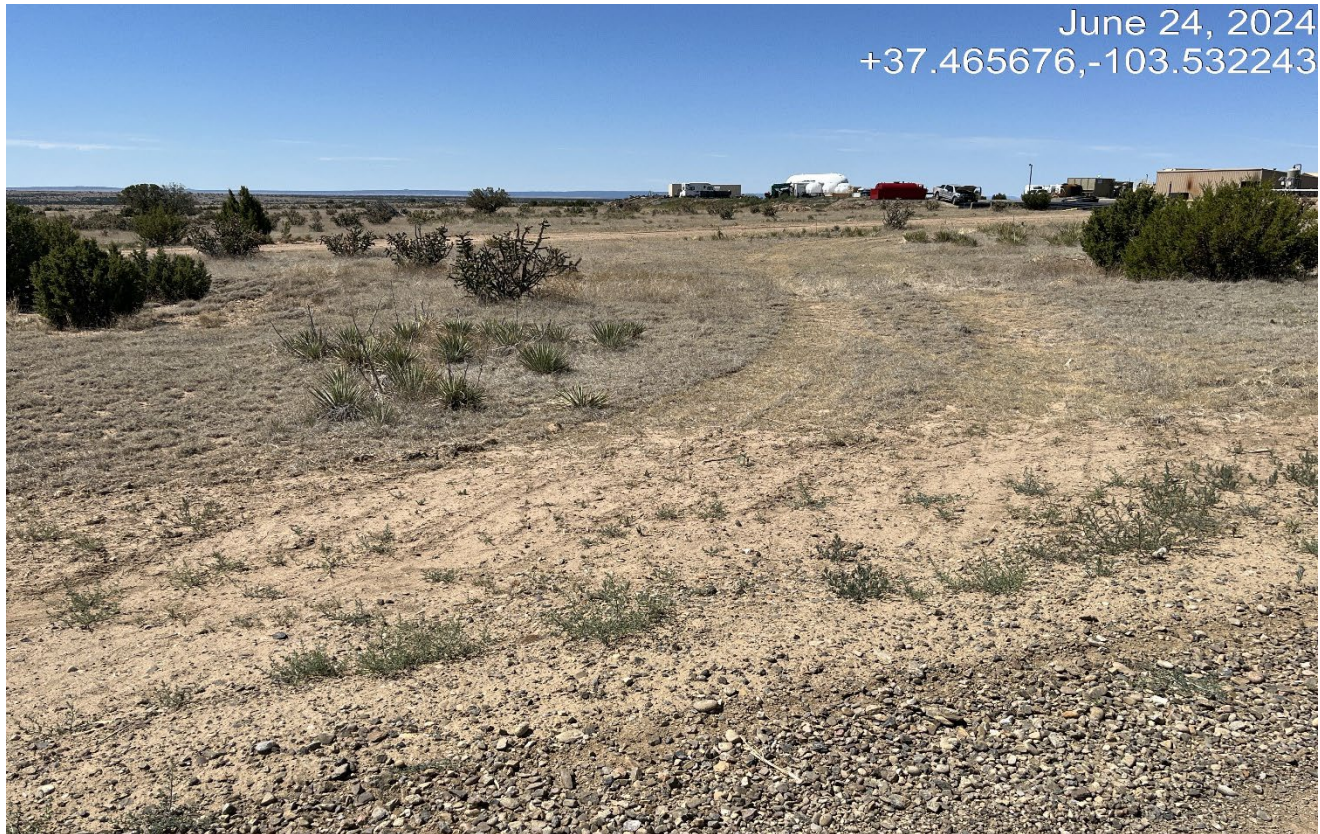
Photo 6. Facing southwest along the access road. There are vehicle tracks going off the road causing unnecessary disturbance.
