Well Name : Price 13-25

API # : 115-06056

COLORADO
Oil & Gas Conservation
Commission
Department of Natural Resources

Inspection Document Number: 698600703

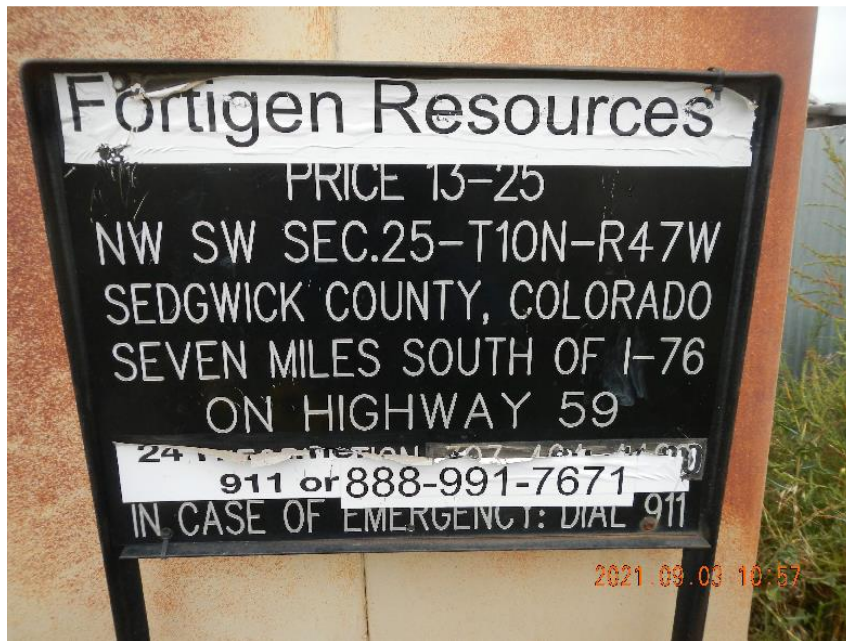
Photo 1: View of sign at the separator.

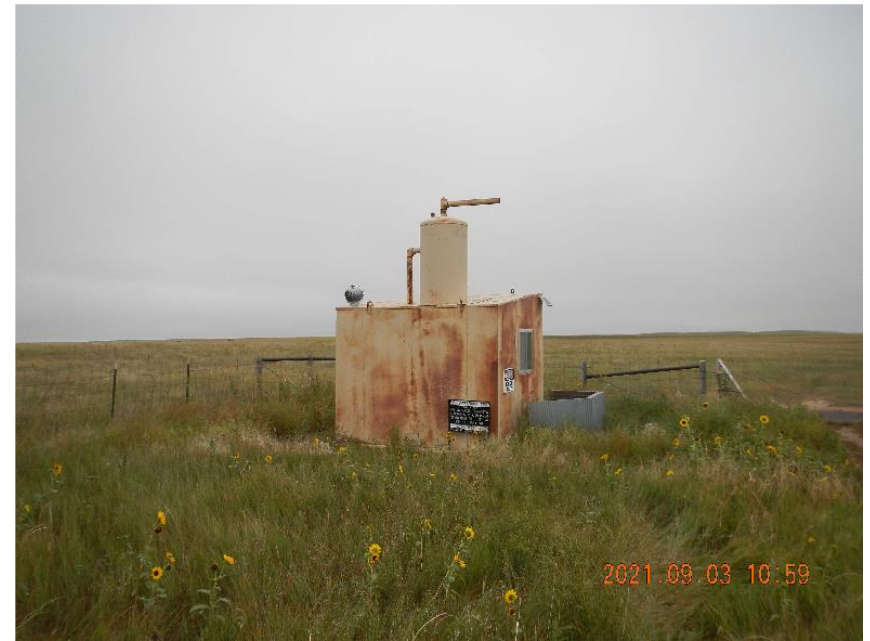
Photo 2: View of separator and vegetation around it.

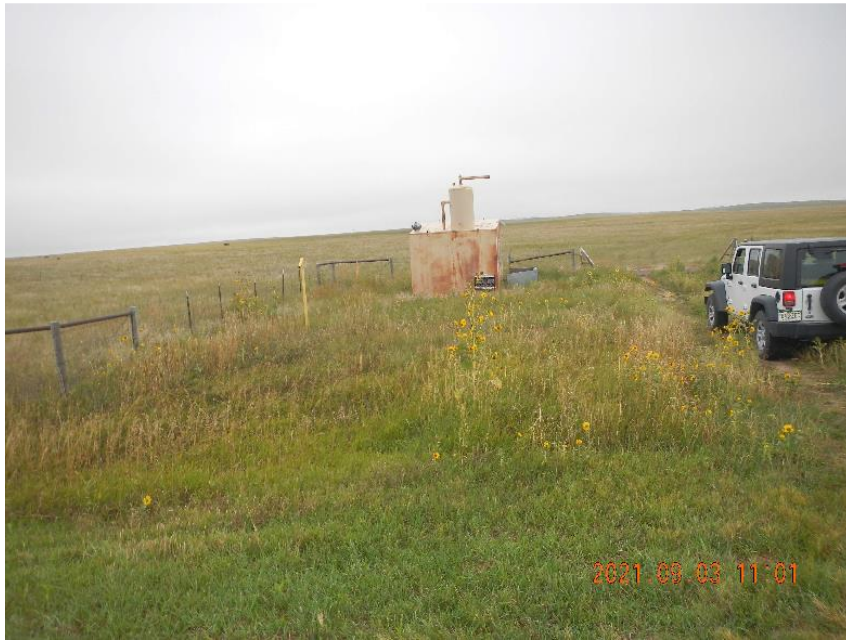
Photo 3: View of location entrance from CR with separator and vegetation around it.

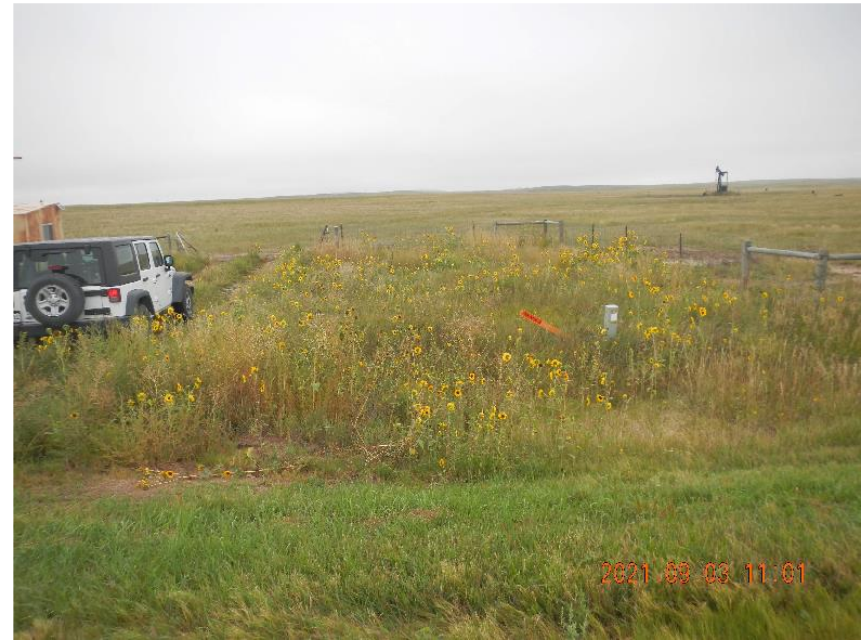
Photo 4: Additional view of location entrance from CR with separator, vegetation, and pumping unit in background.

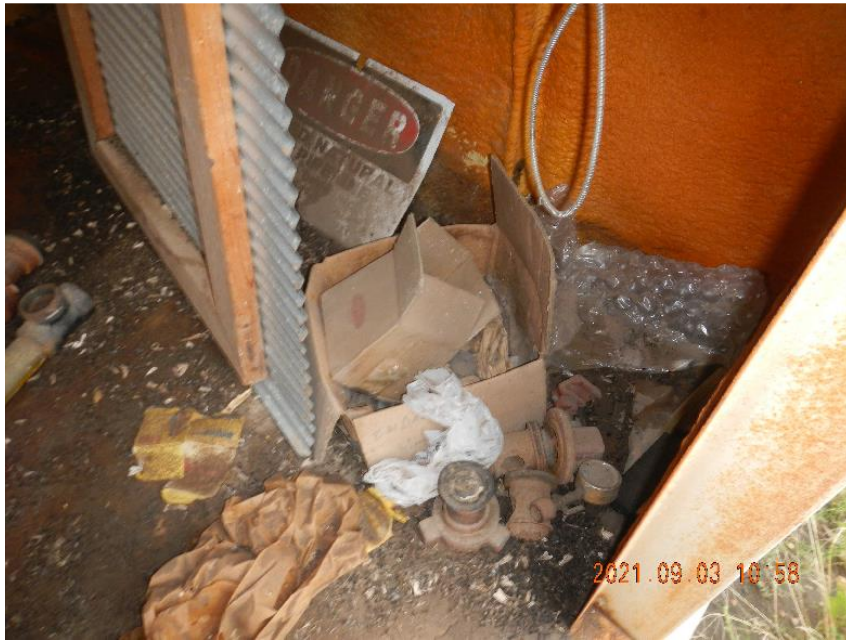
Photo 5: View of trash and rubbish inside separator house.

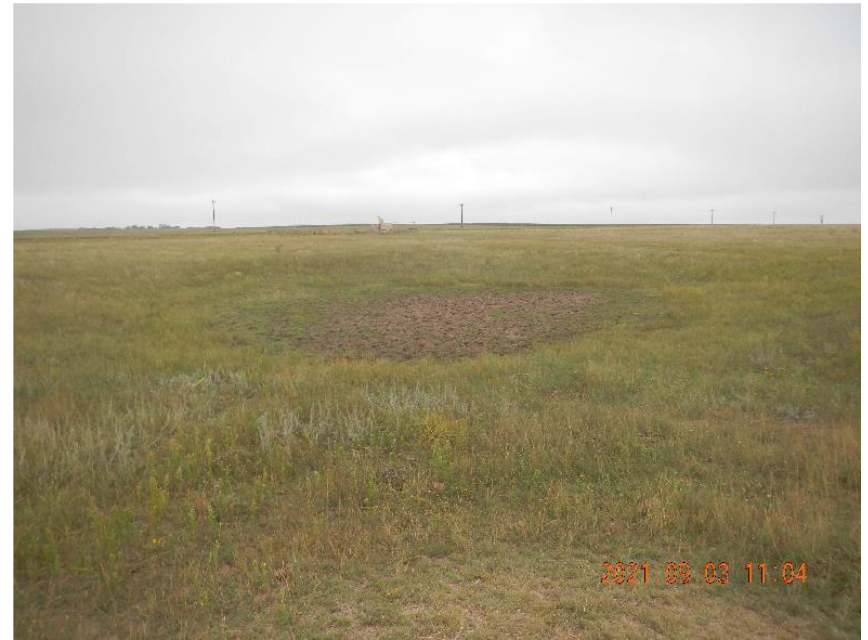
Photo 6: View of what appears to be old pit site in pasture between well site and separator facility.

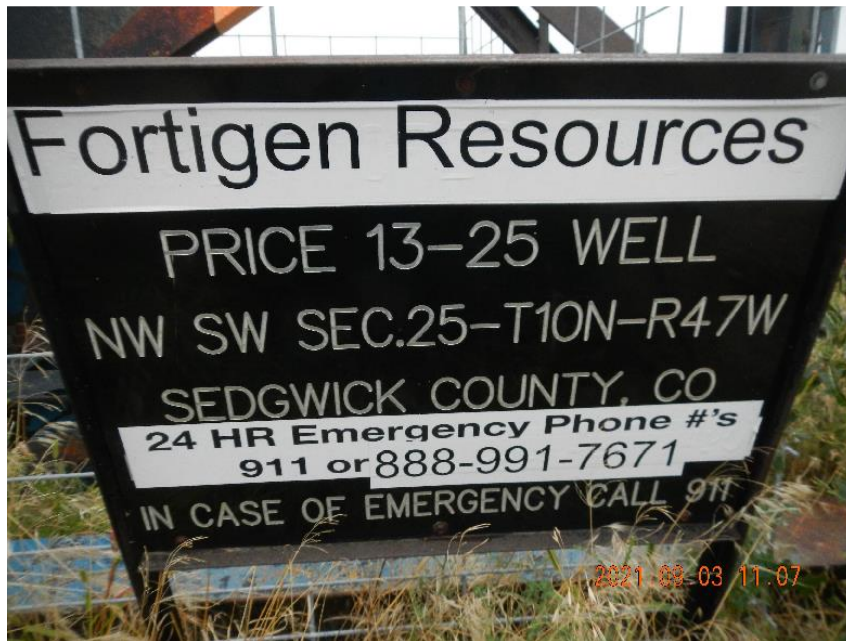
Photo 7: View of wellhead sign at well site.

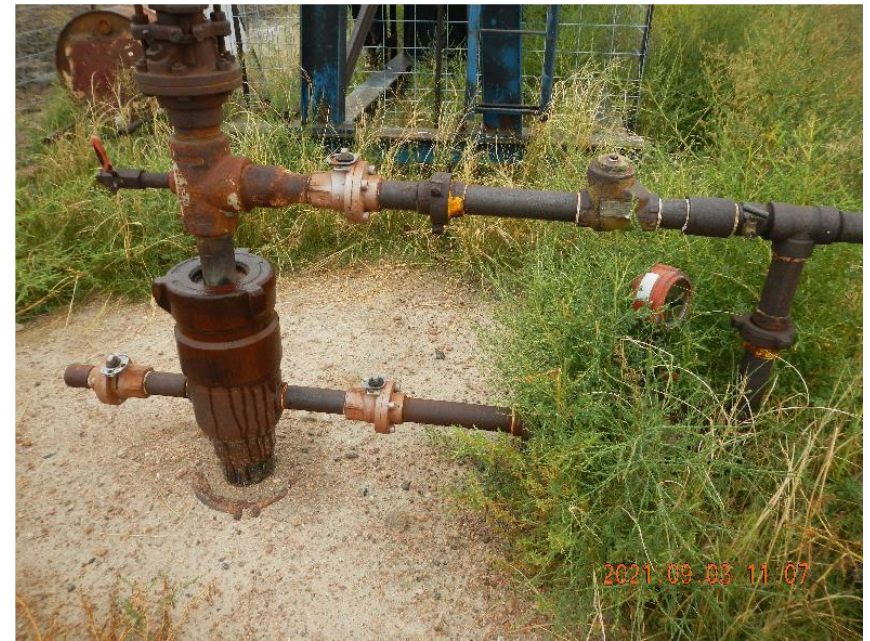
Photo 8: View of wellhead and tree. Well actively venting at packing/cap. Valves were found closed at time of inspection.

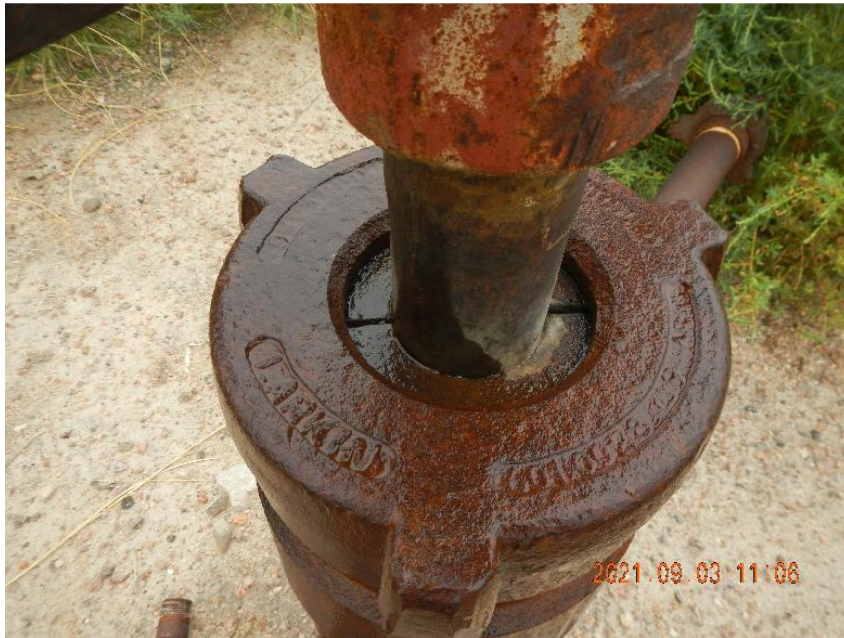
Photo 9: View of packing and cap.

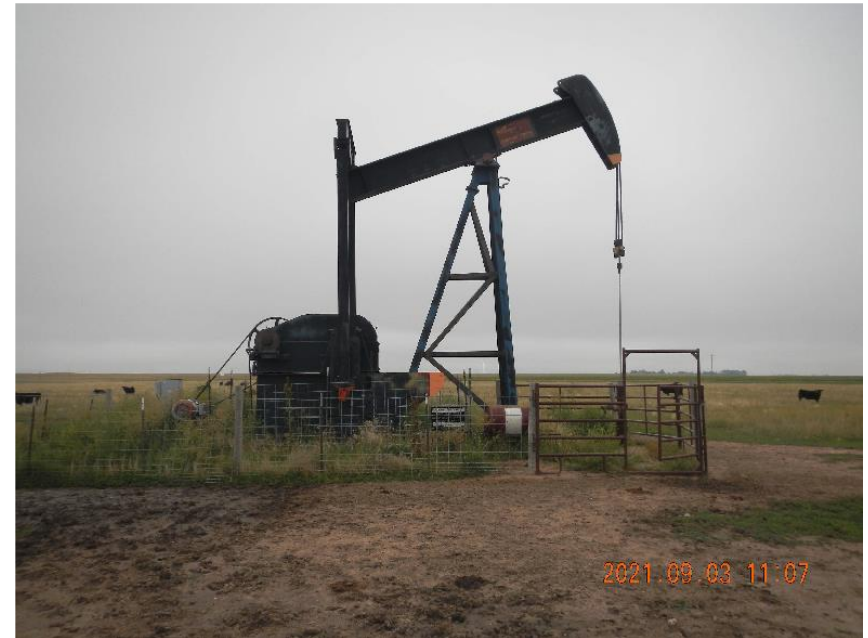
Photo 10: View of pumping unit and vegetation inside the fencing. Polish rod is attached to the bridge.

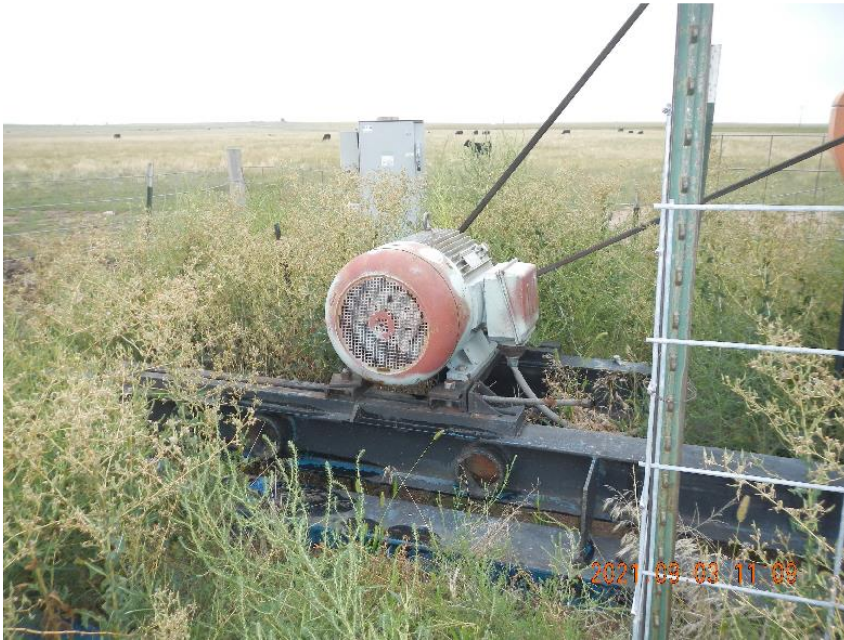
Photo 11: View of electric prime mover and vegetation inside fencing.

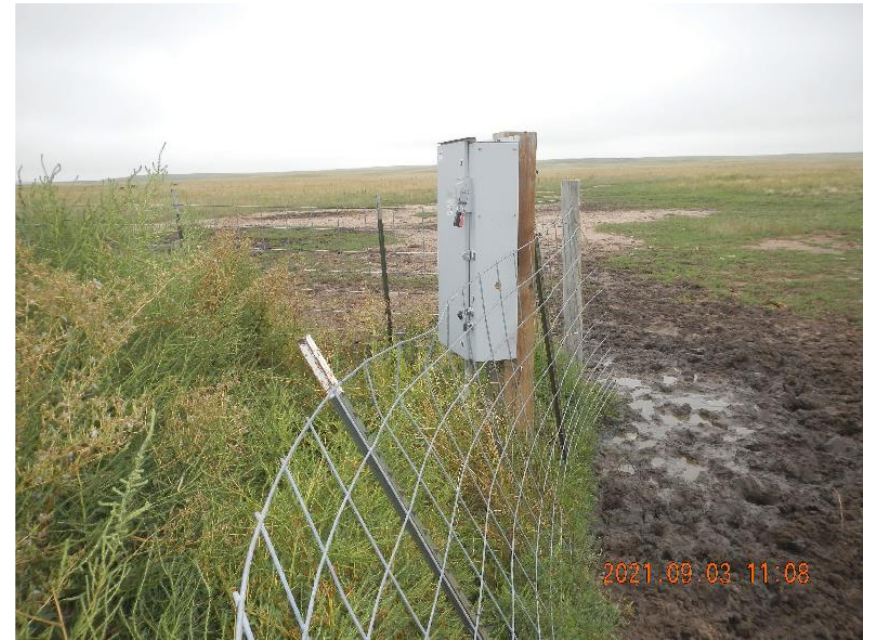
Photo 12: View of control box and vegetation inside fencing.

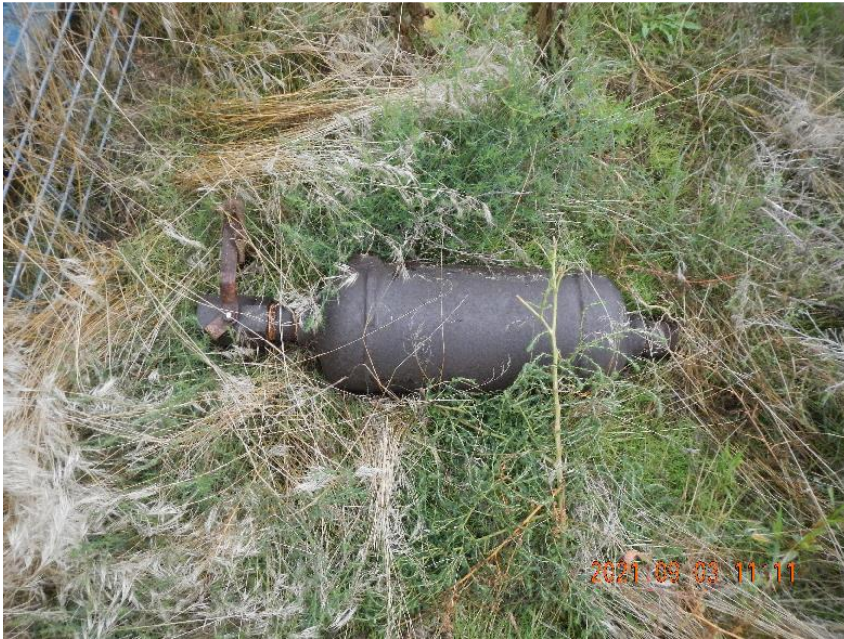
Photo 13: View of disconnected dryer vessel laying inside pumping unit fencing.

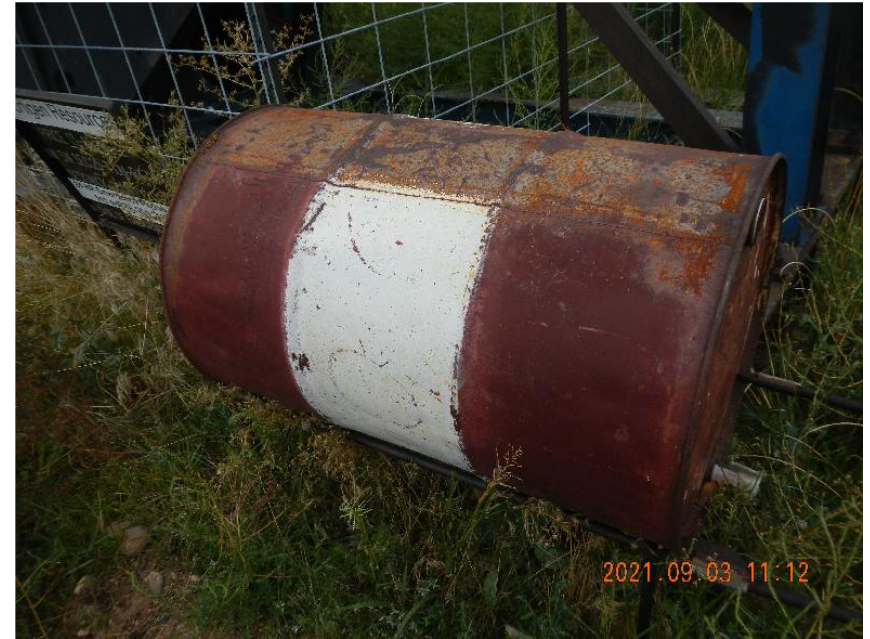
Photo 14: View of disconnected/empty 55 gallon drum on skid mount inside pumping unit fencing.

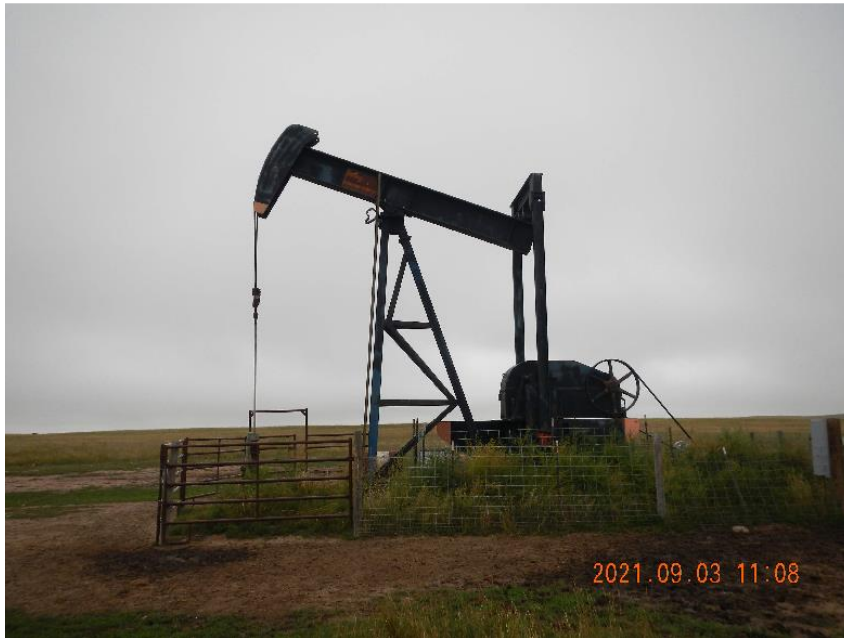
Photo 15: View of Pumping unit, polish rod, and bridle. Note vegetation inside fencing.

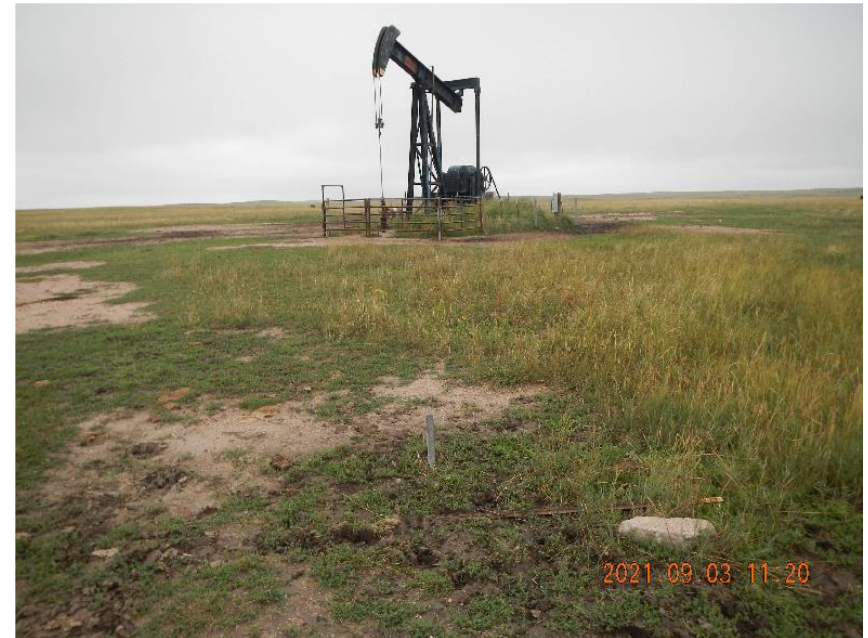
Photo 16: View of well site. One of four located anchors with markers down at time of inspection.
